# Federal Lands Highway Road Inventory Program

Road Inventory and Condition Assessment

## Homestead National Monument of America

### Cycle 5 Report

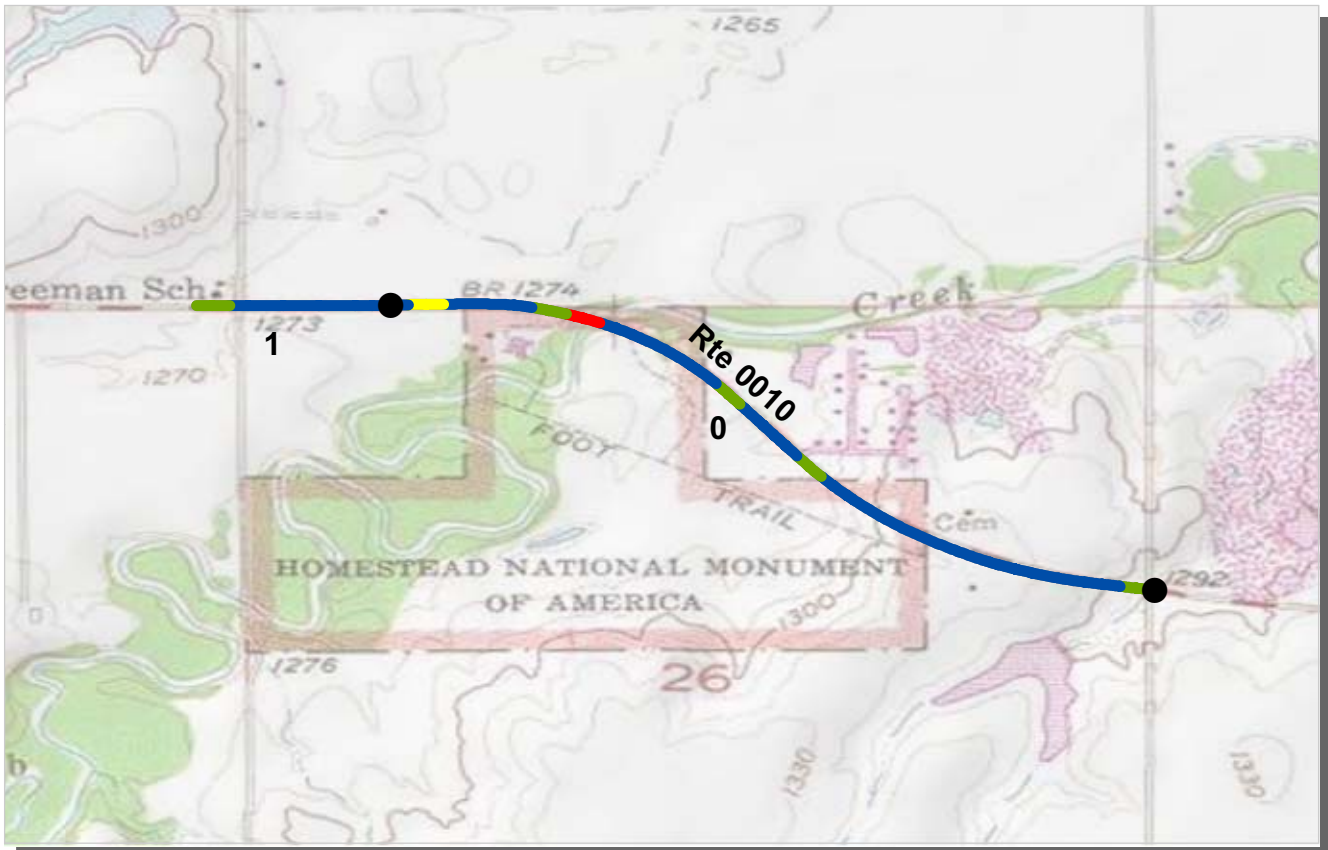
ROUTE: 0010 STATE ROUTE 4

PCR    Poor ■    Fair ■    Good ■    Excellent ■    No Data ■  
           (0 - 60)           (61 - 84)           (85 - 94)           (95 - 100)

| SCR (Surface Condition Rating) | 96 | 97 | | | |
| PCR (Pavement Condition Rating) | 98 | 98 | | | |
| Structural Crack Index | 97 | 99 | | | |
| Transverse Cracking Index | 98 | 99 | | | |
| Roughness Condition Index (RCI) | 100 | 100 | | | |

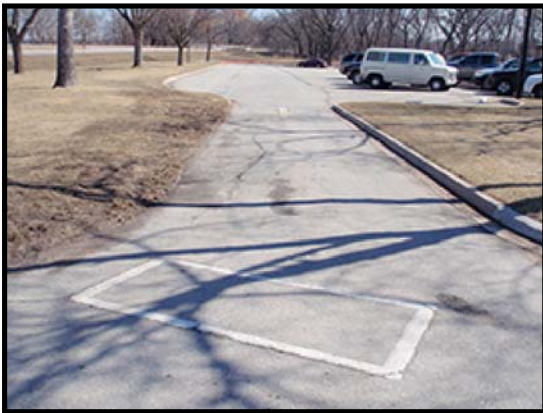
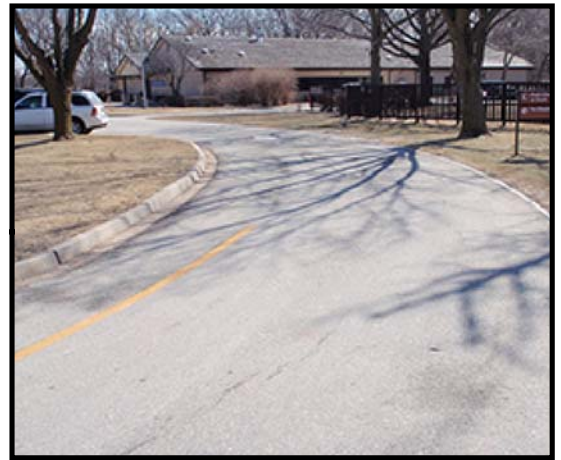
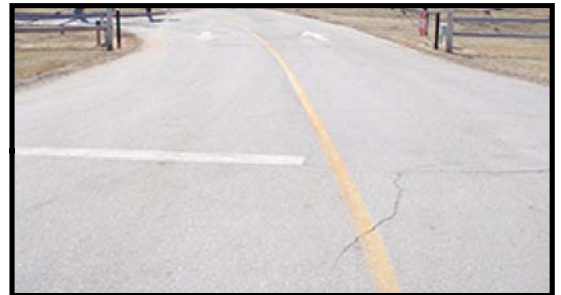
## Route 0900

| Route Number | Public / NonPublic | Date Visited | Area (sq ft) | Lane Miles * | Surface Type |
|---|---|---|---|---|---|
| 1 | 3 | 1 | CONCRETE CURB AND GUTTER | NO CURB | FAIR/73 |

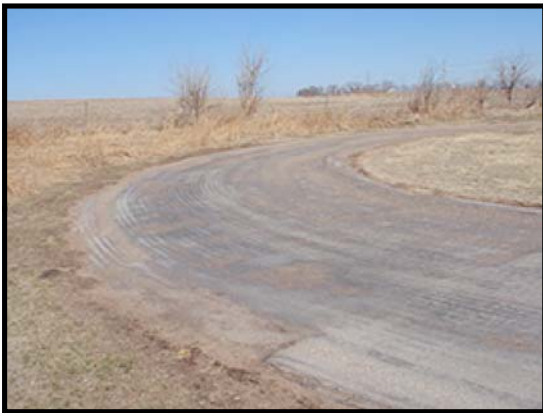
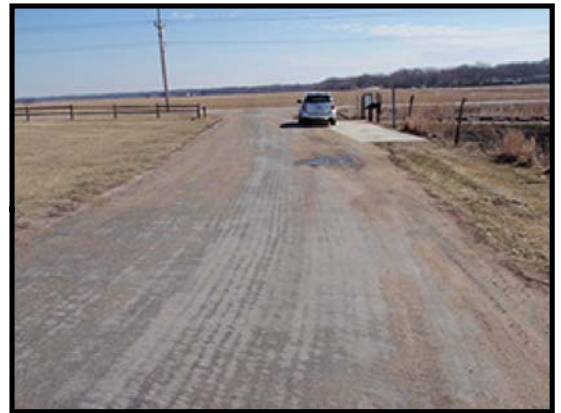
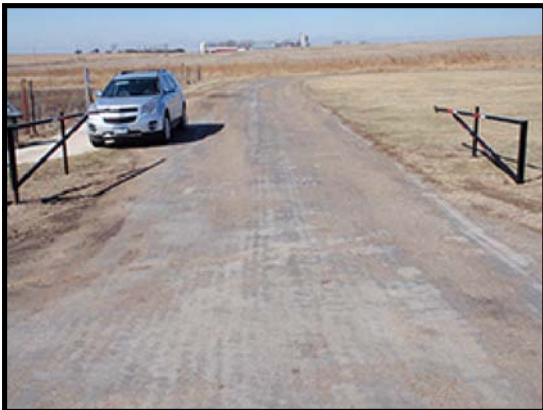
## Route 0901B

| Route Number | Public / NonPublic | Date Visited | Area (sq ft) | Lane Miles * | Surface Type |
|---|---|---|---|---|---|
| 1 | 0 | 2 | NO CURB AND GUTTER | NO CURB | FAIR/73 |

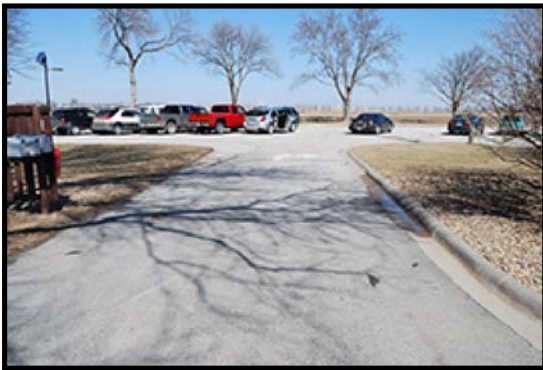
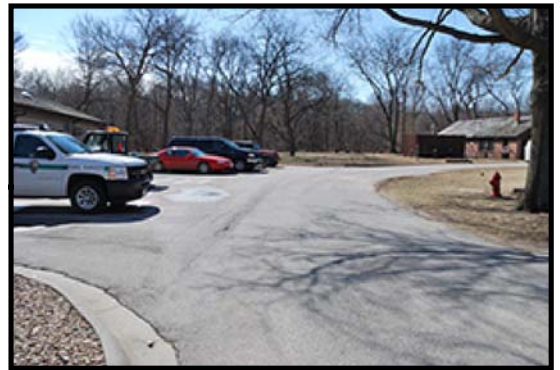
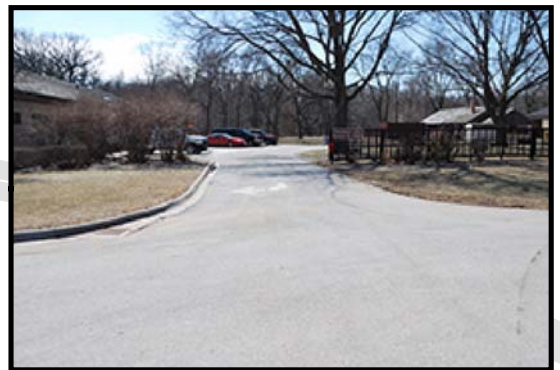
## Route 0902

| Route Number | Public / NonPublic | Date Visited | Area (sq ft) | Lane Miles * | Surface Type |
|---|---|---|---|---|---|
| 0 | 3 | 0 | CONCRETE CURB AND GUTTER | NO CURB | GOOD/90 |

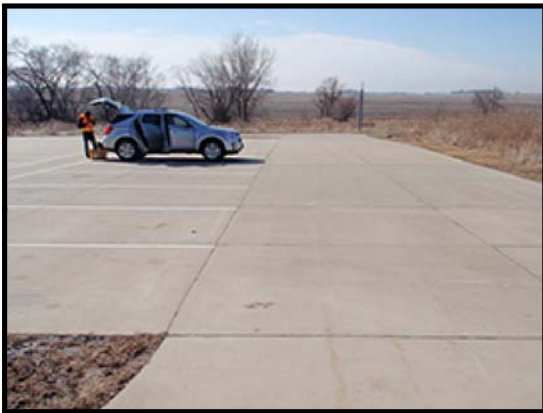
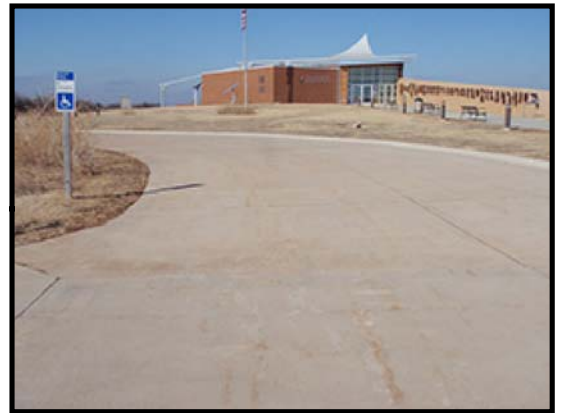
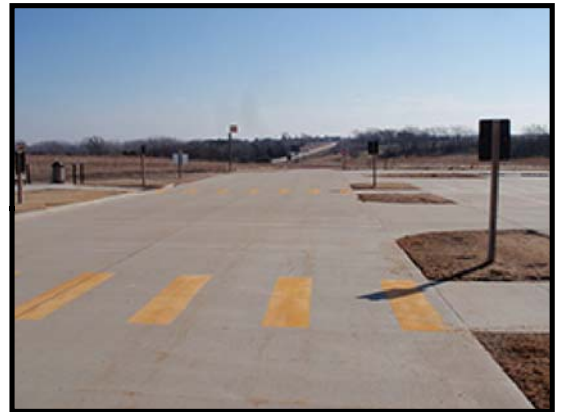
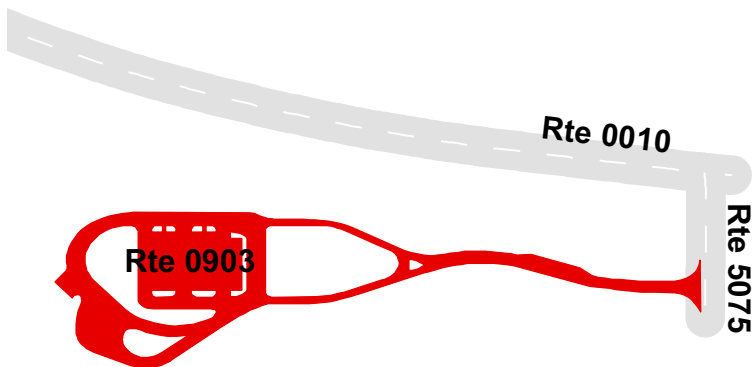
## Route 0903

| Route Number | Public / NonPublic | Date Visited | Area (sq ft) | Lane Miles * | Surface Type |
|---|---|---|---|---|---|
| 1 | 0 | 1 | NO CURB AND GUTTER | CONCRETE CURB | GOOD/90 |
