Federal Lands Highway Road Inventory Program

Road Inventory and Condition Assessment

Hot Springs National Park
HOSP - 7300

Cycle 5 Report

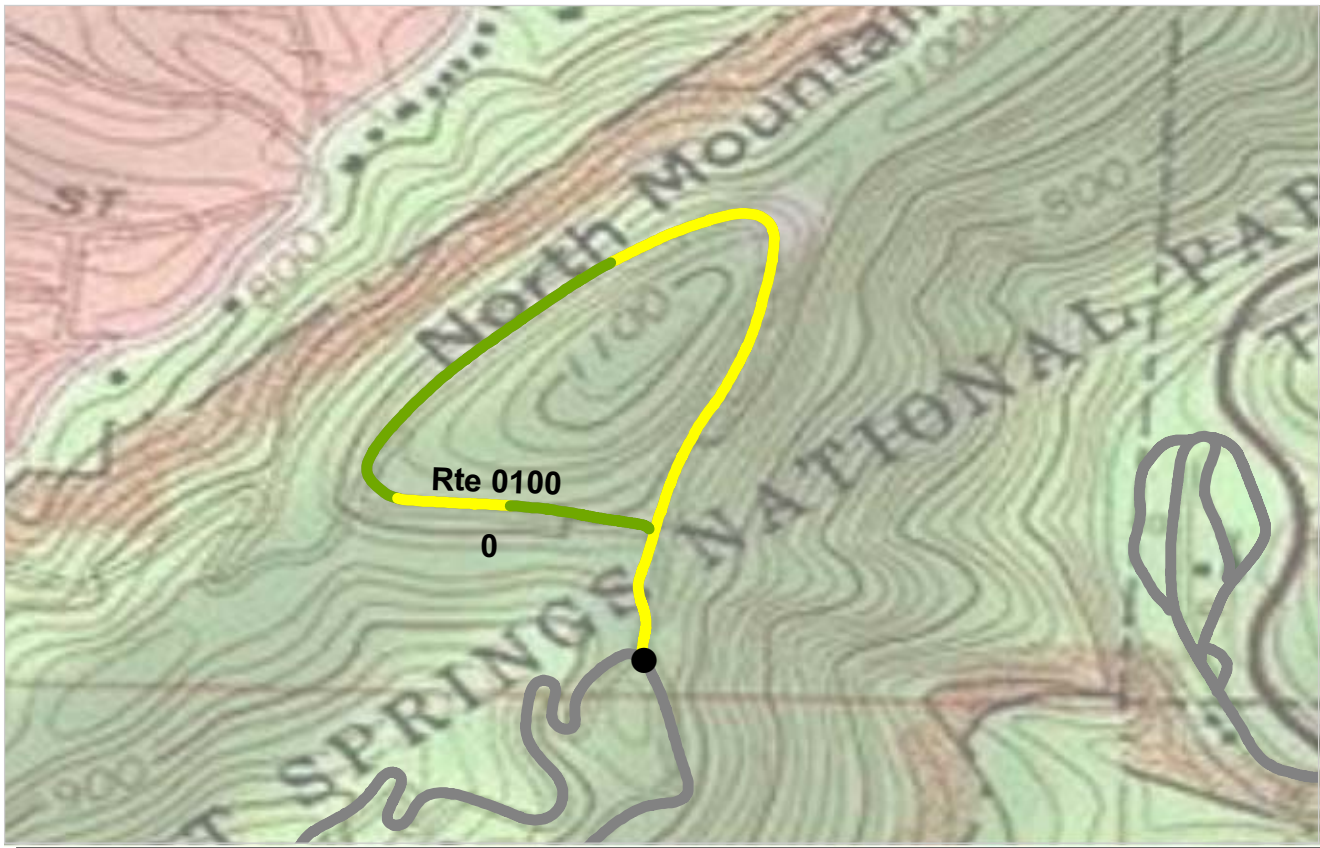
ROUTE: 0100 NORTH MOUNTAIN LOOP ROAD

Section Number	0				
Section Length (mi)	0.76				
Cross Section Information					
Number of Lanes	1				
Paved Width (ft)	16				
Lane Width (ft)	13				
Roadway Condition Information					
SCR (Surface Condition Rating)	98				
PCR (Pavement Condition Rating)	80				
Distress Index Values					
Structural Crack Index	100				
Transverse Cracking Index	100				
Patching Index	100				
Rutting Index	98				
Roughness Condition Index (RCI)	53

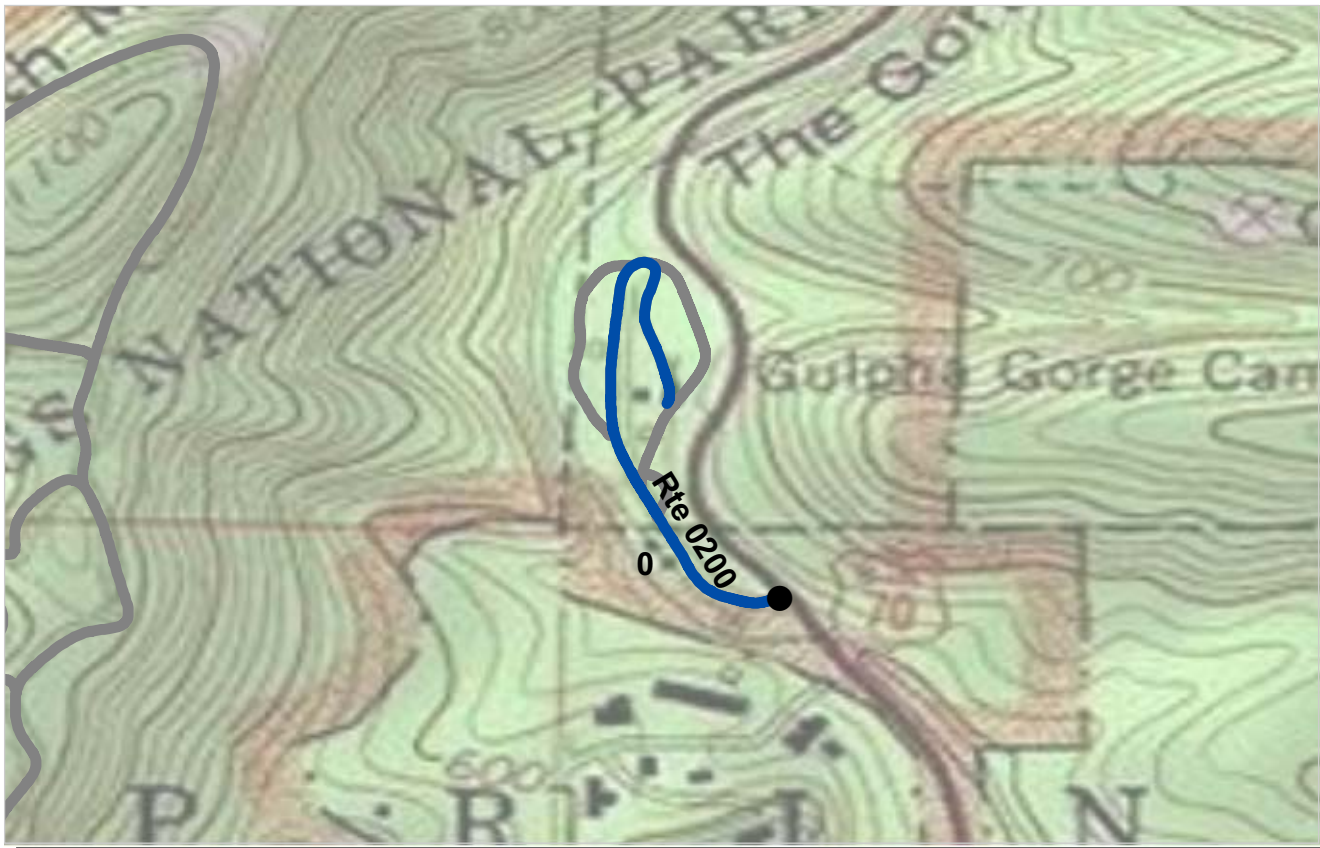
ROUTE: 0200 GULPHA GORGE CAMPGROUND ROAD

Section Number	0				
Section Length (mi)	0.38				
Cross Section Information					
Number of Lanes	2				
Paved Width (ft)	21				
Lane Width (ft)	11				
Roadway Condition Information					
SCR (Surface Condition Rating)	100				
PCR (Pavement Condition Rating)	100				
Distress Index Values					
Structural Crack Index	100				
Transverse Cracking Index	100				
Patching Index	100				
Rutting Index	100				
Roughness Condition Index (RCI)	NC

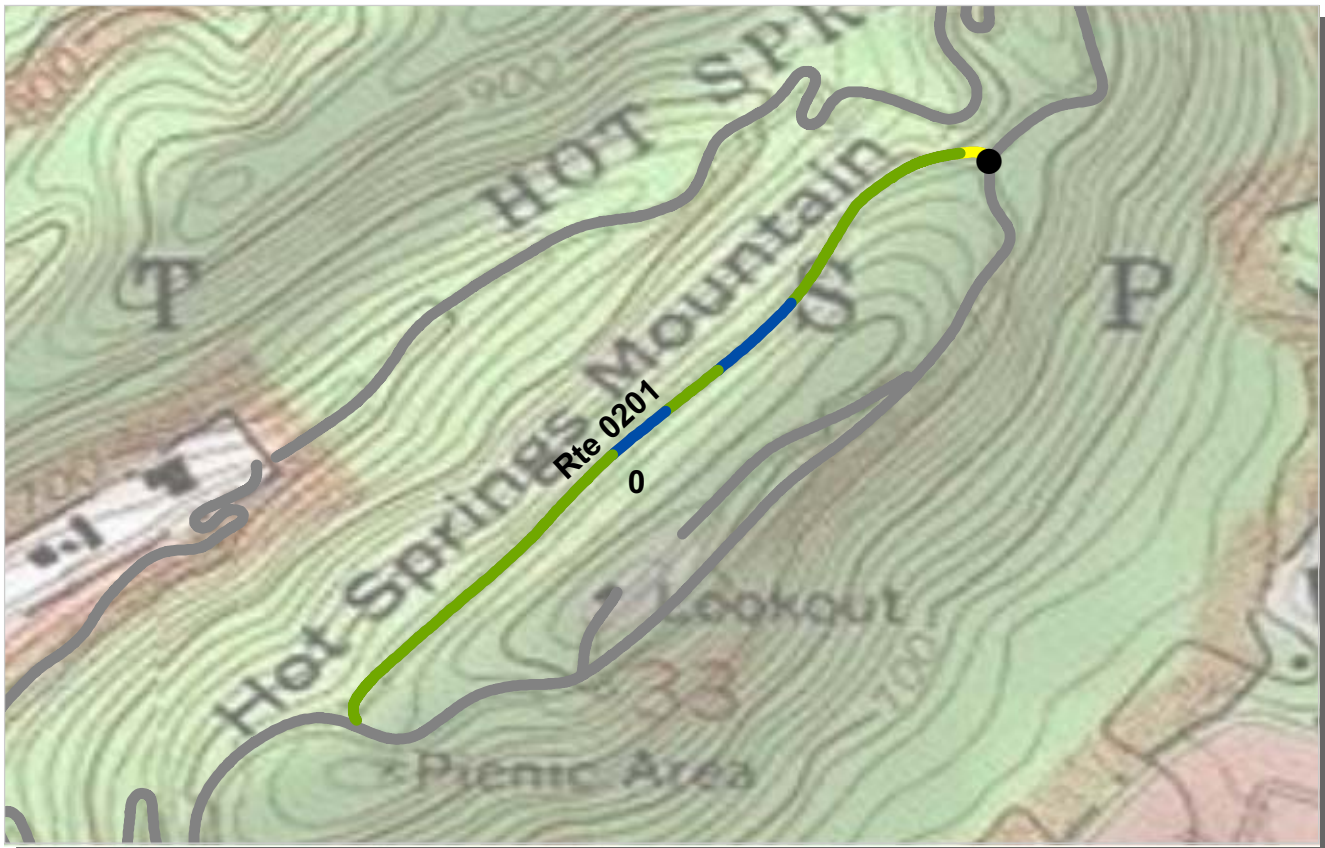
ROUTE: 0201 TOWER RETURN ROAD

Section Number	0				
Section Length (mi)	0.53				
Cross Section Information					
Number of Lanes	1				
Paved Width (ft)	15				
Lane Width (ft)	13				
Roadway Condition Information					
SCR (Surface Condition Rating)	99				
PCR (Pavement Condition Rating)	87				
Distress Index Values					
Structural Crack Index	100				
Transverse Cracking Index	100				
Patching Index	100				
Rutting Index	99				
Roughness Condition Index (RCI)	69

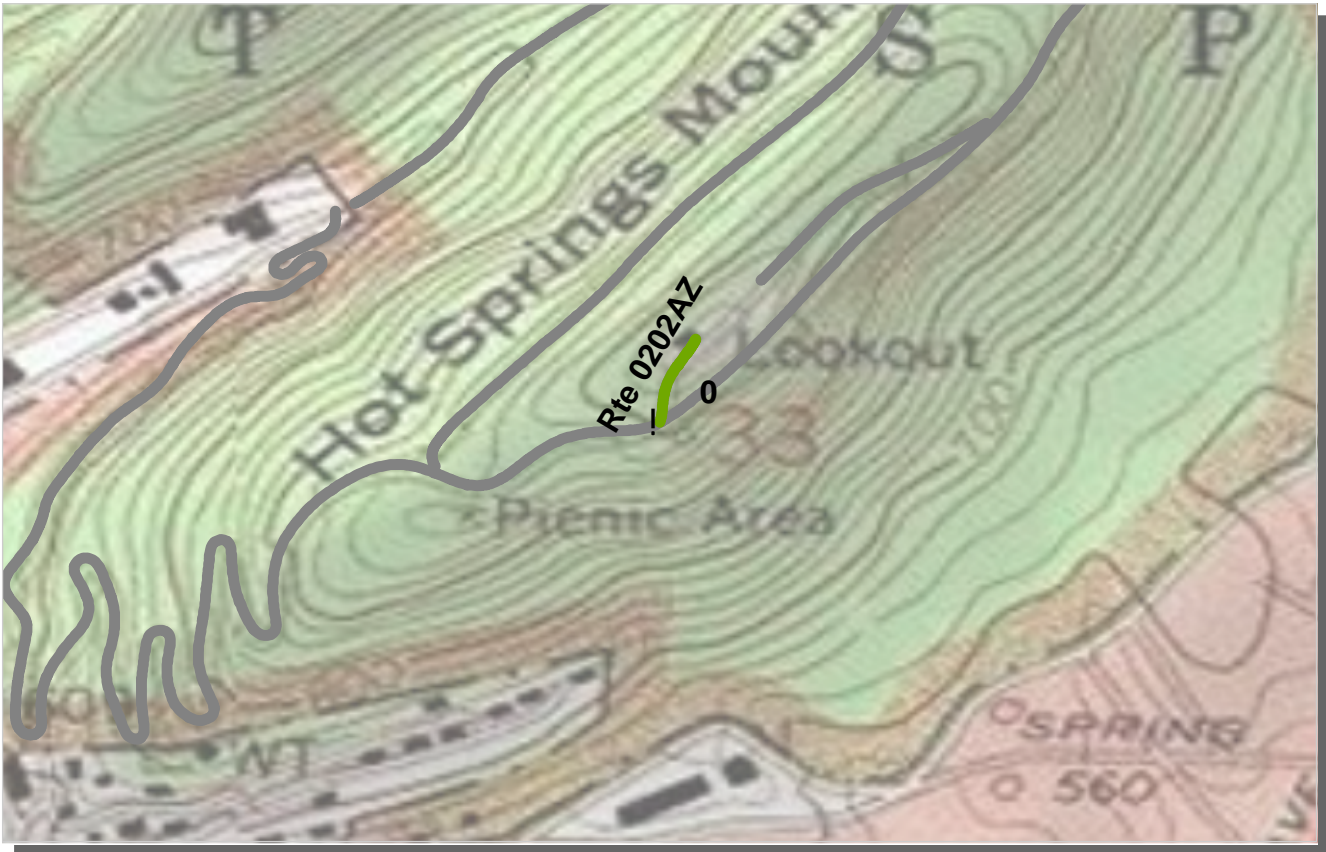
ROUTE: 0202ZZ TOWER PARKING ROADS

PCR Poor ■ Fair ■ Good ■ Excellent ■ No Data ■
 (0 - 60) (61 - 84) (85 - 94) (95 - 100)

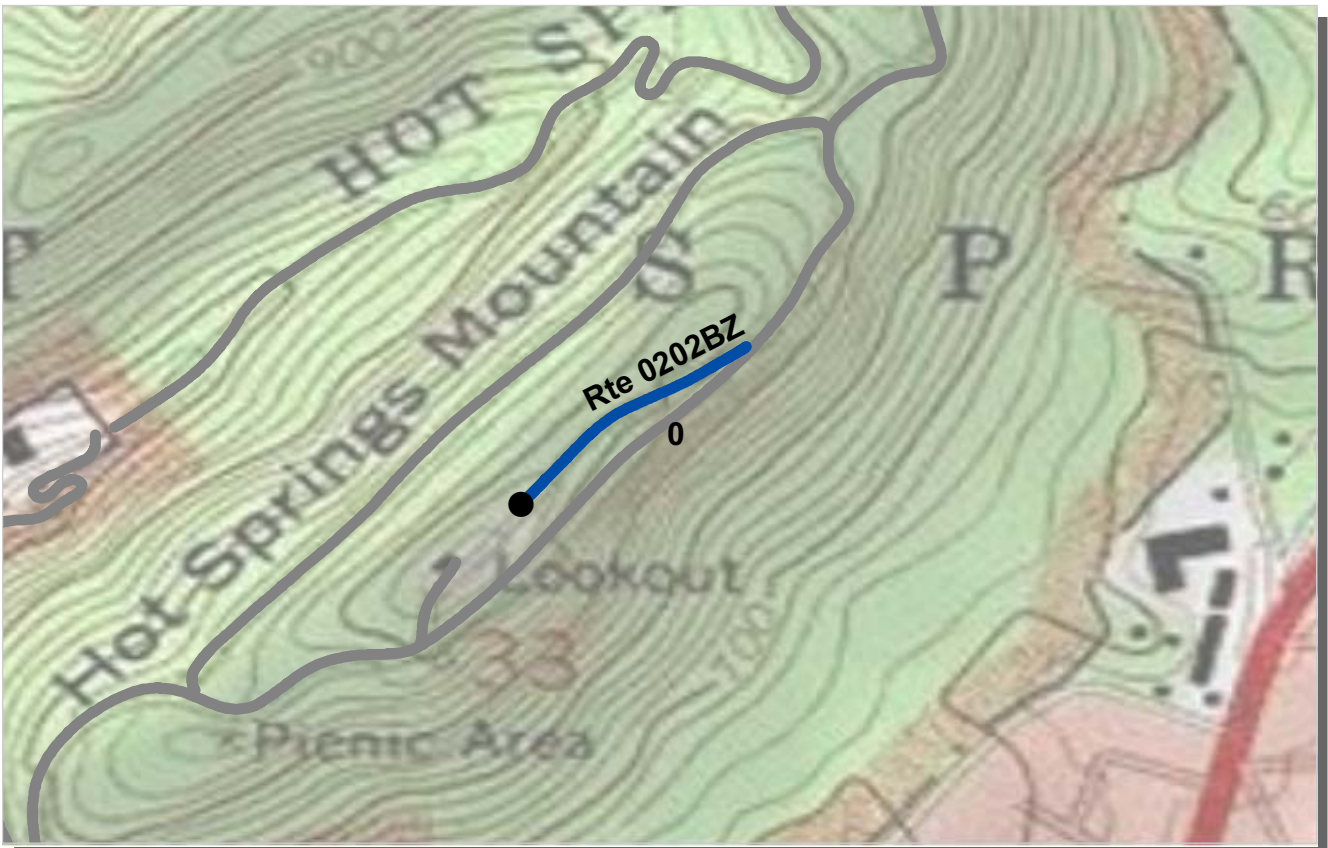
ROUTE: 0202AZ TOWER PARKING ENTRANCE ROAD

PCR	Poor (0 - 60)	Fair (61 - 84)	Good (85 - 94)	Excellent (95 - 100)	No Data

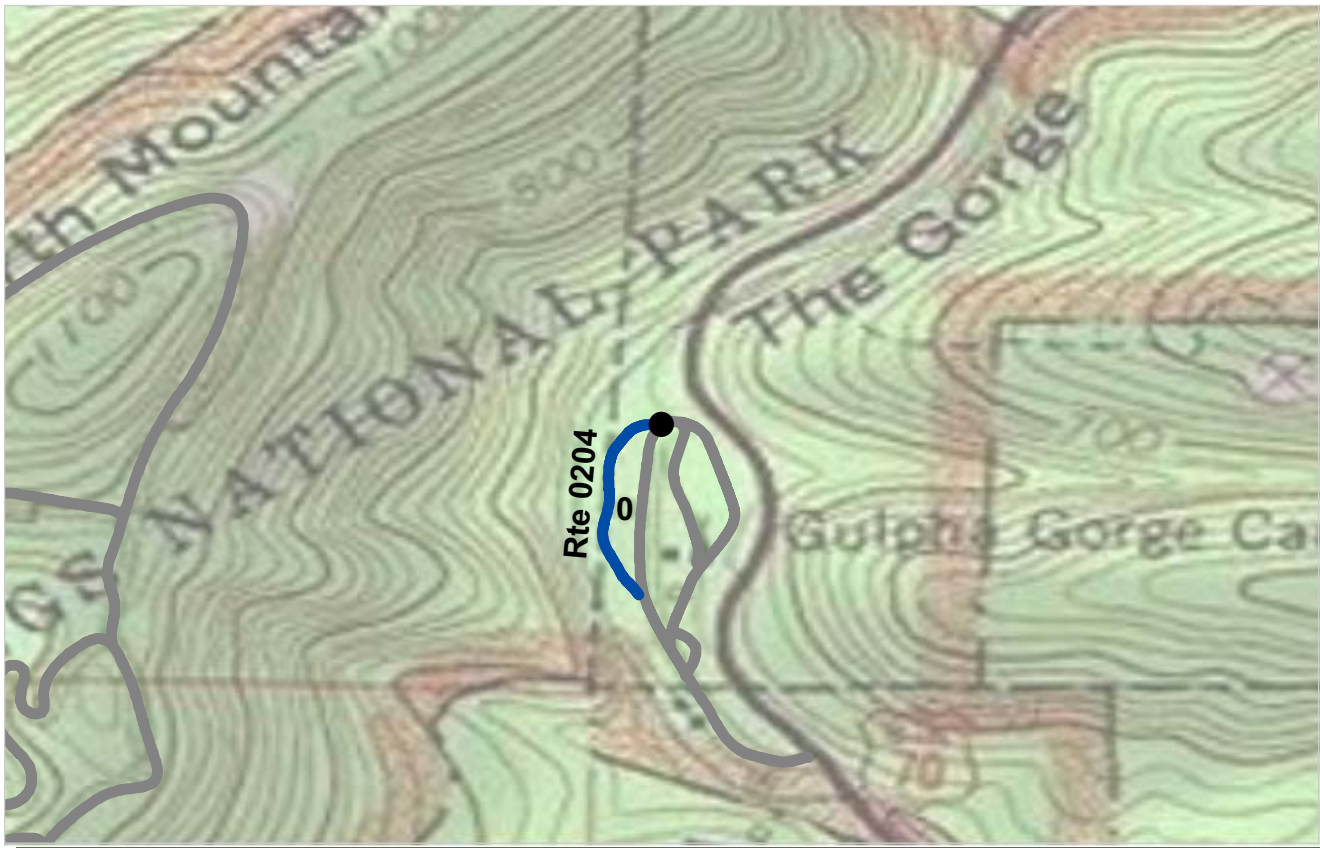
ROUTE: 0203 GULPHA GORGE CAMPGROUND UPPER LOOP

PCR Poor ■ Fair ■ Good ■ Excellent ■ No Data ■
 (0 - 60) (61 - 84) (85 - 94) (95 - 100)

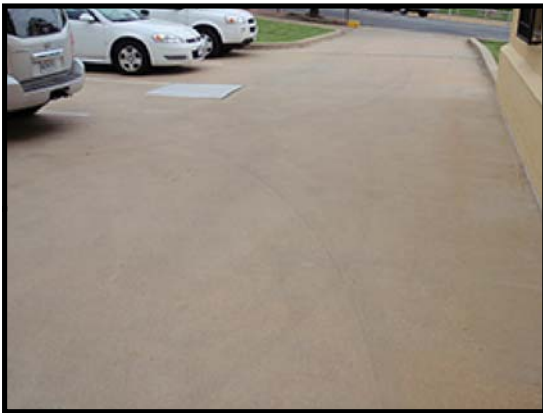
Rte 0900

Route Number	Public / NonPublic	Date Visited	Area (sq ft)	Lane Miles *	Surface Type
0900	NONPUBLIC	4/14/2011	2,348	0.04	CO
Culverts	Drop Inlets	Gates	Curb & Gutter	Curb	PCR
0	1	0	NO CURB AND GUTTER	CONCRETE CURB	GOOD/90

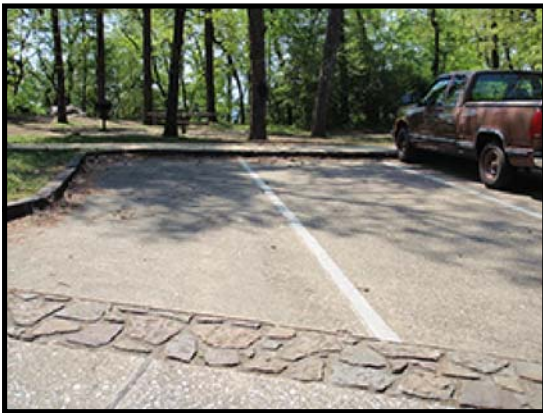
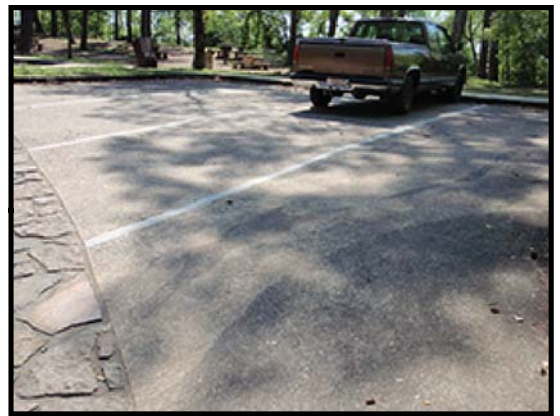
Route Number	Public / NonPublic	Date Visited	Area (sq ft)	Lane Miles *	Surface Type
0901A	PUBLIC	4/14/2011	1,131	0.02	CO
Culverts	Drop Inlets	Gates	Curb & Gutter	Curb	PCR
1	0	0	NO CURB AND GUTTER	STONE CURB	GOOD/90

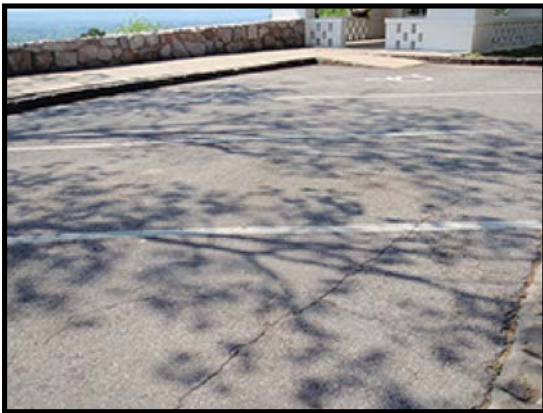
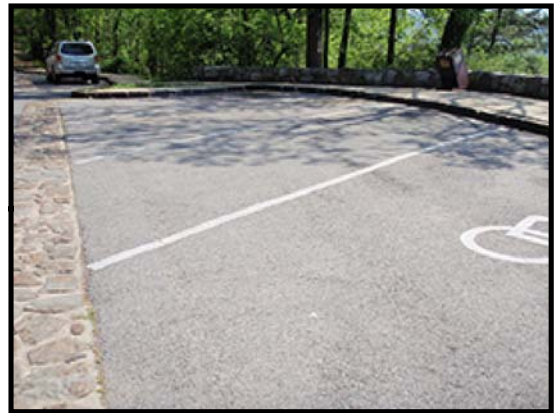
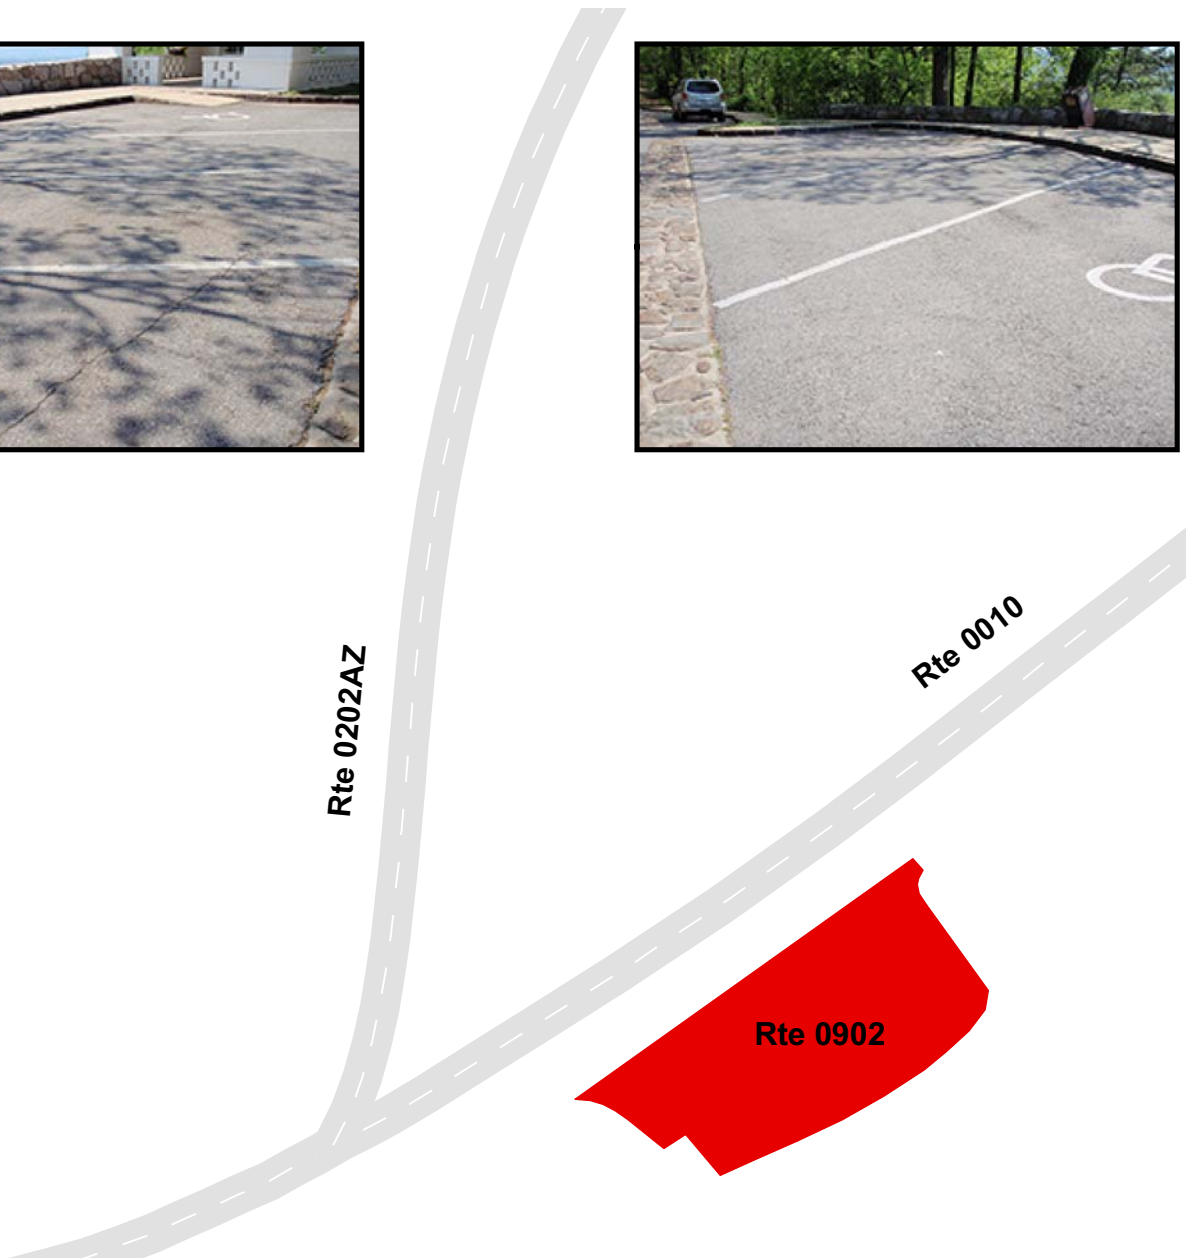
Route 0902

Route Number	Public / NonPublic	Date Visited	Area (sq ft)	Lane Miles *	Surface Type
0902	PUBLIC	4/14/2011	953	0.02	AS
Culverts	Drop Inlets	Gates	Curb & Gutter	Curb	PCR
0	0	0	NO CURB AND GUTTER	STONE CURB	FAIR/73

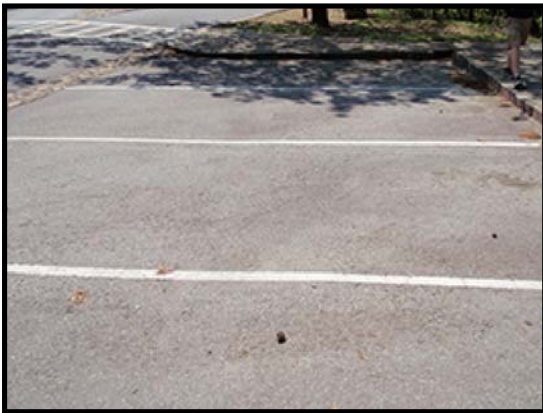
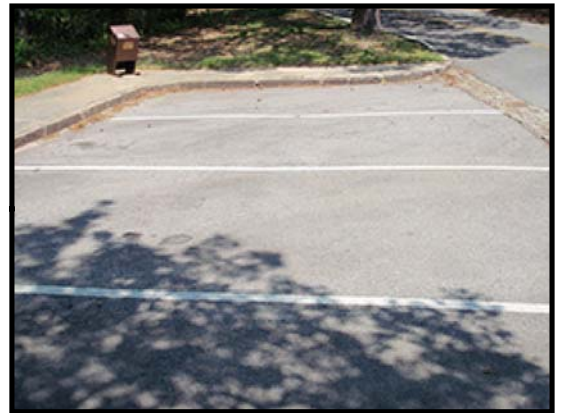
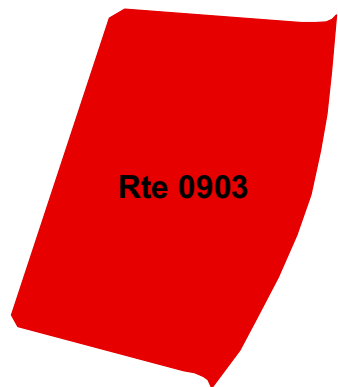
Route 0903

Route Number	Public / NonPublic	Date Visited	Area (sq ft)	Lane Miles *	Surface Type
0903	PUBLIC	4/14/2011	820	0.01	AS
Culverts	Drop Inlets	Gates	Curb & Gutter	Curb	PCR
0	0	0	NO CURB AND GUTTER	STONE CURB	FAIR/73

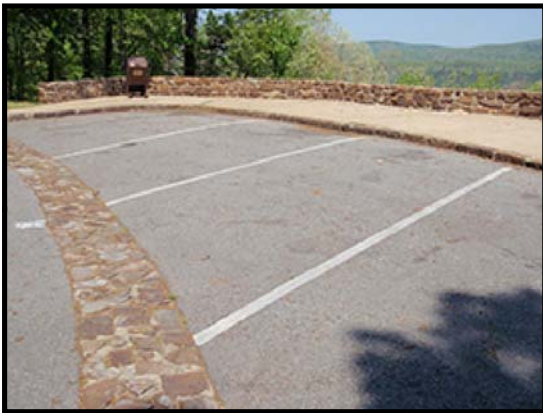
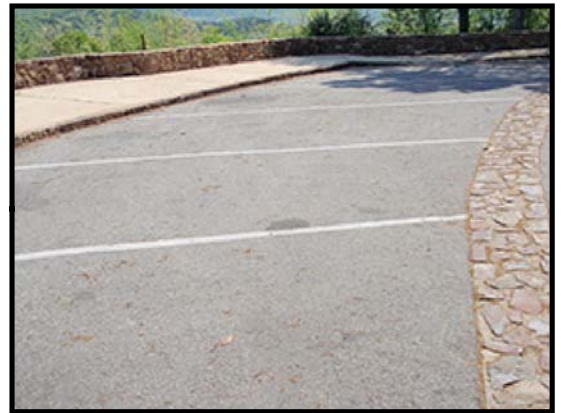
Route 0904

Route Number	Public / NonPublic	Date Visited	Area (sq ft)	Lane Miles *	Surface Type
0904	PUBLIC	4/14/2011	1,294	0.02	AS
Culverts	Drop Inlets	Gates	Curb & Gutter	Curb	PCR
0	0	0	NO CURB AND GUTTER	STONE CURB	FAIR/73

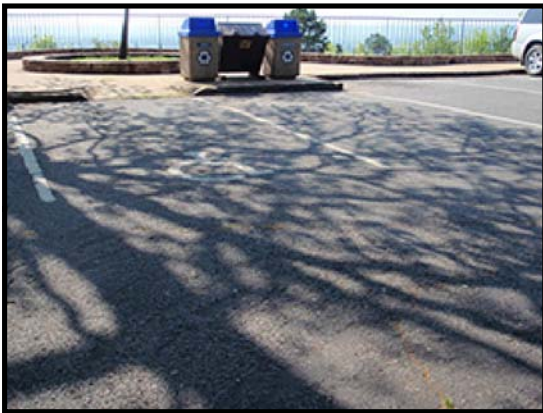
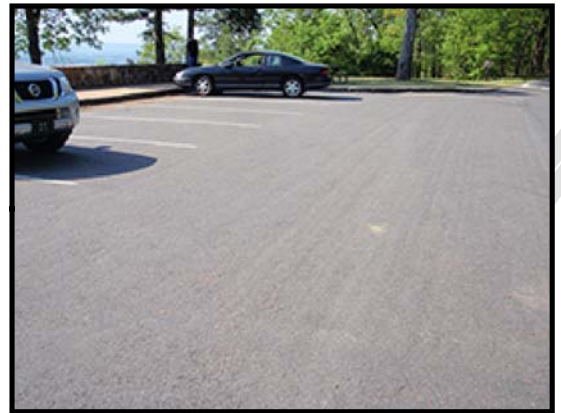
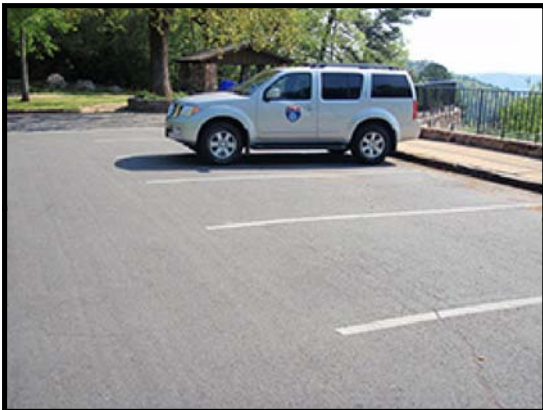
Route 0905

Route Number	Public / NonPublic	Date Visited	Area (sq ft)	Lane Miles *	Surface Type
0905	PUBLIC	4/14/2011	3,205	0.06	AS
Culverts	Drop Inlets	Gates	Curb & Gutter	Curb	PCR
0	0	0	NO CURB AND GUTTER	STONE CURB	GOOD/90

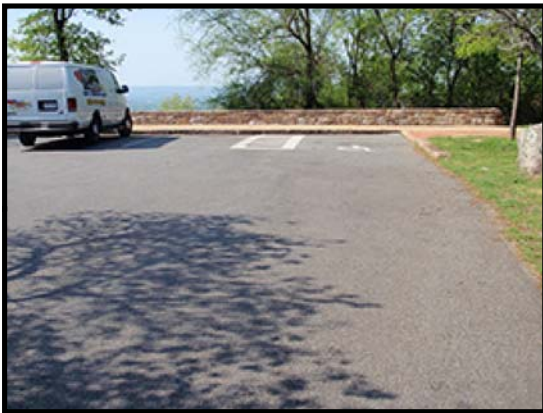
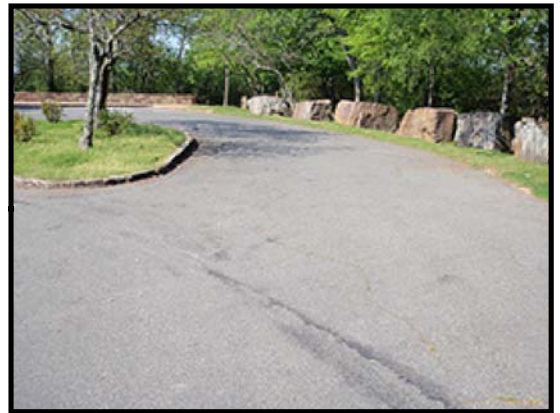
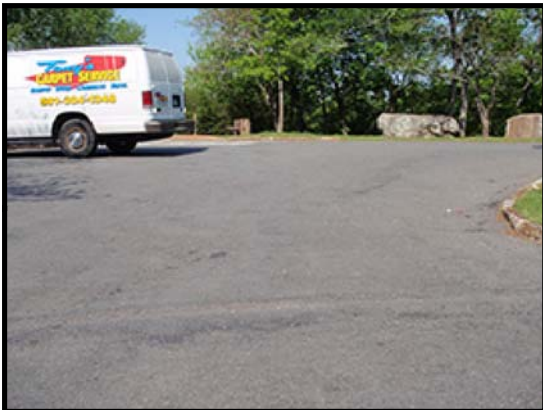
Route 0906

Route Number	Public / NonPublic	Date Visited	Area (sq ft)	Lane Miles *	Surface Type
0906	PUBLIC	4/14/2011	3,393	0.06	AS
Culverts	Drop Inlets	Gates	Curb & Gutter	Curb	PCR
0	0	0	NO CURB AND GUTTER	CONCRETE & STONE CURB	GOOD/90

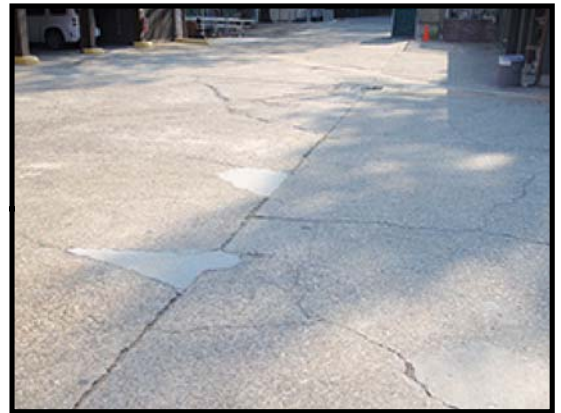
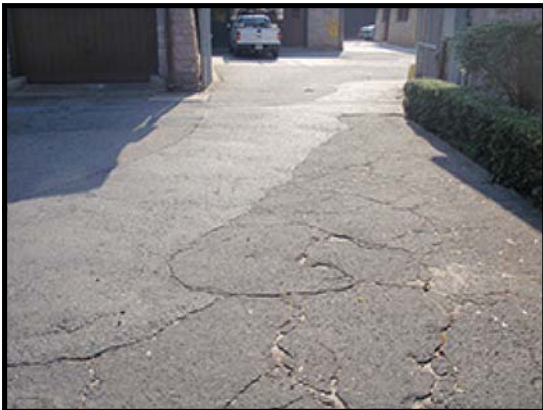
Route 0907

Route Number	Public / NonPublic	Date Visited	Area (sq ft)	Lane Miles *	Surface Type
0907	NONPUBLIC	4/14/2011	24,540	0.42	AS
Culverts	Drop Inlets	Gates	Curb & Gutter	Curb	PCR
0	6	2	NO CURB AND GUTTER	NO CURB	FAIR/73

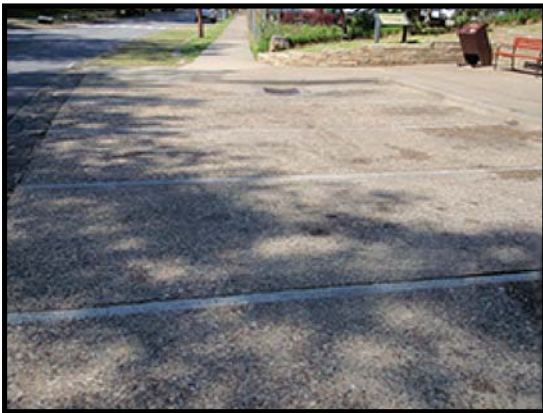
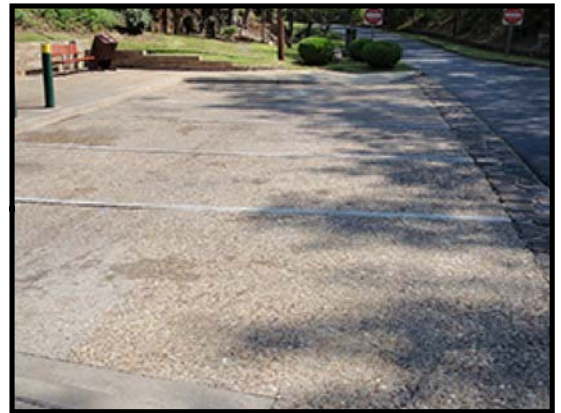
Route 0908

Route Number	Public / NonPublic	Date Visited	Area (sq ft)	Lane Miles *	Surface Type
0908	PUBLIC	4/14/2011	1,046	0.02	CO
Culverts	Drop Inlets	Gates	Curb & Gutter	Curb	PCR
0	1	0	CONCRETE CURB AND GUTTER	NO CURB	GOOD/90

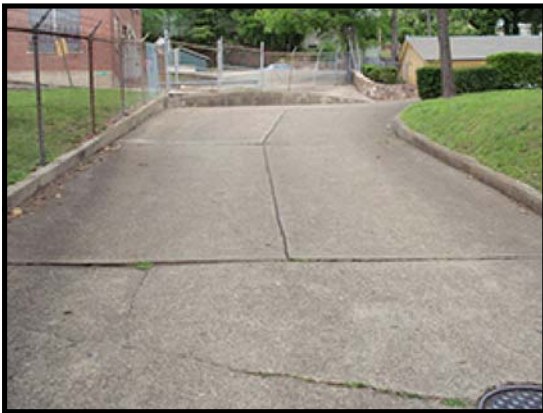
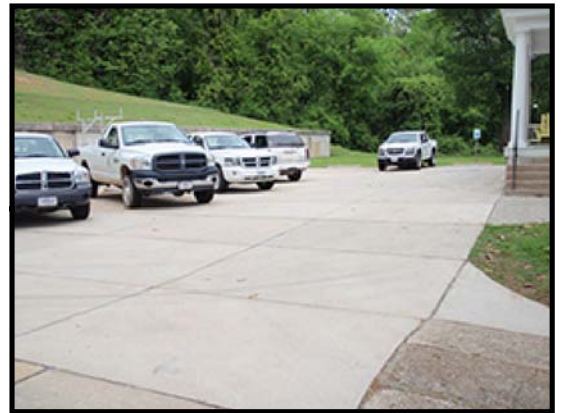
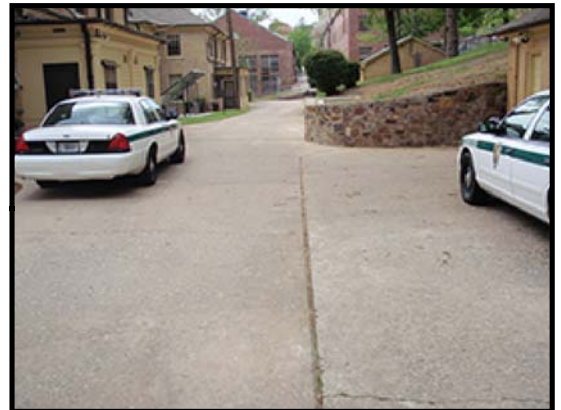
HOT SPRINGS NATIONAL PARK
Route 0910
 MAINTENANCE AREA EMPLOYEE PARKING
 ADJACENT TO QUARTZ STREET ON LEFT

Route Number	Public / NonPublic	Date Visited	Area (sq ft)	Lane Miles *	Surface Type
0910	NONPUBLIC	4/14/2011	2,496	0.04	AS
Culverts	Drop Inlets	Gates	Curb & Gutter	Curb	PCR
0	2	0	NO CURB AND GUTTER	NO CURB	GOOD/90

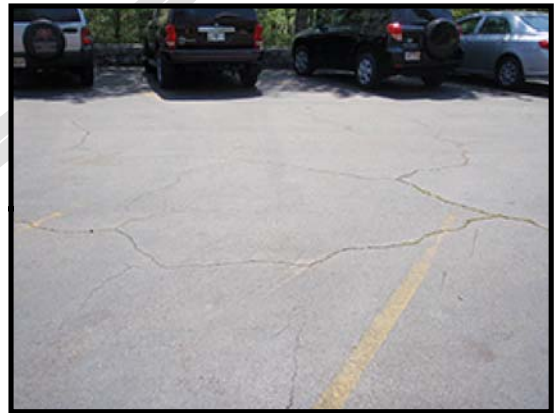
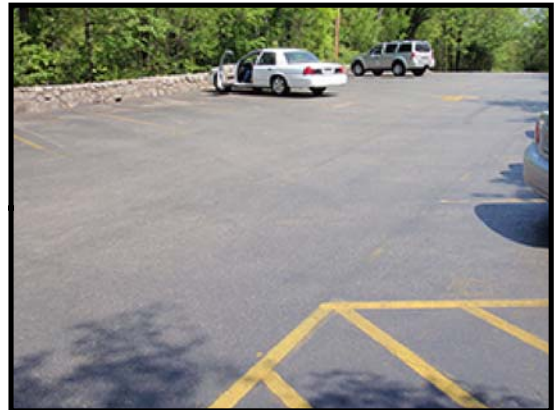
Route 0912

Route Number	Public / NonPublic	Date Visited	Area (sq ft)	Lane Miles *	Surface Type
0912	PUBLIC	4/14/2011	16,211	0.28	AS
Culverts	Drop Inlets	Gates	Curb & Gutter	Curb	PCR
0	0	0	NO CURB AND GUTTER	STONE CURB	FAIR/73
