### Federal Lands Highway Road Inventory Program

Road Inventory and Condition Assessment

### **Hovenweep National Monument HOVE**

Cycle 5 Report

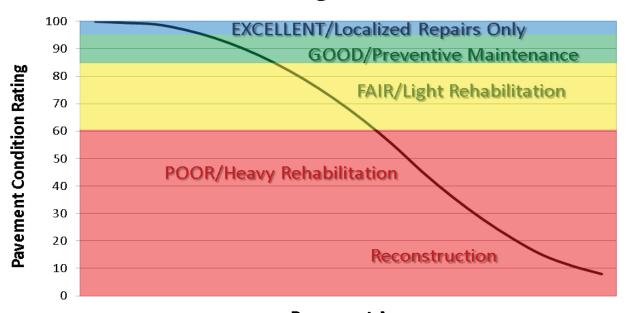
### **Condition Categories and Treatments**

- Excellent/New: PCR of 95-100. Pavements in this range will require only spot repairs
- Good: PCR of 85-94. Pavements in this range will likely be candidates for Preventive Maintenance. Examples include Chip and Slurry Seals, Micro Surfacing and Thin Overlays.
- Fair: PCR of 61-84. Pavements in this range will likely be candidates of Light Rehabilitation (L3R). Examples include single-lift overlays up to 2.5 inches in total thickness, milling and overlays.
- Poor: PCR of 0-60. Pavements in this range will likely be candidates of Heavy Rehabilitation or Reconstruction (H3R or 4R). Examples include Pulverization, Multiple Lift Overlays, and Reconstruction.

At this time, specific Maintenance and Rehabilitation activities should be evaluated and recommended at the project level. Site-specific conditions that influence treatment type should be determined based on performing a subsurface investigation and/or pavement condition survey, and not be based solely on RIP data. Additionally, RIP produces a snapshot of conditions the year in which the data was collected. For further information or to obtain additional Pavement Management System's data from our Highway Pavement Management Application (HPMA) please contact the Eastern Federal Lands pavement team.
