# Federal Lands Highway Road Inventory Program

Road Inventory and Condition Assessment

## Jewel Cave National Monument JECA - 1569

### Cycle 5 Report

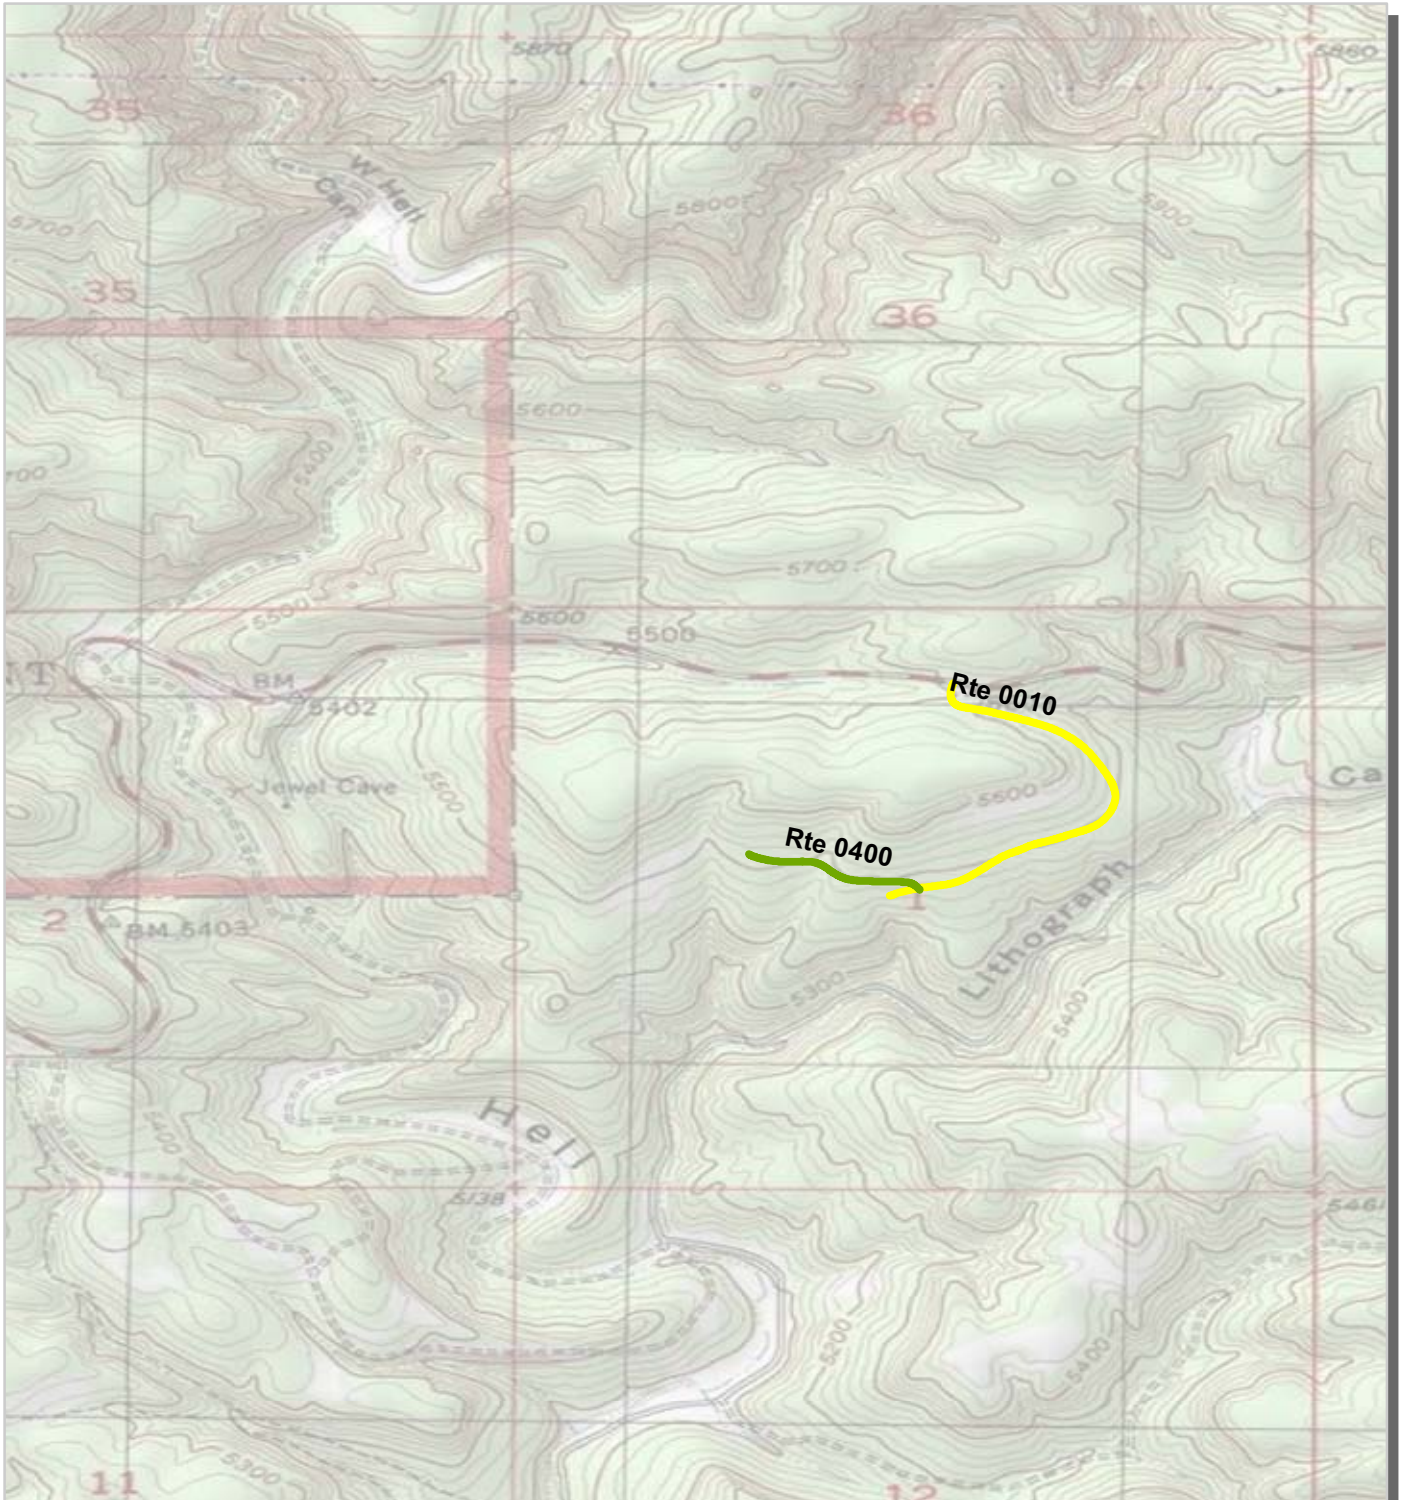
# Jewel Cave National Monument Route Condition Map PCR - Mile by Mile Area 1

PCR	Poor	<span style="display: inline-block; width: 20px; height: 10px; background-color: red; border: 1px solid black;"></span>	Fair	<span style="display: inline-block; width: 20px; height: 10px; background-color: yellow; border: 1px solid black;"></span>	Good	<span style="display: inline-block; width: 20px; height: 10px; background-color: green; border: 1px solid black;"></span>	Excellent	<span style="display: inline-block; width: 20px; height: 10px; background-color: blue; border: 1px solid black;"></span>	No Data	<span style="display: inline-block; width: 20px; height: 10px; background-color: black; border: 1px solid black;"></span>
	(0 - 60)		(61 - 84)	(85 - 94)		(95 - 100)

\* If the PCR rating is not available for a section, the SCR rating will be displayed. See appendix for definitions and formulas.

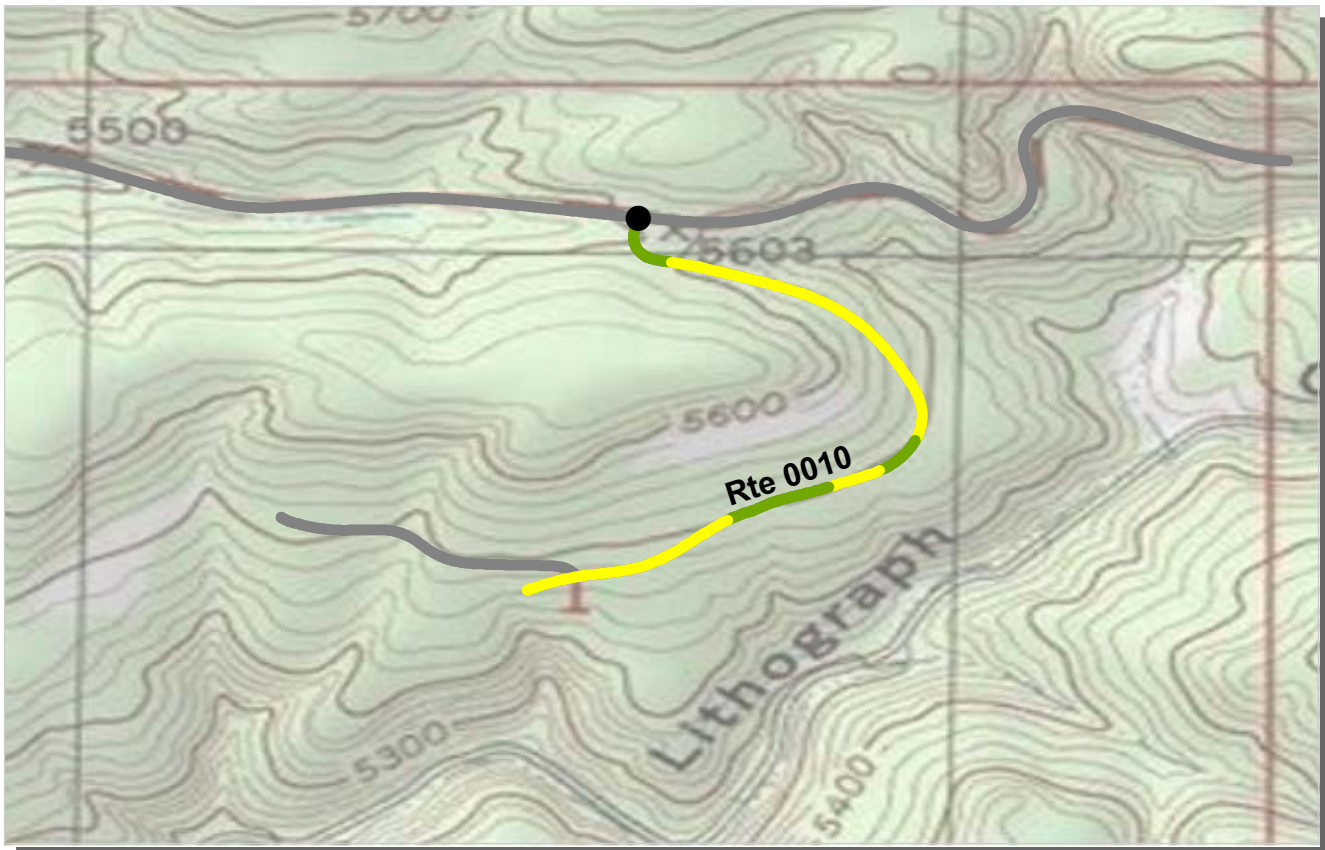
**ROUTE: 0010 JEWEL CAVE ROAD**

<b>Section Number</b>	0				
<b>Section Length (mi)</b>	0.66				
<b>Cross Section Information</b>					
Number of Lanes	2				
Paved Width (ft)	22				
Lane Width (ft)	9				
<b>Roadway Condition Information</b>					
SCR (Surface Condition Rating)	93				
PCR (Pavement Condition Rating)	78				
<b>Distress Index Values</b>					
Structural Crack Index	96				
Transverse Cracking Index	93				
Patching Index	100				
Rutting Index	97				
Roughness Condition Index (RCI)	56

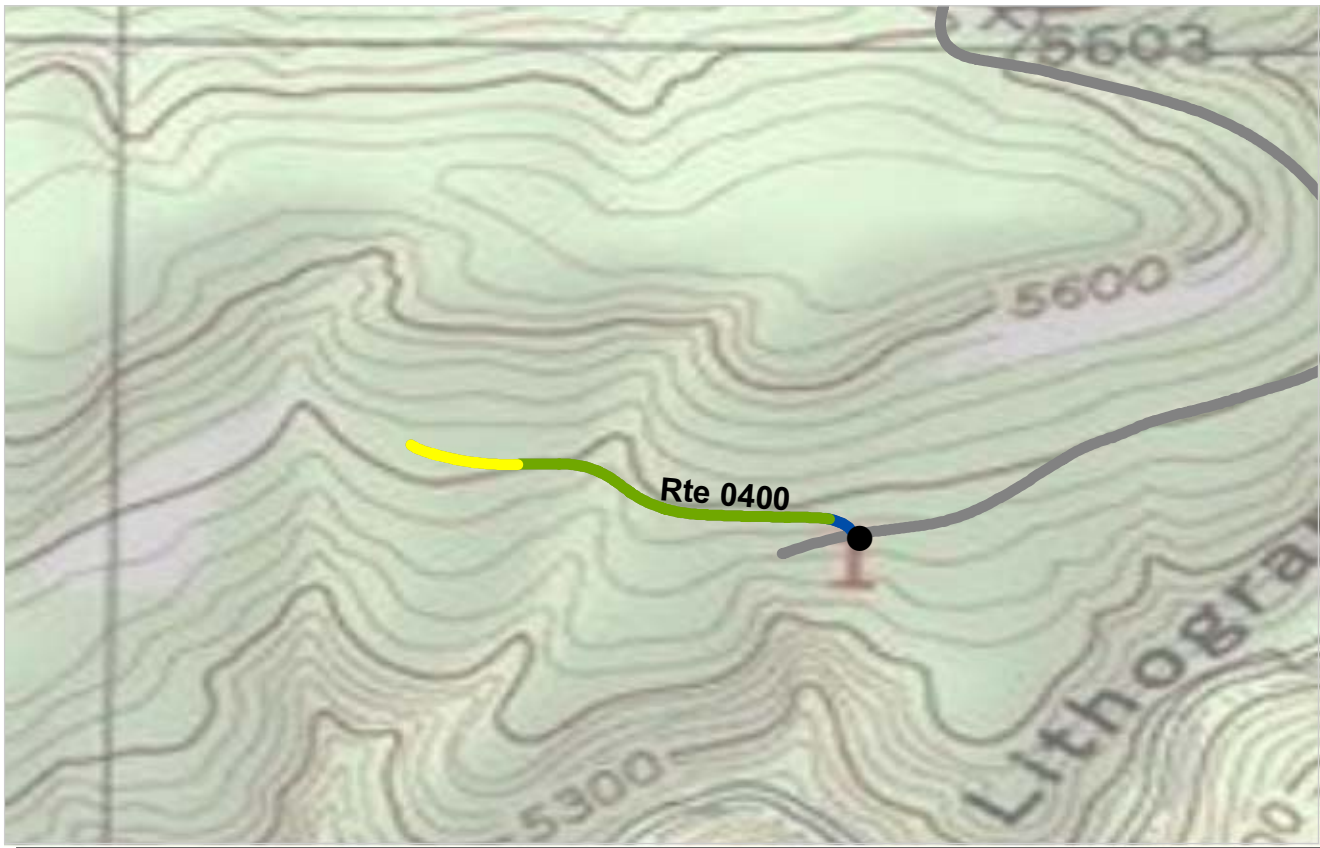
**ROUTE: 0400 HOUSING/ADMINISTRATION AREA ROAD**

<b>Section Number</b>	0				
<b>Section Length (mi)</b>	0.23				
<b>Cross Section Information</b>					
Number of Lanes	2				
Paved Width (ft)	20				
Lane Width (ft)	10				
<b>Roadway Condition Information</b>					
SCR (Surface Condition Rating)	88				
PCR (Pavement Condition Rating)	88				
<b>Distress Index Values</b>					
Structural Crack Index	97				
Transverse Cracking Index	88				
Patching Index	100				
Rutting Index	97				
Roughness Condition Index (RCI)	NC
