Federal Lands Highway Road Inventory Program

Road Inventory and Condition Assessment

John D. Rockefeller, Jr. Memorial Parkway JODR - 1467

Cycle 5 Report

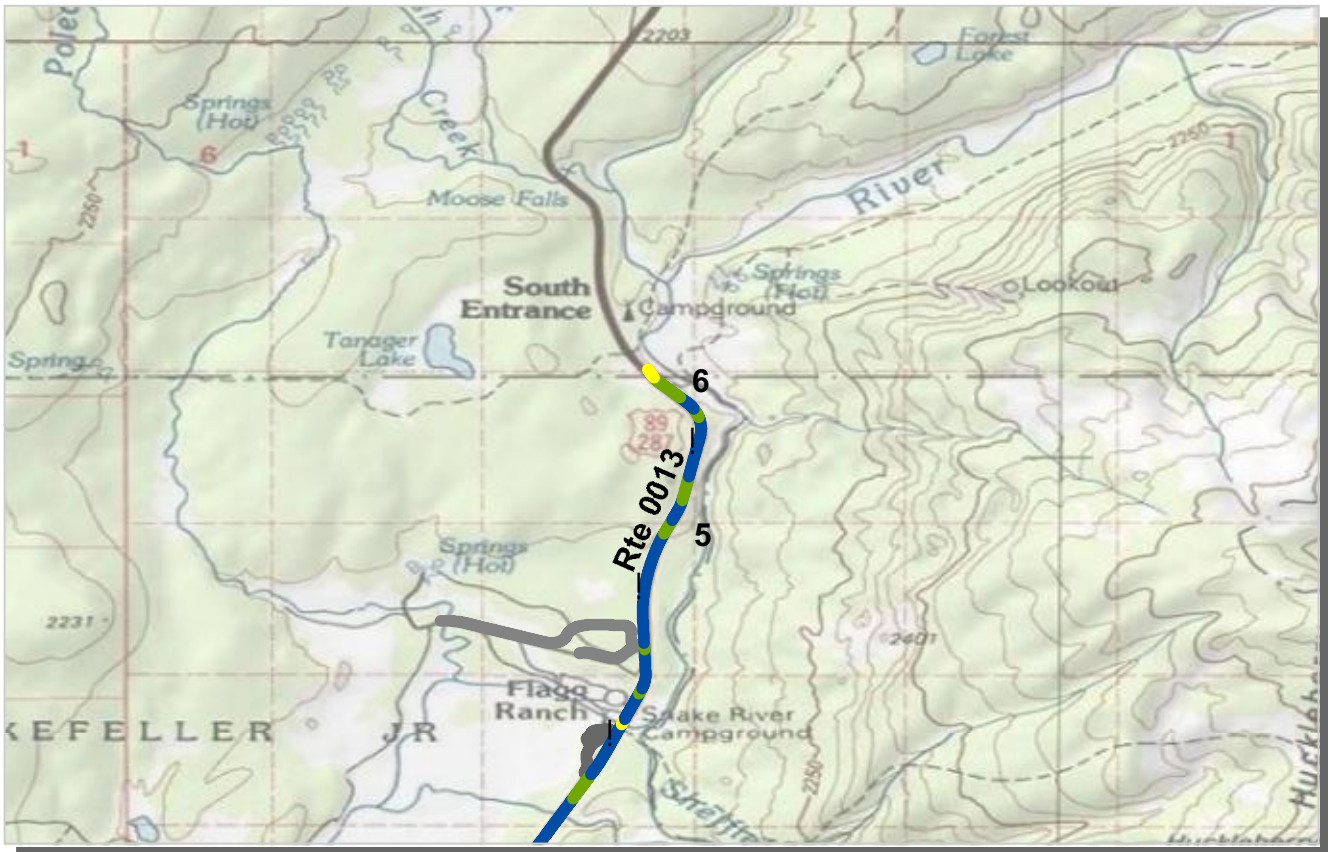
ROUTE: 0013 JDR PARKWAY ROAD

| <i>Section Number</i> | 5 | 6 | | | |
|---|---|---|--|--|--|
| SCR (Surface Condition Rating) | 92 | 90 | | | |
| PCR (Pavement Condition Rating) | 95 | 94 | | | |

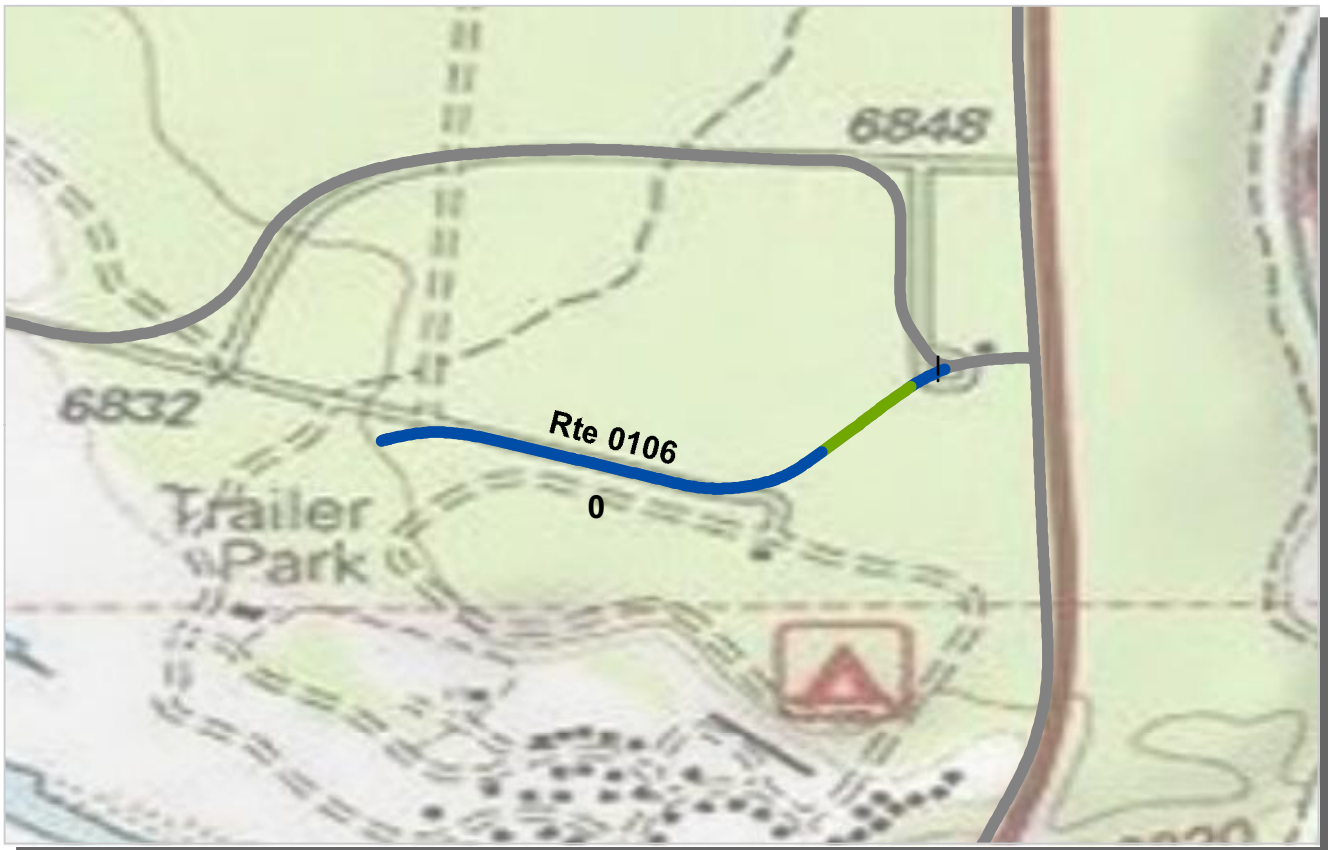
ROUTE: 0106 FLAGG SOUTH PARKING LOT ACCESS ROAD

| SCR (Surface Condition Rating) | 97 | | | | |
| PCR (Pavement Condition Rating) | 97 | | | | |
