Federal Lands Highway Road Inventory Program

Road Inventory and Condition Assessment

John Muir National Historic Site
JOMU – 8510

Cycle 5 Report

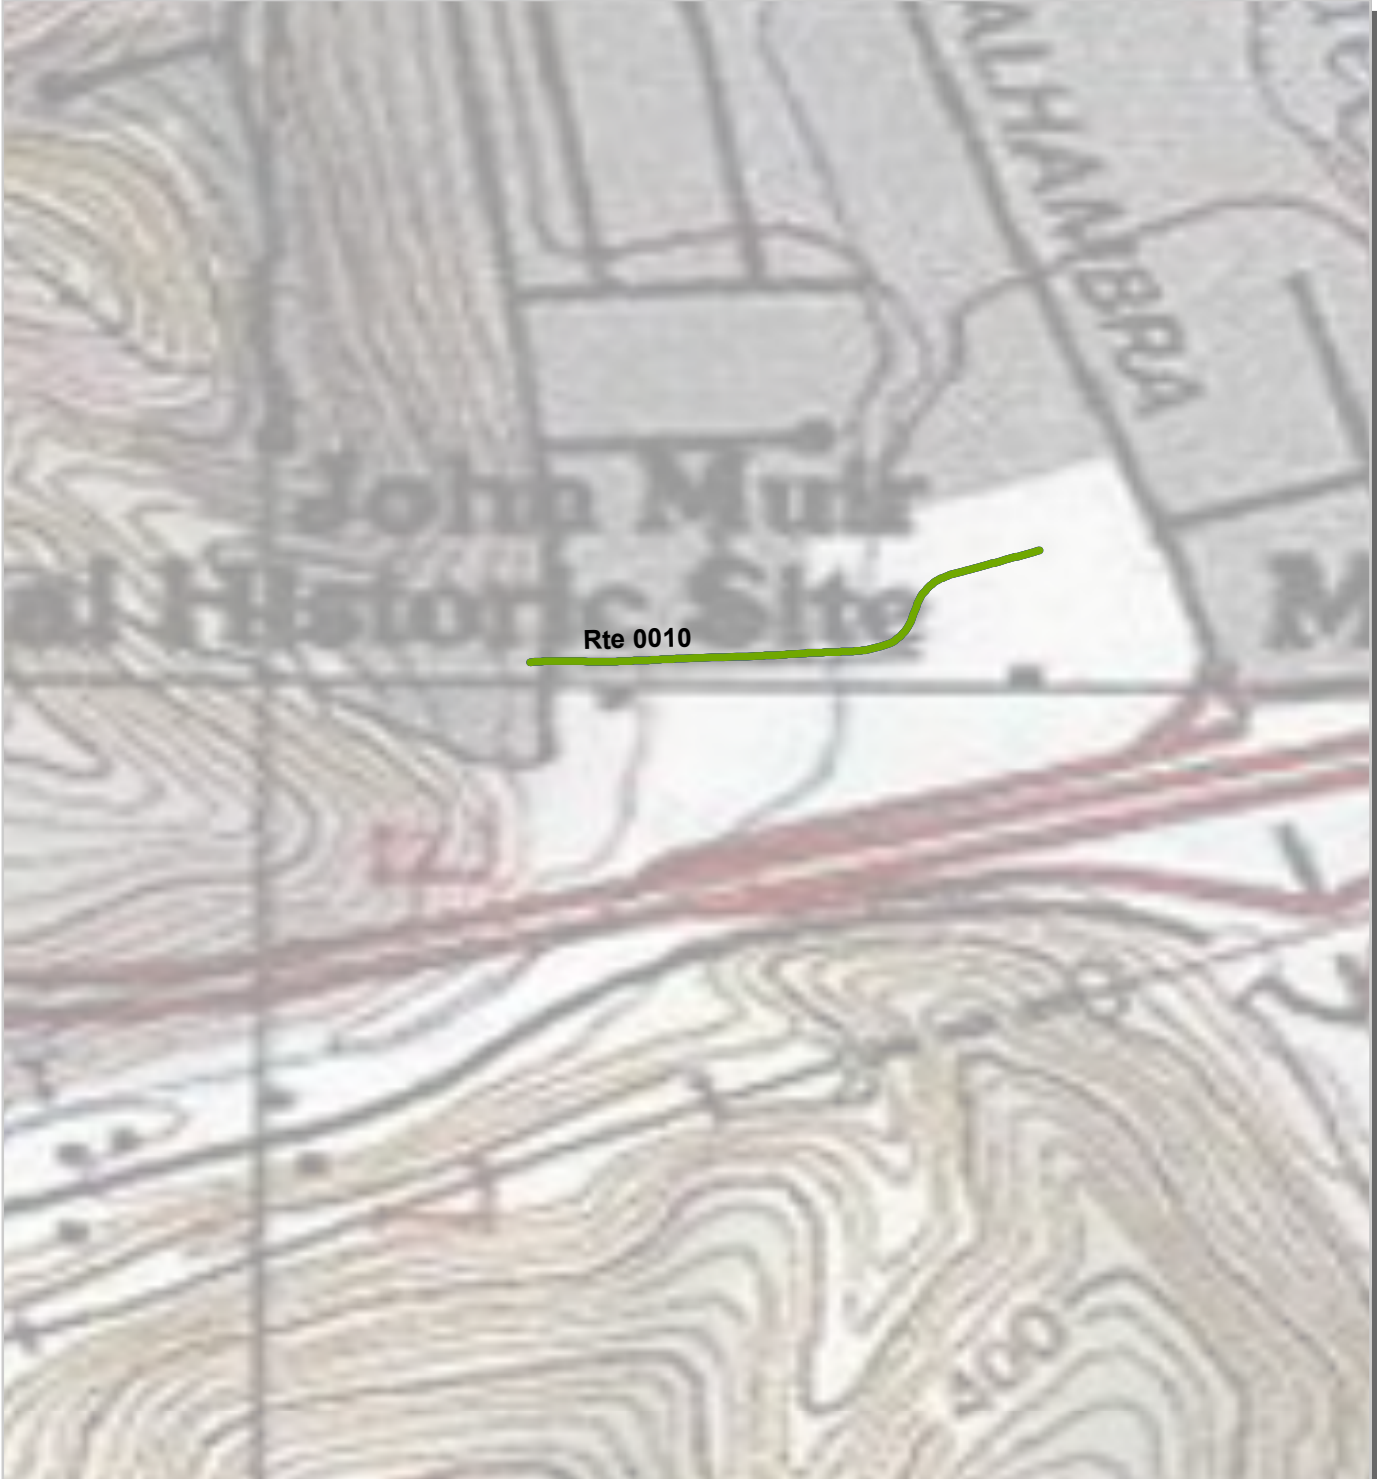
**John Muir National Historic Site
Route Condition Map
PCR - Mile by Mile
Area 1**

PCR	Poor	(0 - 60)	Fair	(61 - 84)	Good	(85 - 94)	Excellent	(95 - 100)	No Data	
-----	------	----------	------	-----------	------	-----------	-----------	------------	---------	--

* If the PCR rating is not available for a section, the SCR rating will be displayed. See appendix for definitions and formulas.

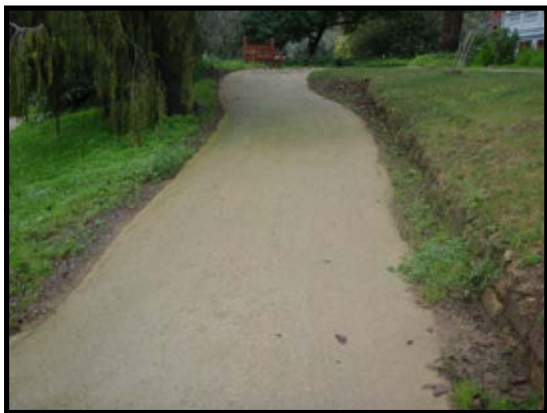
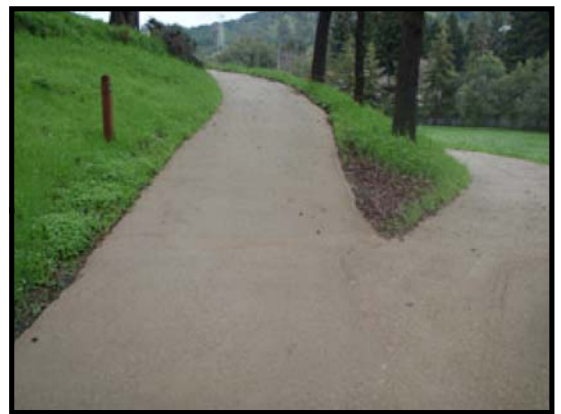
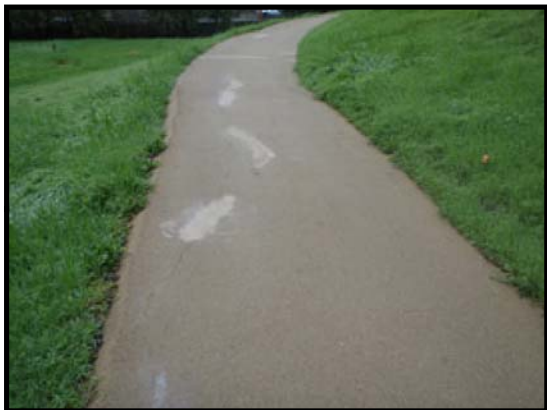
Route 0400

Route Number	Public / NonPublic	Date Visited	Area (sq ft)	Lane Miles *	MRL	
					Length (mi)	Width (ft)
0400	NONPUBLIC	1/27/2010	4,263	0.07	0.12	6.9
Culverts	Drop Inlets	Gates	Curb & Gutter	Curb	PCR	Surface Type
0	0	0	NO CURB AND GUTTER	NO CURB	GOOD/90	AS

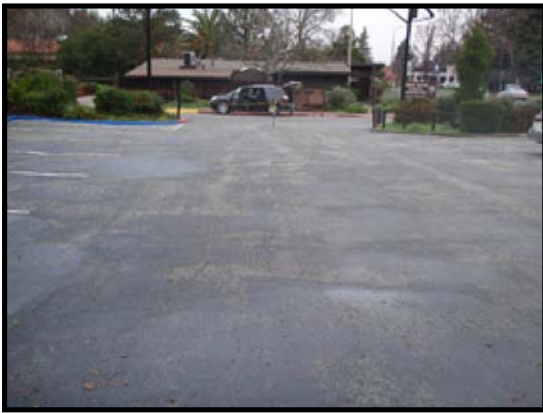
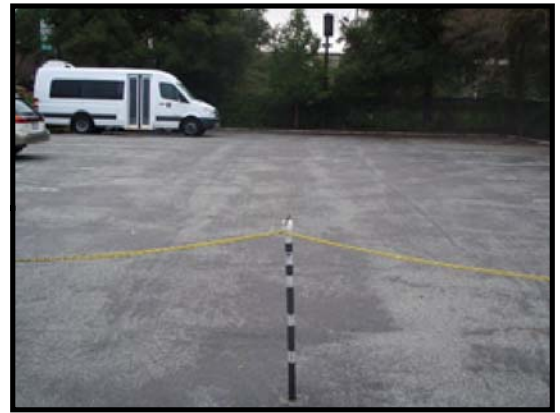
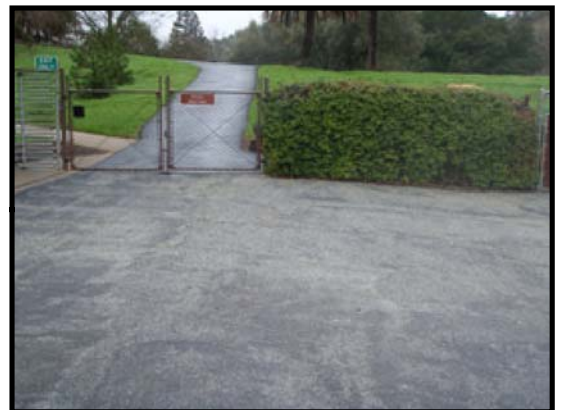
Route 0900

Route Number	Public / NonPublic	Date Visited	Area (sq ft)	Lane Miles *	Surface Type
0900	PUBLIC	1/27/2010	9,403	0.16	AS
Culverts	Drop Inlets	Gates	Curb & Gutter	Curb	PCR
0	0	2	CONCRETE CURB AND GUTTER	CONCRETE CURB	POOR/45

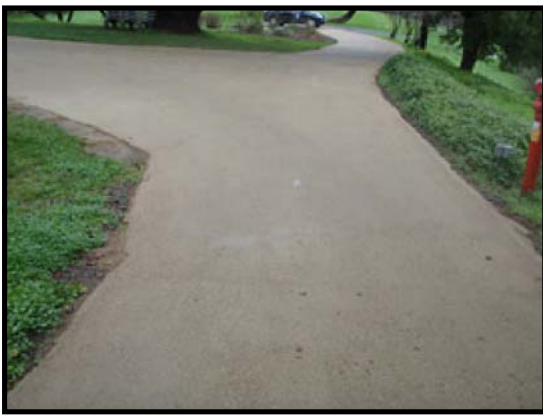
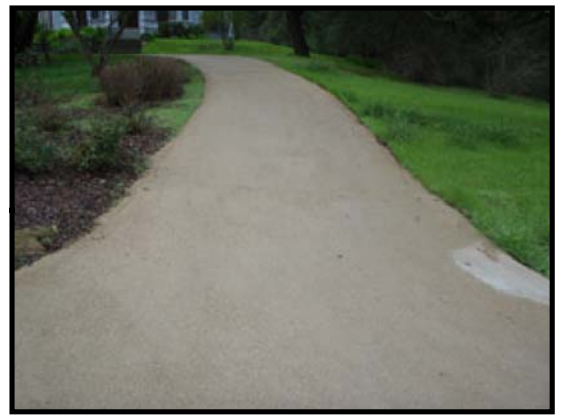
Route 0901

Route Number	Public / NonPublic	Date Visited	Area (sq ft)	Lane Miles *	Surface Type
0901	NONPUBLIC	1/27/2010	4,517	0.08	AS
Culverts	Drop Inlets	Gates	Curb & Gutter	Curb	PCR
0	0	0	NO CURB AND GUTTER	NO CURB	GOOD/90

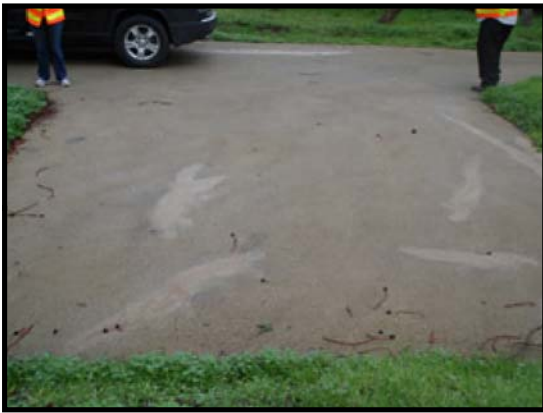
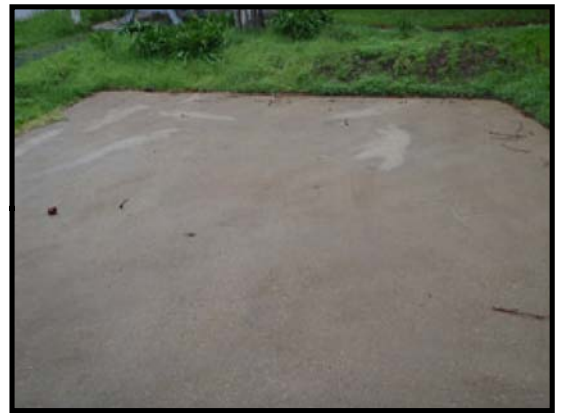
Route 0902

Route Number	Public / NonPublic	Date Visited	Area (sq ft)	Lane Miles *	Surface Type
0902	NONPUBLIC	1/27/2010	359	0.01	AS
Culverts	Drop Inlets	Gates	Curb & Gutter	Curb	PCR
0	0	0	NO CURB AND GUTTER	NO CURB	GOOD/90

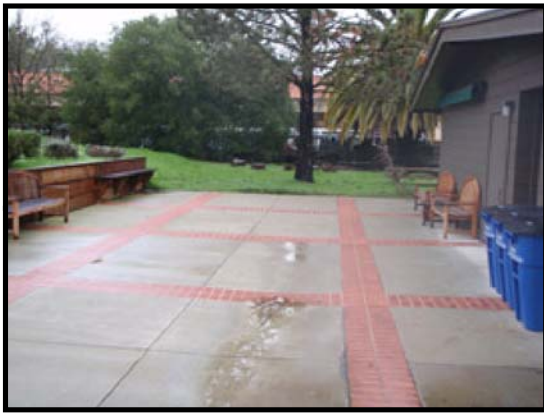
Route 0903

Route Number	Public / NonPublic	Date Visited	Area (sq ft)	Lane Miles *	Surface Type
0903	NONPUBLIC	1/27/2010	1,397	0.02	CO
Culverts	Drop Inlets	Gates	Curb & Gutter	Curb	PCR
0	0	0	NO CURB AND GUTTER	NO CURB	GOOD/90

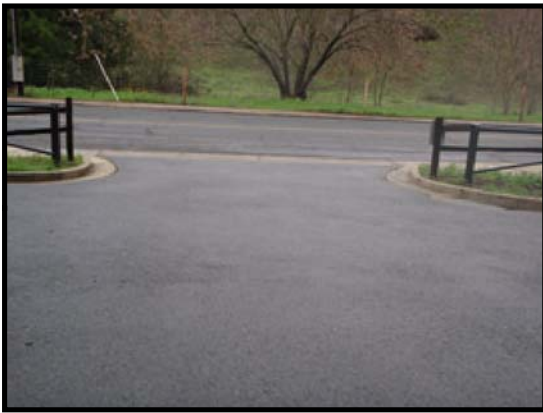
Route 0904AZ

Route Number	Public / NonPublic	Date Visited	Area (sq ft)	Lane Miles *	Surface Type
0904AZ	NONPUBLIC	1/27/2010	2,764	0.05	AS
Culverts	Drop Inlets	Gates	Curb & Gutter	Curb	PCR
0	1	1	CONCRETE CURB AND GUTTER	NO CURB	GOOD/90

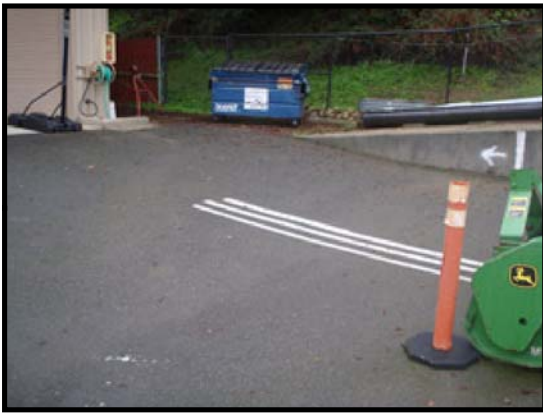
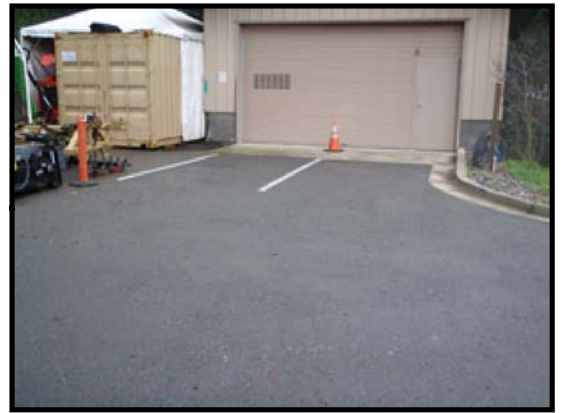
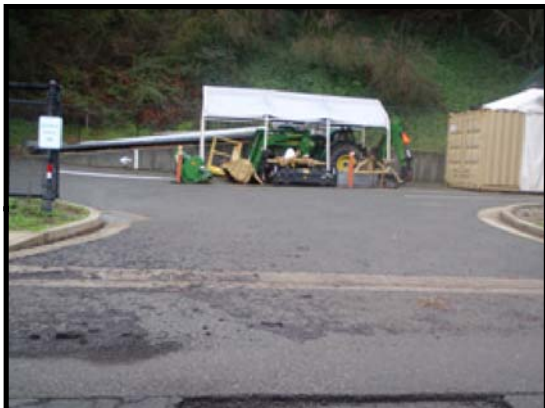
Route 0904BZ

Route Number	Public / NonPublic	Date Visited	Area (sq ft)	Lane Miles *	Surface Type
0904BZ	NONPUBLIC	1/27/2010	2,150	0.04	AS
Culverts	Drop Inlets	Gates	Curb & Gutter	Curb	PCR
0	1	1	CONCRETE CURB AND GUTTER	NO CURB	GOOD/90
