Federal Lands Highway Road Inventory Program

Road Inventory and Condition Assessment

Joshua Tree National Park JOTR

Cycle 5 Report

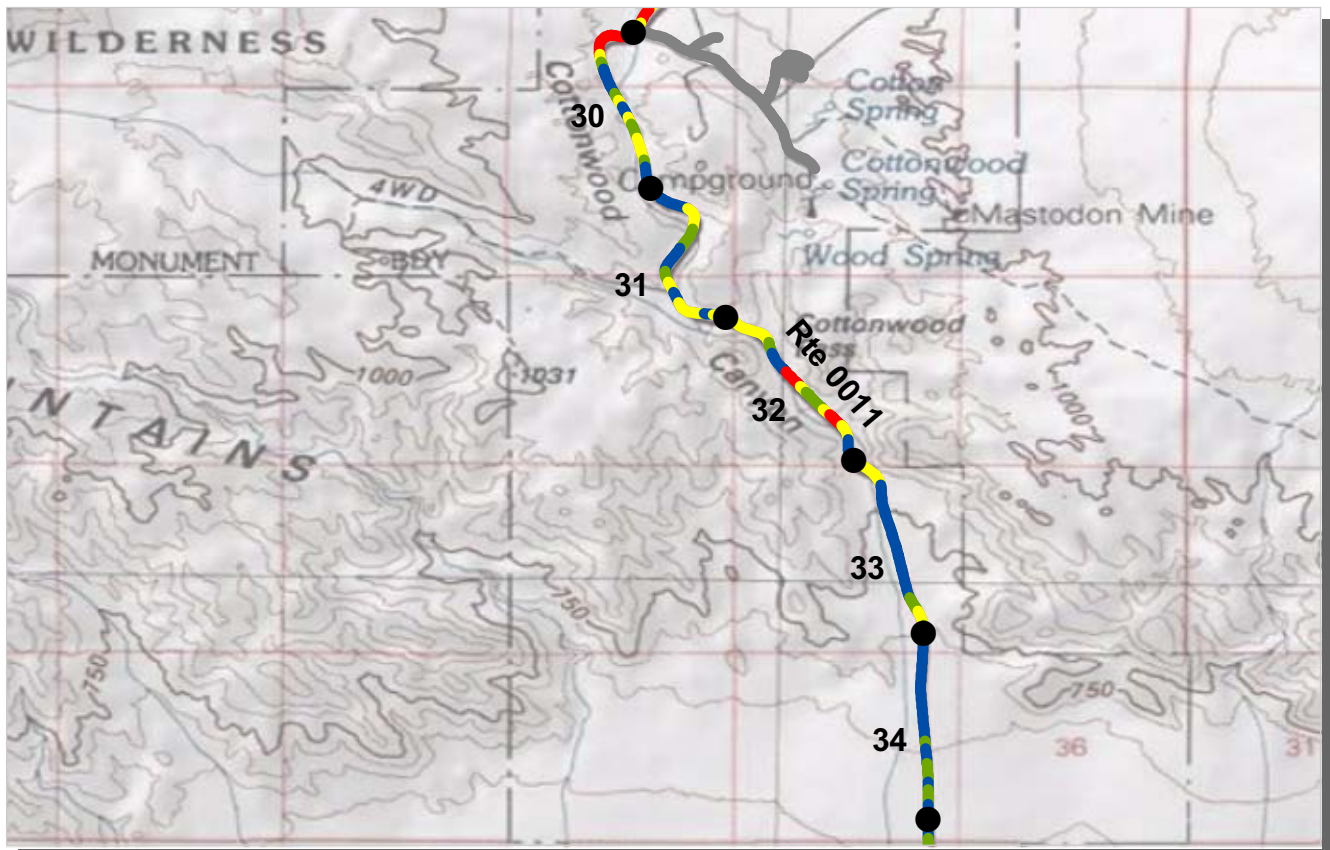
ROUTE: 0011 PINTO BASIN ROAD

<i>Section Number</i>	30	31	32	33	34
<i>Section Length (mi)</i>	1.00	1.00	1.00	1.00	1.00
<i>Cross Section Information</i>					
Number of Lanes	2	2	2	2	2
Paved Width (ft)	25	26	27	26	25
Lane Width (ft)	10	11	11	11	11
<i>Roadway Condition Information</i>					
SCR (Surface Condition Rating)	81	94	92	92	93
PCR (Pavement Condition Rating)	77	90	82	89	96
<i>Distress Index Values</i>					
Structural Crack Index	81	94	92	92	98
Transverse Cracking Index	96	96	97	97	94
Patching Index	98	100	100	100	100
Rutting Index	95	98	97	97	93
Roughness Condition Index (RCI)	72	84	68	85	100

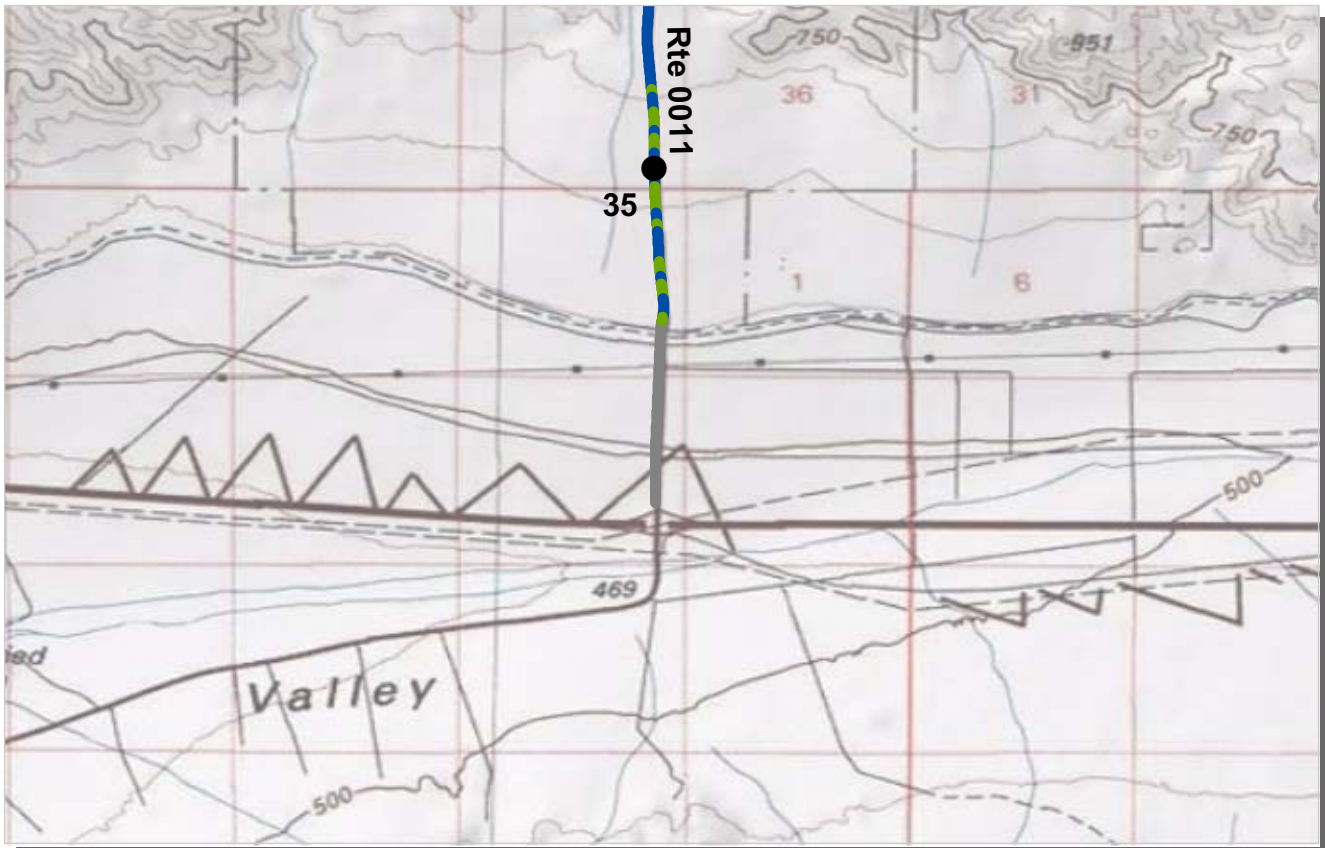
ROUTE: 0011 PINTO BASIN ROAD

Section Number	35				
Section Length (mi)	0.82				
Cross Section Information					
Number of Lanes	2				
Paved Width (ft)	25				
Lane Width (ft)	11				
Roadway Condition Information					
SCR (Surface Condition Rating)	94				
PCR (Pavement Condition Rating)	96				
Distress Index Values					
Structural Crack Index	99				
Transverse Cracking Index	95				
Patching Index	100				
Rutting Index	94				
Roughness Condition Index (RCI)	99

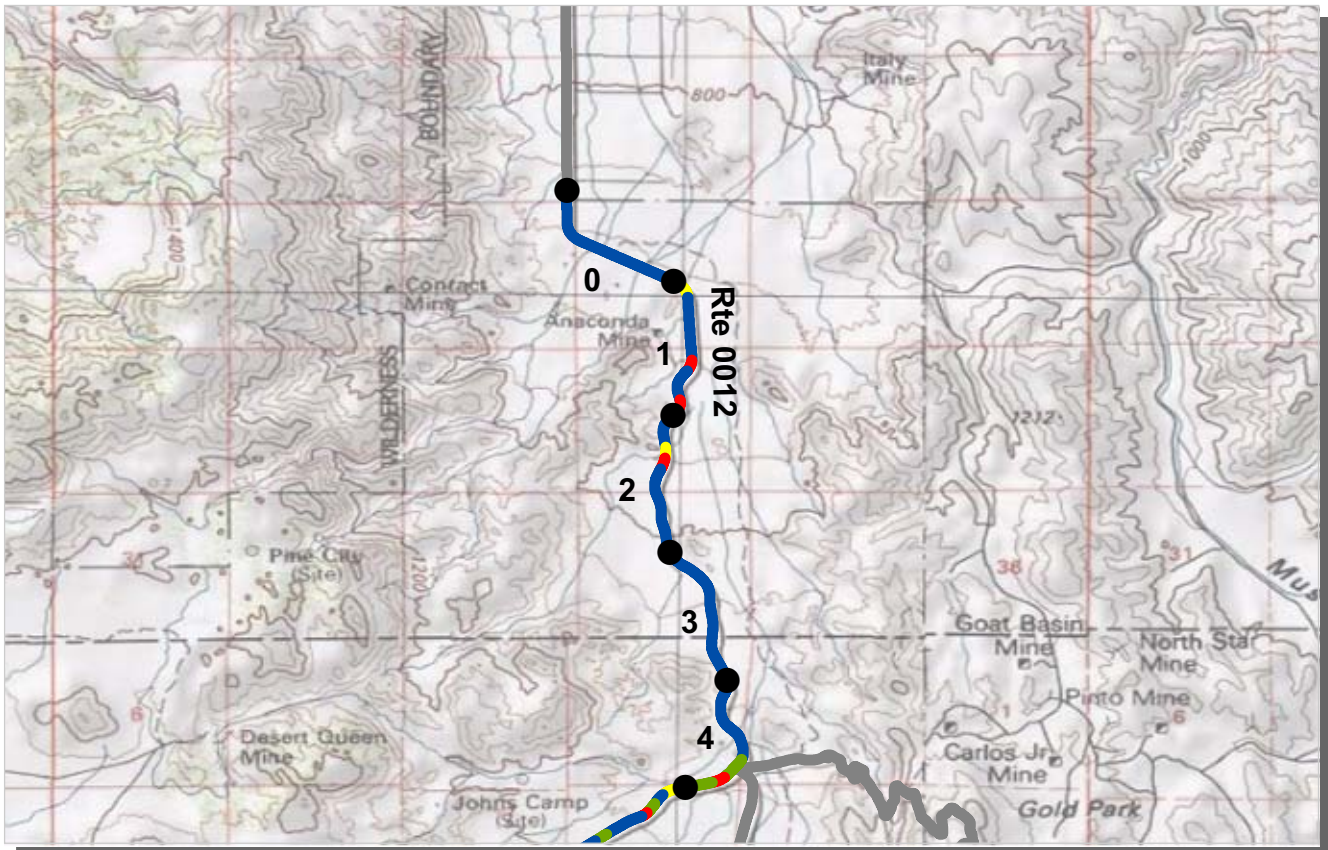
ROUTE: 0012 EAST-WEST HIGHWAY

<i>Section Number</i>	0	1	2	3	4
<i>Section Length (mi)</i>	1.00	1.00	1.00	1.00	1.00
<i>Cross Section Information</i>					
Number of Lanes	2	2	2	2	2
Paved Width (ft)	27	27	26	26	28
Lane Width (ft)	11	11	11	11	12
<i>Roadway Condition Information</i>					
SCR (Surface Condition Rating)	98	75	88	98	96
PCR (Pavement Condition Rating)	99	85	93	99	95
<i>Distress Index Values</i>					
Structural Crack Index	100	75	88	100	96
Transverse Cracking Index	99	100	100	100	99
Patching Index	100	100	100	100	100
Rutting Index	98	99	98	98	99
Roughness Condition Index (RCI)	100	100	100	100	94

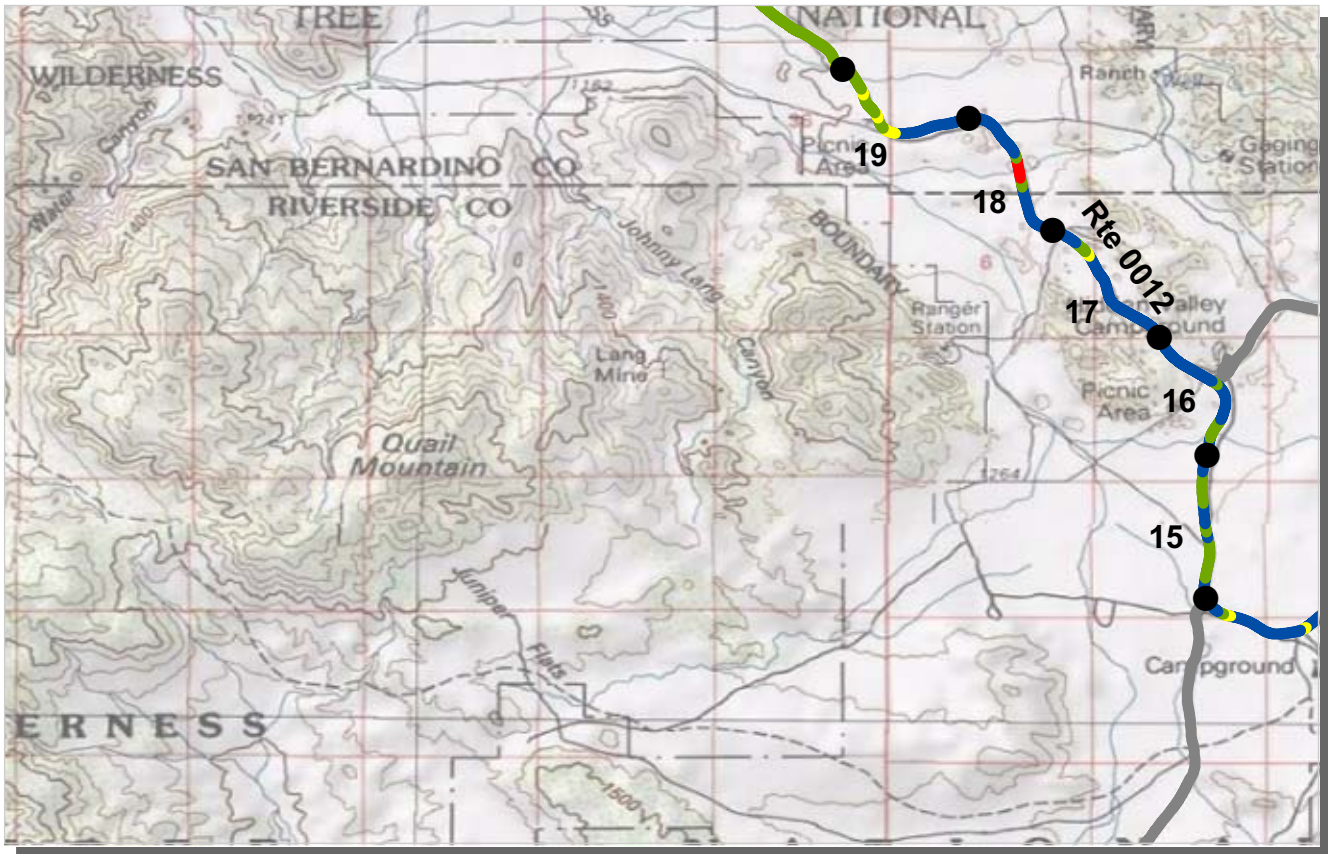
ROUTE: 0012 EAST-WEST HIGHWAY

<i>Section Number</i>	15	16	17	18	19
<i>Section Length (mi)</i>	1.00	1.00	1.00	1.00	1.00
<i>Cross Section Information</i>					
Number of Lanes	2	2	2	2	2
Paved Width (ft)	25	26	24	26	25
Lane Width (ft)	11	11	11	11	11
<i>Roadway Condition Information</i>					
SCR (Surface Condition Rating)	97	97	95	96	92
PCR (Pavement Condition Rating)	93	97	97	94	92
<i>Distress Index Values</i>					
Structural Crack Index	100	100	100	100	96
Transverse Cracking Index	100	100	100	100	92
Patching Index	100	100	100	100	100
Rutting Index	97	97	95	96	98
Roughness Condition Index (RCI)	88	97	100	92	92

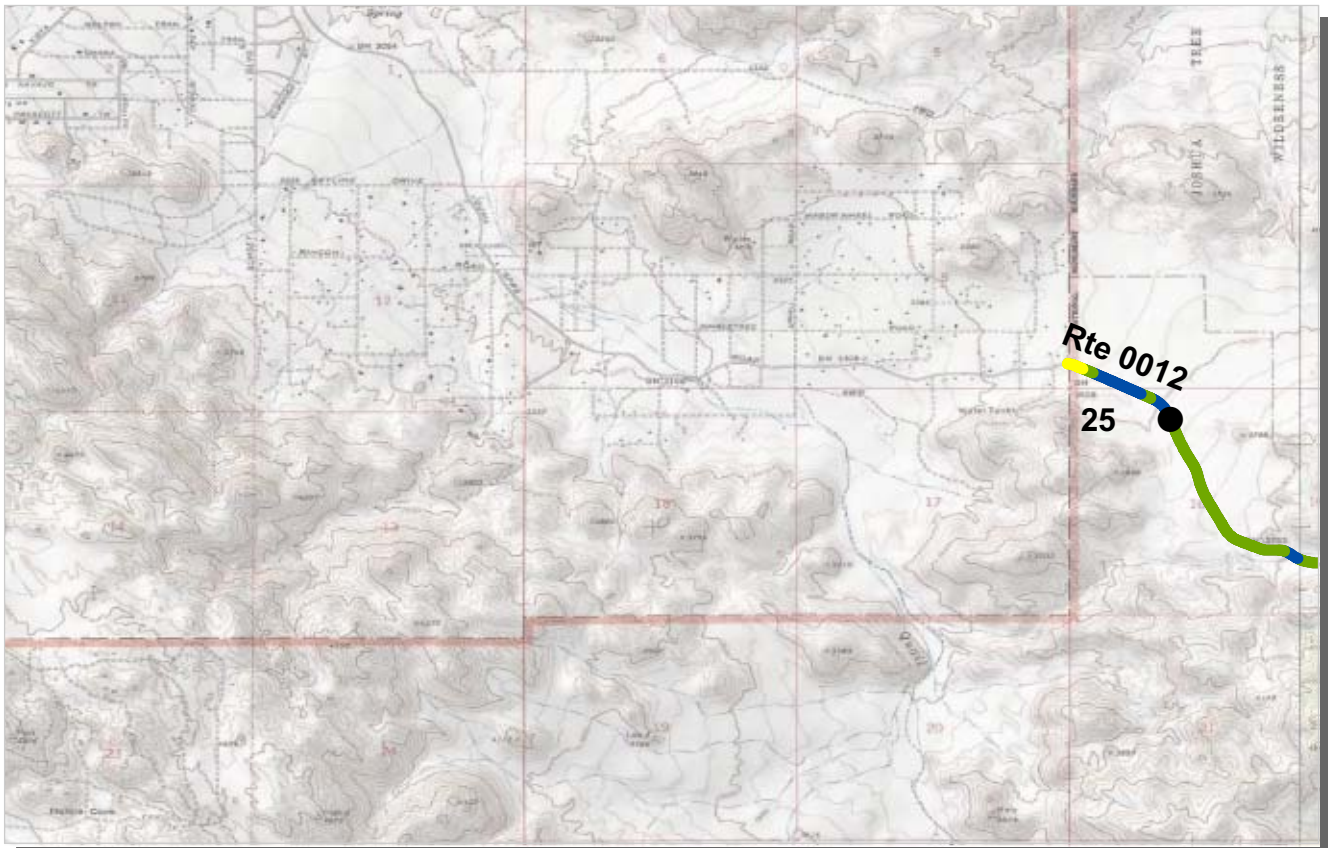
ROUTE: 0012 EAST-WEST HIGHWAY

Section Number	25				
Section Length (mi)	0.46				
Cross Section Information					
Number of Lanes	2				
Paved Width (ft)	25				
Lane Width (ft)	11				
Roadway Condition Information					
SCR (Surface Condition Rating)	95				
PCR (Pavement Condition Rating)	94				
Distress Index Values					
Structural Crack Index	97				
Transverse Cracking Index	96				
Patching Index	100				
Rutting Index	95				
Roughness Condition Index (RCI)	92

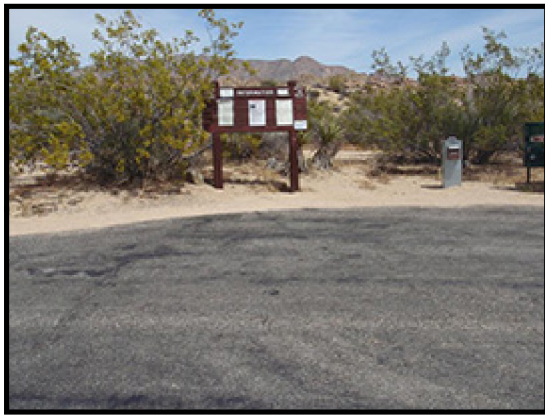
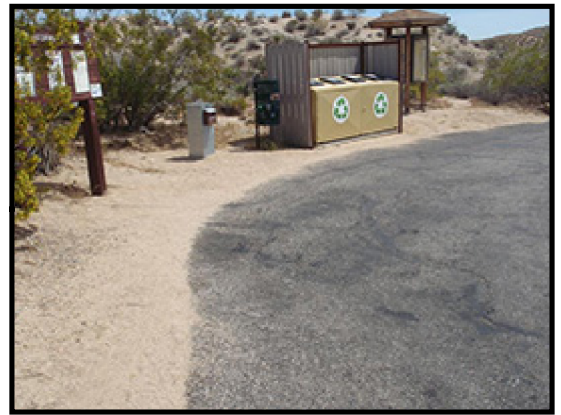
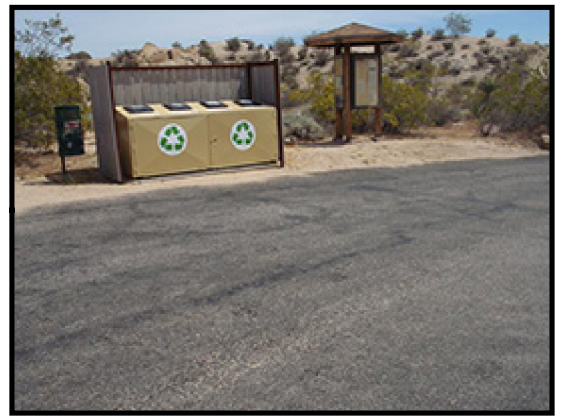
Route 0912

Route Number	Public / NonPublic	Date Visited	Area (sq ft)	Lane Miles *	Surface Type
0912	PUBLIC	4/29/2012	33,678	0.58	AS
Culverts	Drop Inlets	Gates	Curb & Gutter	Curb	PCR
0	0	0	NO CURB AND GUTTER	CONCRETE CURB	GOOD/90

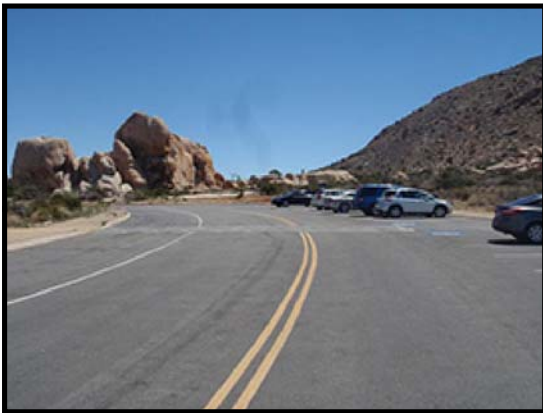
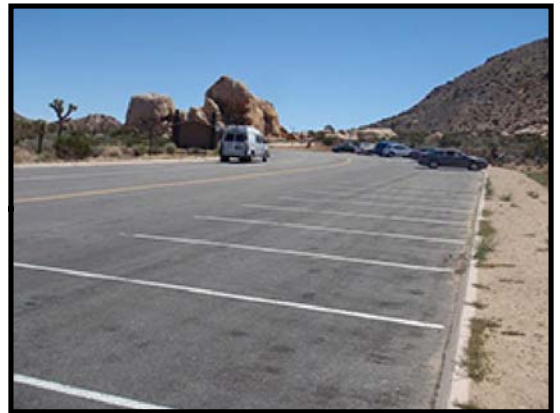
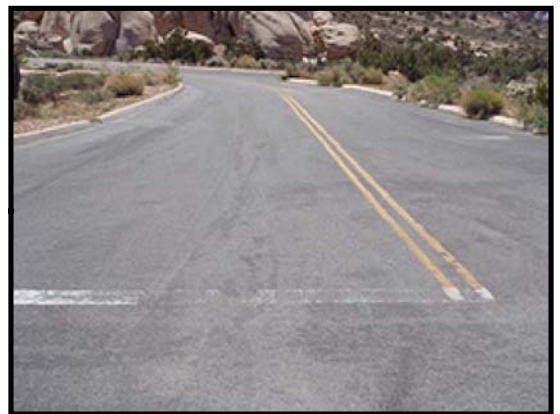
Route 0953

Route Number	Public / NonPublic	Date Visited	Area (sq ft)	Lane Miles *	Surface Type
0953	PUBLIC	4/29/2012	33,244	0.57	AS
Culverts	Drop Inlets	Gates	Curb & Gutter	Curb	PCR
0	0	1	NO CURB AND GUTTER	CONCRETE CURB	GOOD/90

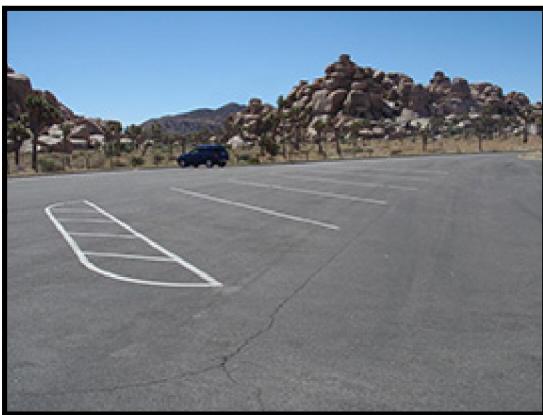
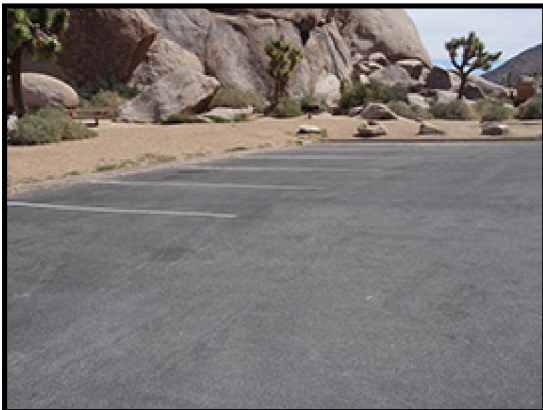
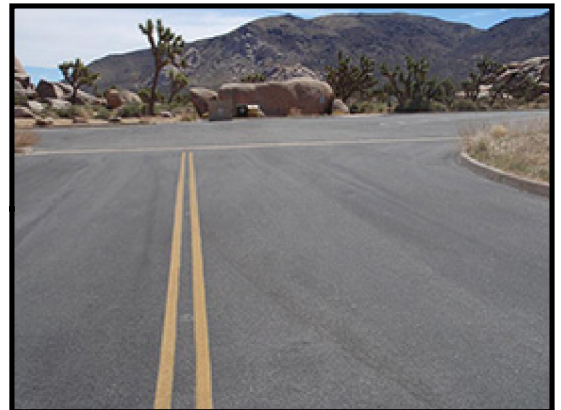
JOSHUA TREE NATIONAL PARK
Route 0956
 NORTH ENTRANCE SIGN PARKING
 ADJACENT TO ROUTE 0012 (EAST-WEST HIGHWAY)

Route Number	Public / NonPublic	Date Visited	Area (sq ft)	Lane Miles *	Surface Type
0956	PUBLIC	4/29/2012	2,912	0.05	AS
Culverts	Drop Inlets	Gates	Curb & Gutter	Curb	PCR
0	0	0	NO CURB AND GUTTER	NO CURB	FAIR/73

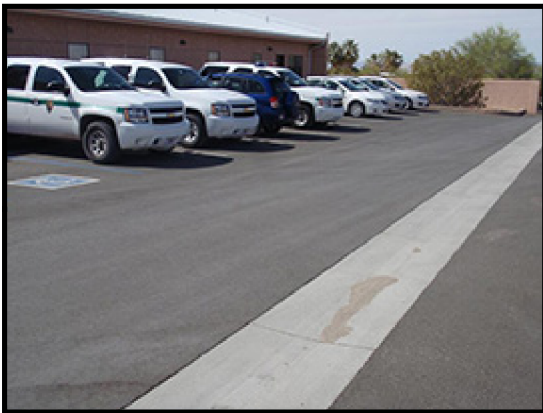
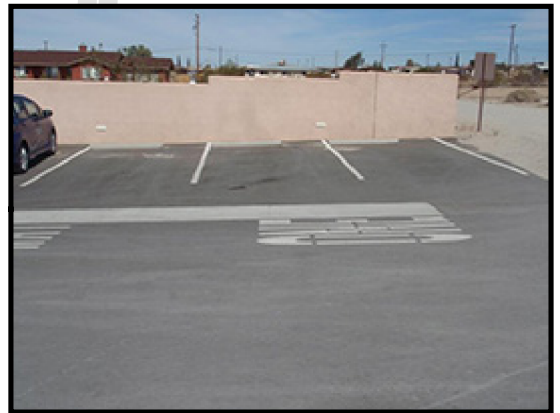
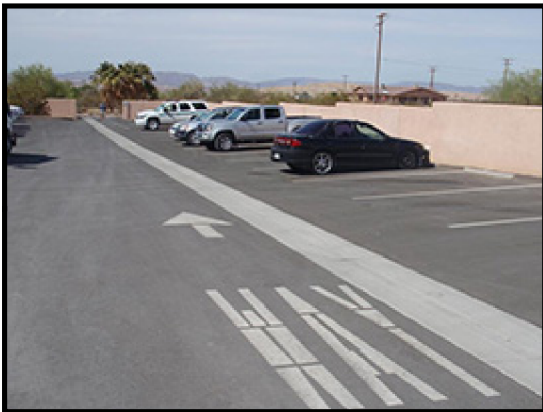
Route 0964ZZ

Route Number	Public / NonPublic	Date Visited	Area (sq ft)	Lane Miles *	Surface Type
0964AZ	NONPUBLIC	4/29/2012	12,187	0.21	AS
Culverts	Drop Inlets	Gates	Curb & Gutter	Curb	PCR
0	0	0	NO CURB AND GUTTER	CONCRETE CURB	EXCELLENT/97

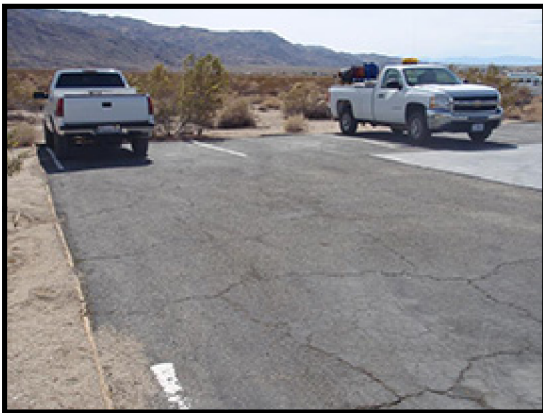
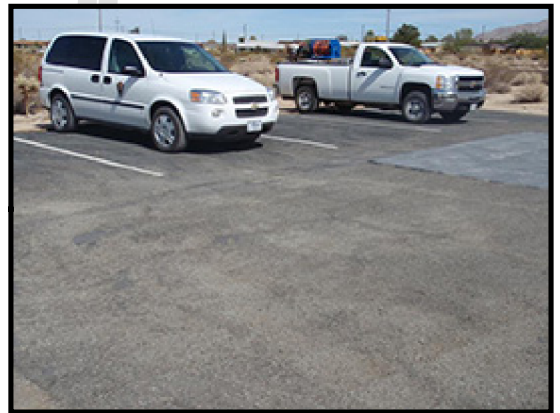
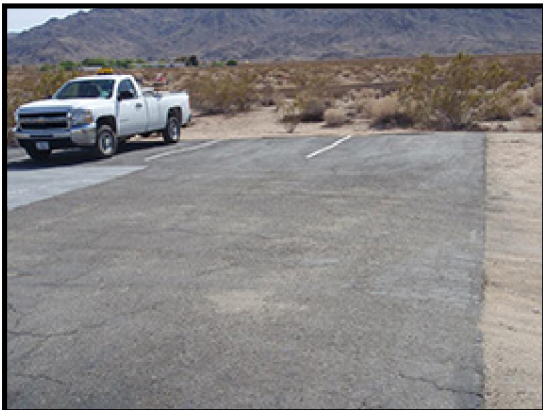
Route 0964BZ

Route Number	Public / NonPublic	Date Visited	Area (sq ft)	Lane Miles *	Surface Type
0964BZ	NONPUBLIC	4/24/2012	3,583	0.06	AS
Culverts	Drop Inlets	Gates	Curb & Gutter	Curb	PCR
0	0	0	NO CURB AND GUTTER	NO CURB	FAIR/73
