Federal Lands Highway Road Inventory Program

Road Inventory and Condition Assessment

Kenai Fjords National Park
KEFJ - 9845

Cycle 5 Report

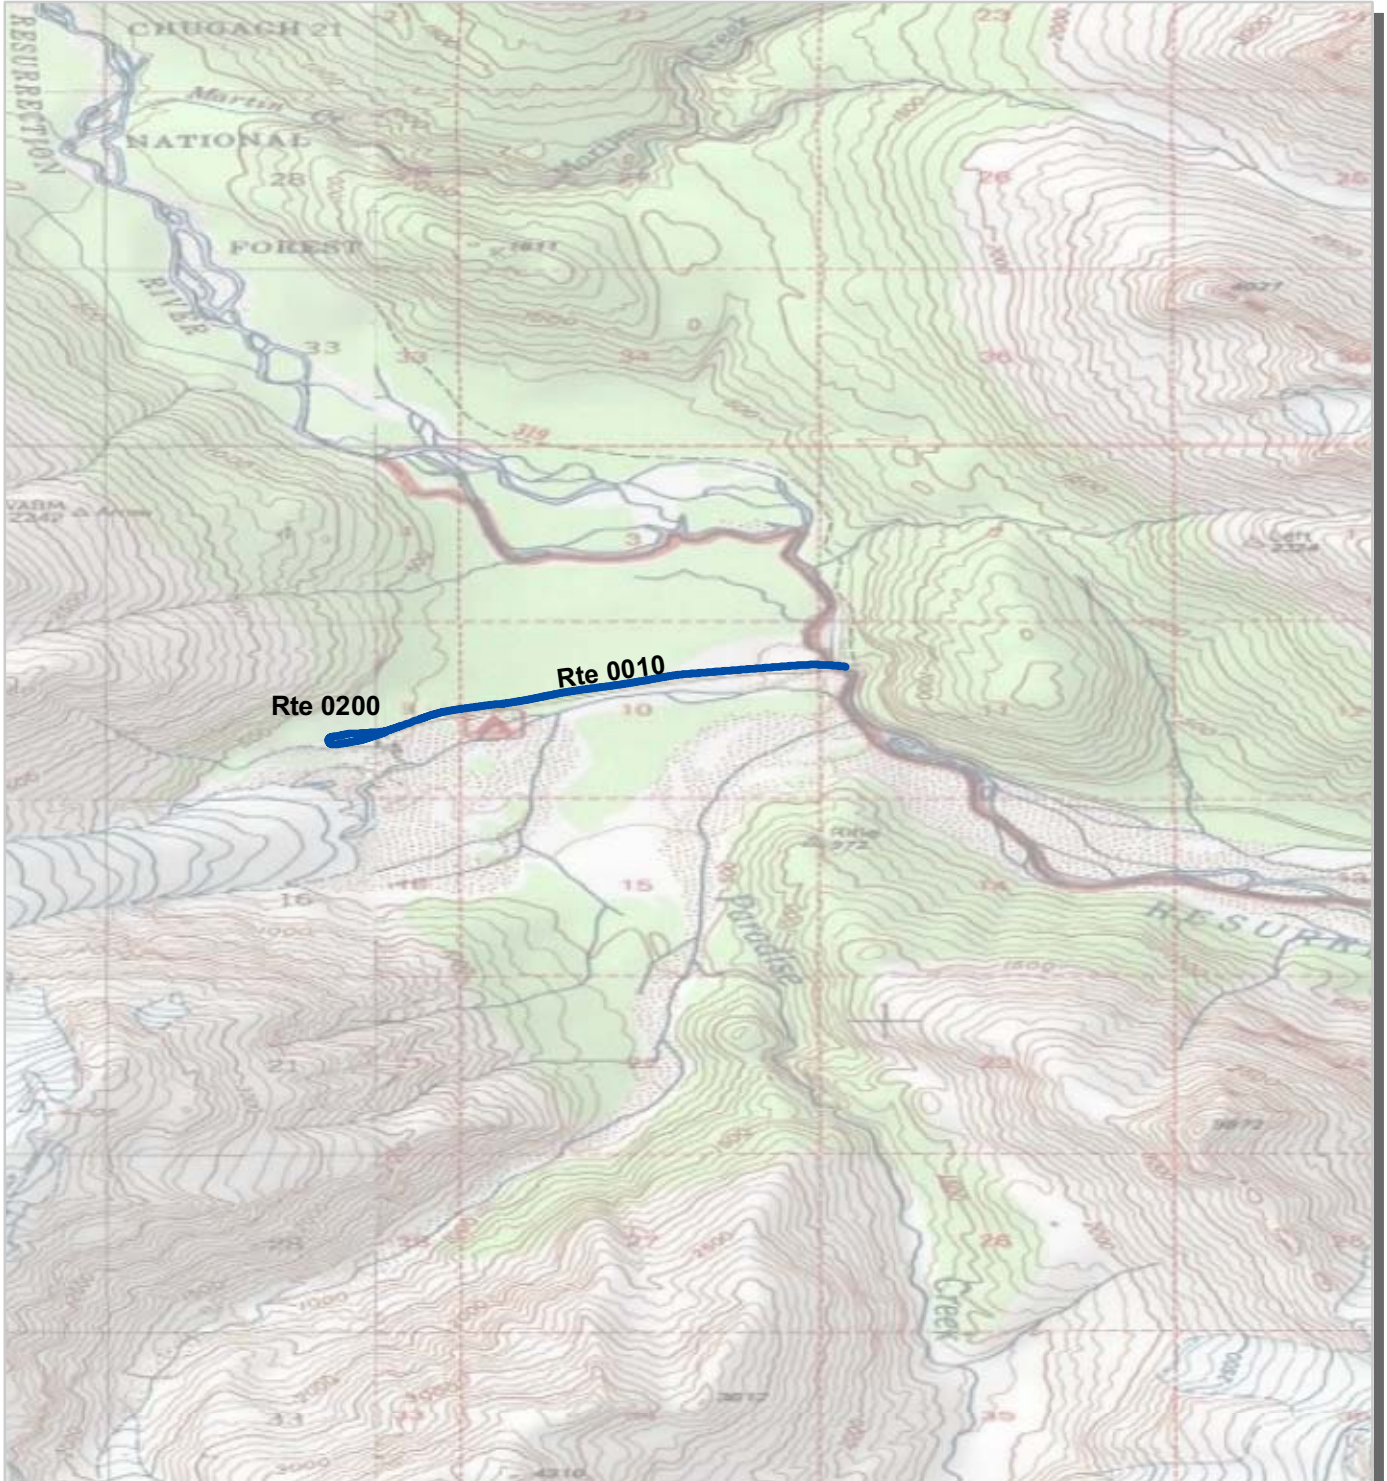
Kenai Fjords National Park Route Condition Map PCR - Mile by Mile Area 1

PCR	Poor		Fair		Good		Excellent		No Data	
	(0 - 60)		(61 - 84)	(85 - 94)		(95 - 100)

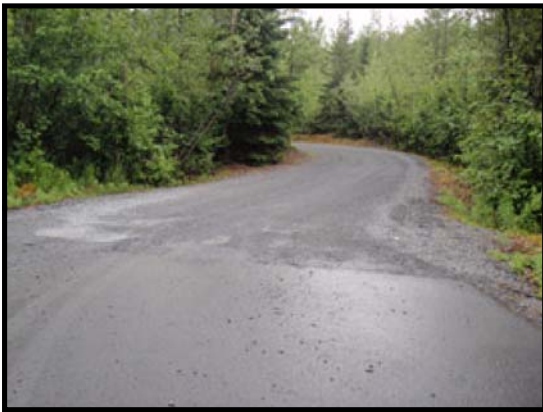
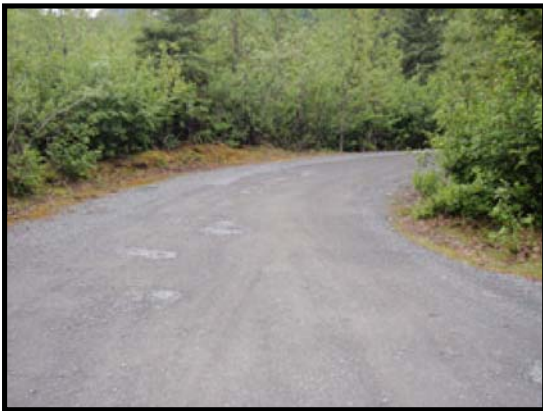
Route 0401

Route Number	Public / NonPublic	Date Visited	Area (sq ft)	Lane Miles *	MRL	
					Length (mi)	Width (ft)
0401	PUBLIC	7/2/2010	2,640	0.05	0.05	10
Culverts	Drop Inlets	Gates	Curb & Gutter	Curb	PCR	Surface Type
1	0	0	NO CURB AND GUTTER	NO CURB	FAIR/73	GR

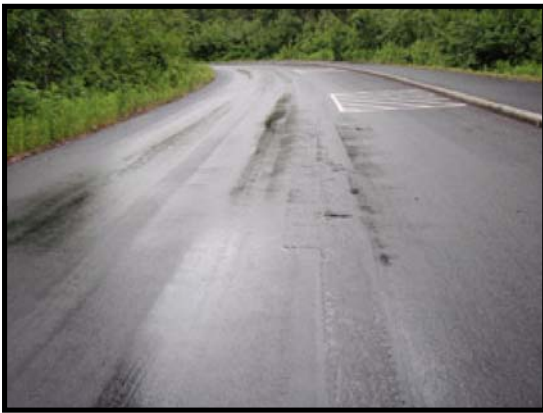
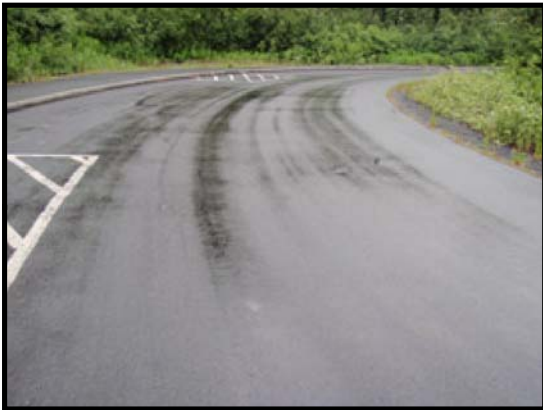
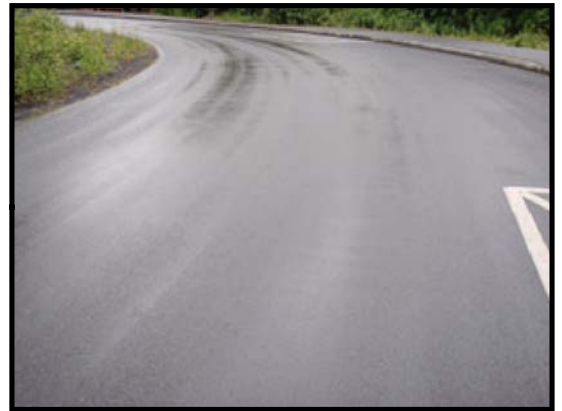
Route 0900BZ

Route Number	Public / NonPublic	Date Visited	Area (sq ft)	Lane Miles *	Surface Type
0900BZ	PUBLIC	7/2/2010	30,107	0.52	AS
Culverts	Drop Inlets	Gates	Curb & Gutter	Curb	PCR
0	0	0	NO CURB AND GUTTER	CONCRETE CURB	GOOD/90

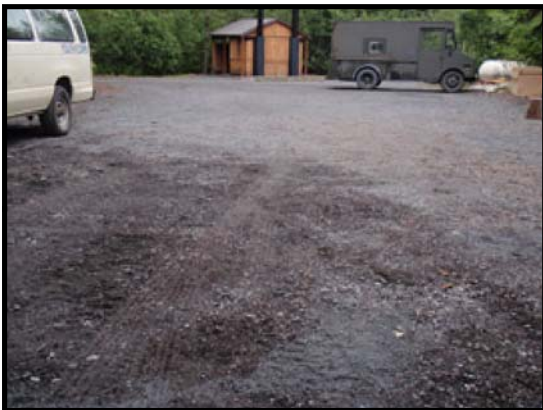
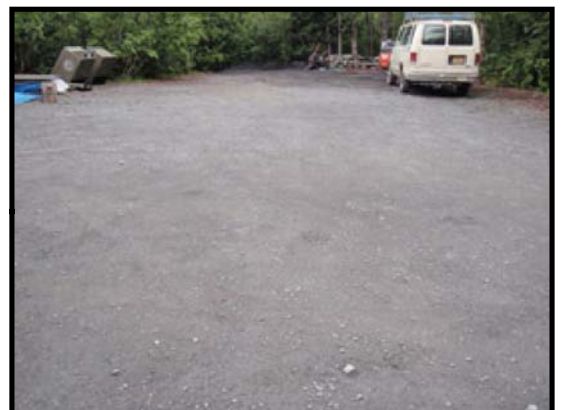
Route 0902

Route Number	Public / NonPublic	Date Visited	Area (sq ft)	Lane Miles *	Surface Type
0902	PUBLIC	7/2/2010	6,952	0.12	GR
Culverts	Drop Inlets	Gates	Curb & Gutter	Curb	PCR
0	0	0	NO CURB AND GUTTER	NO CURB	FAIR/73
