# Federal Lands Highway Road Inventory Program

Road Inventory and Condition Assessment

## Kings Canyon National Park KICA

### Cycle 5 Report

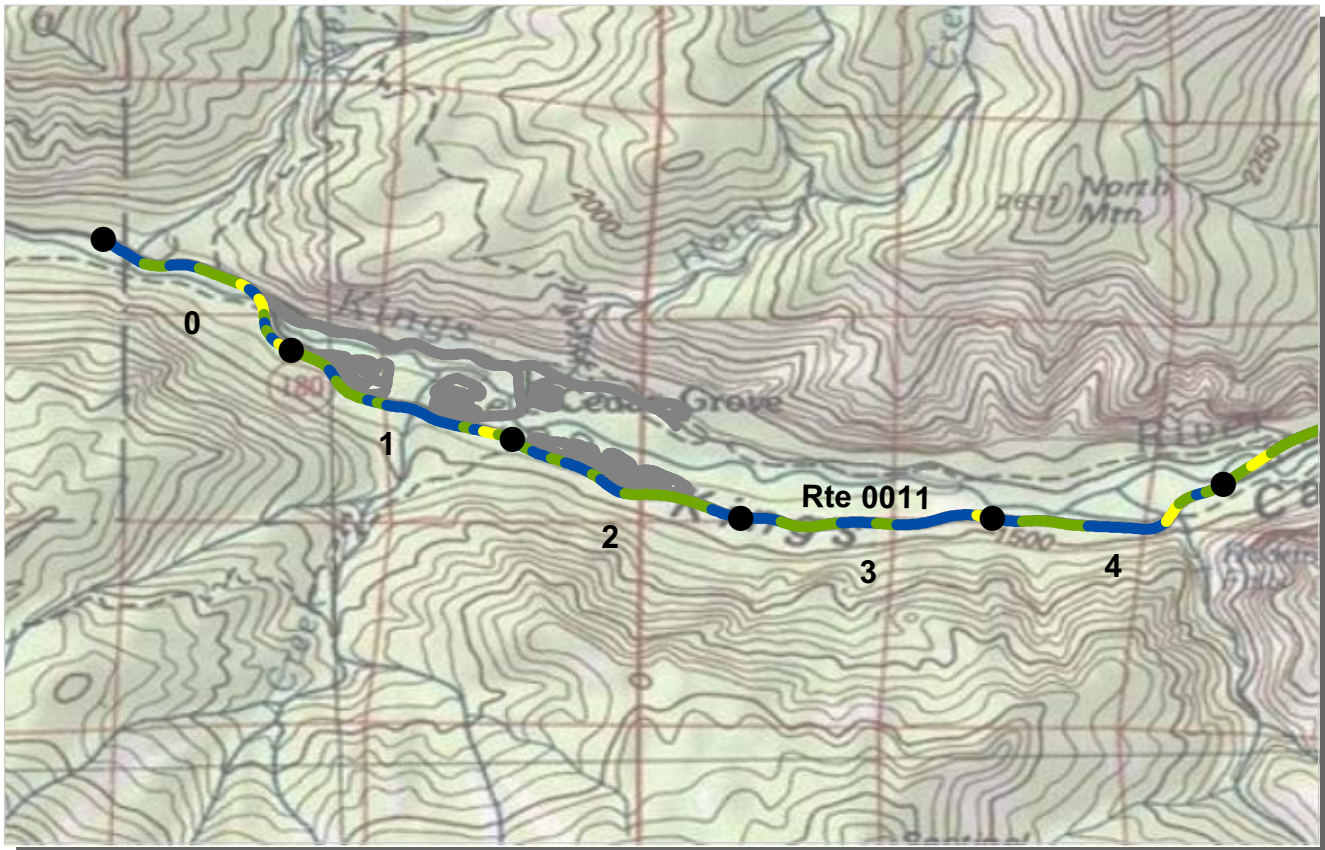
<i>Section Number</i>	0	1	2	3	4
<i>Section Length (mi)</i>	1.00	1.00	1.00	1.00	1.00
<i>Cross Section Information</i>					
Number of Lanes	2	2	2	2	2
Paved Width (ft)	25	25	25	25	25
Lane Width (ft)	12	12	12	11	12
<i>Roadway Condition Information</i>					
SCR (Surface Condition Rating)	96	98	95	97	96
PCR (Pavement Condition Rating)	91	93	93	92	92
<i>Distress Index Values</i>					
Structural Crack Index	100	100	100	100	100
Transverse Cracking Index	100	100	100	100	100
Patching Index	100	100	100	100	100
Rutting Index	96	98	95	97	96
Roughness Condition Index (RCI)	84	85	91	85	87

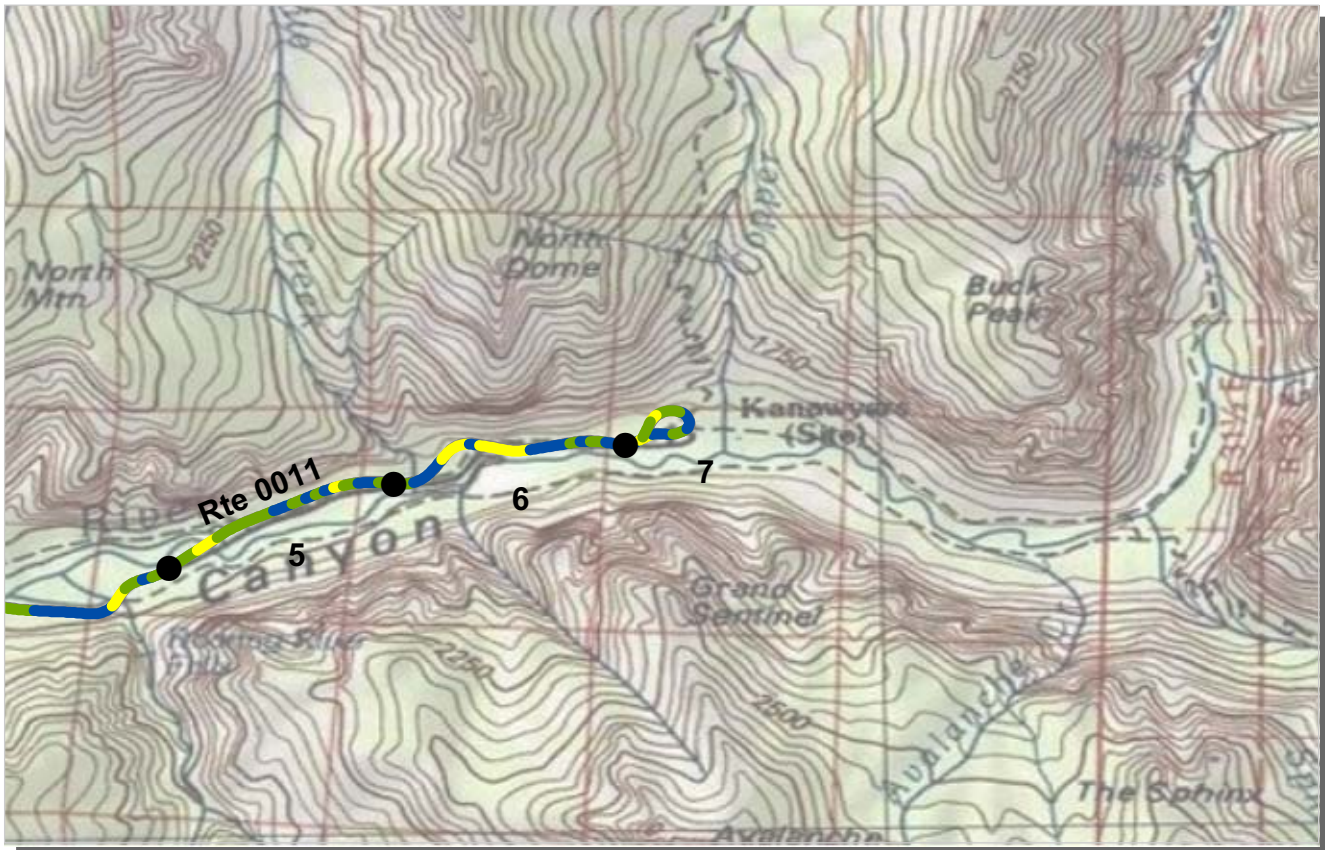
**ROUTE: 0011 CEDAR GROVE ROAD**

PCR    Poor ■    Fair ■    Good ■    Excellent ■    No Data ■  
           (0 - 60)           (61 - 84)           (85 - 94)           (95 - 100)

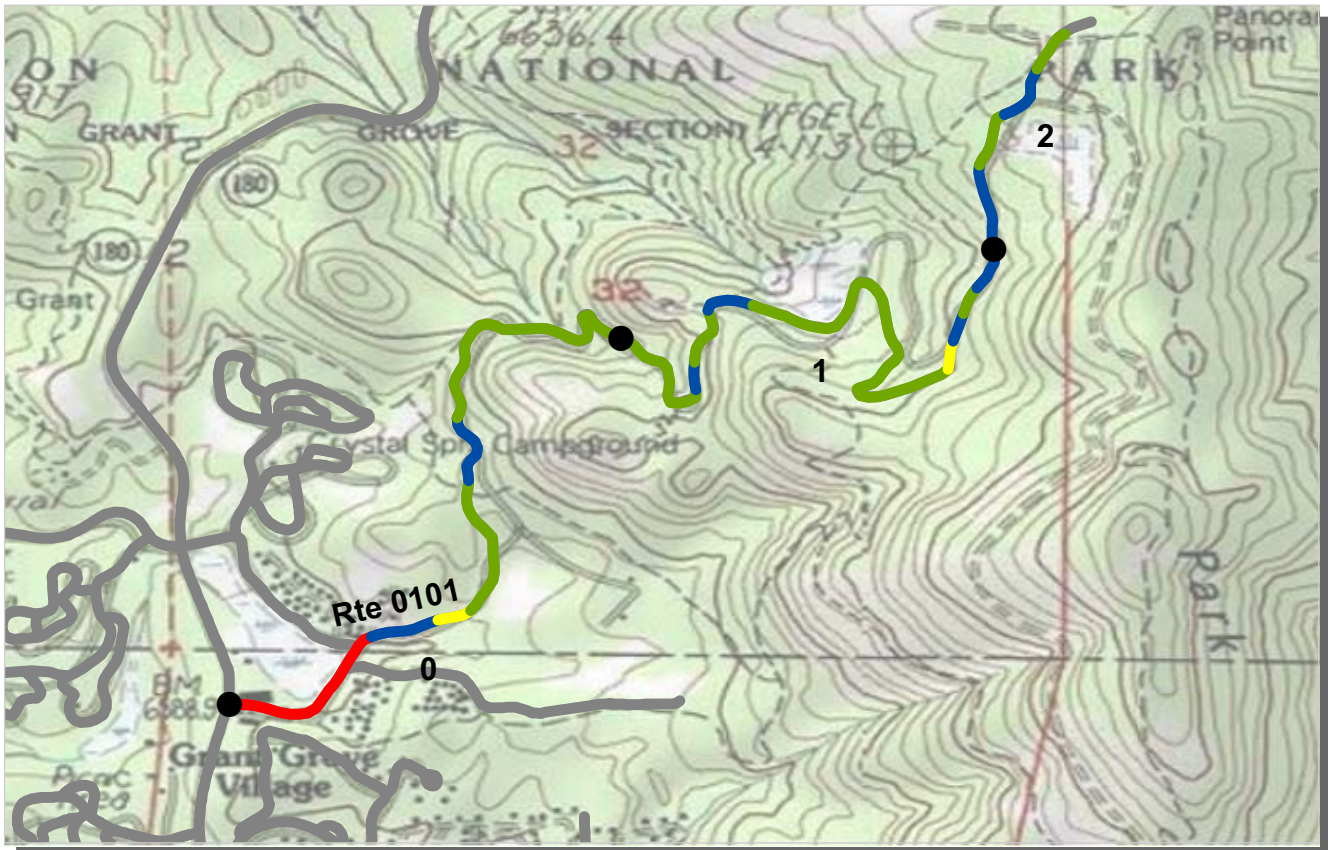
**ROUTE: 0015 GRANT GROVE ROAD**

PCR    Poor ■    Fair ■    Good ■    Excellent ■    No Data ■  
           (0 - 60)           (61 - 84)           (85 - 94)           (95 - 100)

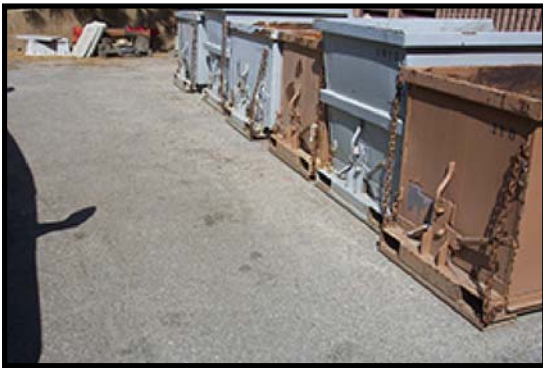
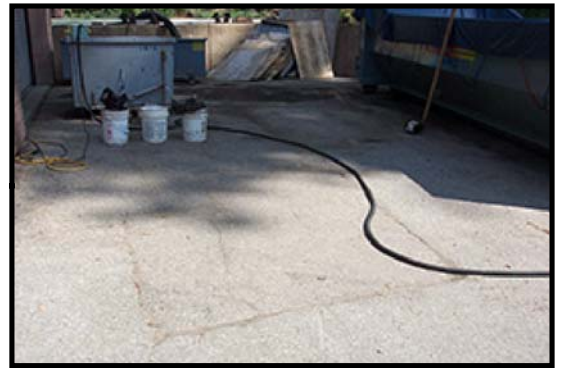
## Route 0936BZ

Route Number	Public / NonPublic	Date Visited	Area (sq ft)	Lane Miles *	Surface Type
0936AZ	NONPUBLIC	9/19/2011	1,614	0.03	AS
Culverts	Drop Inlets	Gates	Curb & Gutter	Curb	PCR
0	0	0	NO CURB AND GUTTER	NO CURB	POOR/45
