Federal Lands Highway Road Inventory Program

Road Inventory and Condition Assessment

Lava Beds National Monument

Cycle 5 Report

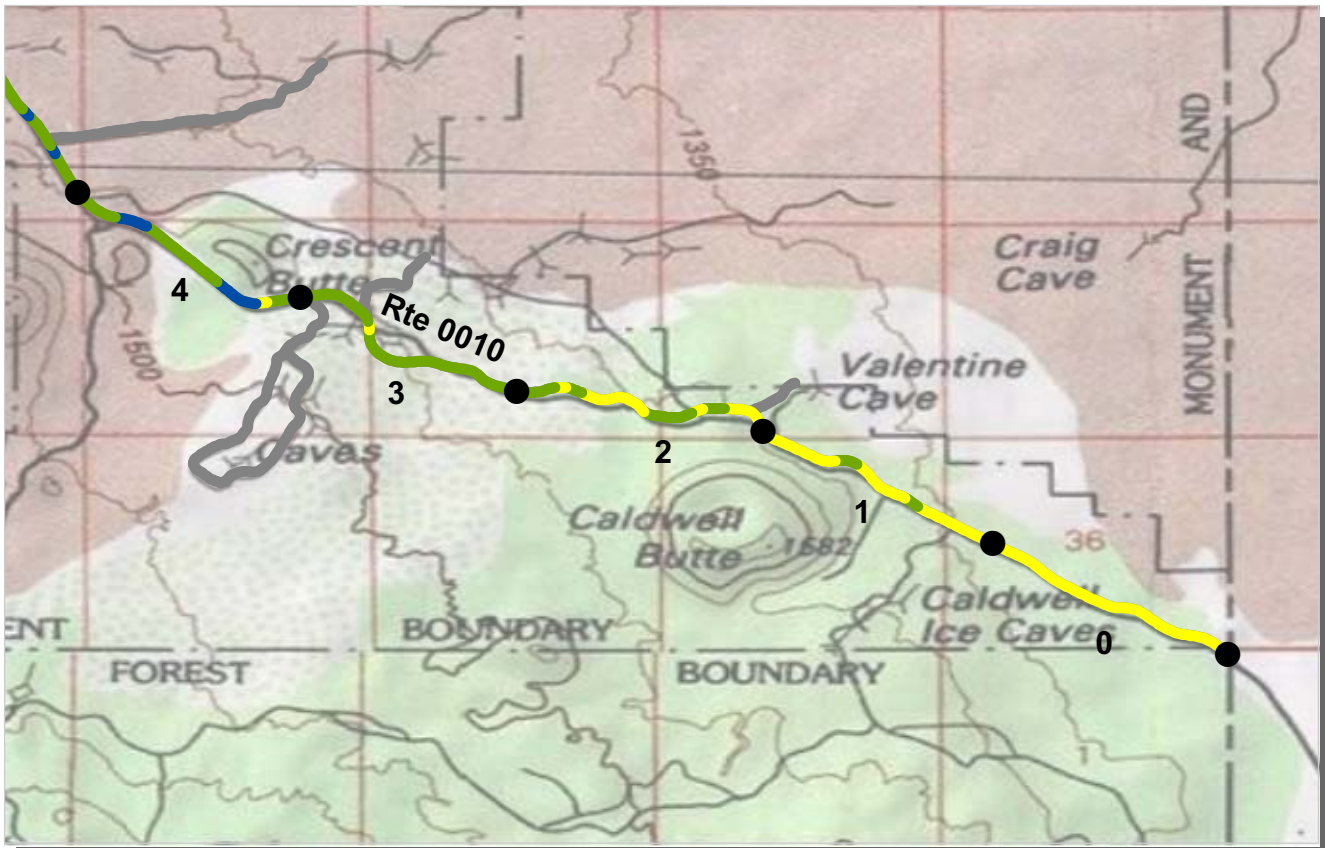
<i>Section Number</i>	0	1	2	3	4
<i>Section Length (mi)</i>	1.00	1.00	1.00	1.00	1.00
<i>Cross Section Information</i>					
Number of Lanes	2	2	2	2	2
Paved Width (ft)	24	24	26	26	26
Lane Width (ft)	11	12	12	12	12
<i>Roadway Condition Information</i>					
SCR (Surface Condition Rating)	92	92	95	97	97
PCR (Pavement Condition Rating)	77	78	82	89	92
<i>Distress Index Values</i>					
Structural Crack Index	100	100	100	100	100
Transverse Cracking Index	99	99	100	100	100
Patching Index	100	100	100	100	100
Rutting Index	92	92	95	97	97
Roughness Condition Index (RCI)	54	56	63	77	84

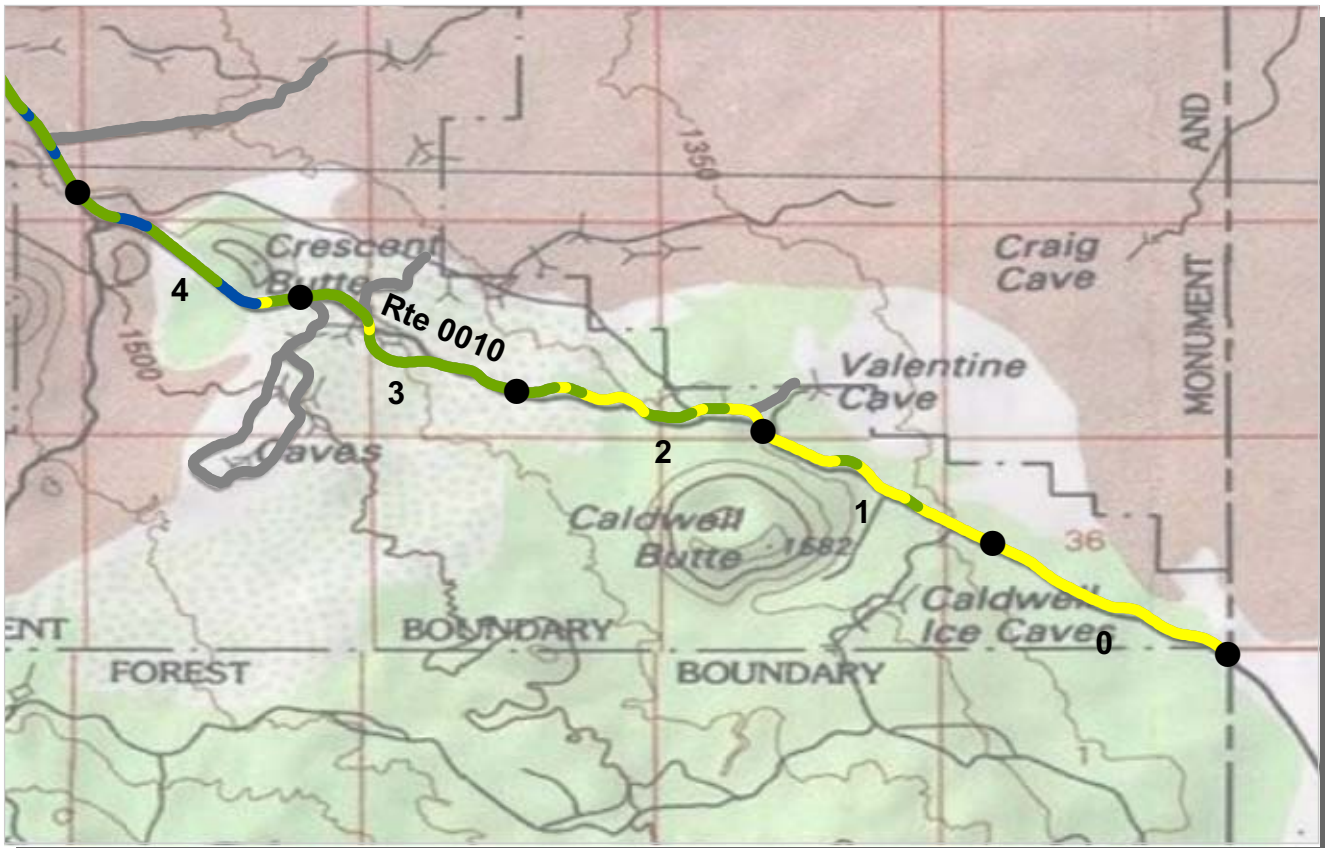
ROUTE: 0010 MAIN PARK ROAD

<i>Section Number</i>	0	1	2	3	4
<i>Section Length (mi)</i>	1.00	1.00	1.00	1.00	1.00
<i>Cross Section Information</i>					
Number of Lanes	2	2	2	2	2
Paved Width (ft)	24	24	26	26	26
Lane Width (ft)	11	12	12	12	12
<i>Roadway Condition Information</i>					
SCR (Surface Condition Rating)	92	92	95	97	97
PCR (Pavement Condition Rating)	77	78	82	89	92
<i>Distress Index Values</i>					
Structural Crack Index	100	100	100	100	100
Transverse Cracking Index	99	99	100	100	100
Patching Index	100	100	100	100	100
Rutting Index	92	92	95	97	97
Roughness Condition Index (RCI)	54	56	63	77	84

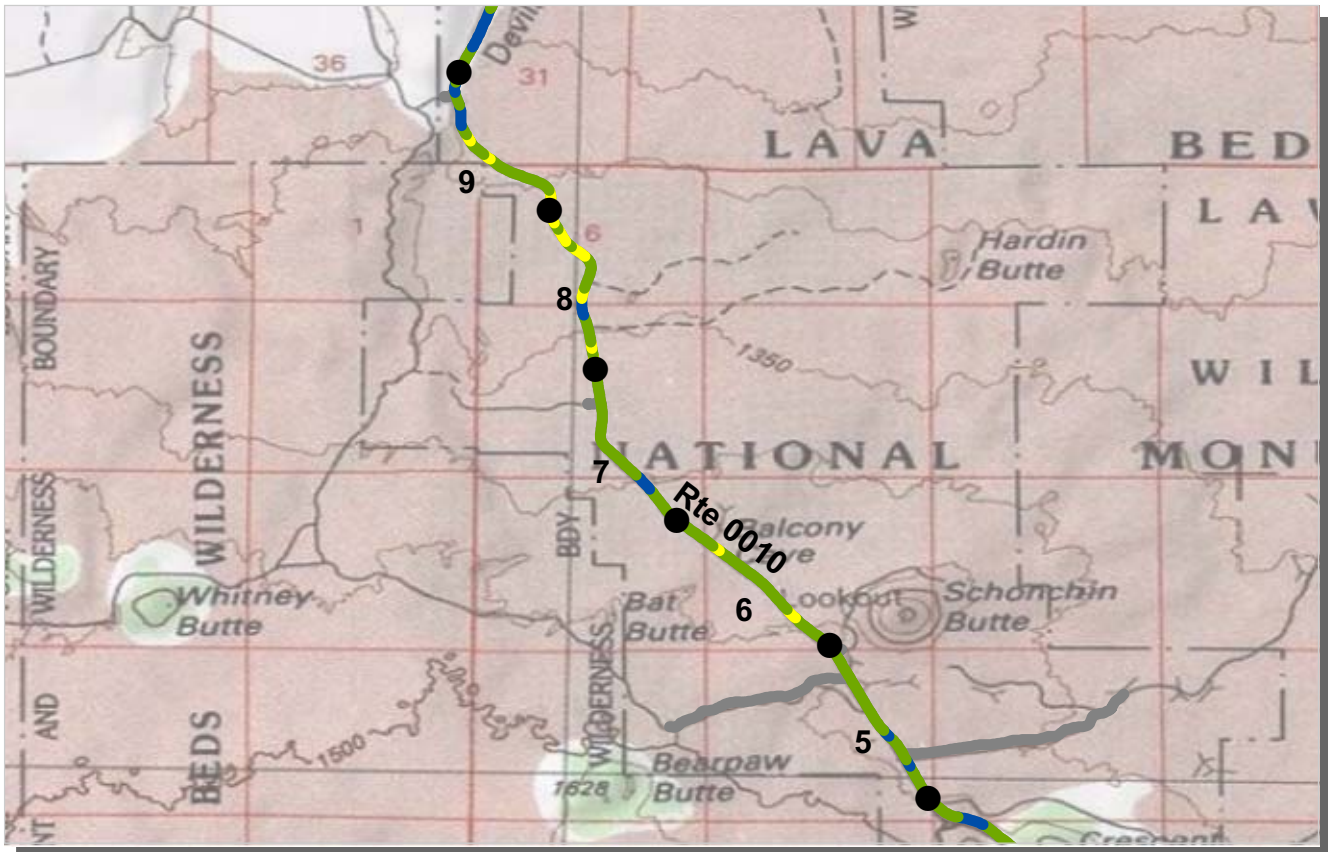
ROUTE: 0010 MAIN PARK ROAD

<i>Section Number</i>	5	6	7	8	9
<i>Section Length (mi)</i>	1.00	1.00	1.00	1.00	1.00
<i>Cross Section Information</i>					
Number of Lanes	2	2	2	2	2
Paved Width (ft)	26	25	25	25	25
Lane Width (ft)	12	12	12	12	12
<i>Roadway Condition Information</i>					
SCR (Surface Condition Rating)	94	90	92	91	93
PCR (Pavement Condition Rating)	90	90	89	86	89
<i>Distress Index Values</i>					
Structural Crack Index	100	100	100	100	100
Transverse Cracking Index	100	100	100	100	99
Patching Index	100	100	100	100	100
Rutting Index	94	90	92	91	93
Roughness Condition Index (RCI)	84	90	84	78	84

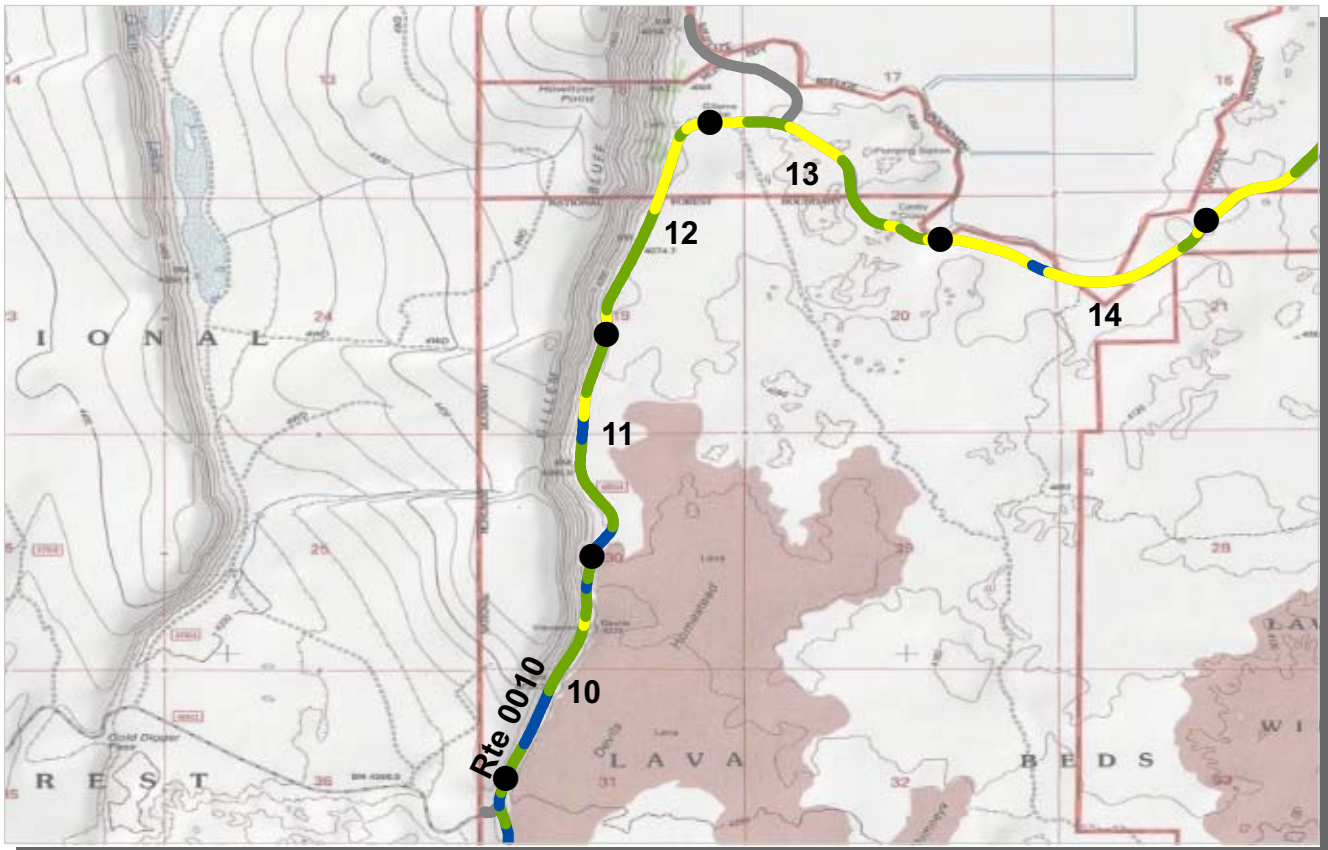
ROUTE: 0010 MAIN PARK ROAD

<i>Section Number</i>	10	11	12	13	14
<i>Section Length (mi)</i>	1.00	1.00	1.00	1.00	1.00
<i>Cross Section Information</i>					
Number of Lanes	2	2	2	2	2
Paved Width (ft)	26	25	26	26	25
Lane Width (ft)	12	13	12	12	12
<i>Roadway Condition Information</i>					
SCR (Surface Condition Rating)	92	92	86	91	90
PCR (Pavement Condition Rating)	91	93	84	85	80
<i>Distress Index Values</i>					
Structural Crack Index	100	100	100	100	100
Transverse Cracking Index	100	100	100	100	100
Patching Index	100	100	100	100	100
Rutting Index	92	92	86	91	90
Roughness Condition Index (RCI)	90	94	82	75	65

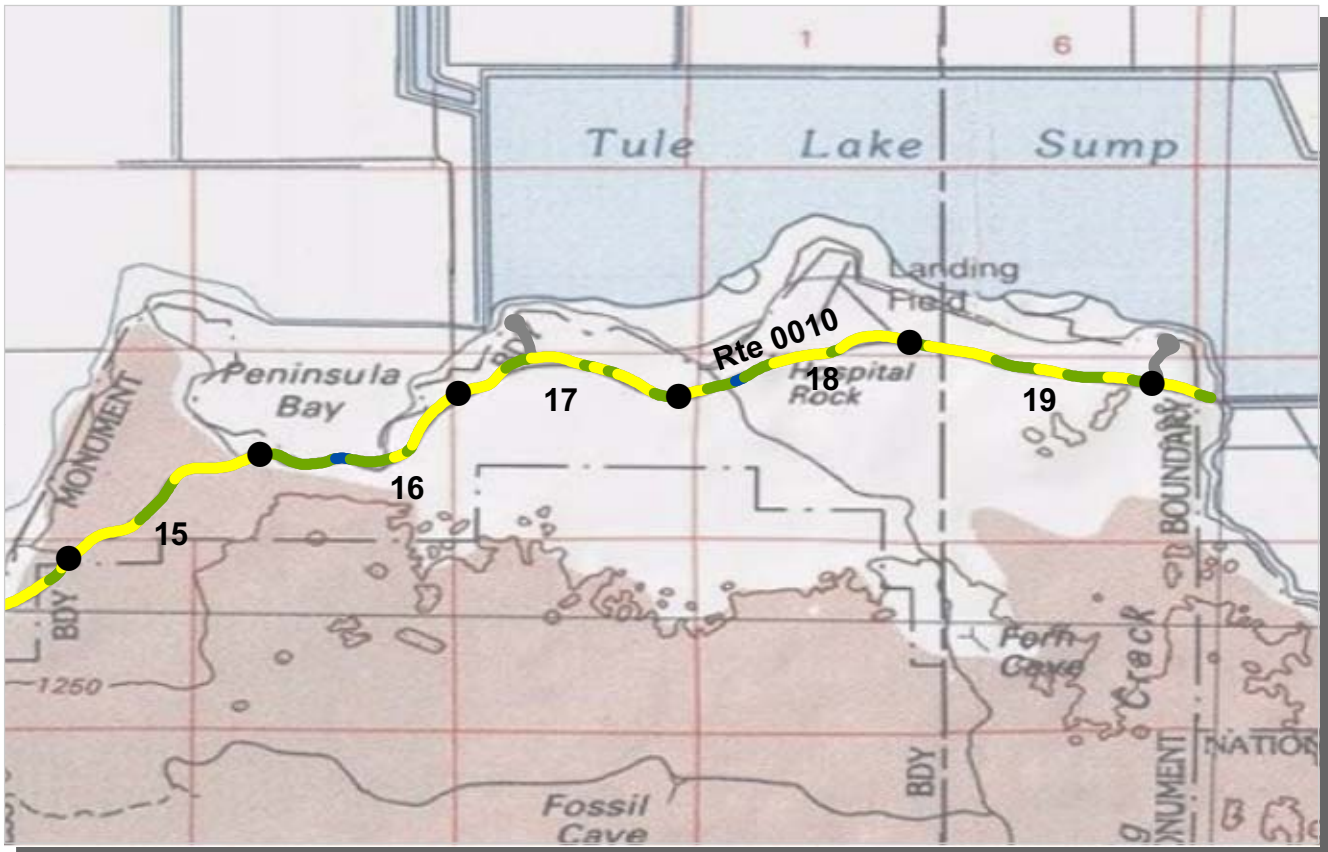
ROUTE: 0010 MAIN PARK ROAD

Section Number	15	16	17	18	19
Section Length (mi)	1.00	1.00	1.00	1.00	1.00
Cross Section Information					
Number of Lanes	2	2	2	2	2
Paved Width (ft)	25	26	26	26	26
Lane Width (ft)	12	12	12	12	12
Roadway Condition Information					
SCR (Surface Condition Rating)	90	91	89	92	93
PCR (Pavement Condition Rating)	81	84	82	83	85
Distress Index Values					
Structural Crack Index	100	100	100	100	100
Transverse Cracking Index	99	100	100	100	100
Patching Index	100	100	100	100	100
Rutting Index	90	91	89	92	93
Roughness Condition Index (RCI)	68	73	71	70	73

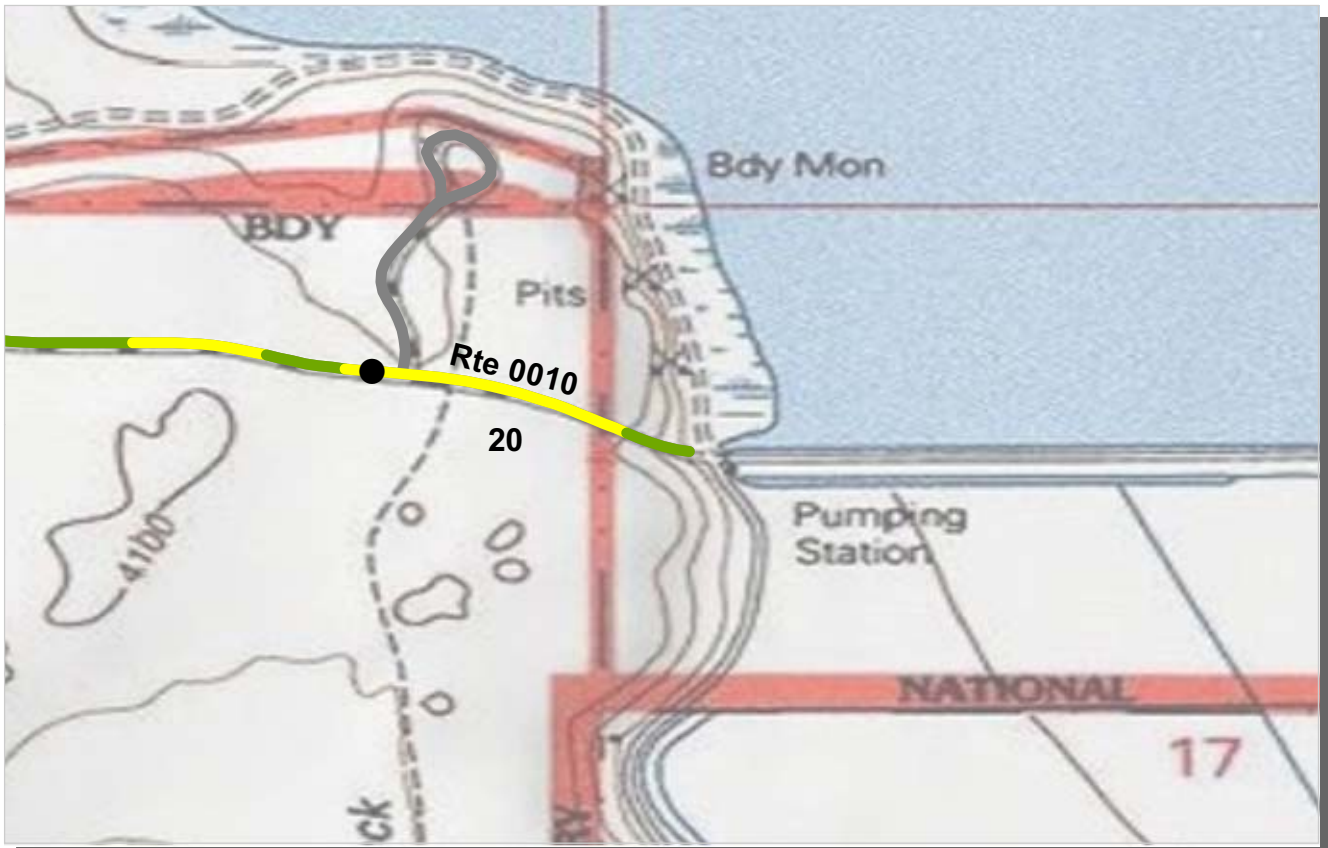
ROUTE: 0010 MAIN PARK ROAD

Section Number	20				
Section Length (mi)	0.25				
Cross Section Information					
Number of Lanes	2				
Paved Width (ft)	26				
Lane Width (ft)	13				
Roadway Condition Information					
SCR (Surface Condition Rating)	89				
PCR (Pavement Condition Rating)	80				
Distress Index Values					
Structural Crack Index	100				
Transverse Cracking Index	99				
Patching Index	100				
Rutting Index	89				
Roughness Condition Index (RCI)	66

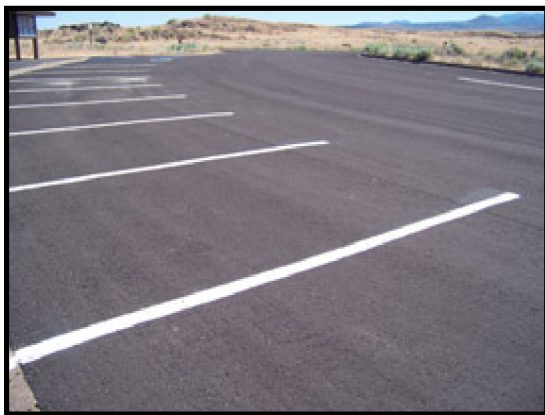
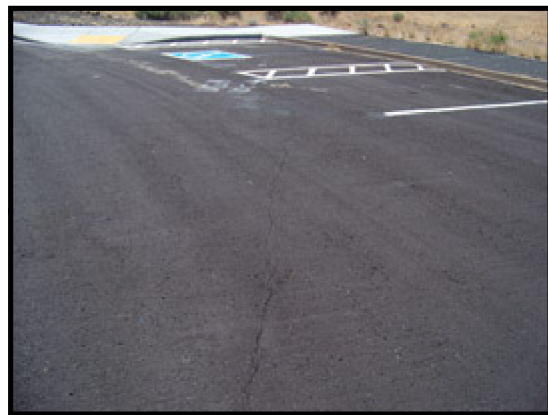
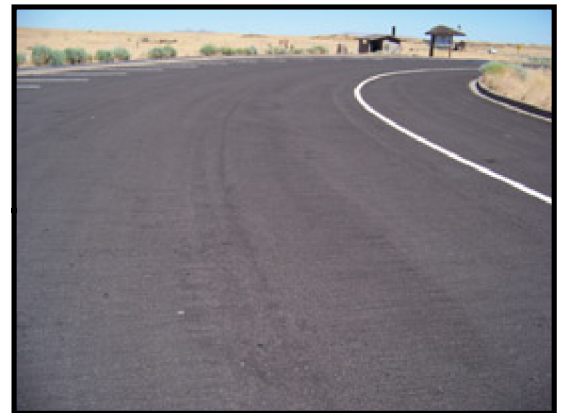
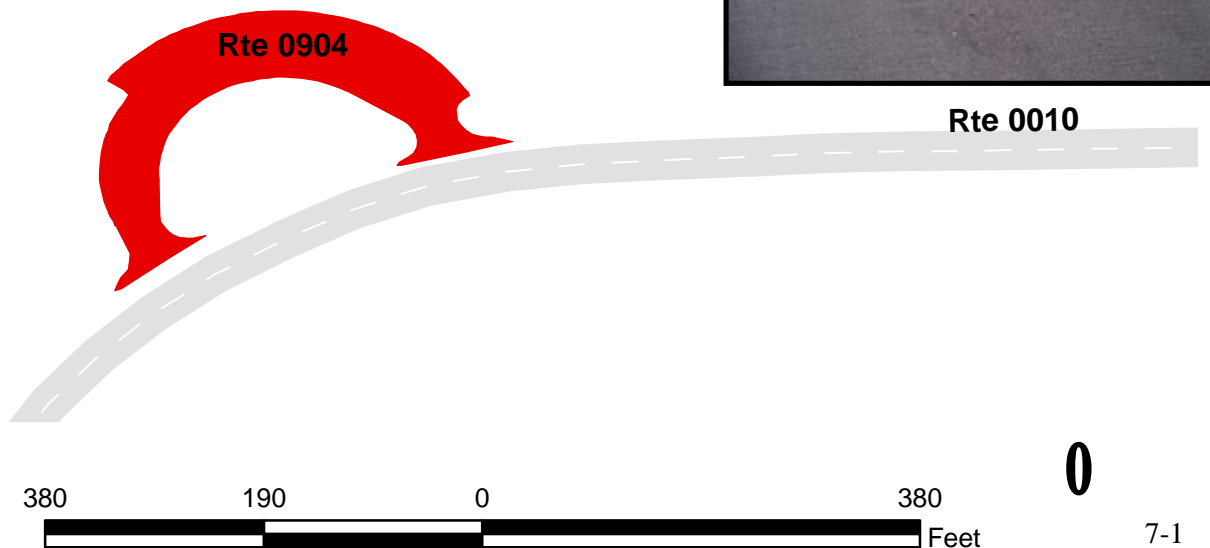
Route Number	Public / NonPublic	Date Visited	Area (sq ft)	Lane Miles *	Surface Type
0904	PUBLIC	8/13/2010	19,695	0.34	AS
Culverts	Drop Inlets	Gates	Curb & Gutter	Curb	PCR
0	1	0	CONCRETE CURB AND GUTTER	NO CURB	GOOD/90
