# Federal Lands Highway Road Inventory Program

Road Inventory and Condition Assessment

## Lake Meredith National Recreation Area

### Cycle 5 Report

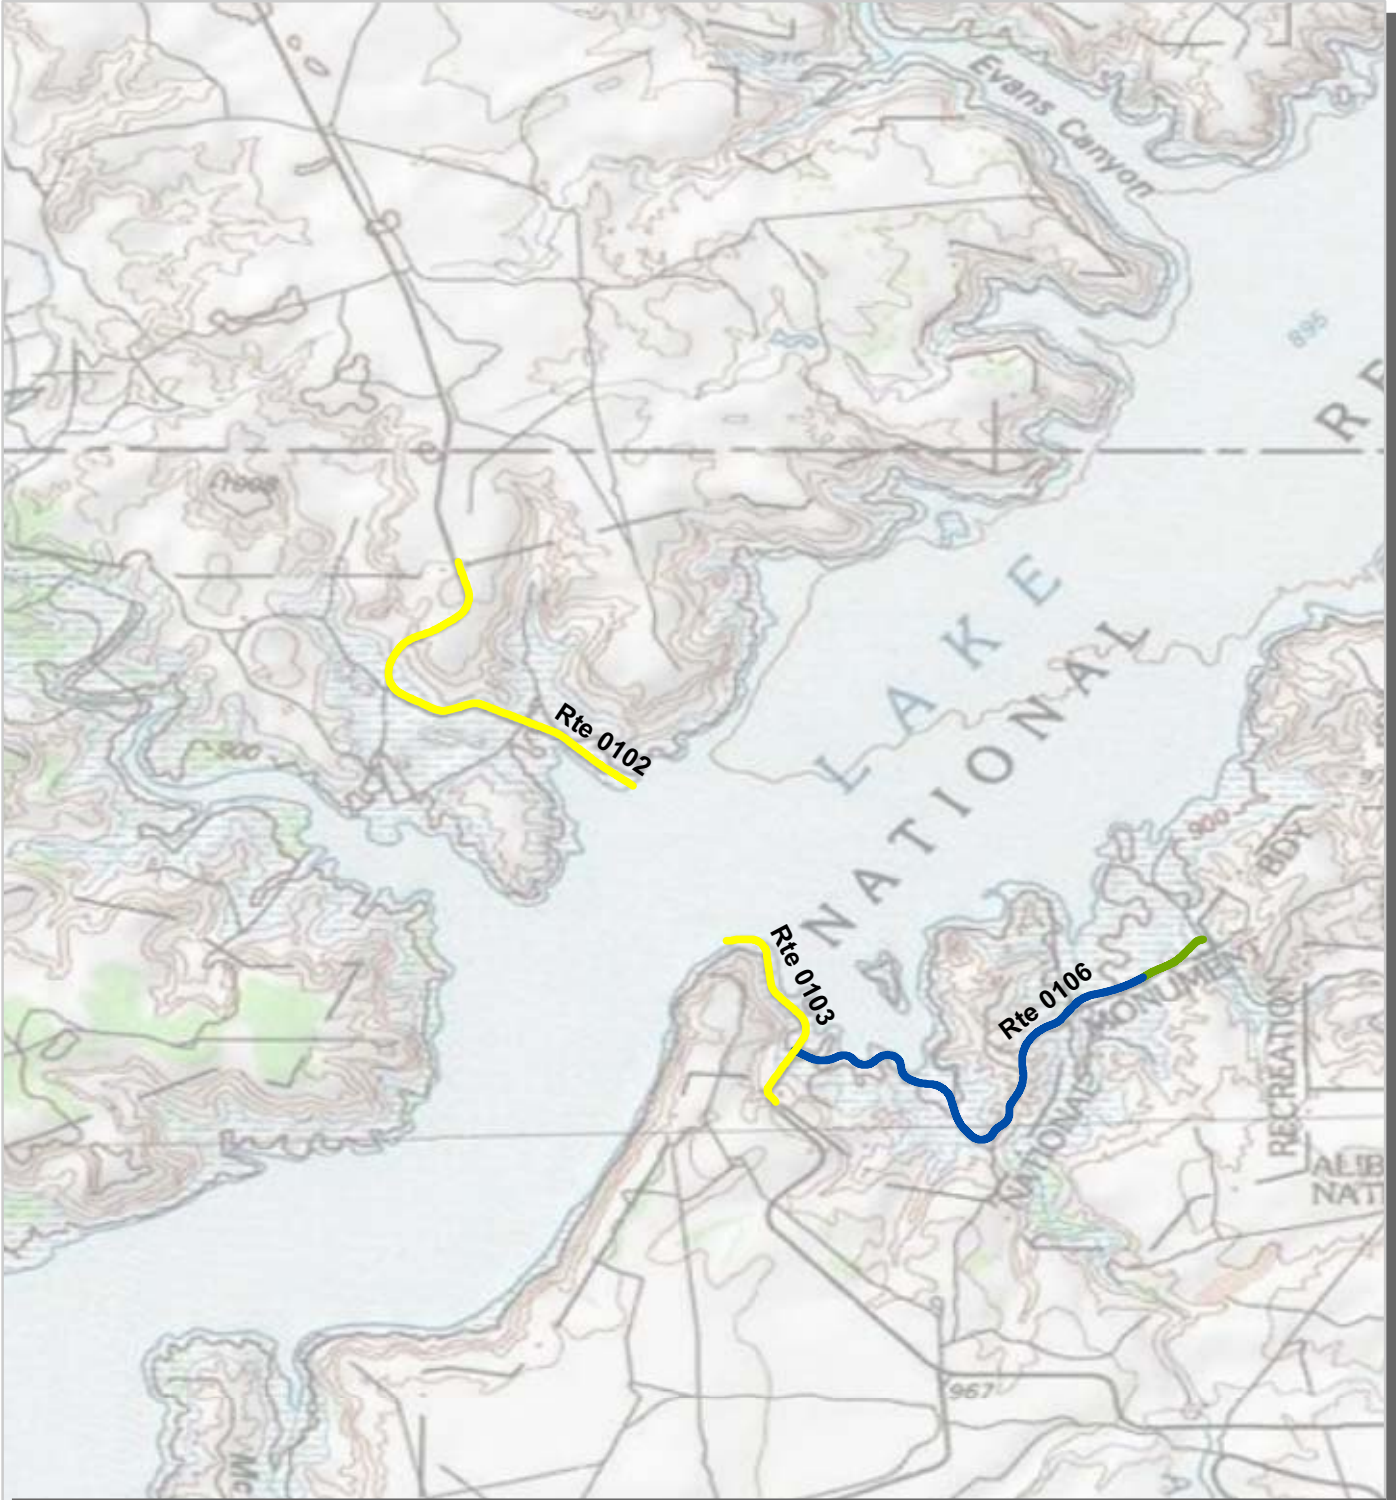
**Lake Meredith National Recreation Area  
Route Condition Map  
PCR - Mile by Mile  
Area 2**

PCR	Poor	<span style="display: inline-block; width: 20px; height: 10px; background-color: red; border: 1px solid black;"></span>	Fair	<span style="display: inline-block; width: 20px; height: 10px; background-color: yellow; border: 1px solid black;"></span>	Good	<span style="display: inline-block; width: 20px; height: 10px; background-color: green; border: 1px solid black;"></span>	Excellent	<span style="display: inline-block; width: 20px; height: 10px; background-color: blue; border: 1px solid black;"></span>	No Data	<span style="display: inline-block; width: 20px; height: 10px; background-color: black; border: 1px solid black;"></span>
	(0 - 60)		(61 - 84)	(85 - 94)		(95 - 100)
