Federal Lands Highway Road Inventory Program

Road Inventory and Condition Assessment

Lake Roosevelt National Recreation Area LARO - 9260

Cycle 5 Report

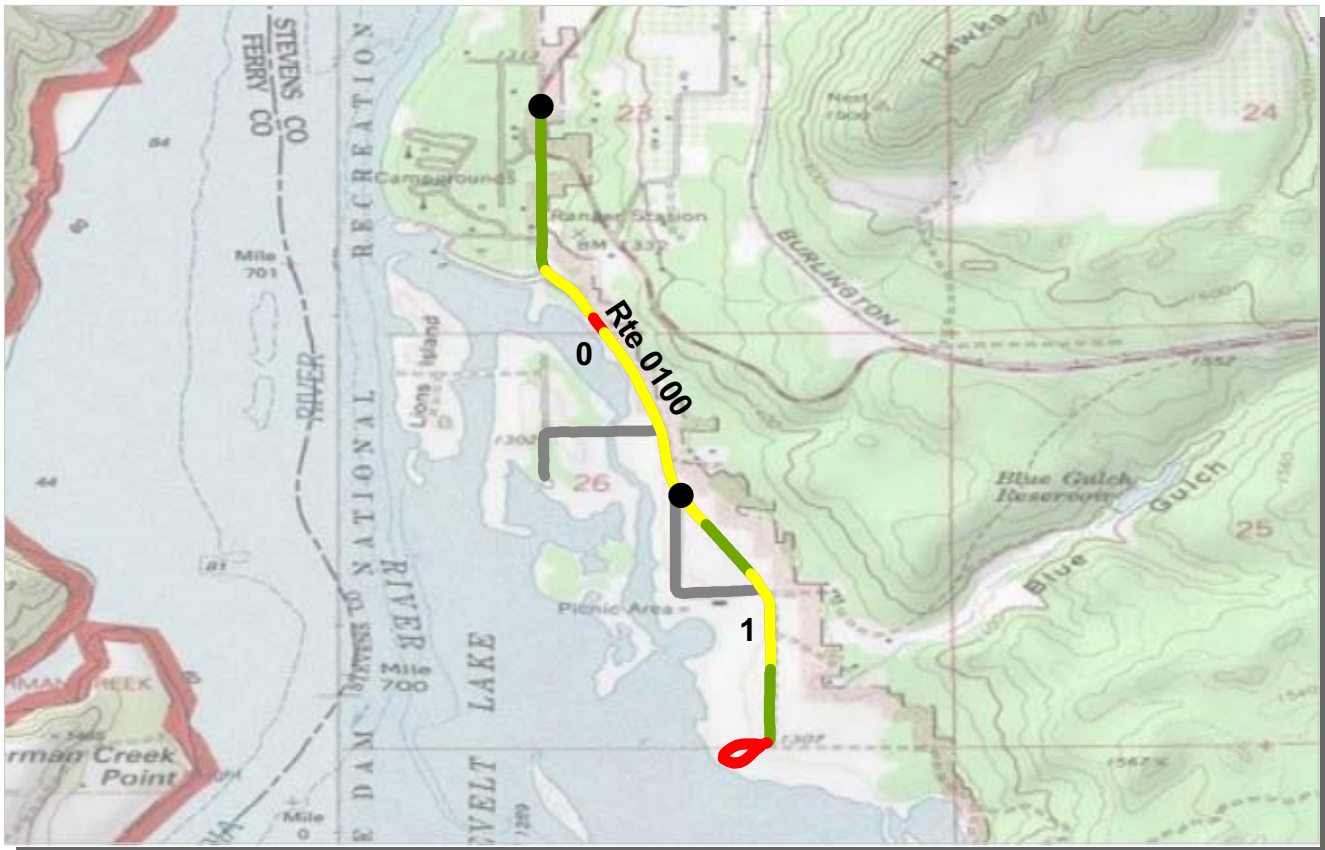
ROUTE: 0100 KETTLE FALLS ENTRANCE ROAD

<i>Section Number</i>	0	1			
<i>Section Length (mi)</i>	1.00	0.81			
<i>Cross Section Information</i>					
Number of Lanes	2	2			
Paved Width (ft)	21	18			
Lane Width (ft)	10	10			
<i>Roadway Condition Information</i>					
SCR (Surface Condition Rating)	89	18			
PCR (Pavement Condition Rating)	81	34			
<i>Distress Index Values</i>					
Structural Crack Index	89	18			
Transverse Cracking Index	95	95			
Patching Index	99	100			
Rutting Index	95	87			
Roughness Condition Index (RCI)	70	58

Structural Crack Index is a combination of the Longitudinal Cracking Index and Alligator Cracking Index.
 See Section 10 for explanation of SCR, PCR, & all Distress Index Values.

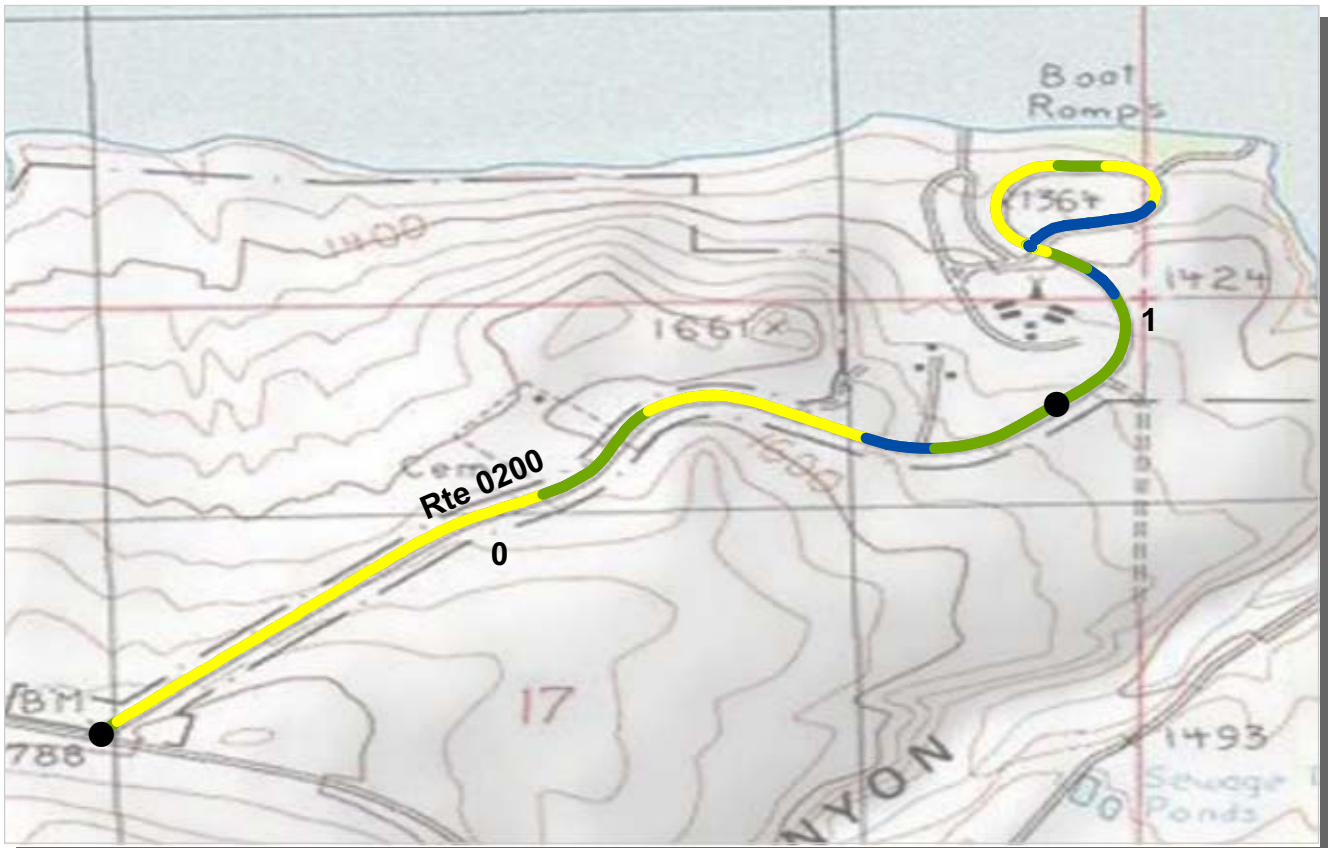
ROUTE: 0200 SPRING CANYON ROAD

<i>Section Number</i>	0	1			
<i>Section Length (mi)</i>	1.00	0.64			
<i>Cross Section Information</i>					
Number of Lanes	2	2			
Paved Width (ft)	22	22			
Lane Width (ft)	10	11			
<i>Roadway Condition Information</i>					
SCR (Surface Condition Rating)	94	95			
PCR (Pavement Condition Rating)	82	80			
<i>Distress Index Values</i>					
Structural Crack Index	100	100			
Transverse Cracking Index	100	100			
Patching Index	100	100			
Rutting Index	94	95			
Roughness Condition Index (RCI)	63	58

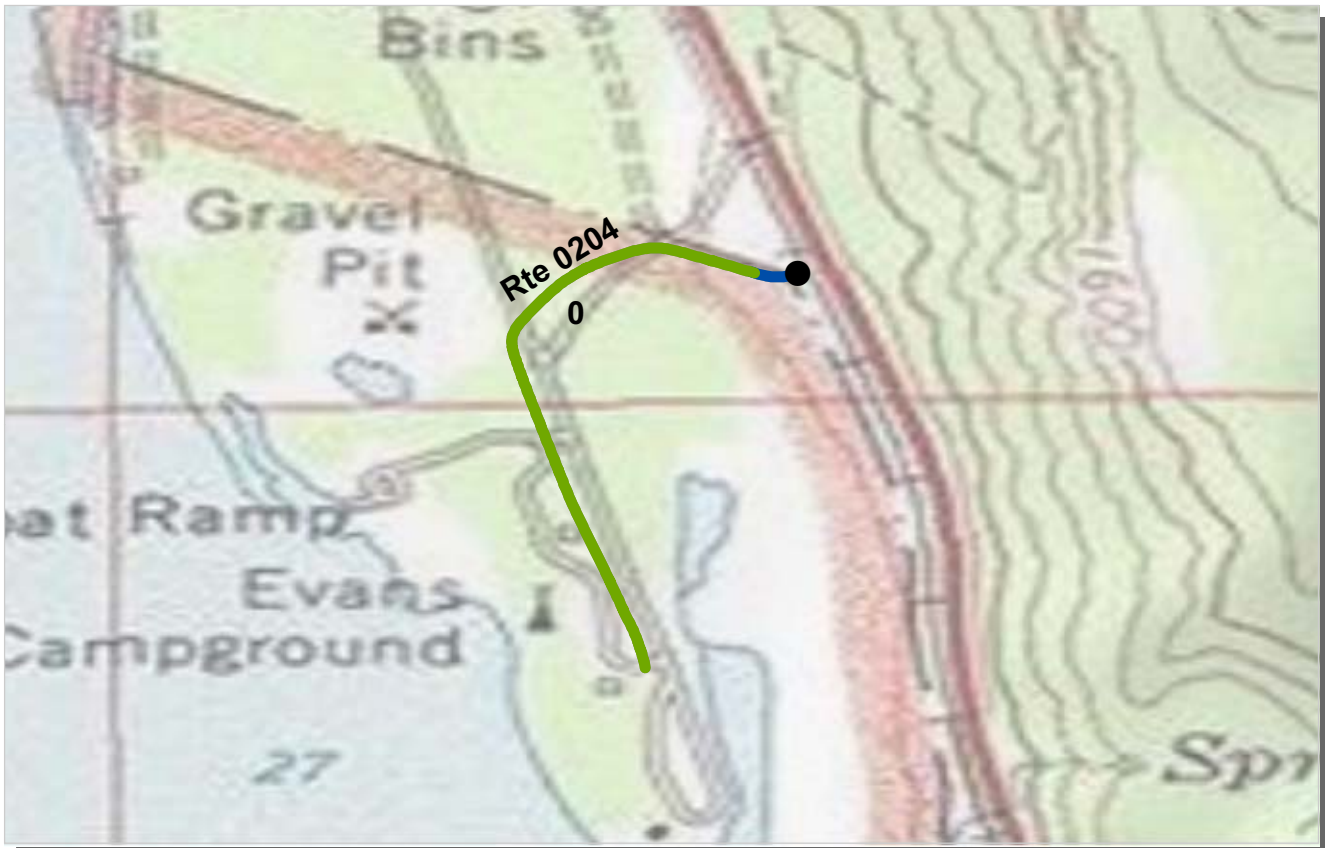
ROUTE: 0204 EVANS CAMPGROUND ROAD

Section Number	0				
Section Length (mi)	0.38				
Cross Section Information					
Number of Lanes	2				
Paved Width (ft)	19				
Lane Width (ft)	10				
Roadway Condition Information					
SCR (Surface Condition Rating)	90				
PCR (Pavement Condition Rating)	90				
Distress Index Values					
Structural Crack Index	99				
Transverse Cracking Index	99				
Patching Index	99				
Rutting Index	90				
Roughness Condition Index (RCI)	NC

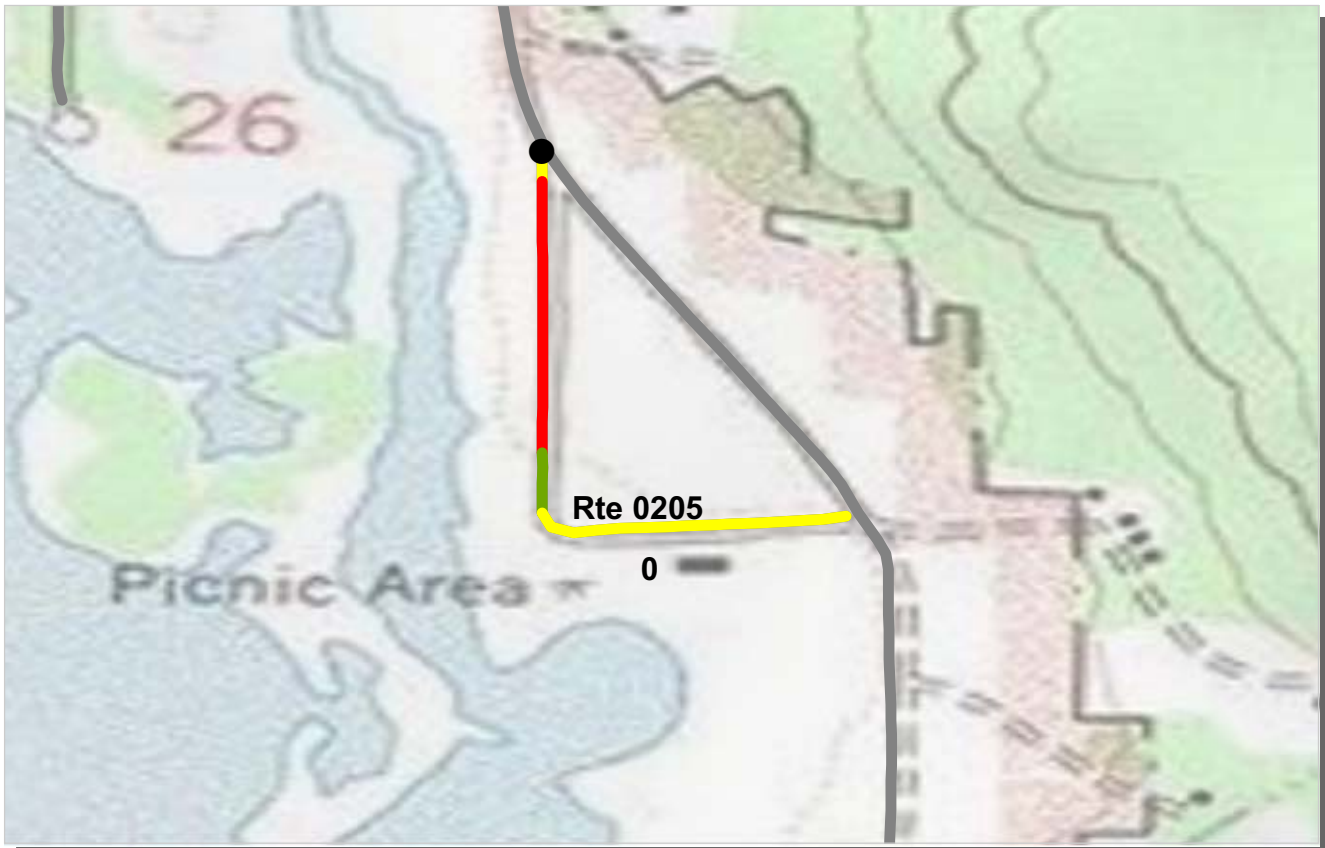
ROUTE: 0205 KETTLE FALLS PICNIC ROAD

Section Number	0				
Section Length (mi)	0.38				
Cross Section Information					
Number of Lanes	2				
Paved Width (ft)	24				
Lane Width (ft)	10				
Roadway Condition Information					
SCR (Surface Condition Rating)	56				
PCR (Pavement Condition Rating)	56				
Distress Index Values					
Structural Crack Index	56				
Transverse Cracking Index	80				
Patching Index	100				
Rutting Index	93				
Roughness Condition Index (RCI)	NC

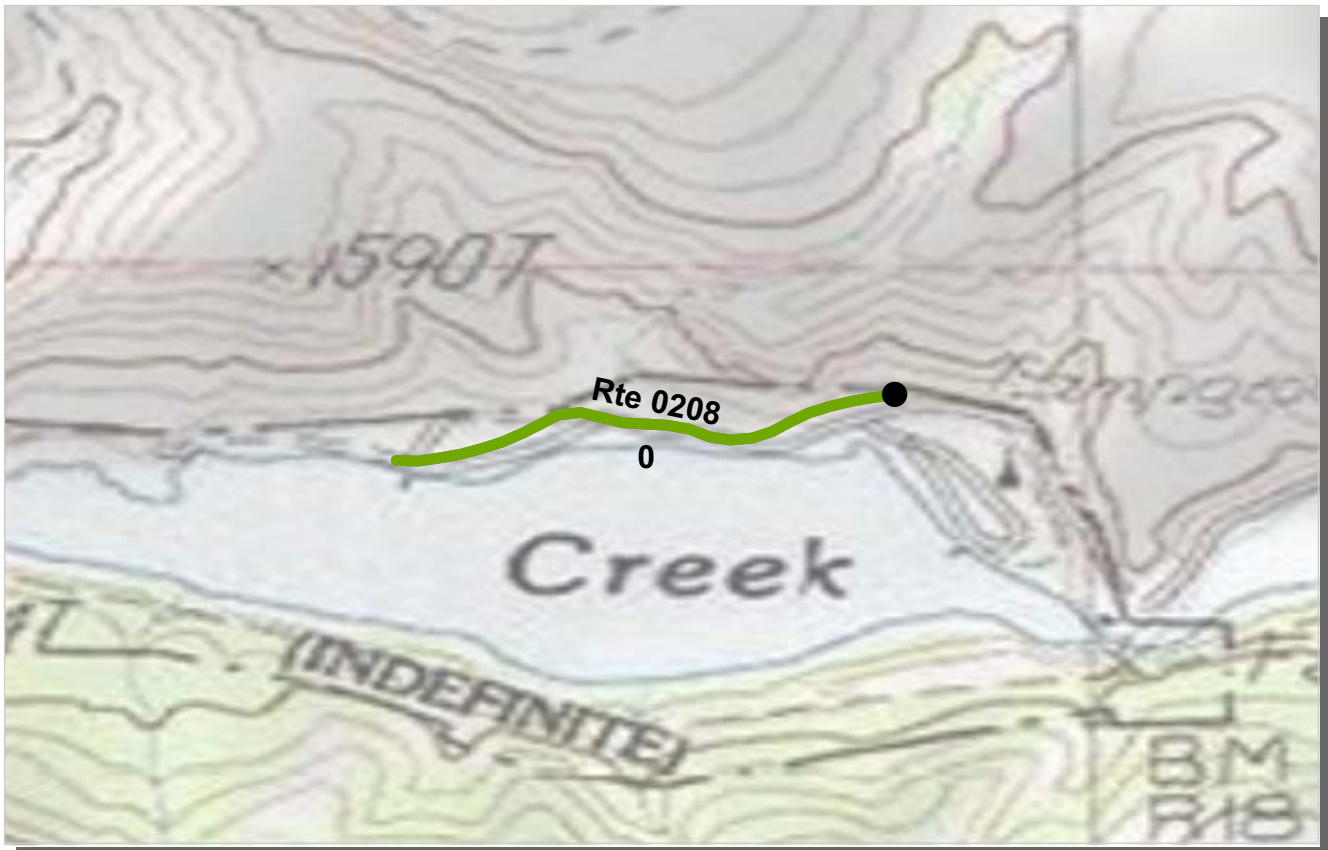
ROUTE: 0208 HAWK CREEK CAMPGROUND ROAD

Section Number	0				
Section Length (mi)	0.24				
Cross Section Information					
Number of Lanes	2				
Paved Width (ft)	18				
Lane Width (ft)	9				
Roadway Condition Information					
SCR (Surface Condition Rating)	93				
PCR (Pavement Condition Rating)	93				
Distress Index Values					
Structural Crack Index	100				
Transverse Cracking Index	100				
Patching Index	100				
Rutting Index	93				
Roughness Condition Index (RCI)	NC

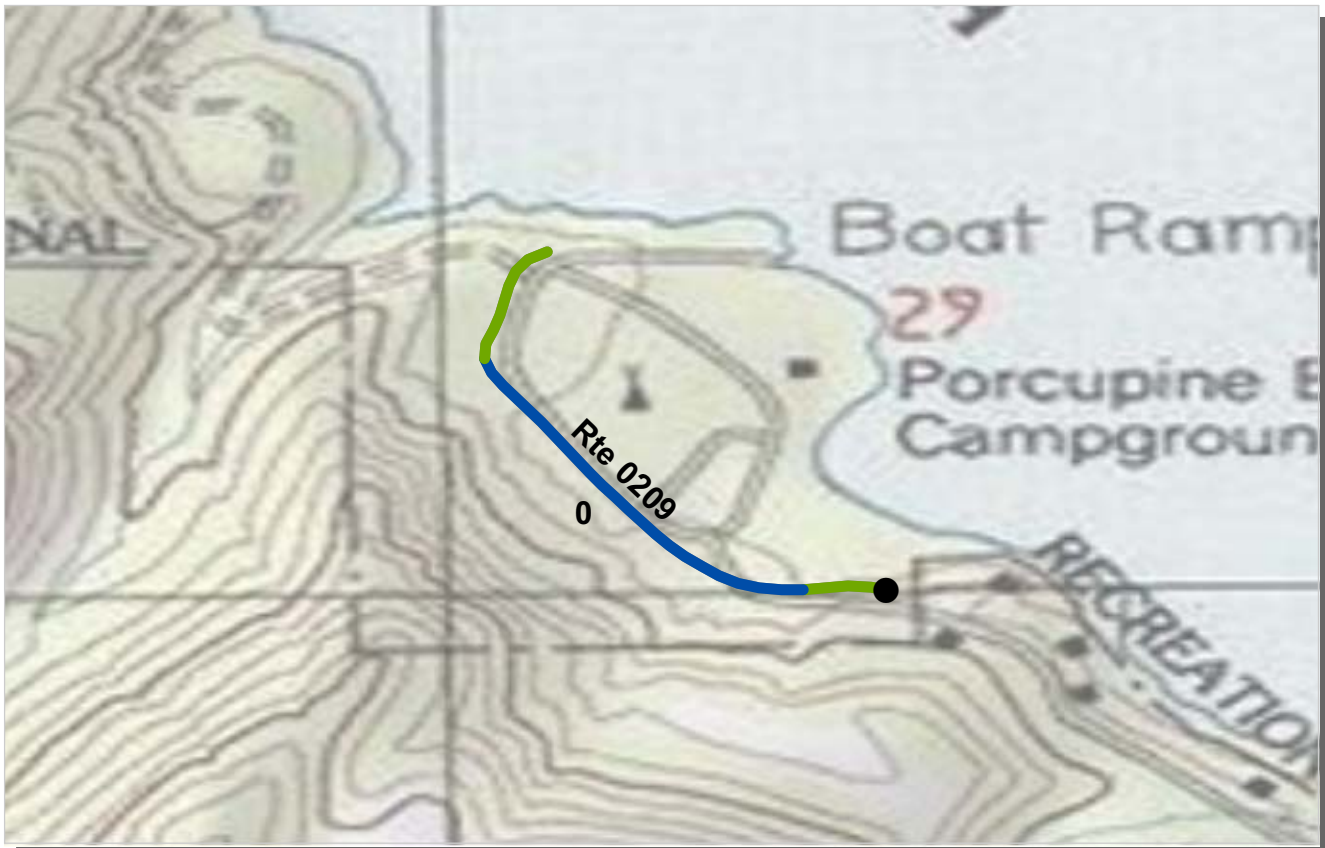
ROUTE: 0209 PORCUPINE BAY CAMPGROUND ROAD

Section Number	0				
Section Length (mi)	0.34				
Cross Section Information					
Number of Lanes	2				
Paved Width (ft)	21				
Lane Width (ft)	9				
Roadway Condition Information					
SCR (Surface Condition Rating)	96				
PCR (Pavement Condition Rating)	96				
Distress Index Values					
Structural Crack Index	99				
Transverse Cracking Index	98				
Patching Index	100				
Rutting Index	96				
Roughness Condition Index (RCI)	NC

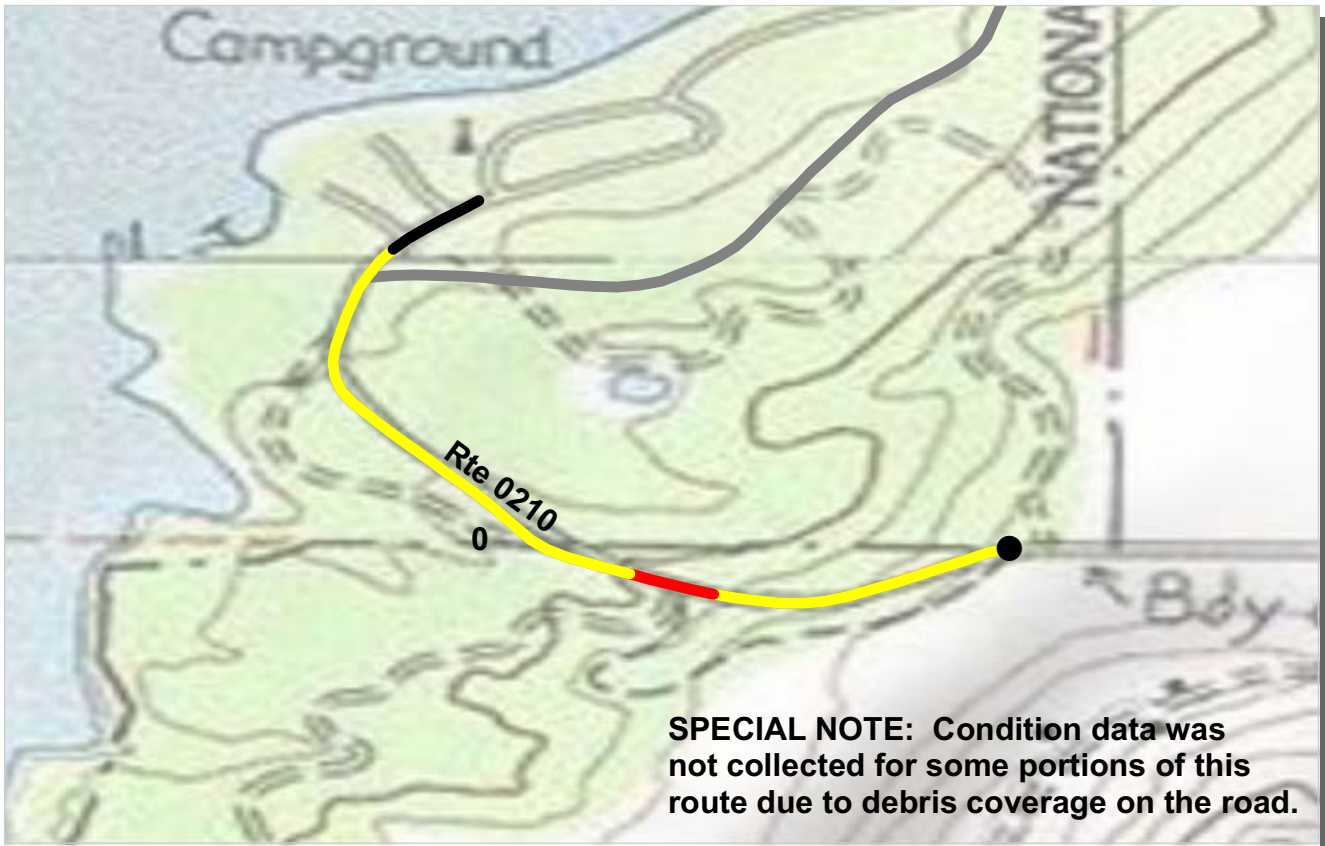
ROUTE: 0210 HUNTERS CAMPGROUND ACCESS ROAD

Section Number	0				
Section Length (mi)	0.51				
Cross Section Information					
Number of Lanes	2				
Paved Width (ft)	19				
Lane Width (ft)	10				
Roadway Condition Information					
SCR (Surface Condition Rating)	89				
PCR (Pavement Condition Rating)	73				
Distress Index Values					
Structural Crack Index	89				
Transverse Cracking Index	99				
Patching Index	100				
Rutting Index	90				
Roughness Condition Index (RCI)	50

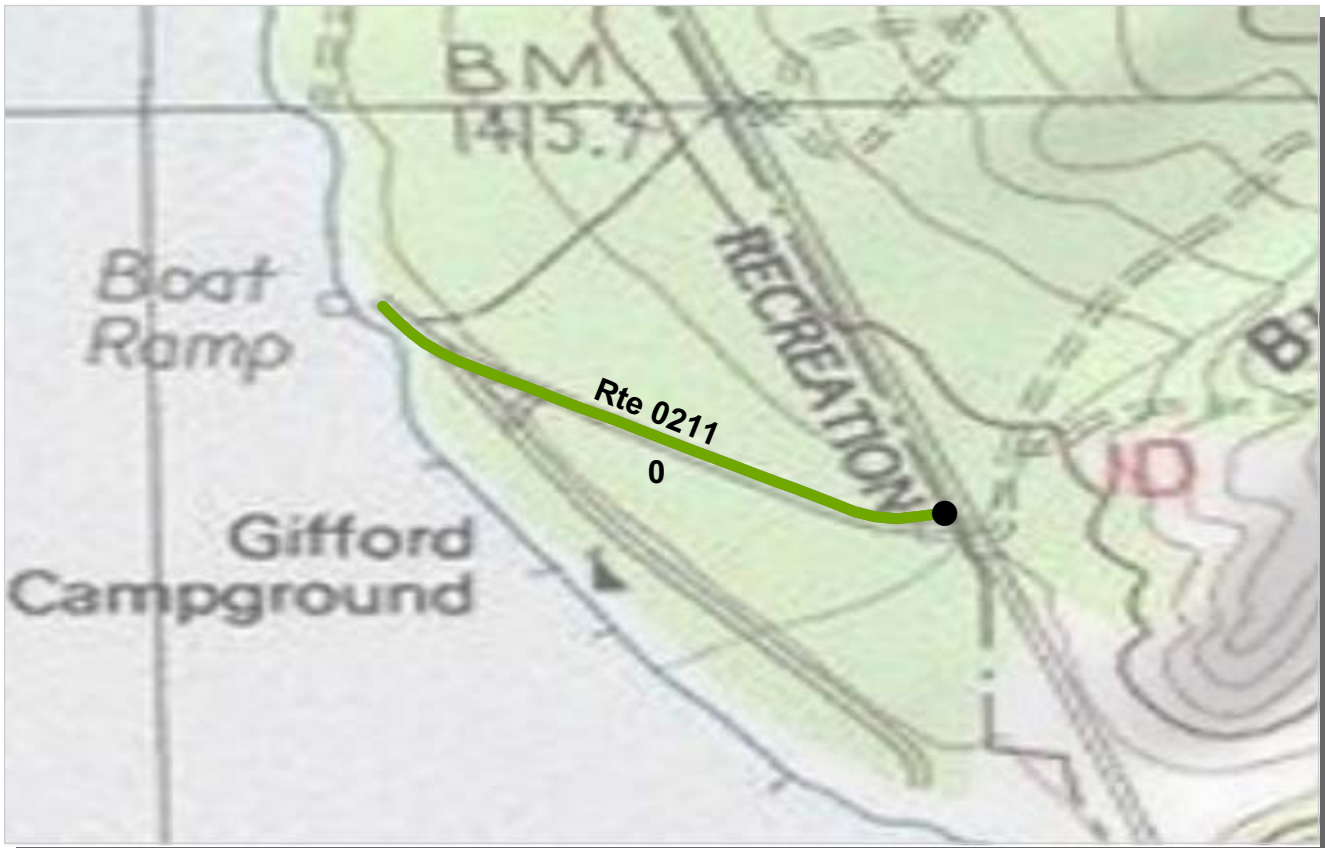
ROUTE: 0211 GIFFORD CAMPGROUND ACCESS ROAD

Section Number	0				
Section Length (mi)	0.29				
Cross Section Information					
Number of Lanes	2				
Paved Width (ft)	21				
Lane Width (ft)	10				
Roadway Condition Information					
SCR (Surface Condition Rating)	92				
PCR (Pavement Condition Rating)	92				
Distress Index Values					
Structural Crack Index	99				
Transverse Cracking Index	99				
Patching Index	100				
Rutting Index	92				
Roughness Condition Index (RCI)	NC

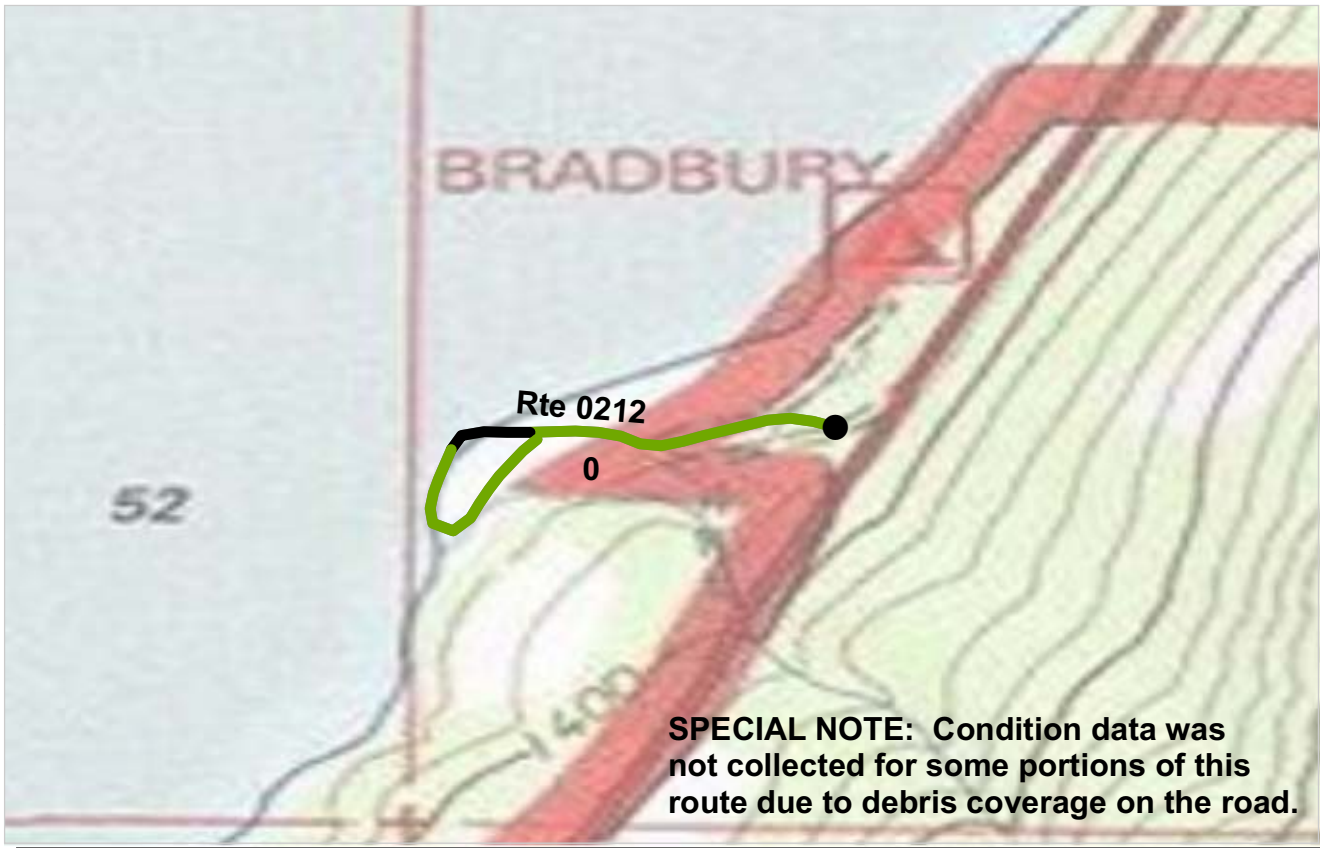
ROUTE: 0212 BRADBURY DAY USE AREA ROAD

Section Number	0				
Section Length (mi)	0.31				
Cross Section Information					
Number of Lanes	1				
Paved Width (ft)	21				
Lane Width (ft)	15				
Roadway Condition Information					
SCR (Surface Condition Rating)	93				
PCR (Pavement Condition Rating)	93				
Distress Index Values					
Structural Crack Index	100				
Transverse Cracking Index	100				
Patching Index	100				
Rutting Index	93				
Roughness Condition Index (RCI)	NC

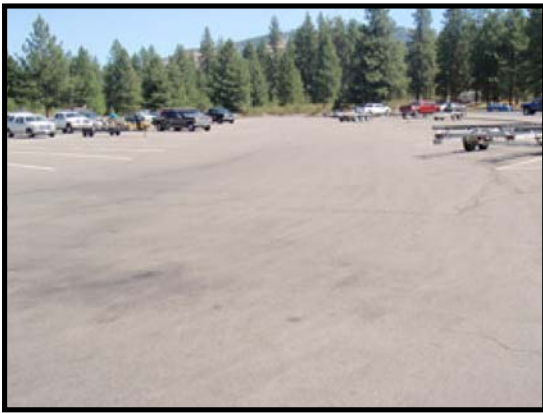
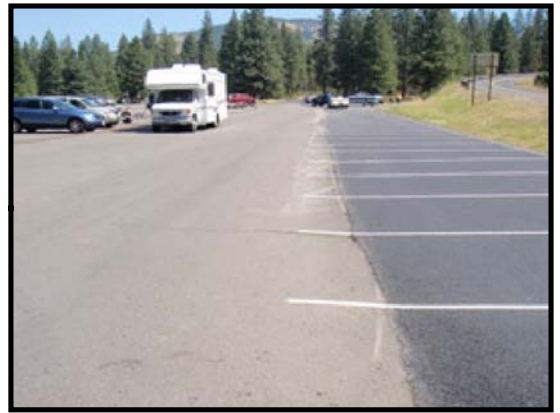
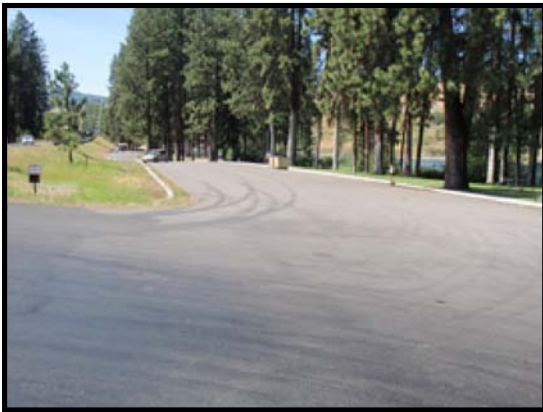
Route 0939

Route Number	Public / NonPublic	Date Visited	Area (sq ft)	Lane Miles *	Surface Type
0939	PUBLIC	8/16/2010	7,365	0.13	AS
Culverts	Drop Inlets	Gates	Curb & Gutter	Curb	PCR
0	0	0	NO CURB AND GUTTER	NO CURB	EXCELLENT/97

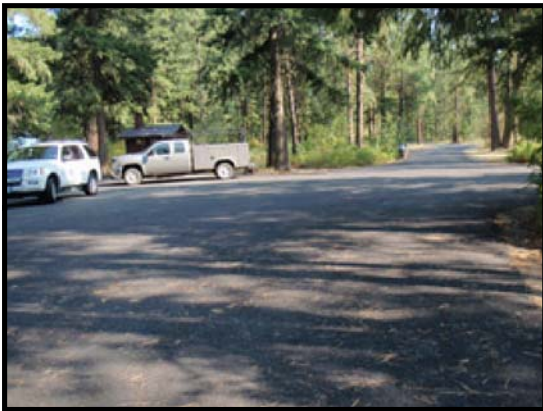
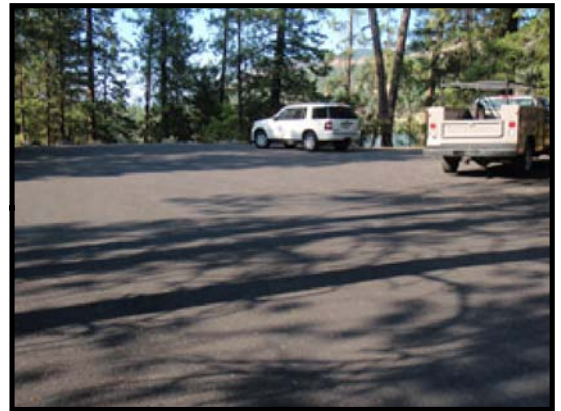
Route 0943

Route Number	Public / NonPublic	Date Visited	Area (sq ft)	Lane Miles *	Surface Type
0943	PUBLIC	8/16/2010	22,307	0.38	AS
Culverts	Drop Inlets	Gates	Curb & Gutter	Curb	PCR
0	0	0	NO CURB AND GUTTER	CONCRETE CURB	GOOD/90

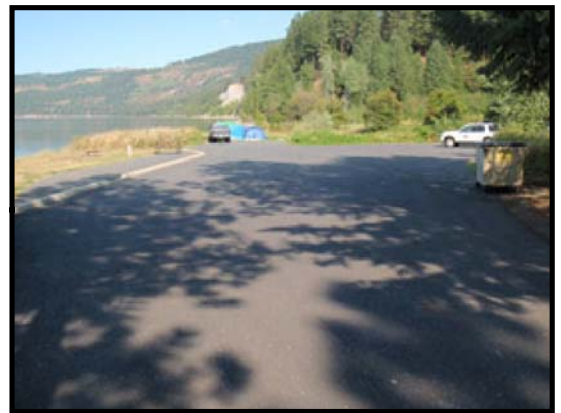
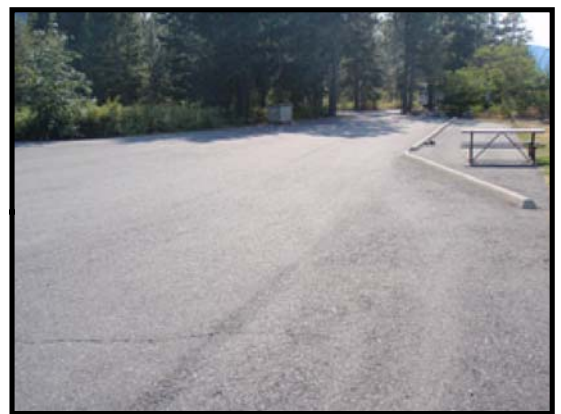
Route 0958

Route Number	Public / NonPublic	Date Visited	Area (sq ft)	Lane Miles *	Surface Type
0958	PUBLIC	8/16/2010	44,106	0.76	AS
Culverts	Drop Inlets	Gates	Curb & Gutter	Curb	PCR
0	0	0	NO CURB AND GUTTER	NO CURB	GOOD/90

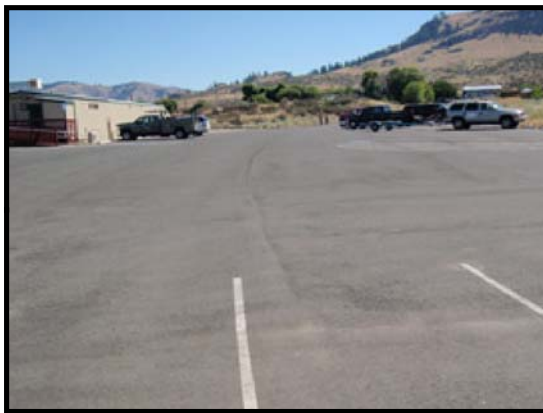
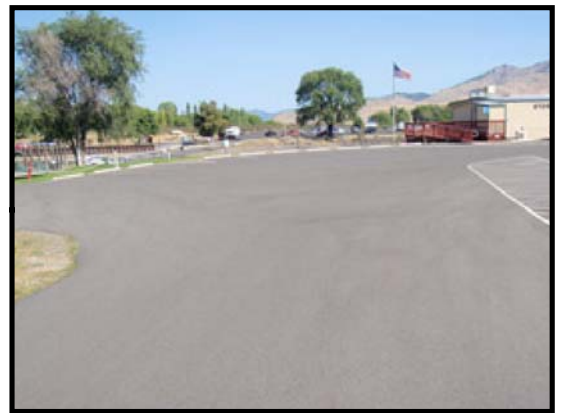
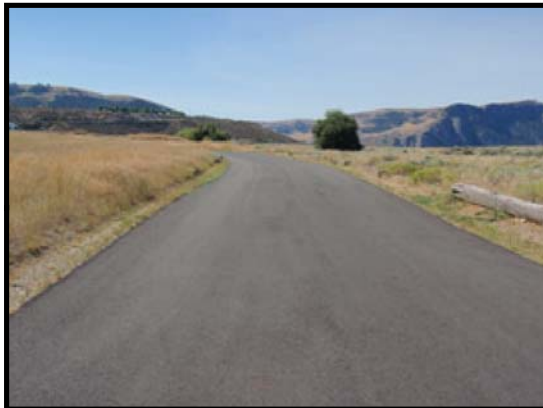
Route 0964

Route Number	Public / NonPublic	Date Visited	Area (sq ft)	Lane Miles *	Surface Type
0964	PUBLIC	8/16/2010	18,699	0.32	AS
Culverts	Drop Inlets	Gates	Curb & Gutter	Curb	PCR
0	2	1	NO CURB AND GUTTER	CONCRETE CURB	GOOD/90

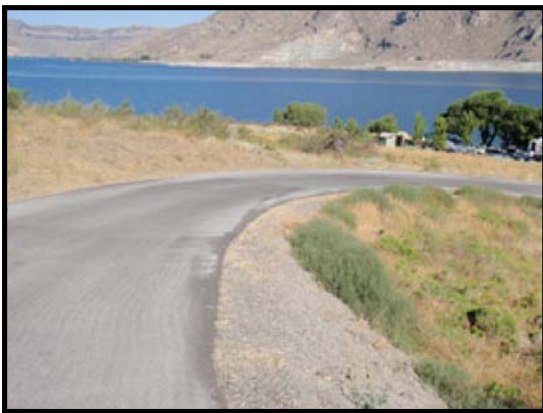
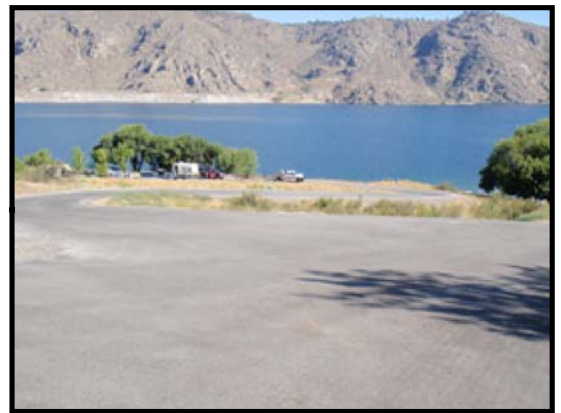
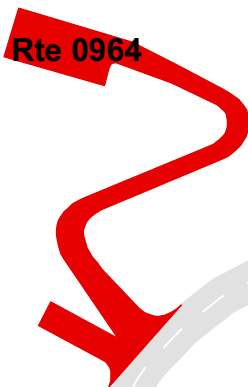
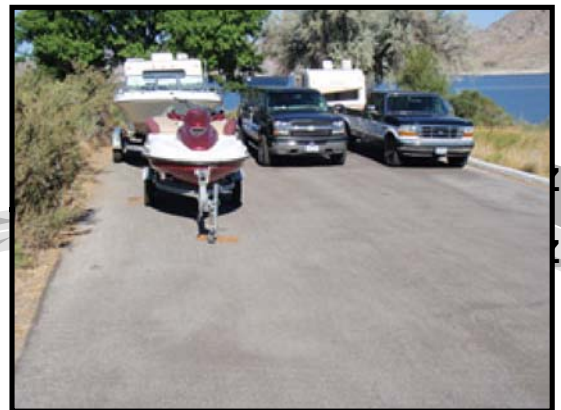
Route 0965

Route Number	Public / NonPublic	Date Visited	Area (sq ft)	Lane Miles *	Surface Type
0965	PUBLIC	8/16/2010	32,738	0.56	AS
Culverts	Drop Inlets	Gates	Curb & Gutter	Curb	PCR
0	0	0	NO CURB AND GUTTER	CONCRETE CURB	EXCELLENT/97
