Federal Lands Highway Road Inventory Program

Road Inventory and Condition Assessment

Lewis and Clark National Historical Park
LEWI - 9420

Cycle 5 Report

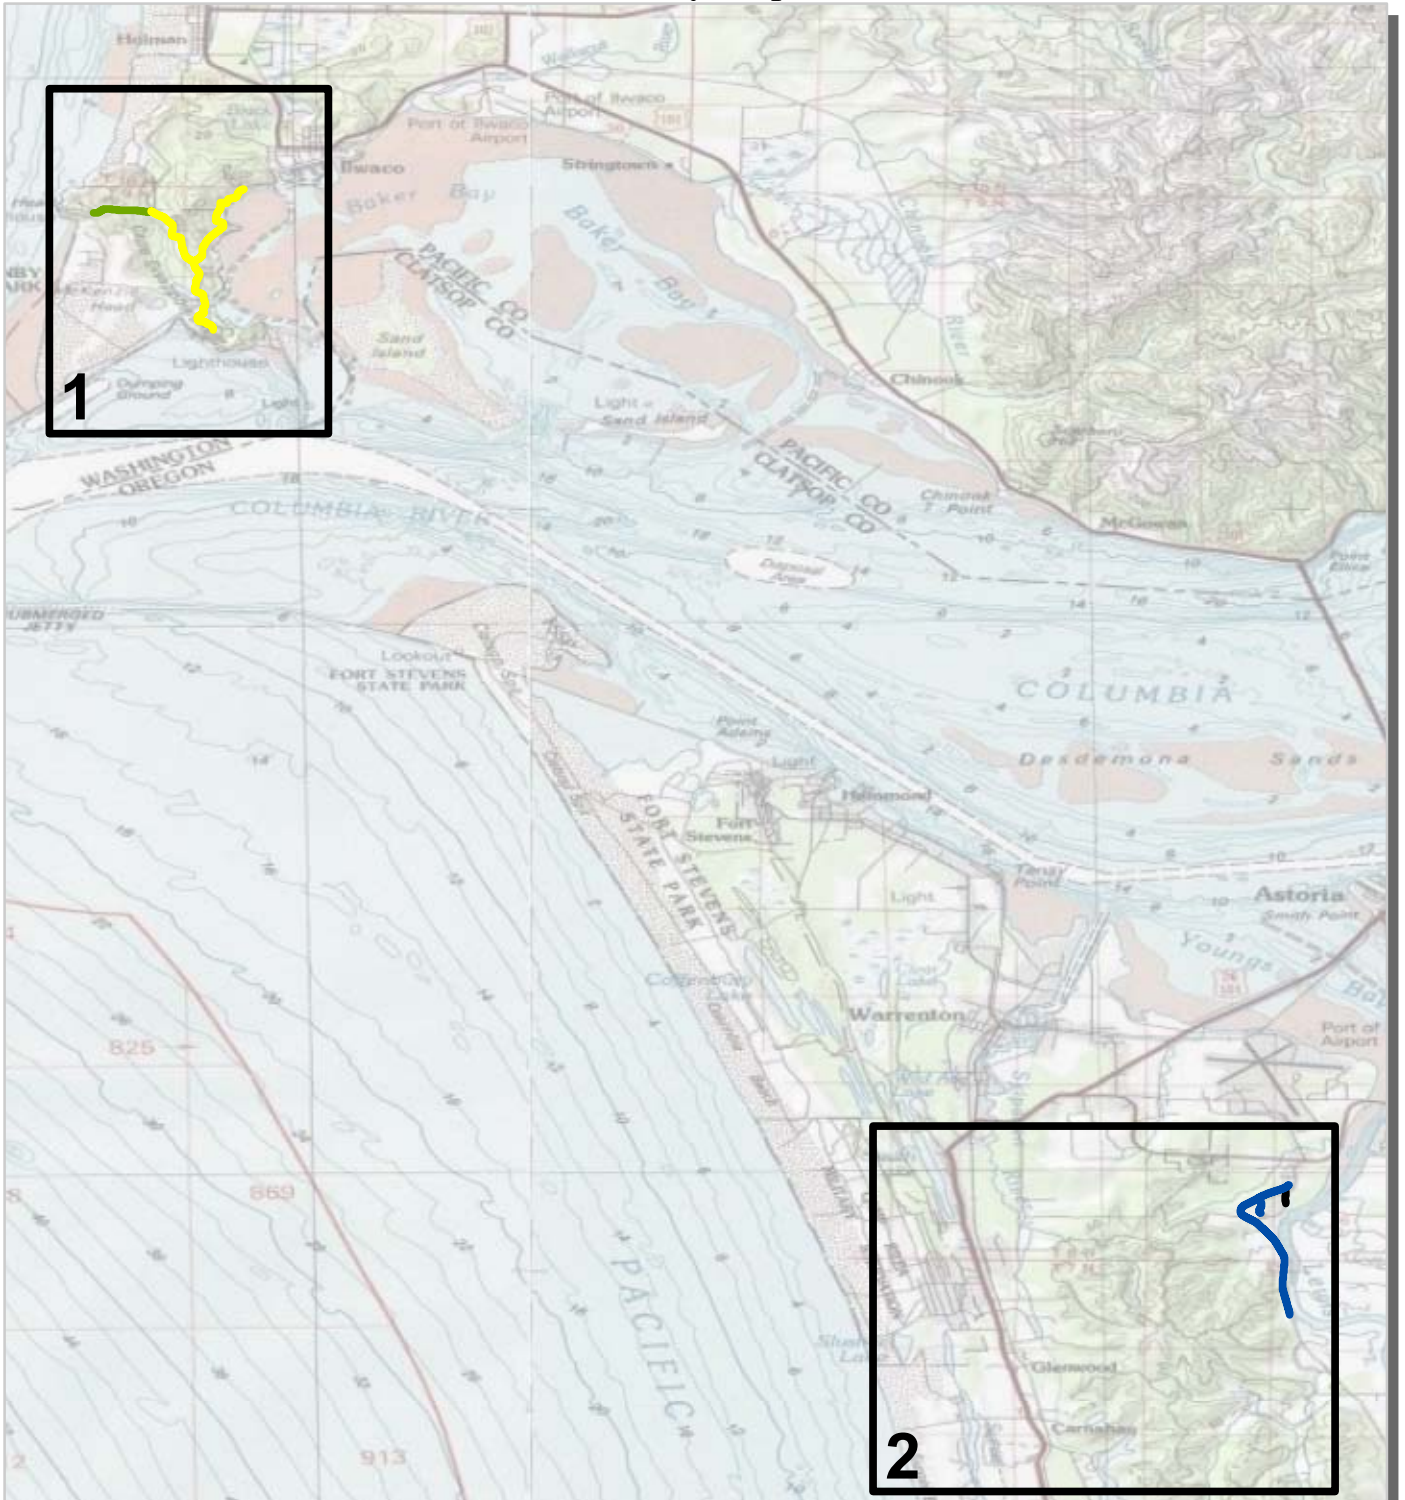
Lewis and Clark National Historical Park Route Condition Map PCR - Mile by Mile Key Map

PCR	Poor	Fair	Good	Excellent	No Data
	█	█	█	█	█
	(0 - 60)	(61 - 84)	(85 - 94)	(95 - 100)

* If the PCR rating is not available for a section, the SCR rating will be displayed. See appendix for definitions and formulas.

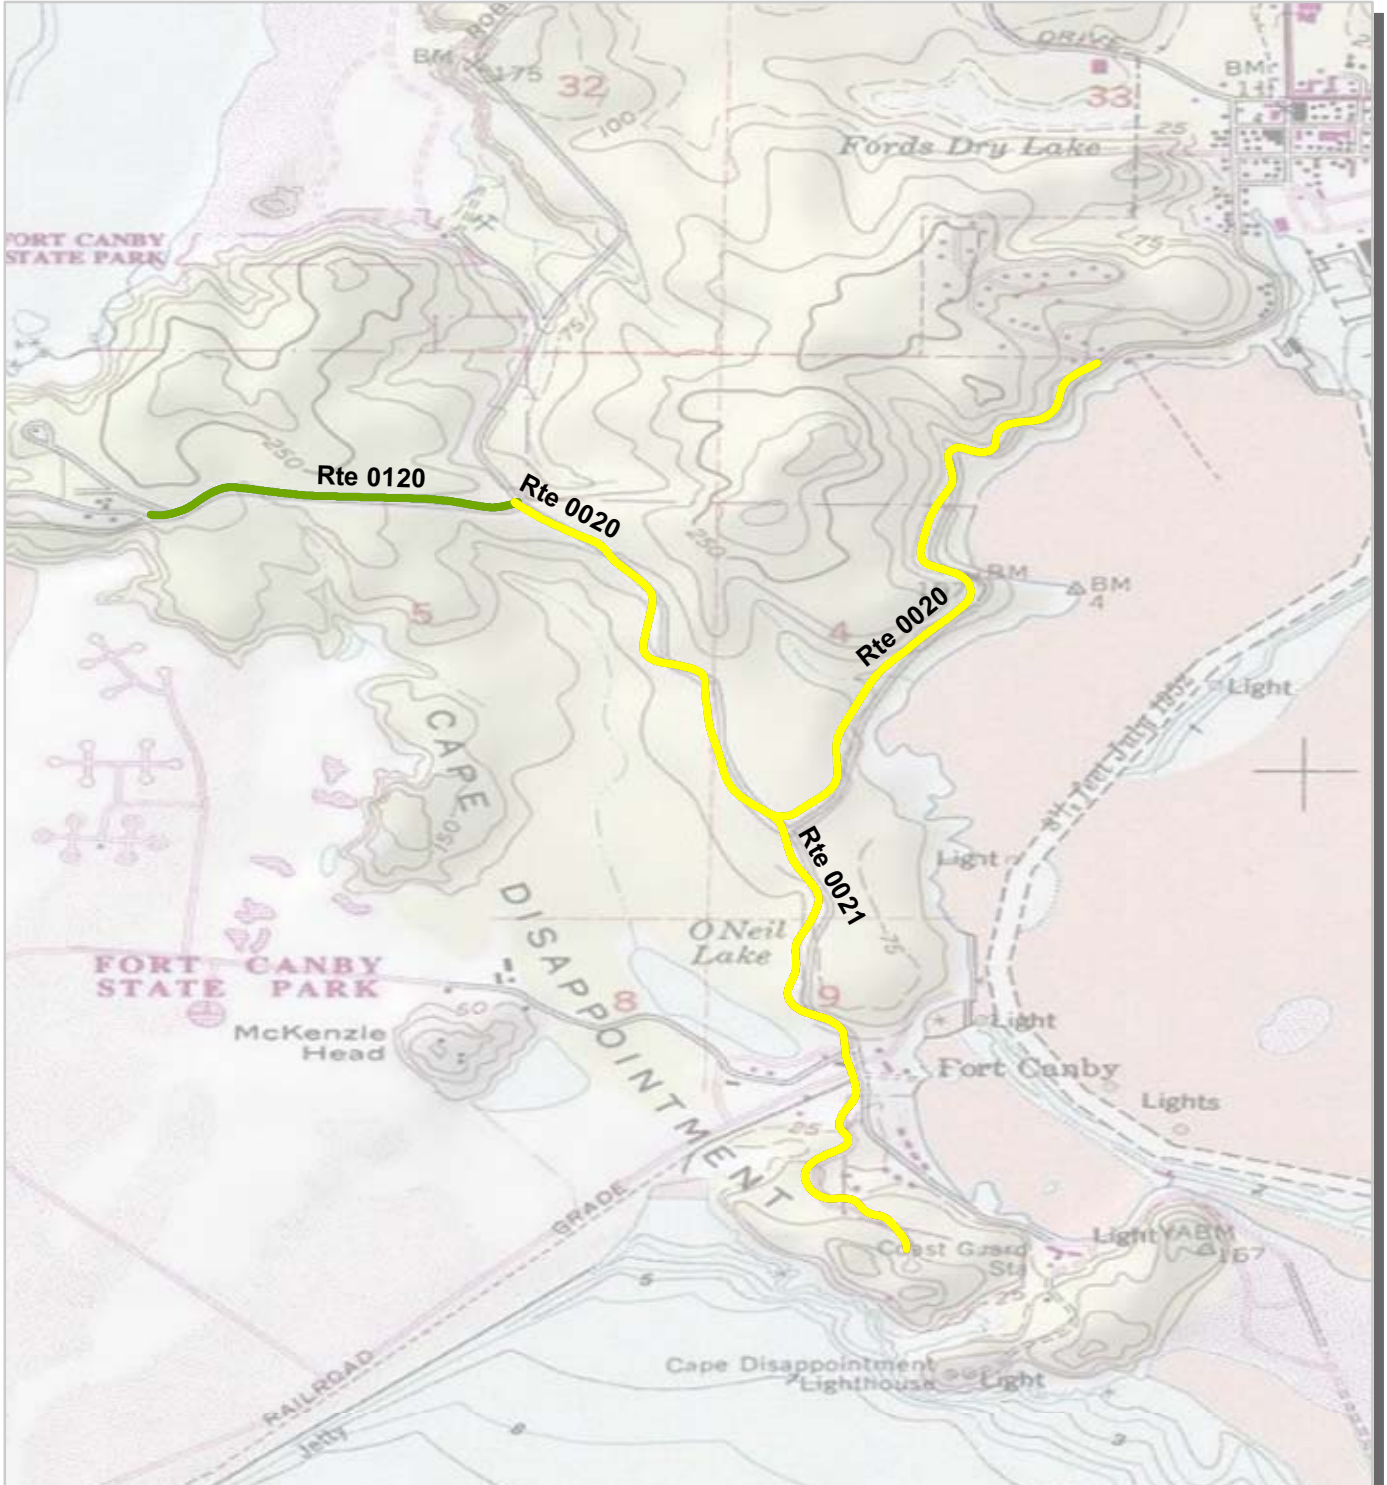
Lewis and Clark National Historical Park Route Condition Map PCR - Mile by Mile Area 1

PCR	Poor	Fair	Good	Excellent	No Data
	■	■	■	■	■
	(0 - 60)	(61 - 84)	(85 - 94)	(95 - 100)

* If the PCR rating is not available for a section, the SCR rating will be displayed. See appendix for definitions and formulas.

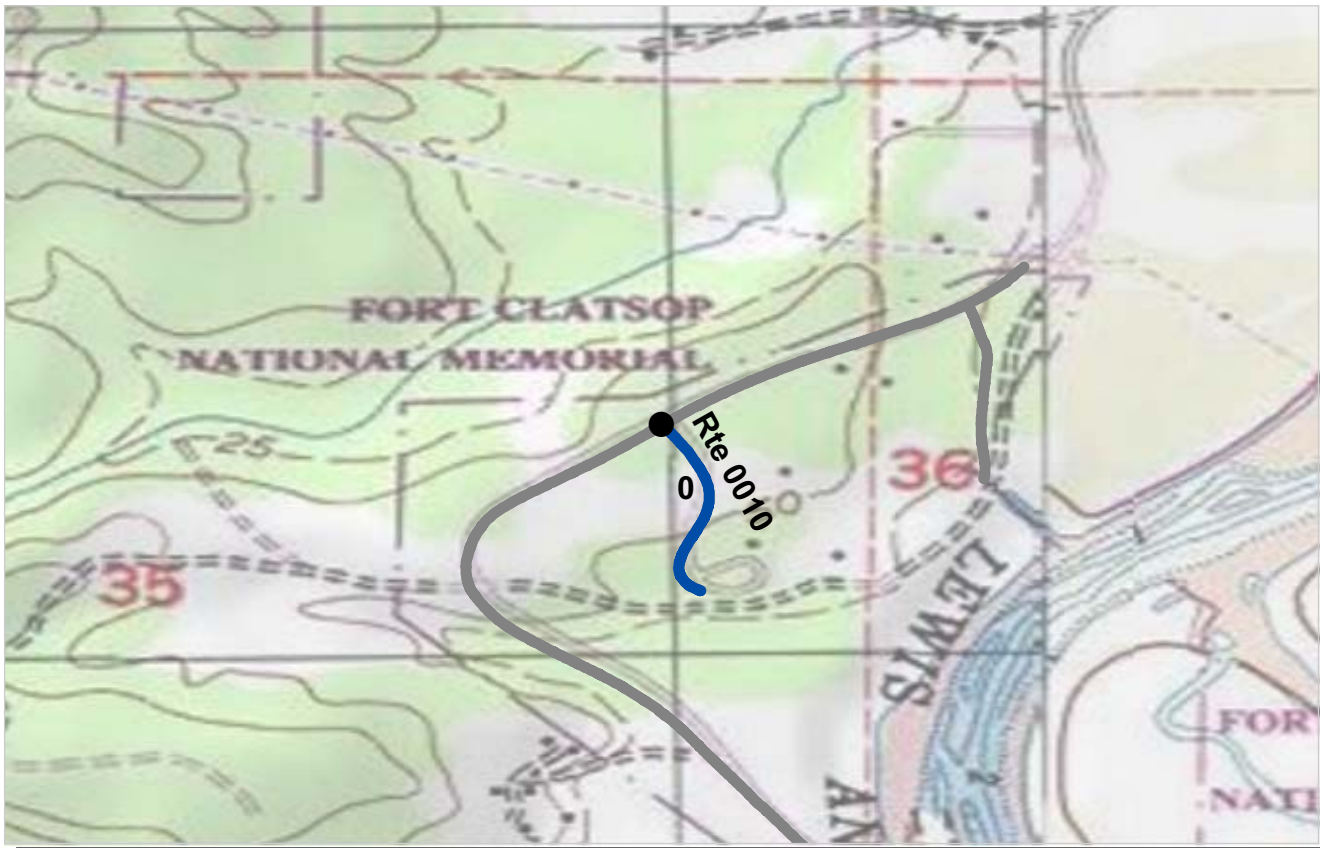
ROUTE: 0010 VISITOR CENTER ACCESS ROAD

Section Number	0				
Section Length (mi)	0.18				
Cross Section Information					
Number of Lanes	2				
Paved Width (ft)	23				
Lane Width (ft)	11				
Roadway Condition Information					
SCR (Surface Condition Rating)	96				
PCR (Pavement Condition Rating)	96				
Distress Index Values					
Structural Crack Index	98				
Transverse Cracking Index	99				
Patching Index	100				
Rutting Index	96				
Roughness Condition Index (RCI)	NC

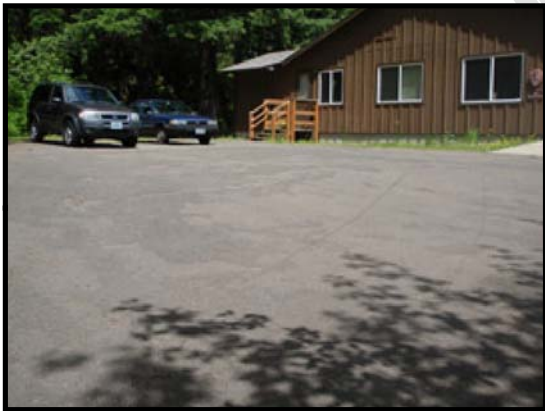
Route 0901

Route Number	Public / NonPublic	Date Visited	Area (sq ft)	Lane Miles *	Surface Type
0901	NONPUBLIC	6/15/2010	6,938	0.12	AS
Culverts	Drop Inlets	Gates	Curb & Gutter	Curb	PCR
0	0	0	CONCRETE CURB AND GUTTER	NO CURB	FAIR/73

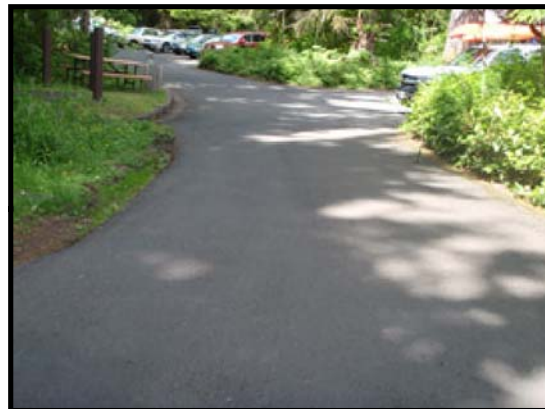
Route 0902ZZ

Route Number	Public / NonPublic	Date Visited	Area (sq ft)	Lane Miles *	Surface Type
0902Z	PUBLIC	6/15/2010	22,517	0.39	AS
Culverts	Drop Inlets	Gates	Curb & Gutter	Curb	PCR
0	2	0	CONCRETE CURB AND GUTTER	NO CURB	GOOD/90

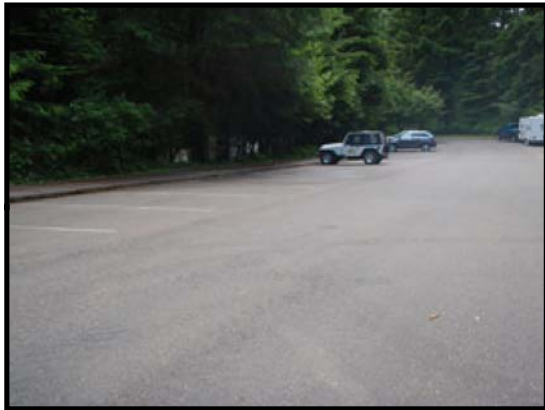
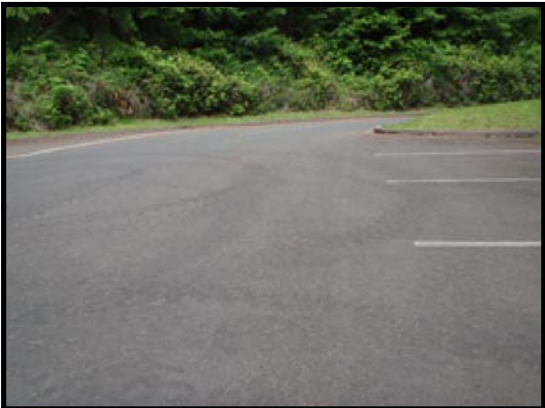
Route 0908Z

Route Number	Public / NonPublic	Date Visited	Area (sq ft)	Lane Miles *	Surface Type
0908Z	PUBLIC	6/15/2010	4,790	0.08	AS
Culverts	Drop Inlets	Gates	Curb & Gutter	Curb	PCR
0	0	0	NO CURB AND GUTTER	CONCRETE CURB	GOOD/90

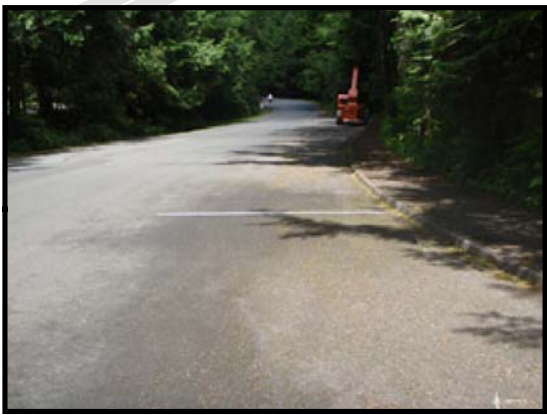
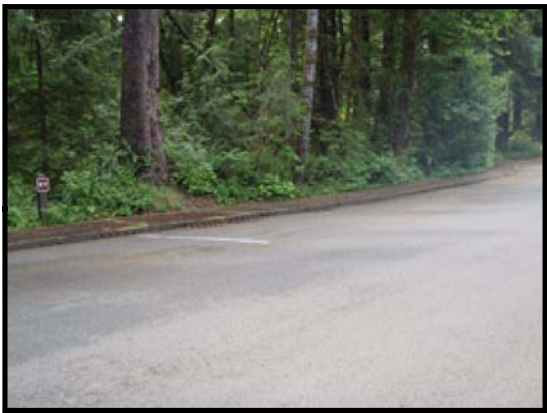
Route 0903

Route Number	Public / NonPublic	Date Visited	Area (sq ft)	Lane Miles *	Surface Type
0903	PUBLIC	6/15/2010	18,177	0.31	AS
Culverts	Drop Inlets	Gates	Curb & Gutter	Curb	PCR
0	3	0	CONCRETE CURB AND GUTTER	CONCRETE CURB	GOOD/90

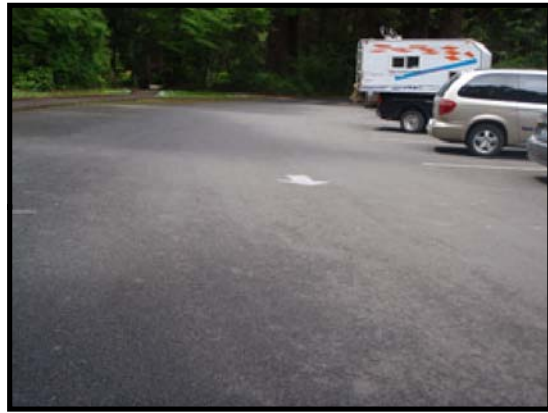
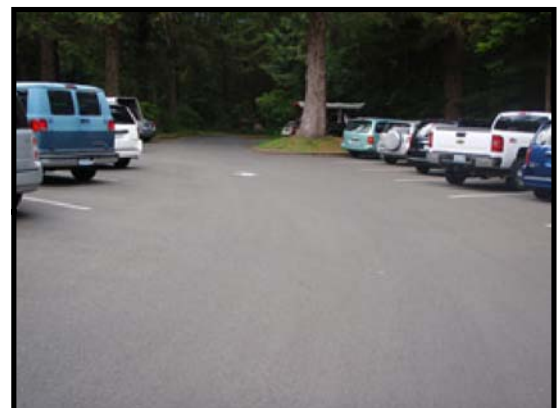
Route 0904ZZ

Route Number	Public / NonPublic	Date Visited	Area (sq ft)	Lane Miles *	Surface Type
0904Z	NONPUBLIC	6/15/2010	9,334	0.16	AS
Culverts	Drop Inlets	Gates	Curb & Gutter	Curb	PCR
1	1	0	NO CURB AND GUTTER	NO CURB	FAIR/73

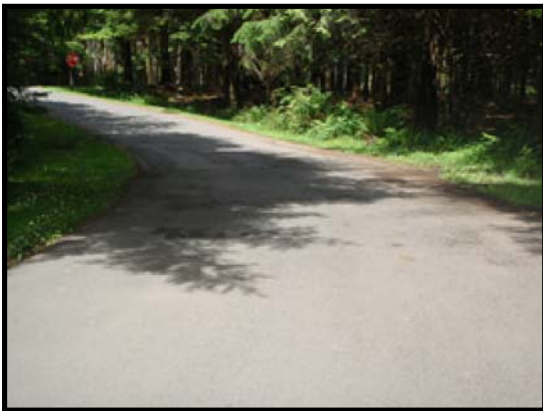
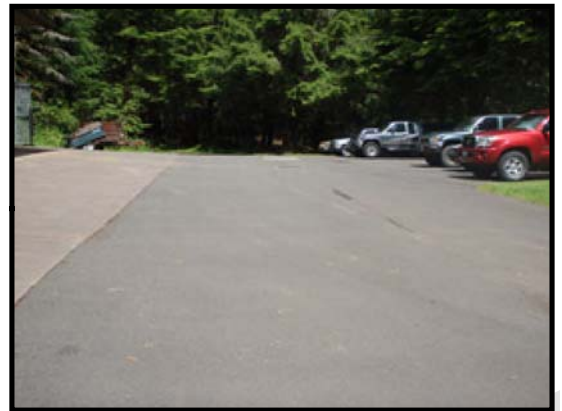
Route 0905Z

Route Number	Public / NonPublic	Date Visited	Area (sq ft)	Lane Miles *	Surface Type
0905Z	NONPUBLIC	6/15/2010	1,871	0.03	AS
Culverts	Drop Inlets	Gates	Curb & Gutter	Curb	PCR
0	0	0	NO CURB AND GUTTER	NO CURB	FAIR/73

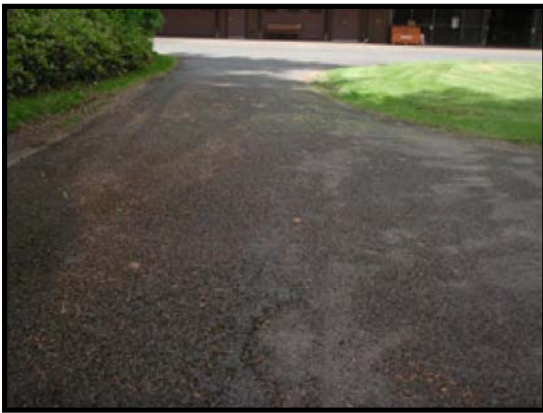
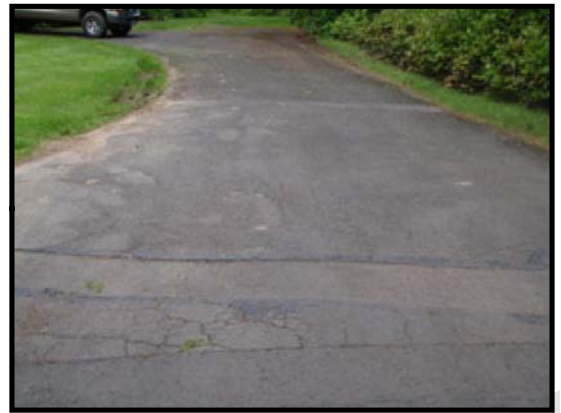
Route 0909ZZ

Route Number	Public / NonPublic	Date Visited	Area (sq ft)	Lane Miles *	Surface Type
0909ZZ	PUBLIC	6/15/2010	94,093	1.62	AS
Culverts	Drop Inlets	Gates	Curb & Gutter	Curb	PCR
2	0	2	NO CURB AND GUTTER	CONCRETE CURB	SUMMARY/90

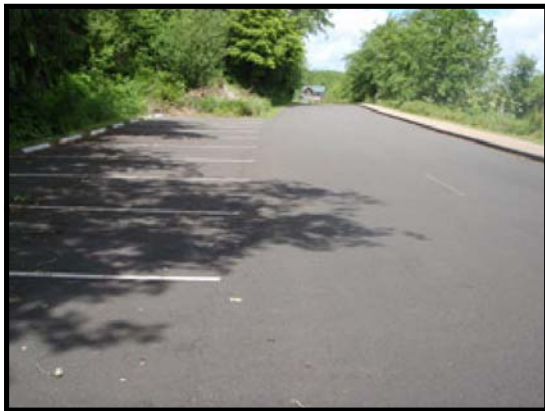
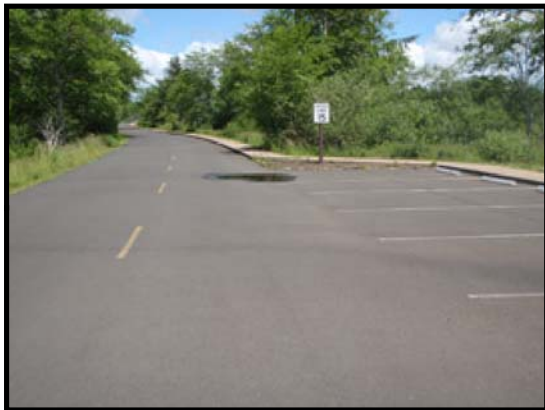
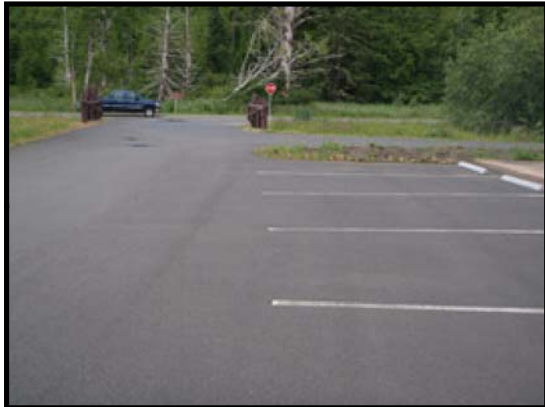
Route 0909BZ

Route Number	Public / NonPublic	Date Visited	Area (sq ft)	Lane Miles *	Surface Type
0909BZ	PUBLIC	6/15/2010	21,875	0.38	AS
Culverts	Drop Inlets	Gates	Curb & Gutter	Curb	PCR
0	0	1	NO CURB AND GUTTER	CONCRETE CURB	GOOD/90

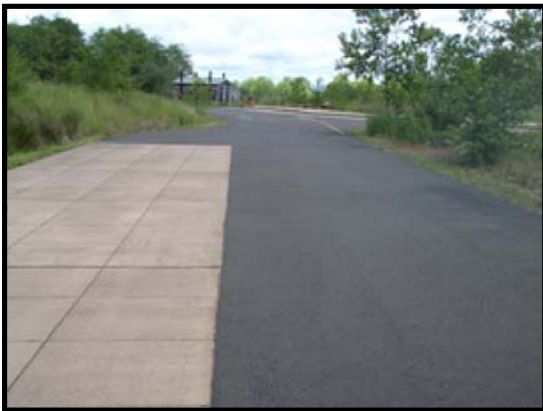
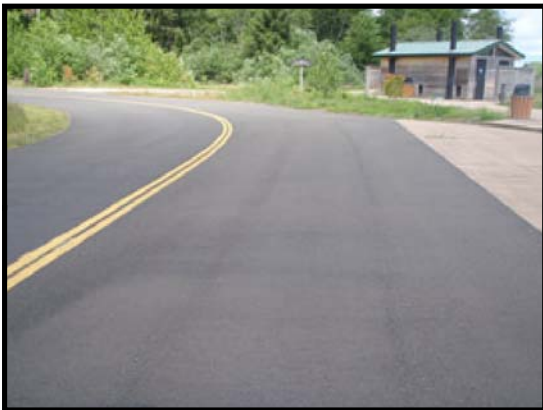
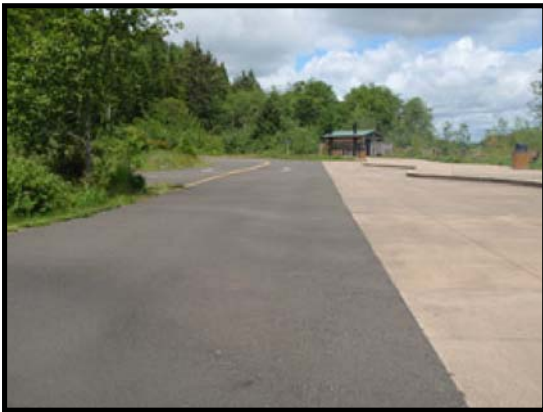
Route 0910

Route Number	Public / NonPublic	Date Visited	Area (sq ft)	Lane Miles *	Surface Type
0910	PUBLIC	6/15/2010	5,320	0.09	AS
Culverts	Drop Inlets	Gates	Curb & Gutter	Curb	PCR
0	0	2	NO CURB AND GUTTER	CONCRETE CURB	GOOD/90

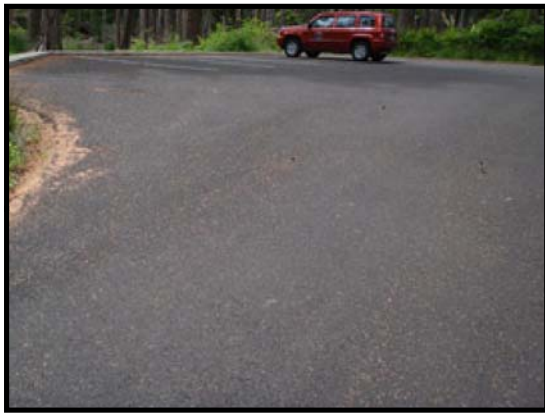
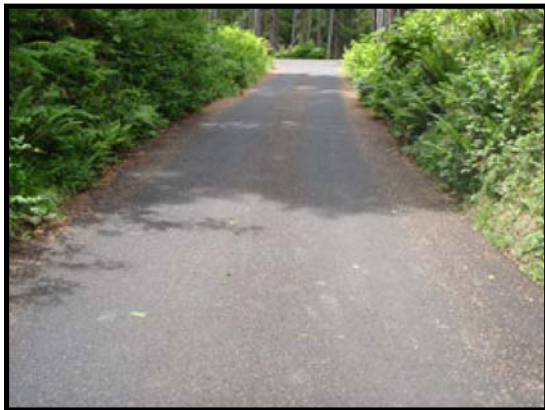
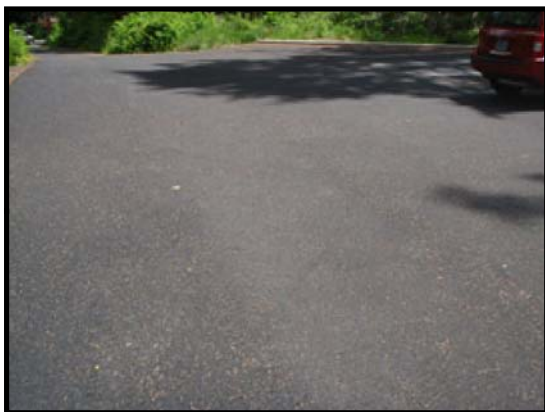
Route 0911

Route Number	Public / NonPublic	Date Visited	Area (sq ft)	Lane Miles *	Surface Type
0911	PUBLIC	6/15/2010	18,103	0.31	AS
Culverts	Drop Inlets	Gates	Curb & Gutter	Curb	PCR
0	0	1	NO CURB AND GUTTER	NO CURB	GOOD/90

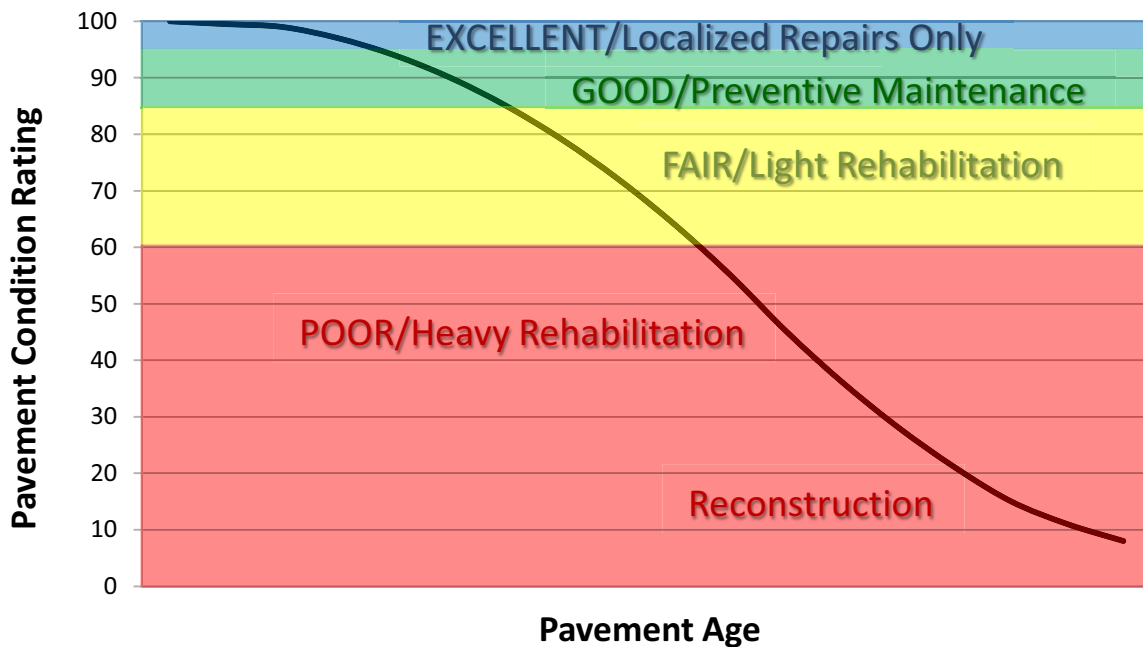
Condition Categories and Treatments

- Excellent/New: PCR of 95-100. Pavements in this range will require only spot repairs
- Good: PCR of 85-94. Pavements in this range will likely be candidates for Preventive Maintenance. Examples include Chip and Slurry Seals, Micro Surfacing and Thin Overlays.
- Fair: PCR of 61-84. Pavements in this range will likely be candidates of Light Rehabilitation (L3R). Examples include single-lift overlays up to 2.5 inches in total thickness, milling and overlays.
- Poor: PCR of 60 or below. Pavements in this range will likely be candidates of Heavy Rehabilitation or Reconstruction (H3R or 4R). Examples include Pulverization, Multiple Lift Overlays, and Reconstruction.

At this time, specific Maintenance and Rehabilitation activities should be evaluated and recommended at the project level. Site-specific conditions that influence treatment type should be determined based on performing a subsurface investigation and/or pavement condition survey, and not be based solely on RIP data. Additionally, RIP produces a snapshot of conditions the year in which the data was collected. For further information or to obtain additional Pavement Management System’s data from our Highway Pavement Management Application (HPMA) please contact the Eastern Federal Lands pavement team.
