Federal Lands Highway Road Inventory Program

Road Inventory and Condition Assessment

Little Bighorn Battlefield National Monument LIBI - 1380

Cycle 5 Report

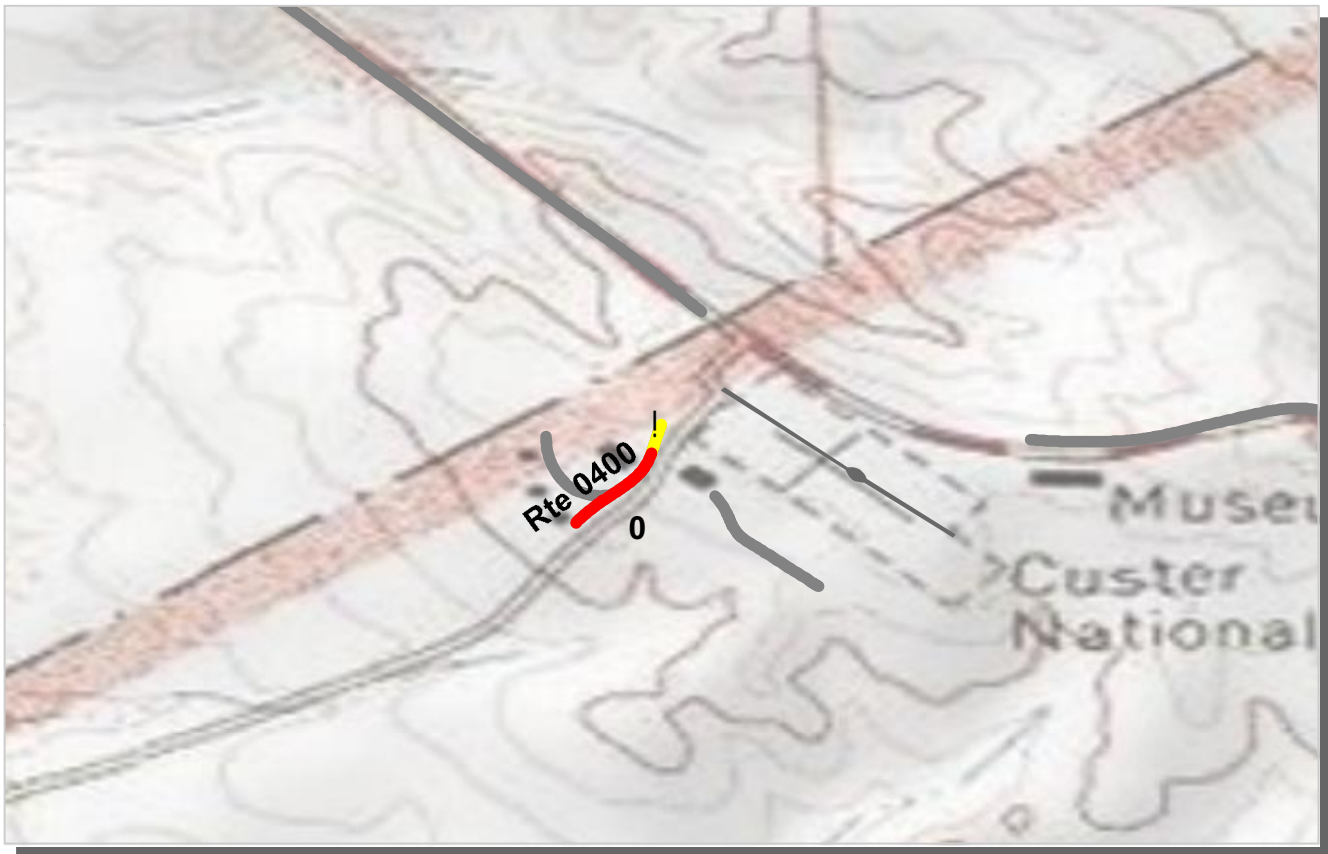
ROUTE: 0400 MAINTENANCE / HOUSING ACCESS ROAD

Section Number	0				
Section Length (mi)	0.08				
Cross Section Information					
Number of Lanes	2				
Paved Width (ft)	19				
Lane Width (ft)	9				
Roadway Condition Information					
SCR (Surface Condition Rating)	40				
PCR (Pavement Condition Rating)	40				
Distress Index Values					
Structural Crack Index	40				
Transverse Cracking Index	86				
Patching Index	99				
Rutting Index	93				
Roughness Condition Index (RCI)	NC

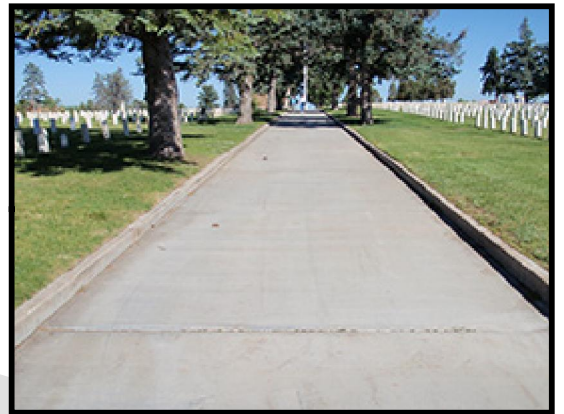
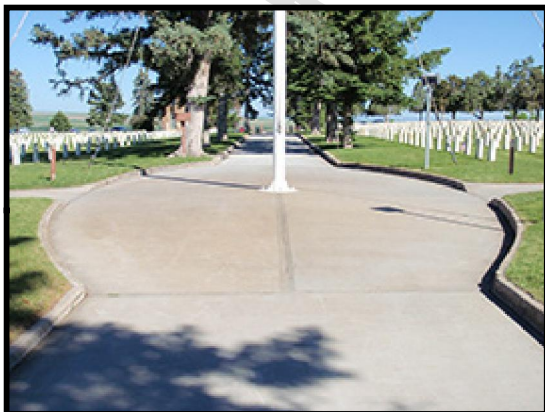
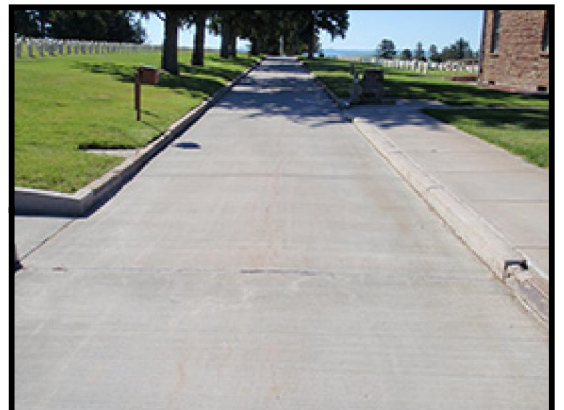
Route 0200

Route Number	Public / NonPublic	Date Visited	Area (sq ft)	Lane Miles *	Surface Type
0200	PUBLIC	6/24/2011	10,550	0.18	CO
Culverts	Drop Inlets	Gates	Curb & Gutter	Curb	PCR
0	0	1	NO CURB AND GUTTER	CONCRETE CURB	GOOD/90

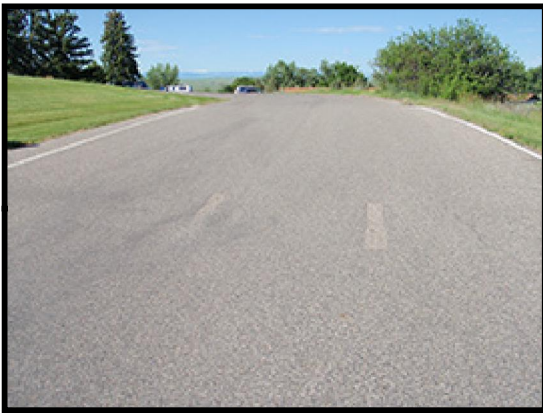
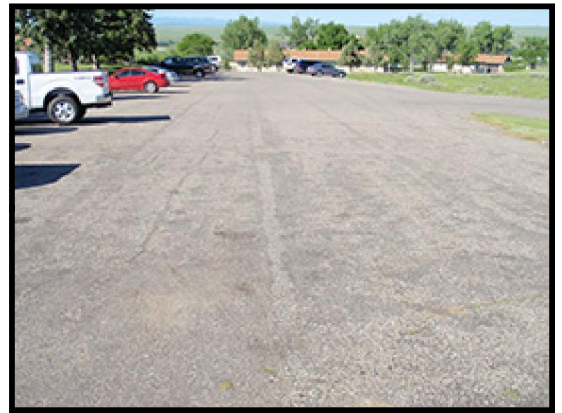
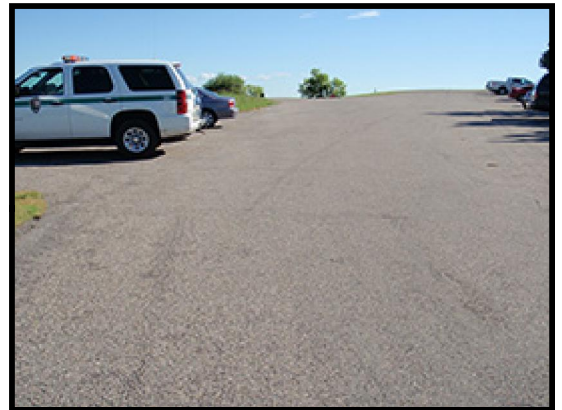
Route 0900

Route Number	Public / NonPublic	Date Visited	Area (sq ft)	Lane Miles *	Surface Type
0900	PUBLIC	6/24/2011	23,361	0.40	AS
Culverts	Drop Inlets	Gates	Curb & Gutter	Curb	PCR
1	0	0	CONCRETE CURB AND GUTTER	NO CURB	GOOD/90

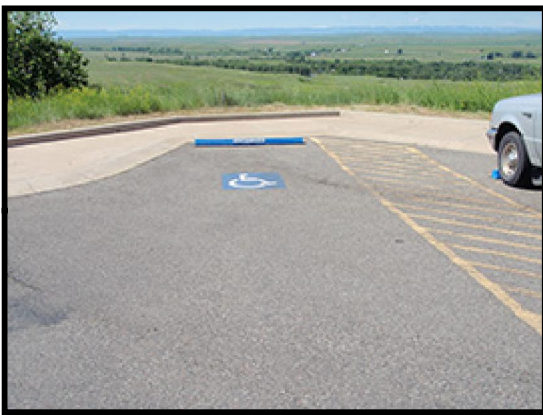
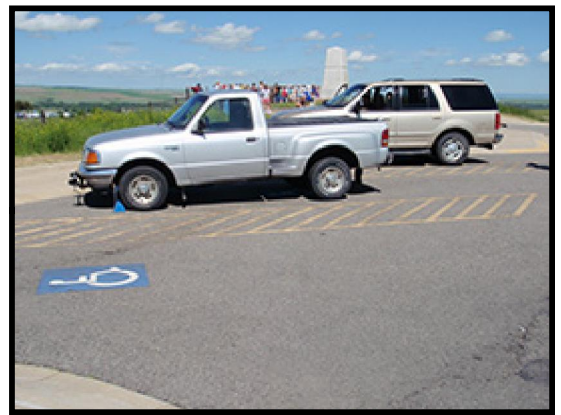
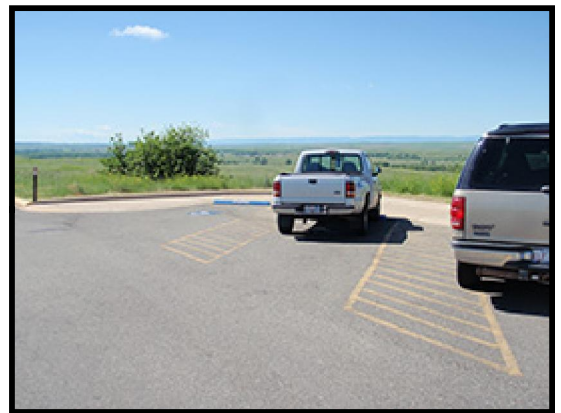
Route 0902

Route Number	Public / NonPublic	Date Visited	Area (sq ft)	Lane Miles *	Surface Type
0902	PUBLIC	6/24/2011	1,168	0.02	AS
Culverts	Drop Inlets	Gates	Curb & Gutter	Curb	PCR
0	0	0	NO CURB AND GUTTER	CONCRETE CURB	GOOD/90

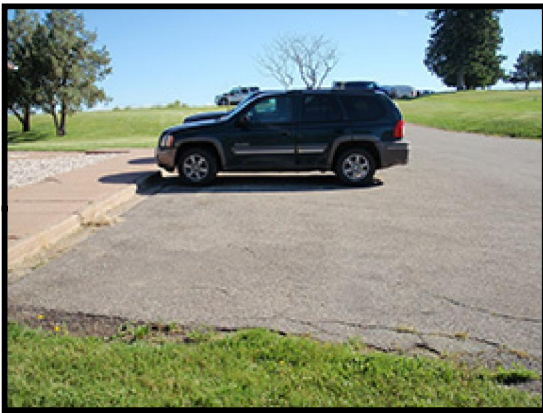
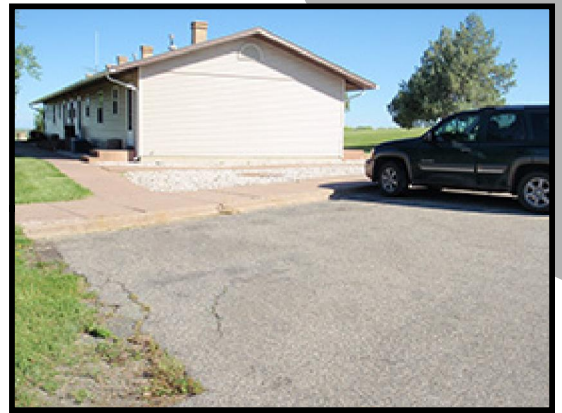
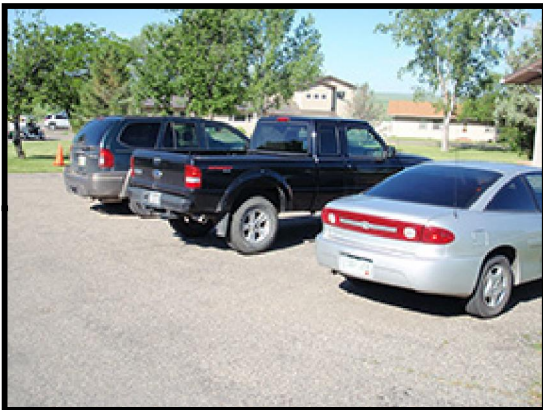
Route 0915

Route Number	Public / NonPublic	Date Visited	Area (sq ft)	Lane Miles *	Surface Type
0915	NONPUBLIC	6/24/2011	1,087	0.02	AS
Culverts	Drop Inlets	Gates	Curb & Gutter	Curb	PCR
0	0	0	CONCRETE CURB AND GUTTER	NO CURB	FAIR/73
