Federal Lands Highway Road Inventory Program

Road Inventory and Condition Assessment

Lincoln Boyhood National Memorial LIBO

Cycle 5 Report

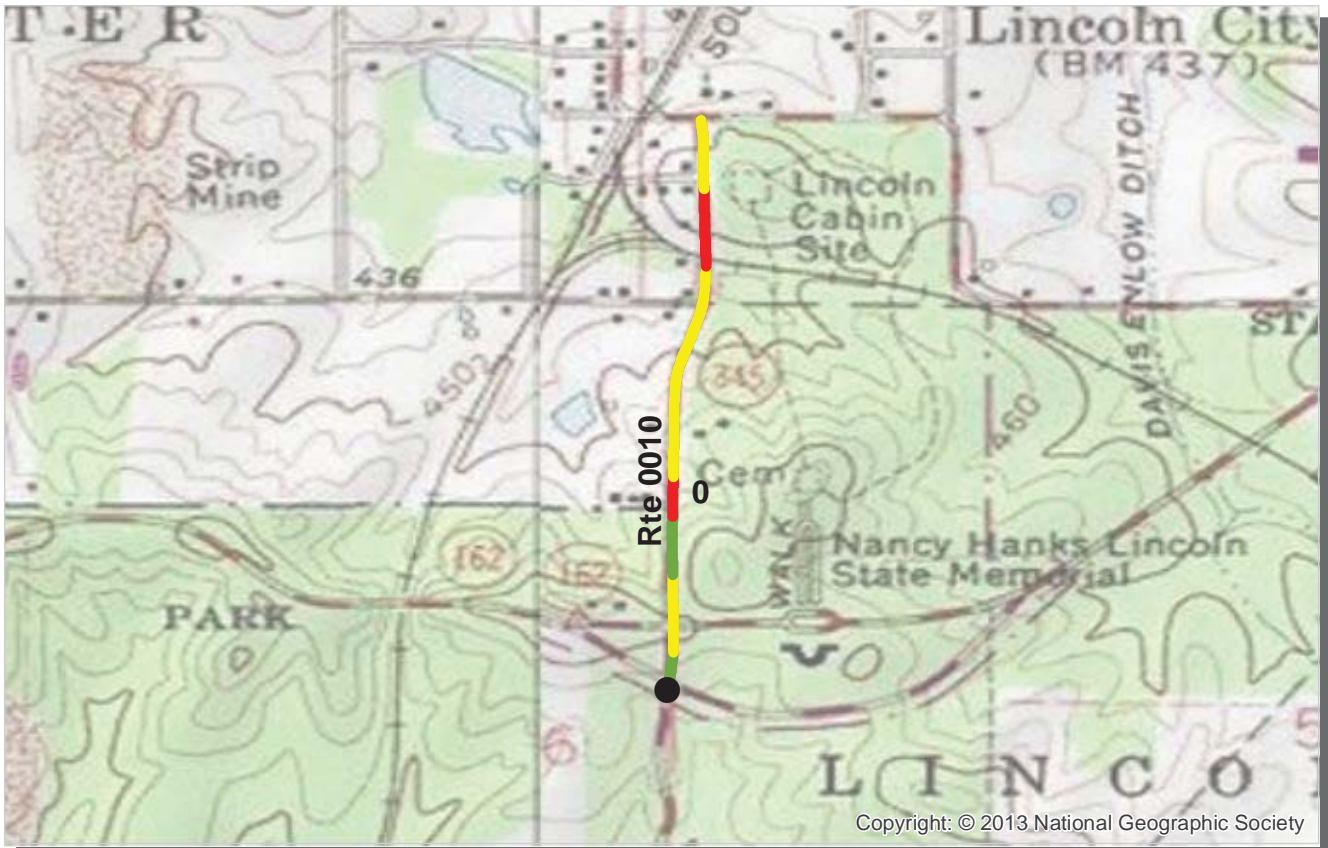
ROUTE: 0010 COUNTY ROAD 300E

PCR Poor ■ Fair ■ Good ■ Excellent ■ No Data ■
 (0 - 60) (61 - 84) (85 - 94) (95 - 100)

Section Number	0				
Section Length (mi)	0.59				
Cross Section Information					
Number of Lanes	2				
Paved Width (ft)	19				
Lane Width (ft)	9				
Roadway Condition Information					
SCR (Surface Condition Rating)	64				
PCR (Pavement Condition Rating)	66				
Distress Index Values					
Structural Crack Index	64				
Transverse Cracking Index	92				
Patching Index	100				
Rutting Index	97				
Roughness Condition Index (RCI)	69

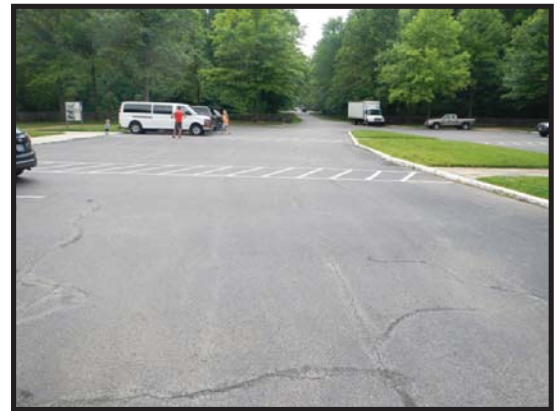
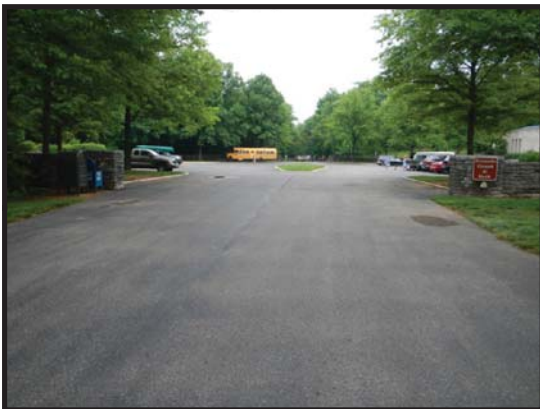
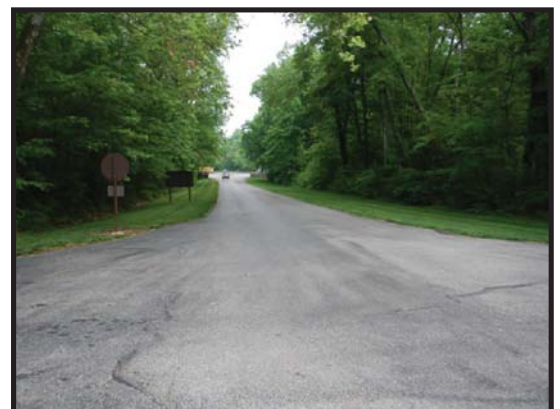
Route Number	Public / NonPublic	Date Visited	Area (sq ft)	Lane Miles *	Surface Type
0900	PUBLIC	5/21/2012	39,424	0.68	AS
Culverts	Drop Inlets	Gates	Curb & Gutter	Curb	PCR
0	8	1	NO CURB AND GUTTER	CONCRETE CURB	FAIR/73

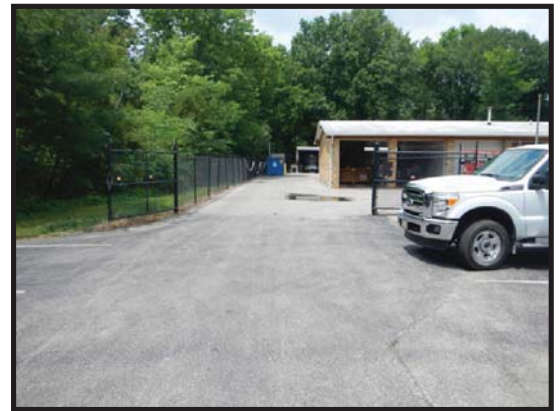
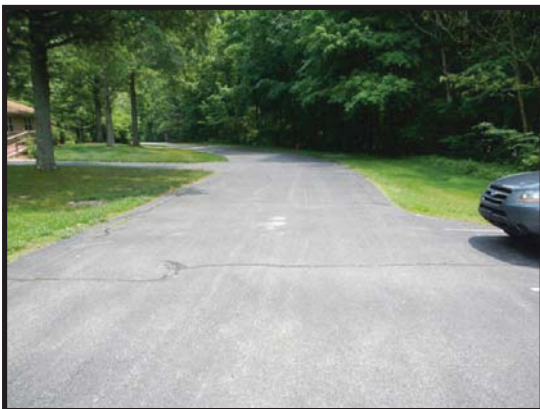
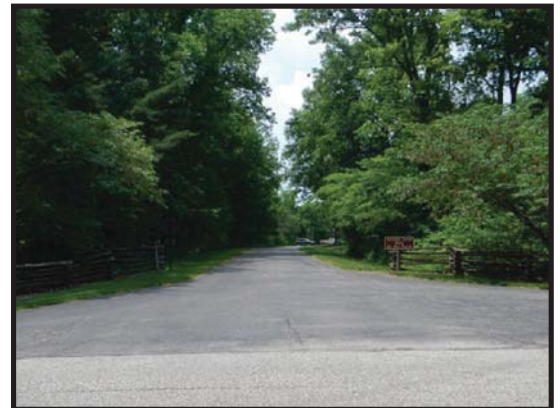
Route 0901

Route Number	Public / NonPublic	Date Visited	Area (sq ft)	Lane Miles *	Surface Type
0901	NONPUBLIC	5/21/2012	26,557	0.46	AS
Culverts	Drop Inlets	Gates	Curb & Gutter	Curb	PCR
0	0	2	NO CURB AND GUTTER	NO CURB	GOOD/90

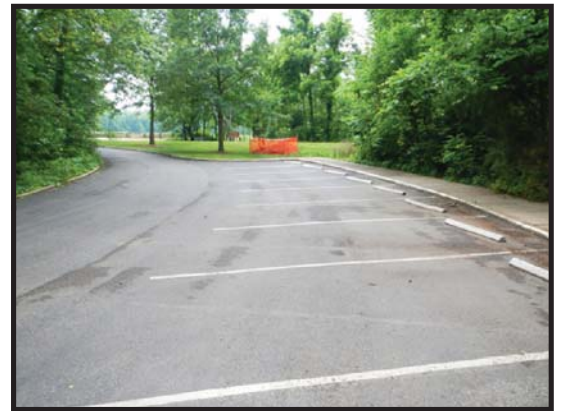
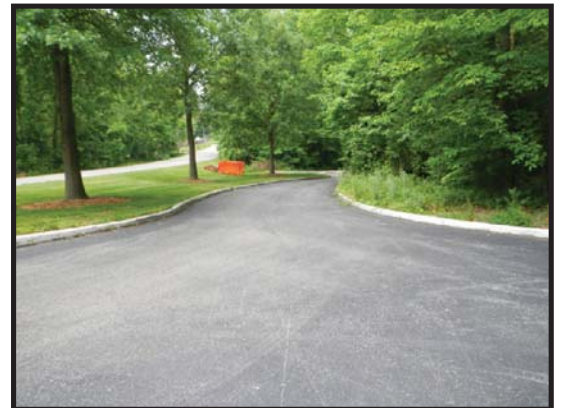
Route 0902

Route Number	Public / NonPublic	Date Visited	Area (sq ft)	Lane Miles *	Surface Type
0902	PUBLIC	5/21/2012	14,911	0.26	AS
Culverts	Drop Inlets	Gates	Curb & Gutter	Curb	PCR
0	2	0	NO CURB AND GUTTER	CONCRETE CURB	GOOD/90
