Federal Lands Highway Road Inventory Program

Road Inventory and Condition Assessment

Little River Canyon National Preserve LIRI

Cycle 5 Report

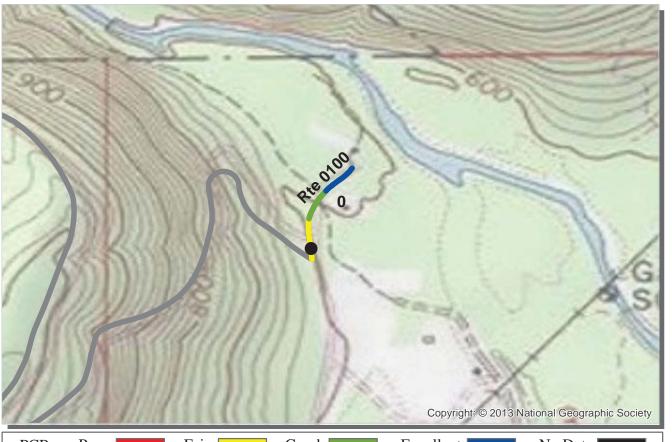
Γ	PCR	Poor		Fair	Good	Excellent	No Data
			(0 - 60)	(61 - 84)	(85 - 94)	(95 - 10	00)
*	If the PCI	R rating i	s not availab	ble for a section, the	SCR rating will be dis	played. See appendix f	or definitions and formulas.

•••	LECTED:	11/4/2012
SOUTHEAST REGION		TOTAL	LENGTH:	0.12 Miles
Section Number	0			
Section Length (mi)	0.12			
Cross Section Information				
Number of Lanes	2			
Paved Width (ft)	22			
Lane Width (ft)	11			
Roadway Condition Information				
SCR (Surface Condition Rating)	92			
PCR (Pavement Condition Rating)	92			
Distress Index Values				
Structural Crack Index	100			
Transverse Cracking Index	100			
Patching Index	100			
Rutting Index	92			
Roughness Condition Index (RCI)	NC

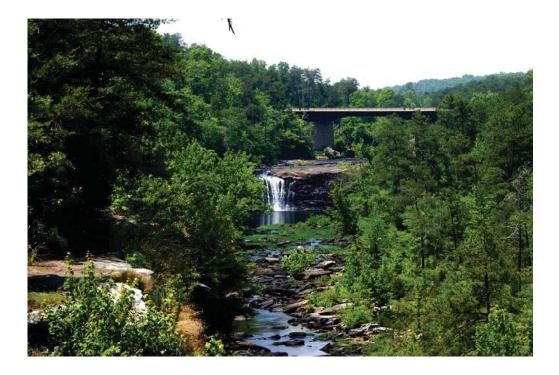
LITTLE RIVER CANYON NATIONAL PRESERVE Route 0900

Route	Public /				
Number	NonPublic	Date Visited	Area (sq ft)	Lane Miles *	Surface Type
0900	PUBLIC	5/24/2012	67,102	1.16	AS
Culverts	Drop Inlets	Gates	Curb & Gutter	Curb	PCR
			CONCRETE CURB		
1	2	0	AND GUTTER	NO CURB	EXCELLENT/97
