Federal Lands Highway Road Inventory Program

Road Inventory and Condition Assessment

Lyndon B. Johnson National Historical Park LYJO - 7350

Cycle 5 Report

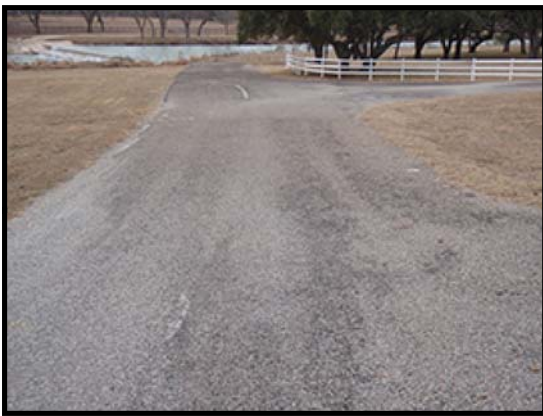
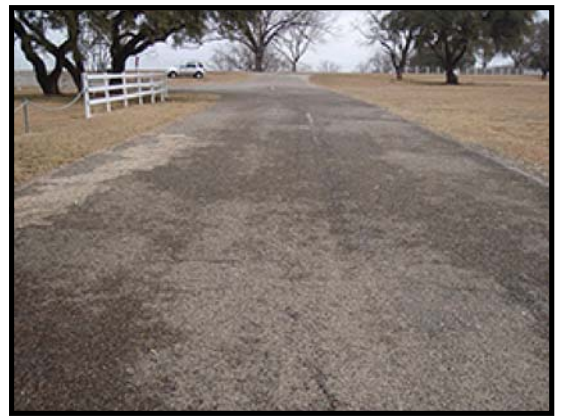
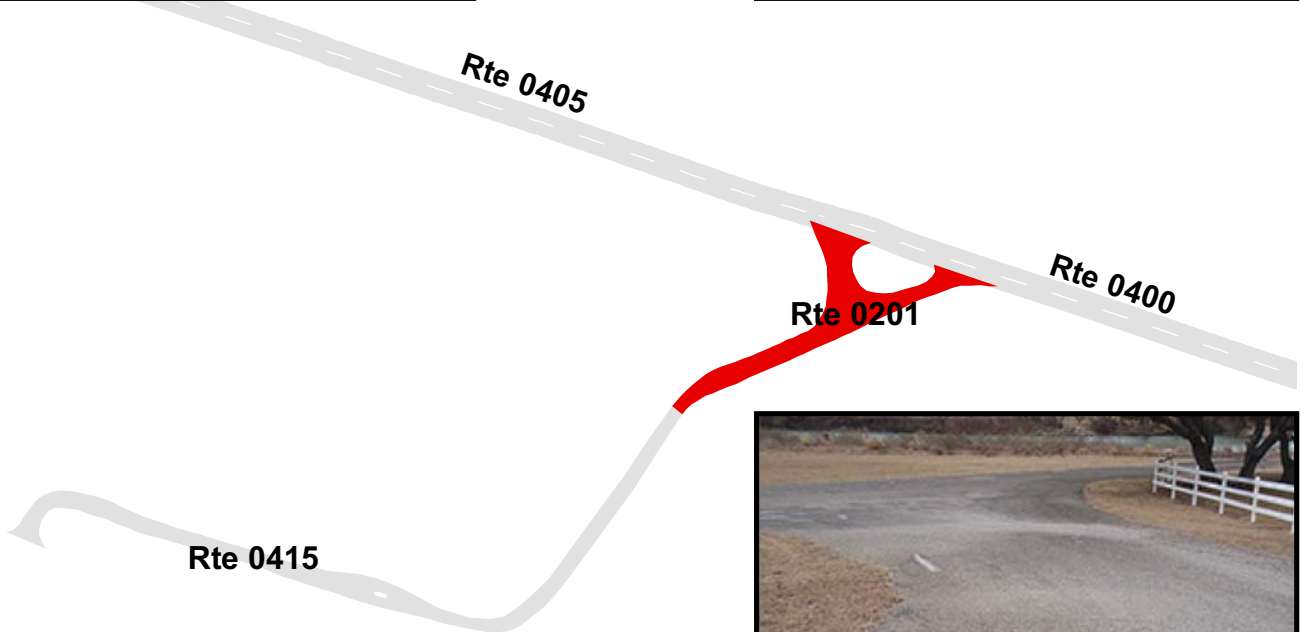
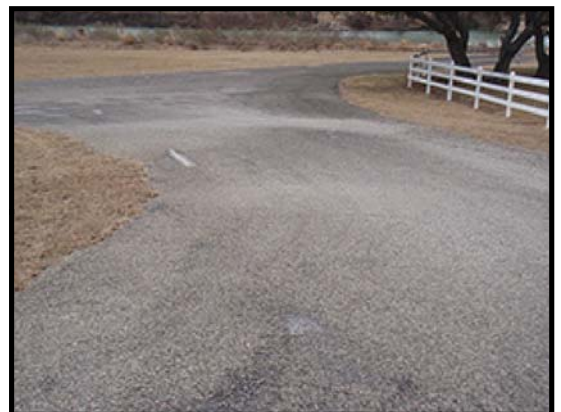
Route 0415

Route Number	Public / NonPublic	Date Visited	Area (sq ft)	Lane Miles *	Surface Type
0415	NONPUBLIC	2/9/2011	14,677	0.25	AS
Culverts	Drop Inlets	Gates	Curb & Gutter	Curb	PCR
0	0	1	NO CURB AND GUTTER	NO CURB	POOR/45

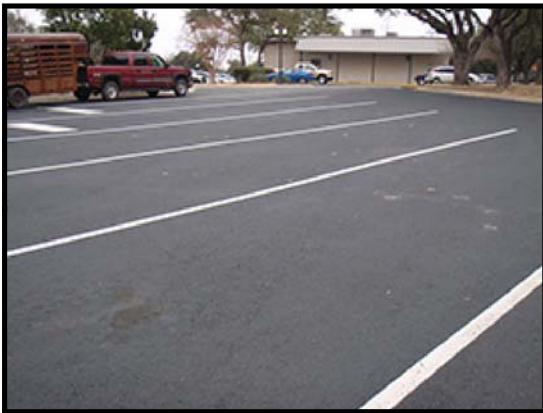
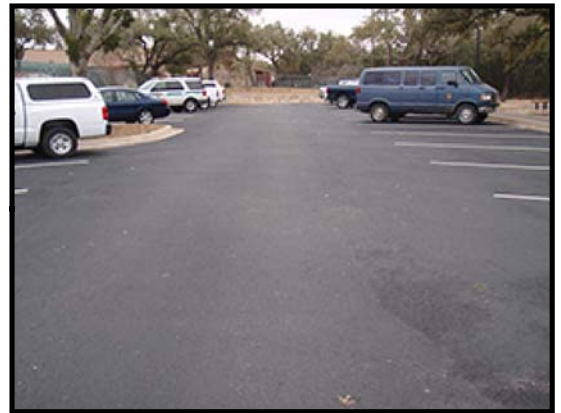
Route Number	Public / NonPublic	Date Visited	Area (sq ft)	Lane Miles *	Surface Type
0900	PUBLIC	2/9/2011	35,623	0.61	AS
Culverts	Drop Inlets	Gates	Curb & Gutter	Curb	PCR
0	5	0	CONCRETE CURB AND GUTTER	CONCRETE CURB	GOOD/90

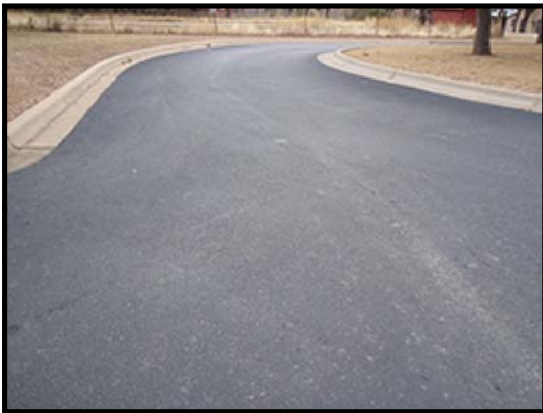
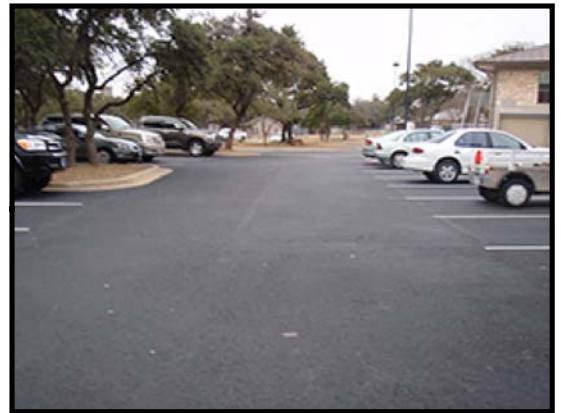
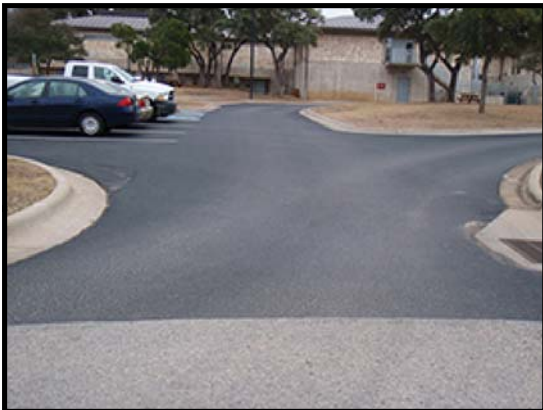
Route 0901

Route Number	Public / NonPublic	Date Visited	Area (sq ft)	Lane Miles *	Surface Type
0901	NONPUBLIC	2/9/2011	13,671	0.24	AS
Culverts	Drop Inlets	Gates	Curb & Gutter	Curb	PCR
0	1	0	CONCRETE CURB AND GUTTER	NO CURB	GOOD/90

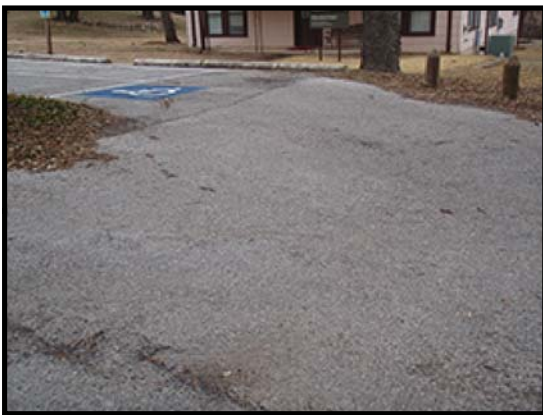
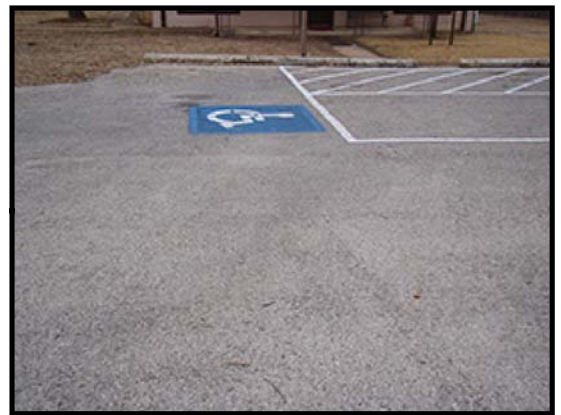
Route 0902

Route Number	Public / NonPublic	Date Visited	Area (sq ft)	Lane Miles *	Surface Type
0902	PUBLIC	2/9/2011	2,229	0.04	AS
Culverts	Drop Inlets	Gates	Curb & Gutter	Curb	PCR
0	0	0	NO CURB AND GUTTER	NO CURB	FAIR/73

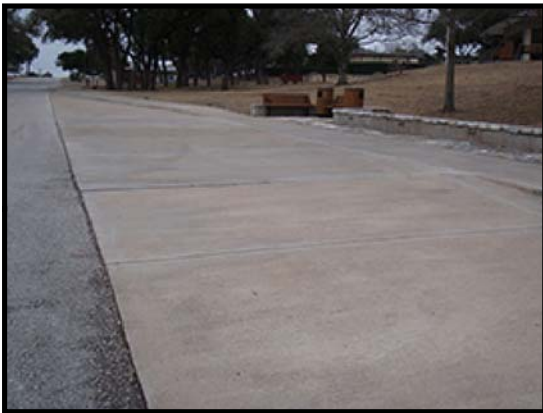
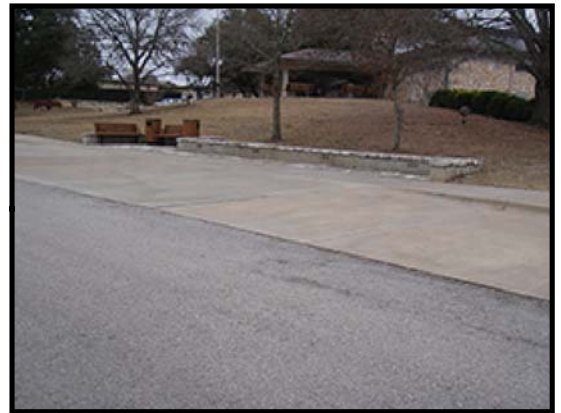
Route 0904

Route Number	Public / NonPublic	Date Visited	Area (sq ft)	Lane Miles *	Surface Type
0904	PUBLIC	2/9/2011	1,729	0.03	CO
Culverts	Drop Inlets	Gates	Curb & Gutter	Curb	PCR
0	0	0	CONCRETE CURB AND GUTTER	NO CURB	GOOD/90

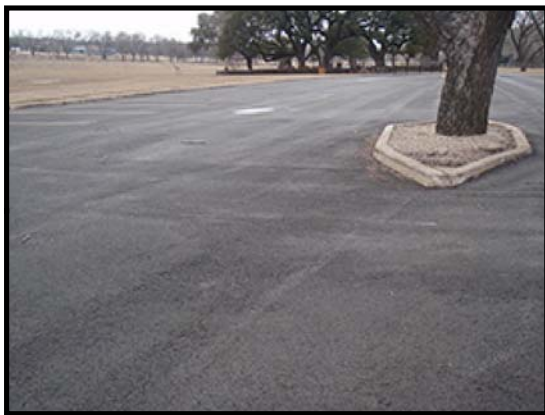
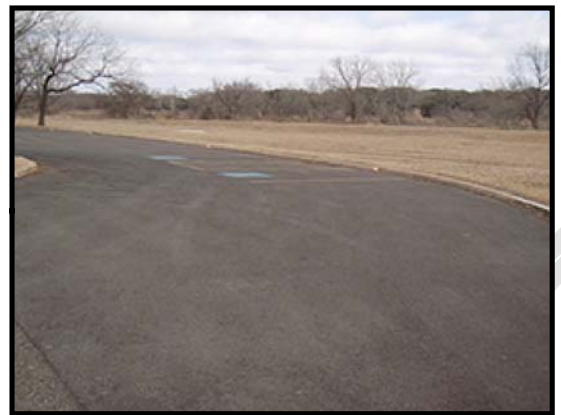
Route 0905

Route Number	Public / NonPublic	Date Visited	Area (sq ft)	Lane Miles *	Surface Type
0905	PUBLIC	2/9/2011	9,767	0.17	AS
Culverts	Drop Inlets	Gates	Curb & Gutter	Curb	PCR
0	0	0	NO CURB AND GUTTER	CONCRETE & STONE CURB	GOOD/90

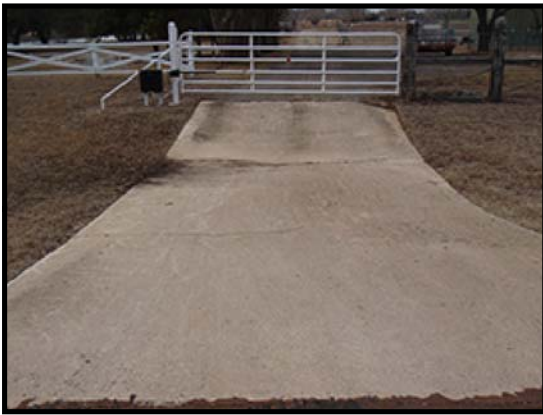
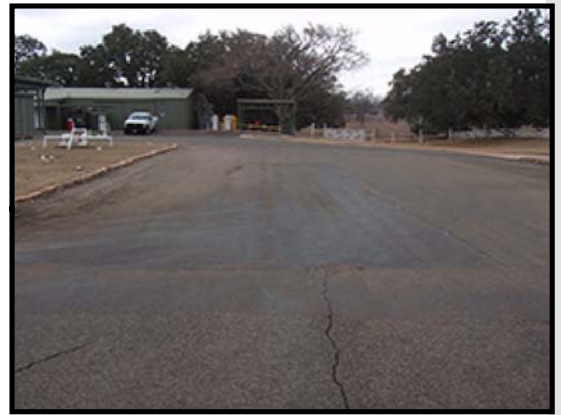
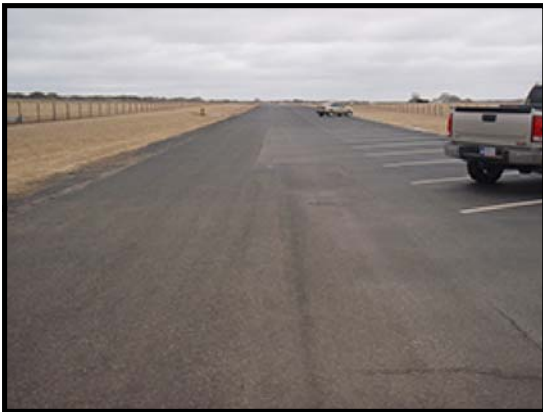
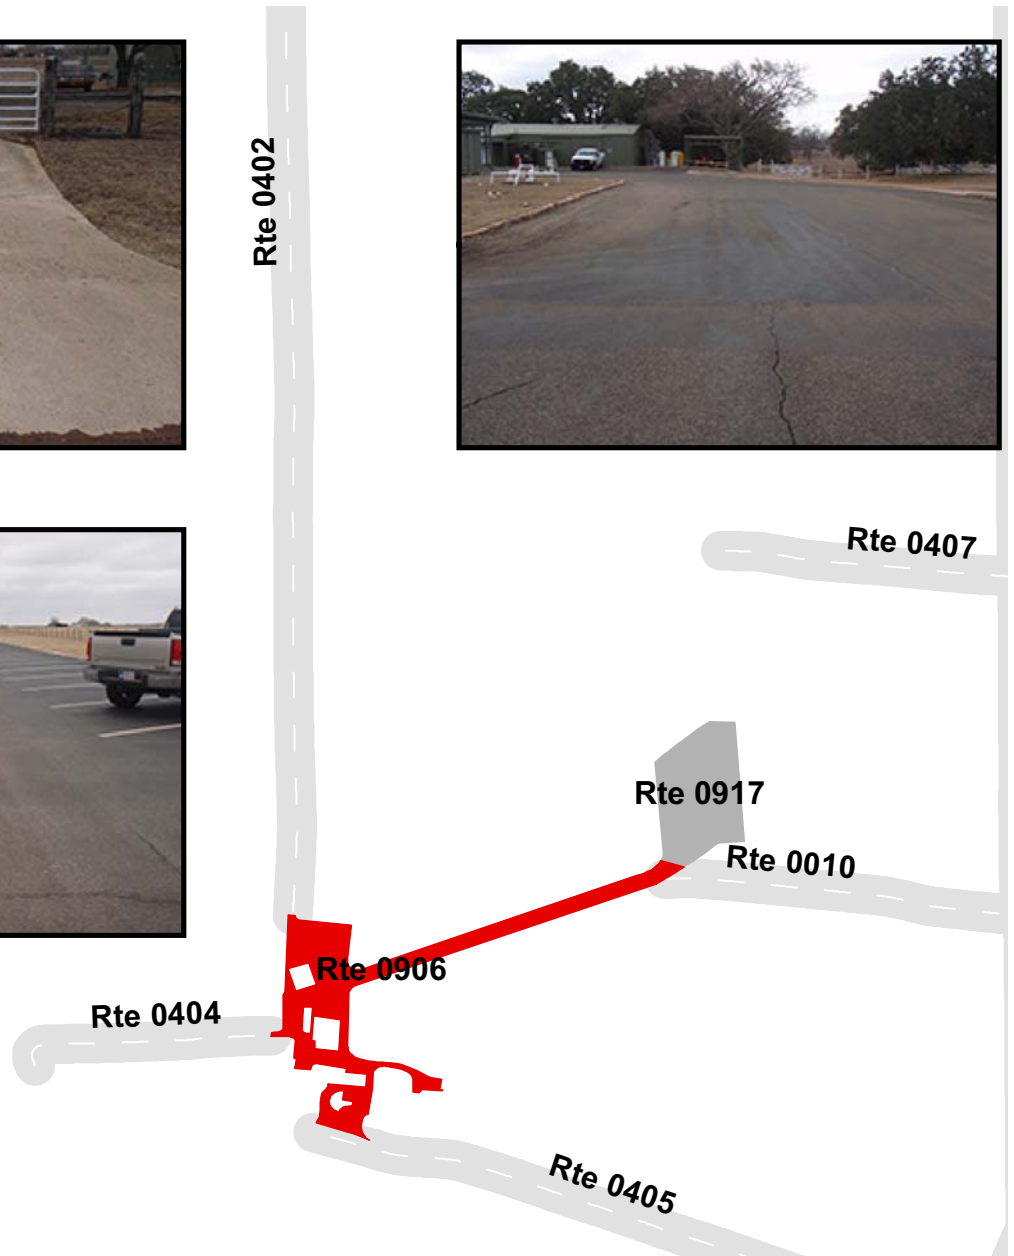
Route 0906

Route Number	Public / NonPublic	Date Visited	Area (sq ft)	Lane Miles *	Surface Type
0906	PUBLIC	2/9/2011	123,994	2.14	AS
Culverts	Drop Inlets	Gates	Curb & Gutter	Curb	PCR
0	14	1	NO CURB AND GUTTER	STONE CURB	FAIR/73

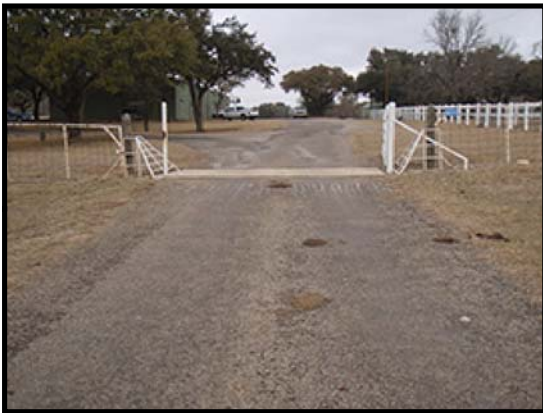
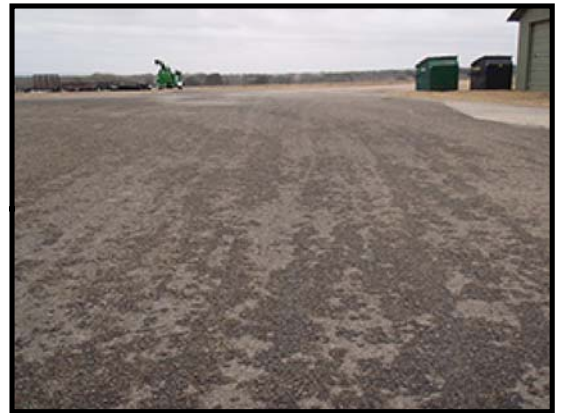
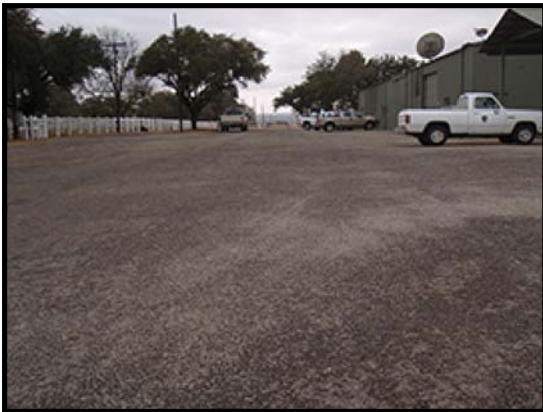
Route 0907

Route Number	Public / NonPublic	Date Visited	Area (sq ft)	Lane Miles *	Surface Type
0907	NONPUBLIC	2/9/2011	62,856	1.08	AS
Culverts	Drop Inlets	Gates	Curb & Gutter	Curb	PCR
0	0	2	NO CURB AND GUTTER	NO CURB	FAIR/73

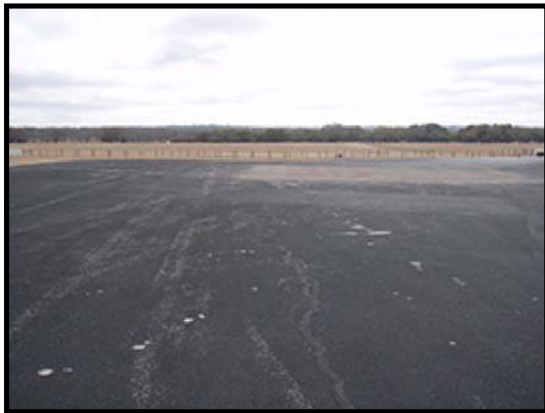
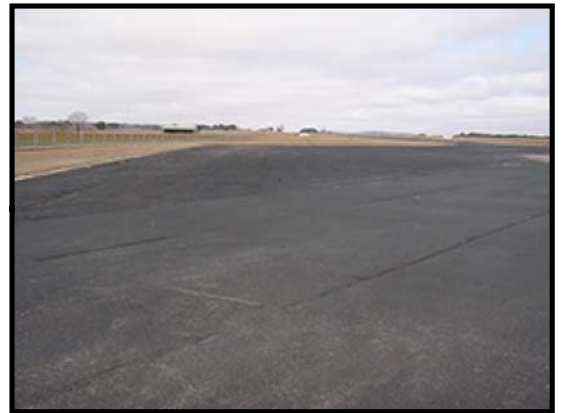
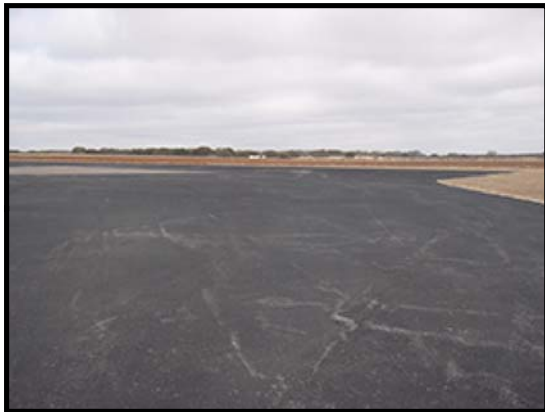
Route 0917

Route Number	Public / NonPublic	Date Visited	Area (sq ft)	Lane Miles *	Surface Type
0917	PUBLIC	2/9/2011	80,474	1.39	AS
Culverts	Drop Inlets	Gates	Curb & Gutter	Curb	PCR
0	0	0	NO CURB AND GUTTER	NO CURB	POOR/45
