Federal Lands Highway Road Inventory Program

Road Inventory and Condition Assessment

Mammoth Cave National Park MACA

Cycle 5 Report

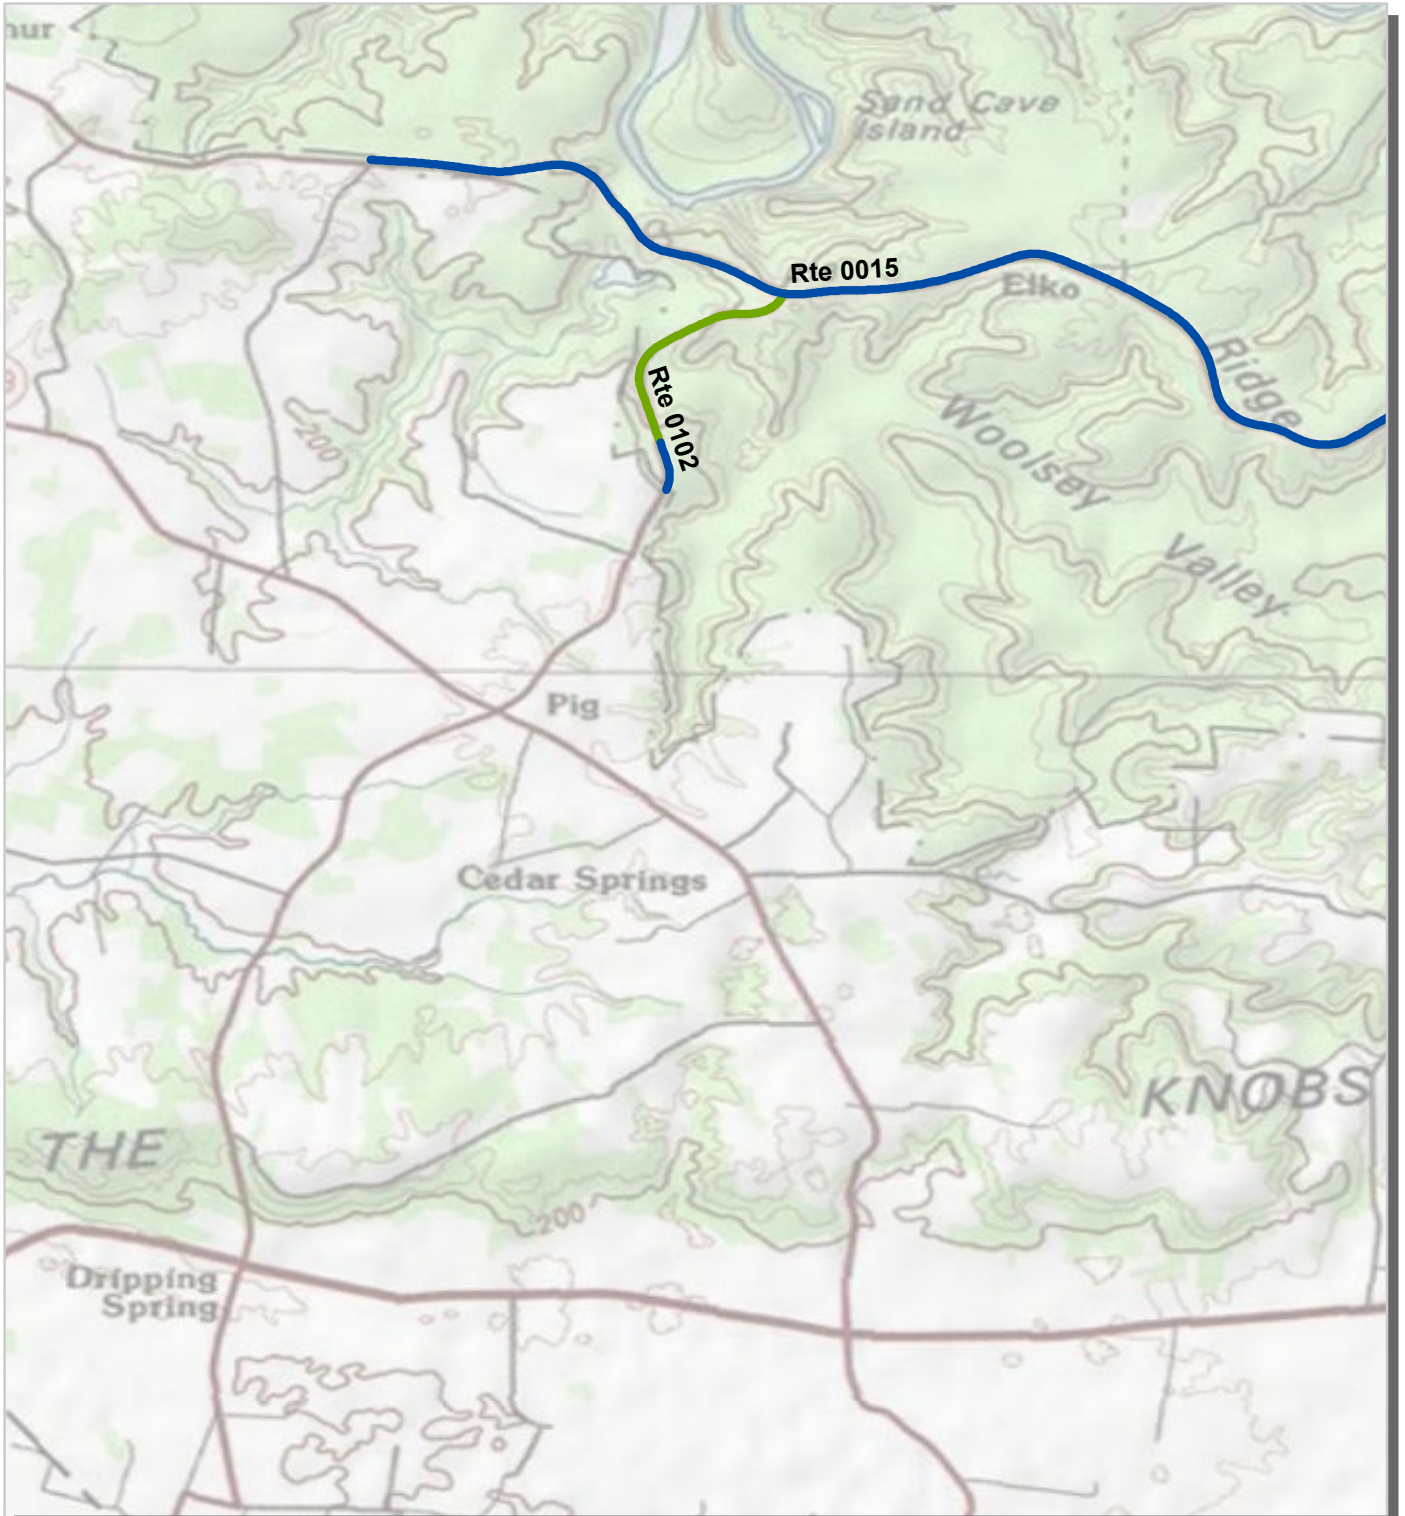
**Mammoth Cave National Park
Route Condition Map
PCR - Mile by Mile
Area 4**

PCR	Poor		Fair		Good		Excellent		No Data	
	(0 - 60)		(61 - 84)	(85 - 94)	(95 - 100)

* If the PCR rating is not available for a section, the SCR rating will be displayed. See appendix for definitions and formulas.

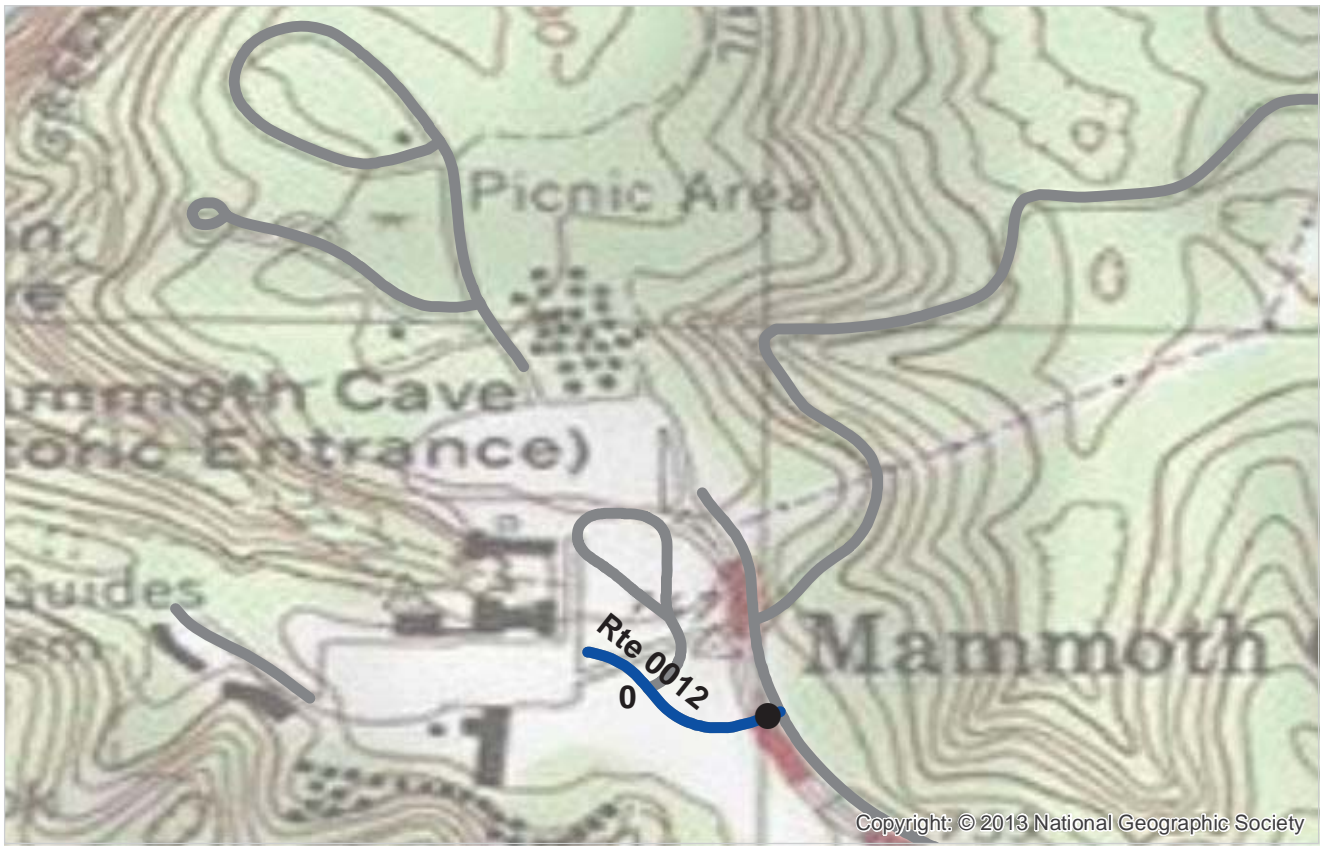
ROUTE: 0012 HOTEL ENTRANCE ROAD

Section Number	0				
Section Length (mi)	0.12				
Cross Section Information					
Number of Lanes	2				
Paved Width (ft)	20				
Lane Width (ft)	9				
Roadway Condition Information					
SCR (Surface Condition Rating)	99				
PCR (Pavement Condition Rating)	99				
Distress Index Values					
Structural Crack Index	100				
Transverse Cracking Index	100				
Patching Index	100				
Rutting Index	99				
Roughness Condition Index (RCI)	NC

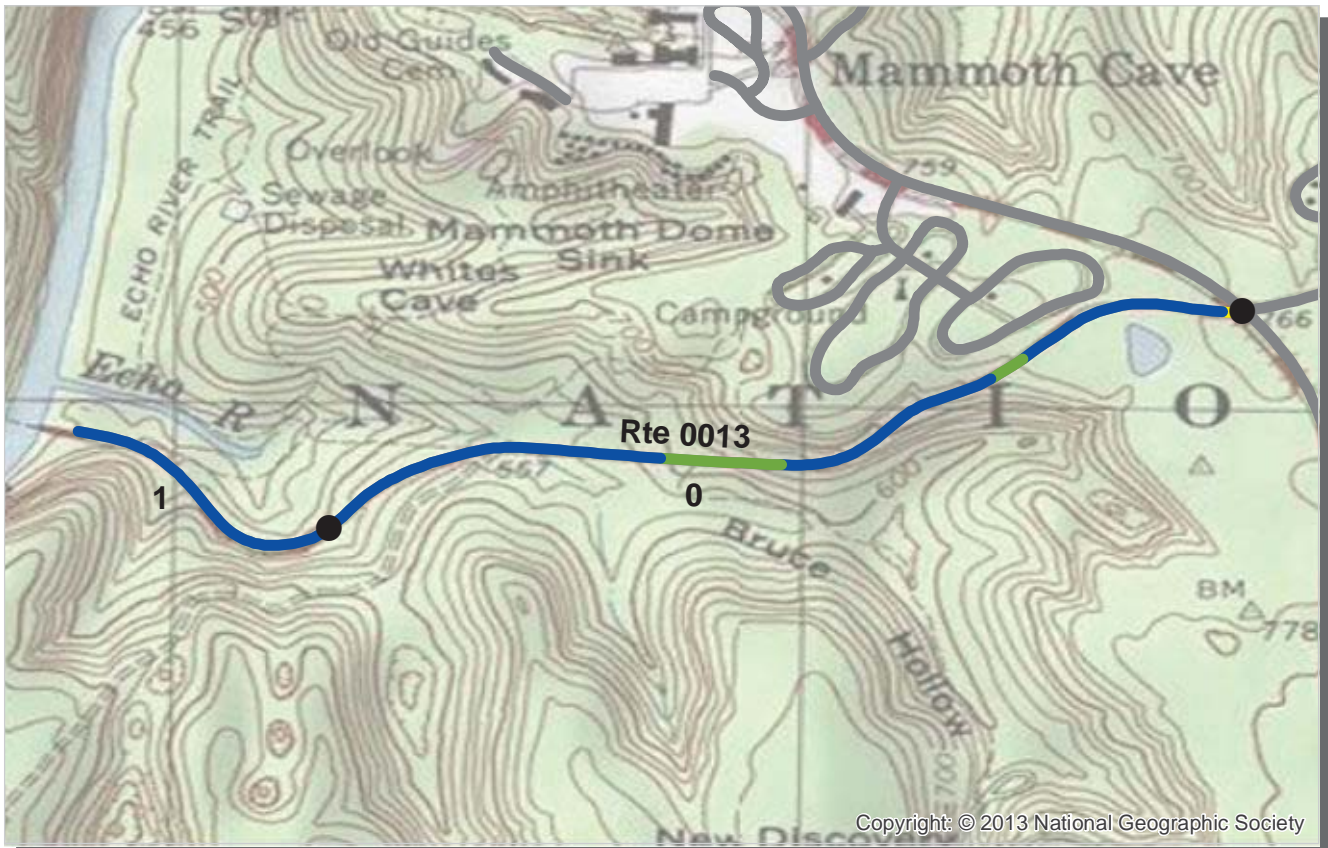
ROUTE: 0013 GREEN RIVER FERRY ROAD SOUTH

<i>Section Number</i>	0	1			
<i>Section Length (mi)</i>	1.00	0.31			
<i>Cross Section Information</i>					
Number of Lanes	2	2			
Paved Width (ft)	21	23			
Lane Width (ft)	9	9			
<i>Roadway Condition Information</i>					
SCR (Surface Condition Rating)	99	99			
PCR (Pavement Condition Rating)	97	99			
<i>Distress Index Values</i>					
Structural Crack Index	99	99			
Transverse Cracking Index	100	100			
Patching Index	100	100			
Rutting Index	99	99			
Roughness Condition Index (RCI)	93	100

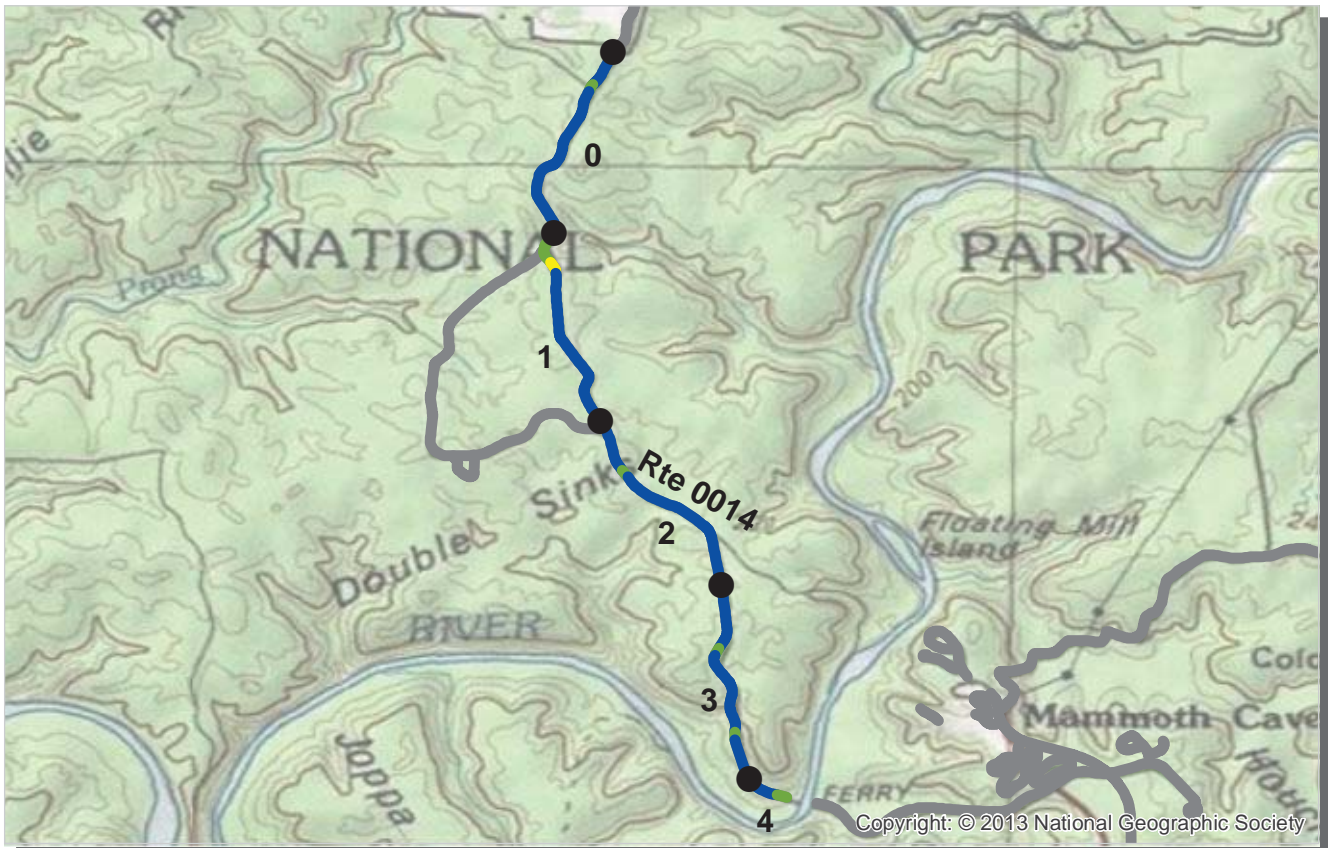
ROUTE: 0014 GREEN RIVER FERRY ROAD NORTH

<i>Section Number</i>	0	1	2	3	4
<i>Section Length (mi)</i>	1.00	1.00	1.00	1.00	0.18
<i>Cross Section Information</i>					
Number of Lanes	2	2	2	2	2
Paved Width (ft)	18	18	18	18	19
Lane Width (ft)	8	8	8	8	8
<i>Roadway Condition Information</i>					
SCR (Surface Condition Rating)	99	99	99	100	99
PCR (Pavement Condition Rating)	98	97	99	100	93
<i>Distress Index Values</i>					
Structural Crack Index	99	99	99	100	100
Transverse Cracking Index	100	100	100	100	100
Patching Index	100	100	100	100	100
Rutting Index	99	99	100	100	99
Roughness Condition Index (RCI)	96	94	100	100	84

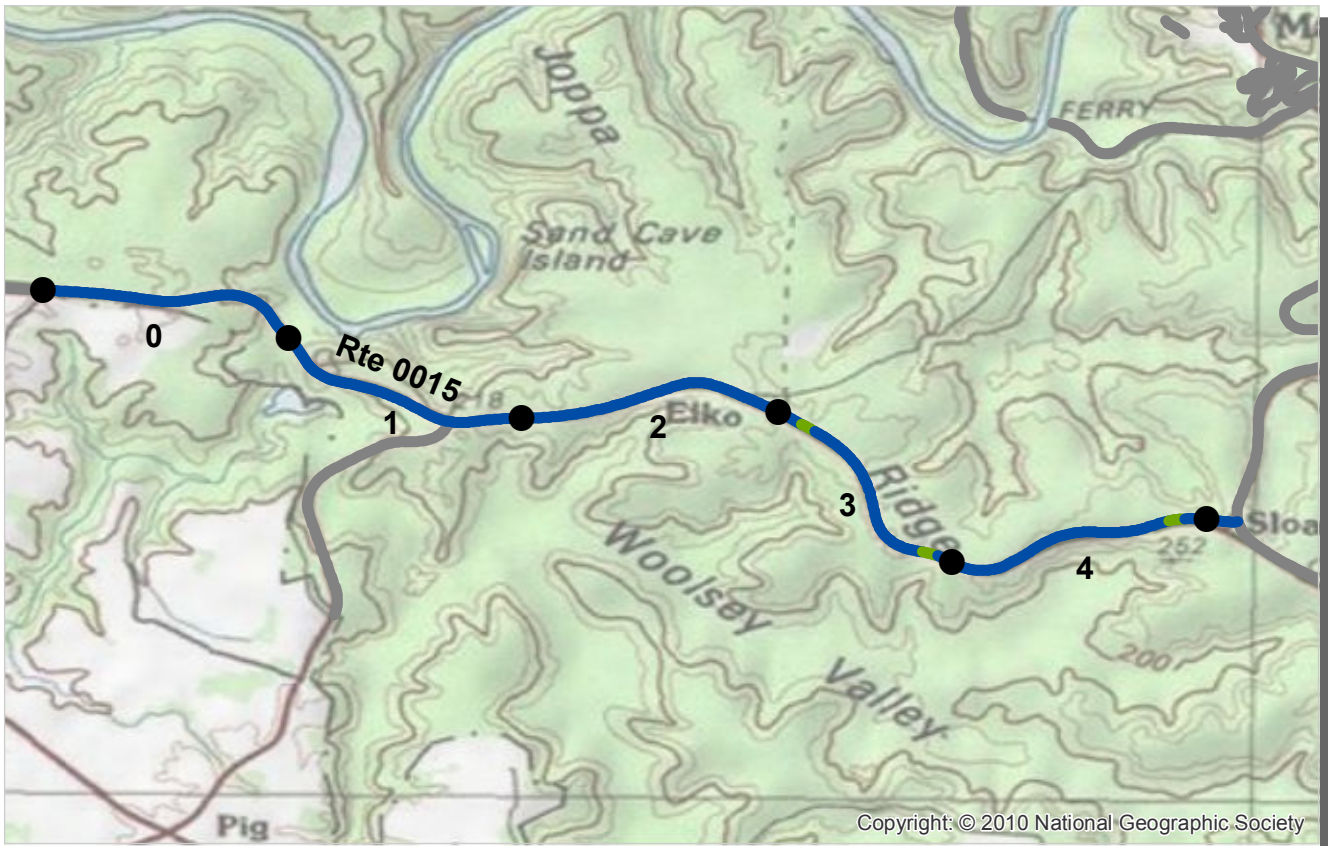
ROUTE: 0015 BROWNSVILLE ROAD

<i>Section Number</i>	0	1	2	3	4
<i>Section Length (mi)</i>	1.00	1.00	1.00	1.00	1.00
<i>Cross Section Information</i>					
Number of Lanes	2	2	2	2	2
Paved Width (ft)	21	21	21	21	21
Lane Width (ft)	9	9	9	9	9
<i>Roadway Condition Information</i>					
SCR (Surface Condition Rating)	100	99	100	95	99
PCR (Pavement Condition Rating)	100	99	100	97	99
<i>Distress Index Values</i>					
Structural Crack Index	100	99	100	95	99
Transverse Cracking Index	100	100	100	100	100
Patching Index	100	100	100	100	100
Rutting Index	100	100	100	100	100
Roughness Condition Index (RCI)	100	100	100	100	100

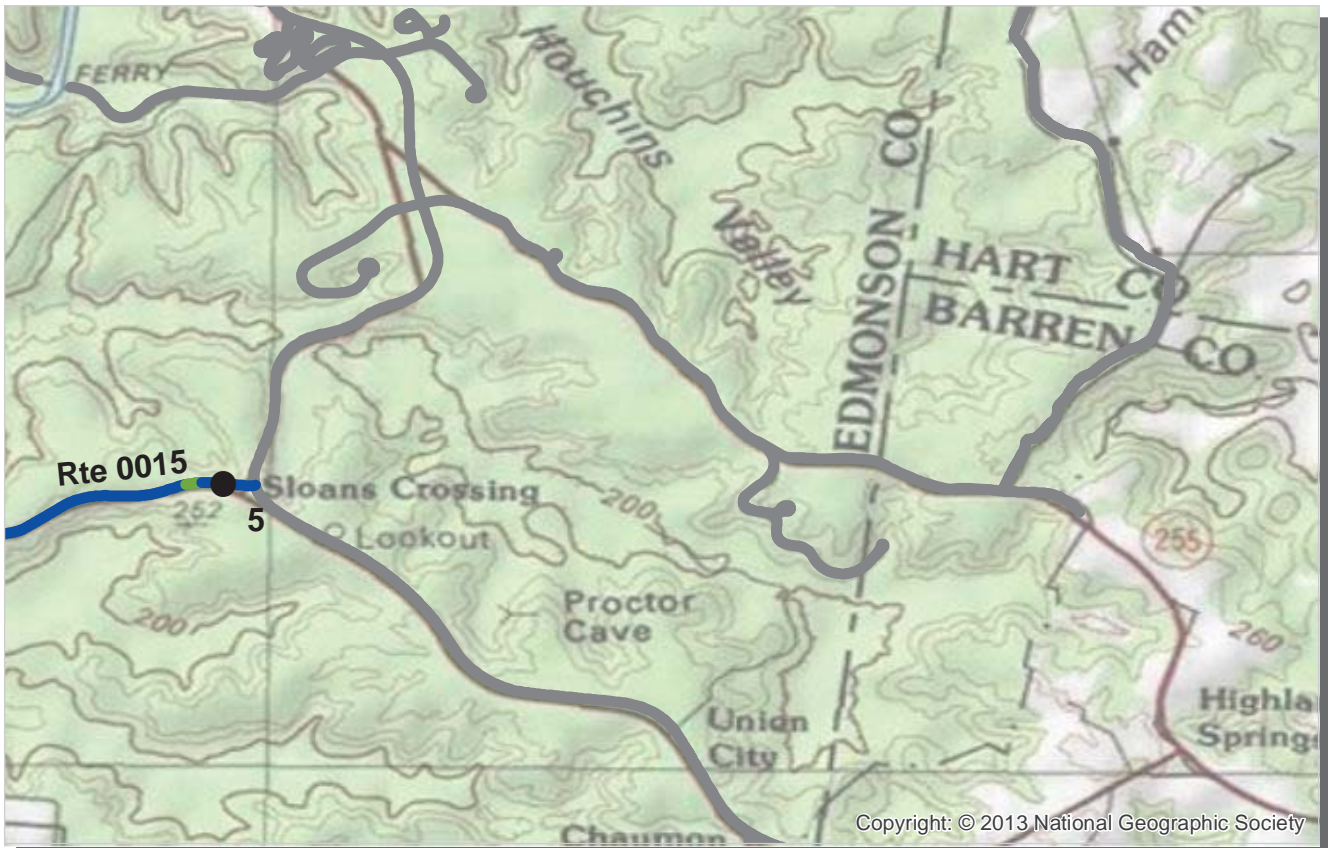
PCR Poor ■ Fair ■ Good ■ Excellent ■ No Data ■
 (0 - 60) (61 - 84) (85 - 94) (95 - 100)

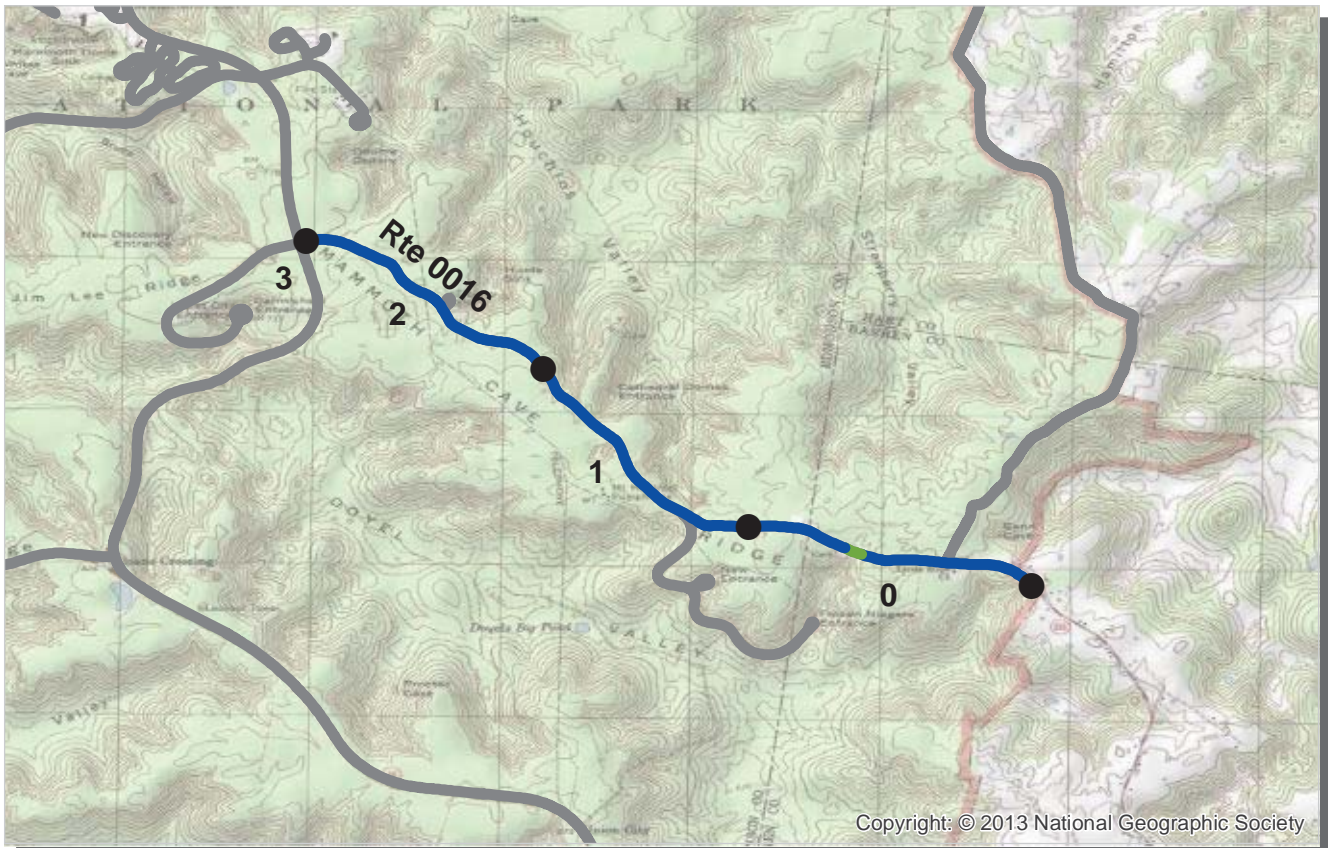
ROUTE: 0016 CAVE CITY ROAD

<i>Section Number</i>	0	1	2	3	
<i>Section Length (mi)</i>	1.00	1.00	1.00	0.02	
<i>Cross Section Information</i>					
Number of Lanes	2	2	2	2	
Paved Width (ft)	20	21	21	22	
Lane Width (ft)	9	9	9	9	
<i>Roadway Condition Information</i>					
SCR (Surface Condition Rating)	100	99	99	95	
PCR (Pavement Condition Rating)	100	99	99	95	
<i>Distress Index Values</i>					
Structural Crack Index	100	99	99	100	
Transverse Cracking Index	100	100	100	98	
Patching Index	100	100	100	100	
Rutting Index	100	100	100	95	
Roughness Condition Index (RCI)	100	100	100	NC

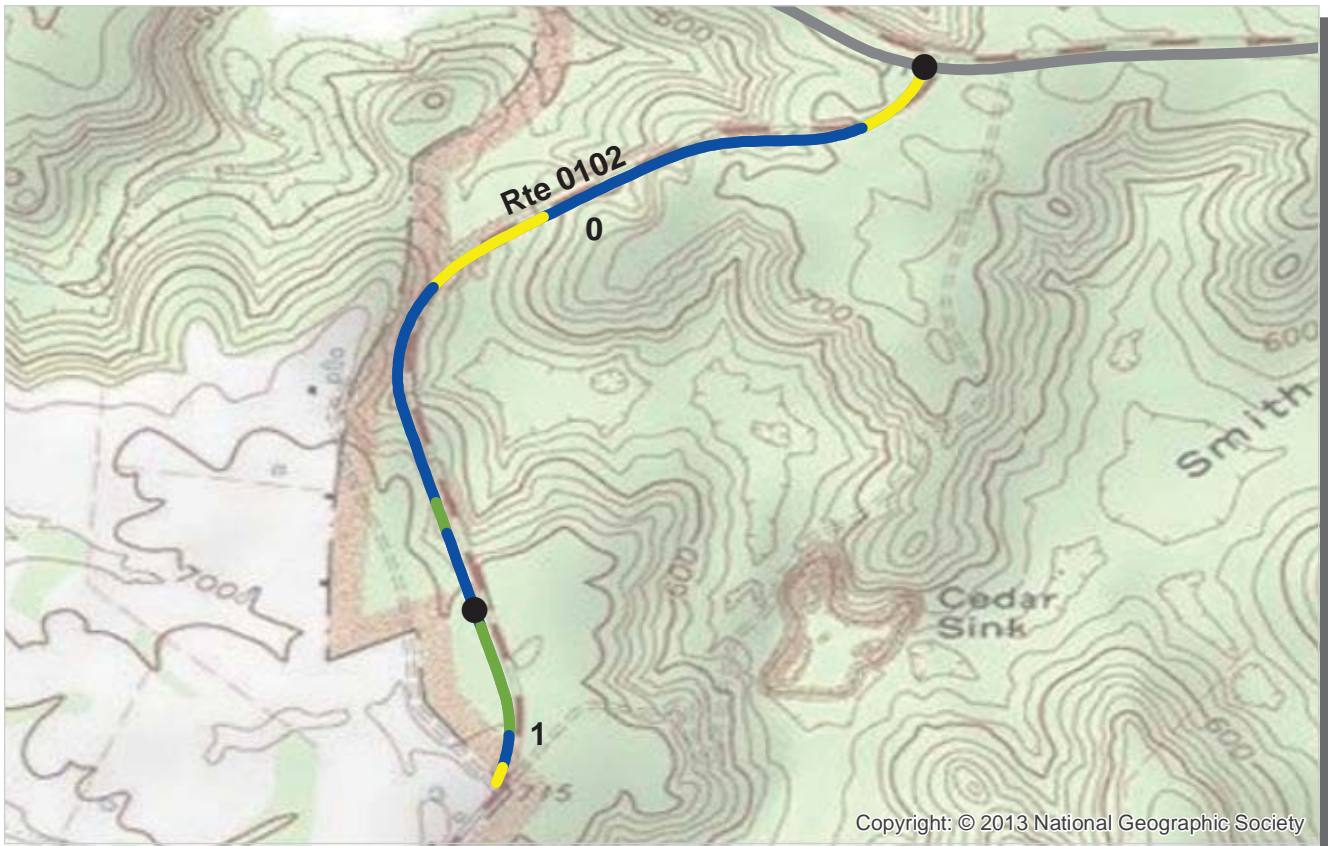
ROUTE: 0102 CEDAR SINK ROAD

<i>Section Number</i>	0	1			
<i>Section Length (mi)</i>	1.00	0.22			
<i>Cross Section Information</i>					
Number of Lanes	2	2			
Paved Width (ft)	20	20			
Lane Width (ft)	9	9			
<i>Roadway Condition Information</i>					
SCR (Surface Condition Rating)	87	93			
PCR (Pavement Condition Rating)	90	96			
<i>Distress Index Values</i>					
Structural Crack Index	87	93			
Transverse Cracking Index	97	94			
Patching Index	100	100			
Rutting Index	98	99			
Roughness Condition Index (RCI)	94	100

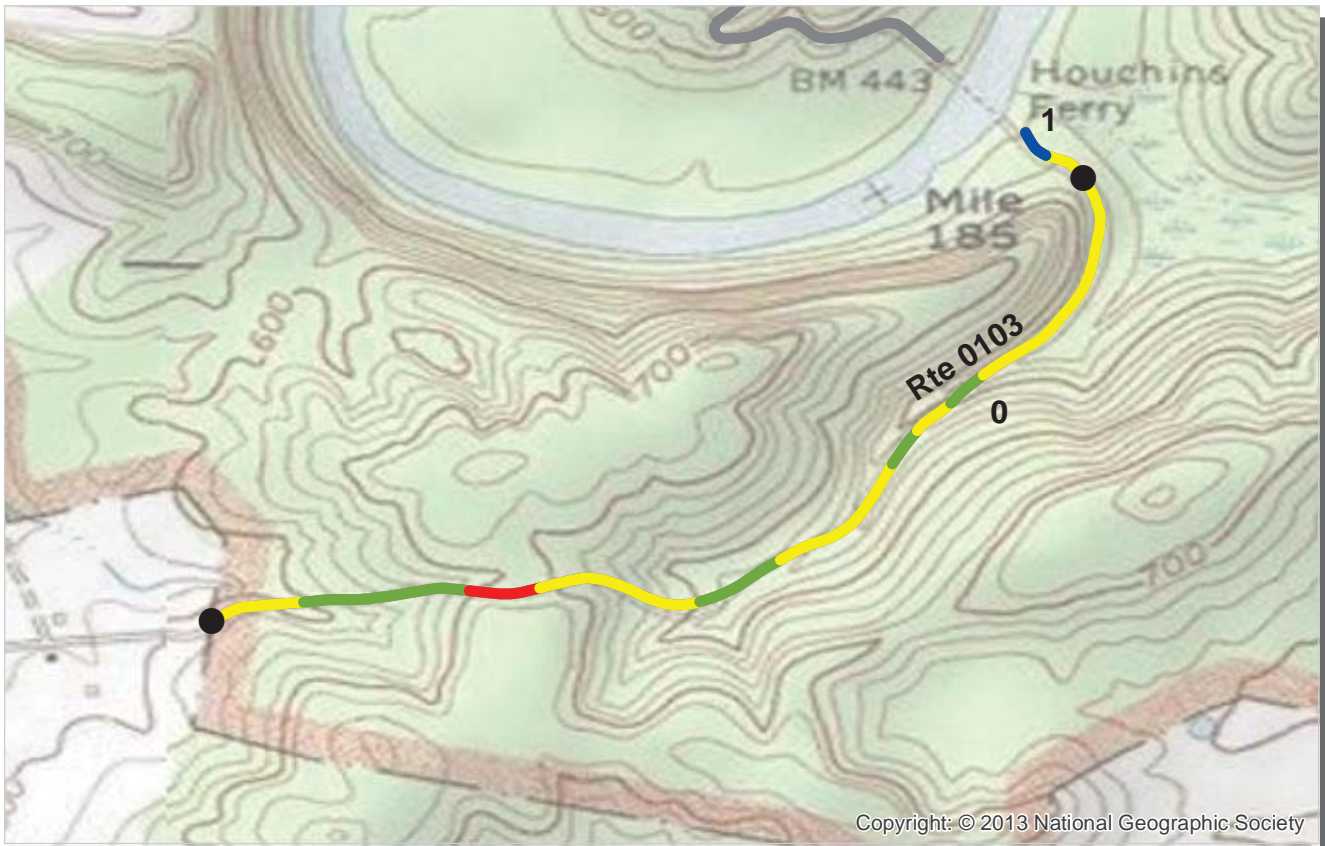
ROUTE: 0103 HOUCHINS FERRY ROAD SOUTH

Section Number	0	1			
Section Length (mi)	1.00	0.07			
Cross Section Information					
Number of Lanes	2	2			
Paved Width (ft)	18	18			
Lane Width (ft)	8	8			
Roadway Condition Information					
SCR (Surface Condition Rating)	91	88			
PCR (Pavement Condition Rating)	79	62			
Distress Index Values					
Structural Crack Index	91	96			
Transverse Cracking Index	100	100			
Patching Index	100	100			
Rutting Index	91	88			
Roughness Condition Index (RCI)	62	24

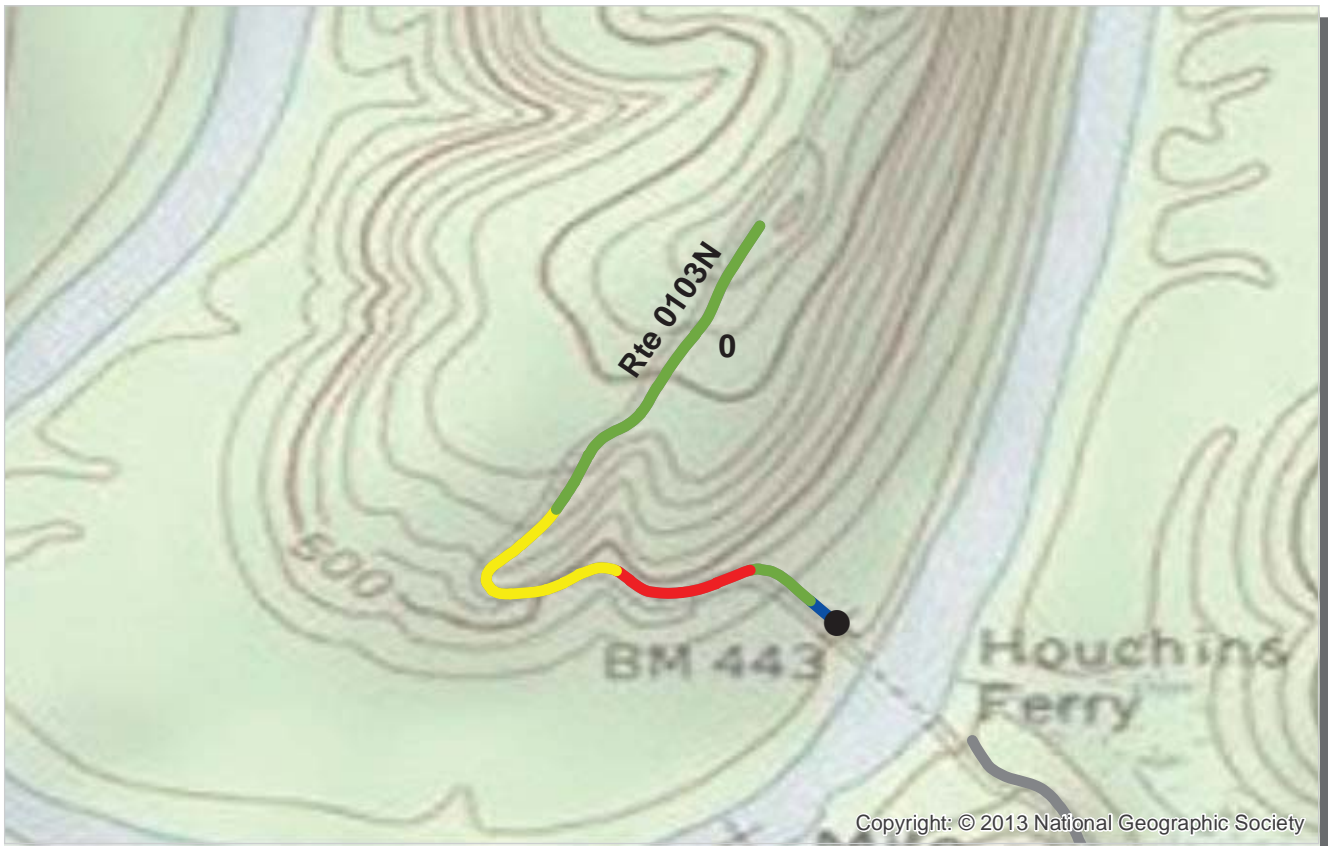
ROUTE: 0103N HOUCHINS FERRY ROAD NORTH

Section Number	0				
Section Length (mi)	0.50				
Cross Section Information					
Number of Lanes	2				
Paved Width (ft)	16				
Lane Width (ft)	9				
Roadway Condition Information					
SCR (Surface Condition Rating)	83				
PCR (Pavement Condition Rating)	73				
Distress Index Values					
Structural Crack Index	83				
Transverse Cracking Index	100				
Patching Index	100				
Rutting Index	95				
Roughness Condition Index (RCI)	57

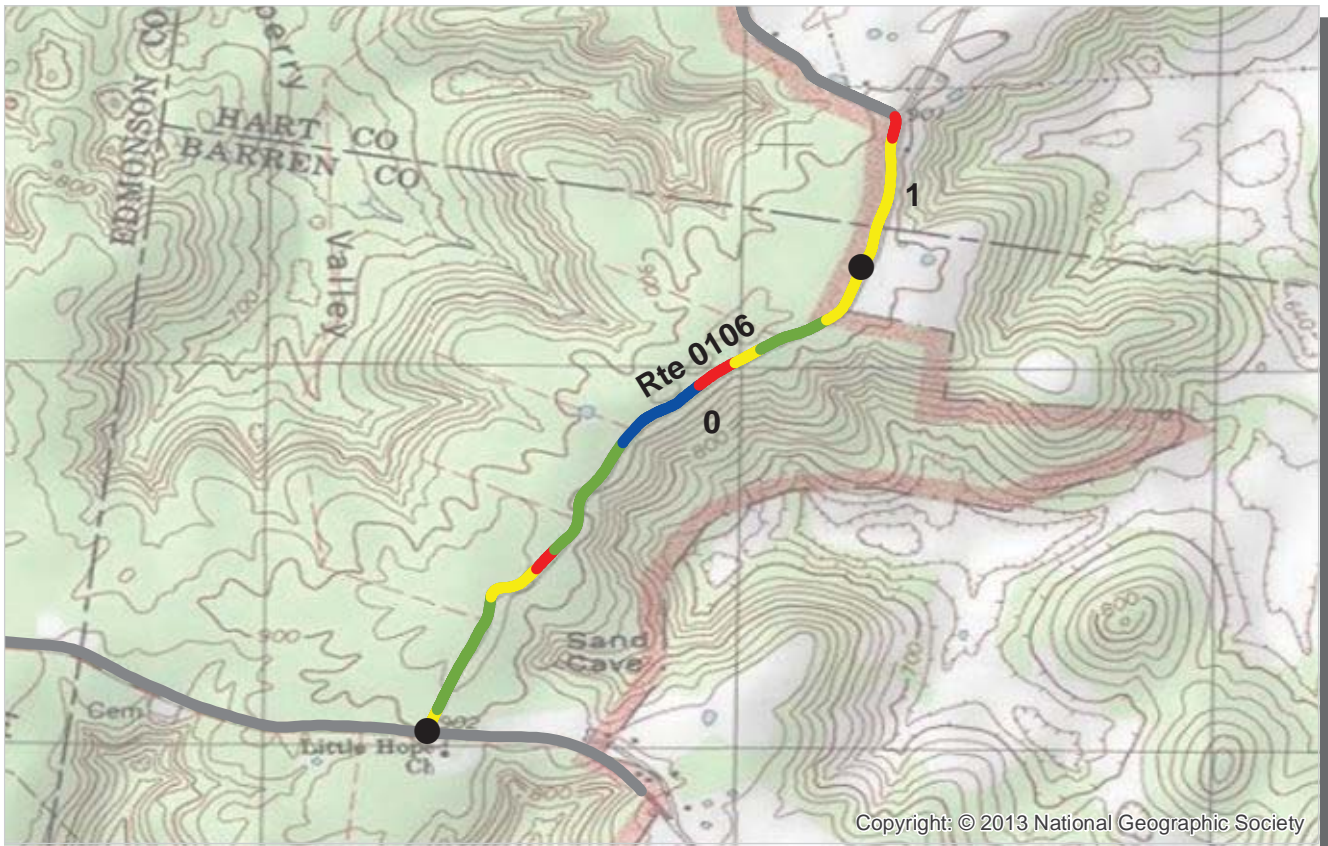
ROUTE: 0106 PARK RIDGE ROAD

<i>Section Number</i>	0	1			
<i>Section Length (mi)</i>	1.00	0.26			
<i>Cross Section Information</i>					
Number of Lanes	2	2			
Paved Width (ft)	16	14			
Lane Width (ft)	8	7			
<i>Roadway Condition Information</i>					
SCR (Surface Condition Rating)	85	80			
PCR (Pavement Condition Rating)	82	67			
<i>Distress Index Values</i>					
Structural Crack Index	85	98			
Transverse Cracking Index	100	100			
Patching Index	100	100			
Rutting Index	95	80			
Roughness Condition Index (RCI)	78	48
