Federal Lands Highway Road Inventory Program

Road Inventory and Condition Assessment

Manassas National Battlefield Park MANA

Cycle 5 Report

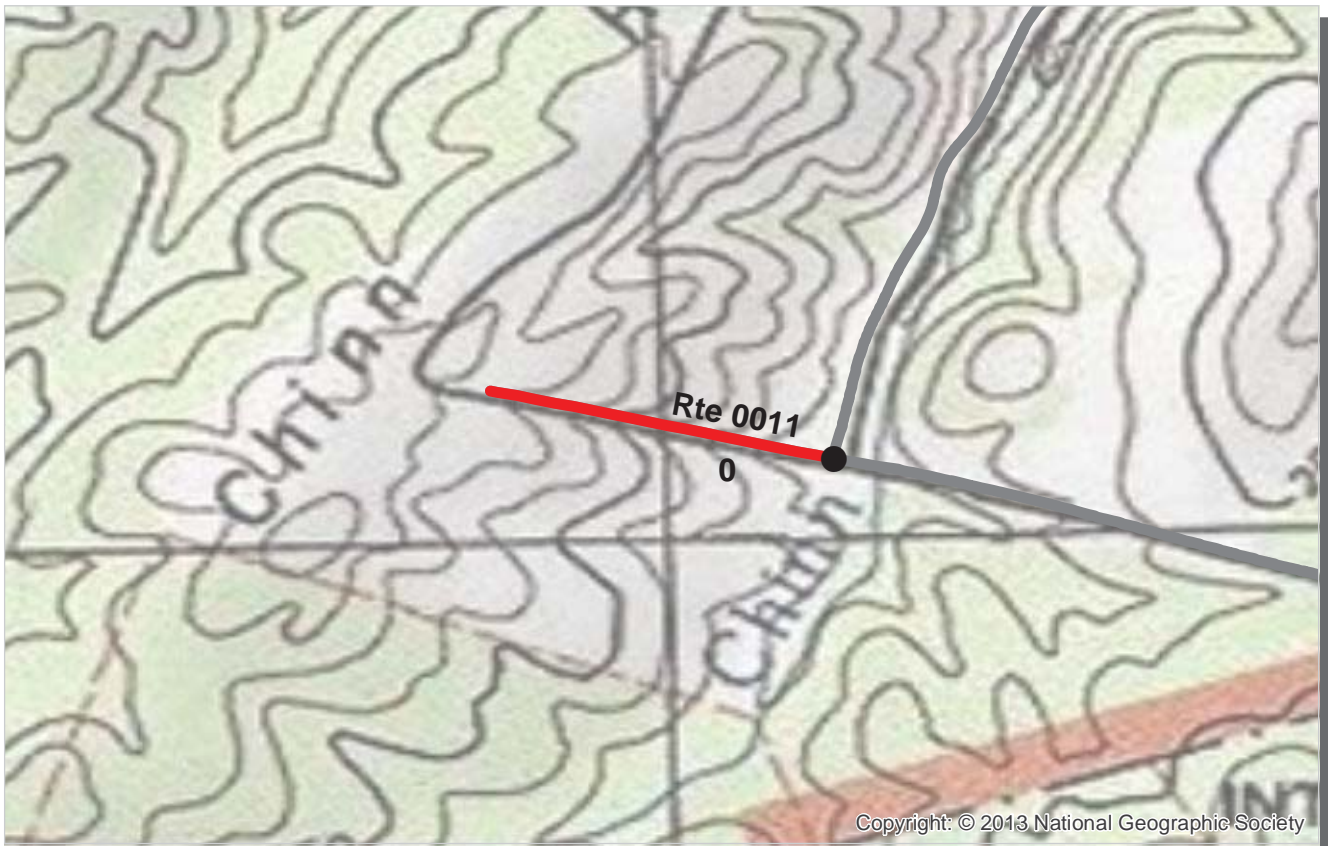
ROUTE: 0011 SOUTH CHINN RIDGE ROAD

Section Number	0				
Section Length (mi)	0.18				
Cross Section Information					
Number of Lanes	2				
Paved Width (ft)	19				
Lane Width (ft)	9				
Roadway Condition Information					
SCR (Surface Condition Rating)	0				
PCR (Pavement Condition Rating)	0				
Distress Index Values					
Structural Crack Index	0				
Transverse Cracking Index	62				
Patching Index	100				
Rutting Index	95				
Roughness Condition Index (RCI)	NC

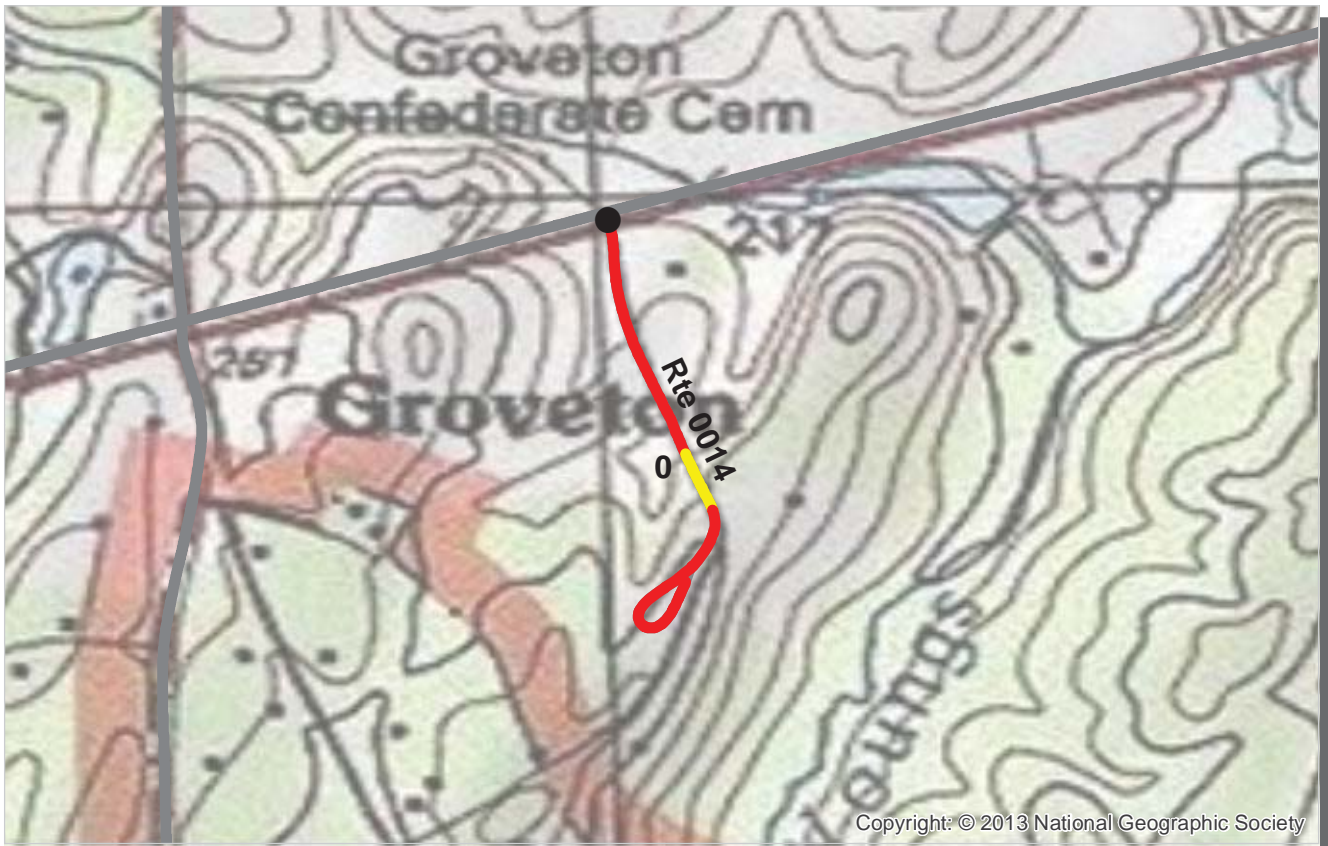
ROUTE: 0014 NEW YORK AVENUE

Section Number	0				
Section Length (mi)	0.33				
Cross Section Information					
Number of Lanes	2				
Paved Width (ft)	16				
Lane Width (ft)	9				
Roadway Condition Information					
SCR (Surface Condition Rating)	0				
PCR (Pavement Condition Rating)	0				
Distress Index Values					
Structural Crack Index	0				
Transverse Cracking Index	78				
Patching Index	100				
Rutting Index	99				
Roughness Condition Index (RCI)	NC

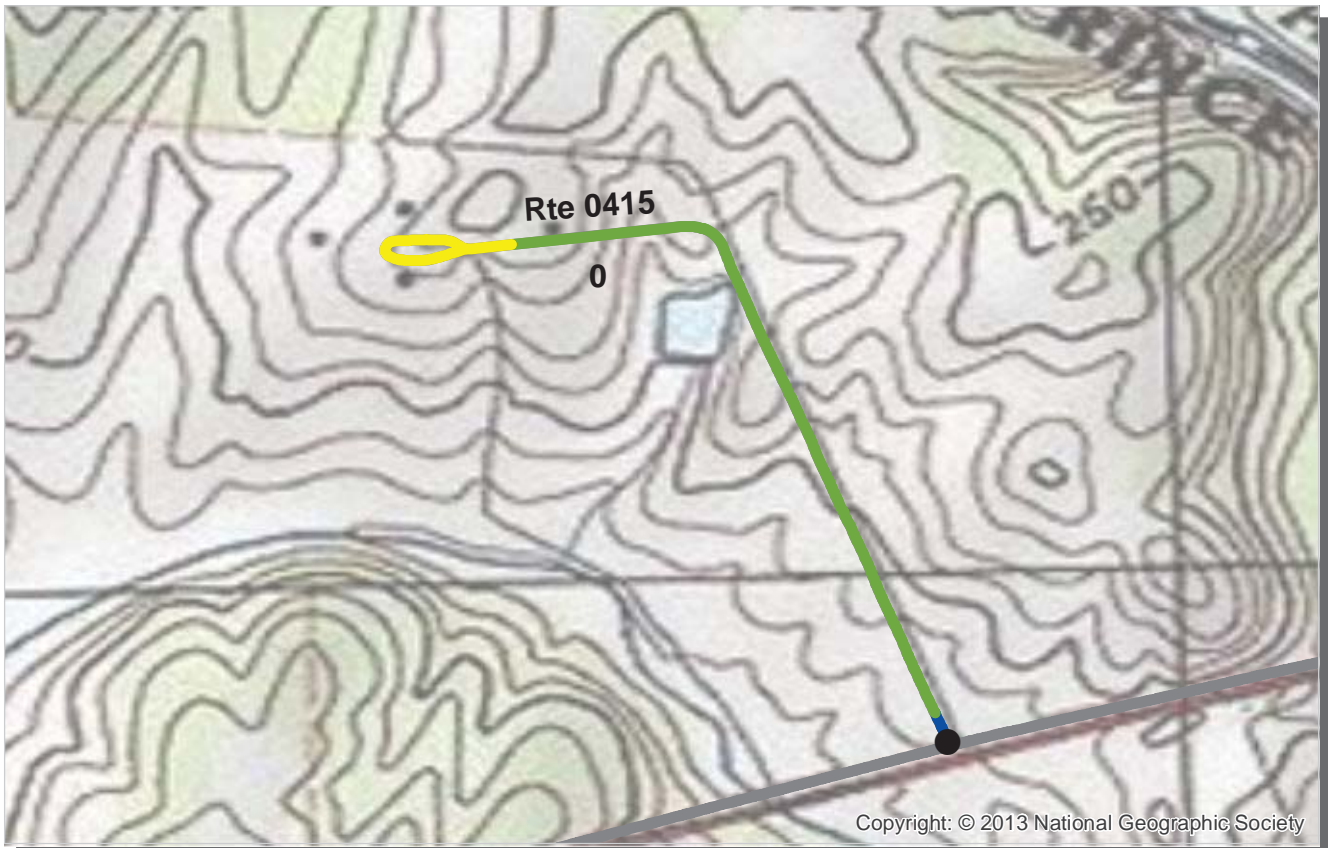
Section Number	0				
Section Length (mi)	0.57				
Cross Section Information					
Number of Lanes	1				
Paved Width (ft)	11				
Lane Width (ft)	11				
Roadway Condition Information					
SCR (Surface Condition Rating)	89				
PCR (Pavement Condition Rating)	89				
Distress Index Values					
Structural Crack Index	96				
Transverse Cracking Index	89				
Patching Index	100				
Rutting Index	97				
Roughness Condition Index (RCI)	NC

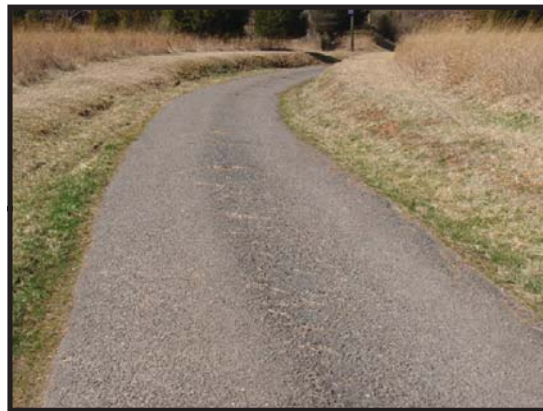
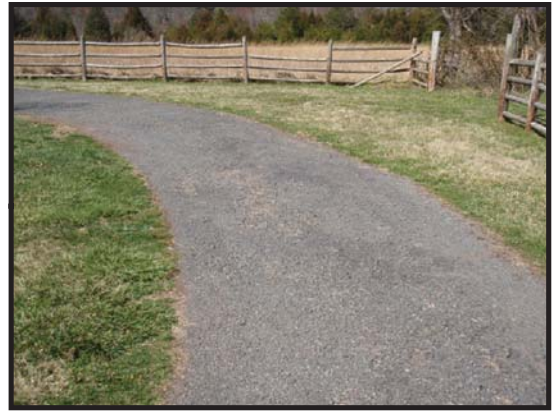
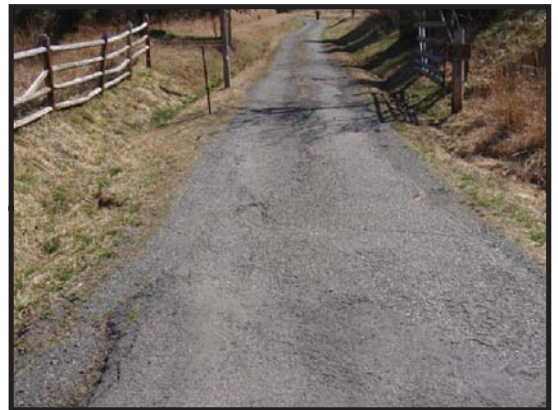
Route Number	Public / NonPublic	Date Visited	Area (sq ft)	Lane Miles *	Paved Length (mi)	Paved Width (ft)
0412	NONPUBLIC	3/13/2012	4,847	0.08	0.10	9
Culverts	Drop Inlets	Gates	Curb & Gutter	Curb	PCR	Surface Type
1	0	1	NO CURB AND GUTTER	NO CURB	POOR/45	AS

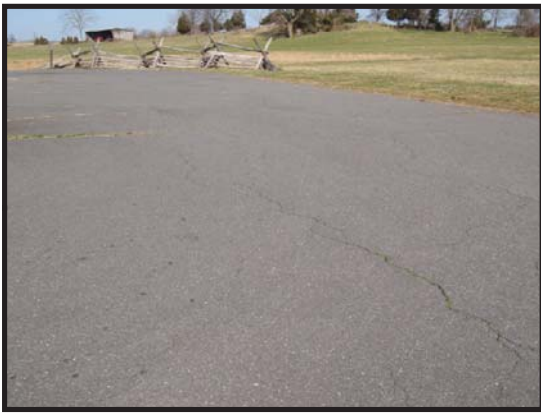
Route Number	Public / NonPublic	Date Visited	Area (sq ft)	Lane Miles *	Surface Type
0900	PUBLIC	3/13/2012	12,904	0.22	AS
Culverts	Drop Inlets	Gates	Curb & Gutter	Curb	PCR
2	0	0	NO CURB AND GUTTER	NO CURB	FAIR/73

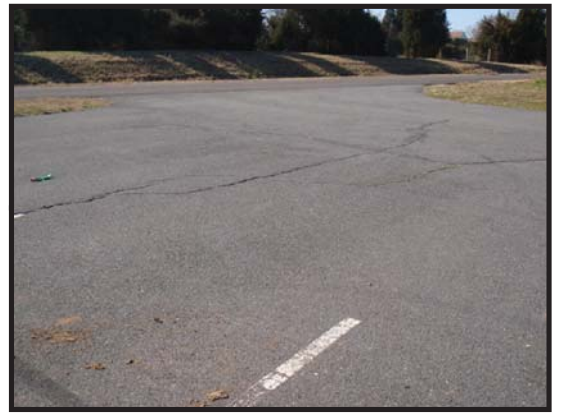
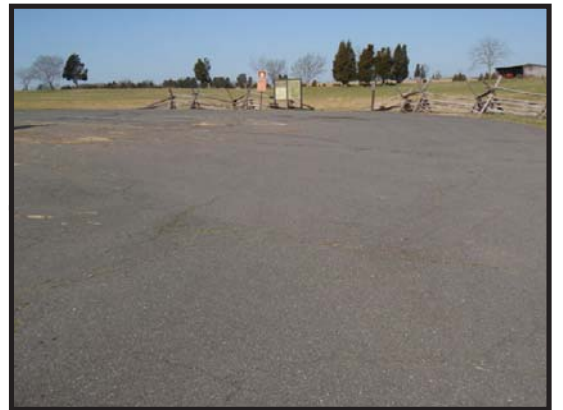
Route 0902

Route Number	Public / NonPublic	Date Visited	Area (sq ft)	Lane Miles *	Surface Type
0902	PUBLIC	3/13/2012	62,315	1.07	AS
Culverts	Drop Inlets	Gates	Curb & Gutter	Curb	PCR
1	0	1	NO CURB AND GUTTER	NO CURB	FAIR/73

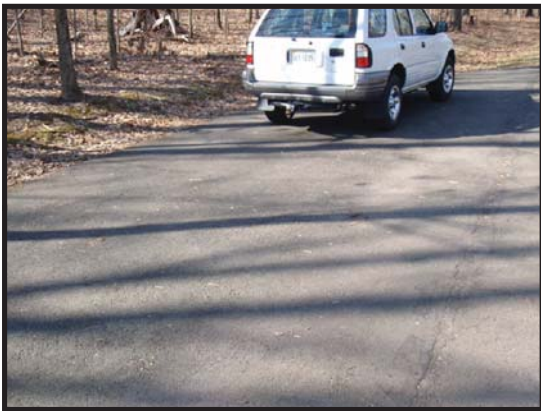
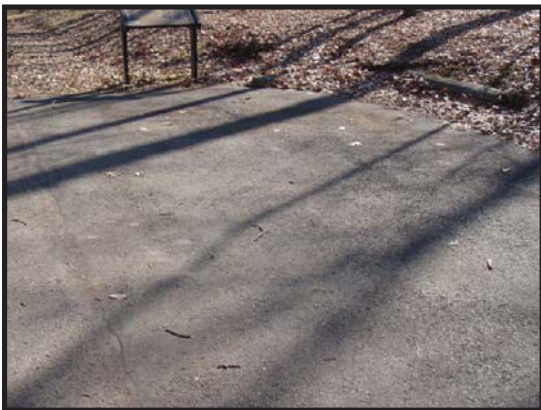
Route 0903

Route Number	Public / NonPublic	Date Visited	Area (sq ft)	Lane Miles *	Surface Type
0903	PUBLIC	3/13/2012	1,010	0.02	AS
Culverts	Drop Inlets	Gates	Curb & Gutter	Curb	PCR
0	0	0	NO CURB AND GUTTER	NO CURB	GOOD/90

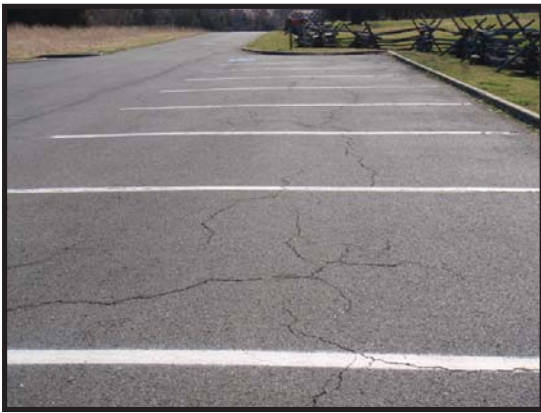
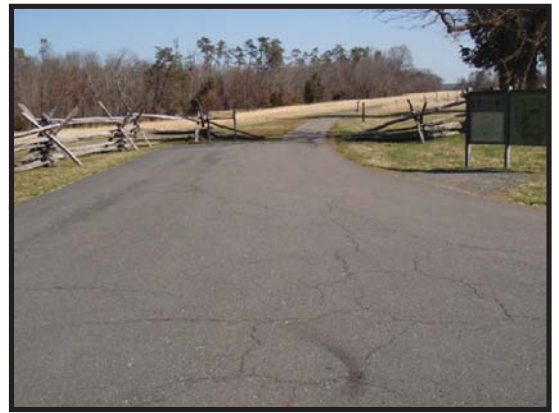
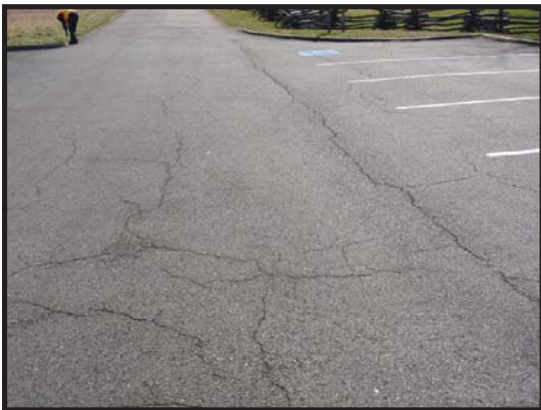
Route 0904

Route Number	Public / NonPublic	Date Visited	Area (sq ft)	Lane Miles *	Surface Type
0904	PUBLIC	3/13/2012	14,024	0.24	AS
Culverts	Drop Inlets	Gates	Curb & Gutter	Curb	PCR
0	0	1	NO CURB AND GUTTER	CONCRETE CURB	POOR/45

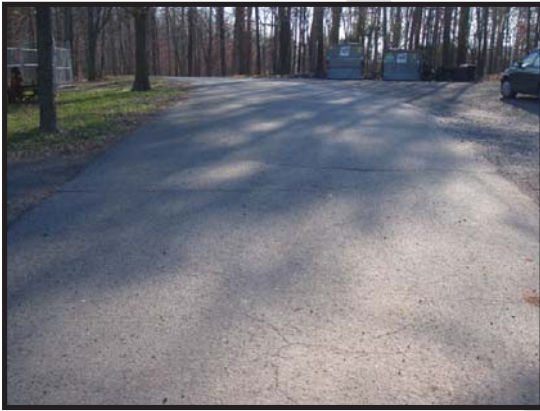
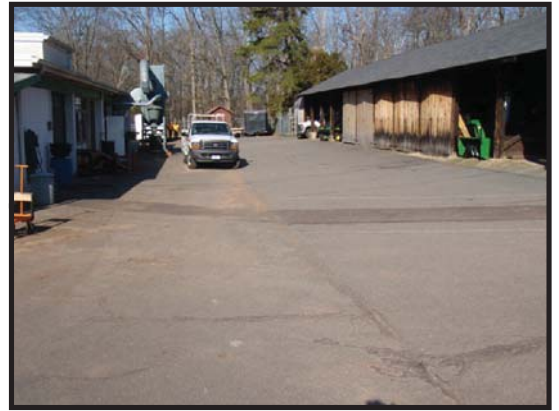
Route 0905

Route Number	Public / NonPublic	Date Visited	Area (sq ft)	Lane Miles *	Surface Type
0905	NONPUBLIC	3/13/2012	38,303	0.66	AS
Culverts	Drop Inlets	Gates	Curb & Gutter	Curb	PCR
2	0	5	NO CURB AND GUTTER	CONCRETE CURB	FAIR/73

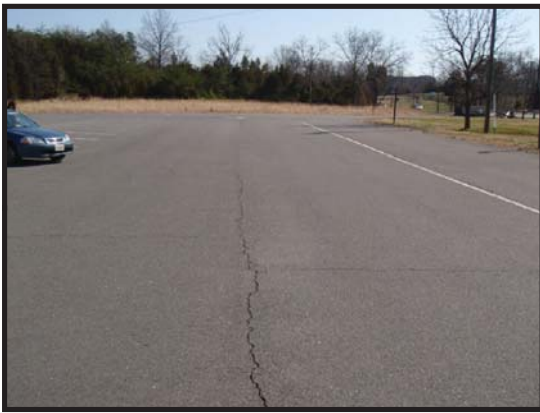
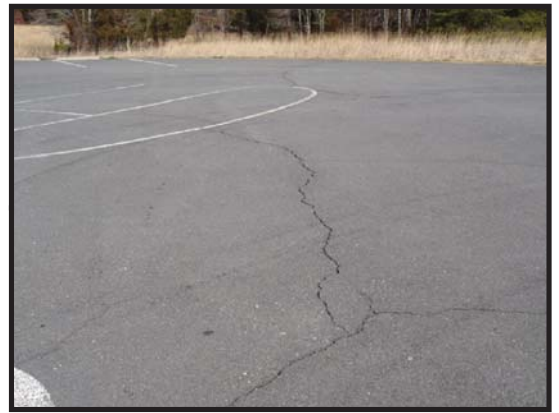
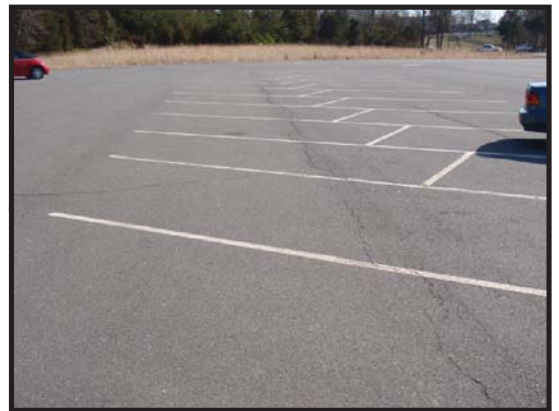
Route 0907

Route Number	Public / NonPublic	Date Visited	Area (sq ft)	Lane Miles *	Surface Type
0907	PUBLIC	3/13/2012	36,196	0.62	AS
Culverts	Drop Inlets	Gates	Curb & Gutter	Curb	PCR
1	0	1	NO CURB AND GUTTER	NO CURB	FAIR/73

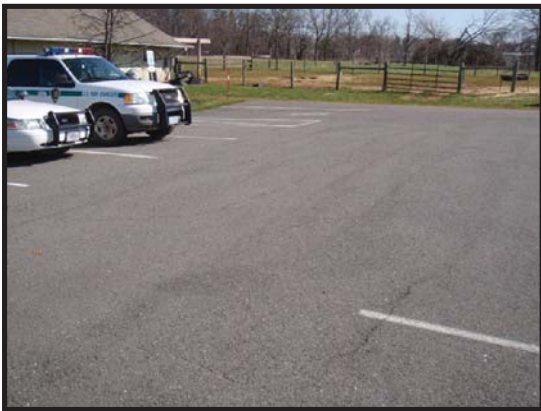
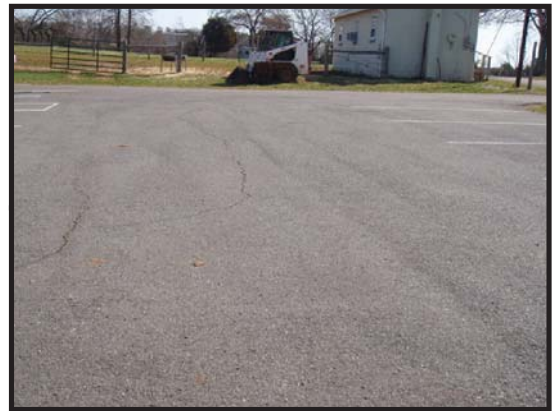
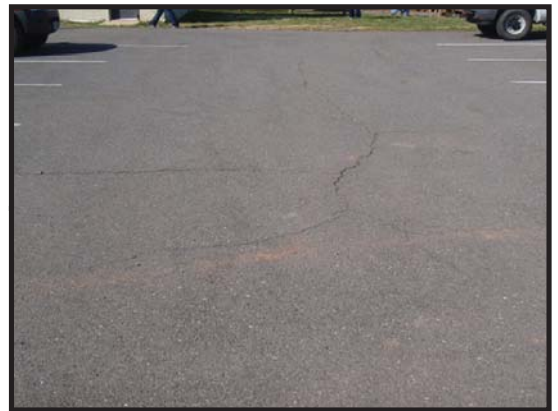
Route 0908

Route Number	Public / NonPublic	Date Visited	Area (sq ft)	Lane Miles *	Surface Type
0908	NONPUBLIC	3/13/2012	4,772	0.08	AS
Culverts	Drop Inlets	Gates	Curb & Gutter	Curb	PCR
0	0	1	NO CURB AND GUTTER	NO CURB	FAIR/73

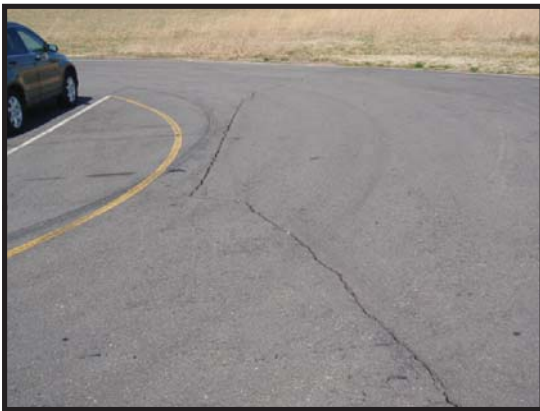
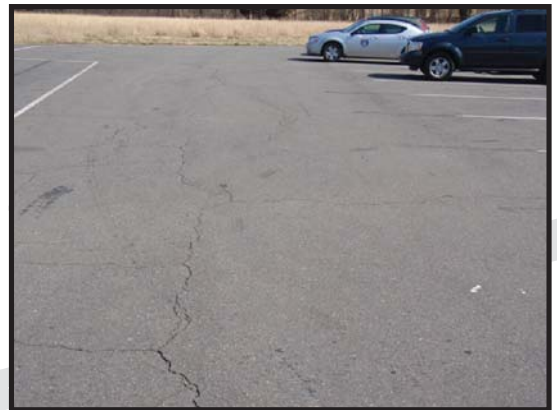
Route 0909

Route Number	Public / NonPublic	Date Visited	Area (sq ft)	Lane Miles *	Surface Type
0909	PUBLIC	3/13/2012	15,657	0.27	AS
Culverts	Drop Inlets	Gates	Curb & Gutter	Curb	PCR
1	0	1	NO CURB AND GUTTER	NO CURB	FAIR/73

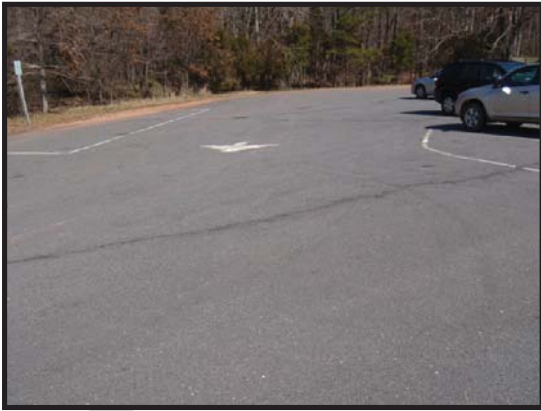
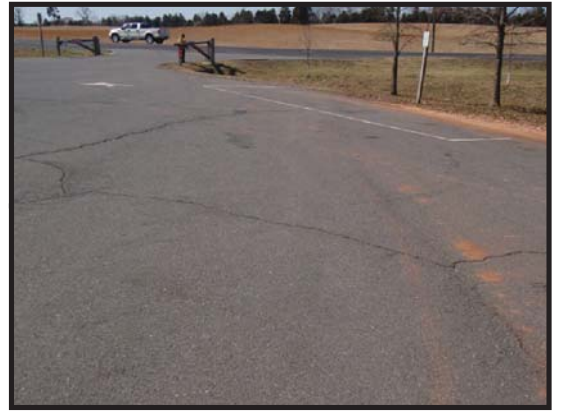
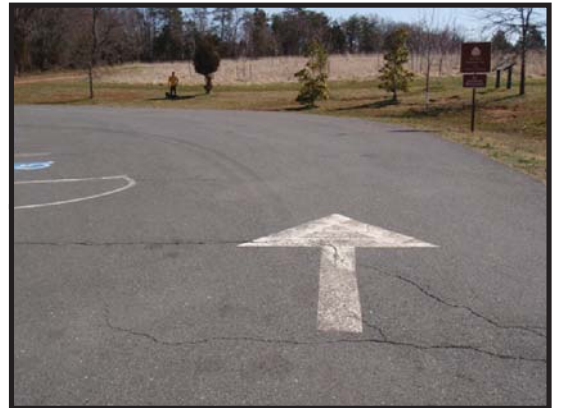
Route 0910

Route Number	Public / NonPublic	Date Visited	Area (sq ft)	Lane Miles *	Surface Type
0910	PUBLIC	3/13/2012	15,816	0.27	AS
Culverts	Drop Inlets	Gates	Curb & Gutter	Curb	PCR
1	0	1	NO CURB AND GUTTER	NO CURB	FAIR/73

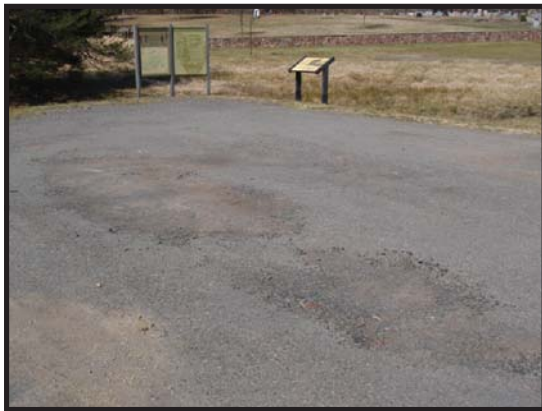
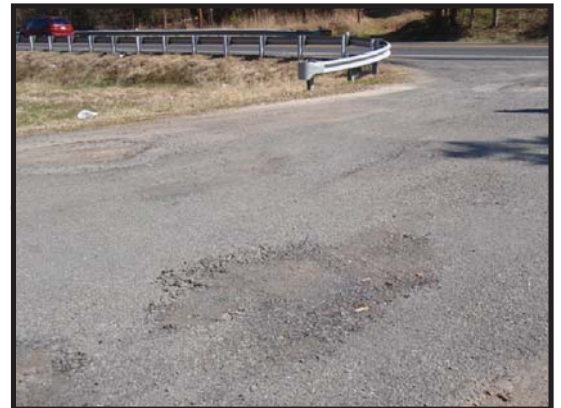
Route 0911

Route Number	Public / NonPublic	Date Visited	Area (sq ft)	Lane Miles *	Surface Type
0911	PUBLIC	3/13/2012	3,334	0.06	AS
Culverts	Drop Inlets	Gates	Curb & Gutter	Curb	PCR
0	0	0	NO CURB AND GUTTER	NO CURB	POOR/45

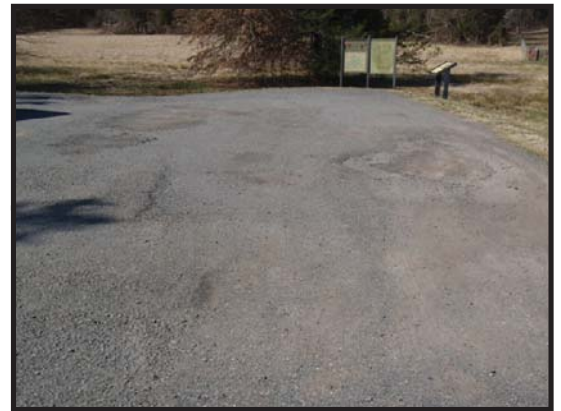
Route 0912

0912	UNFINISHED RAILROAD PARKING	SURFACE TYPE CHANGE	THIS PARKING LOT WAS CONSIDERED UNPAVED IN CYCLE 3 (IT APPEARED TO BE UNPAVED), BUT IT WAS ACTUALLY PAVED AND IN VERY POOR CONDITION. SURFACE TYPE WAS UPDATED FROM GRAVEL TO ASPHALT, AND COLLECTED IN CYCLE 5.
0918	BROWNSVILLE PICNIC AREA PARKING	ROUTE NAME	ROUTE NAME CHANGED FROM "STUARTS HILL PICNIC SITE PARKING".
0920	NEW YORK 5TH AND 10TH PARKING	ROUTE NAME	ROUTE NAME CHANGED FROM "NEW YORK 5TH PARKING".
0921	BROOKLYN 14TH PARKING	ROUTE NAME	ROUTE NAME CHANGED FROM "NEW YORK 10TH PARKING".
0922	ROSEFIELD SITE PARKING	ROUTE NAME	ROUTE NAME CHANGED FROM "RESOURCE MANAGEMENT PARKING".

Route Number	Public / NonPublic	Date Visited	Area (sq ft)	Lane Miles *	Surface Type
0912	PUBLIC	3/13/2012	4,658	0.08	AS
Culverts	Drop Inlets	Gates	Curb & Gutter	Curb	PCR
0	0	0	NO CURB AND GUTTER	WOOD CURB	POOR/45

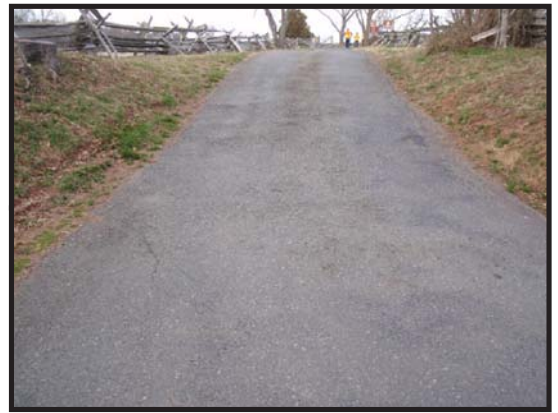
Rte 0914

Route Number	Public / NonPublic	Date Visited	Area (sq ft)	Lane Miles *	Surface Type
0914	PUBLIC	3/13/2012	5,167	0.09	AS
Culverts	Drop Inlets	Gates	Curb & Gutter	Curb	PCR
0	0	1	NO CURB AND GUTTER	NO CURB	POOR/45
