Federal Lands Highway Road Inventory Program

Road Inventory and Condition Assessment

Manzanar National Historic Site MANZ

Cycle 5 Report

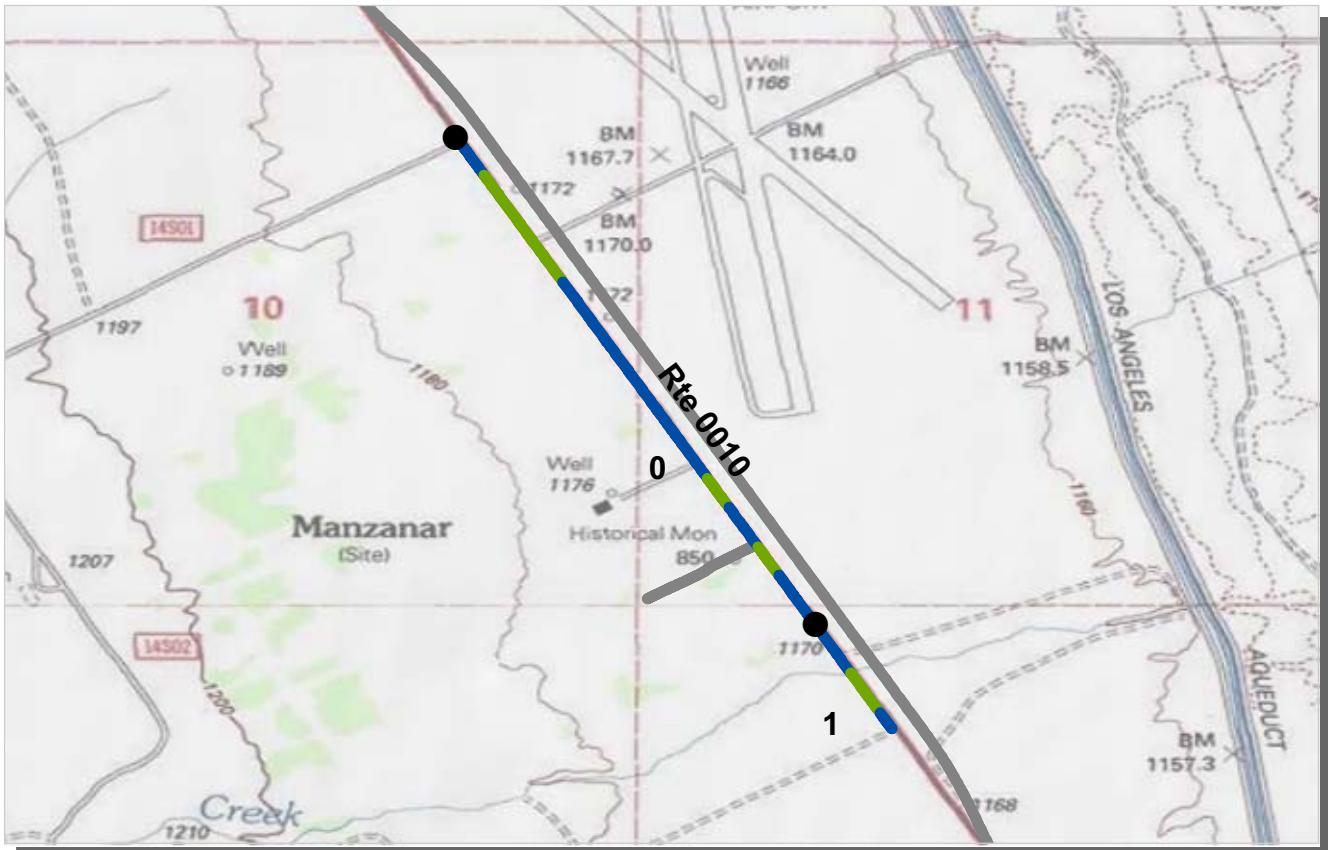
ROUTE: 0010 FRONTAGE ROAD

<i>Section Number</i>	0	1			
<i>Section Length (mi)</i>	1.00	0.21			
<i>Cross Section Information</i>					
Number of Lanes	2	2			
Paved Width (ft)	27	24			
Lane Width (ft)	11	11			
<i>Roadway Condition Information</i>					
SCR (Surface Condition Rating)	93	94			
PCR (Pavement Condition Rating)	96	92			
<i>Distress Index Values</i>					
Structural Crack Index	100	100			
Transverse Cracking Index	100	100			
Patching Index	100	100			
Rutting Index	93	94			
Roughness Condition Index (RCI)	100	89

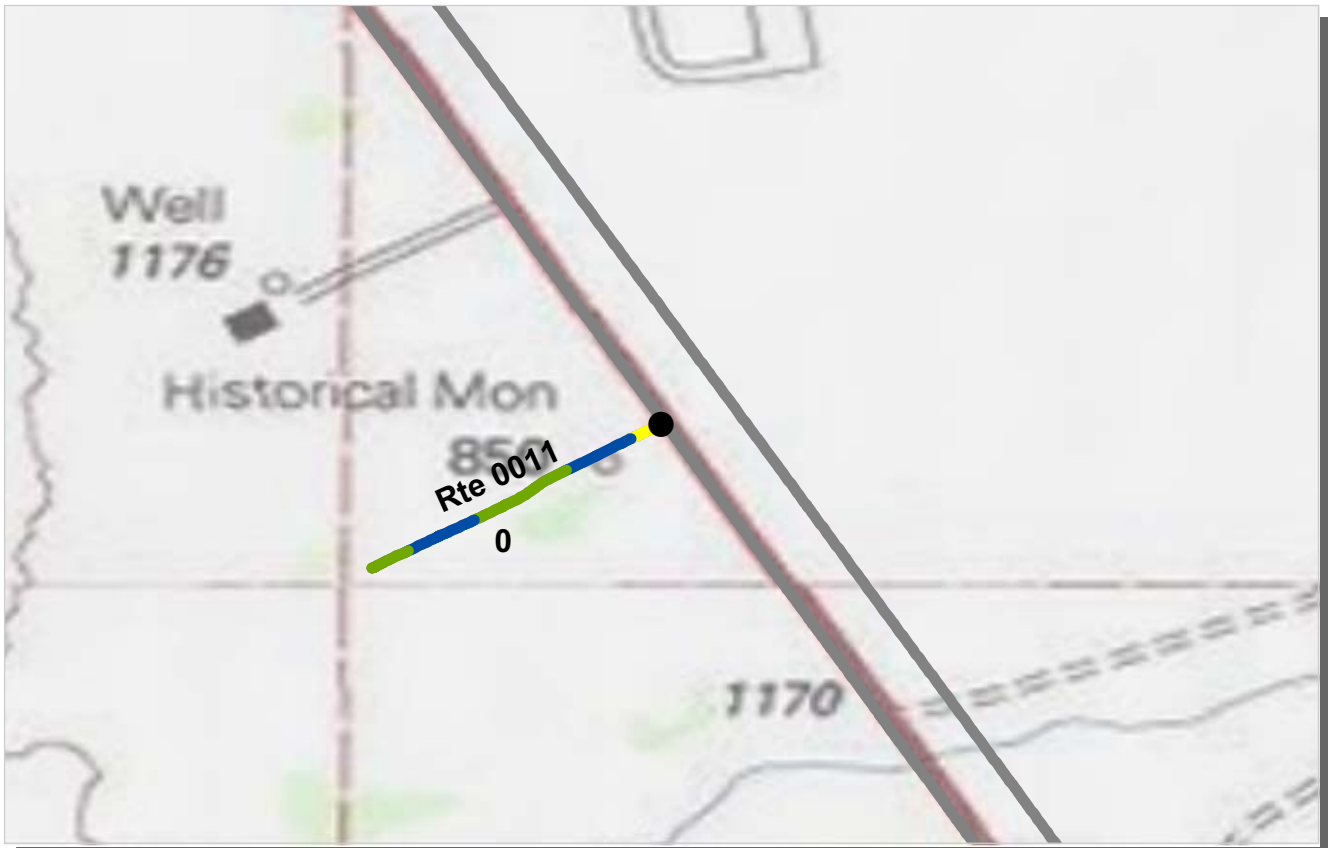
ROUTE: 0011 HISTORIC ENTRANCE ROAD

Section Number	0				
Section Length (mi)	0.18				
Cross Section Information					
Number of Lanes	2				
Paved Width (ft)	36				
Lane Width (ft)	18				
Roadway Condition Information					
SCR (Surface Condition Rating)	91				
PCR (Pavement Condition Rating)	91				
Distress Index Values					
Structural Crack Index	98				
Transverse Cracking Index	91				
Patching Index	100				
Rutting Index	96				
Roughness Condition Index (RCI)	NC

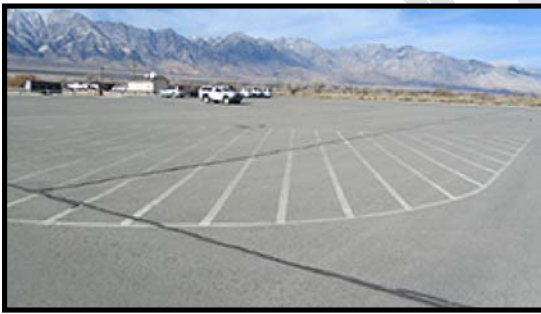
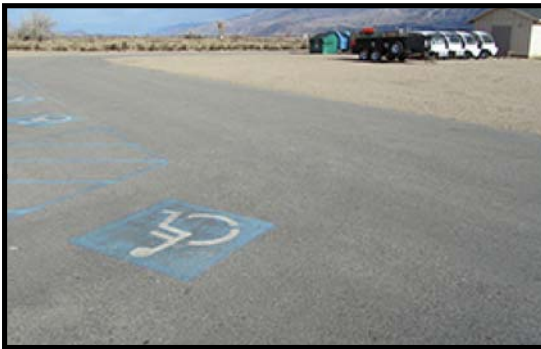
Route 0900

Route Number	Public / NonPublic	Date Visited	Area (sq ft)	Lane Miles *	Surface Type
0900	PUBLIC	12/11/2011	119,941	2.07	AS
Culverts	Drop Inlets	Gates	Curb & Gutter	Curb	PCR
0	0	2	NO CURB AND GUTTER	CONCRETE CURB	FAIR/73
