Federal Lands Highway Road Inventory Program

Road Inventory and Condition Assessment

Martin Van Buren National Historic Site MAVA

Cycle 5 Report

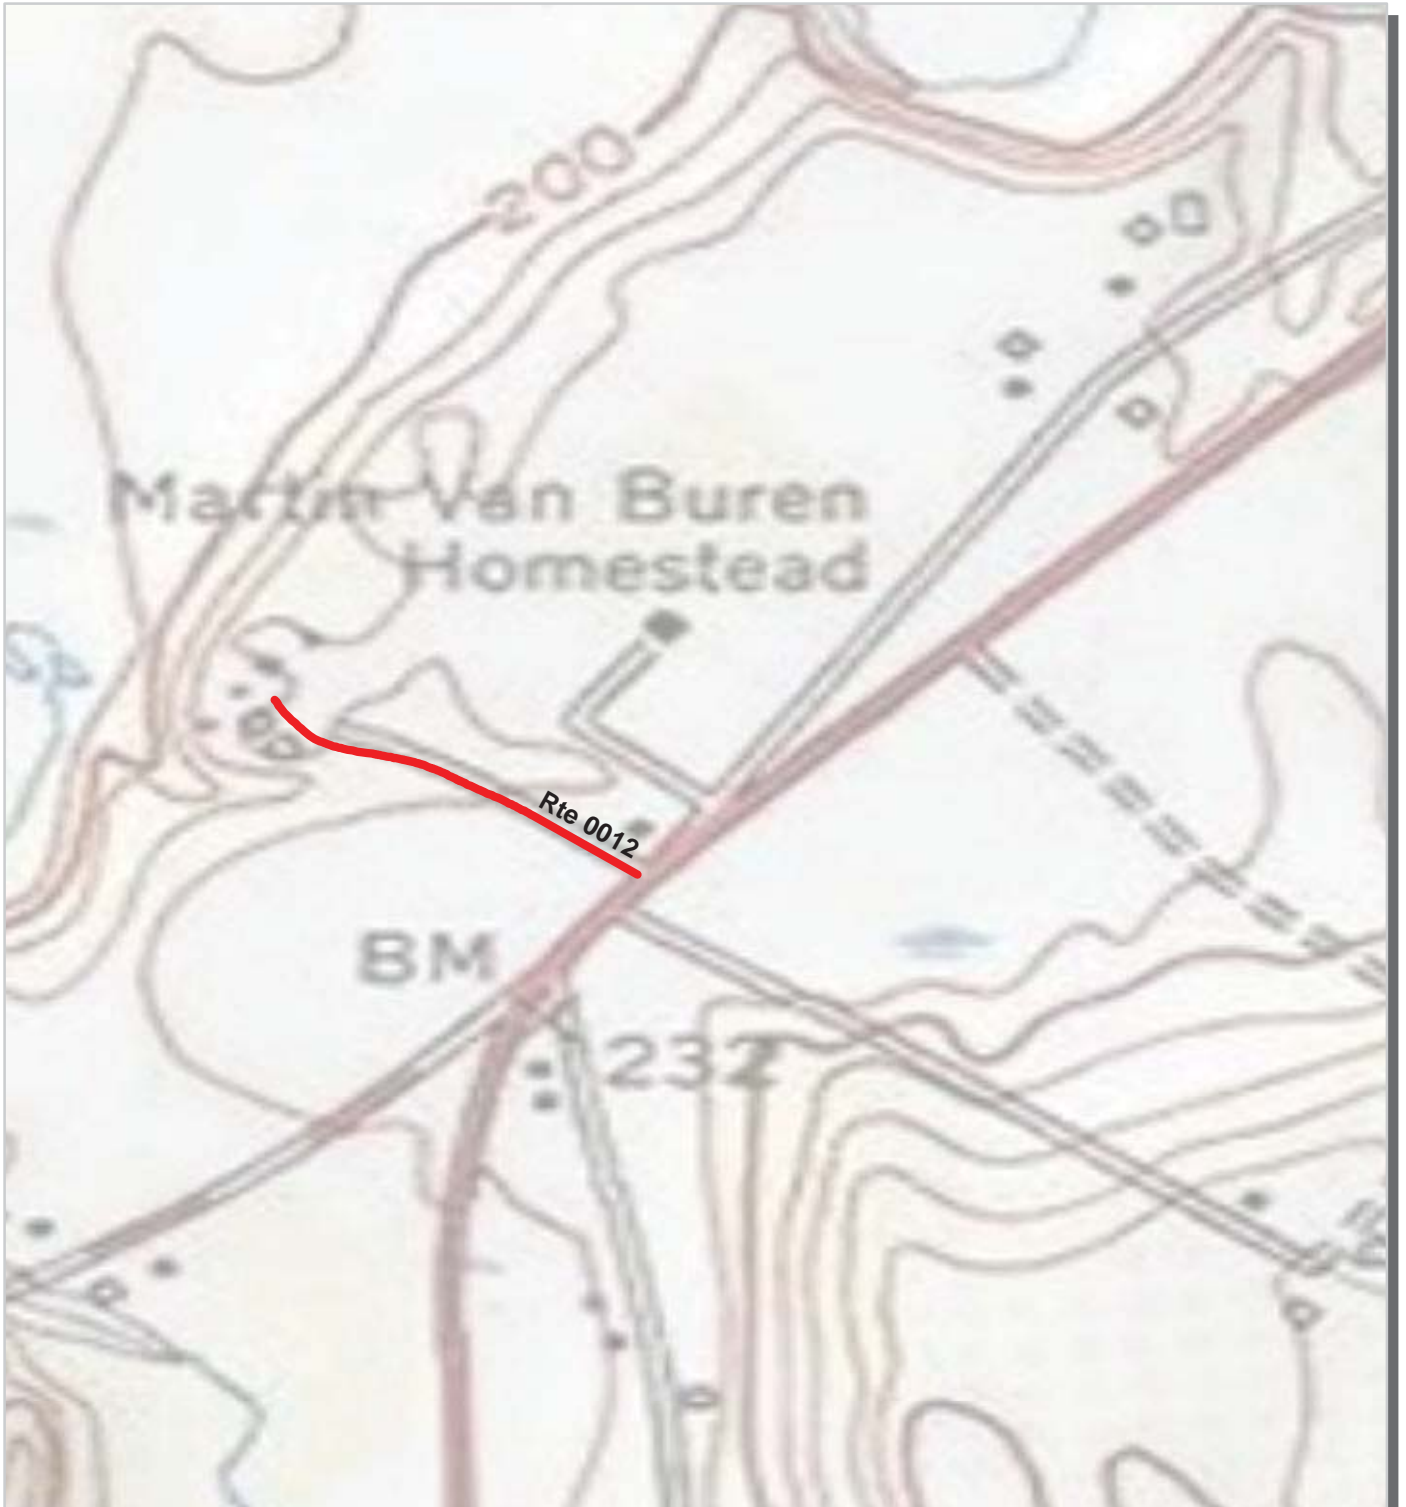
Martin Van Buren National Historic Site
Route Condition Map
PCR - Mile by Mile
Area 1

PCR	Poor
