# Federal Lands Highway Road Inventory Program

Road Inventory and Condition Assessment

## Minute Man National Historical Park MIMA

### Cycle 5 Report

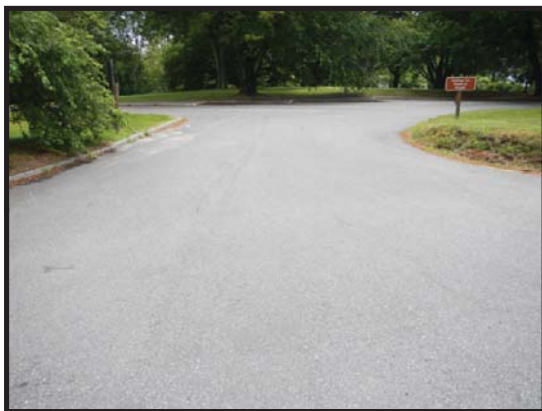
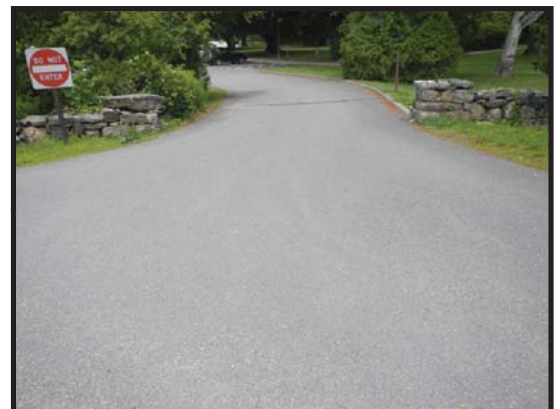
Route Number	Public / NonPublic	Date Visited	Area (sq ft)	Lane Miles *	Surface Type
0900	PUBLIC	6/28/2013	22,893	0.39	AS
Culverts	Drop Inlets	Gates	Curb & Gutter	Curb	PCR
0	2	2	NO CURB AND GUTTER	STONE CURB	GOOD/90

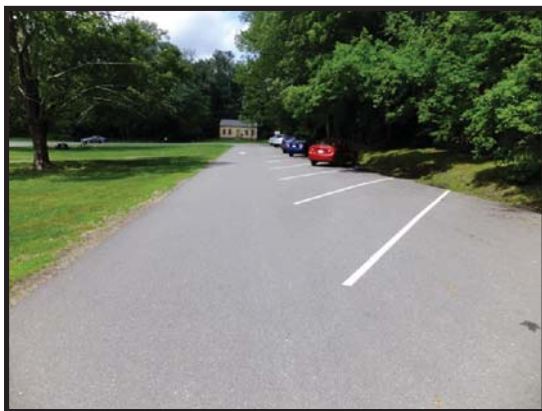
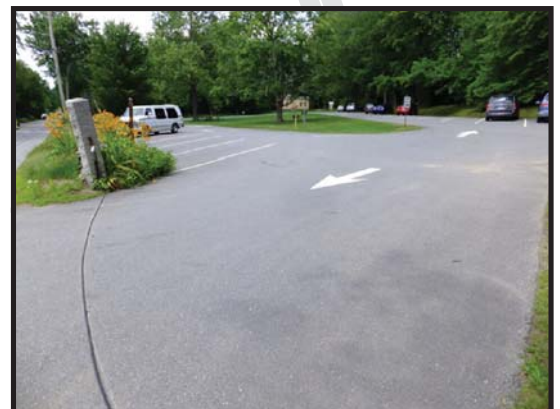
## Route 0901

Route Number	Public / NonPublic	Date Visited	Area (sq ft)	Lane Miles *	Surface Type
0901	PUBLIC	6/28/2013	32,140	0.55	AS
Culverts	Drop Inlets	Gates	Curb & Gutter	Curb	PCR
1	4	3	NO CURB AND GUTTER	STONE CURB	GOOD/90
