Federal Lands Highway Road Inventory Program

Road Inventory and Condition Assessment

Montezuma Castle National Monument MOCA

Cycle 5 Report

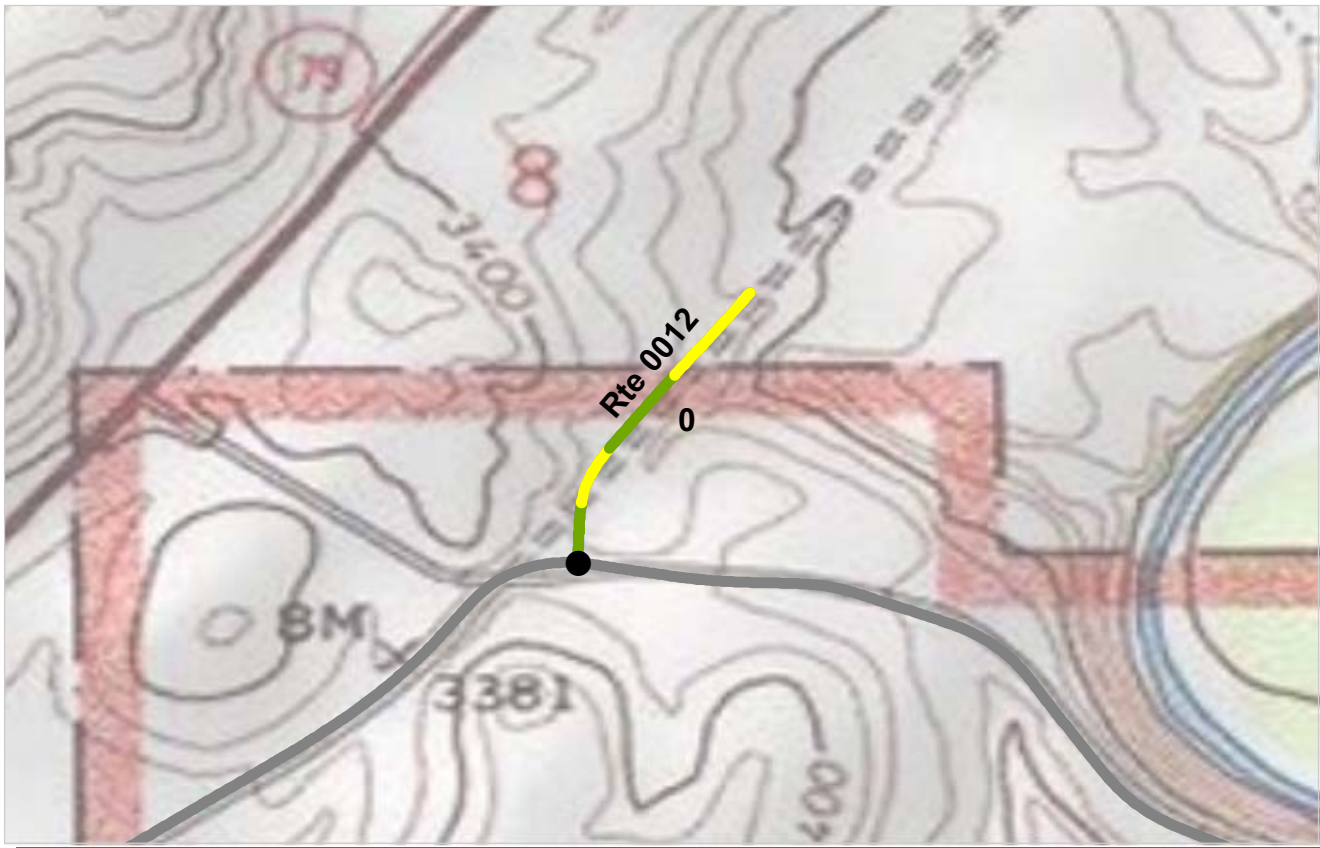
ROUTE: 0012 MOCA BEAVER CREEK ESTATES ROAD

Section Number	0				
Section Length (mi)	0.21				
Cross Section Information					
Number of Lanes	2				
Paved Width (ft)	23				
Lane Width (ft)	12				
Roadway Condition Information					
SCR (Surface Condition Rating)	86				
PCR (Pavement Condition Rating)	86				
Distress Index Values					
Structural Crack Index	97				
Transverse Cracking Index	86				
Patching Index	100				
Rutting Index	96				
Roughness Condition Index (RCI)	NC

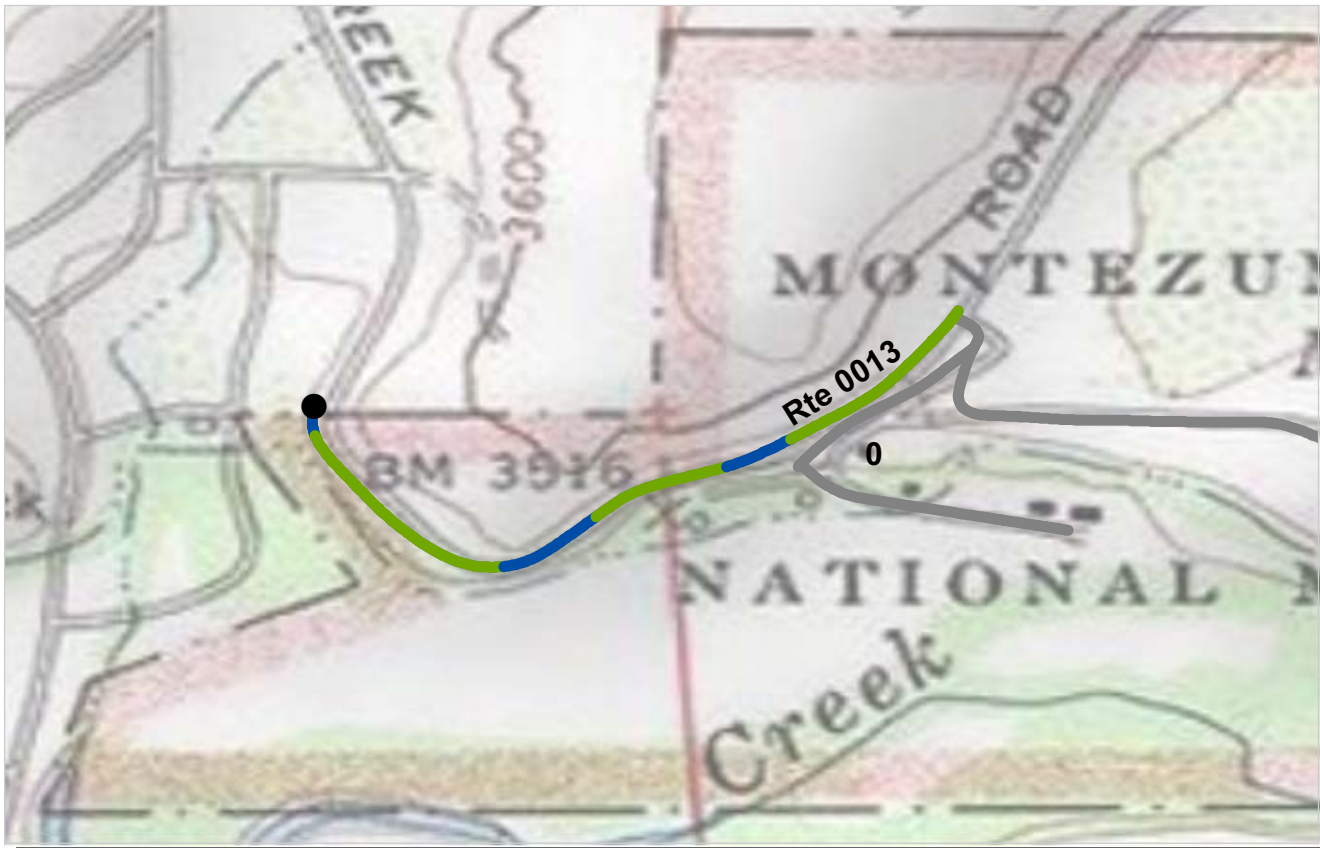
ROUTE: 0013 MOWE BEAVER CREEK ROAD

Section Number	0				
Section Length (mi)	0.47				
Cross Section Information					
Number of Lanes	2				
Paved Width (ft)	21				
Lane Width (ft)	9				
Roadway Condition Information					
SCR (Surface Condition Rating)	95				
PCR (Pavement Condition Rating)	95				
Distress Index Values					
Structural Crack Index	95				
Transverse Cracking Index	96				
Patching Index	100				
Rutting Index	95				
Roughness Condition Index (RCI)	NC

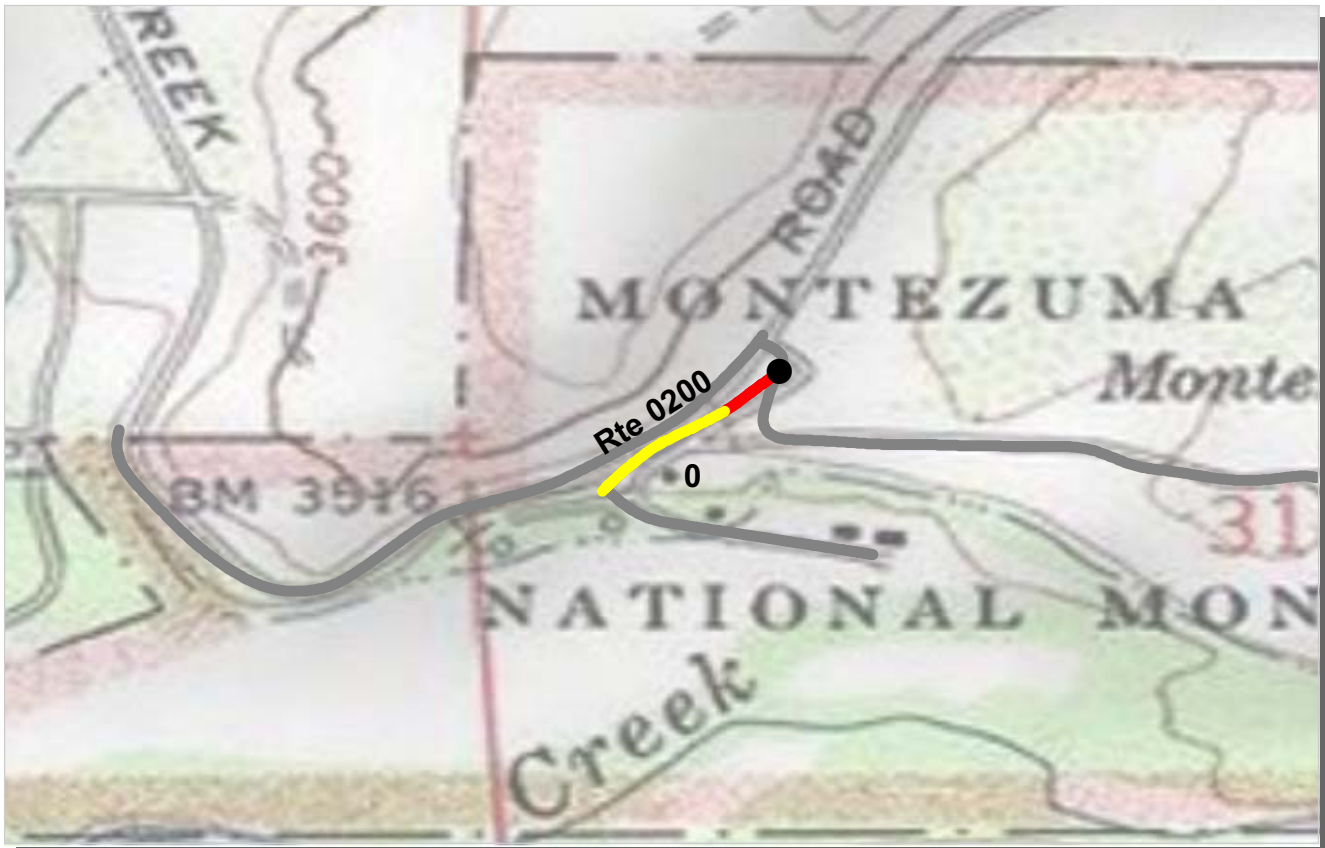
ROUTE: 0200 MOWE PICNIC AREA ROAD

Section Number	0				
Section Length (mi)	0.12				
Cross Section Information					
Number of Lanes	2				
Paved Width (ft)	19				
Lane Width (ft)	9				
Roadway Condition Information					
SCR (Surface Condition Rating)	62				
PCR (Pavement Condition Rating)	62				
Distress Index Values					
Structural Crack Index	65				
Transverse Cracking Index	62				
Patching Index	100				
Rutting Index	93				
Roughness Condition Index (RCI)	NC

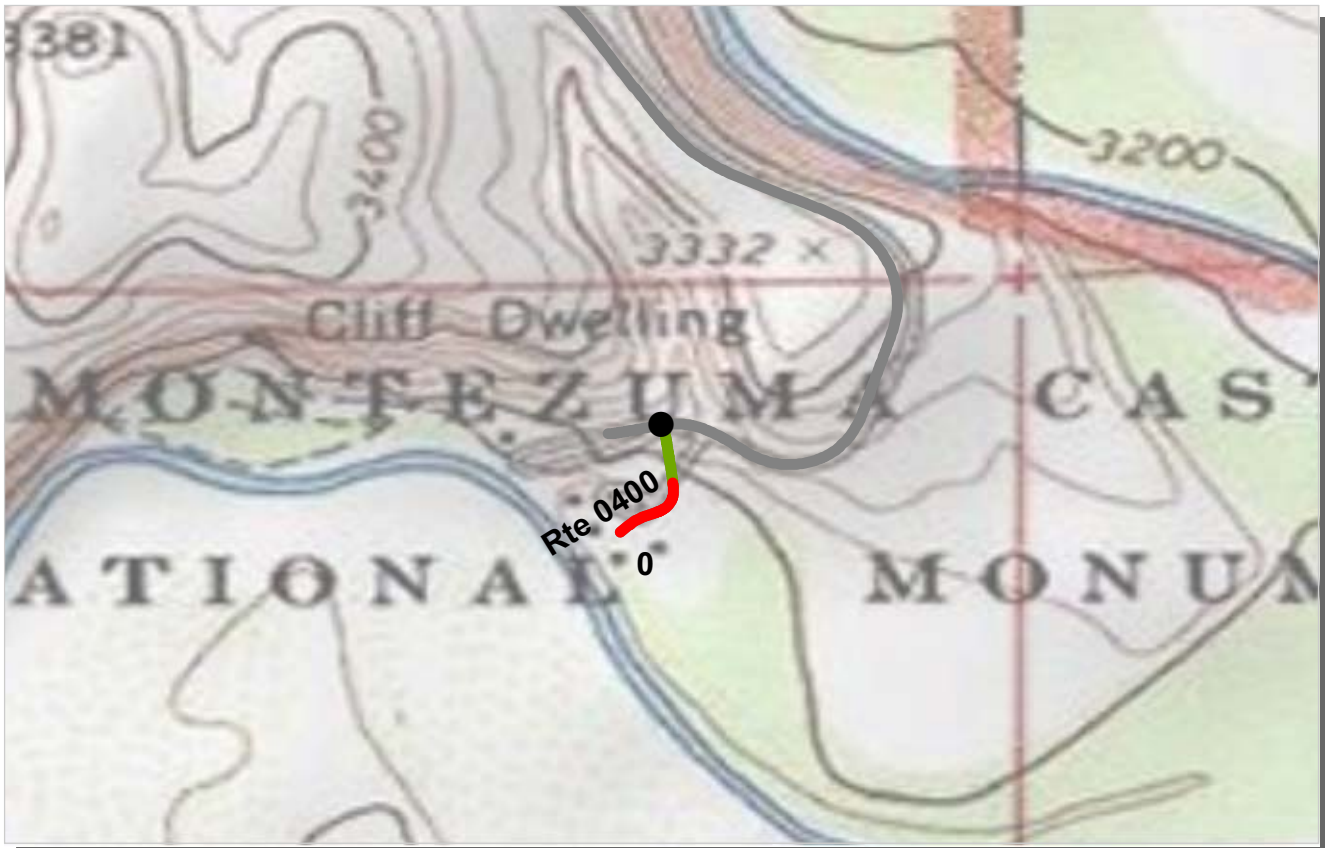
ROUTE: 0400 MOCA RESIDENCE AREA ROAD

Section Number	0				
Section Length (mi)	0.09				
Cross Section Information					
Number of Lanes	2				
Paved Width (ft)	21				
Lane Width (ft)	11				
Roadway Condition Information					
SCR (Surface Condition Rating)	63				
PCR (Pavement Condition Rating)	63				
Distress Index Values					
Structural Crack Index	63				
Transverse Cracking Index	79				
Patching Index	100				
Rutting Index	95				
Roughness Condition Index (RCI)	NC
