Federal Lands Highway Road Inventory Program

Road Inventory and Condition Assessment

Mojave National Preserve MOJA

Cycle 5 Report

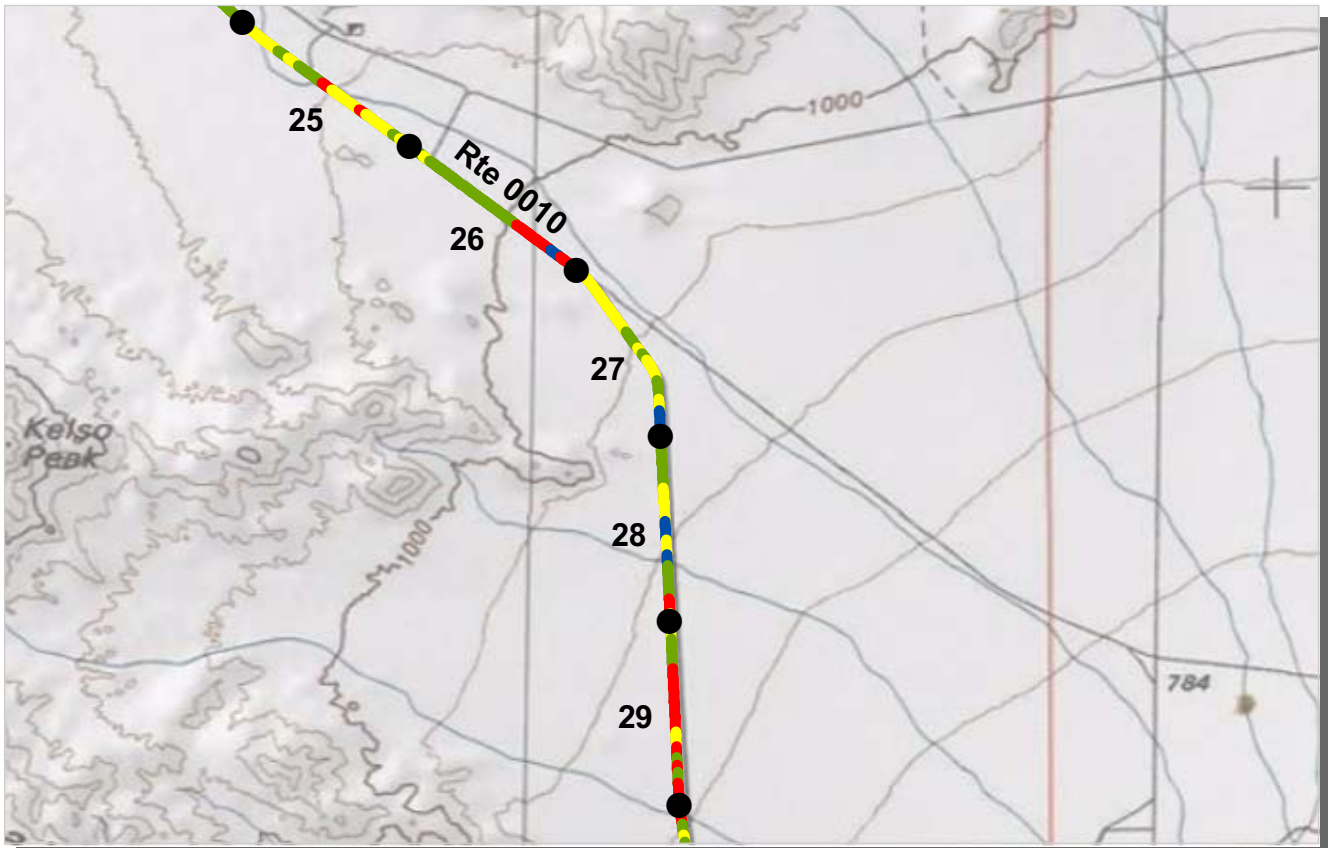
ROUTE: 0010 KELBAKER ROAD

<i>Section Number</i>	25	26	27	28	29
<i>Section Length (mi)</i>	1.00	1.00	1.00	1.00	1.00
<i>Cross Section Information</i>					
Number of Lanes	2	2	2	2	2
Paved Width (ft)	23	23	24	23	23
Lane Width (ft)	10	10	10	10	10
<i>Roadway Condition Information</i>					
SCR (Surface Condition Rating)	79	81	82	85	0
PCR (Pavement Condition Rating)	78	79	84	84	31
<i>Distress Index Values</i>					
Structural Crack Index	97	93	99	100	0
Transverse Cracking Index	99	97	100	100	94
Patching Index	82	89	99	94	99
Rutting Index	79	81	82	85	84
Roughness Condition Index (RCI)	77	77	87	82	77

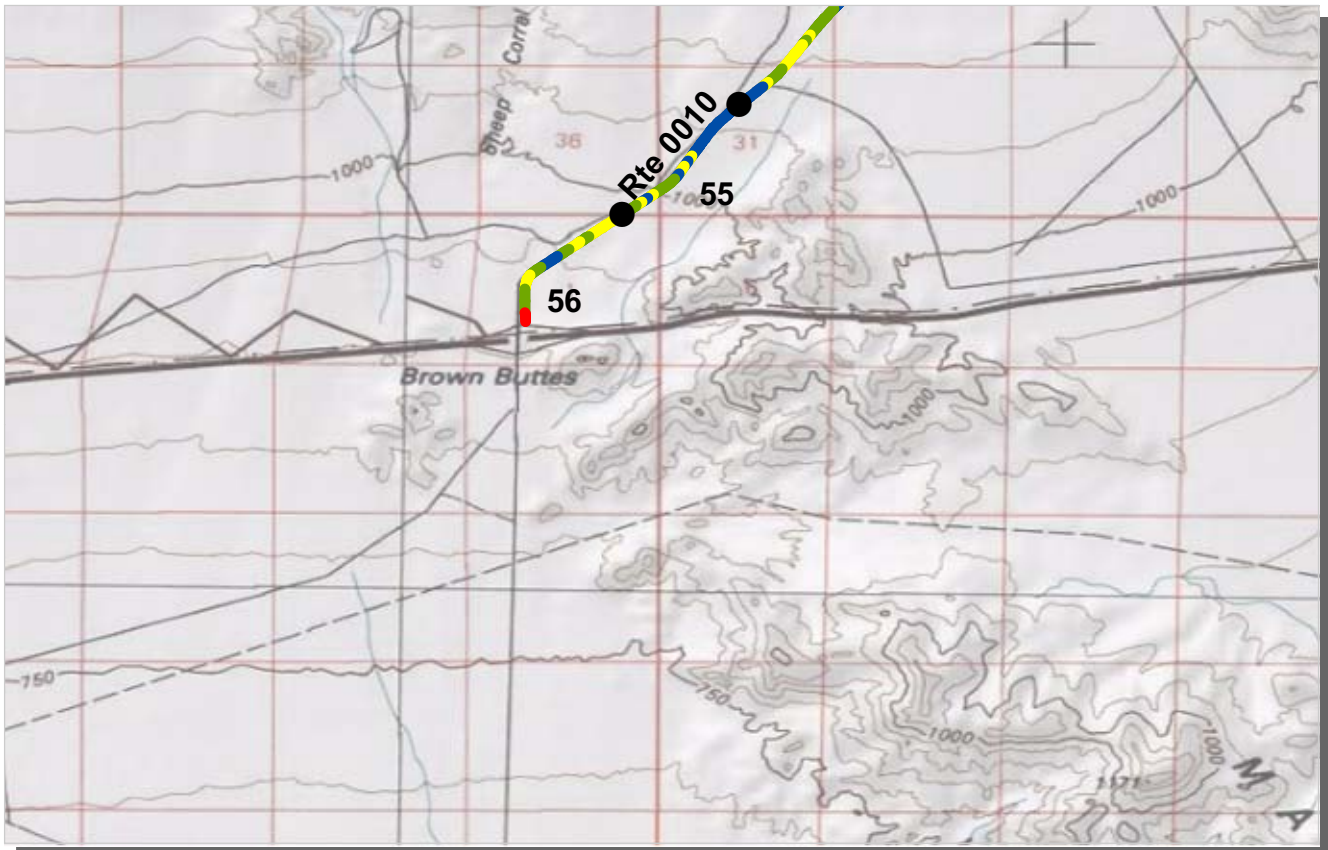
ROUTE: 0010 KELBAKER ROAD

<i>Section Number</i>	55	56			
<i>Section Length (mi)</i>	1.00	0.98			
<i>Cross Section Information</i>					
Number of Lanes	2	2			
Paved Width (ft)	27	27			
Lane Width (ft)	11	11			
<i>Roadway Condition Information</i>					
SCR (Surface Condition Rating)	94	83			
PCR (Pavement Condition Rating)	95	80			
<i>Distress Index Values</i>					
Structural Crack Index	95	83			
Transverse Cracking Index	99	97			
Patching Index	100	99			
Rutting Index	94	91			
Roughness Condition Index (RCI)	97	75
