# **Road Inventory Program**

Road Inventory and Condition Assessment

## Monocacy National Battlefield MONO

## **Cycle 5 Report**

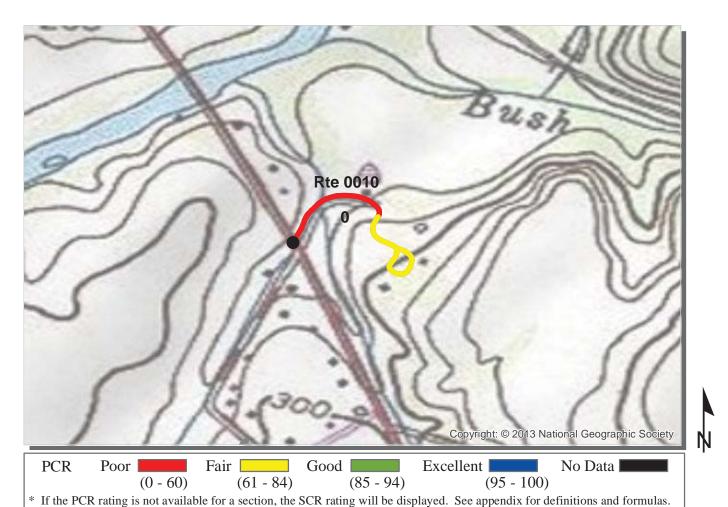
ECTED:	2/25/2013
NATIONAL CAPITAL REGION		TOTAL LE	NGTH:	0.28 Miles
Section Number	0			
Section Length (mi)	0.28			
Cross Section Information				
Number of Lanes	1			
Paved Width (ft)	12			
Lane Width (ft)	12			
Roadway Condition Information				
SCR (Surface Condition Rating)	0			
PCR (Pavement Condition Rating)	0			
Distress Index Values				
Structural Crack Index	0			
Transverse Cracking Index	93			
Patching Index	100			
Rutting Index	85			
Roughness Condition Index (RCI)	NC

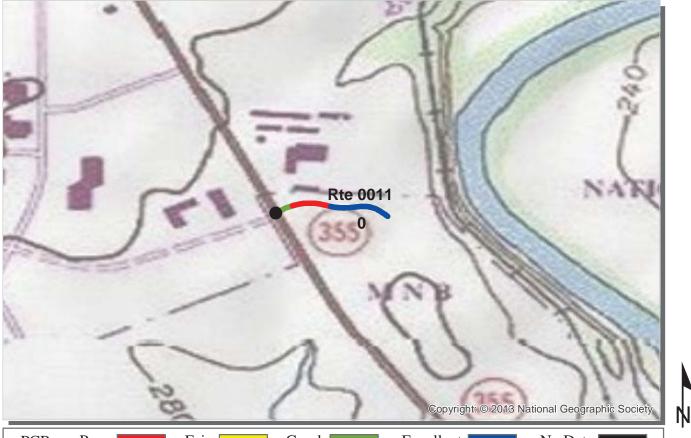
CO	LLECTED:	2/25/2013	
NATIONAL CAPITAL REGION		TOTAL LENGTH			0.12 Miles	
Section Number	0					
Section Length (mi)	0.12					
Cross Section Information						
Number of Lanes	2					
Paved Width (ft)	25					
Lane Width (ft)	12					
Roadway Condition Information						
SCR (Surface Condition Rating)	87					
PCR (Pavement Condition Rating)	87					
Distress Index Values						
Structural Crack Index	87					
Transverse Cracking Index	98					
Patching Index	100					
Rutting Index	98					
Roughness Condition Index (RCI)	NC

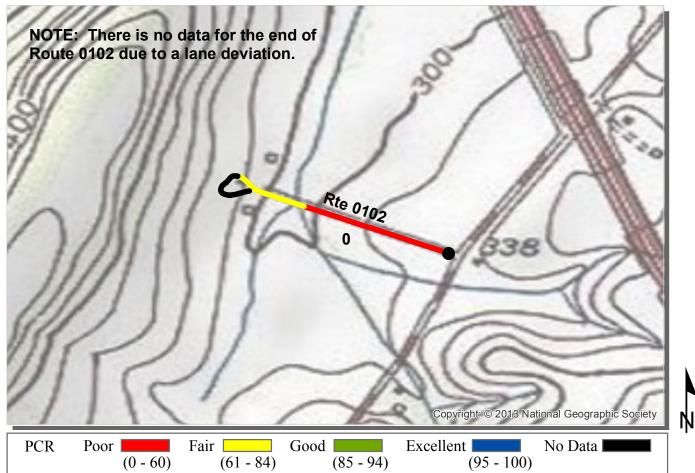
COL	LECTED:	2/25/2013
NATIONAL CAPITAL REGION	TOTAL LENGTH		LENGTH:	: 0.30 Miles	
Section Number	0				
Section Length (mi)	0.30				
Cross Section Information					
Number of Lanes	1				
Paved Width (ft)	11				
Lane Width (ft)	11				
Roadway Condition Information					
SCR (Surface Condition Rating)	0				
PCR (Pavement Condition Rating)	0				
Distress Index Values					
Structural Crack Index	0				
Transverse Cracking Index	93				
Patching Index	100				
Rutting Index	75				
Roughness Condition Index (RCI)	NC

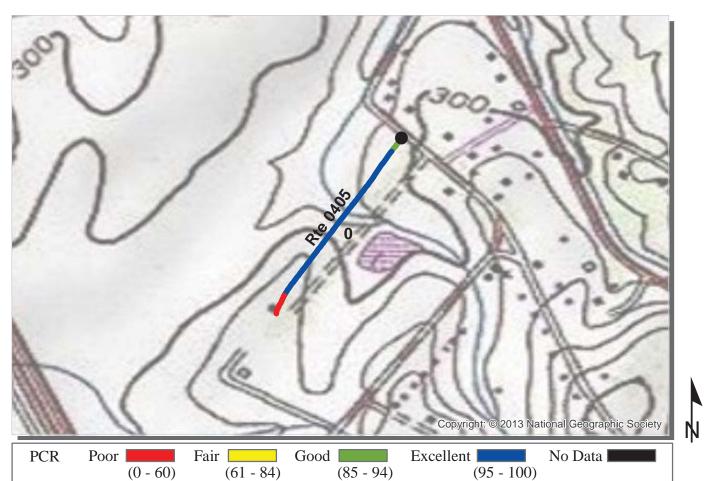
COLLECTED:	2/25/2013
NATIONAL CAPITAL REGION			TOTAL LENGTH:	0.26 Miles
Section Number	0			
Section Length (mi)	0.26			
Cross Section Information				
Number of Lanes	1			
Paved Width (ft)	9			
Lane Width (ft)	9			
Roadway Condition Information				
SCR (Surface Condition Rating)	83			
PCR (Pavement Condition Rating)	83			
Distress Index Values				
Structural Crack Index	83			
Transverse Cracking Index	100			
Patching Index	100			
Rutting Index	97			
Roughness Condition Index (RCI)	NC
