Federal Lands Highway Road Inventory Program

Road Inventory and Condition Assessment

Mount Rainier National Park
MORA - 9450

Cycle 5 Report

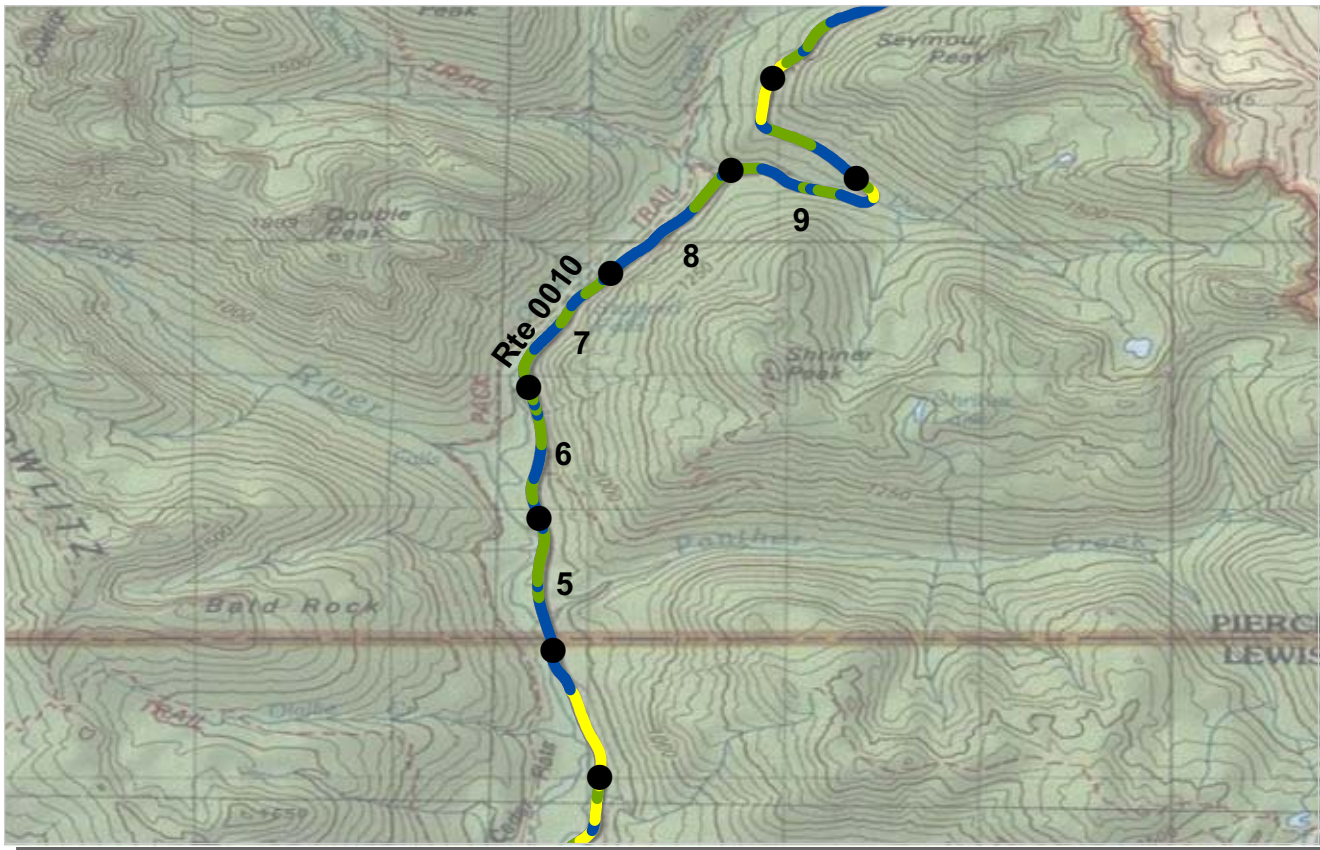
ROUTE: 0010 STATE ROUTE 123 (EAST SIDE HIGHWAY)

<i>Section Number</i>	5	6	7	8	9
<i>Section Length (mi)</i>	1.00	1.00	1.00	1.00	1.00
<i>Cross Section Information</i>					
Number of Lanes	2	2	2	2	2
Paved Width (ft)	28	28	26	26	25
Lane Width (ft)	14	14	13	11	10
<i>Roadway Condition Information</i>					
SCR (Surface Condition Rating)	92	92	93	93	91
PCR (Pavement Condition Rating)	95	95	95	96	95
<i>Distress Index Values</i>					
Structural Crack Index	100	100	100	100	100
Transverse Cracking Index	100	100	100	100	100
Patching Index	100	100	100	100	100
Rutting Index	92	92	93	93	91
Roughness Condition Index (RCI)	100	100	99	100	100

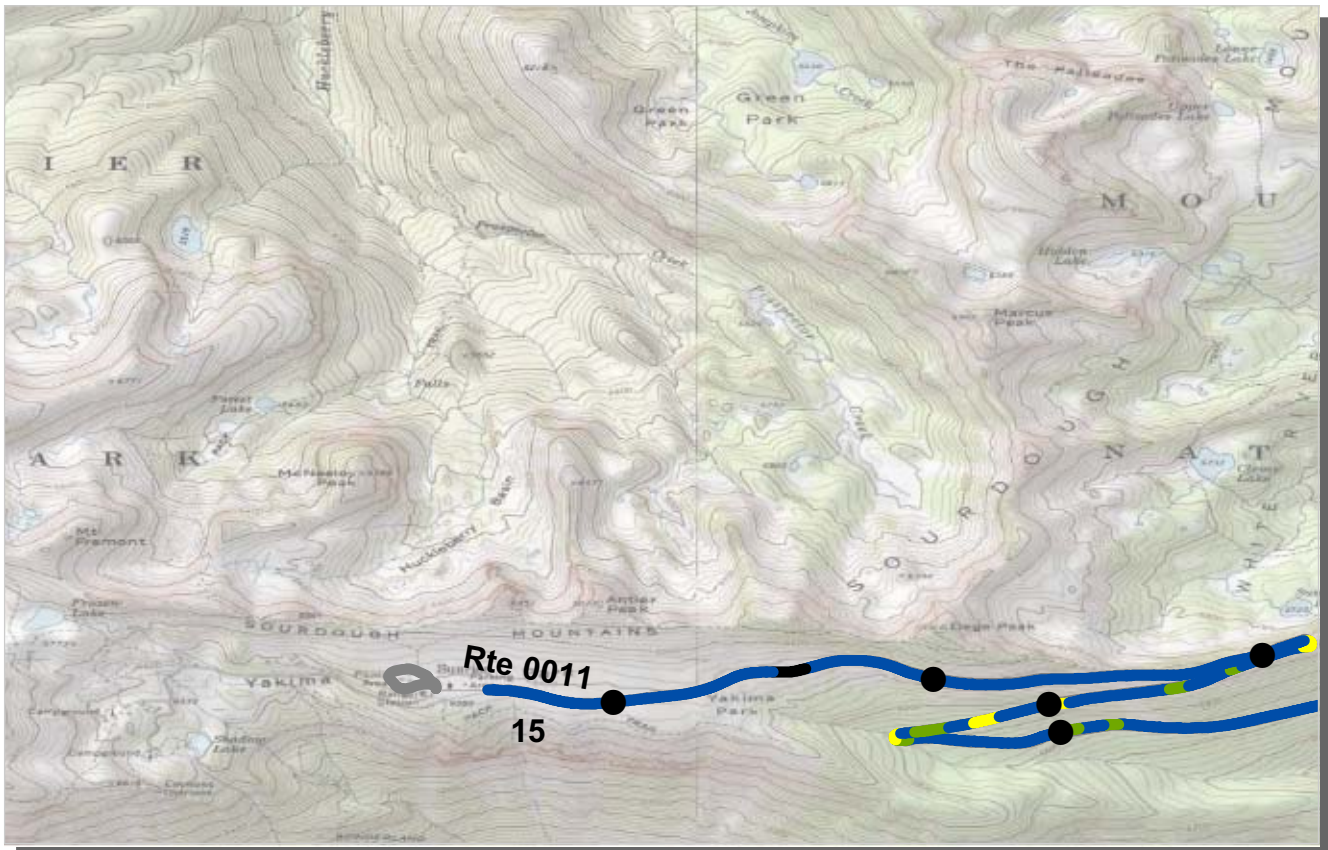
ROUTE: 0011 SUNRISE ROAD

Section Number	15				
Section Length (mi)	0.38				
Cross Section Information					
Number of Lanes	2				
Paved Width (ft)	21				
Lane Width (ft)	10				
Roadway Condition Information					
SCR (Surface Condition Rating)	95				
PCR (Pavement Condition Rating)	97				
Distress Index Values					
Structural Crack Index	100				
Transverse Cracking Index	100				
Patching Index	100				
Rutting Index	95				
Roughness Condition Index (RCI)	100

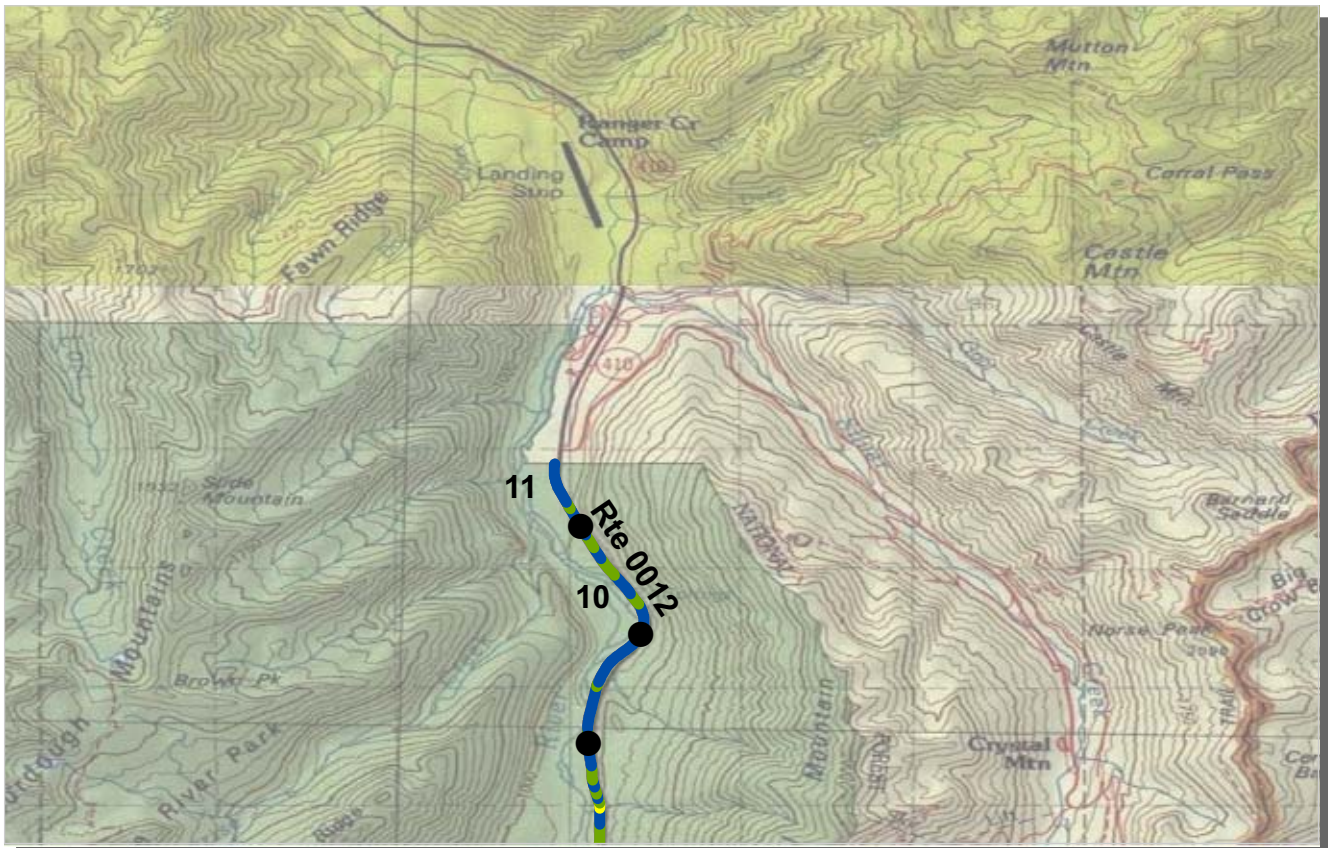
ROUTE: 0012 STATE ROUTE 410 (MATHER MEMORIAL PARKWAY)

Section Number	10	11			
Section Length (mi)	1.00	0.56			
Cross Section Information					
Number of Lanes	2	2			
Paved Width (ft)	24	25			
Lane Width (ft)	11	10			
Roadway Condition Information					
SCR (Surface Condition Rating)	100	100			
PCR (Pavement Condition Rating)	96	100			
Distress Index Values					
Structural Crack Index	100	100			
Transverse Cracking Index	100	100			
Patching Index	100	100			
Rutting Index	100	100			
Roughness Condition Index (RCI)	89	100

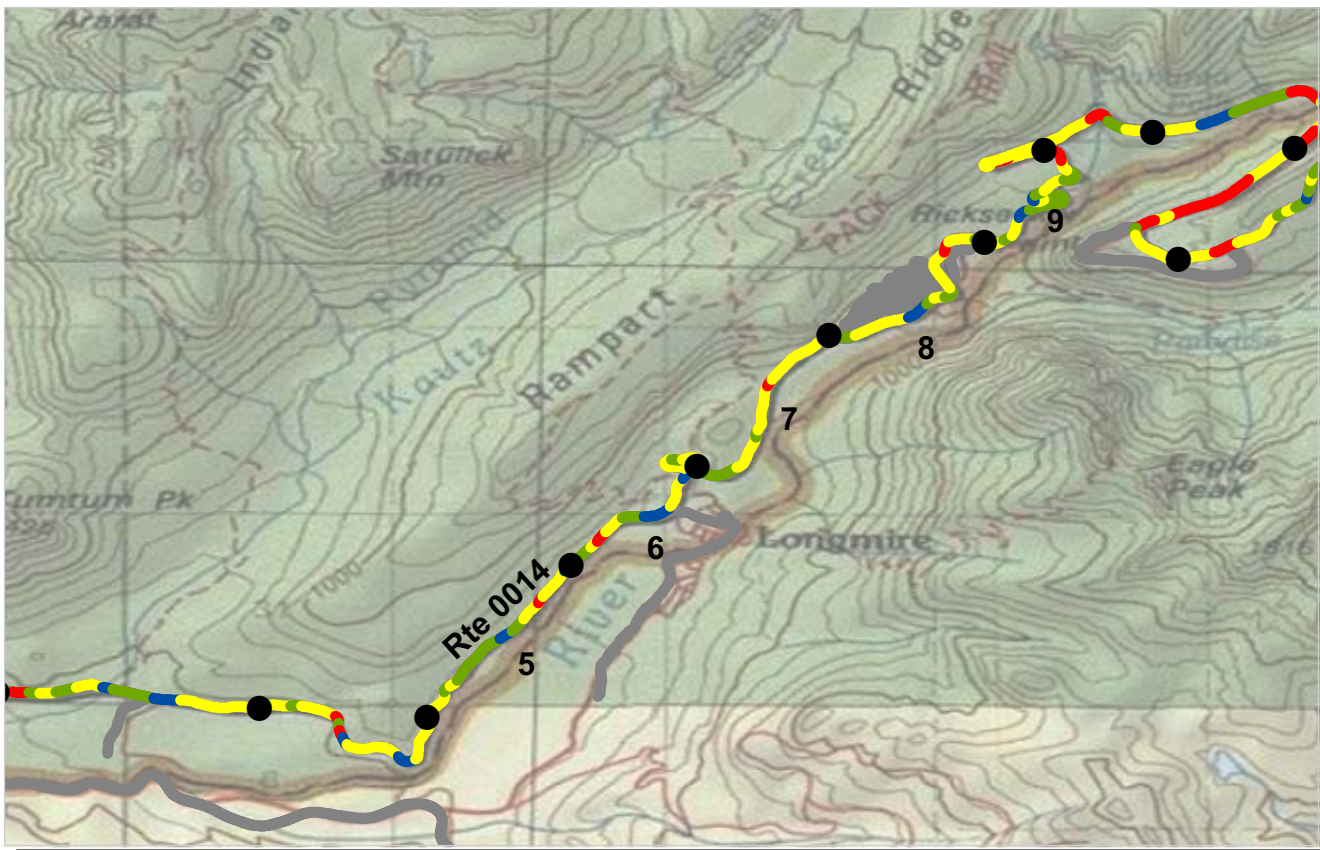
ROUTE: 0014 NISQUALLY ROAD

PCR Poor ■ Fair ■ Good ■ Excellent ■ No Data ■
 (0 - 60) (61 - 84) (85 - 94) (95 - 100)

* If the PCR rating is not available for a section, the SCR rating will be displayed. See appendix for definitions and formulas.

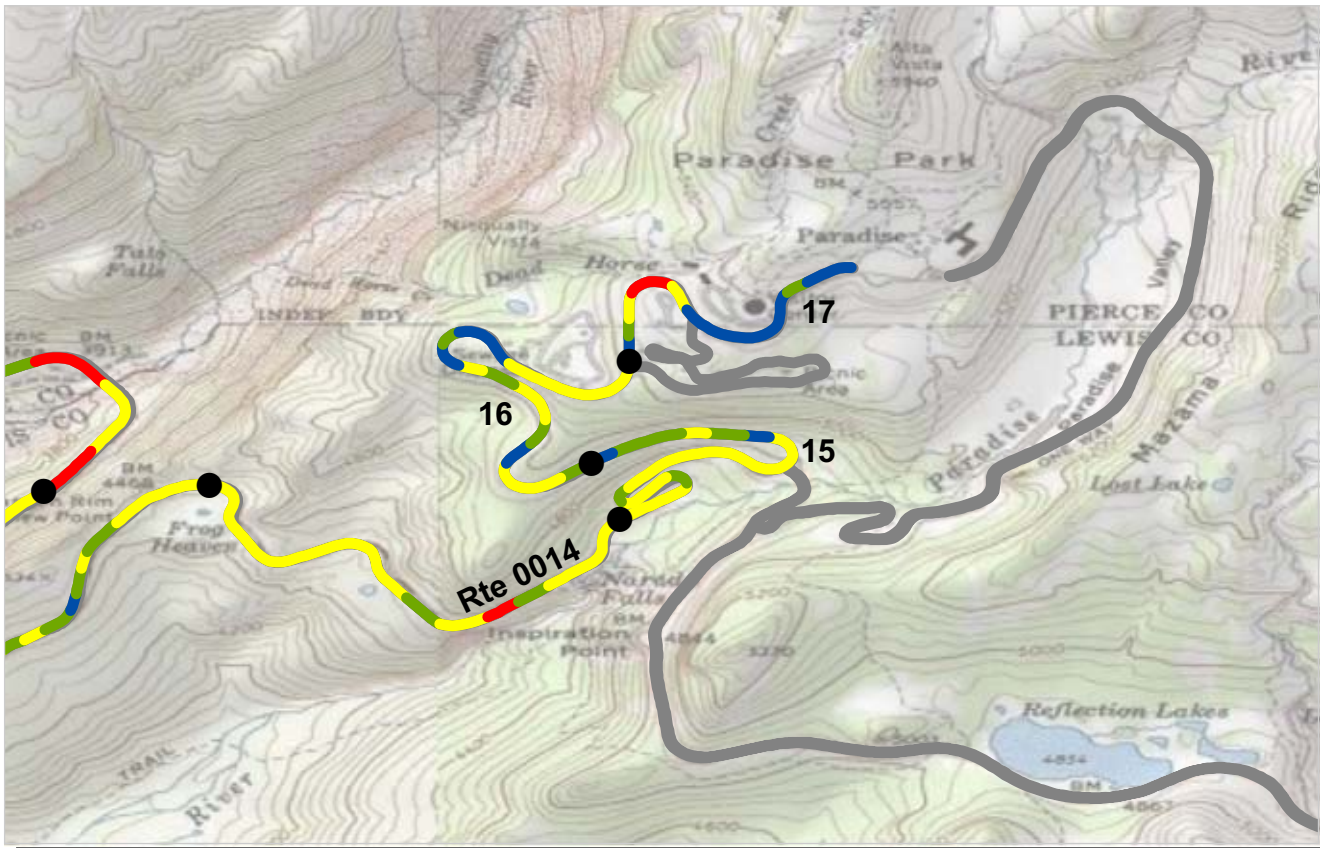
ROUTE: 0014 NISQUALLY ROAD

PCR Poor ■ Fair ■ Good ■ Excellent ■ No Data ■
 (0 - 60) (61 - 84) (85 - 94) (95 - 100)

* If the PCR rating is not available for a section, the SCR rating will be displayed. See appendix for definitions and formulas.

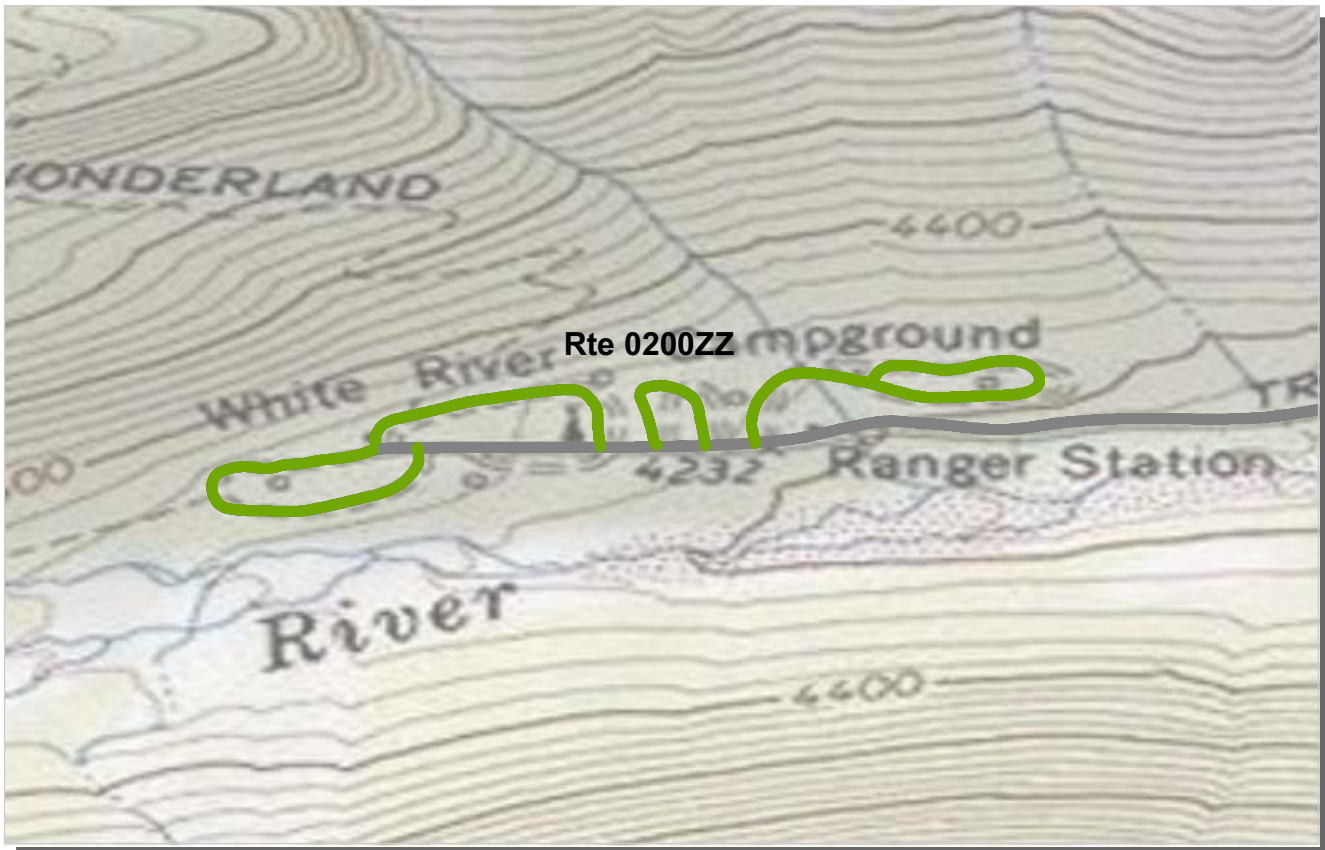
ROUTE: 0200A WHITE RIVER CAMPGROUND ROAD

PCR Poor ■ Fair ■ Good ■ Excellent ■ No Data ■
 (0 - 60) (61 - 84) (85 - 94) (95 - 100)

* If the PCR rating is not available for a section, the SCR rating will be displayed. See appendix for definitions and formulas.
