Federal Lands Highway Road Inventory Program

Road Inventory and Condition Assessment

Mount Rushmore National Memorial MORU - 1500

Cycle 5 Report

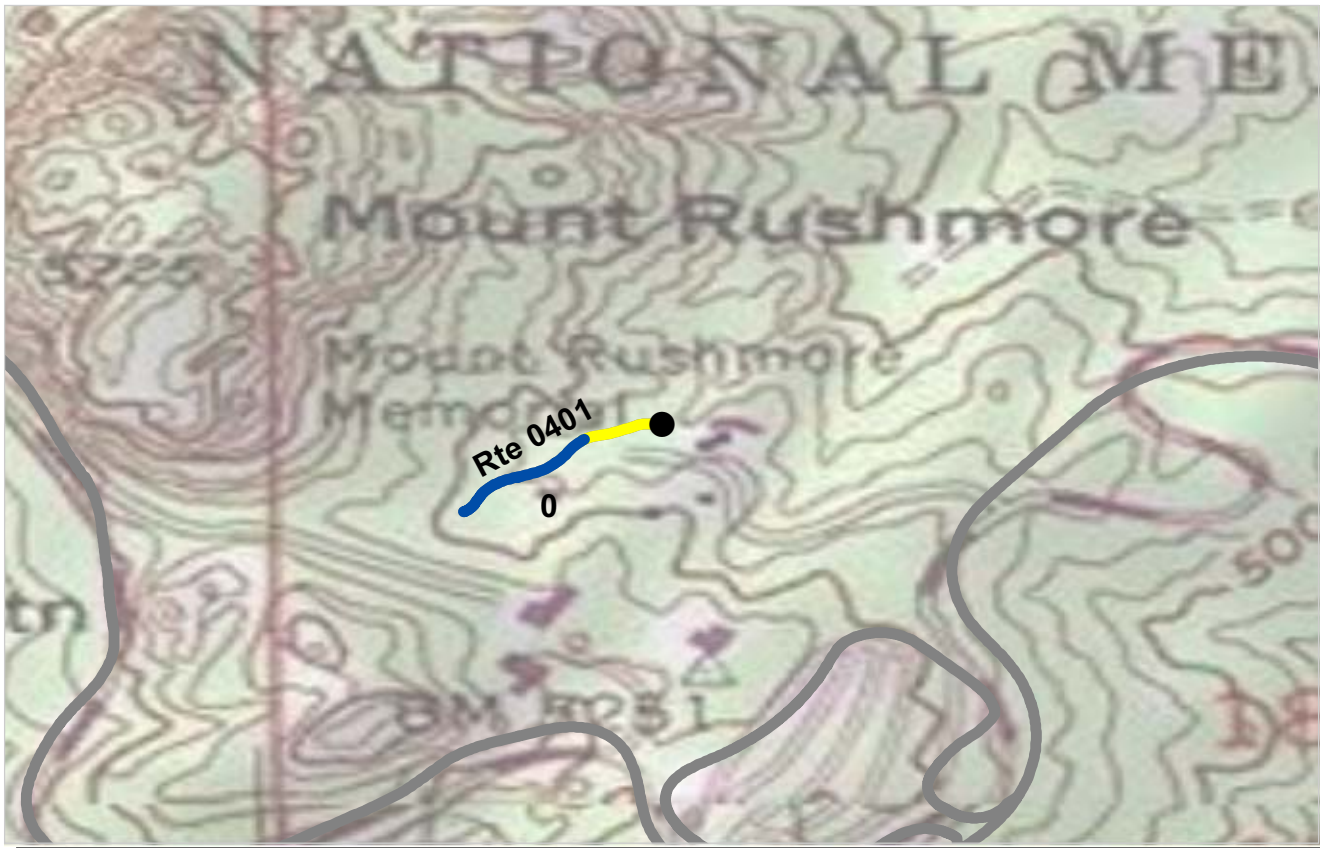
| Roadway Condition Information | | | | | |
| SCR (Surface Condition Rating) | 93 | | | | |
| PCR (Pavement Condition Rating) | 93 | | | | |
| Structural Crack Index | 99 | | | | |
| Transverse Cracking Index | 100 | | | | |
