Federal Lands Highway Road Inventory Program

Road Inventory and Condition Assessment

Natural Bridges National Monument NABR

Cycle 5 Report

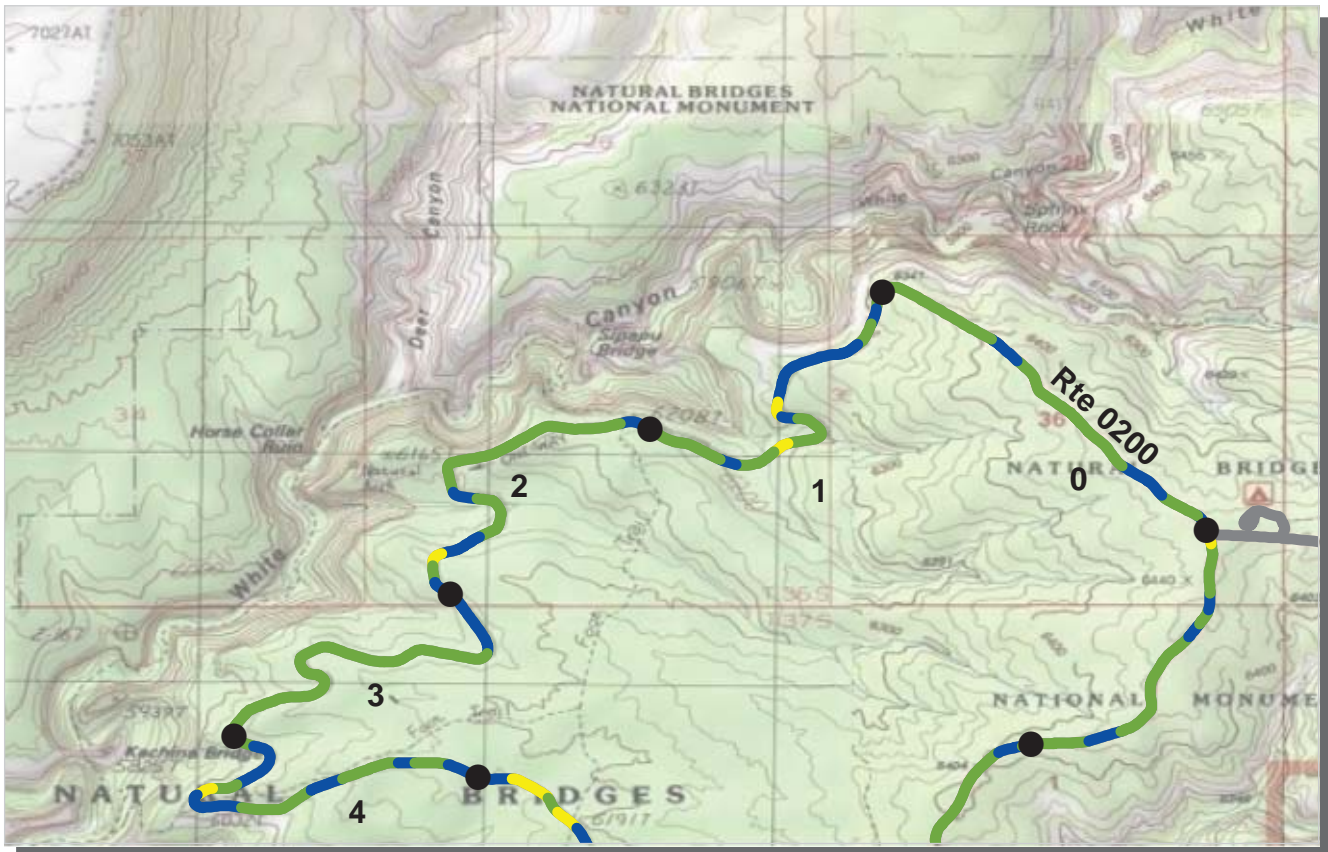
ROUTE: 0200 BRIDGE VIEW DRIVE

<i>Section Number</i>	0	1	2	3	4
<i>Section Length (mi)</i>	1.00	1.00	1.00	1.00	1.00
<i>Cross Section Information</i>					
Number of Lanes	1	1	1	1	1
Paved Width (ft)	14	14	14	14	13
Lane Width (ft)	12	12	12	11	11
<i>Roadway Condition Information</i>					
SCR (Surface Condition Rating)	96	98	97	96	97
PCR (Pavement Condition Rating)	92	93	91	90	93
<i>Distress Index Values</i>					
Structural Crack Index	100	100	100	100	100
Transverse Cracking Index	96	98	97	96	97
Patching Index	100	100	100	100	100
Rutting Index	97	98	98	98	97
Roughness Condition Index (RCI)	86	85	83	81	86

Structural Crack Index is a combination of the Longitudinal Cracking Index and Alligator Cracking Index.
 See Section 10 for explanation of SCR, PCR, & all Distress Index Values.

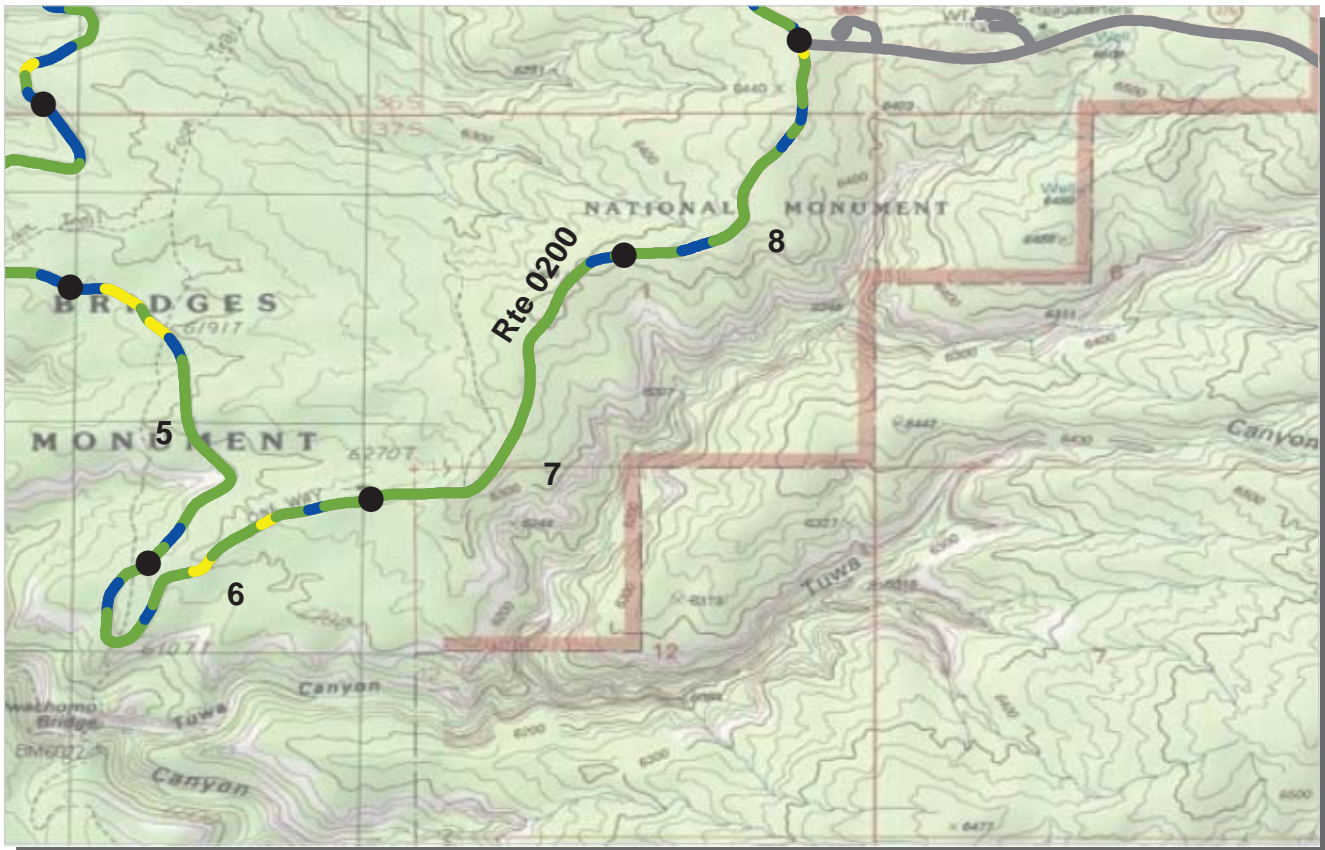
ROUTE: 0200 BRIDGE VIEW DRIVE

<i>Section Number</i>	5	6	7	8
<i>Section Length (mi)</i>	1.00	1.00	1.00	0.82
<i>Cross Section Information</i>				
Number of Lanes	1	1	1	1
Paved Width (ft)	14	14	14	14
Lane Width (ft)	12	12	12	12
<i>Roadway Condition Information</i>				
SCR (Surface Condition Rating)	96	96	96	95
PCR (Pavement Condition Rating)	89	90	92	89
<i>Distress Index Values</i>				
Structural Crack Index	100	100	100	100
Transverse Cracking Index	96	96	96	95
Patching Index	100	100	100	100
Rutting Index	97	98	98	97
Roughness Condition Index (RCI)	78	82	85	81

Structural Crack Index is a combination of the Longitudinal Cracking Index and Alligator Cracking Index.
 See Section 10 for explanation of SCR, PCR, & all Distress Index Values.
