Federal Lands Highway Road Inventory Program

Road Inventory and Condition Assessment

National Capital Parks – East
BAWA, FOWA, GREE, and SUIT reported separately
NACE

Cycle 5 Report

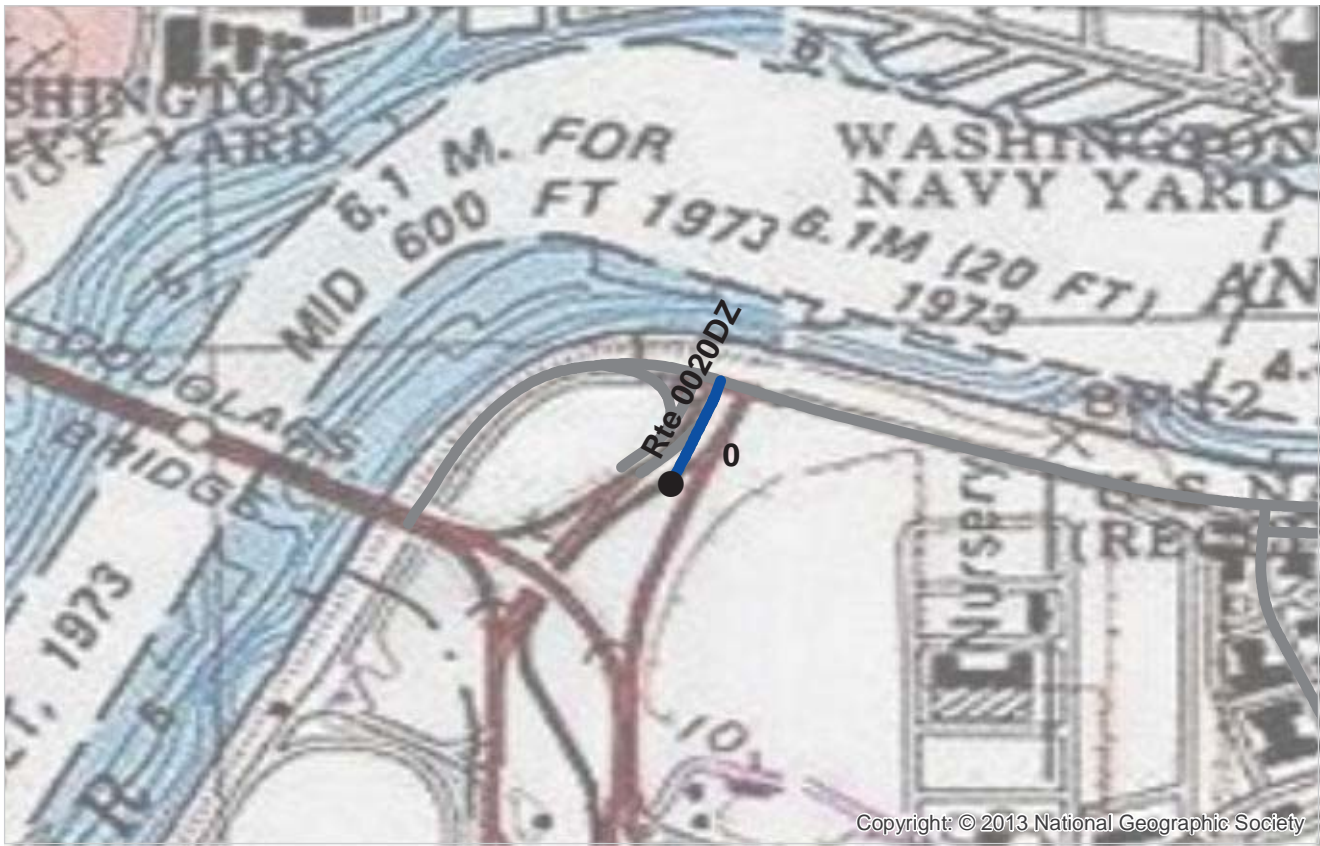
ROUTE: 0020AZ ANACOSTIA DRIVE SE SPUR RAMP TO S CAPITAL STREET SE

Section Number	0				
Section Length (mi)	0.07				
Cross Section Information					
Number of Lanes	1				
Paved Width (ft)	15				
Lane Width (ft)	14				
Roadway Condition Information					
SCR (Surface Condition Rating)	100				
PCR (Pavement Condition Rating)	100				
Distress Index Values					
Structural Crack Index	100				
Transverse Cracking Index	100				
Patching Index	100				
Rutting Index	100				
Roughness Condition Index (RCI)	NC

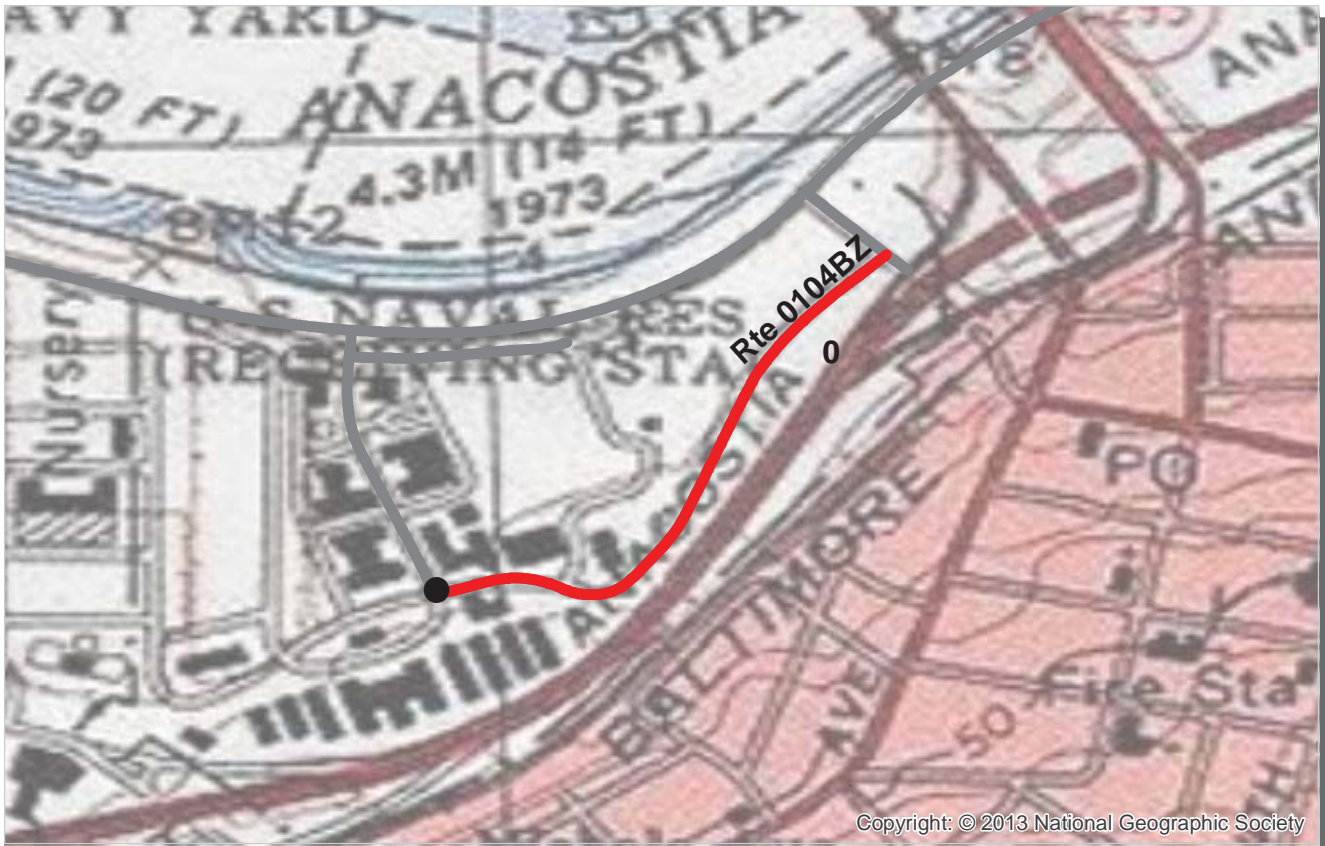
ROUTE: 0104AZ HEADQUARTERS ACCESS

Section Number	0				
Section Length (mi)	0.36				
Cross Section Information					
Number of Lanes	2				
Paved Width (ft)	24				
Lane Width (ft)	11				
Roadway Condition Information					
SCR (Surface Condition Rating)	0				
PCR (Pavement Condition Rating)	0				
Distress Index Values					
Structural Crack Index	0				
Transverse Cracking Index	89				
Patching Index	99				
Rutting Index	97				
Roughness Condition Index (RCI)	NC

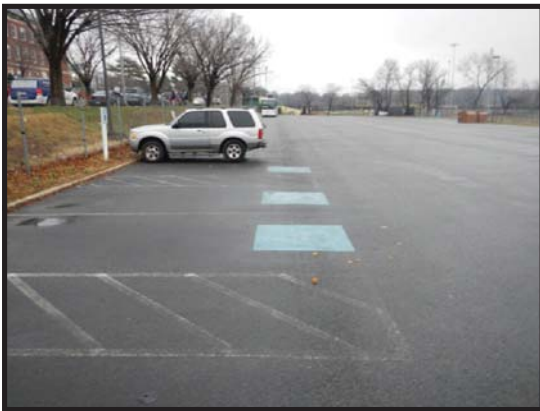
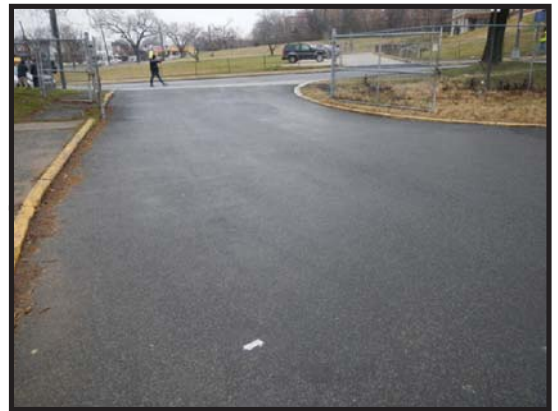
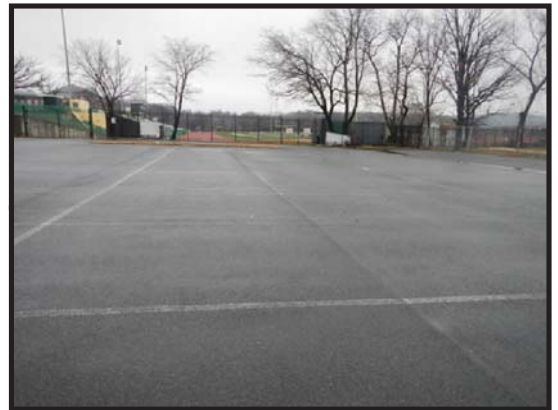
Route Number	Public / NonPublic	Date Visited	Area (sq ft)	Lane Miles *	Surface Type
0905	PUBLIC	1/15/2013	51,676	0.89	AS
Culverts	Drop Inlets	Gates	Curb & Gutter	Curb	PCR
0	1	4	NO CURB AND GUTTER	CONCRETE CURB	GOOD/90

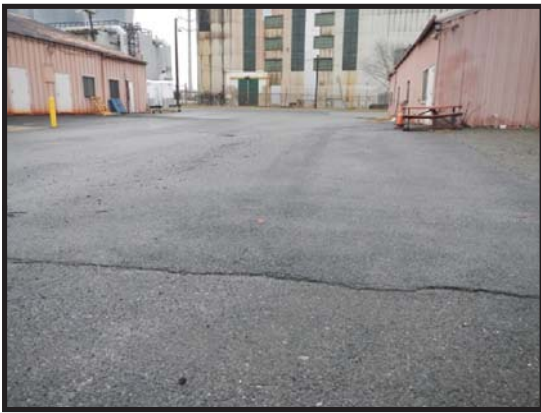
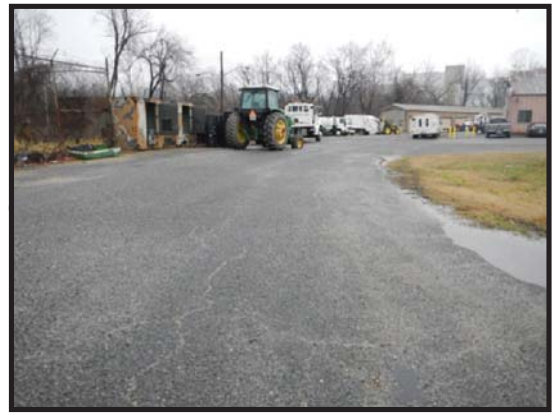
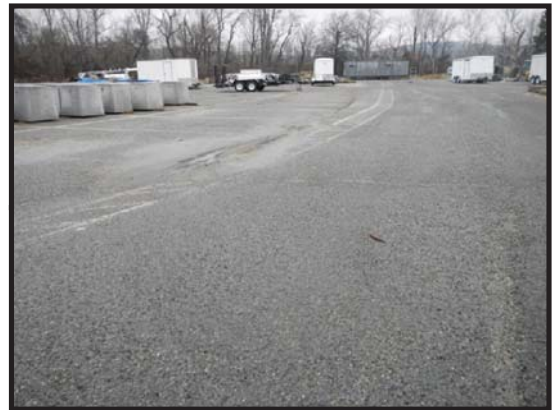
Route 0906

Route Number	Public / NonPublic	Date Visited	Area (sq ft)	Lane Miles *	Surface Type
0906	NONPUBLIC	1/15/2013	53,602	0.92	AS
Culverts	Drop Inlets	Gates	Curb & Gutter	Curb	PCR
1	1	2	NO CURB AND GUTTER	WOOD CURB	POOR/45

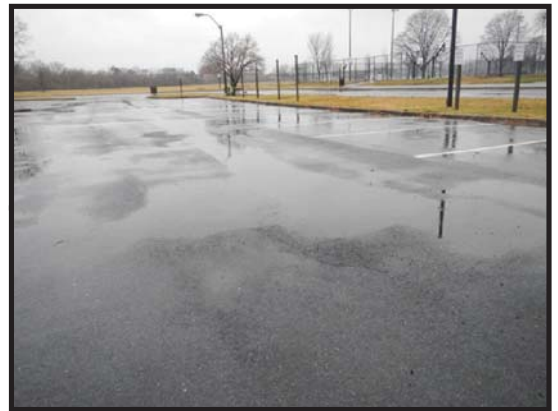
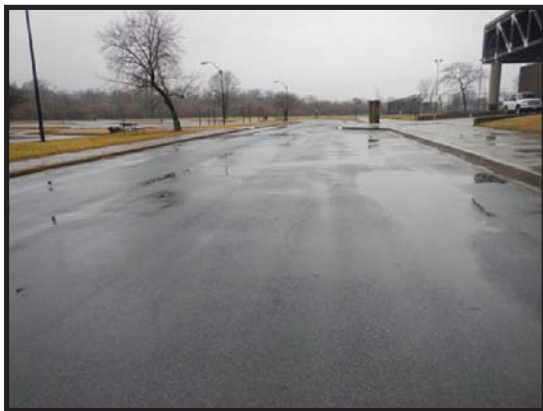
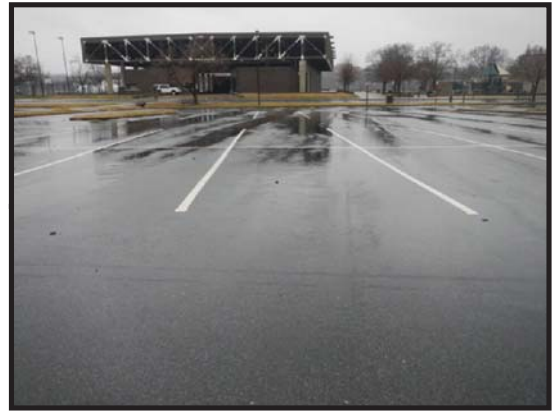
Route 0909

Route Number	Public / NonPublic	Date Visited	Area (sq ft)	Lane Miles *	Surface Type
0909	PUBLIC	1/15/2013	99,603	1.72	AS
Culverts	Drop Inlets	Gates	Curb & Gutter	Curb	PCR
0	4	0	CONCRETE CURB AND GUTTER	NO CURB	GOOD/90

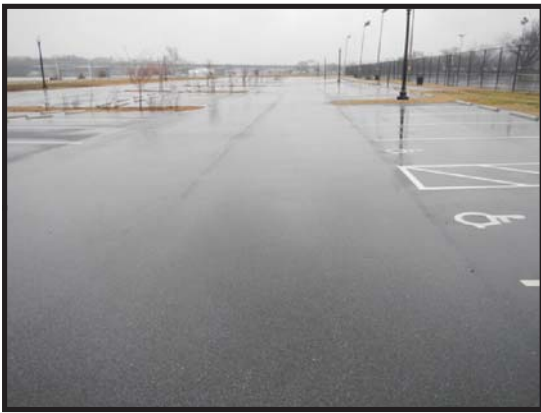
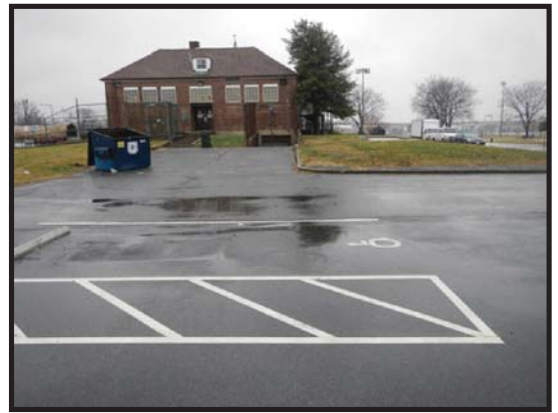
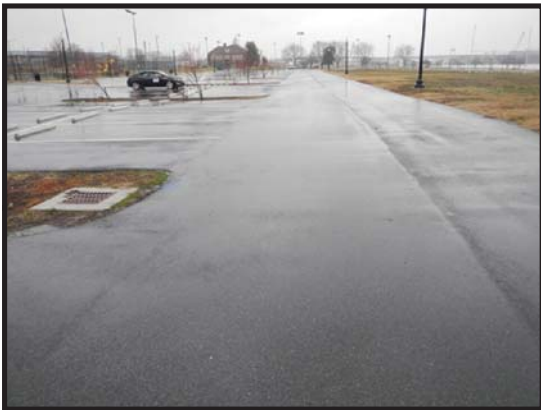
Route 0912

Route Number	Public / NonPublic	Date Visited	Area (sq ft)	Lane Miles *	Surface Type
0912	PUBLIC	1/15/2013	62,597	1.08	AS
Culverts	Drop Inlets	Gates	Curb & Gutter	Curb	PCR
0	8	1	NO CURB AND GUTTER	CONCRETE & WOOD CURB	GOOD/90

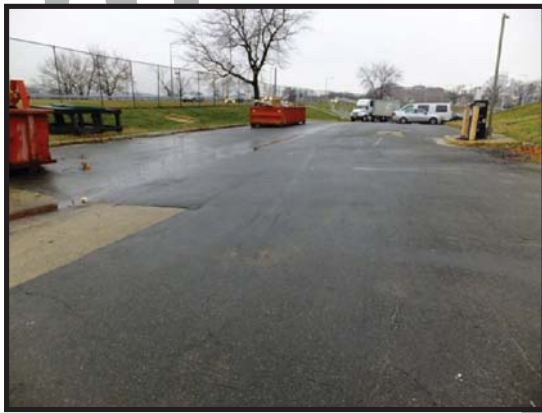
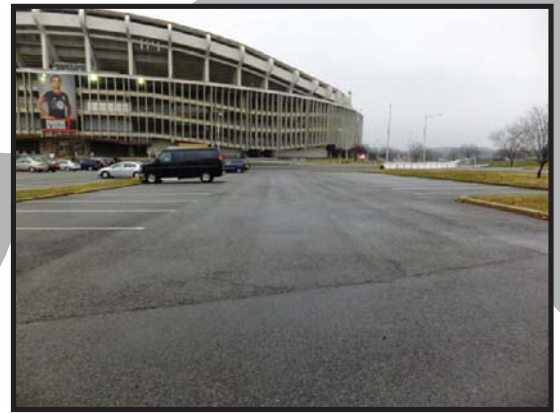
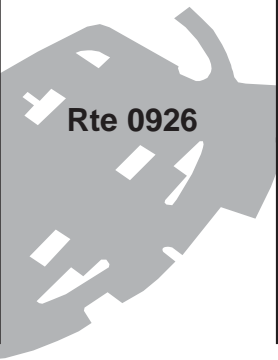
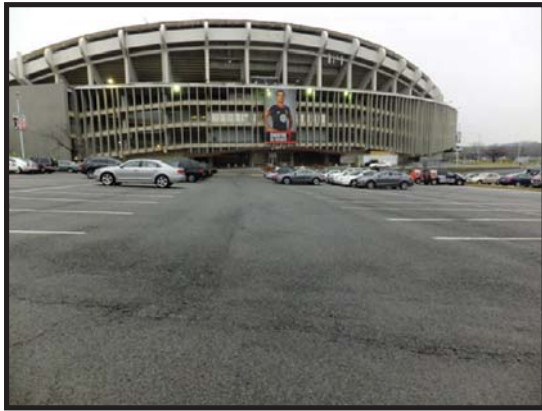
Route 0925

Route Number	Public / NonPublic	Date Visited	Area (sq ft)	Lane Miles *	Surface Type
0925	PUBLIC	1/15/2013	155,079	2.67	AS
Culverts	Drop Inlets	Gates	Curb & Gutter	Curb	PCR
0	8	10	CONCRETE CURB AND GUTTER	CONCRETE CURB	POOR/45

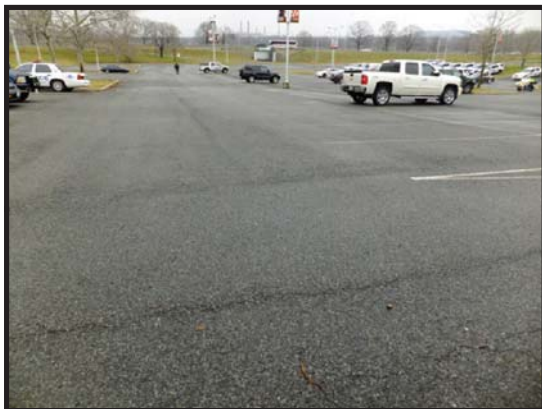
Route 0926

Route Number	Public / NonPublic	Date Visited	Area (sq ft)	Lane Miles *	Surface Type
0926	PUBLIC	1/15/2013	108,267	1.86	AS
Culverts	Drop Inlets	Gates	Curb & Gutter	Curb	PCR
0	5	3	NO CURB AND GUTTER	CONCRETE CURB	GOOD/90

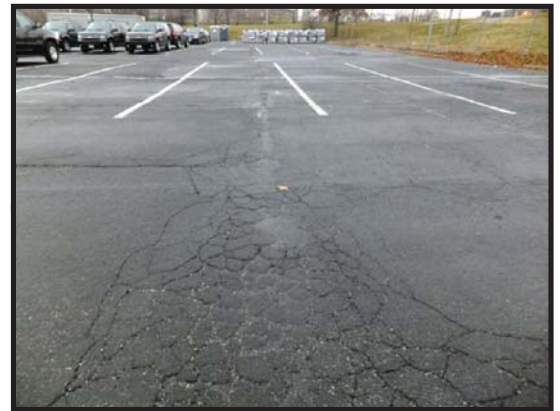
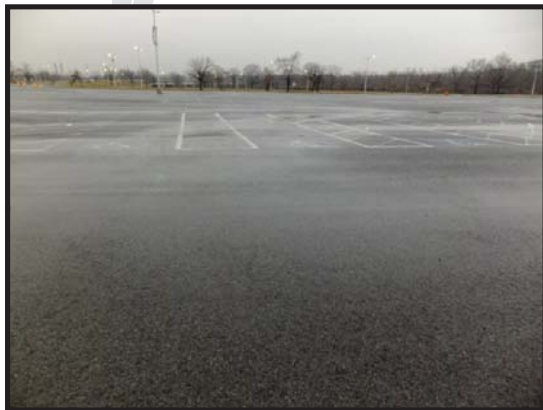
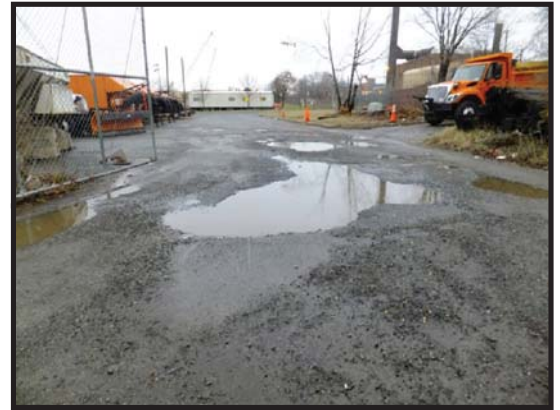
Route 0927

Route Number	Public / NonPublic	Date Visited	Area (sq ft)	Lane Miles *	Surface Type
0927	PUBLIC	1/15/2013	798,743	13.75	AS
Culverts	Drop Inlets	Gates	Curb & Gutter	Curb	PCR
0	17	14	CONCRETE CURB AND GUTTER	NO CURB	POOR/45

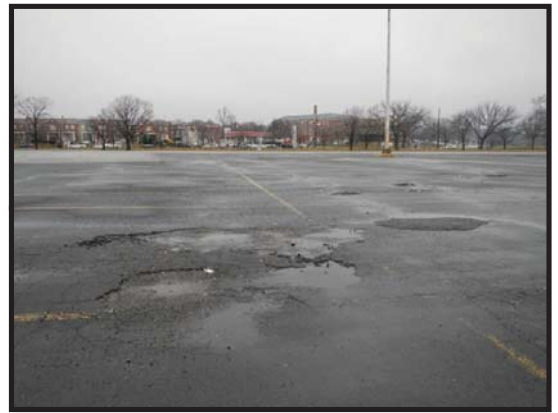
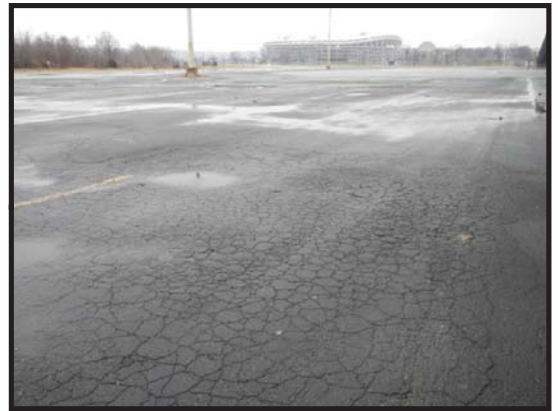
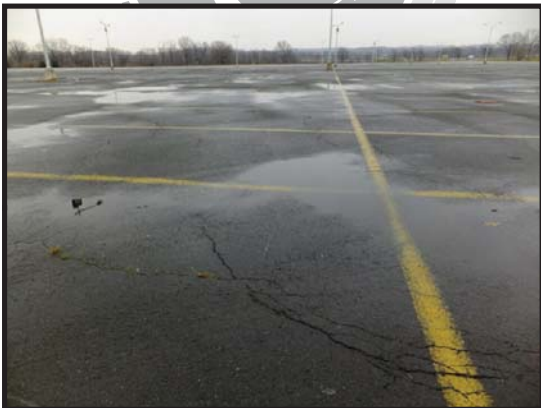
Route 0928

Route Number	Public / NonPublic	Date Visited	Area (sq ft)	Lane Miles *	Surface Type
0928	PUBLIC	1/15/2013	1,624,057	27.96	AS
Culverts	Drop Inlets	Gates	Curb & Gutter	Curb	PCR
0	27	7	CONCRETE CURB AND GUTTER	CONCRETE & STONE CURB	FAIR/73

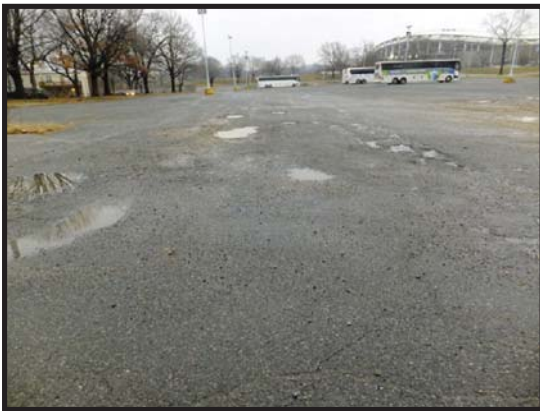
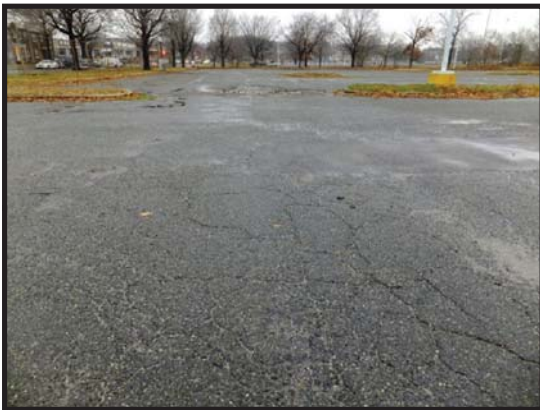
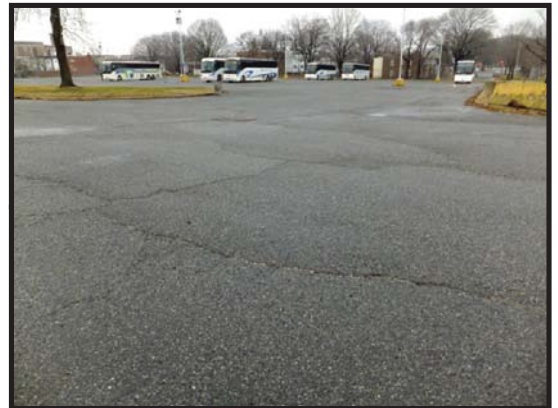
Route Number	Public / NonPublic	Date Visited	Area (sq ft)	Lane Miles *	Surface Type
0930	PUBLIC	1/15/2013	343,080	5.91	AS
Culverts	Drop Inlets	Gates	Curb & Gutter	Curb	PCR
0	11	9	CONCRETE CURB AND GUTTER	NO CURB	POOR/45

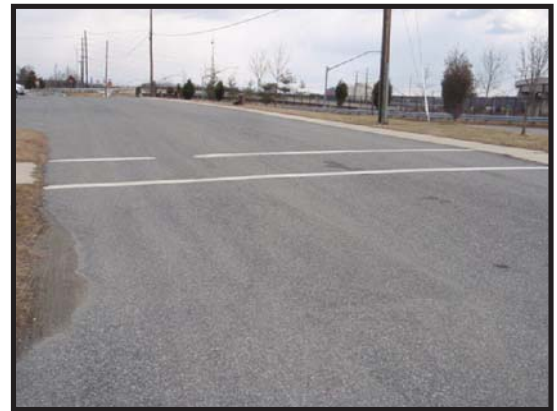
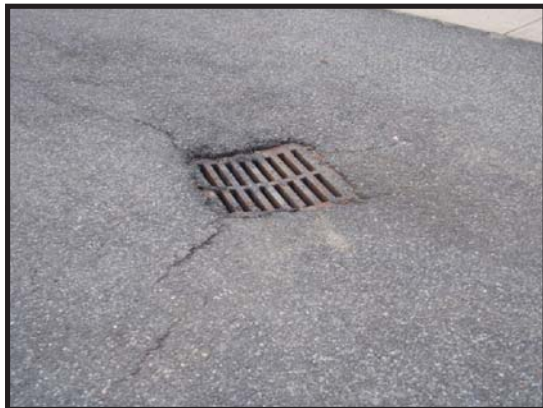
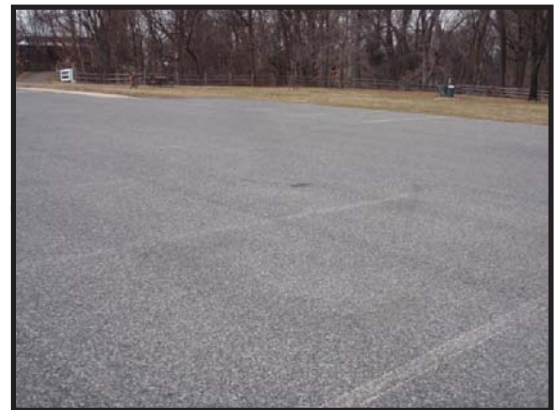
Route 0950

Route Number	Public / NonPublic	Date Visited	Area (sq ft)	Lane Miles *	Surface Type
0950	PUBLIC	2/17/2013	35,573	0.61	AS
Culverts	Drop Inlets	Gates	Curb & Gutter	Curb	PCR
0	1	2	NO CURB AND GUTTER	NO CURB	FAIR/73

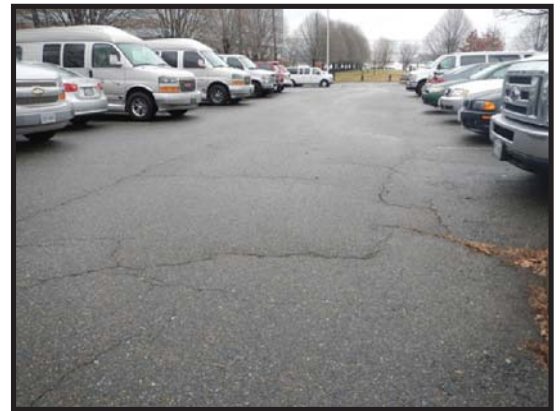
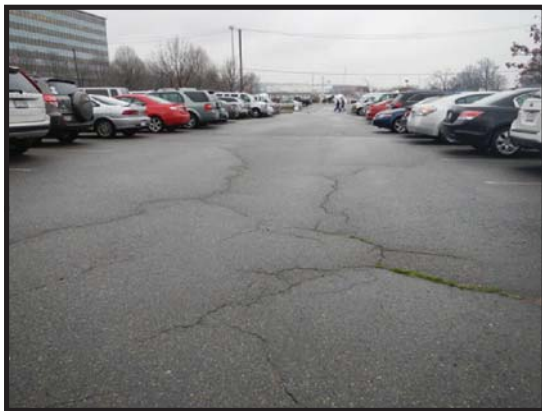
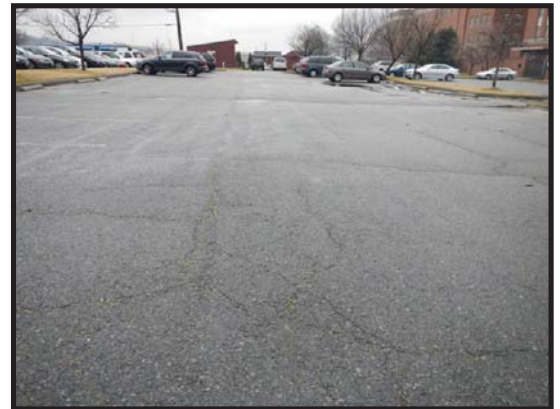
Route 0982

Route Number	Public / NonPublic	Date Visited	Area (sq ft)	Lane Miles *	Surface Type
0982	PUBLIC	1/15/2013	72,121	1.24	AS
Culverts	Drop Inlets	Gates	Curb & Gutter	Curb	PCR
0	0	0	NO CURB AND GUTTER	ASPHALT & CONCRETE	POOR/45

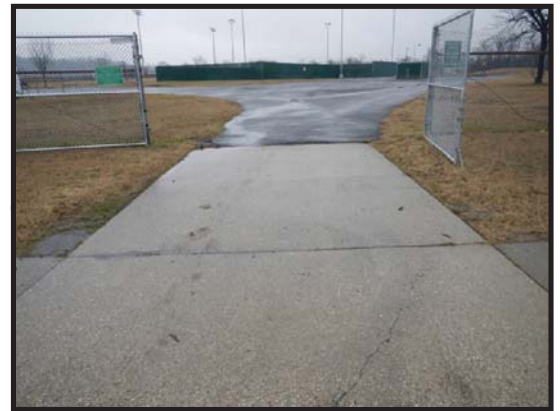
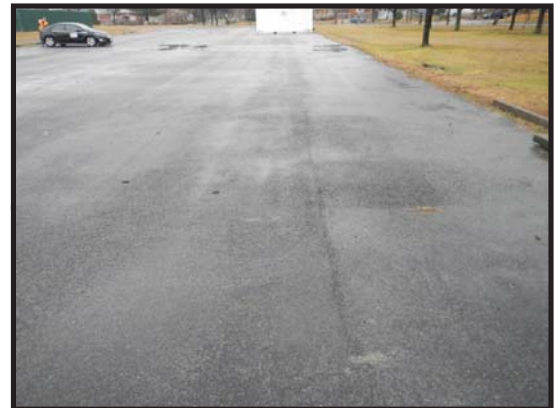
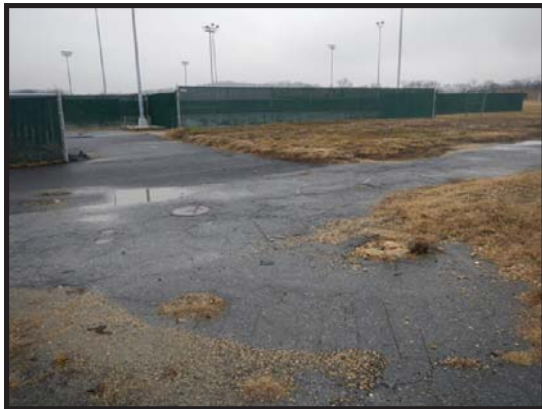
Route 0985

Route Number	Public / NonPublic	Date Visited	Area (sq ft)	Lane Miles *	Surface Type
0985	PUBLIC	1/15/2013	29,220	0.50	AS
Culverts	Drop Inlets	Gates	Curb & Gutter	Curb	PCR
0	1	2	NO CURB AND GUTTER	WOOD CURB	POOR/45

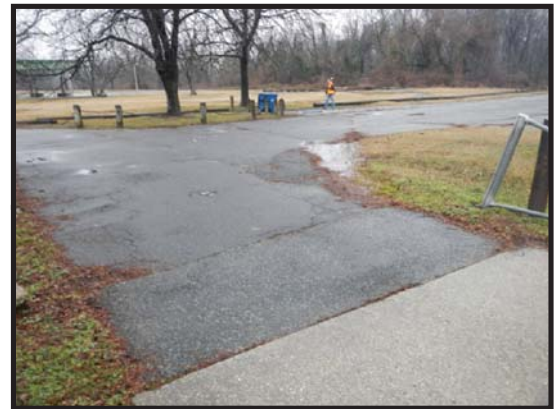
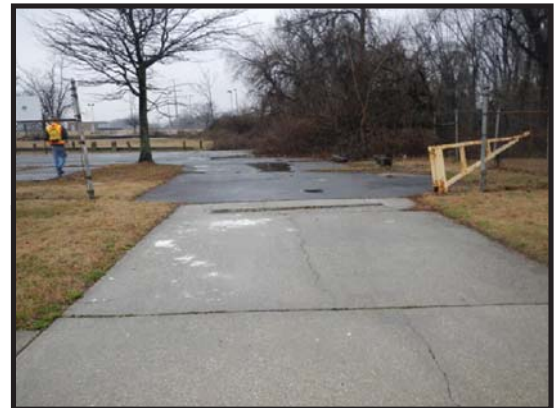
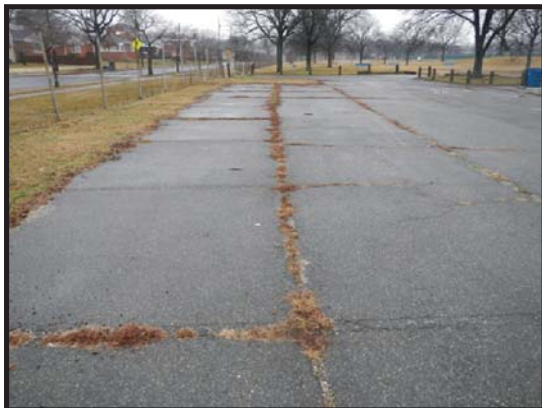
Route 0986

Route Number	Public / NonPublic	Date Visited	Area (sq ft)	Lane Miles *	Surface Type
0986	PUBLIC	1/15/2013	16,391	0.28	AS
Culverts	Drop Inlets	Gates	Curb & Gutter	Curb	PCR
0	1	2	NO CURB AND GUTTER	NO CURB	POOR/45

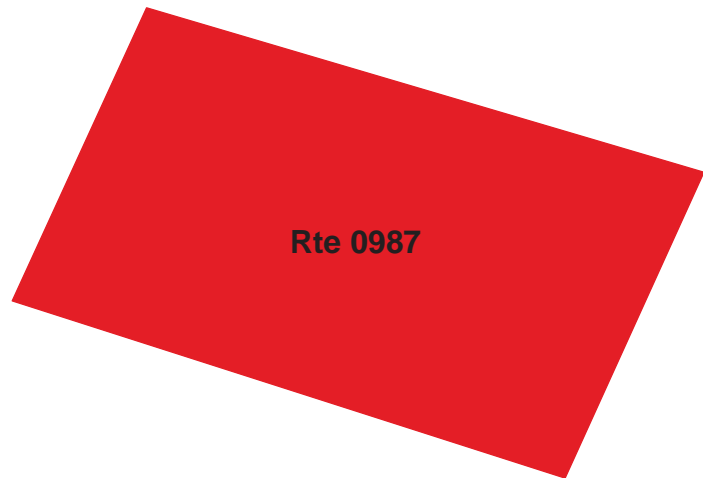
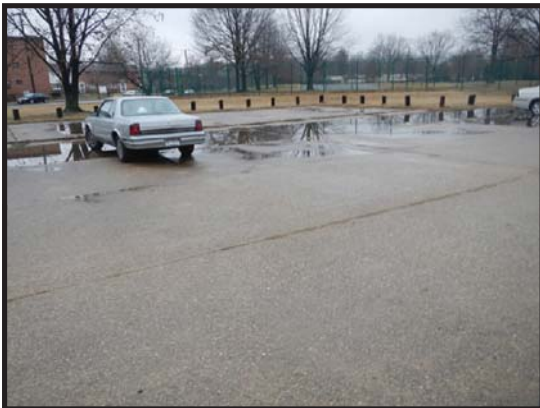
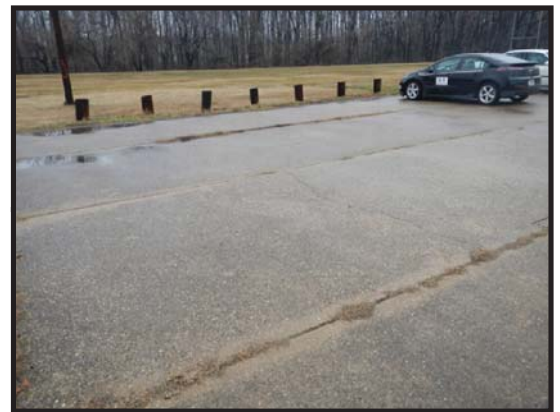
Route 0987

Route Number	Public / NonPublic	Date Visited	Area (sq ft)	Lane Miles *	Surface Type
0987	PUBLIC	1/15/2013	6,953	0.12	AS
Culverts	Drop Inlets	Gates	Curb & Gutter	Curb	PCR
0	0	0	NO CURB AND GUTTER	NO CURB	GOOD/90

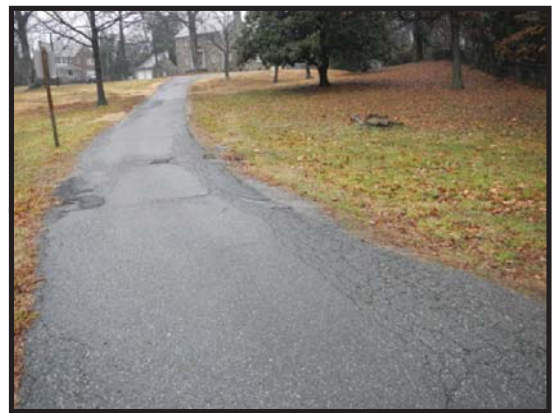
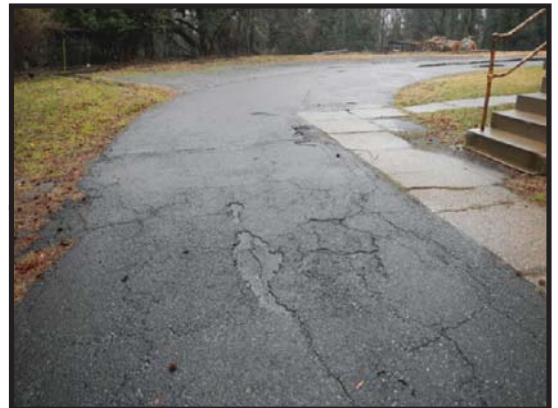
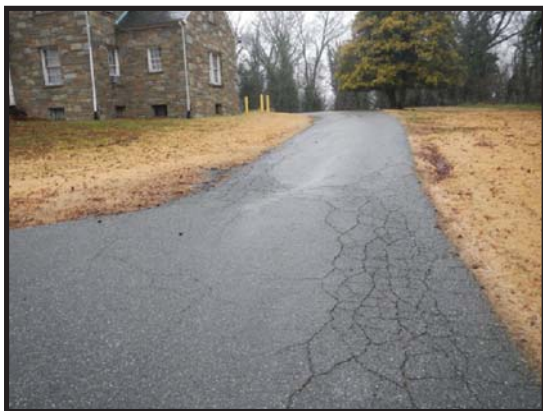
Route 0989

Route Number	Public / NonPublic	Date Visited	Area (sq ft)	Lane Miles *	Surface Type
0989	NONPUBLIC	1/15/2013	8,763	0.15	AS
Culverts	Drop Inlets	Gates	Curb & Gutter	Curb	PCR
0	0	0	NO CURB AND GUTTER	CONCRETE CURB	POOR/45

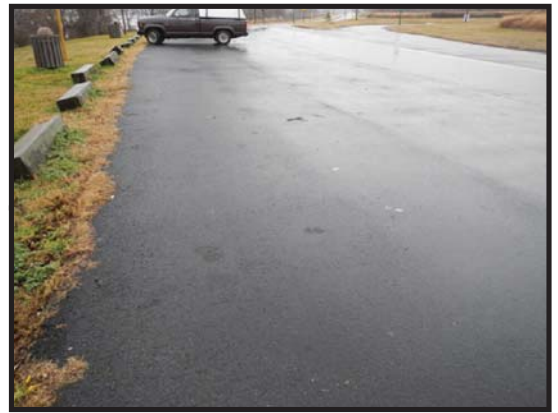
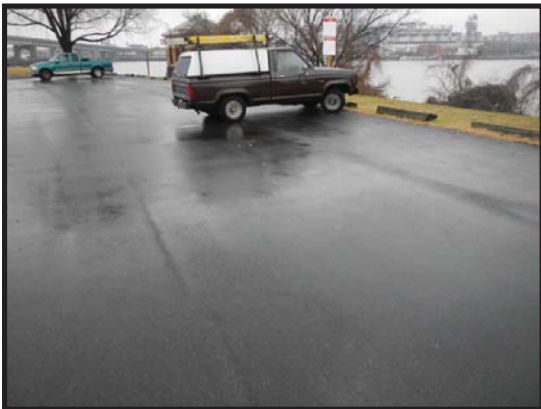
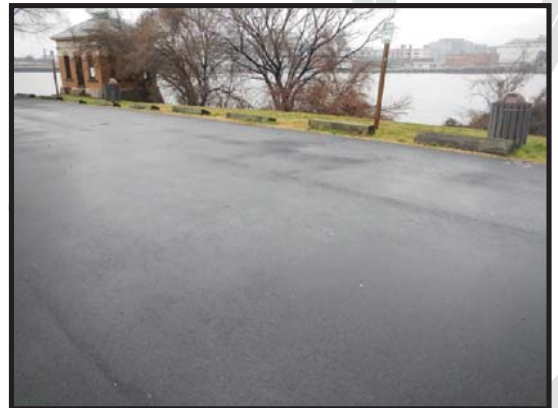
Route 0991

Route Number	Public / NonPublic	Date Visited	Area (sq ft)	Lane Miles *	Surface Type
0991	PUBLIC	1/15/2013	4,273	0.07	AS
Culverts	Drop Inlets	Gates	Curb & Gutter	Curb	PCR
0	0	0	NO CURB AND GUTTER	NO CURB	GOOD/90
