# Federal Lands Highway Road Inventory Program

Road Inventory and Condition Assessment

## National Mall and Memorial Parks NAMA

Prepared By: Federal Highway Administration  
Road Inventory Program (RIP)  
Data Collected: 05/2013  
Report Date: 01/2014

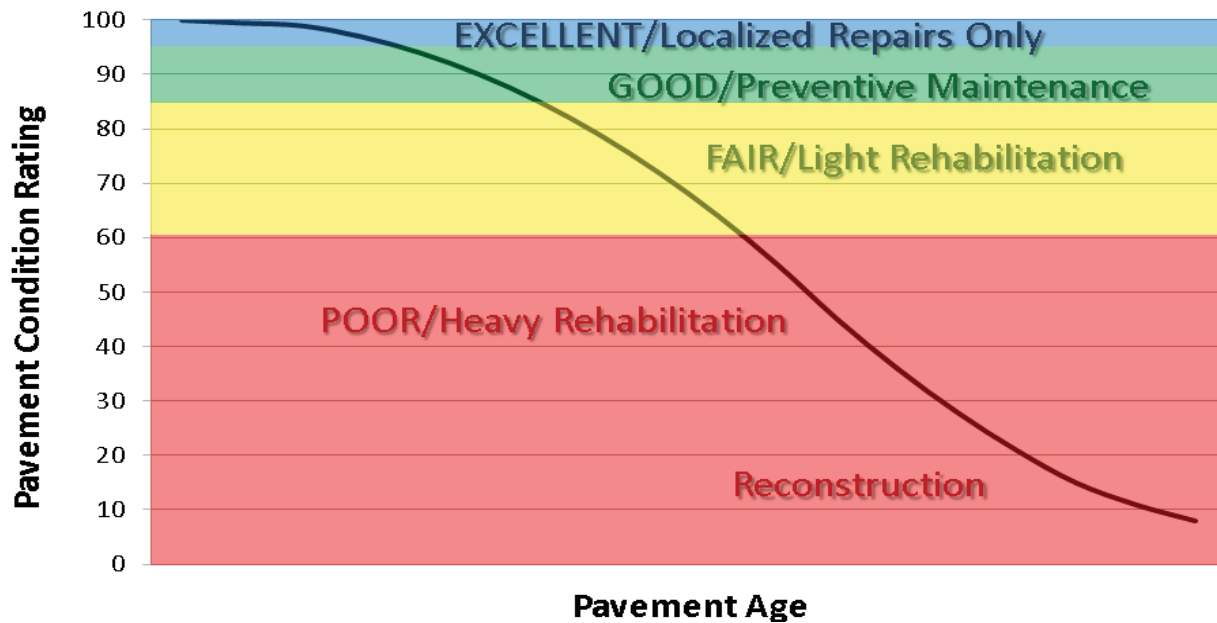
### Condition Categories and Treatments

- Excellent/New: PCR of 95-100. Pavements in this range will require only spot repairs
- Good: PCR of 85-94. Pavements in this range will likely be candidates for Preventive Maintenance. Examples include Chip and Slurry Seals, Micro Surfacing and Thin Overlays.
- Fair: PCR of 61-84. Pavements in this range will likely be candidates of Light Rehabilitation (L3R). Examples include single-lift overlays up to 2.5 inches in total thickness, milling and overlays.
- Poor: PCR of 0-60. Pavements in this range will likely be candidates of Heavy Rehabilitation or Reconstruction (H3R or 4R). Examples include Pulverization, Multiple Lift Overlays, and Reconstruction.

At this time, specific Maintenance and Rehabilitation activities should be evaluated and recommended at the project level. Site-specific conditions that influence treatment type should be determined based on performing a subsurface investigation and/or pavement condition survey, and not be based solely on RIP data. Additionally, RIP produces a snapshot of conditions the year in which the data was collected. For further information or to obtain additional Pavement Management System's data from our Highway Pavement Management Application (HPMA) please contact the Eastern Federal Lands pavement team.

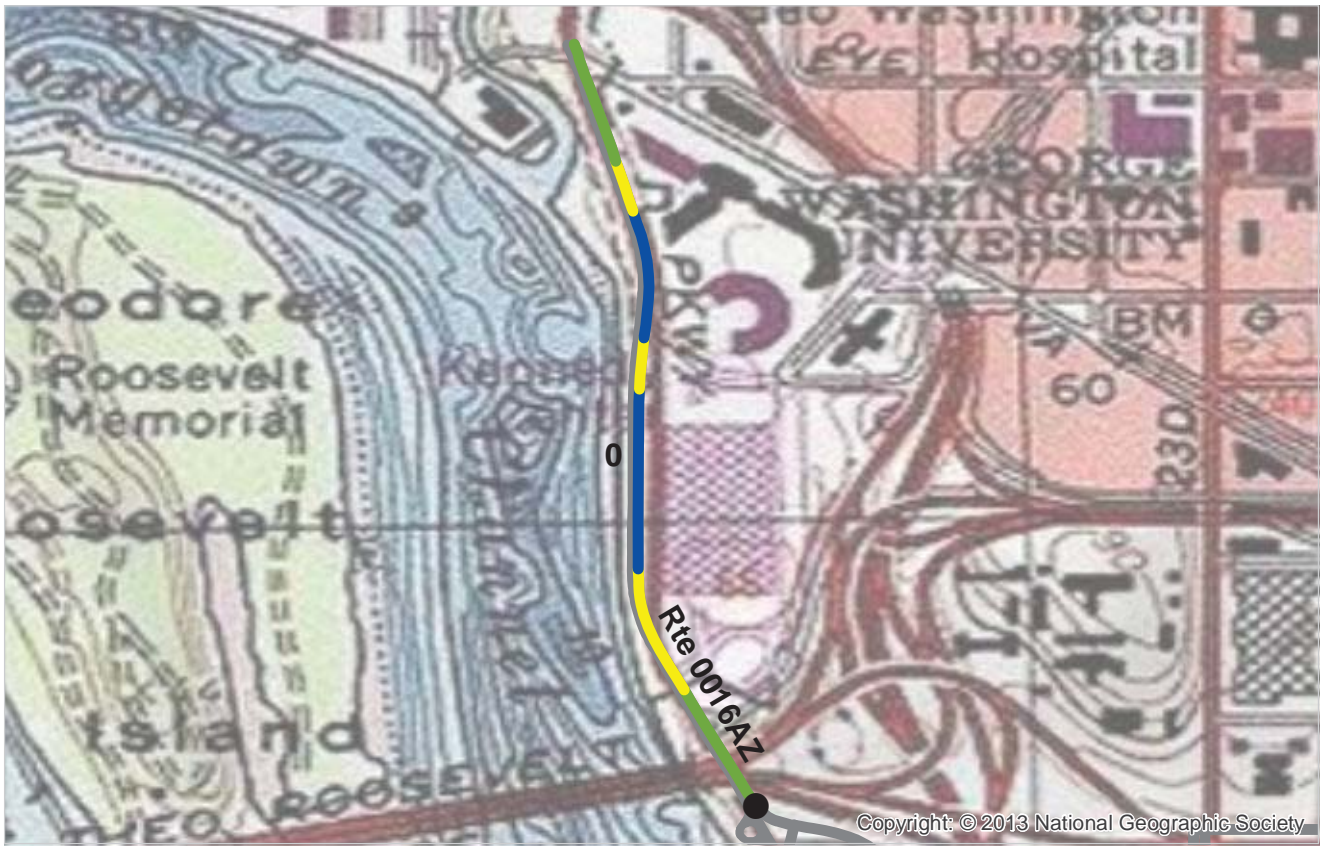
ROUTE: 0016ZZ ROCK CREEK AND POTOMAC PARKWAY

ROUTE NUMBER	ROUTE NAME	FUNCT CLASS	PAVED LENGTH	SURFACE TYPE	AVERAGE SURFACE CONDITION RATING (SCR)	AVERAGE PAVEMENT CONDITION RATING (PCR)
0016ZZ	ROCK CREEK AND POTOMAC PARKWAY	7	1.21	ASPHALT	88	85
0017ZZ	PARKWAY DRIVE NW AND SPURS	7	0.39	ASPHALT	87	87
0018ZZ	23RD STREET NW	7	0.22	ASPHALT	70	70
0019	HENRY BACON DRIVE NW	7	0.15	ASPHALT	82	82
0020ZZ	17TH STREET NW AND SW	7	0.35	ASPHALT	79	79

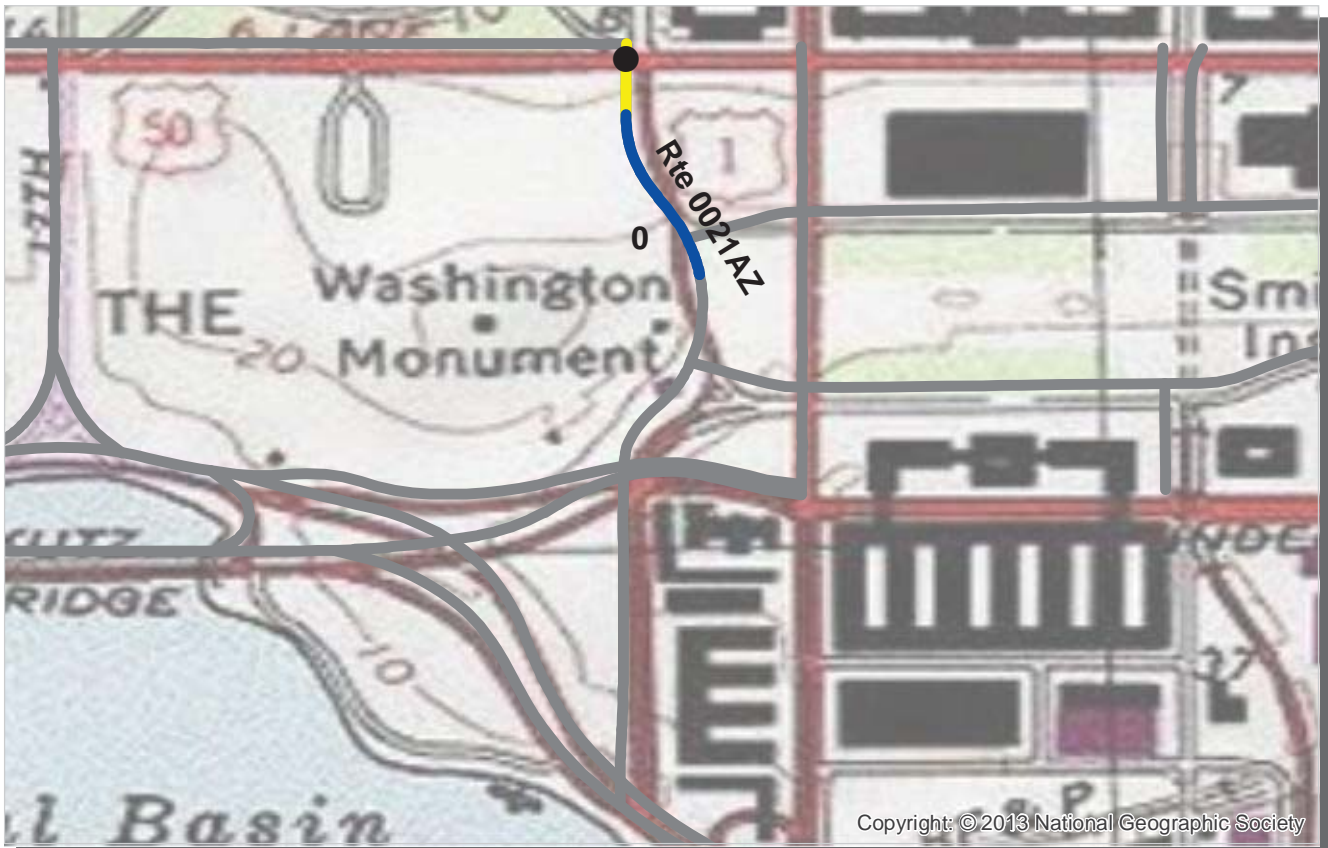
ROUTE: 0021ZZ 15TH STREET NW AND SW

ROUTE NUMBER	ROUTE NAME	FUNCT CLASS	PAVED LENGTH	SURFACE TYPE	AVERAGE SURFACE CONDITION RATING (SCR)	AVERAGE PAVEMENT CONDITION RATING (PCR)
0021ZZ	15TH STREET NW AND SW	7	0.55	ASPHALT	87	87
0022	12TH STREET SW	7	0.07	ASPHALT	69	69
0023ZZ	23RD STREET SW	7	0.13	ASPHALT	93	93
0025ZZ	LINCOLN MEMORIAL CIRCLE NW AND SW	7	0.28	ASPHALT	79	79
0026	OHIO DRIVE SW / HAINS POINT ACCESS LOOP ROAD	7	2.52	ASPHALT	96	84

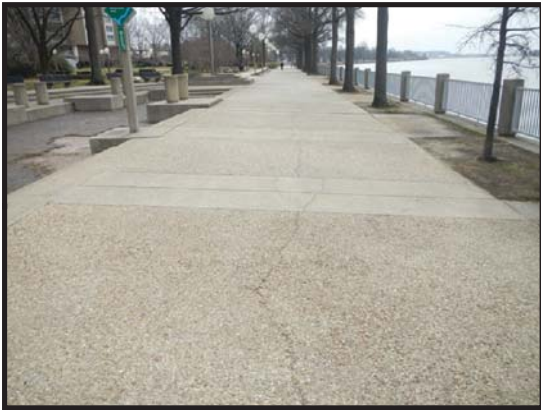
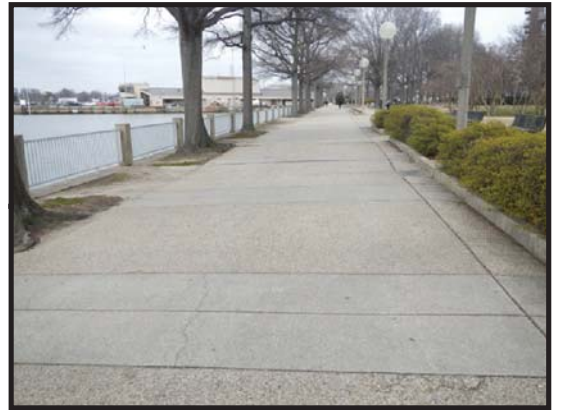
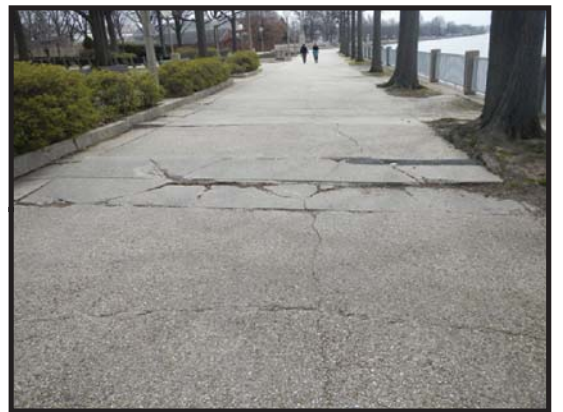
Route Number	Public / NonPublic	Date Visited	Area (sq ft)	Lane Miles *	Paved Length (mi)	Paved Width (ft)
0406	NONPUBLIC	3/11/2013	21,374	0.37	0.23	17.3
Culverts	Drop Inlets	Gates	Curb & Gutter	Curb	PCR	Surface Type
0	1	0	NO CURB AND GUTTER	NO CURB	POOR/45	CO

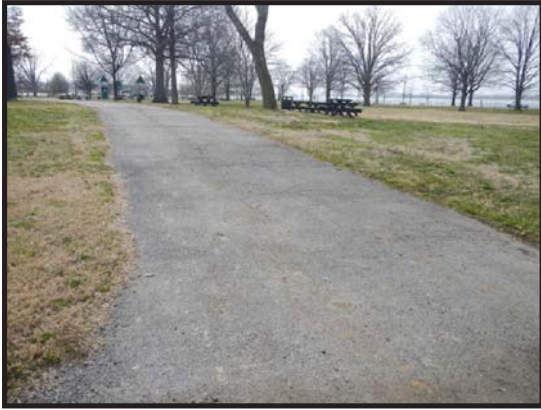
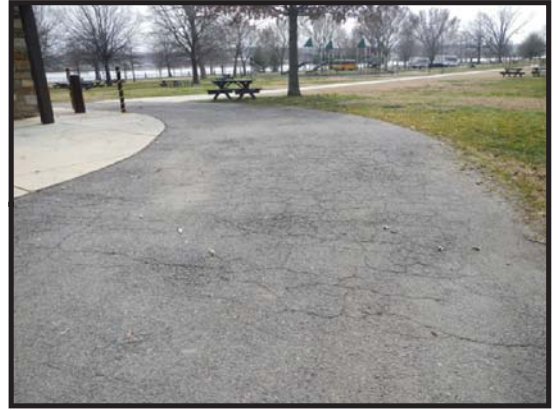
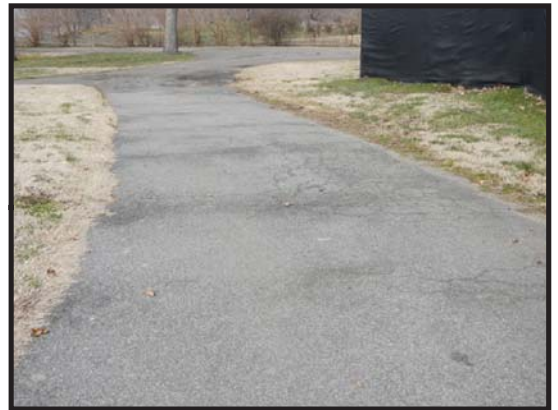
## Route 0408

Route Number	Public / NonPublic	Date Visited	Area (sq ft)	Lane Miles *	Paved Length (mi)	Paved Width (ft)
0408	NONPUBLIC	3/11/2013	4,355	0.08	0.07	11.3
Culverts	Drop Inlets	Gates	Curb & Gutter	Curb	PCR	Surface Type
0	0	0	NO CURB AND GUTTER	NO CURB	POOR/45	AS

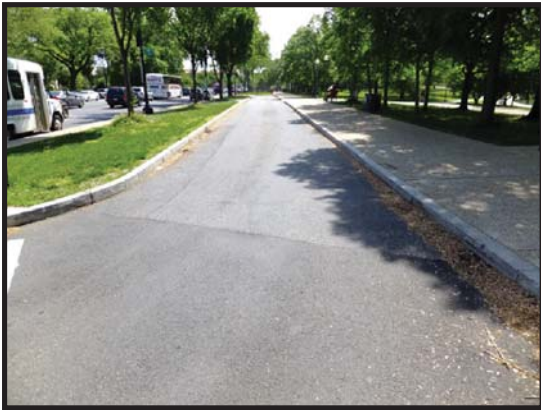
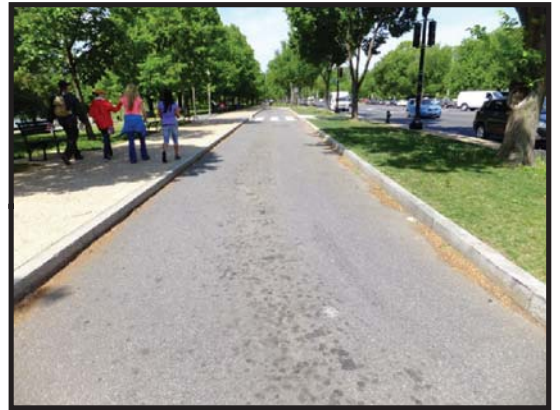
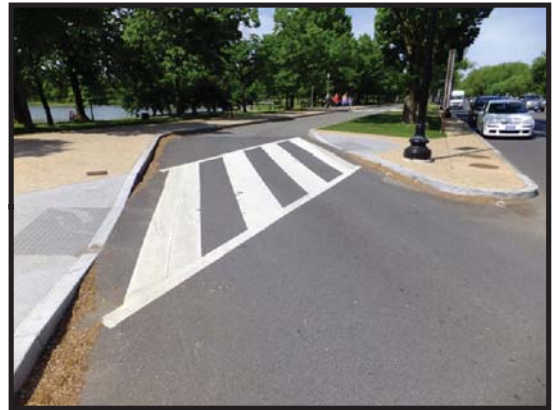
## Route 0409

Route Number	Public / NonPublic	Date Visited	Area (sq ft)	Lane Miles *	Paved Length (mi)	Paved Width (ft)
0409	NONPUBLIC	5/3/2013	4,051	0.07	0.06	13.7
Culverts	Drop Inlets	Gates	Curb & Gutter	Curb	PCR	Surface Type
0	0	0	NO CURB AND GUTTER	STONE CURB	GOOD/90	AS

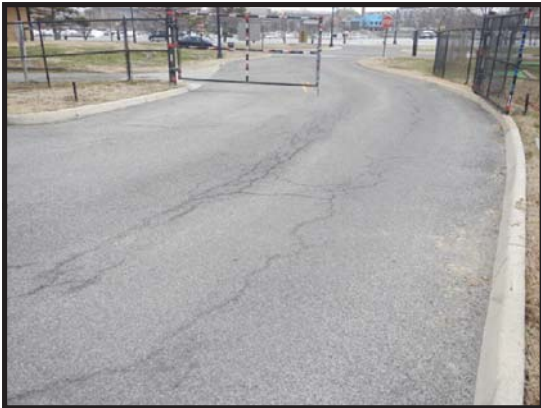
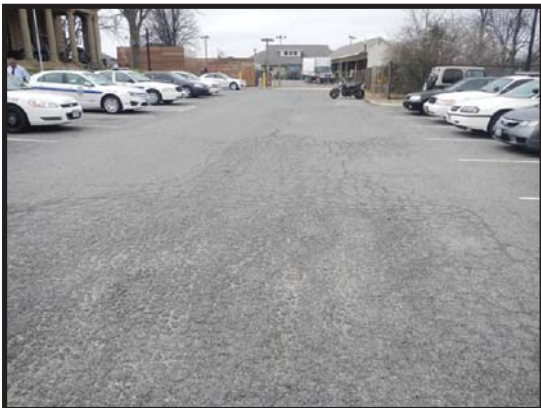
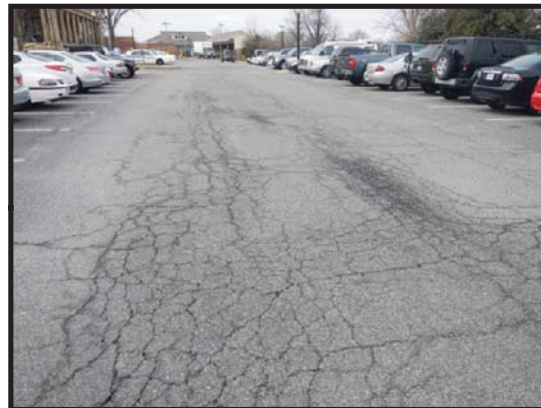
Route Number	Public / NonPublic	Date Visited	Area (sq ft)	Lane Miles *	Surface Type
0909A	NONPUBLIC	3/11/2013	24,720	0.43	AS
Culverts	Drop Inlets	Gates	Curb & Gutter	Curb	PCR
0	6	4	NO CURB AND GUTTER	CONCRETE CURB	POOR/45
