# Federal Lands Highway Road Inventory Program

Road Inventory and Condition Assessment

## Navajo National Monument NAVA

### Cycle 5 Report

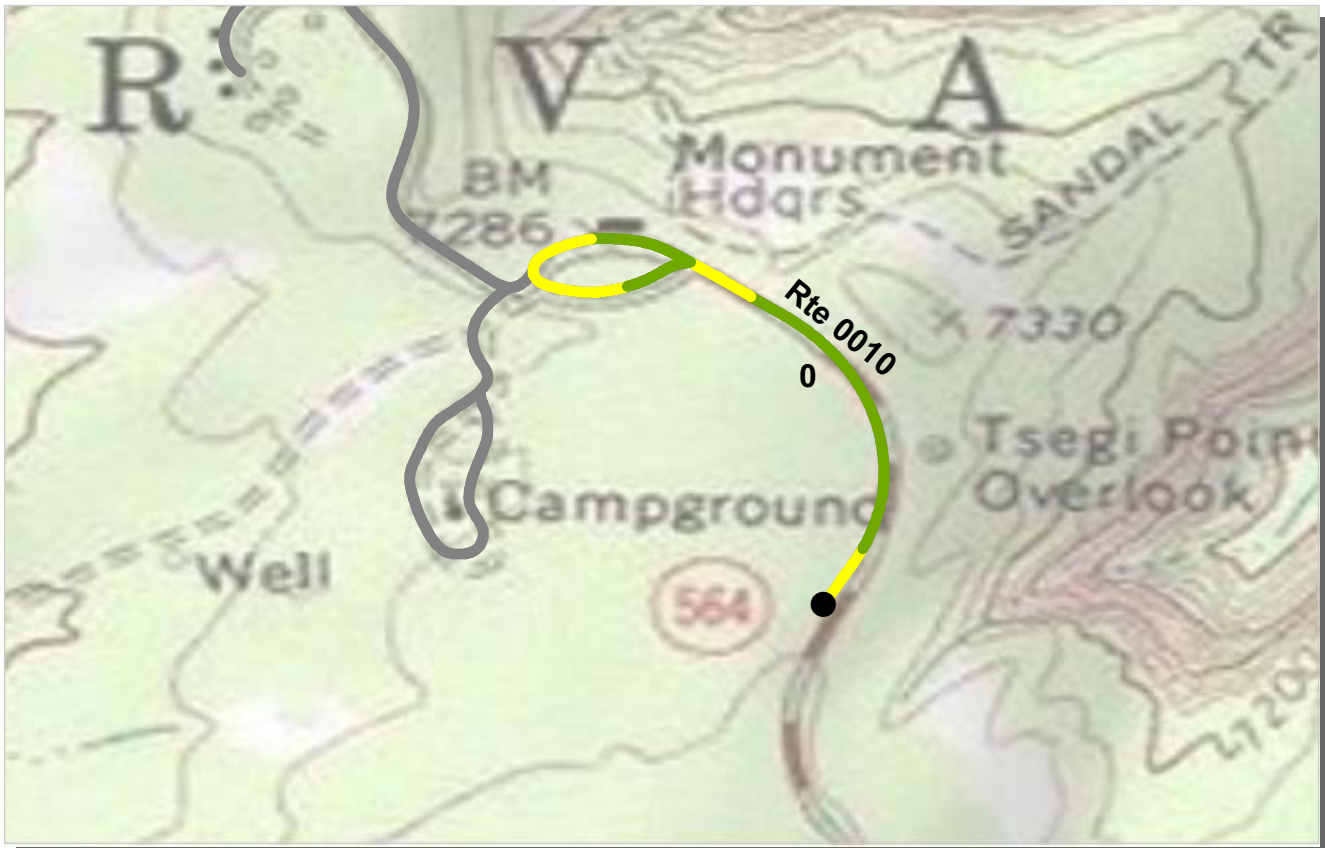
**ROUTE: 0010 MAIN PARK ROAD**

<b>Section Number</b>	0				
<b>Section Length (mi)</b>	0.46				
<b>Cross Section Information</b>					
Number of Lanes	2				
Paved Width (ft)	22				
Lane Width (ft)	13				
<b>Roadway Condition Information</b>					
SCR (Surface Condition Rating)	90				
PCR (Pavement Condition Rating)	90				
<b>Distress Index Values</b>					
Structural Crack Index	90				
Transverse Cracking Index	90				
Patching Index	100				
Rutting Index	95				
Roughness Condition Index (RCI)	NC

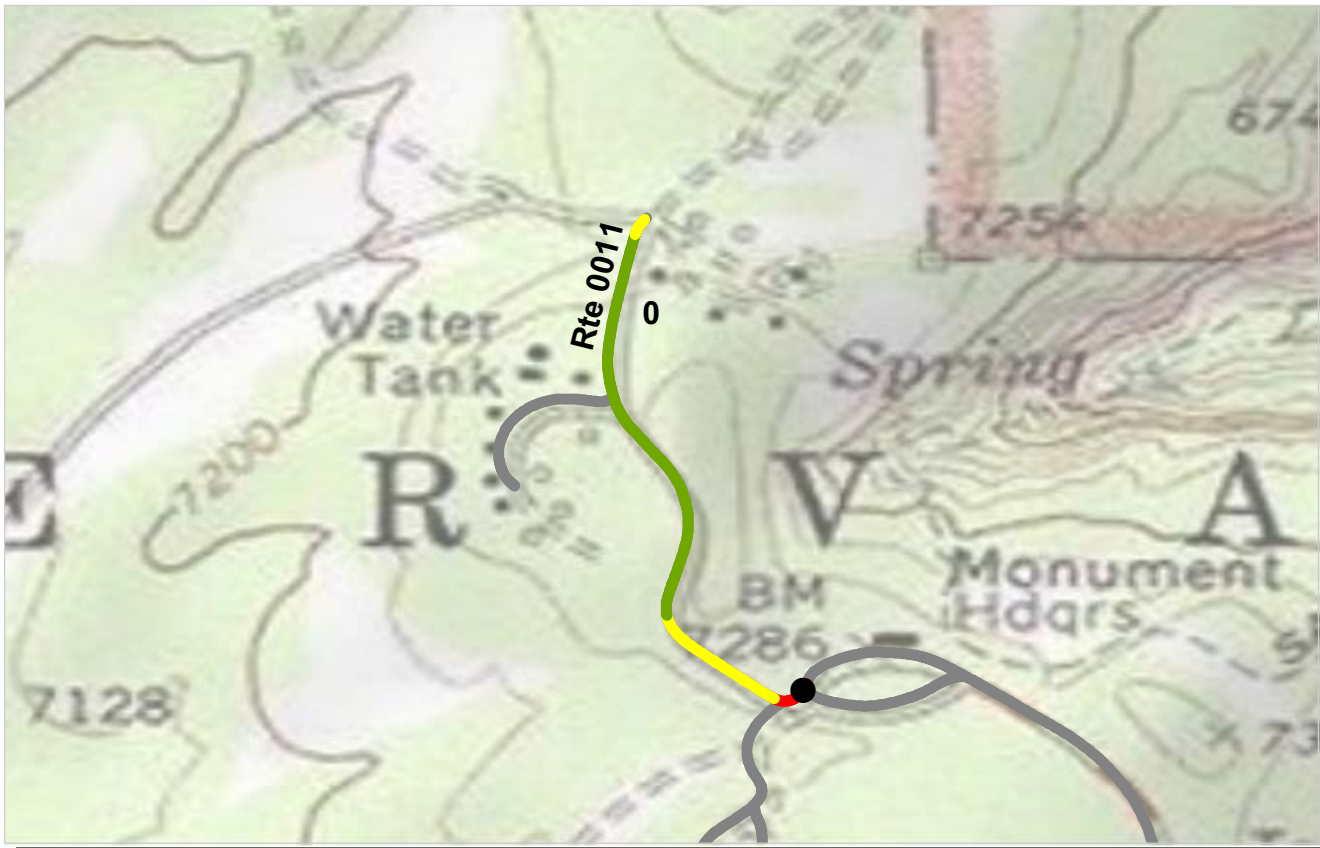
**ROUTE: 0011 NORTH MAIN PARK ROAD**

<b>Section Number</b>	0				
<b>Section Length (mi)</b>	0.38				
<b>Cross Section Information</b>					
Number of Lanes	2				
Paved Width (ft)	22				
Lane Width (ft)	9				
<b>Roadway Condition Information</b>					
SCR (Surface Condition Rating)	87				
PCR (Pavement Condition Rating)	87				
<b>Distress Index Values</b>					
Structural Crack Index	100				
Transverse Cracking Index	87				
Patching Index	99				
Rutting Index	97				
Roughness Condition Index (RCI)	NC

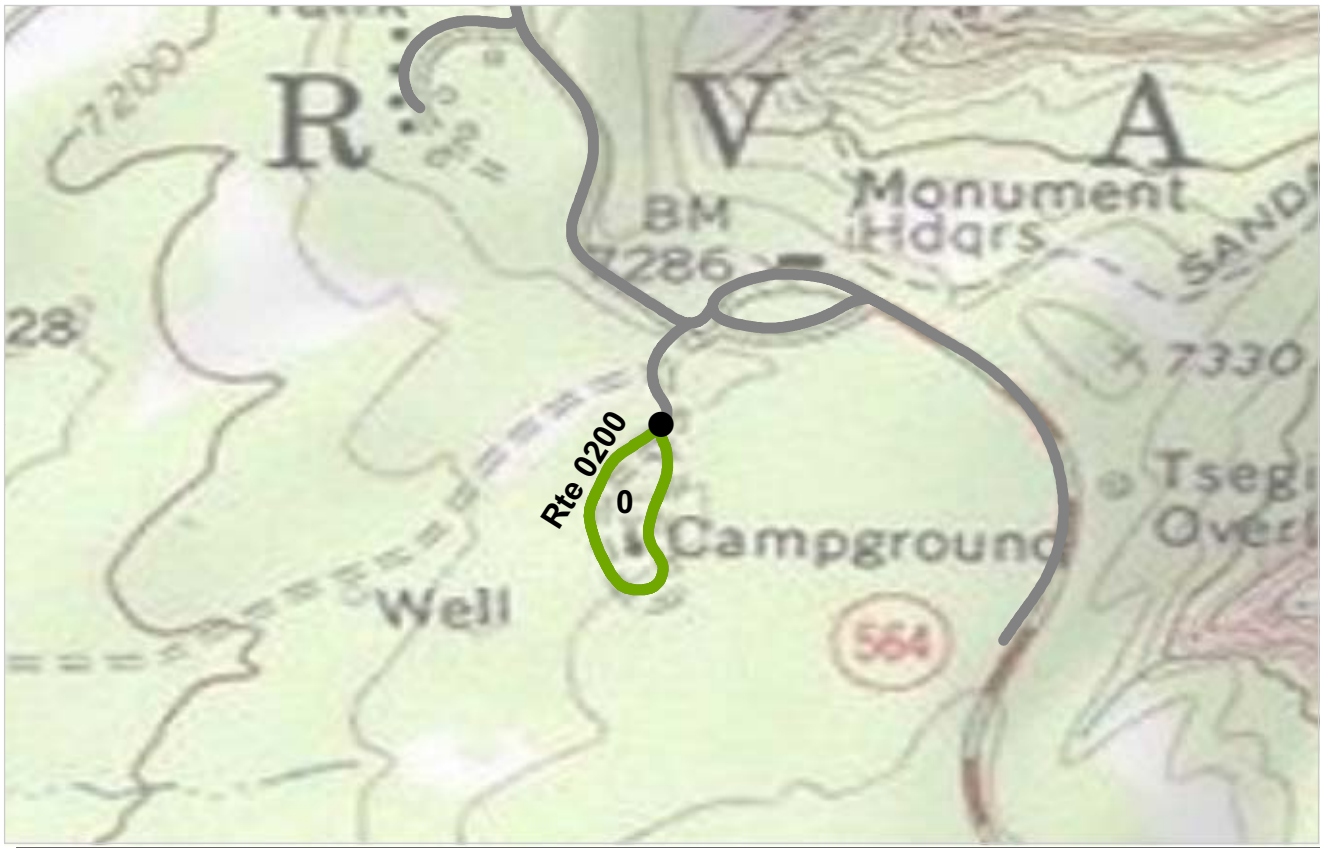
**ROUTE: 0200 SUNSET VIEW CG LOOP ROAD**

<b>Section Number</b>	0				
<b>Section Length (mi)</b>	0.25				
<b>Cross Section Information</b>					
Number of Lanes	1				
Paved Width (ft)	17				
Lane Width (ft)	17				
<b>Roadway Condition Information</b>					
SCR (Surface Condition Rating)	88				
PCR (Pavement Condition Rating)	88				
<b>Distress Index Values</b>					
Structural Crack Index	95				
Transverse Cracking Index	88				
Patching Index	100				
Rutting Index	95				
Roughness Condition Index (RCI)	NC

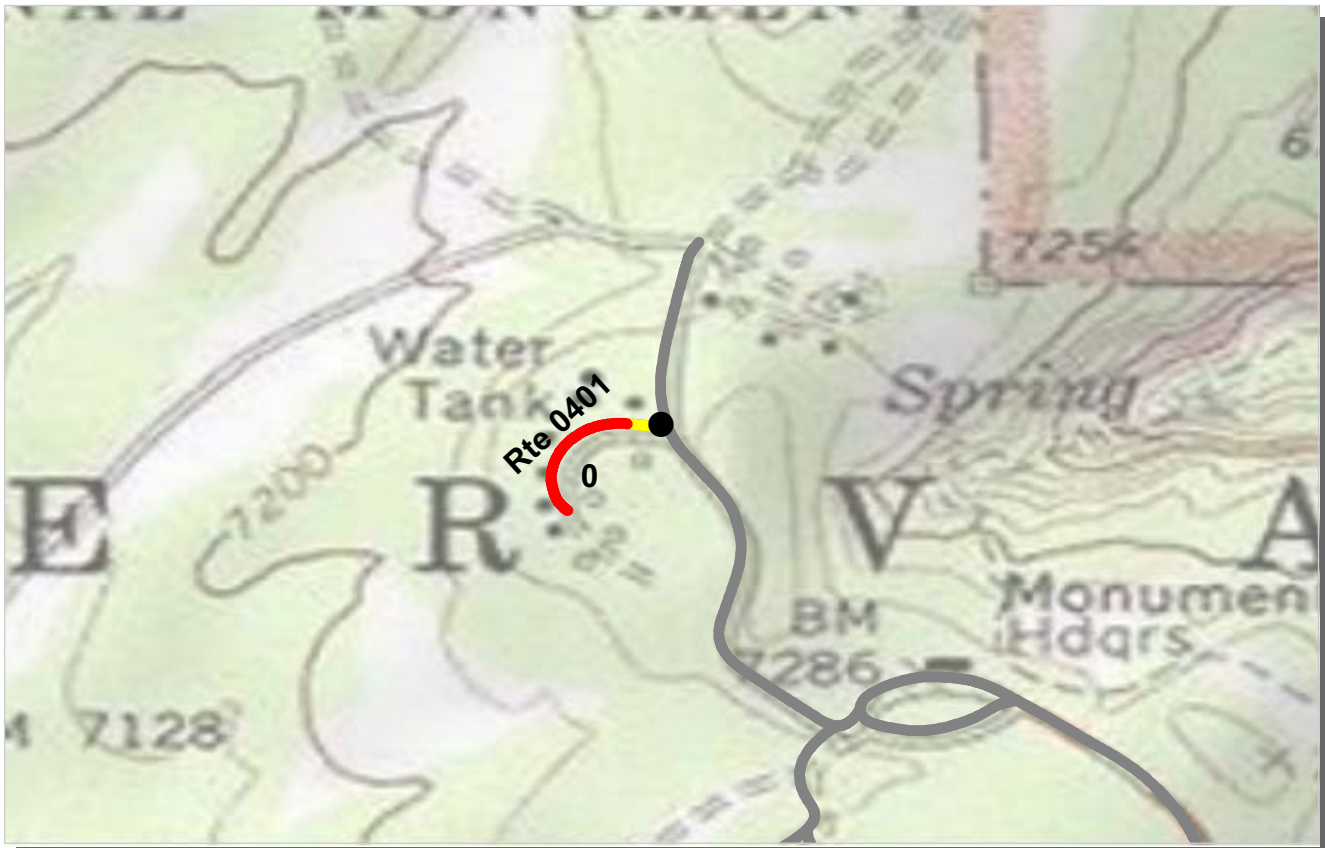
**ROUTE: 0401 ARROWHEAD WAY**

<b>Section Number</b>	0				
<b>Section Length (mi)</b>	0.10				
<b>Cross Section Information</b>					
Number of Lanes	2				
Paved Width (ft)	21				
Lane Width (ft)	8				
<b>Roadway Condition Information</b>					
SCR (Surface Condition Rating)	60				
PCR (Pavement Condition Rating)	60				
<b>Distress Index Values</b>					
Structural Crack Index	60				
Transverse Cracking Index	84				
Patching Index	99				
Rutting Index	95				
Roughness Condition Index (RCI)	NC

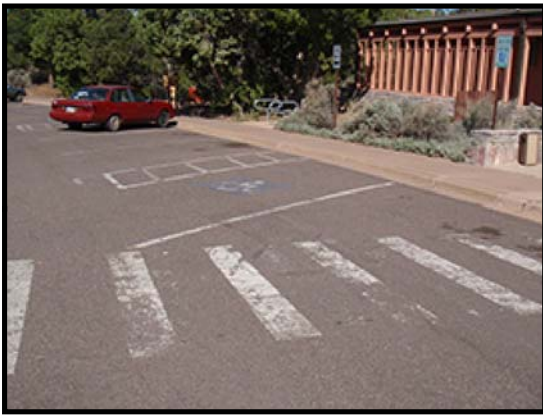
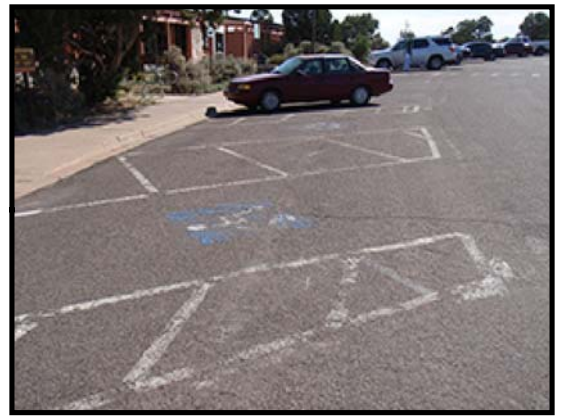
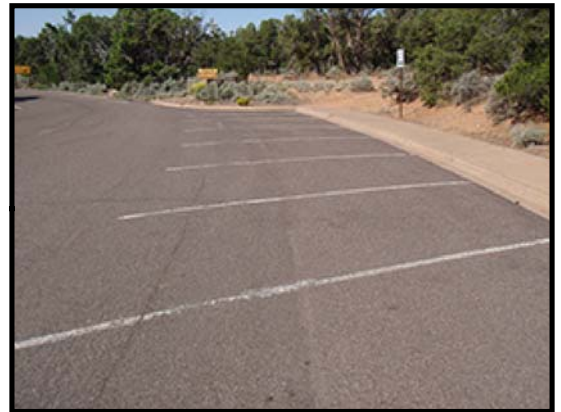
## Route 0900A

Route Number	Public / NonPublic	Date Visited	Area (sq ft)	Lane Miles *	Surface Type
0900A	PUBLIC	9/2/2011	7,587	0.13	AS
Culverts	Drop Inlets	Gates	Curb & Gutter	Curb	PCR
0	0	0	CONCRETE CURB AND GUTTER	NO CURB	FAIR/73

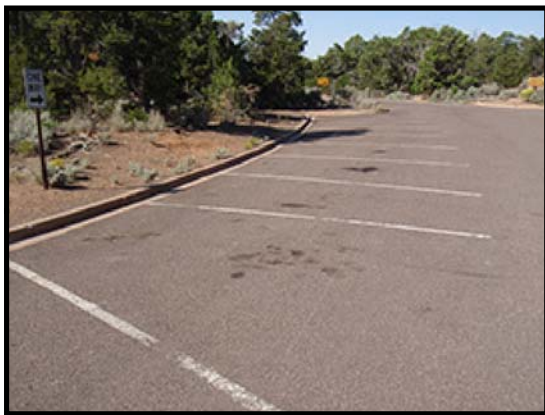
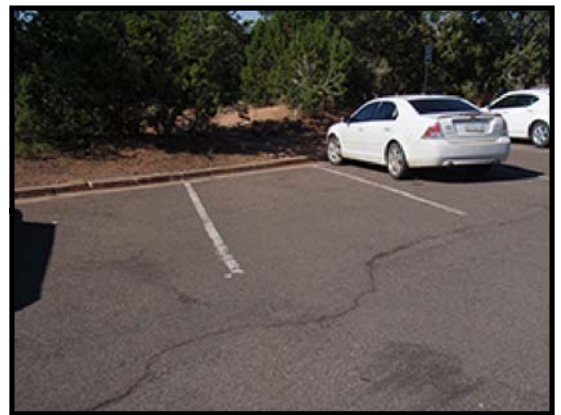
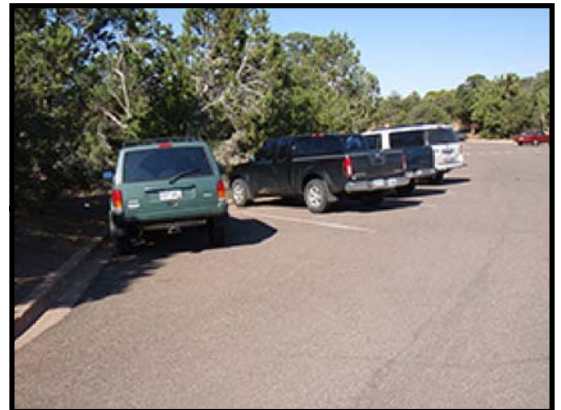
## Route 0900B

Route Number	Public / NonPublic	Date Visited	Area (sq ft)	Lane Miles *	Surface Type
0900B	PUBLIC	9/2/2011	6,216	0.11	AS
Culverts	Drop Inlets	Gates	Curb & Gutter	Curb	PCR
0	2	0	CONCRETE CURB AND GUTTER	NO CURB	FAIR/73

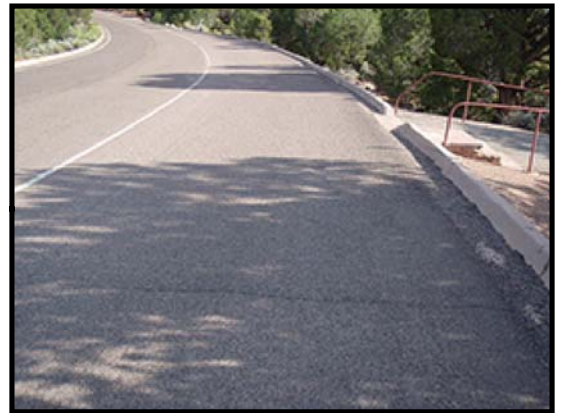
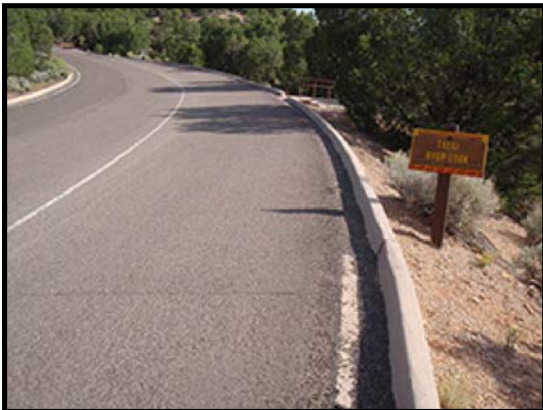
## Route 0901

Route Number	Public / NonPublic	Date Visited	Area (sq ft)	Lane Miles *	Surface Type
0901	PUBLIC	9/2/2011	4,333	0.08	AS
Culverts	Drop Inlets	Gates	Curb & Gutter	Curb	PCR
0	0	0	CONCRETE CURB AND GUTTER	NO CURB	GOOD/90

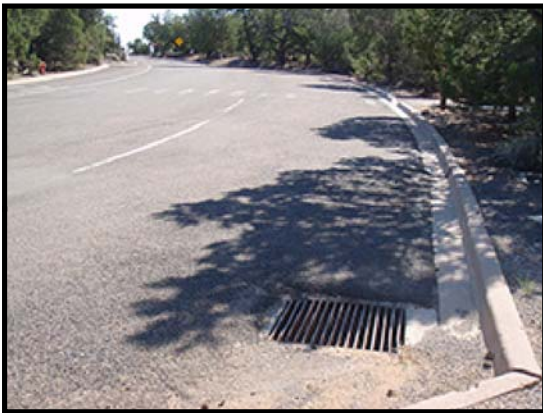
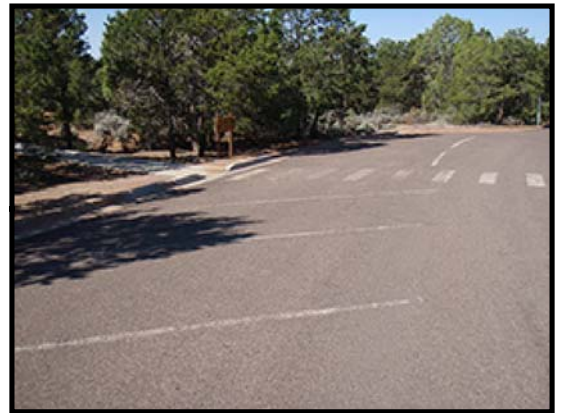
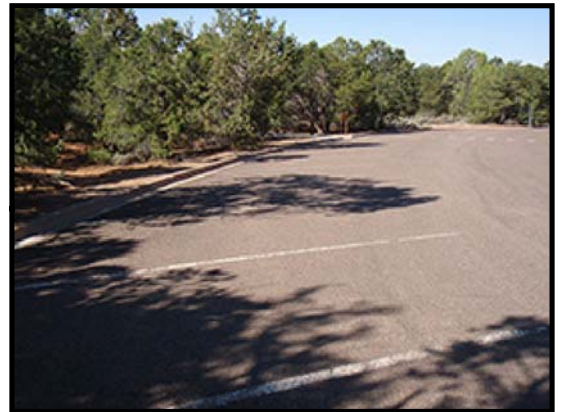
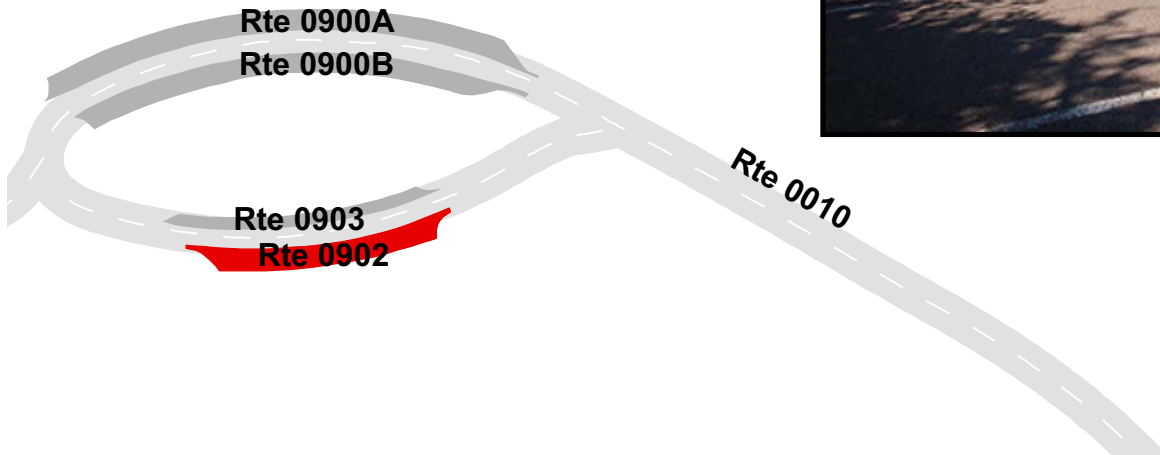
**NAVAJO NATIONAL MONUMENT**  
**Route 0902**  
**PICNIC AREA PARKING**  
 ADJACENT TO ROUTE 0010 (MAIN PARK ROAD) ON RIGHT

Route Number	Public / NonPublic	Date Visited	Area (sq ft)	Lane Miles *	Surface Type
0902	PUBLIC	9/2/2011	3,686	0.06	AS
Culverts	Drop Inlets	Gates	Curb & Gutter	Curb	PCR
0	1	0	CONCRETE CURB AND GUTTER	NO CURB	GOOD/90

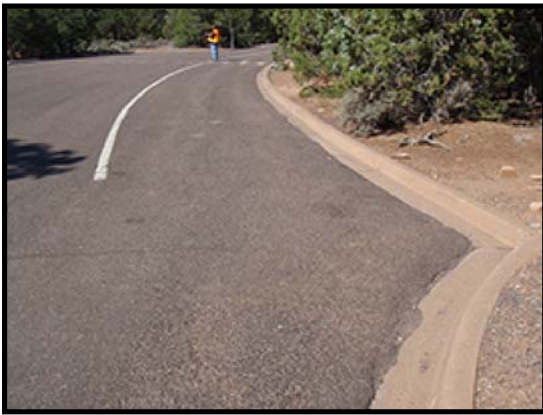
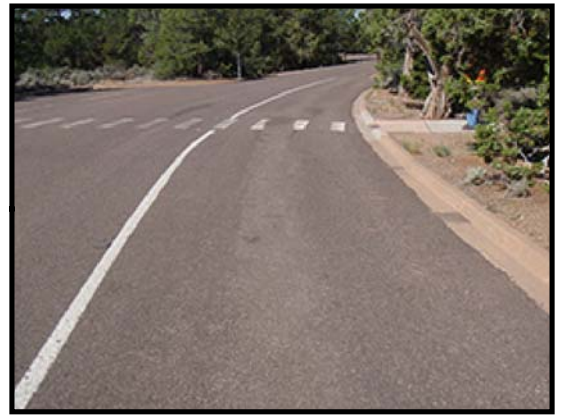
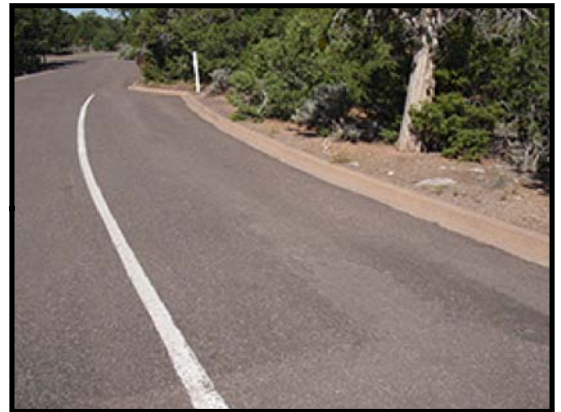
## Route 0903

Route Number	Public / NonPublic	Date Visited	Area (sq ft)	Lane Miles *	Surface Type
0903	PUBLIC	9/2/2011	2,253	0.04	AS
Culverts	Drop Inlets	Gates	Curb & Gutter	Curb	PCR
0	0	0	CONCRETE CURB AND GUTTER	NO CURB	GOOD/90

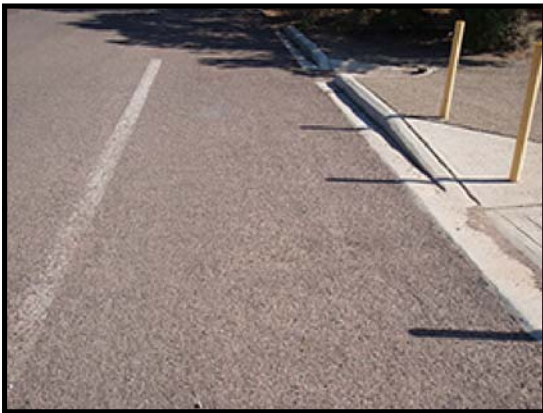
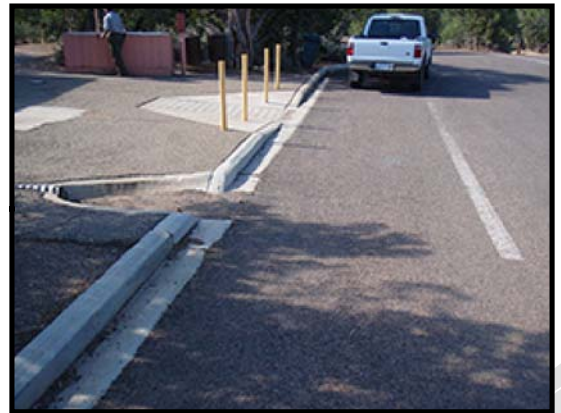
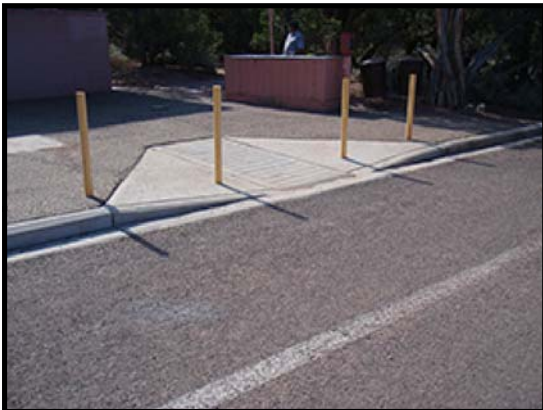
## Route 0905

Route Number	Public / NonPublic	Date Visited	Area (sq ft)	Lane Miles *	Surface Type
0905	PUBLIC	9/2/2011	791	0.01	AS
Culverts	Drop Inlets	Gates	Curb & Gutter	Curb	PCR
0	0	0	CONCRETE CURB AND GUTTER	NO CURB	GOOD/90

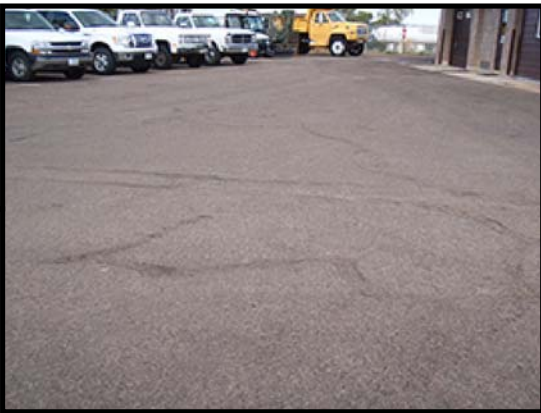
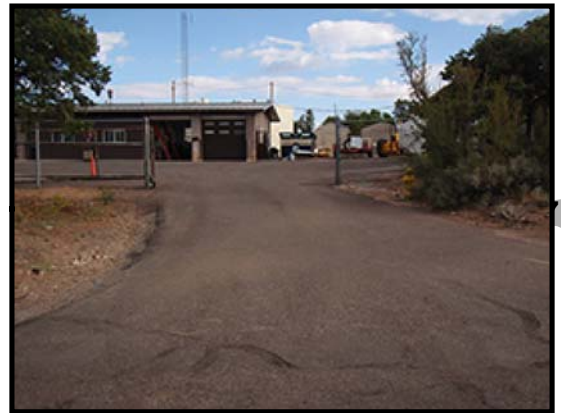
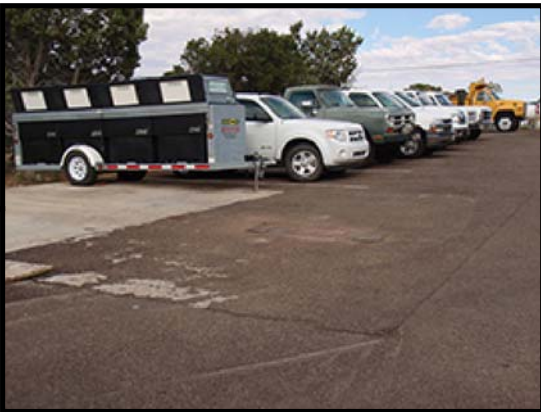
## Route 0906

Route Number	Public / NonPublic	Date Visited	Area (sq ft)	Lane Miles *	Surface Type
0906	NONPUBLIC	9/2/2011	11,902	0.21	AS
Culverts	Drop Inlets	Gates	Curb & Gutter	Curb	PCR
0	1	1	NO CURB AND GUTTER	NO CURB	FAIR/73

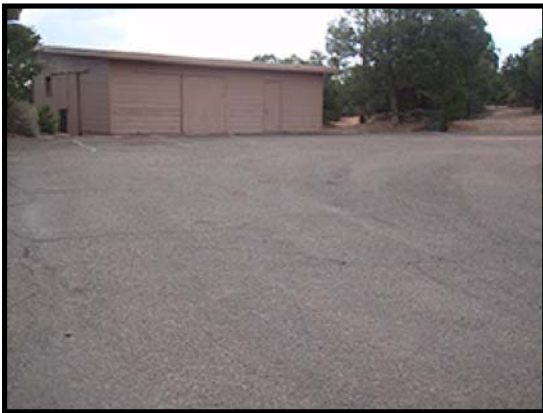
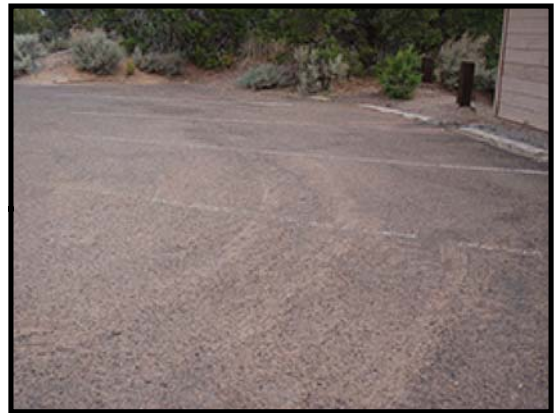
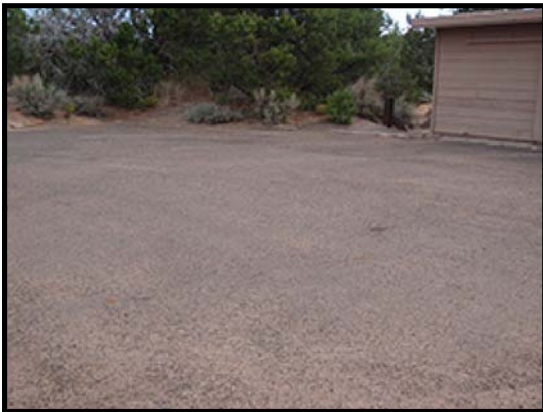
## Route 0907

Route Number	Public / NonPublic	Date Visited	Area (sq ft)	Lane Miles *	Surface Type
0907	PUBLIC	9/2/2011	3,284	0.06	AS
Culverts	Drop Inlets	Gates	Curb & Gutter	Curb	PCR
0	0	0	NO CURB AND GUTTER	NO CURB	FAIR/73

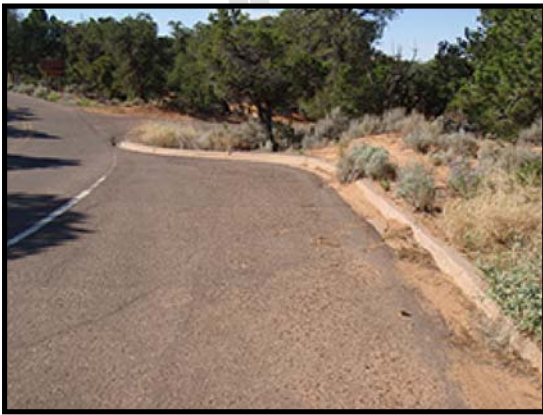
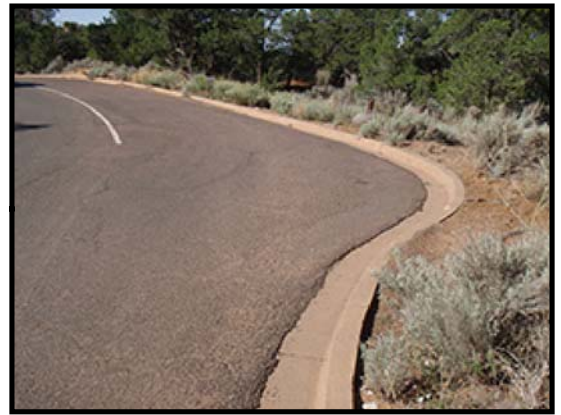
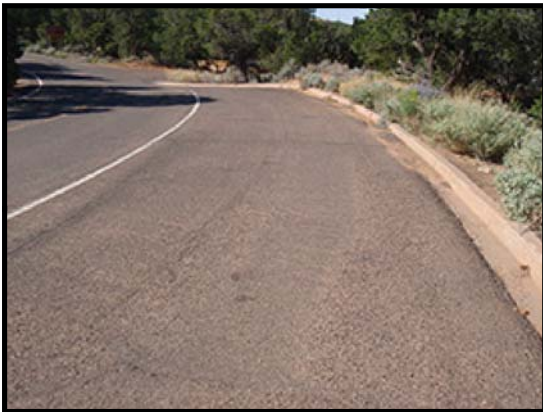
## Route 0909

Route Number	Public / NonPublic	Date Visited	Area (sq ft)	Lane Miles *	Surface Type
0909	PUBLIC	9/2/2011	1,499	0.03	AS
Culverts	Drop Inlets	Gates	Curb & Gutter	Curb	PCR
0	0	0	CONCRETE CURB AND GUTTER	NO CURB	GOOD/90

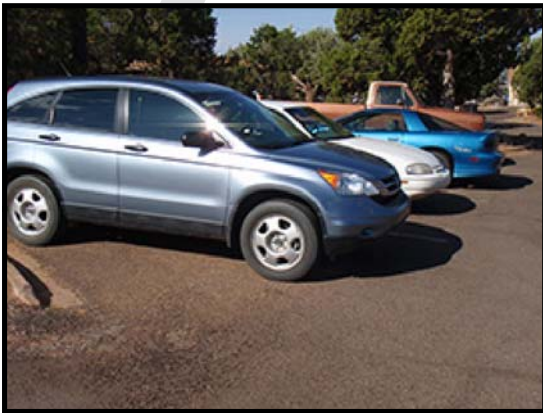
## Route 0910

Route Number	Public / NonPublic	Date Visited	Area (sq ft)	Lane Miles *	Surface Type
0910	PUBLIC	9/2/2011	1,561	0.03	AS
Culverts	Drop Inlets	Gates	Curb & Gutter	Curb	PCR
0	0	0	CONCRETE CURB AND GUTTER	NO CURB	FAIR/73
