Federal Lands Highway Road Inventory Program

Road Inventory and Condition Assessment

Nez Perce National Historical Park
NEPE - 9371

Cycle 5 Report

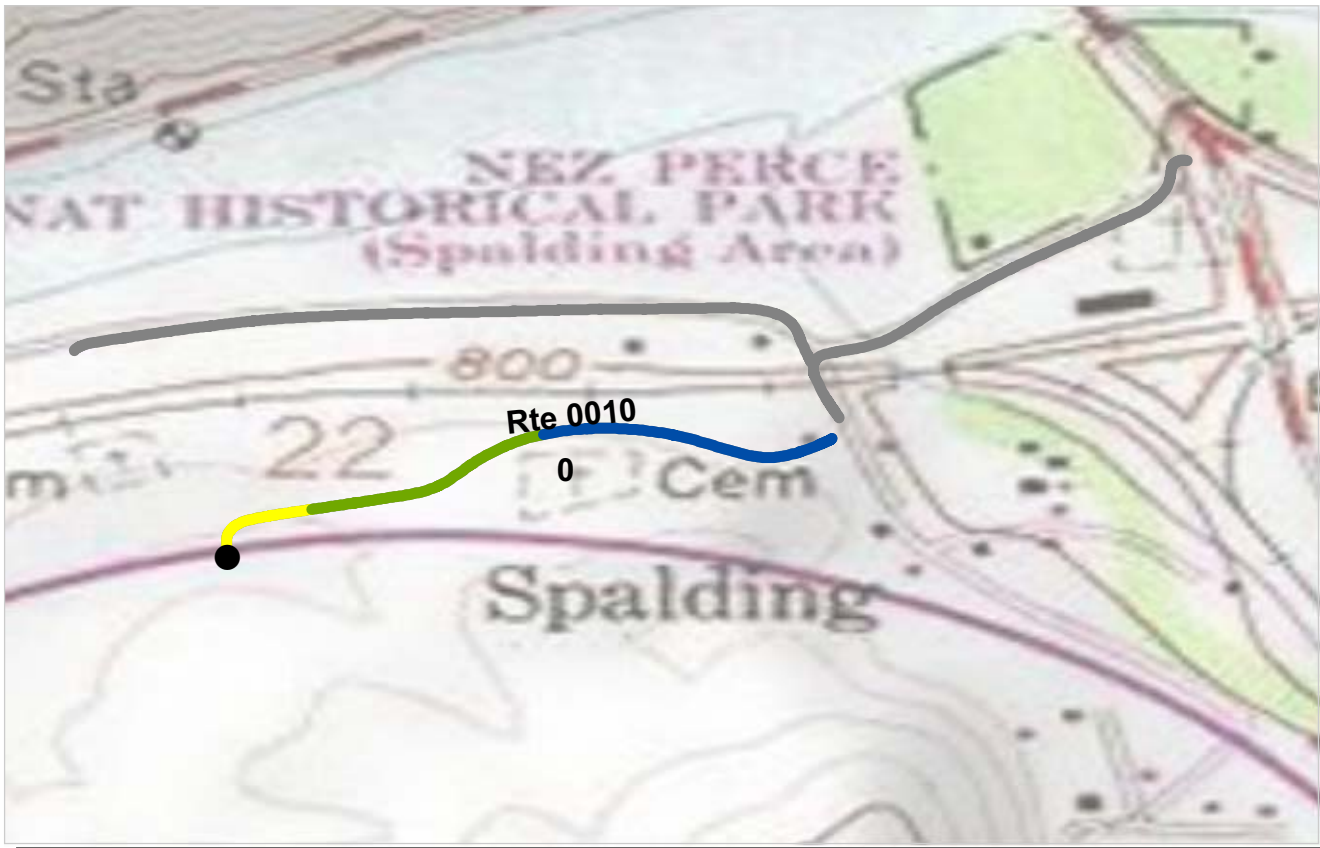
ROUTE: 0010 VISITOR CENTER ACCESS ROAD

Section Number	0				
Section Length (mi)	0.32				
Cross Section Information					
Number of Lanes	2				
Paved Width (ft)	24				
Lane Width (ft)	13				
Roadway Condition Information					
SCR (Surface Condition Rating)	94				
PCR (Pavement Condition Rating)	94				
Distress Index Values					
Structural Crack Index	97				
Transverse Cracking Index	94				
Patching Index	100				
Rutting Index	100				
Roughness Condition Index (RCI)	NC

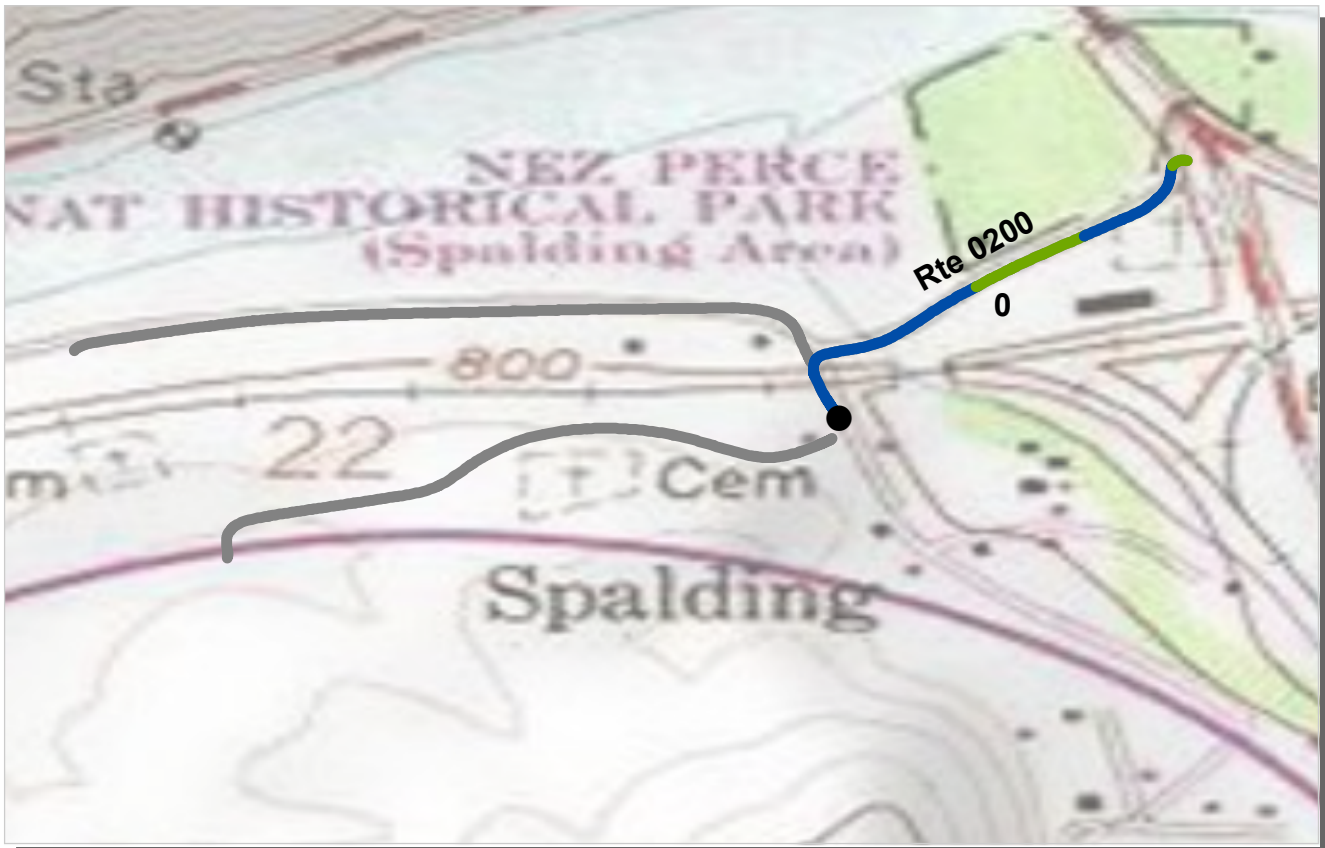
ROUTE: 0200 PICNIC SITE ACCESS ROAD

Section Number	0				
Section Length (mi)	0.29				
Cross Section Information					
Number of Lanes	2				
Paved Width (ft)	19				
Lane Width (ft)	9				
Roadway Condition Information					
SCR (Surface Condition Rating)	93				
PCR (Pavement Condition Rating)	93				
Distress Index Values					
Structural Crack Index	99				
Transverse Cracking Index	93				
Patching Index	100				
Rutting Index	98				
Roughness Condition Index (RCI)	NC

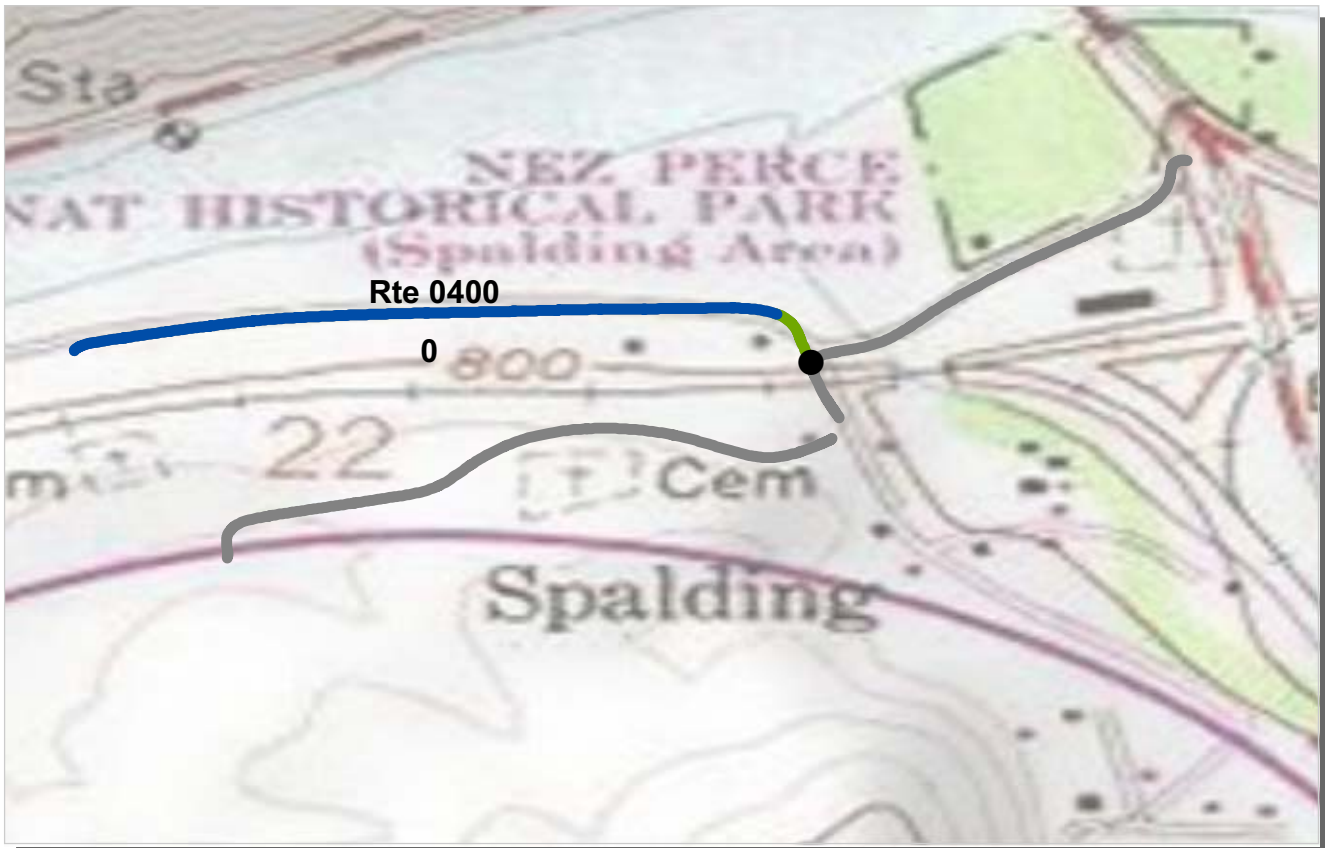
ROUTE: 0400 MAINTENANCE ACCESS ROAD

Section Number	0				
Section Length (mi)	0.36				
Cross Section Information					
Number of Lanes	2				
Paved Width (ft)	18				
Lane Width (ft)	9				
Roadway Condition Information					
SCR (Surface Condition Rating)	96				
PCR (Pavement Condition Rating)	96				
Distress Index Values					
Structural Crack Index	96				
Transverse Cracking Index	97				
Patching Index	100				
Rutting Index	99				
Roughness Condition Index (RCI)	NC

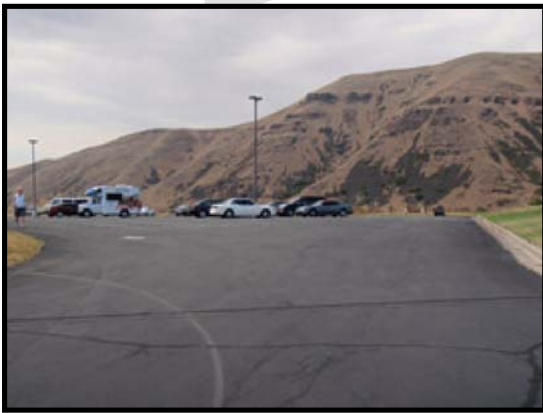
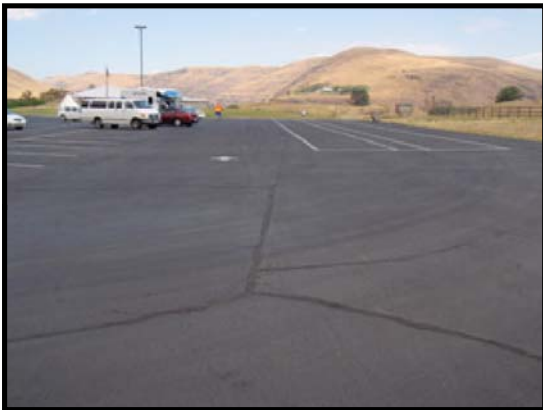
Route 0901

Route Number	Public / NonPublic	Date Visited	Area (sq ft)	Lane Miles *	Surface Type
0901	NONPUBLIC	8/18/2010	7,614	0.13	AS
Culverts	Drop Inlets	Gates	Curb & Gutter	Curb	PCR
0	0	0	CONCRETE CURB AND GUTTER	ASPHALT CURB	FAIR/73

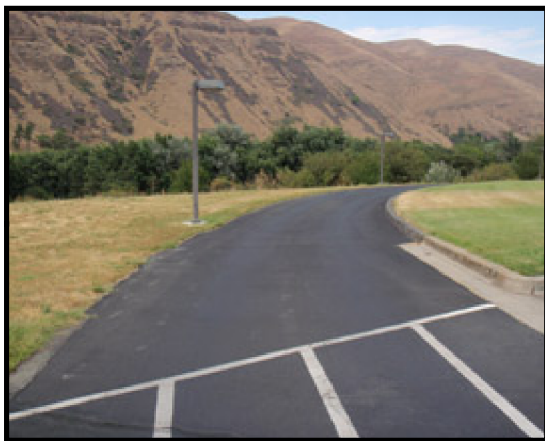
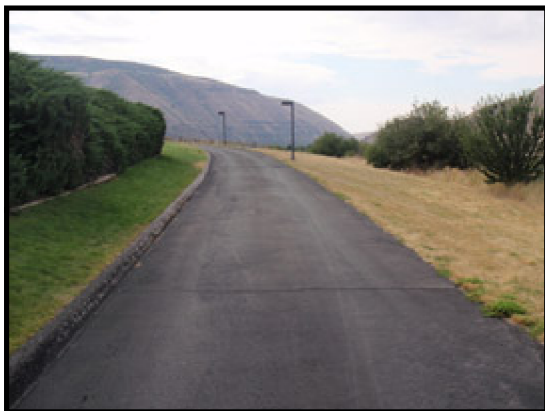
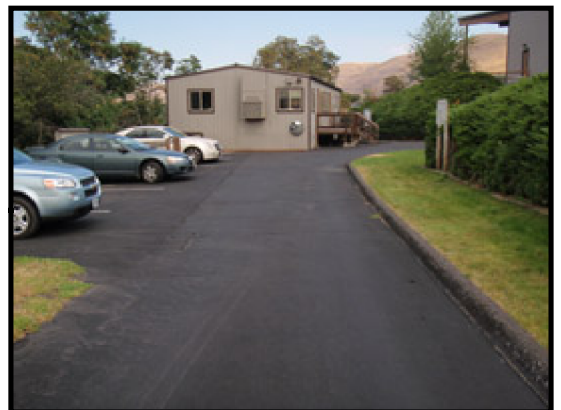
Route 0902

Route Number	Public / NonPublic	Date Visited	Area (sq ft)	Lane Miles *	Surface Type
0902	PUBLIC	8/18/2010	3,726	0.06	AS
Culverts	Drop Inlets	Gates	Curb & Gutter	Curb	PCR
0	0	0	NO CURB AND GUTTER	CONCRETE CURB	EXCELLENT/97

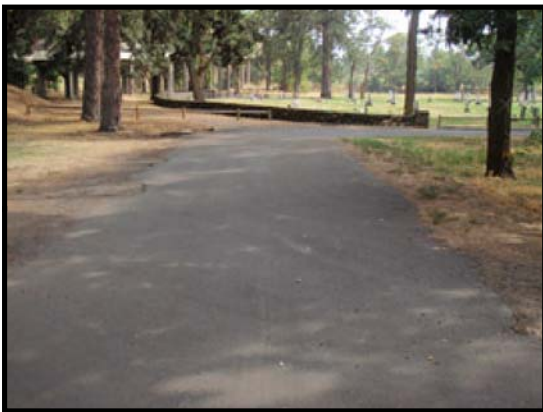
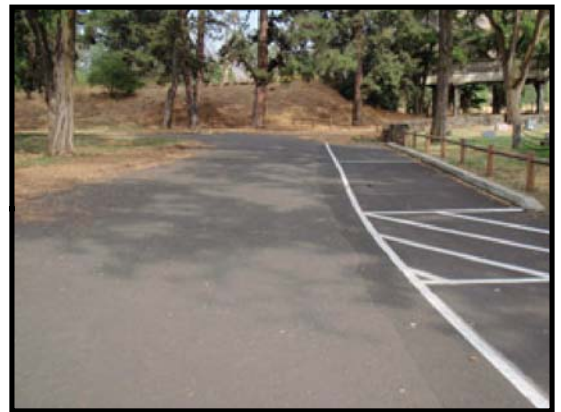
Route 0904A

Route Number	Public / NonPublic	Date Visited	Area (sq ft)	Lane Miles *	Surface Type
0904A	PUBLIC	8/18/2010	4,857	0.08	AS
Culverts	Drop Inlets	Gates	Curb & Gutter	Curb	PCR
0	0	0	NO CURB AND GUTTER	CONCRETE CURB	EXCELLENT/97

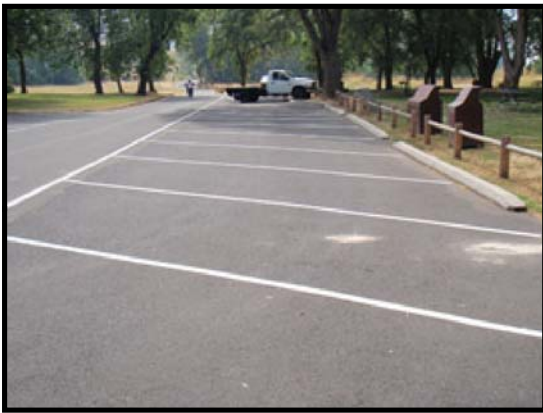
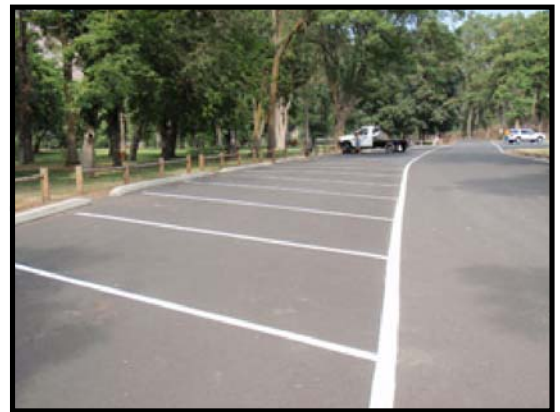
Route 0904B

Route Number	Public / NonPublic	Date Visited	Area (sq ft)	Lane Miles *	Surface Type
0904B	PUBLIC	8/18/2010	2,817	0.05	AS
Culverts	Drop Inlets	Gates	Curb & Gutter	Curb	PCR
0	0	0	NO CURB AND GUTTER	CONCRETE CURB	EXCELLENT/97

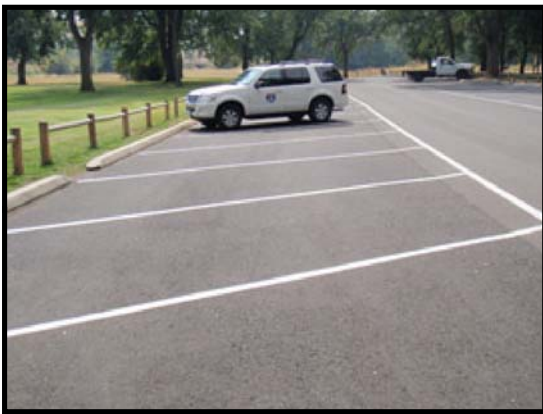
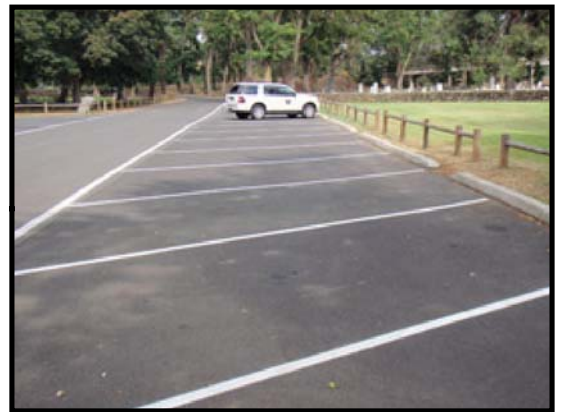
Route 0905

Route Number	Public / NonPublic	Date Visited	Area (sq ft)	Lane Miles *	Surface Type
0905	PUBLIC	8/18/2010	18,961	0.33	AS
Culverts	Drop Inlets	Gates	Curb & Gutter	Curb	PCR
0	0	0	NO CURB AND GUTTER	CONCRETE CURB	GOOD/90

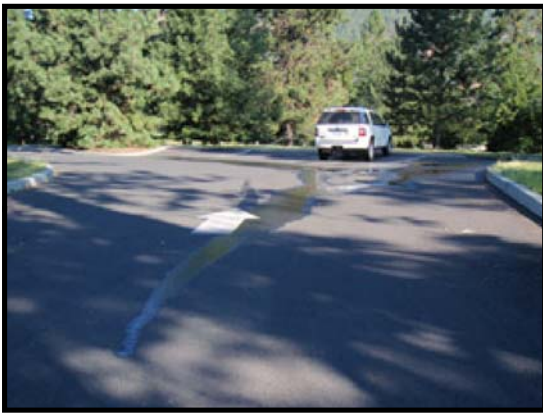
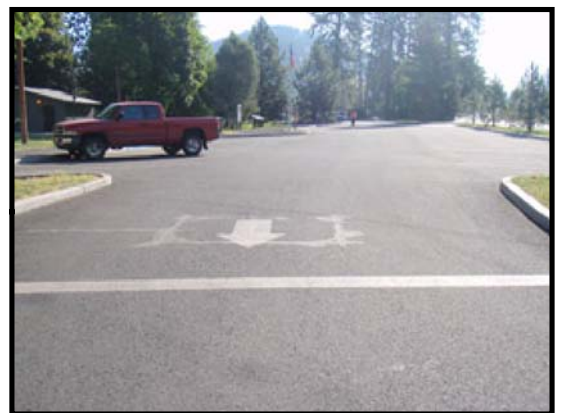
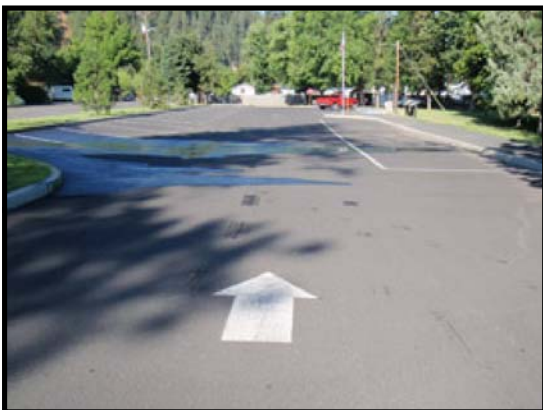
Route 0906

Route Number	Public / NonPublic	Date Visited	Area (sq ft)	Lane Miles *	Surface Type
0906	PUBLIC	8/18/2010	19,211	0.33	AS
Culverts	Drop Inlets	Gates	Curb & Gutter	Curb	PCR
0	0	1	NO CURB AND GUTTER	WOOD CURB	FAIR/73

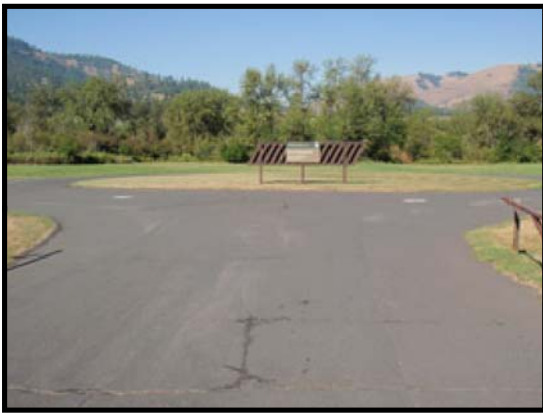
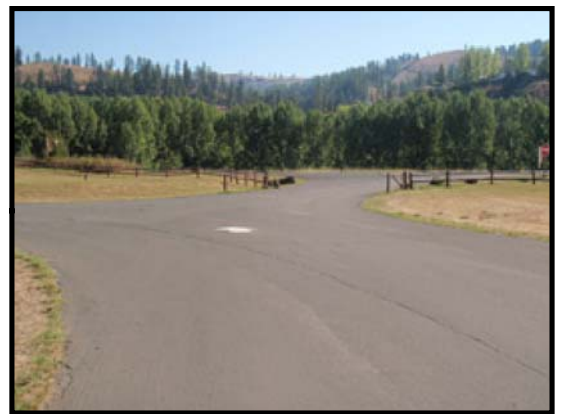
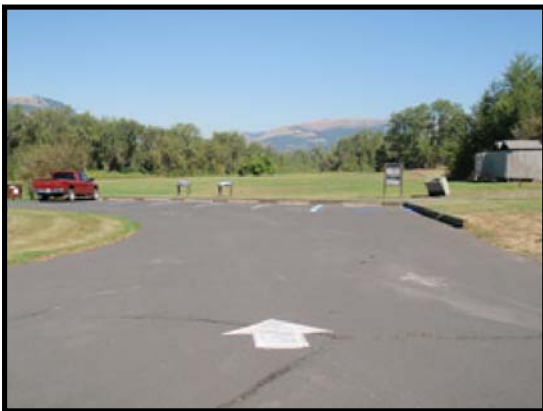
Route 0907

Route Number	Public / NonPublic	Date Visited	Area (sq ft)	Lane Miles *	Surface Type
0907	PUBLIC	8/18/2010	16,215	0.28	AS
Culverts	Drop Inlets	Gates	Curb & Gutter	Curb	PCR
2	0	0	NO CURB AND GUTTER	STONE CURB	GOOD/90
