Federal Lands Highway Road Inventory Program

Road Inventory and Condition Assessment

**New River Gorge National River
NERI**

Cycle 5 Report

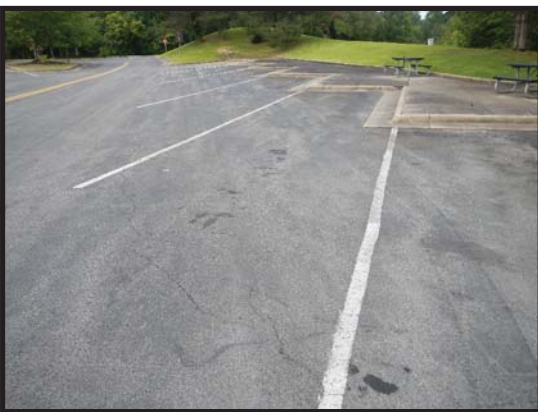
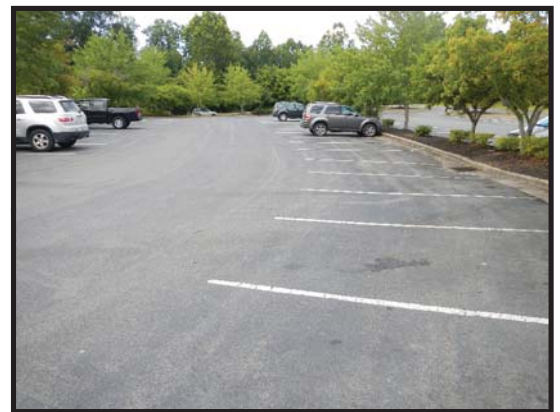
Route Number	Public / NonPublic	Date Visited	Area (sq ft)	Lane Miles *	Surface Type
0906	PUBLIC	8/6/2013	90,108	1.55	AS
Culverts	Drop Inlets	Gates	Curb & Gutter	Curb	PCR
0	11	0	CONCRETE CURB AND GUTTER	NO CURB	GOOD/90

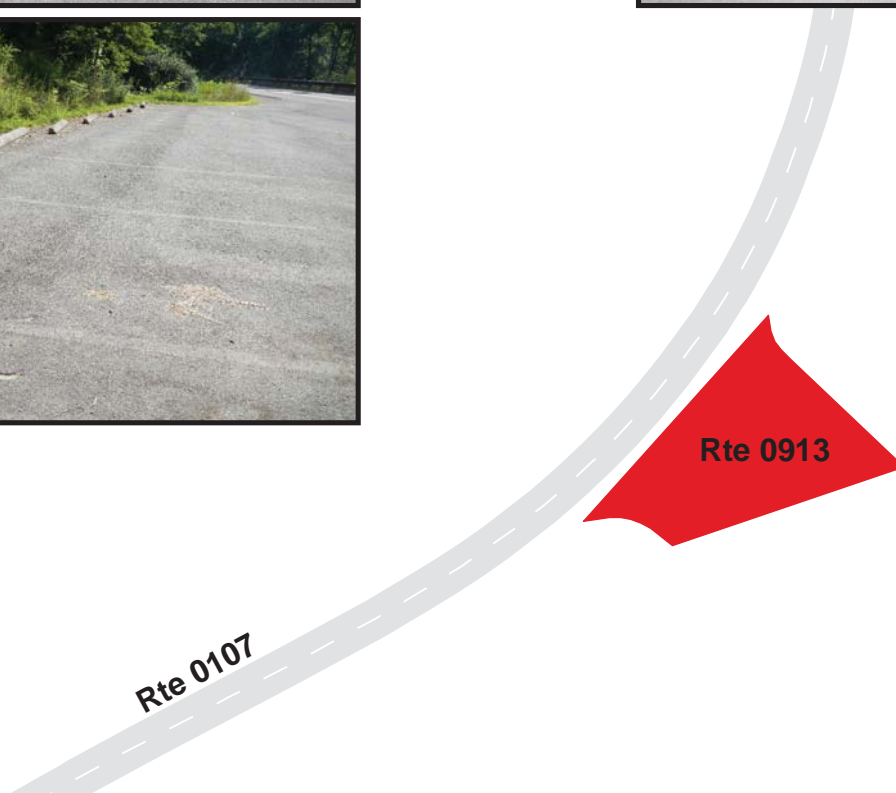
Route 0914ZZ

Route Number	Public / NonPublic	Date Visited	Area (sq ft)	Lane Miles *	Surface Type
0914ZZ	PUBLIC	8/6/2013	42,181	0.73	AS
Culverts	Drop Inlets	Gates	Curb & Gutter	Curb	PCR
1	2	1	CONCRETE CURB AND GUTTER	CONCRETE CURB	SUMMARY/90

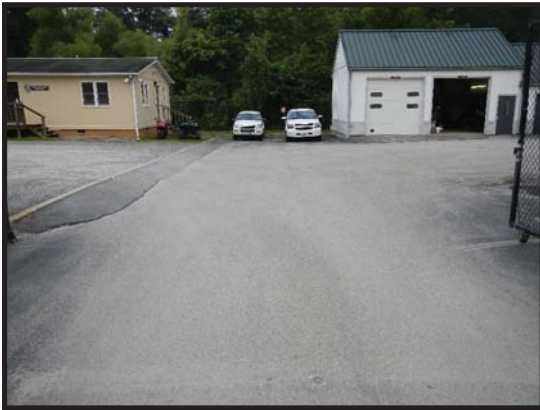
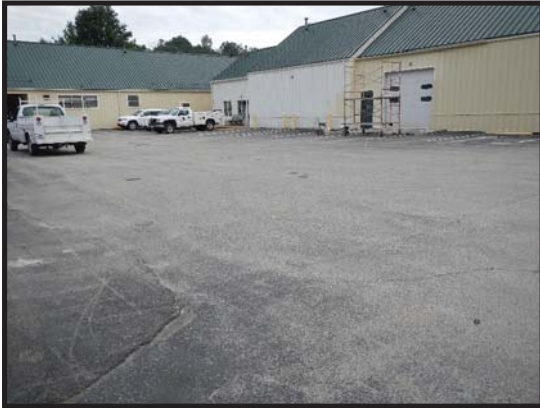
Route 0920Z

Route Number	Public / NonPublic	Date Visited	Area (sq ft)	Lane Miles *	Surface Type
0920Z	NONPUBLIC	8/6/2013	13,015	0.22	AS
Culverts	Drop Inlets	Gates	Curb & Gutter	Curb	PCR
0	2	1	CONCRETE CURB AND GUTTER	CONCRETE CURB	POOR/45

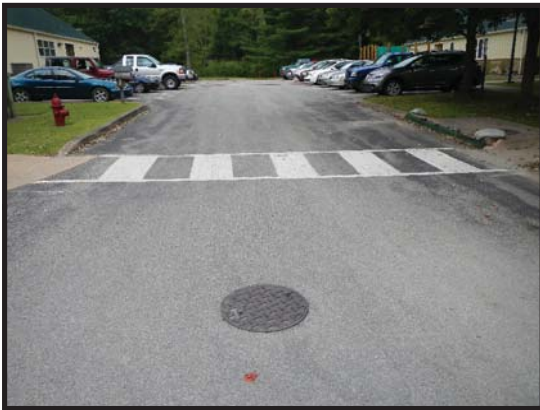
Route 0922Z

Route Number	Public / NonPublic	Date Visited	Area (sq ft)	Lane Miles *	Surface Type
0922Z	NONPUBLIC	8/6/2013	8,704	0.15	AS
Culverts	Drop Inlets	Gates	Curb & Gutter	Curb	PCR
0	1	0	CONCRETE CURB AND GUTTER	CONCRETE CURB	FAIR/73

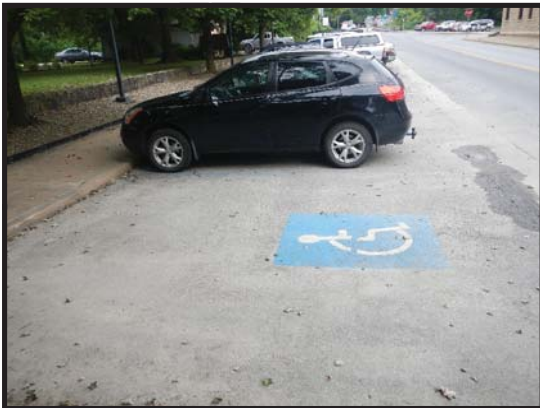
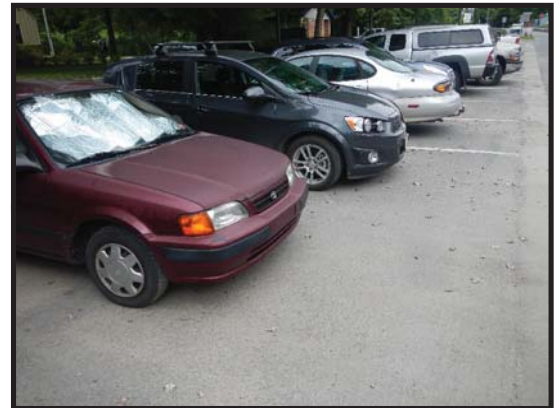
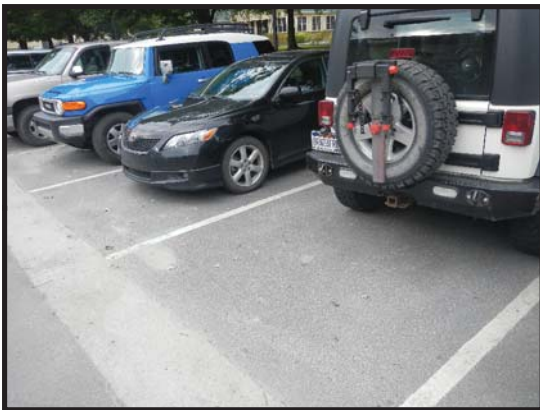
Route Number	Public / NonPublic	Date Visited	Area (sq ft)	Lane Miles *	Surface Type
0919AZ	PUBLIC	8/6/2013	1,852	0.03	AS
Culverts	Drop Inlets	Gates	Curb & Gutter	Curb	PCR
0	1	0	NO CURB AND GUTTER	CONCRETE CURB	GOOD/90

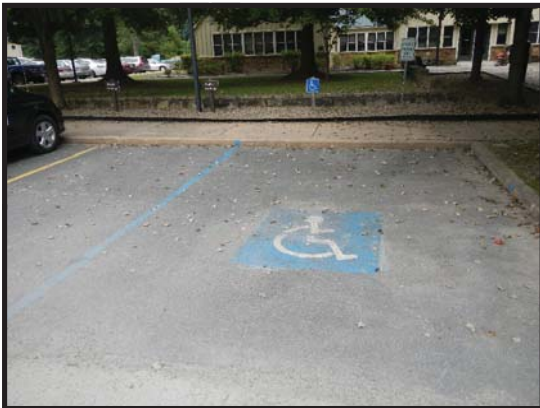
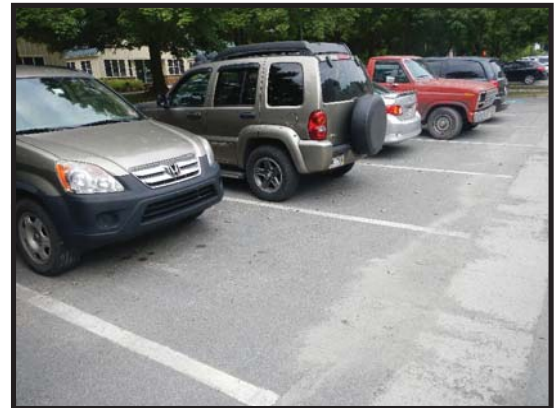
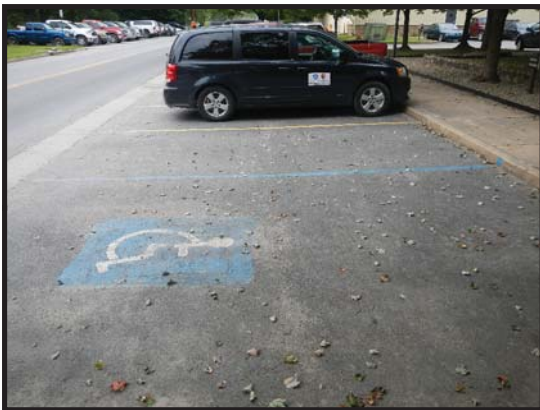
Route 0919BZ

Route Number	Public / NonPublic	Date Visited	Area (sq ft)	Lane Miles *	Surface Type
0919BZ	PUBLIC	8/6/2013	1,305	0.02	AS
Culverts	Drop Inlets	Gates	Curb & Gutter	Curb	PCR
0	0	0	NO CURB AND GUTTER	CONCRETE CURB	GOOD/90

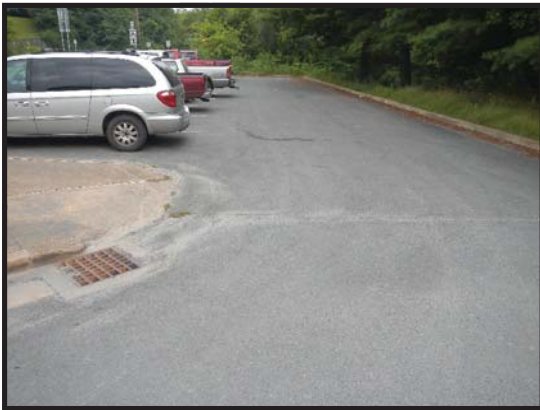
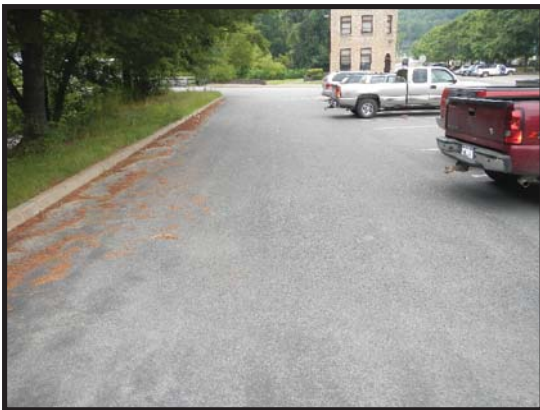
Route 0923Z

Route Number	Public / NonPublic	Date Visited	Area (sq ft)	Lane Miles *	Surface Type
0923Z	PUBLIC	8/6/2013	4,198	0.07	AS
Culverts	Drop Inlets	Gates	Curb & Gutter	Curb	PCR
0	1	0	CONCRETE CURB AND GUTTER	CONCRETE CURB	GOOD/90

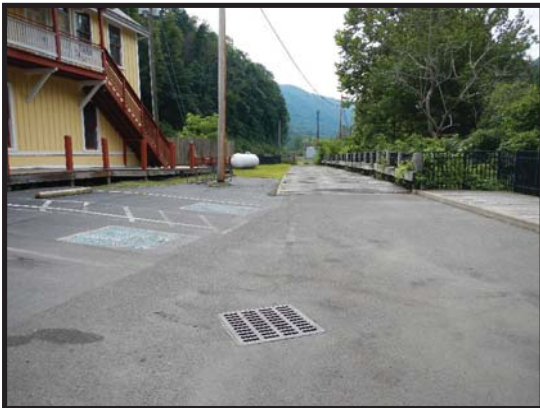
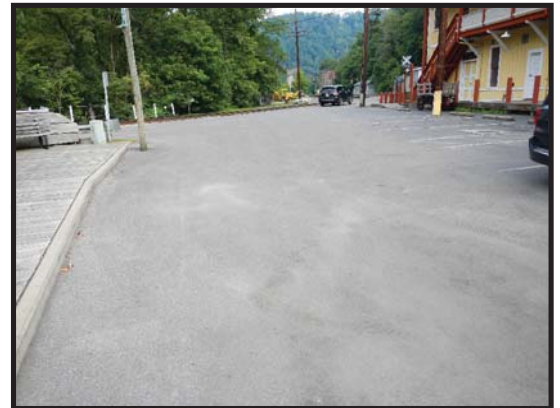
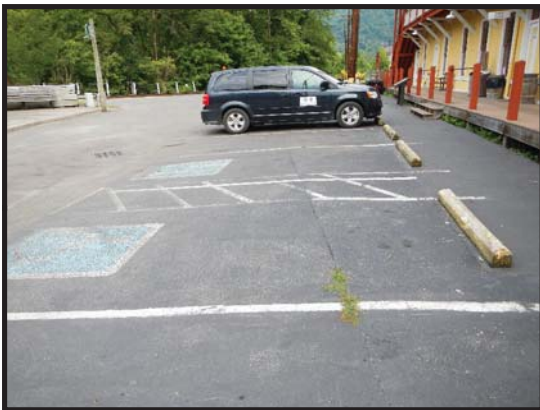
Route 0926

Route Number	Public / NonPublic	Date Visited	Area (sq ft)	Lane Miles *	Surface Type
0926	PUBLIC	8/6/2013	5,399	0.09	AS
Culverts	Drop Inlets	Gates	Curb & Gutter	Curb	PCR
0	2	0	NO CURB AND GUTTER	CONCRETE & WOOD CURB	FAIR/73

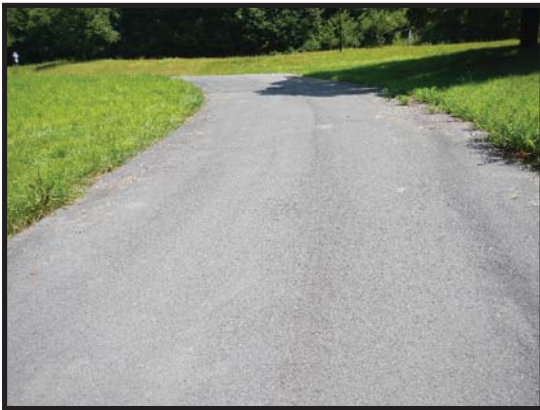
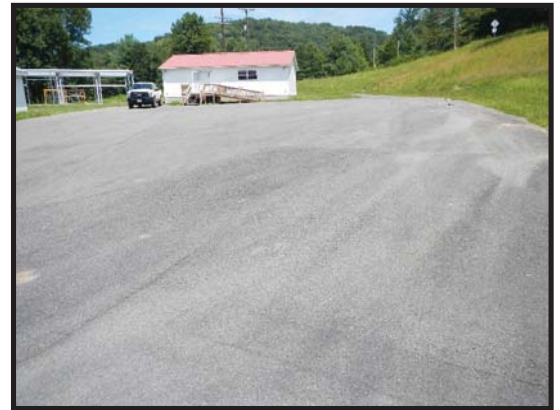
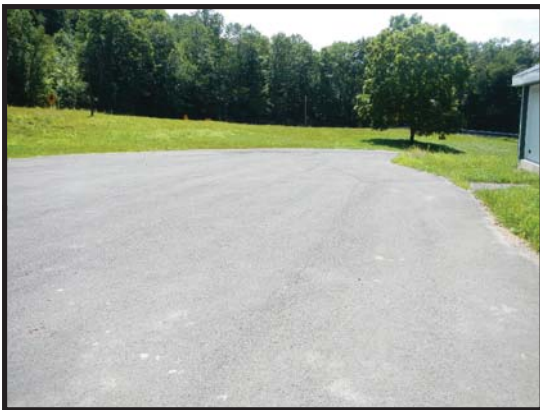
Route 0947

Route Number	Public / NonPublic	Date Visited	Area (sq ft)	Lane Miles *	Surface Type
0947	NONPUBLIC	8/6/2013	14,485	0.25	AS
Culverts	Drop Inlets	Gates	Curb & Gutter	Curb	PCR
1	0	1	NO CURB AND GUTTER	NO CURB	GOOD/90

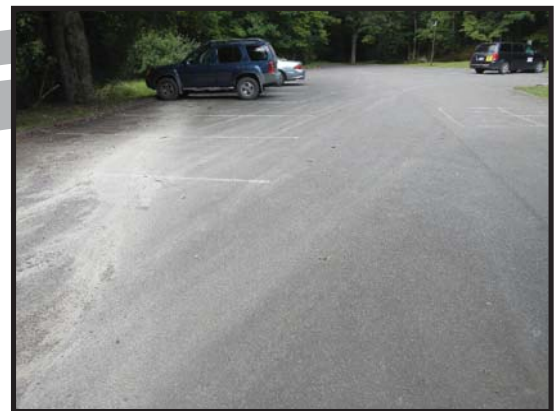
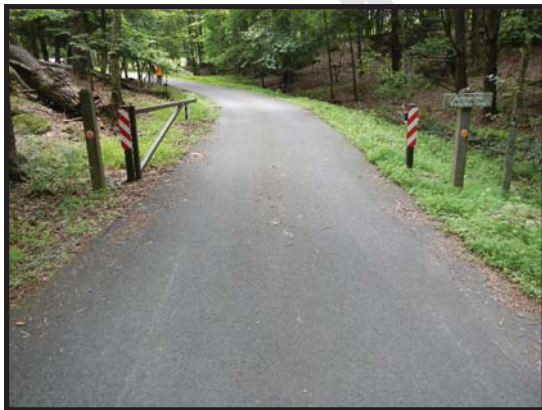
Route Number	Public / NonPublic	Date Visited	Area (sq ft)	Lane Miles *	Surface Type
0958	NONPUBLIC	8/6/2013	11,540	0.20	AS
Culverts	Drop Inlets	Gates	Curb & Gutter	Curb	PCR
2	0	1	NO CURB AND GUTTER	ASPHALT CURB	GOOD/90

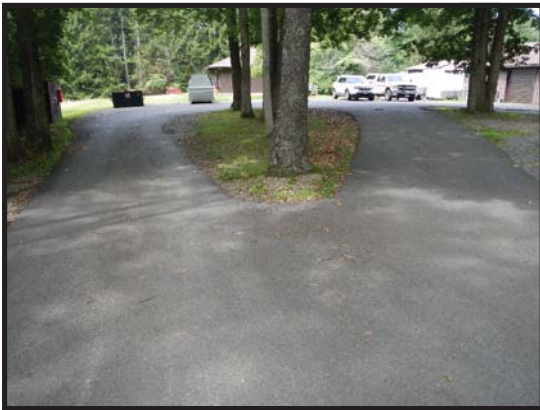
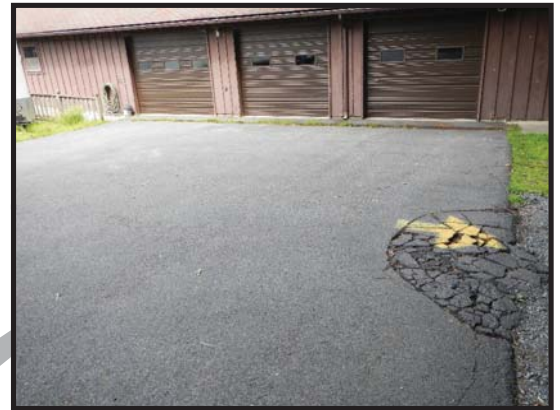
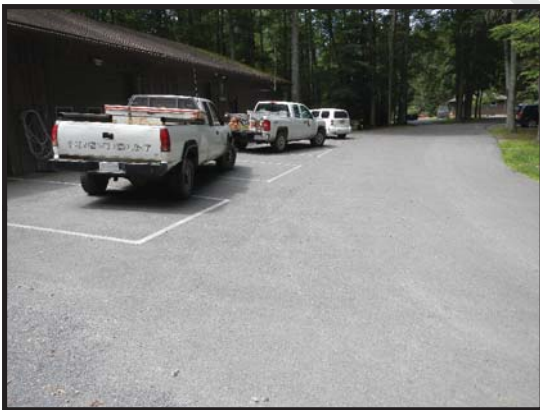
Route 0959

Route Number	Public / NonPublic	Date Visited	Area (sq ft)	Lane Miles *	Surface Type
0959	NONPUBLIC	8/6/2013	8,915	0.15	AS
Culverts	Drop Inlets	Gates	Curb & Gutter	Curb	PCR
0	1	1	NO CURB AND GUTTER	NO CURB	GOOD/90

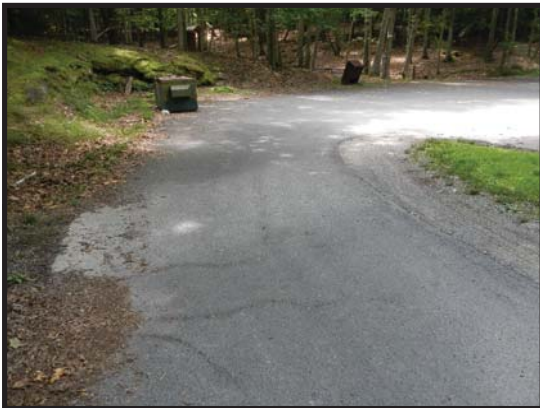
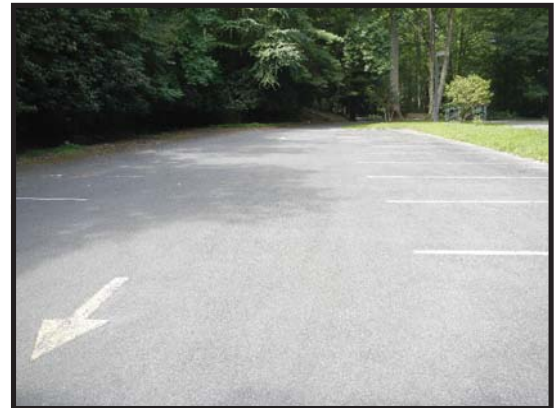
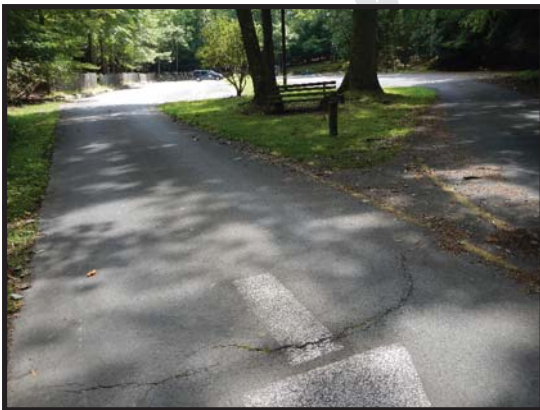
Route 0961

Route Number	Public / NonPublic	Date Visited	Area (sq ft)	Lane Miles *	Surface Type
0961	PUBLIC	8/6/2013	23,853	0.41	AS
Culverts	Drop Inlets	Gates	Curb & Gutter	Curb	PCR
3	2	0	NO CURB AND GUTTER	WOOD CURB	GOOD/90

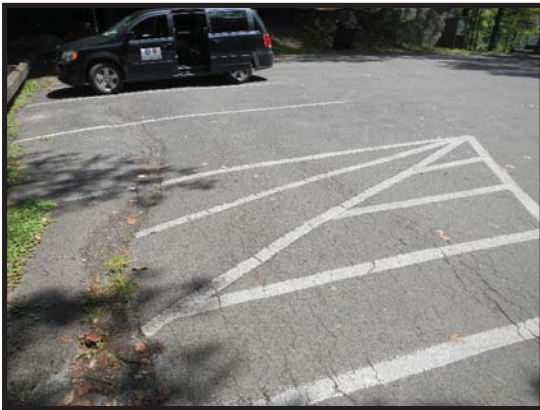
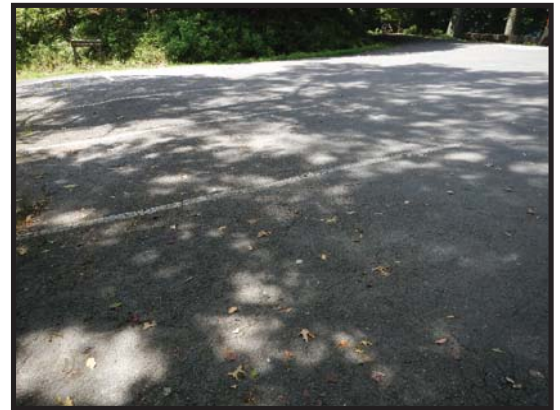
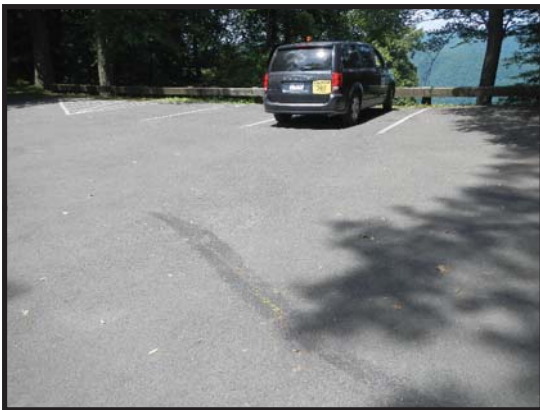
Route 0962

Route Number	Public / NonPublic	Date Visited	Area (sq ft)	Lane Miles *	Surface Type
0962	PUBLIC	8/6/2013	3,845	0.07	AS
Culverts	Drop Inlets	Gates	Curb & Gutter	Curb	PCR
0	0	0	NO CURB AND GUTTER	NO CURB	FAIR/73

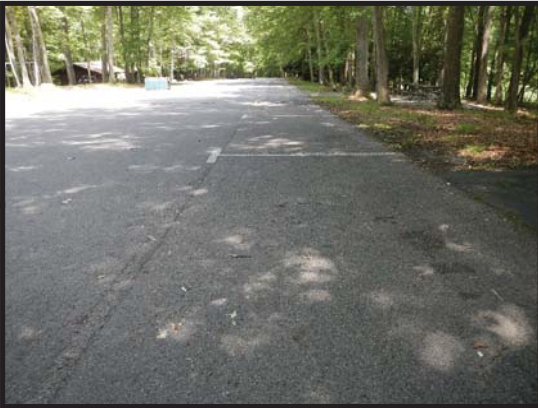
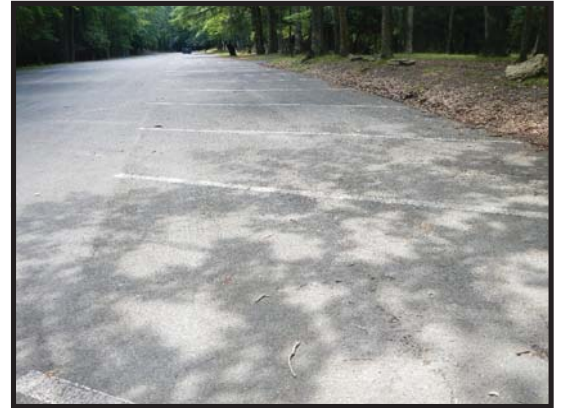
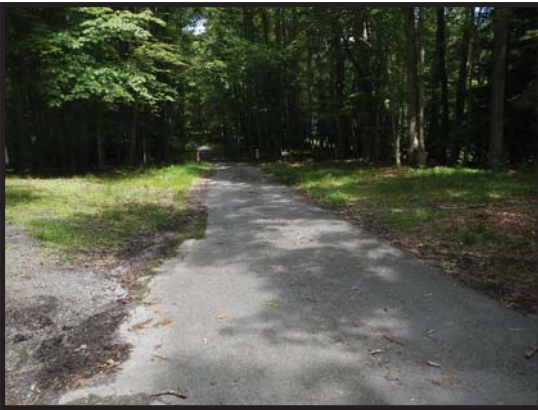
Route 0963

Route Number	Public / NonPublic	Date Visited	Area (sq ft)	Lane Miles *	Surface Type
0963	PUBLIC	8/6/2013	30,399	0.52	AS
Culverts	Drop Inlets	Gates	Curb & Gutter	Curb	PCR
1	0	1	NO CURB AND GUTTER	NO CURB	FAIR/73

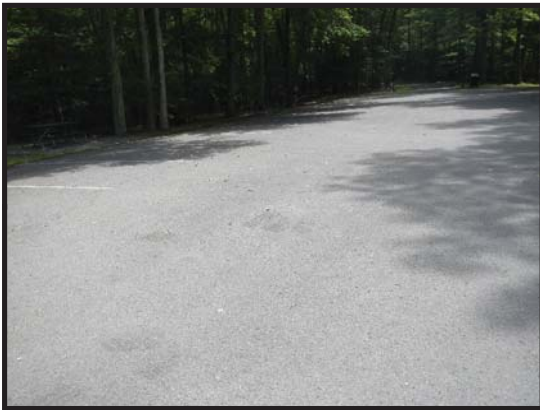
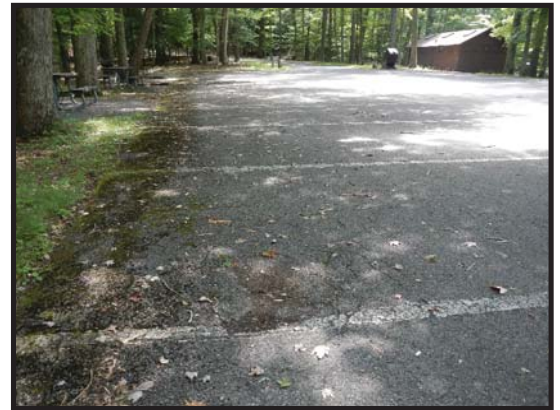
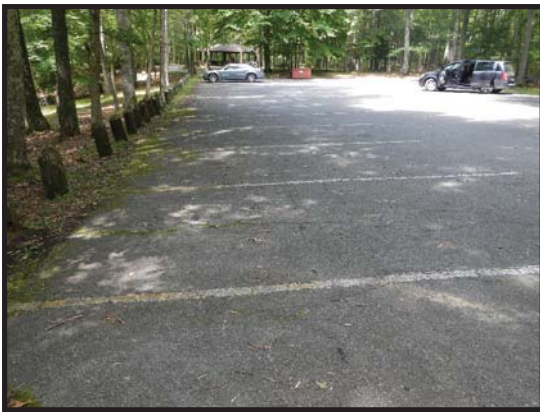
Route 0964

Route Number	Public / NonPublic	Date Visited	Area (sq ft)	Lane Miles *	Surface Type
0964	PUBLIC	8/6/2013	17,167	0.30	AS
Culverts	Drop Inlets	Gates	Curb & Gutter	Curb	PCR
0	0	0	NO CURB AND GUTTER	NO CURB	FAIR/73

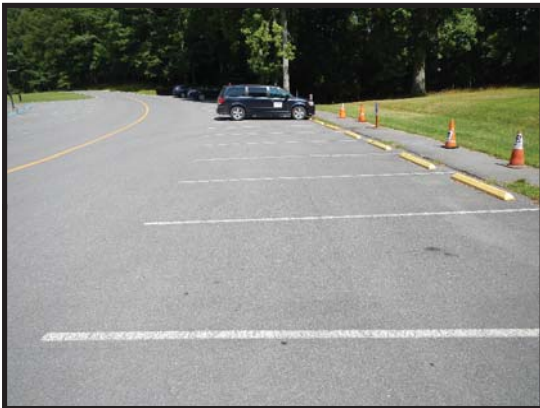
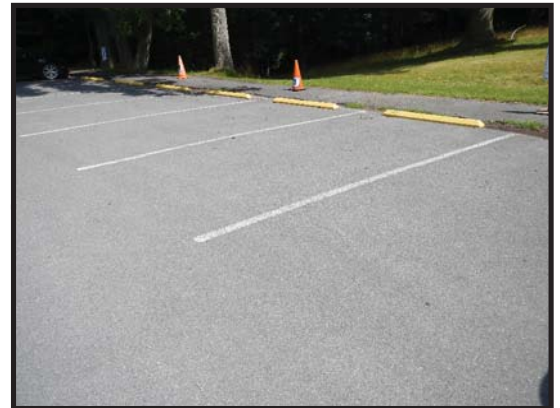
Route Number	Public / NonPublic	Date Visited	Area (sq ft)	Lane Miles *	Surface Type
0965AZ	PUBLIC	8/6/2013	3,900	0.07	AS
Culverts	Drop Inlets	Gates	Curb & Gutter	Curb	PCR
0	0	0	NO CURB AND GUTTER	NO CURB	GOOD/90

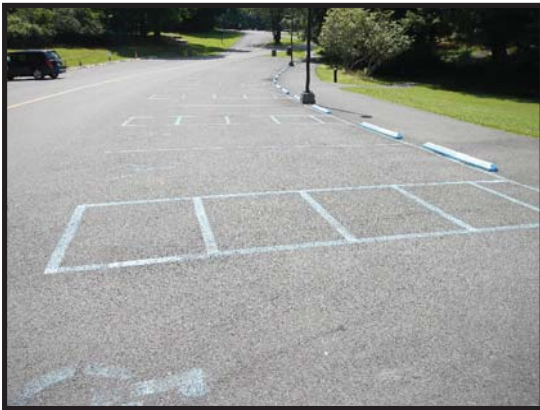
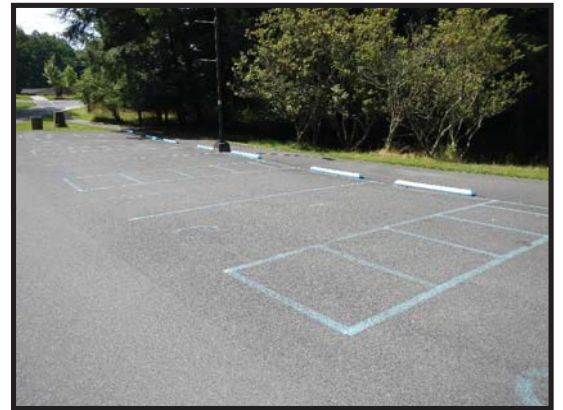
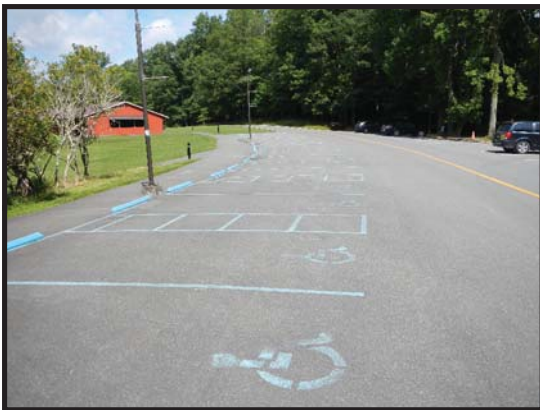
Route 0965BZ

Route Number	Public / NonPublic	Date Visited	Area (sq ft)	Lane Miles *	Surface Type
0965BZ	PUBLIC	8/6/2013	3,331	0.06	AS
Culverts	Drop Inlets	Gates	Curb & Gutter	Curb	PCR
0	1	0	NO CURB AND GUTTER	NO CURB	GOOD/90

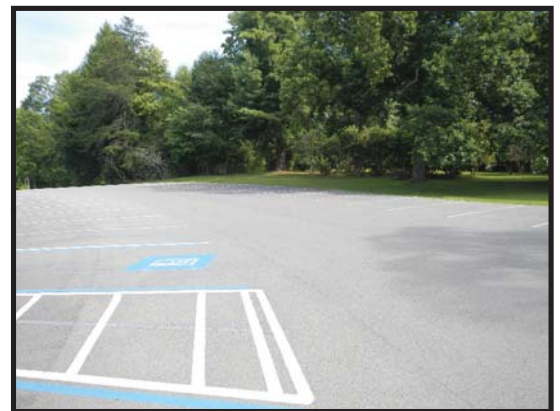
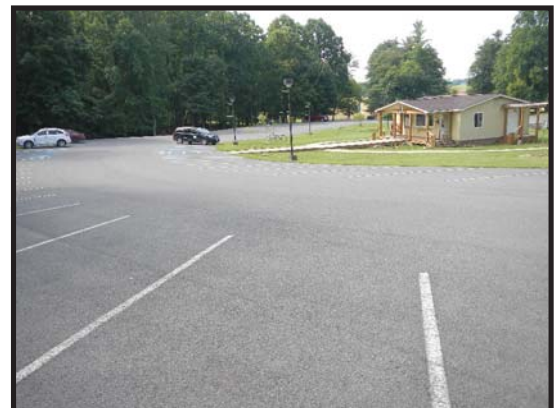
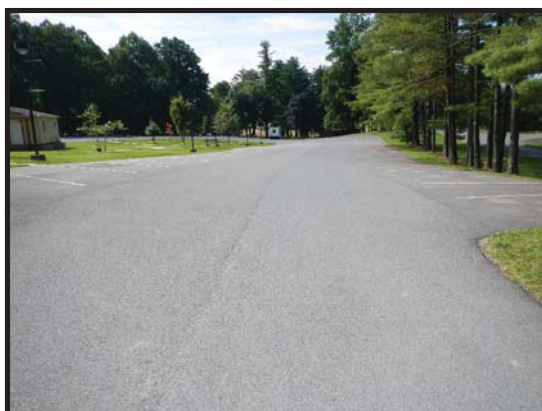
Route 0966

Route Number	Public / NonPublic	Date Visited	Area (sq ft)	Lane Miles *	Surface Type
0966	PUBLIC	8/6/2013	53,065	0.91	AS
Culverts	Drop Inlets	Gates	Curb & Gutter	Curb	PCR
1	1	0	NO CURB AND GUTTER	STONE CURB	GOOD/90

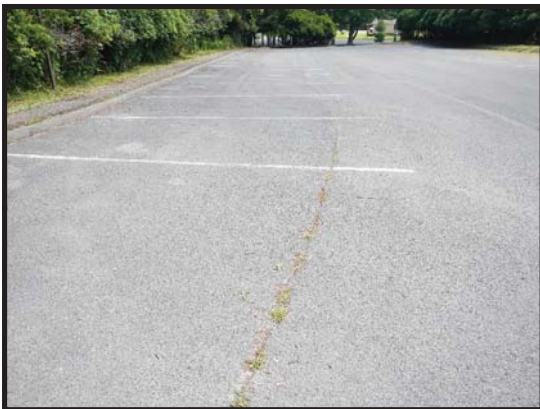
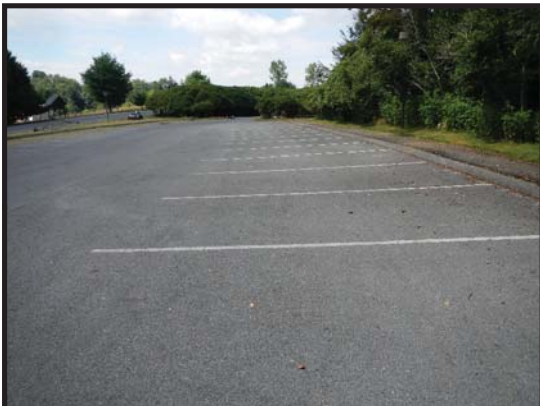
Route Number	Public / NonPublic	Date Visited	Area (sq ft)	Lane Miles *	Surface Type
0967AZ	PUBLIC	8/6/2013	4,677	0.08	AS
Culverts	Drop Inlets	Gates	Curb & Gutter	Curb	PCR
0	0	0	NO CURB AND GUTTER	ASPHALT CURB	GOOD/90

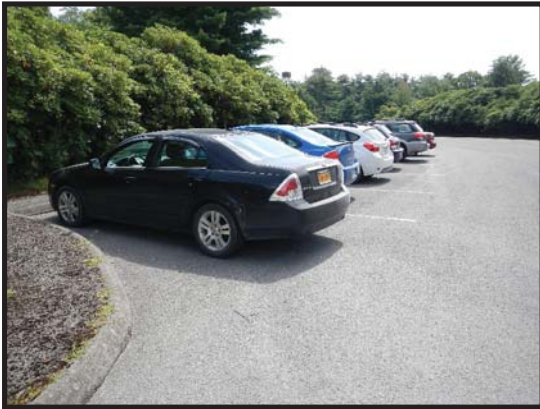
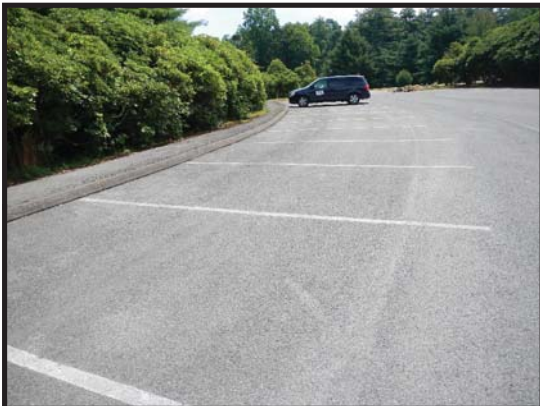
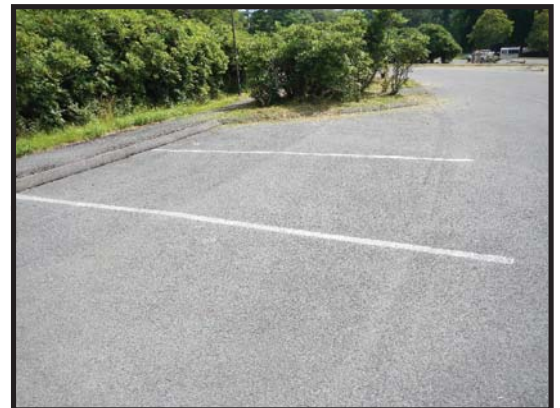
Route 0967BZ

Route Number	Public / NonPublic	Date Visited	Area (sq ft)	Lane Miles *	Surface Type
0967BZ	PUBLIC	8/6/2013	6,846	0.12	AS
Culverts	Drop Inlets	Gates	Curb & Gutter	Curb	PCR
0	0	0	NO CURB AND GUTTER	ASPHALT CURB	GOOD/90

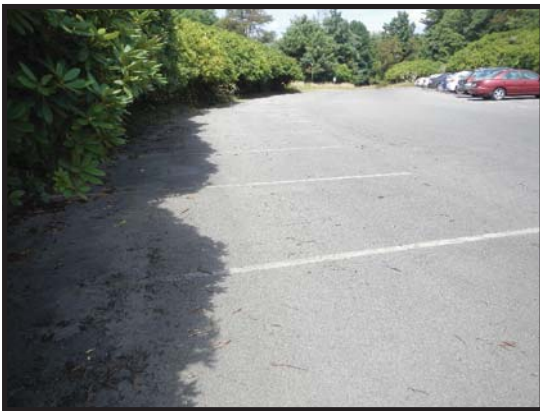
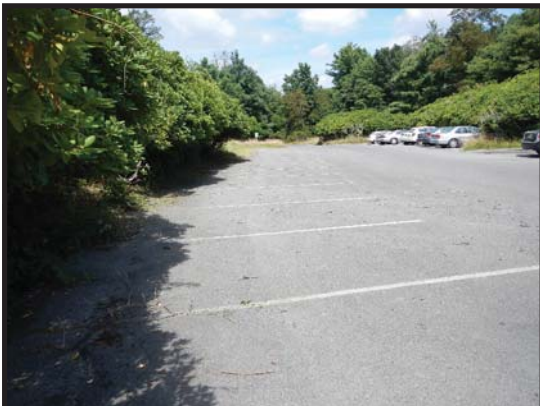
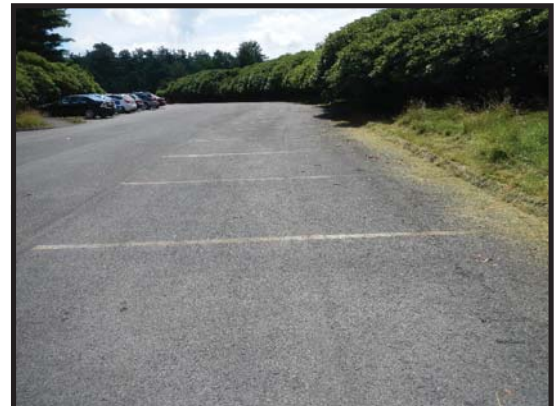
Route 0967CZ

Route Number	Public / NonPublic	Date Visited	Area (sq ft)	Lane Miles *	Surface Type
0967CZ	PUBLIC	8/6/2013	7,179	0.12	AS
Culverts	Drop Inlets	Gates	Curb & Gutter	Curb	PCR
0	0	0	NO CURB AND GUTTER	ASPHALT CURB	GOOD/90

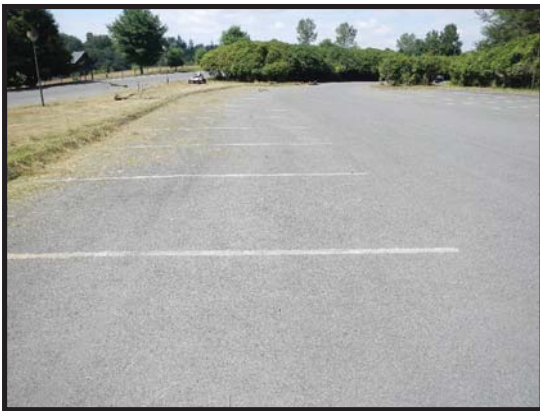
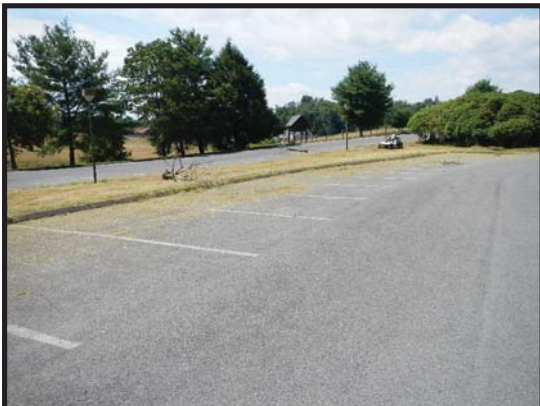
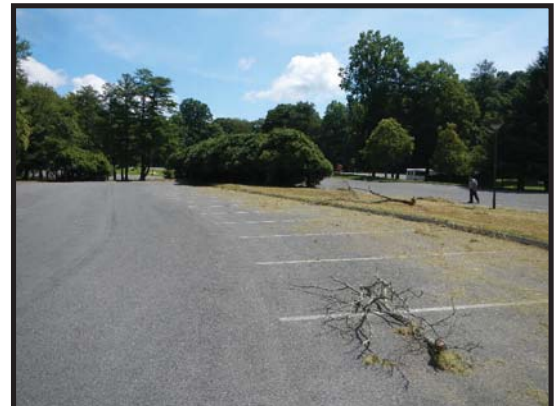
Route 0967DZ

Route Number	Public / NonPublic	Date Visited	Area (sq ft)	Lane Miles *	Surface Type
0967DZ	PUBLIC	8/6/2013	5,386	0.09	AS
Culverts	Drop Inlets	Gates	Curb & Gutter	Curb	PCR
0	0	0	NO CURB AND GUTTER	ASPHALT CURB	GOOD/90
