Federal Lands Highway Road Inventory Program

Road Inventory and Condition Assessment

Ninety Six National Historic Site NISI

Cycle 5 Report

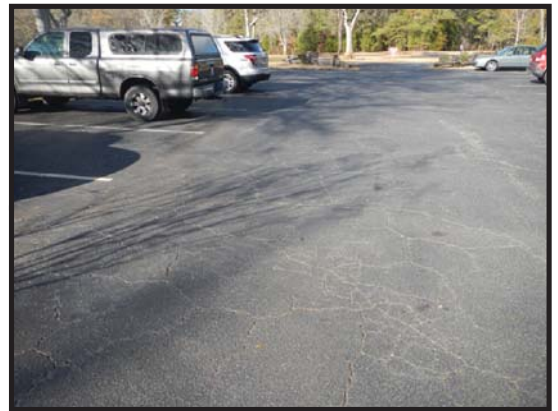
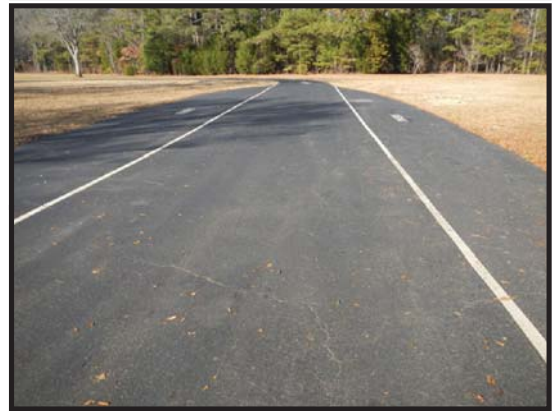
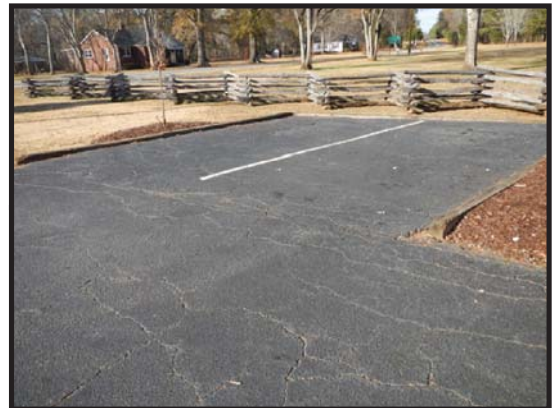
Route Number	Public / NonPublic	Date Visited	Area (sq ft)	Lane Miles *	Surface Type
0900	PUBLIC	12/3/2012	20,963	0.36	AS
Culverts	Drop Inlets	Gates	Curb & Gutter	Curb	PCR
1	0	1	NO CURB AND GUTTER	WOOD CURB	POOR/45

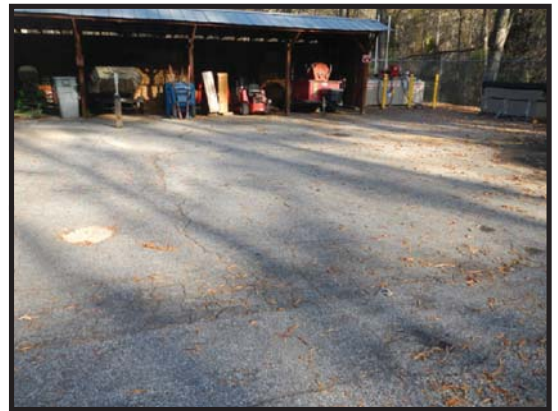
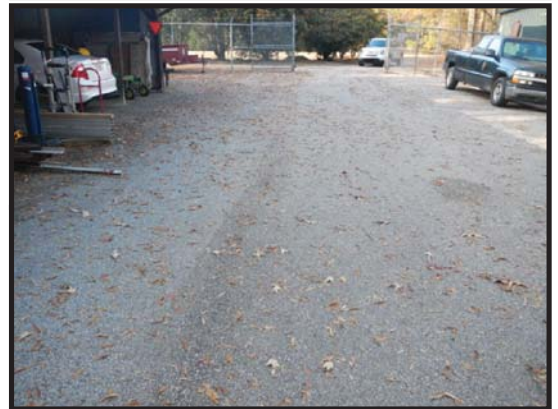
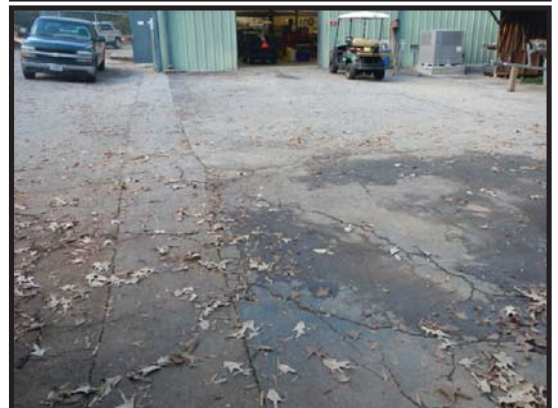
Route 0901

Route Number	Public / NonPublic	Date Visited	Area (sq ft)	Lane Miles *	Surface Type
0901	NONPUBLIC	12/3/2012	6,974	0.12	AS
Culverts	Drop Inlets	Gates	Curb & Gutter	Curb	PCR
0	0	1	NO CURB AND GUTTER	NO CURB	POOR/45
