Road Inventory and Condition Assessment

Ocmulgee National Monument OCMU

Cycle 5 Report

Prepared By: Federal Highway Administration
Road Inventory Program (RIP)
Data Collected: 07/2013
Report Date: 02/2014

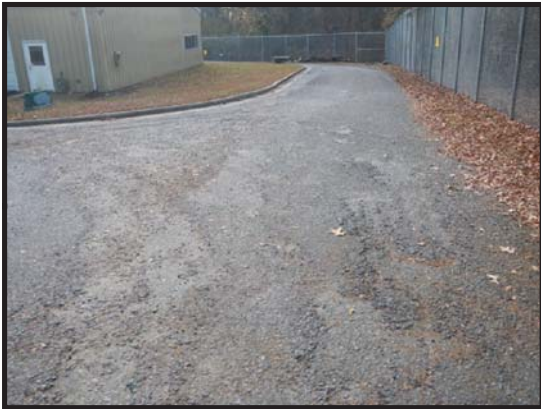
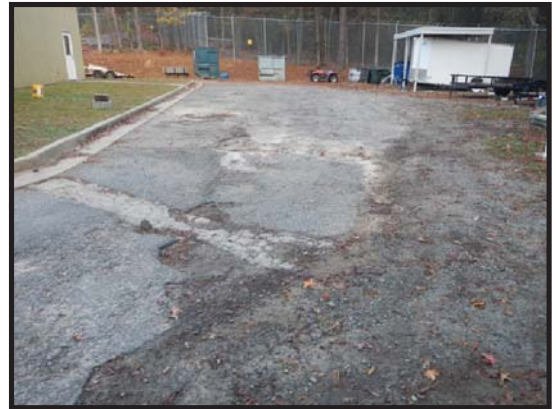
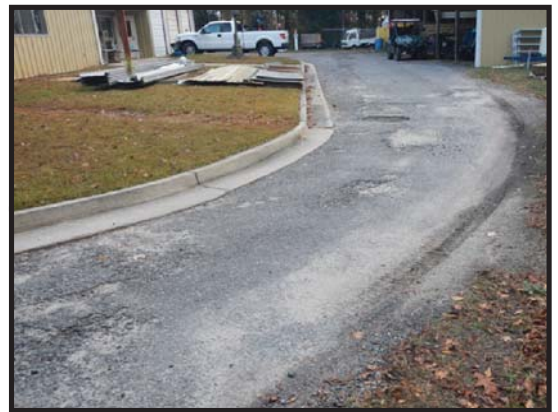
Route 0901

Route Number	Public / NonPublic	Date Visited	Area (sq ft)	Lane Miles *	Surface Type
0901	NONPUBLIC	12/3/2012	7,306	0.13	AS
Culverts	Drop Inlets	Gates	Curb & Gutter	Curb	PCR
0	1	0	NO CURB AND GUTTER	CONCRETE CURB	FAIR/73

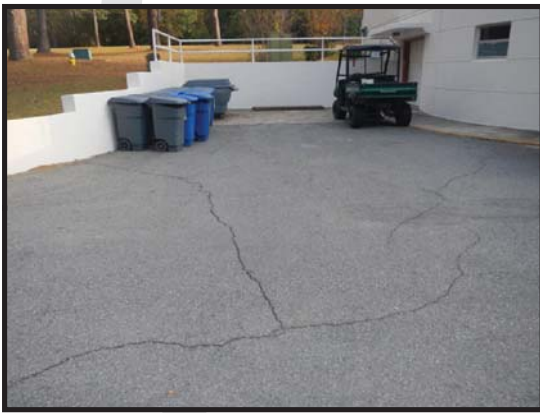
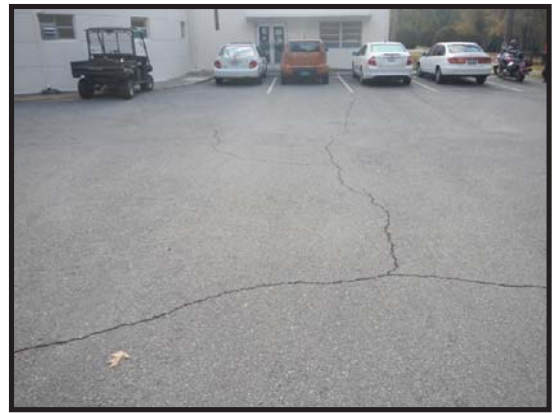
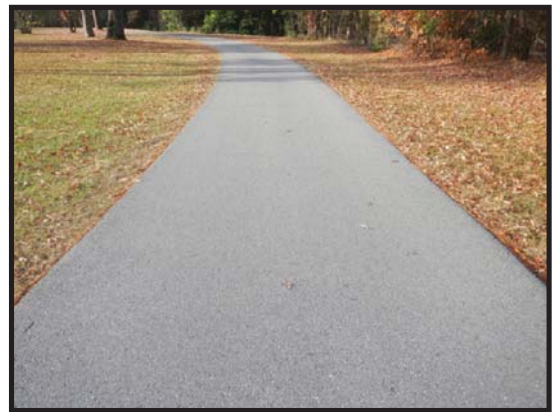
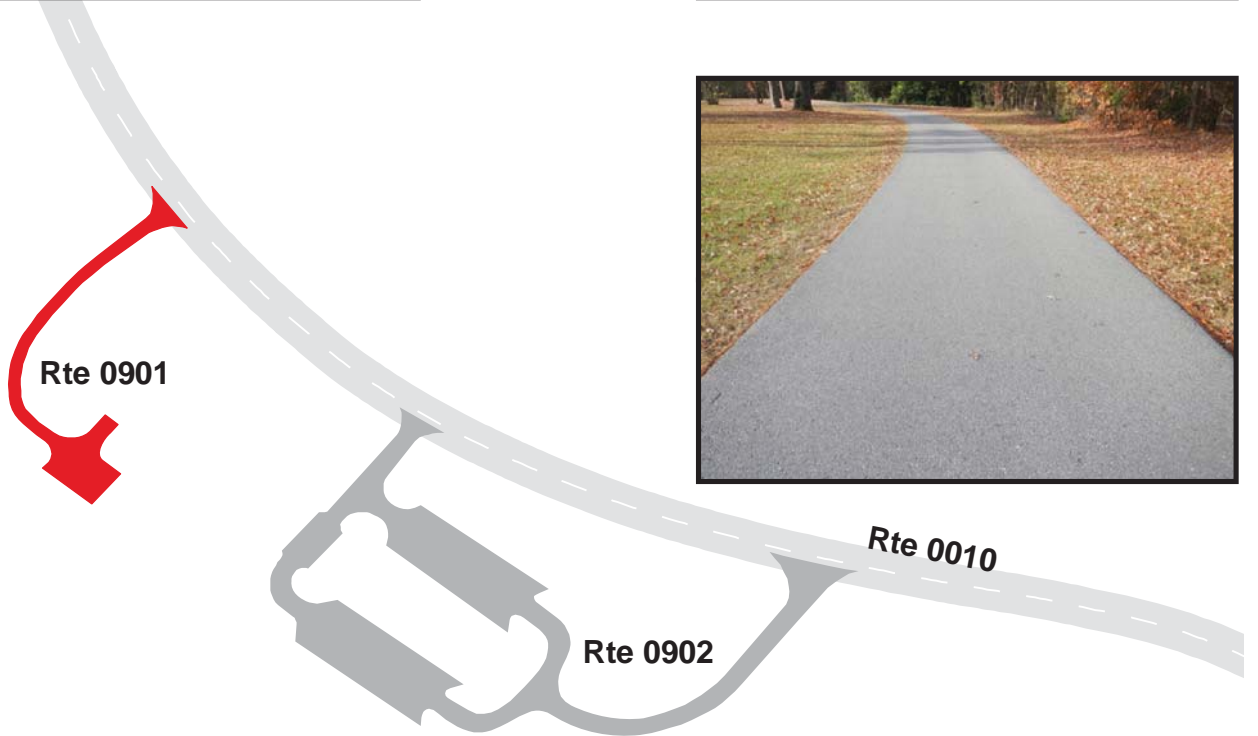
Route 0902

Route Number	Public / NonPublic	Date Visited	Area (sq ft)	Lane Miles *	Surface Type
0902	PUBLIC	12/3/2012	36,179	0.62	AS
Culverts	Drop Inlets	Gates	Curb & Gutter	Curb	PCR
0	7	0	NO CURB AND GUTTER	CONCRETE CURB	FAIR/73

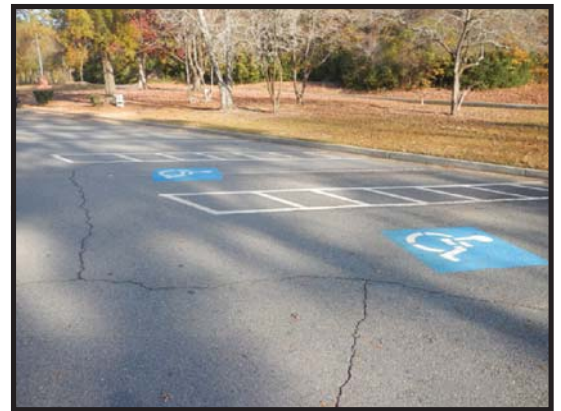
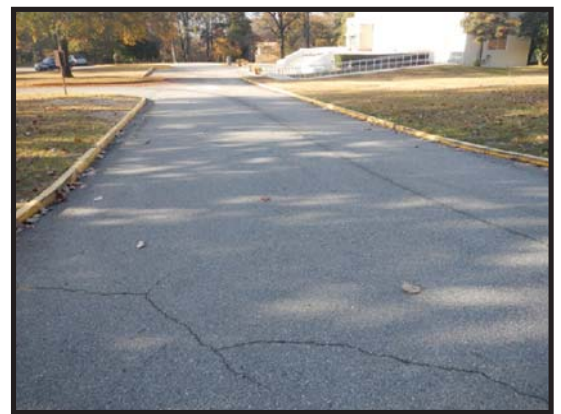
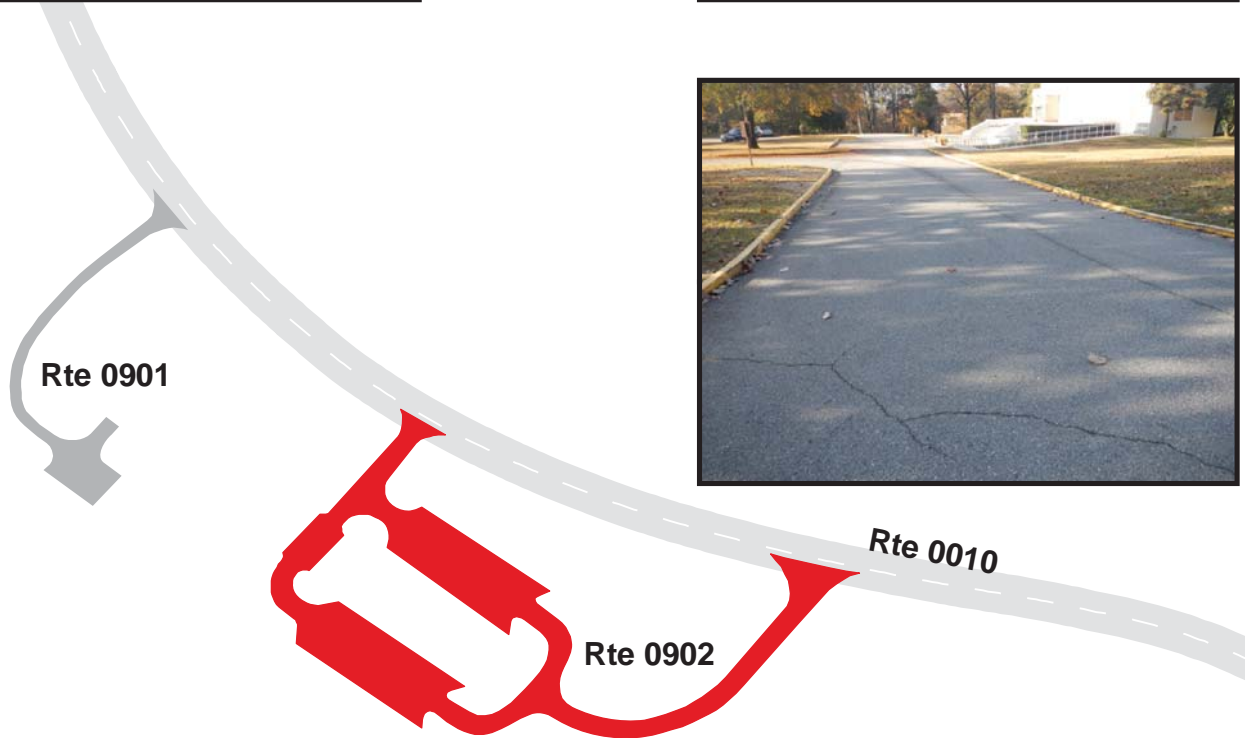
Route 0903

Route Number	Public / NonPublic	Date Visited	Area (sq ft)	Lane Miles *	Surface Type
0903	PUBLIC	12/3/2012	830	0.01	AS
Culverts	Drop Inlets	Gates	Curb & Gutter	Curb	PCR
0	0	0	NO CURB AND GUTTER	NO CURB	GOOD/90

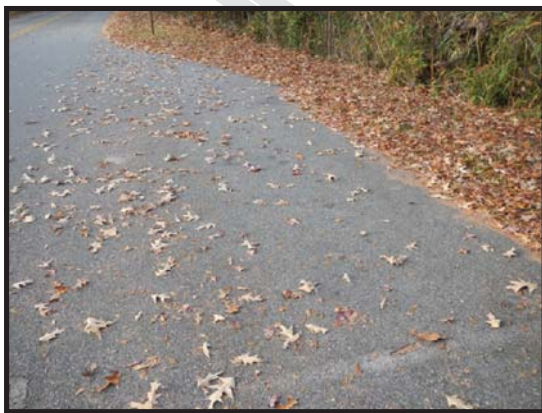
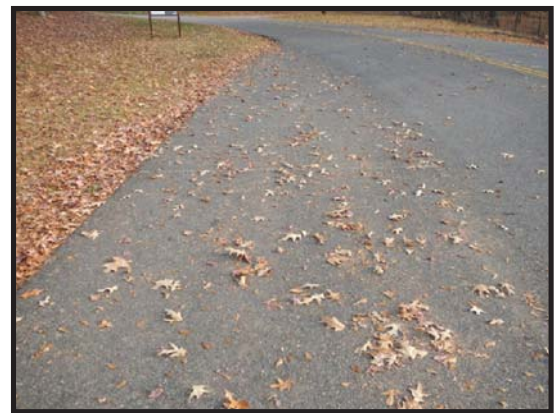
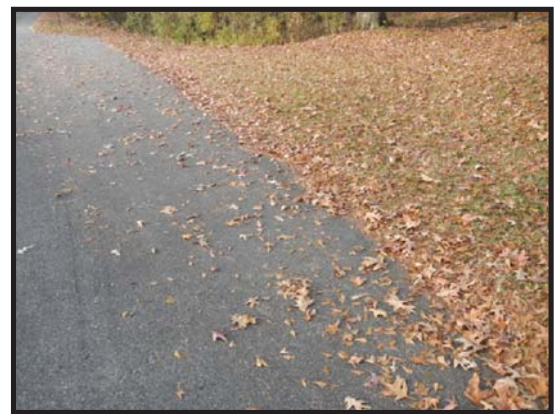
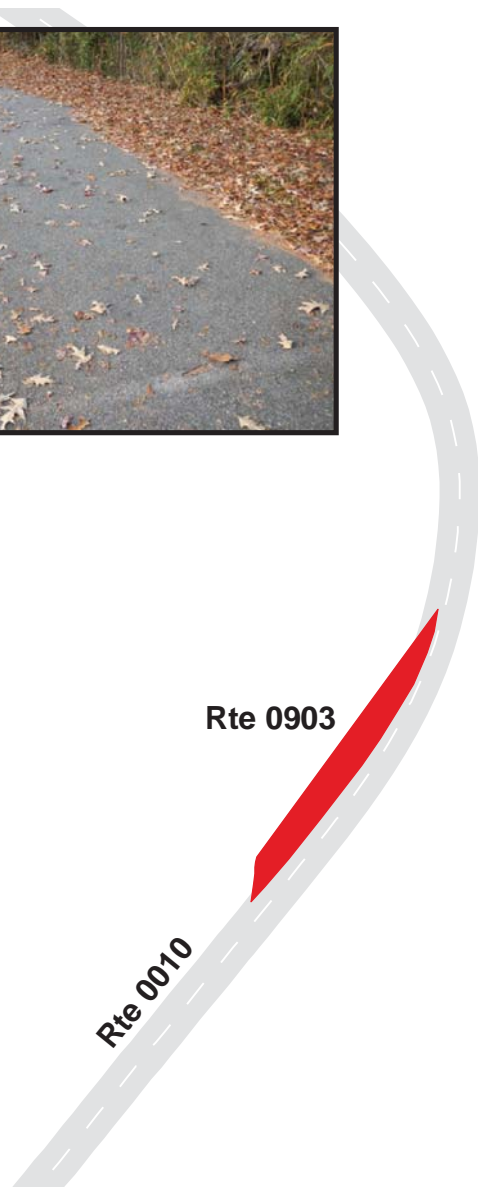
Route 0904

Route Number	Public / NonPublic	Date Visited	Area (sq ft)	Lane Miles *	Surface Type
0904	PUBLIC	12/3/2012	21,892	0.38	AS
Culverts	Drop Inlets	Gates	Curb & Gutter	Curb	PCR
0	4	0	NO CURB AND GUTTER	CONCRETE CURB	POOR/45

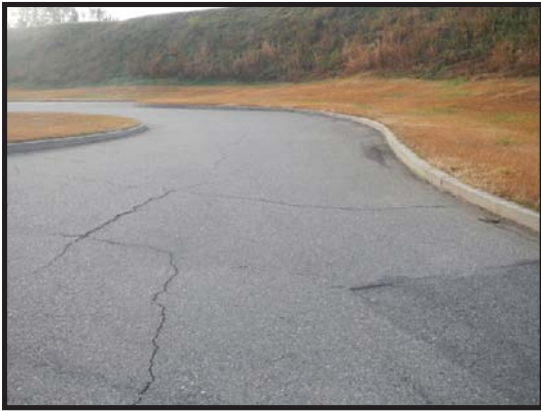
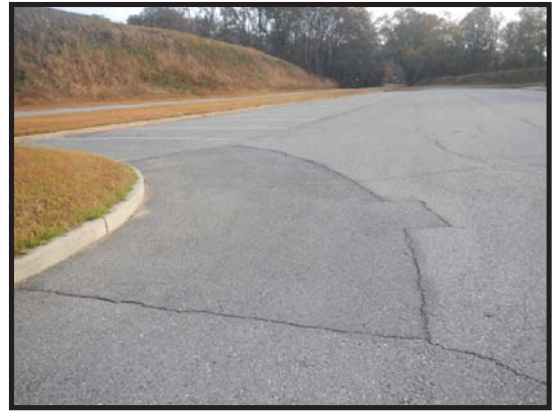
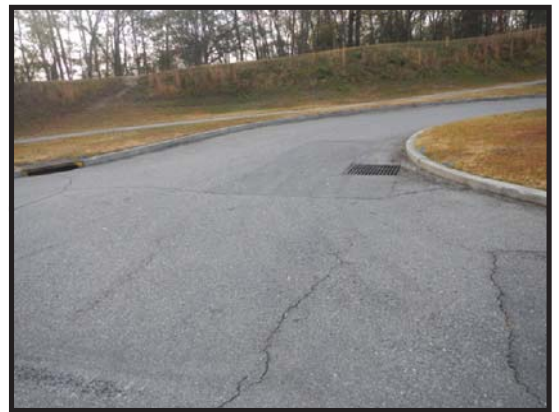
Route 0905

Route Number	Public / NonPublic	Date Visited	Area (sq ft)	Lane Miles *	Surface Type
0905	PUBLIC	12/3/2012	26,586	0.46	AS
Culverts	Drop Inlets	Gates	Curb & Gutter	Curb	PCR
0	3	0	NO CURB AND GUTTER	CONCRETE CURB	POOR/45
