# Federal Lands Highway Road Inventory Program

Road Inventory and Condition Assessment

## Oregon Caves National Monument ORCA - 9340

### Cycle 5 Report

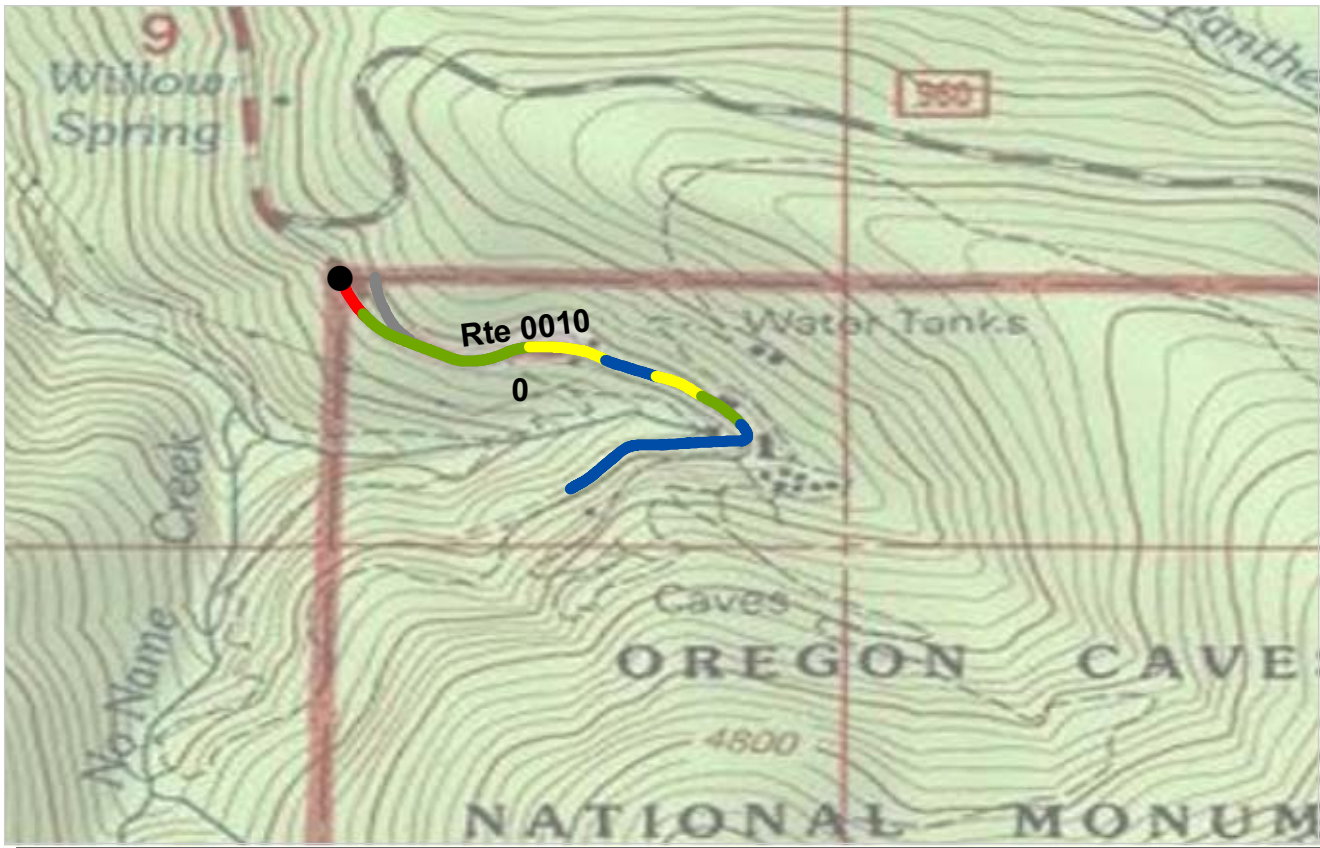
<b>Section Number</b>	0				
<b>Section Length (mi)</b>	0.53				
<b>Cross Section Information</b>					
Number of Lanes	2				
Paved Width (ft)	24				
Lane Width (ft)	11				
<b>Roadway Condition Information</b>					
SCR (Surface Condition Rating)	91				
PCR (Pavement Condition Rating)	91				
<b>Distress Index Values</b>					
Structural Crack Index	91				
Transverse Cracking Index	97				
Patching Index	100				
Rutting Index	92				
Roughness Condition Index (RCI)	NC

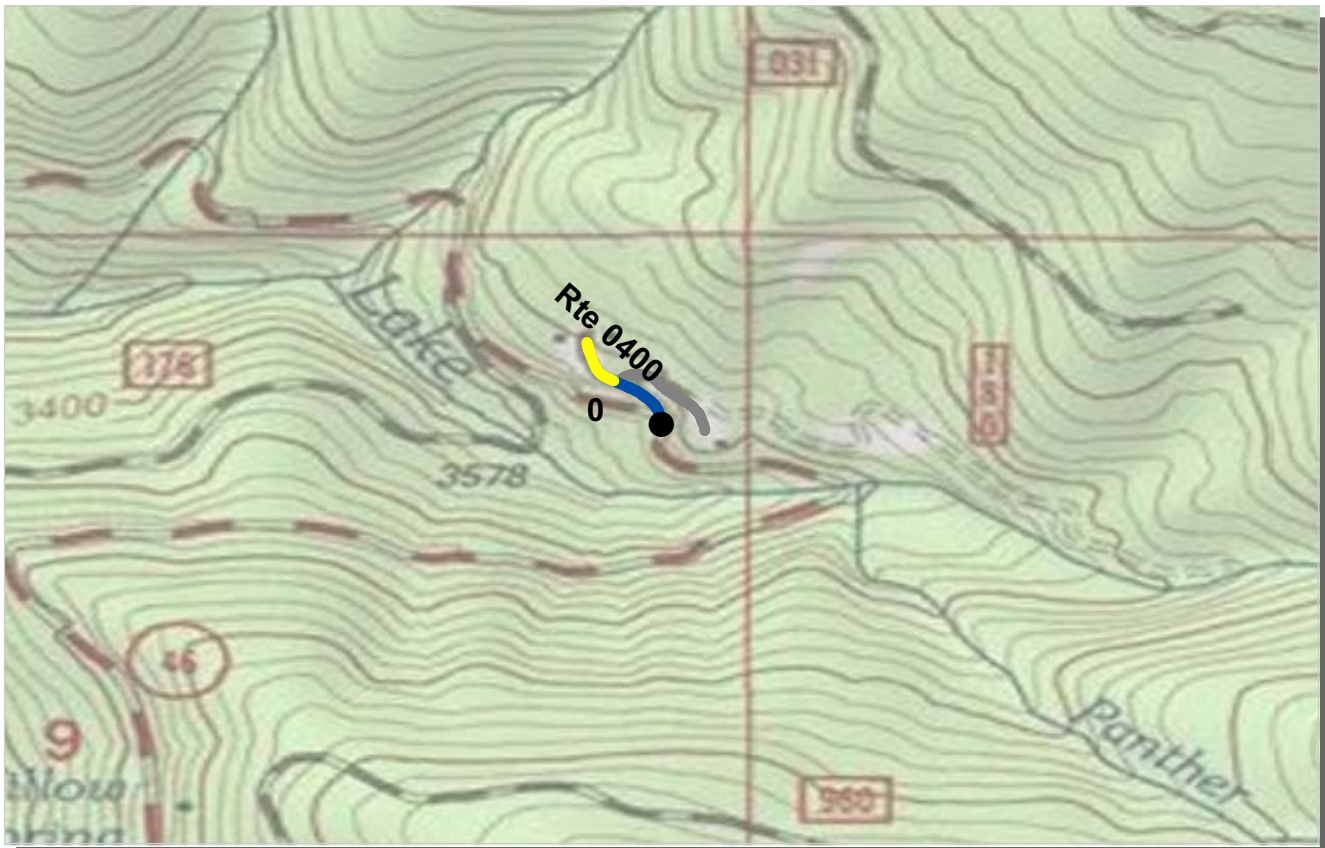
**ROUTE: 0400 RESIDENCE AREA ROAD**

<b>Section Number</b>	0				
<b>Section Length (mi)</b>	0.11				
<b>Cross Section Information</b>					
Number of Lanes	2				
Paved Width (ft)	15				
Lane Width (ft)	7				
<b>Roadway Condition Information</b>					
SCR (Surface Condition Rating)	79				
PCR (Pavement Condition Rating)	79				
<b>Distress Index Values</b>					
Structural Crack Index	79				
Transverse Cracking Index	94				
Patching Index	100				
Rutting Index	95				
Roughness Condition Index (RCI)	NC

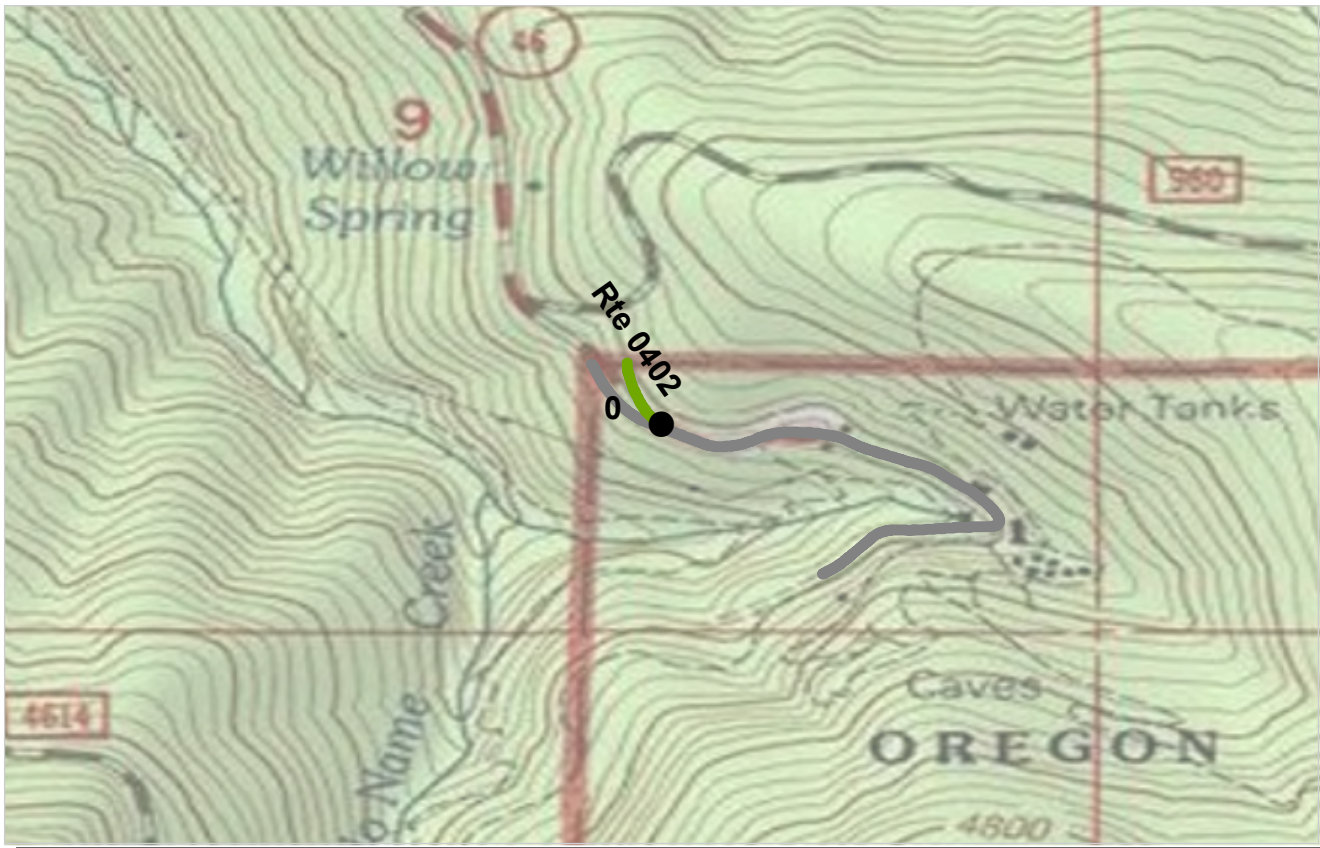
**ROUTE: 0402 FIRE ACCESS ROAD**

<b>Section Number</b>	0				
<b>Section Length (mi)</b>	0.07				
<b>Cross Section Information</b>					
Number of Lanes	2				
Paved Width (ft)	17				
Lane Width (ft)	9				
<b>Roadway Condition Information</b>					
SCR (Surface Condition Rating)	92				
PCR (Pavement Condition Rating)	92				
<b>Distress Index Values</b>					
Structural Crack Index	94				
Transverse Cracking Index	94				
Patching Index	100				
Rutting Index	92				
Roughness Condition Index (RCI)	NC

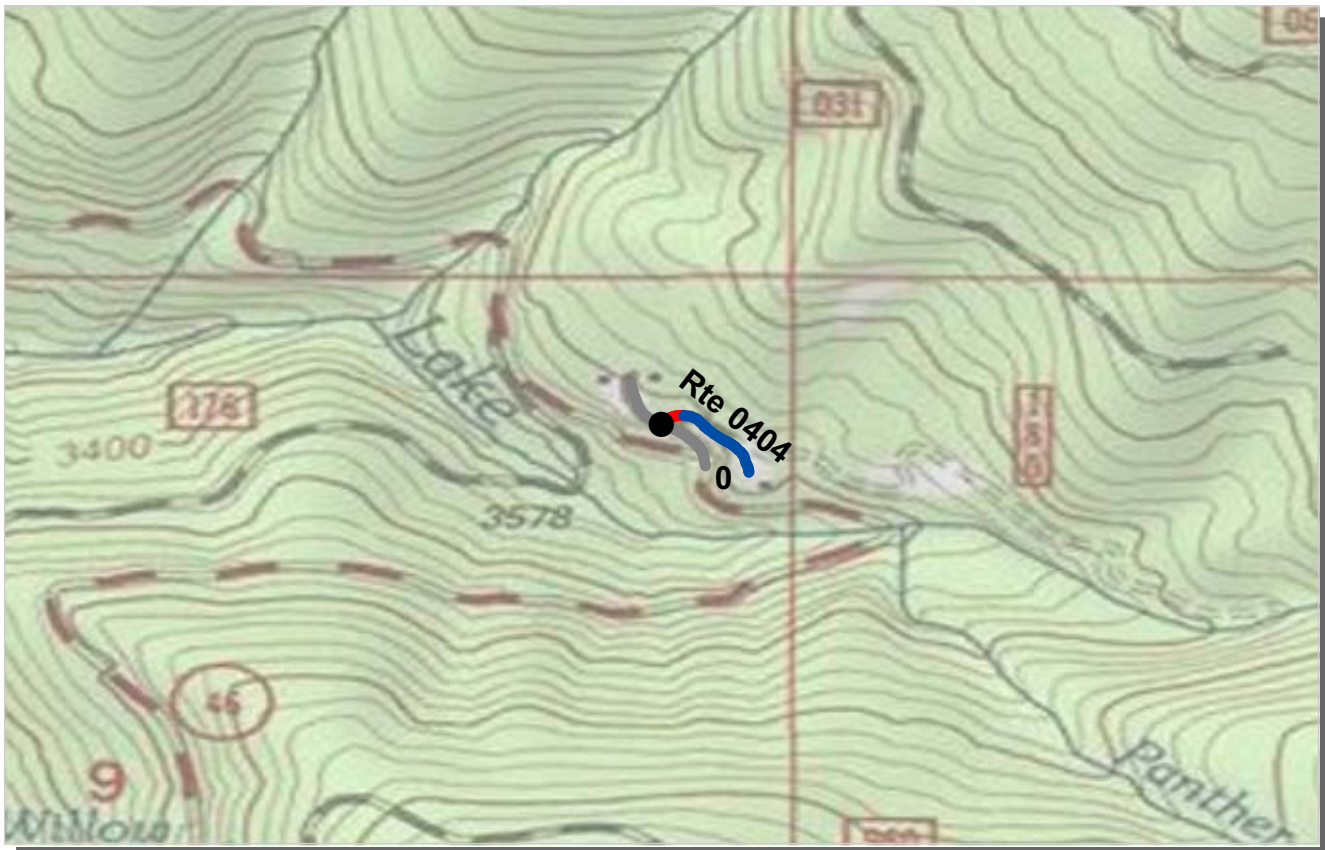
<b>Section Number</b>	0				
<b>Section Length (mi)</b>	0.10				
<b>Cross Section Information</b>					
Number of Lanes	2				
Paved Width (ft)	18				
Lane Width (ft)	9				
<b>Roadway Condition Information</b>					
SCR (Surface Condition Rating)	85				
PCR (Pavement Condition Rating)	85				
<b>Distress Index Values</b>					
Structural Crack Index	85				
Transverse Cracking Index	97				
Patching Index	100				
Rutting Index	96				
Roughness Condition Index (RCI)	NC

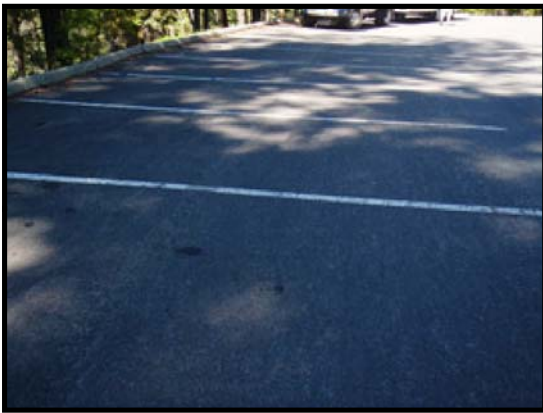
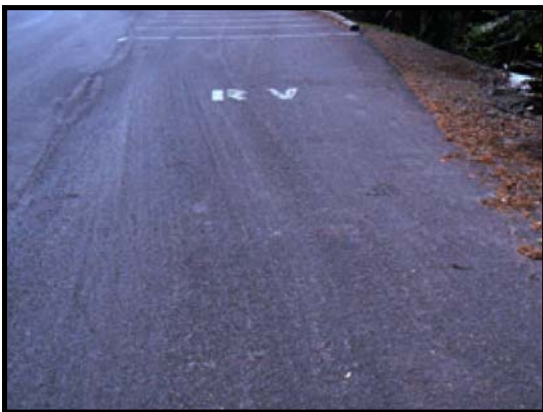
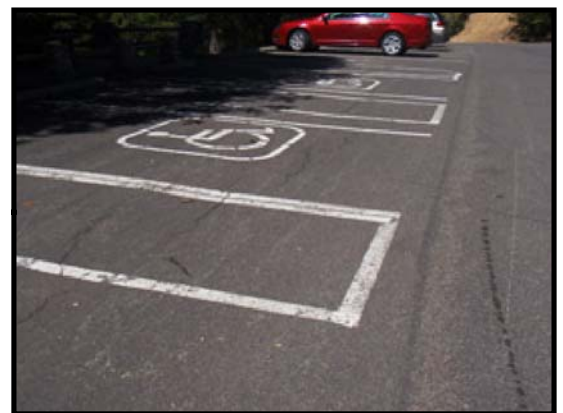
Route Number	Public / NonPublic	Date Visited	Area (sq ft)	Lane Miles *	Surface Type
0900A	PUBLIC	6/15/2010	9,758	0.17	AS
Culverts	Drop Inlets	Gates	Curb & Gutter	Curb	PCR
0	0	0	NO CURB AND GUTTER	NO CURB	FAIR/73

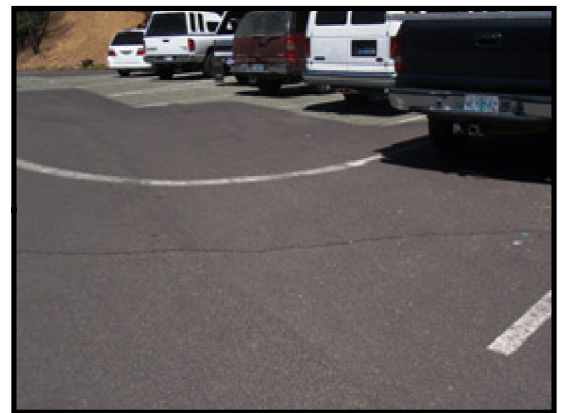
## Route 0900B

Route Number	Public / NonPublic	Date Visited	Area (sq ft)	Lane Miles *	Surface Type
0900B	PUBLIC	6/15/2010	3,783	0.07	AS
Culverts	Drop Inlets	Gates	Curb & Gutter	Curb	PCR
0	0	0	NO CURB AND GUTTER	NO CURB	FAIR/73

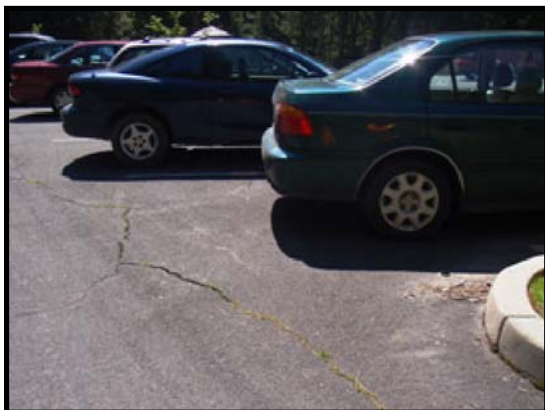
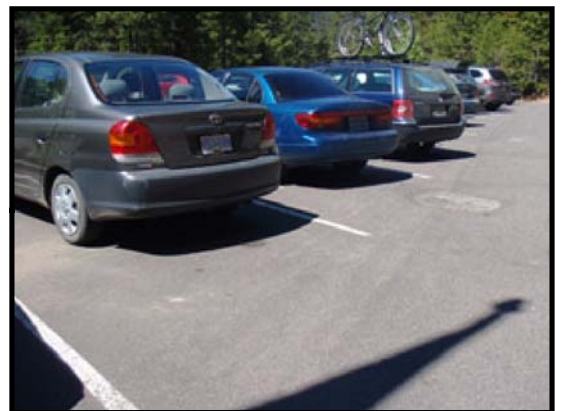
## Route 0900C

Route Number	Public / NonPublic	Date Visited	Area (sq ft)	Lane Miles *	Surface Type
0900C	PUBLIC	6/15/2010	2,001	0.03	AS
Culverts	Drop Inlets	Gates	Curb & Gutter	Curb	PCR
0	0	0	NO CURB AND GUTTER	CONCRETE CURB	FAIR/73

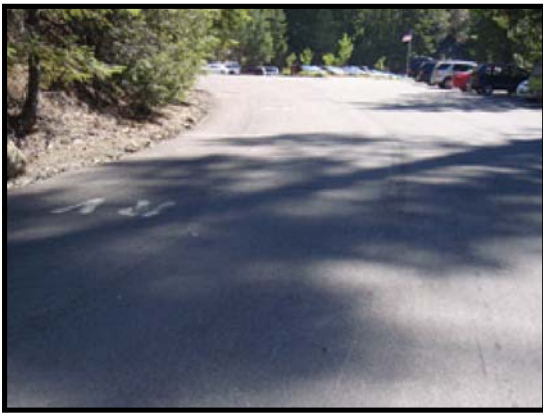
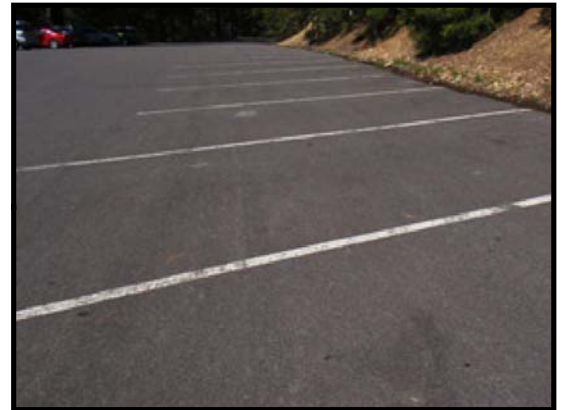
## Route 0900D

Route Number	Public / NonPublic	Date Visited	Area (sq ft)	Lane Miles *	Surface Type
0900D	PUBLIC	6/15/2010	6,642	0.11	AS
Culverts	Drop Inlets	Gates	Curb & Gutter	Curb	PCR
0	0	0	NO CURB AND GUTTER	NO CURB	FAIR/73

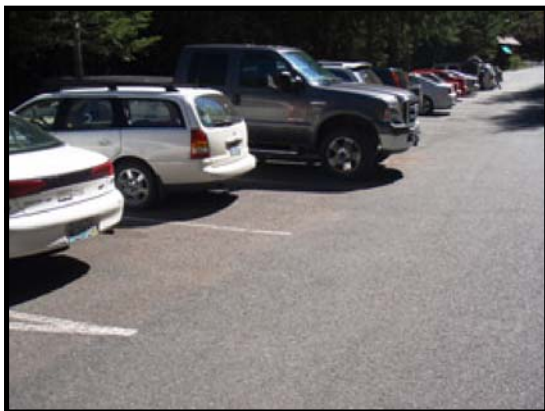
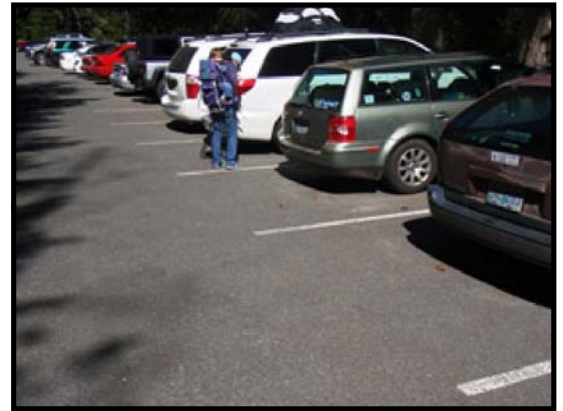
## Route 0901A

Route Number	Public / NonPublic	Date Visited	Area (sq ft)	Lane Miles *	Surface Type
0901A	PUBLIC	6/15/2010	4,973	0.09	AS
Culverts	Drop Inlets	Gates	Curb & Gutter	Curb	PCR
0	2	0	NO CURB AND GUTTER	NO CURB	GOOD/90

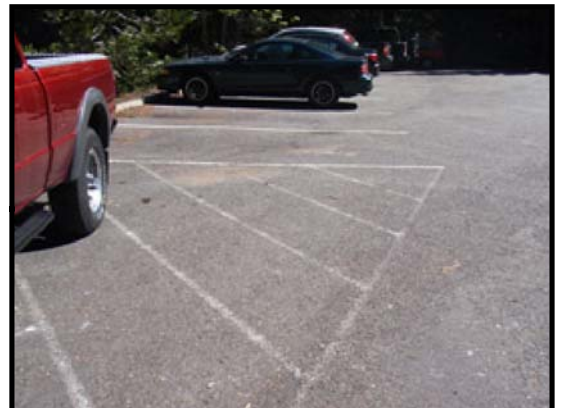
## Route 0901B

Route Number	Public / NonPublic	Date Visited	Area (sq ft)	Lane Miles *	Surface Type
0901B	PUBLIC	6/15/2010	1,779	0.03	AS
Culverts	Drop Inlets	Gates	Curb & Gutter	Curb	PCR
0	0	0	NO CURB AND GUTTER	NO CURB	GOOD/90

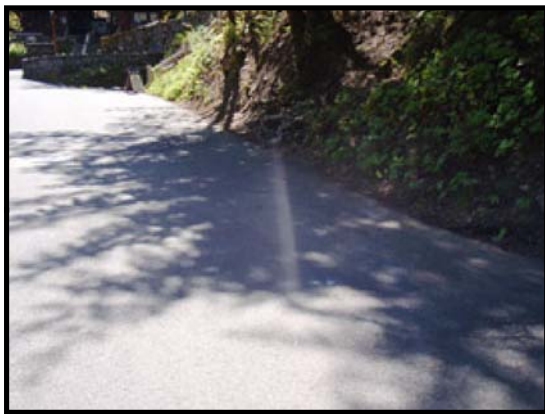
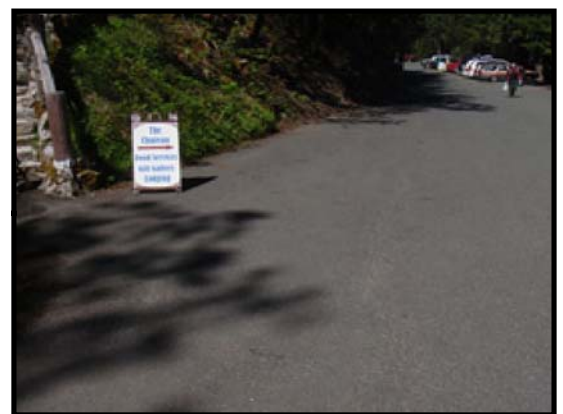
## Route 0902

Route Number	Public / NonPublic	Date Visited	Area (sq ft)	Lane Miles *	Surface Type
0902	PUBLIC	6/15/2010	1,723	0.03	AS
Culverts	Drop Inlets	Gates	Curb & Gutter	Curb	PCR
0	1	0	NO CURB AND GUTTER	NO CURB	GOOD/90

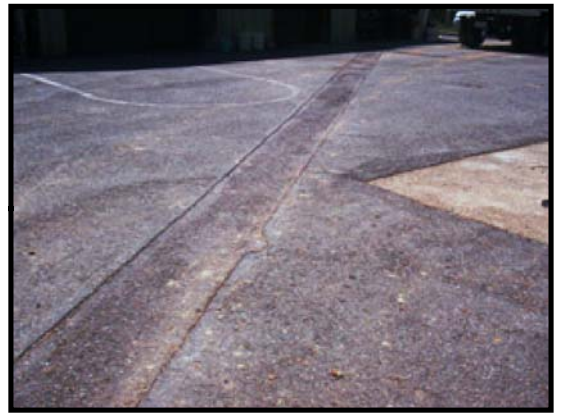
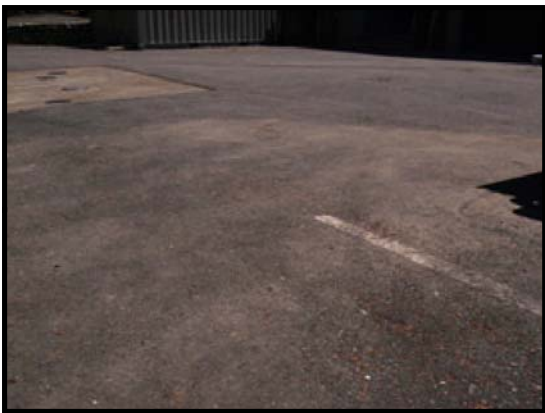
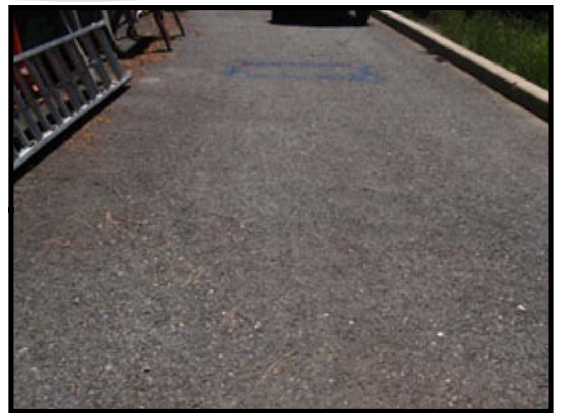
## Route 0903

Route Number	Public / NonPublic	Date Visited	Area (sq ft)	Lane Miles *	Surface Type
0903	NONPUBLIC	6/15/2010	4,541	0.08	AS
Culverts	Drop Inlets	Gates	Curb & Gutter	Curb	PCR
0	0	0	NO CURB AND GUTTER	CONCRETE CURB	FAIR/73

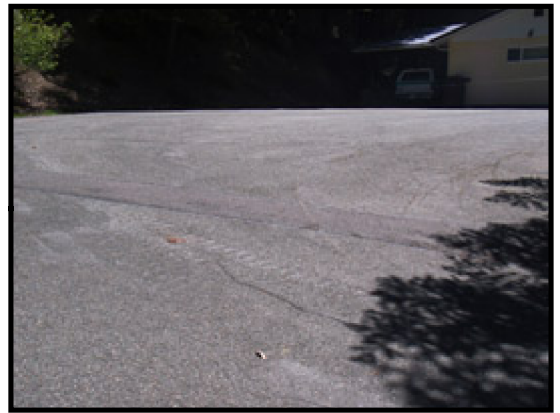
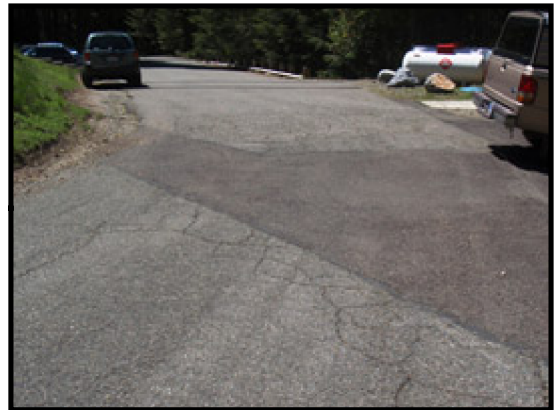
## Route 0904

Route Number	Public / NonPublic	Date Visited	Area (sq ft)	Lane Miles *	Surface Type
0904	NONPUBLIC	6/15/2010	8,096	0.14	AS
Culverts	Drop Inlets	Gates	Curb & Gutter	Curb	PCR
0	0	0	NO CURB AND GUTTER	NO CURB	FAIR/73

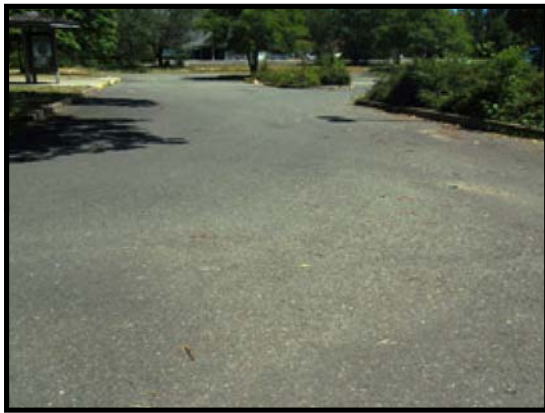
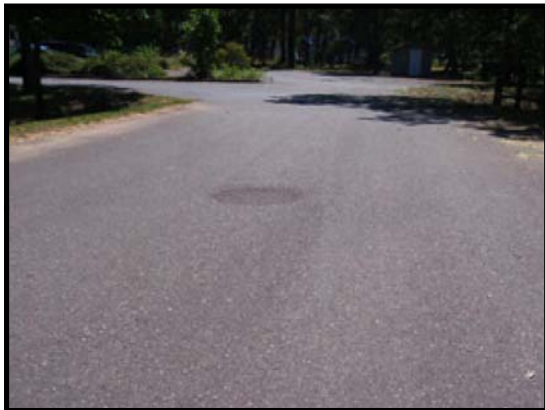
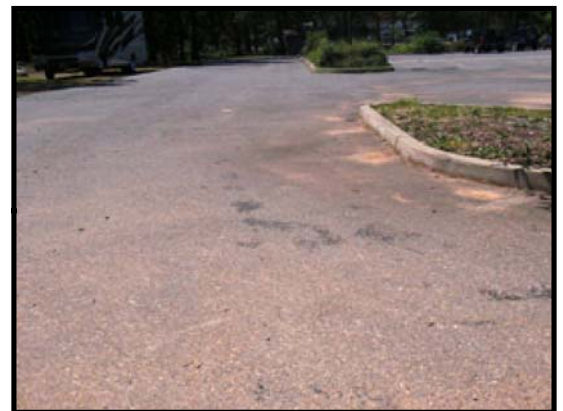
## Route 0905

Route Number	Public / NonPublic	Date Visited	Area (sq ft)	Lane Miles *	Surface Type
0905	PUBLIC	6/15/2010	34,964	0.60	AS
Culverts	Drop Inlets	Gates	Curb & Gutter	Curb	PCR
0	2	0	NO CURB AND GUTTER	CONCRETE CURB	POOR/45
