Federal Lands Highway Road Inventory Program

Road Inventory and Condition Assessment

Organ Pipe Cactus National Monument ORPI

Cycle 5 Report

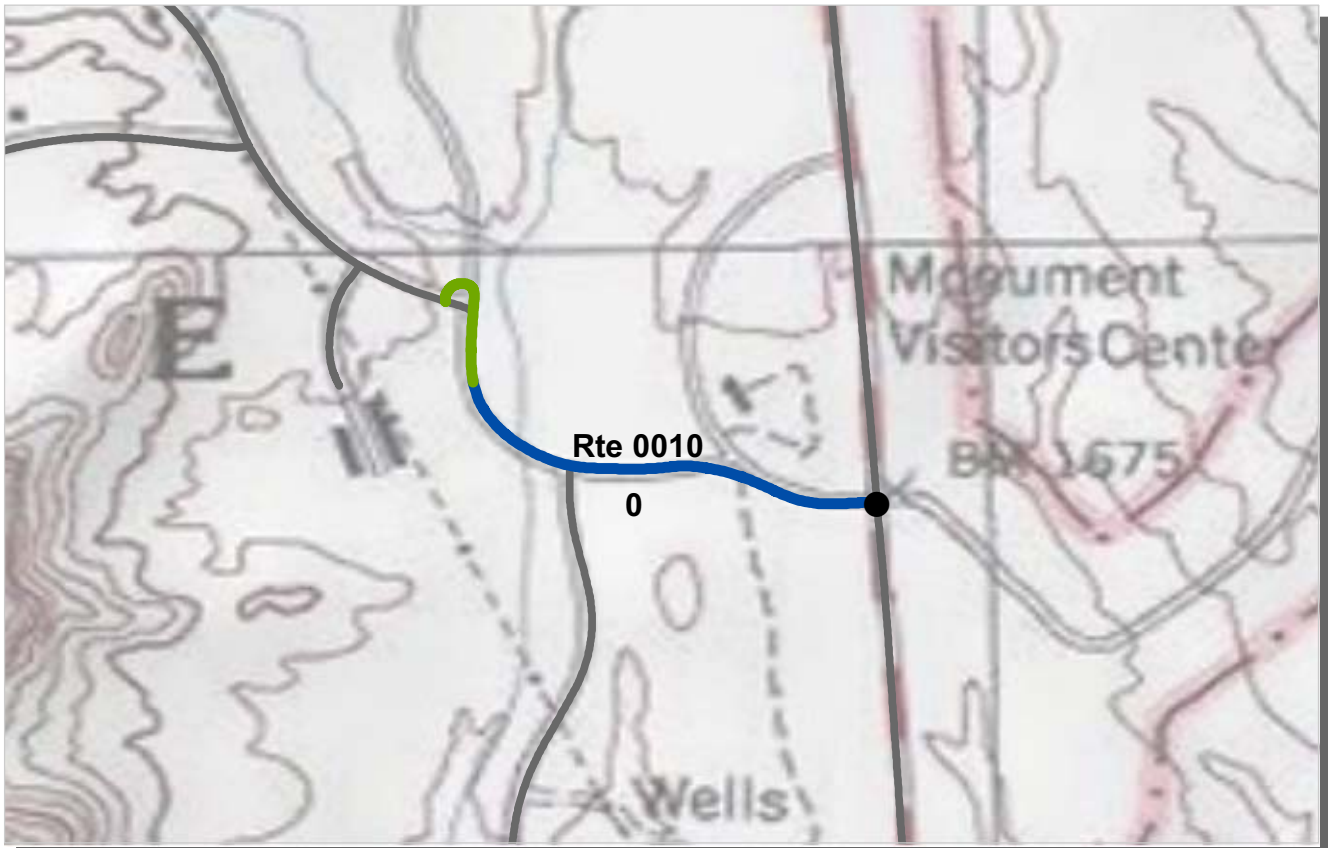
ROUTE: 0010 VISITOR CENTER DRIVE

Section Number	0				
Section Length (mi)	0.34				
Cross Section Information					
Number of Lanes	2				
Paved Width (ft)	26				
Lane Width (ft)	10				
Roadway Condition Information					
SCR (Surface Condition Rating)	95				
PCR (Pavement Condition Rating)	95				
Distress Index Values					
Structural Crack Index	99				
Transverse Cracking Index	95				
Patching Index	100				
Rutting Index	98				
Roughness Condition Index (RCI)	NC

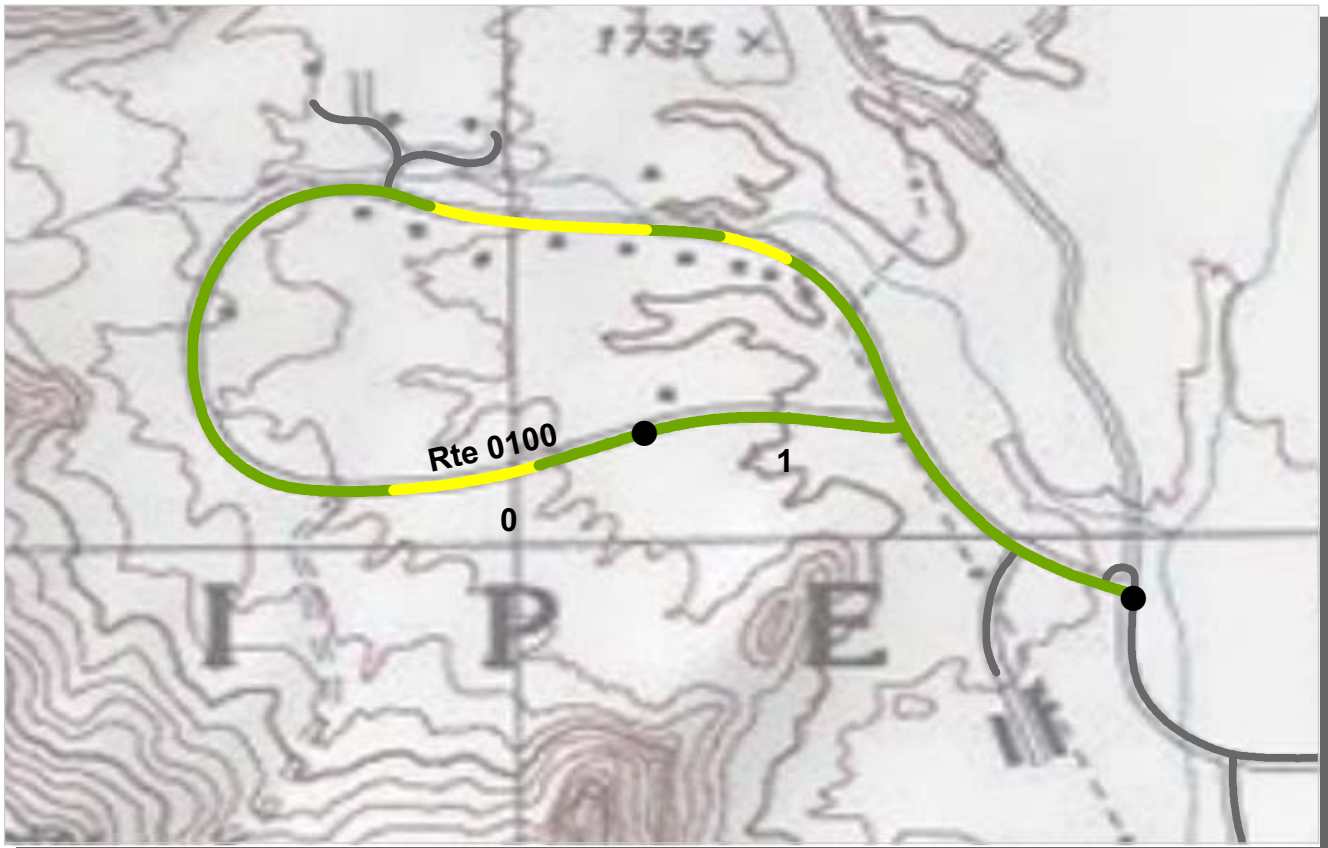
ROUTE: 0100 RESIDENCE ACCESS ROAD

<i>Section Number</i>	0	1			
<i>Section Length (mi)</i>	1.00	0.14			
<i>Cross Section Information</i>					
Number of Lanes	2	2			
Paved Width (ft)	21	19			
Lane Width (ft)	10	9			
<i>Roadway Condition Information</i>					
SCR (Surface Condition Rating)	86	88			
PCR (Pavement Condition Rating)	86	88			
<i>Distress Index Values</i>					
Structural Crack Index	99	100			
Transverse Cracking Index	97	99			
Patching Index	100	100			
Rutting Index	86	88			
Roughness Condition Index (RCI)	NC	NC

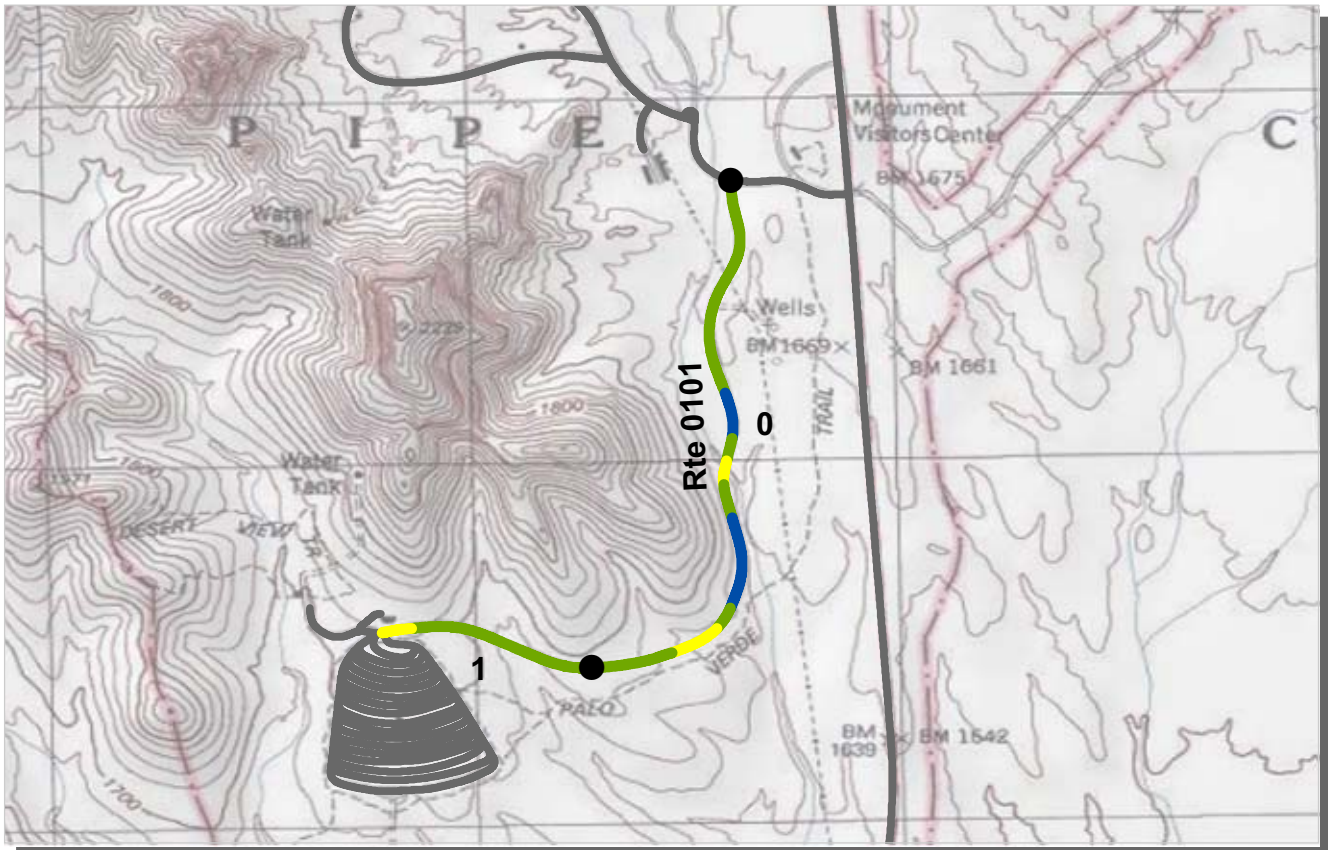
ROUTE: 0101 TWIN PEAKS ACCESS ROAD

<i>Section Number</i>	0	1			
<i>Section Length (mi)</i>	1.00	0.32			
<i>Cross Section Information</i>					
Number of Lanes	2	2			
Paved Width (ft)	24	25			
Lane Width (ft)	10	10			
<i>Roadway Condition Information</i>					
SCR (Surface Condition Rating)	97	95			
PCR (Pavement Condition Rating)	89	84			
<i>Distress Index Values</i>					
Structural Crack Index	100	100			
Transverse Cracking Index	98	99			
Patching Index	100	100			
Rutting Index	97	95			
Roughness Condition Index (RCI)	76	67

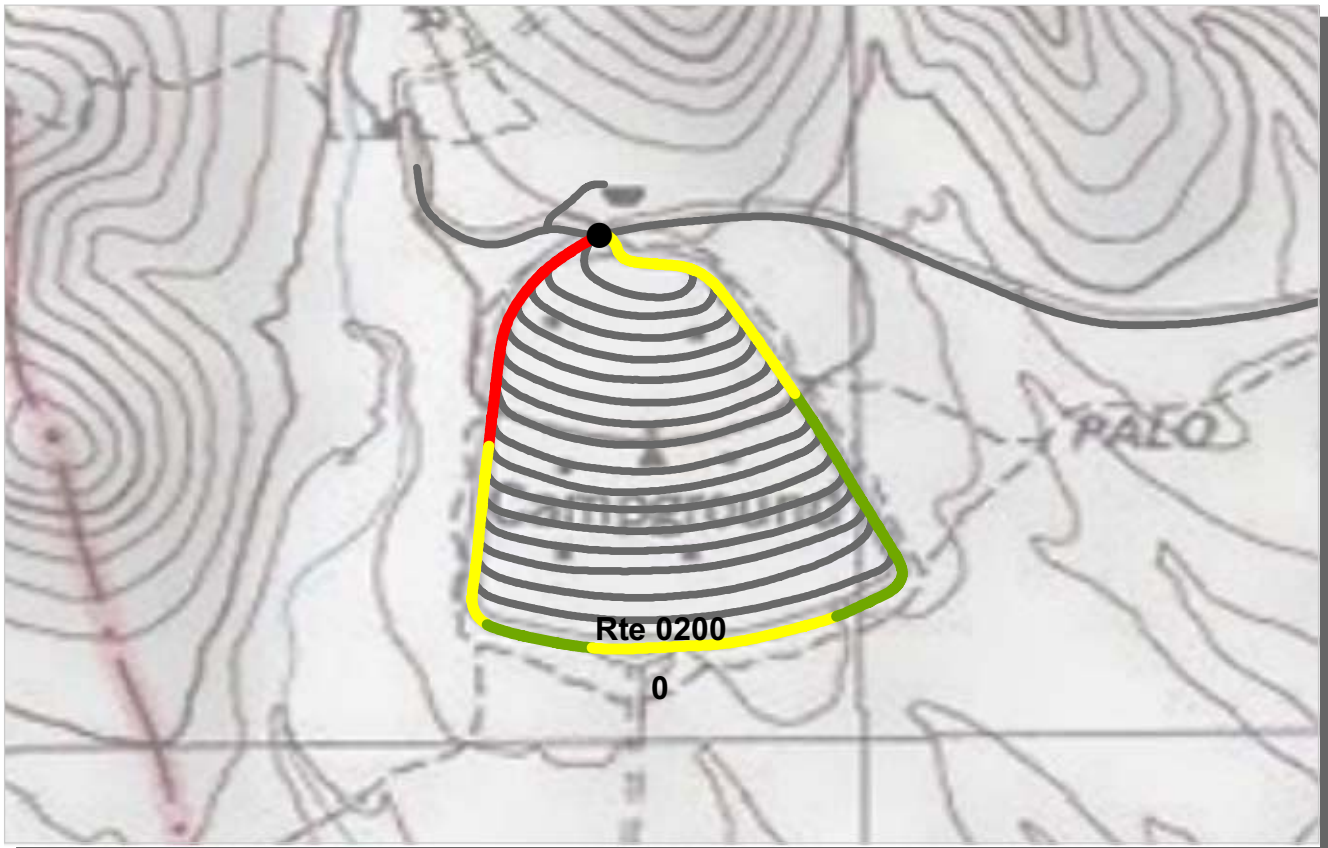
ROUTE: 0200 CAMPGROUND LOOP ROAD

Section Number	0				
Section Length (mi)	0.82				
Cross Section Information					
Number of Lanes	1				
Paved Width (ft)	14				
Lane Width (ft)	14				
Roadway Condition Information					
SCR (Surface Condition Rating)	83				
PCR (Pavement Condition Rating)	83				
Distress Index Values					
Structural Crack Index	83				
Transverse Cracking Index	92				
Patching Index	99				
Rutting Index	84				
Roughness Condition Index (RCI)	NC

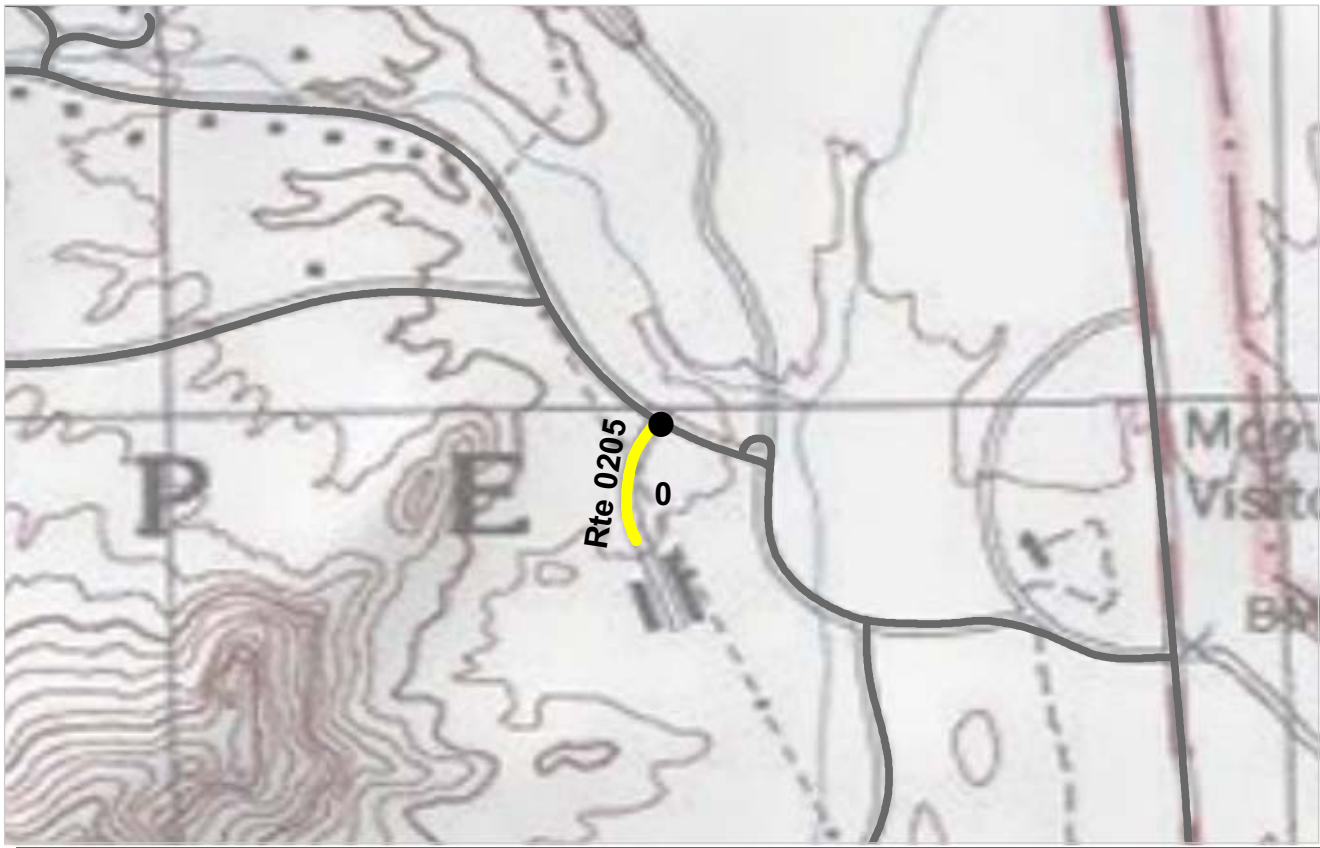
ROUTE: 0205 MAINTENANCE YARD ACCESS ROAD

Section Number	0				
Section Length (mi)	0.08				
Cross Section Information					
Number of Lanes	2				
Paved Width (ft)	22				
Lane Width (ft)	12				
Roadway Condition Information					
SCR (Surface Condition Rating)	82				
PCR (Pavement Condition Rating)	82				
Distress Index Values					
Structural Crack Index	94				
Transverse Cracking Index	94				
Patching Index	100				
Rutting Index	82				
Roughness Condition Index (RCI)	NC

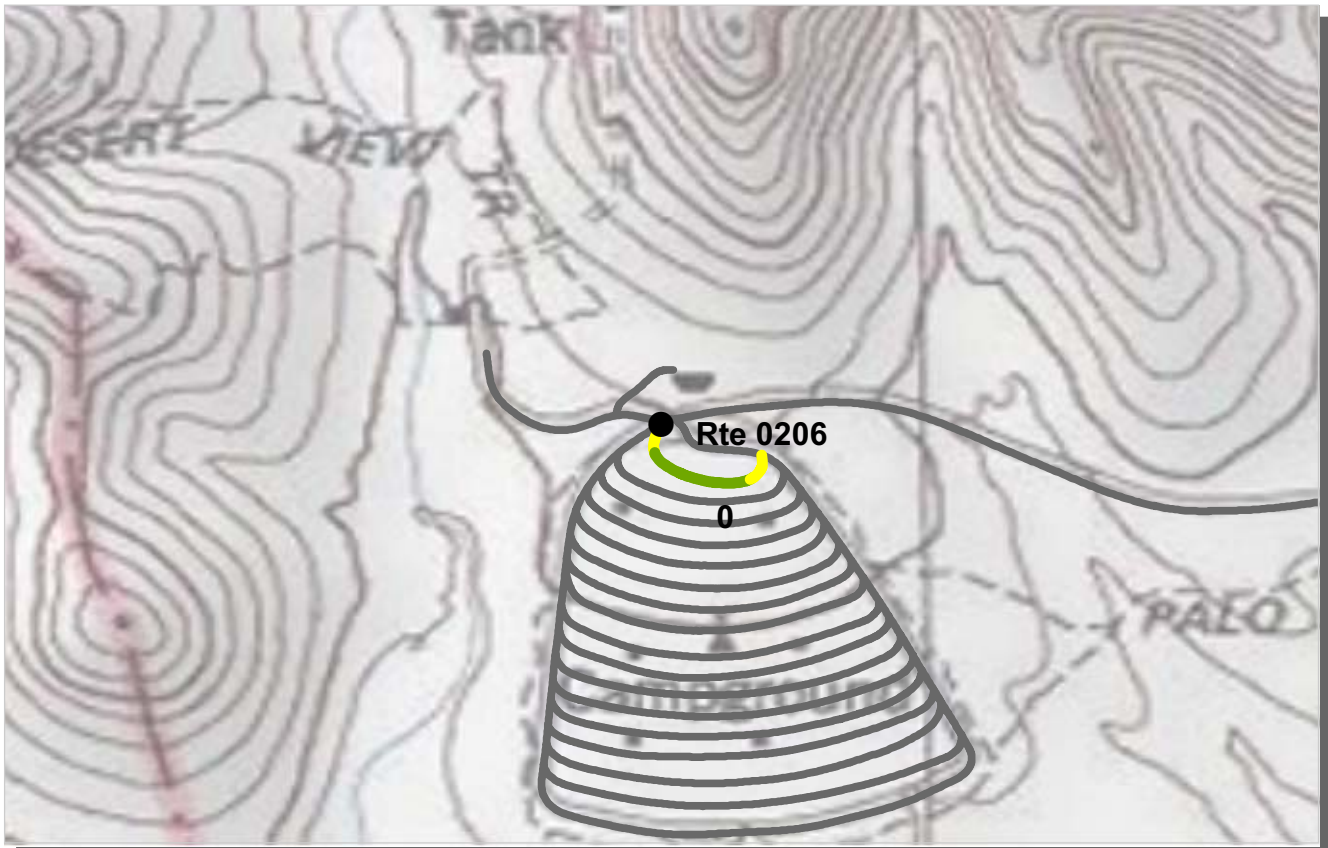
ROUTE: 0206 CAMPGROUND SITES 1-6 ACCESS

Section Number	0				
Section Length (mi)	0.09				
Cross Section Information					
Number of Lanes	1				
Paved Width (ft)	13				
Lane Width (ft)	13				
Roadway Condition Information					
SCR (Surface Condition Rating)	86				
PCR (Pavement Condition Rating)	86				
Distress Index Values					
Structural Crack Index	100				
Transverse Cracking Index	93				
Patching Index	100				
Rutting Index	86				
Roughness Condition Index (RCI)	NC

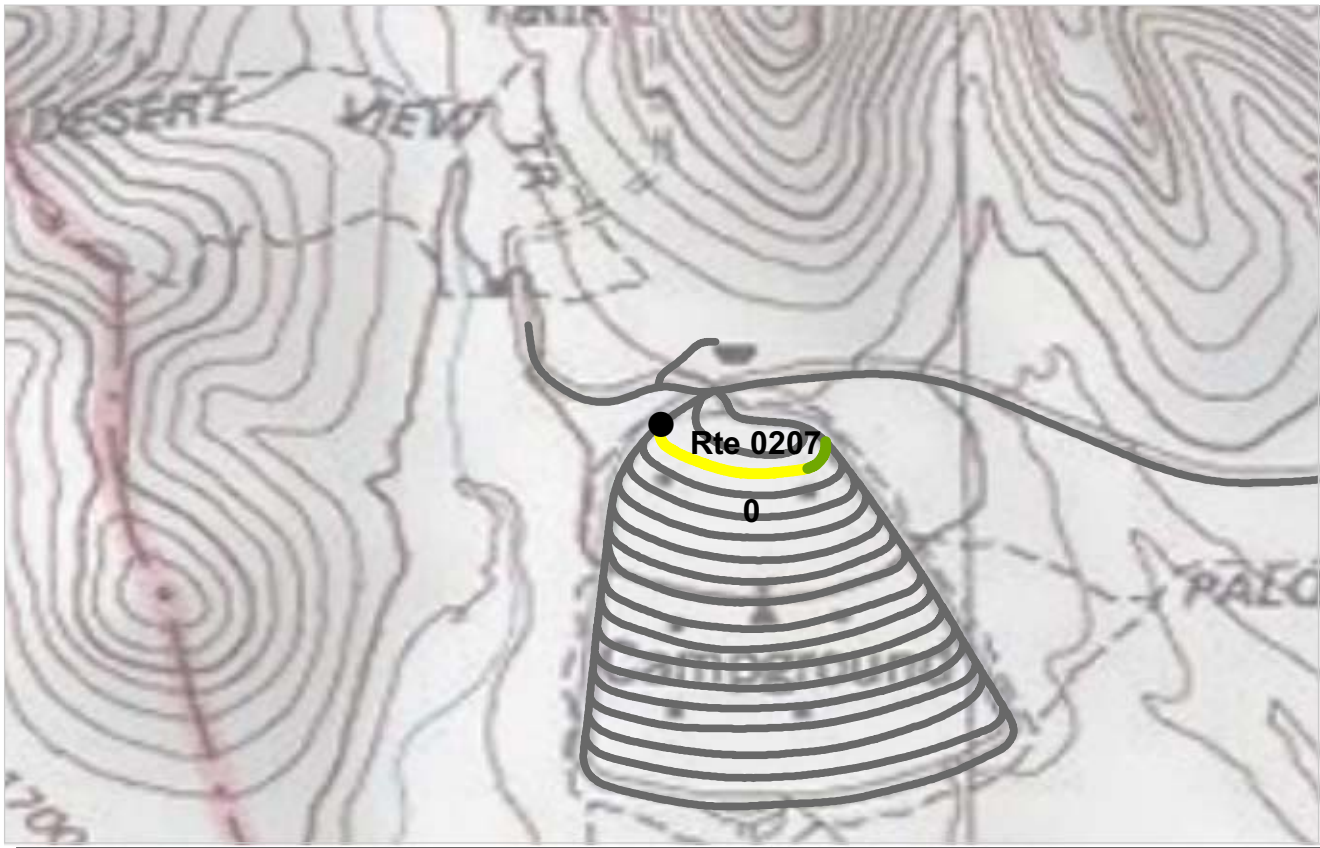
ROUTE: 0207 CAMPGROUND SITES 7-15 ACCESS

Section Number	0				
Section Length (mi)	0.12				
Cross Section Information					
Number of Lanes	1				
Paved Width (ft)	11				
Lane Width (ft)	11				
Roadway Condition Information					
SCR (Surface Condition Rating)	85				
PCR (Pavement Condition Rating)	85				
Distress Index Values					
Structural Crack Index	94				
Transverse Cracking Index	95				
Patching Index	100				
Rutting Index	85				
Roughness Condition Index (RCI)	NC

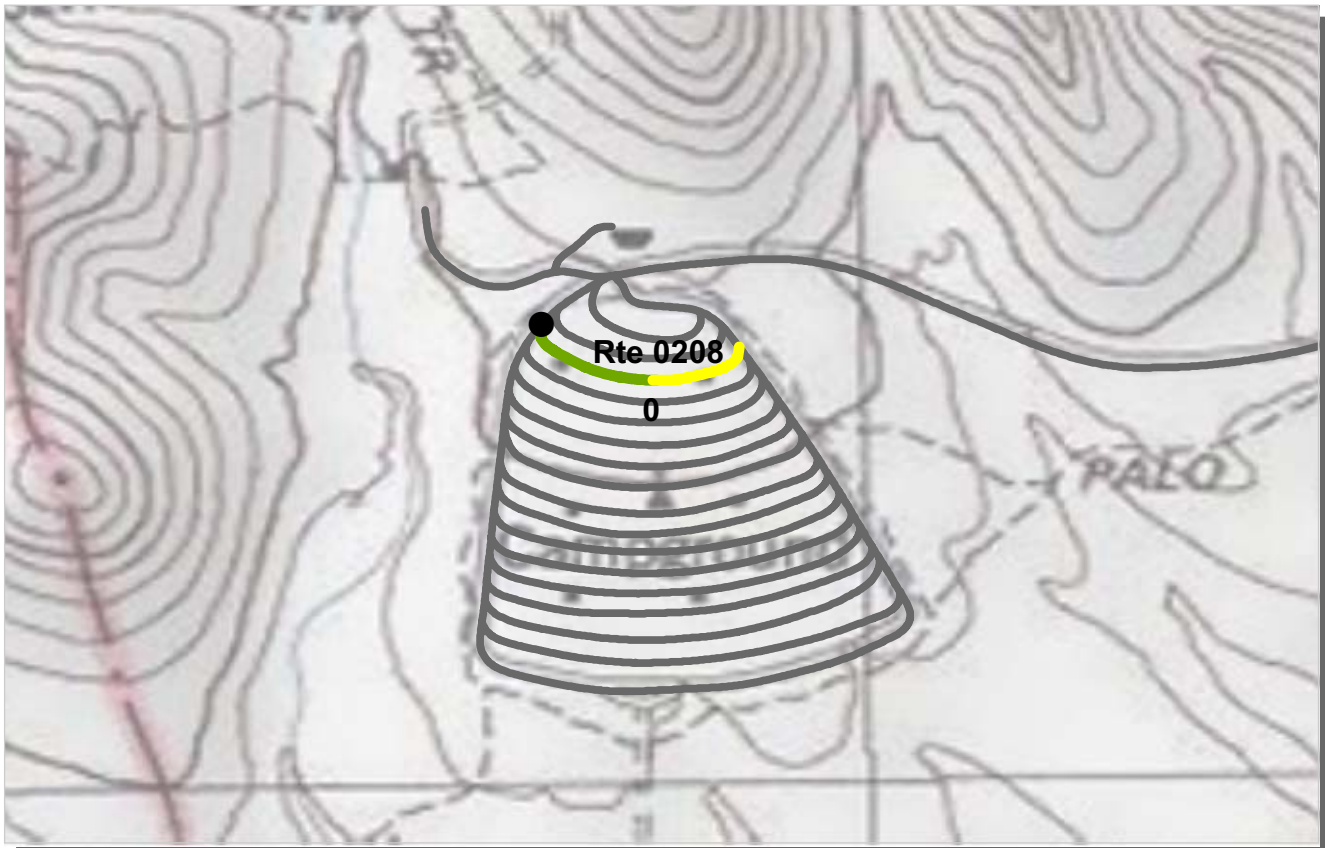
ROUTE: 0208 CAMPGROUND SITES 16-23 ACCESS

Section Number	0				
Section Length (mi)	0.13				
Cross Section Information					
Number of Lanes	1				
Paved Width (ft)	11				
Lane Width (ft)	11				
Roadway Condition Information					
SCR (Surface Condition Rating)	78				
PCR (Pavement Condition Rating)	78				
Distress Index Values					
Structural Crack Index	100				
Transverse Cracking Index	94				
Patching Index	99				
Rutting Index	78				
Roughness Condition Index (RCI)	NC

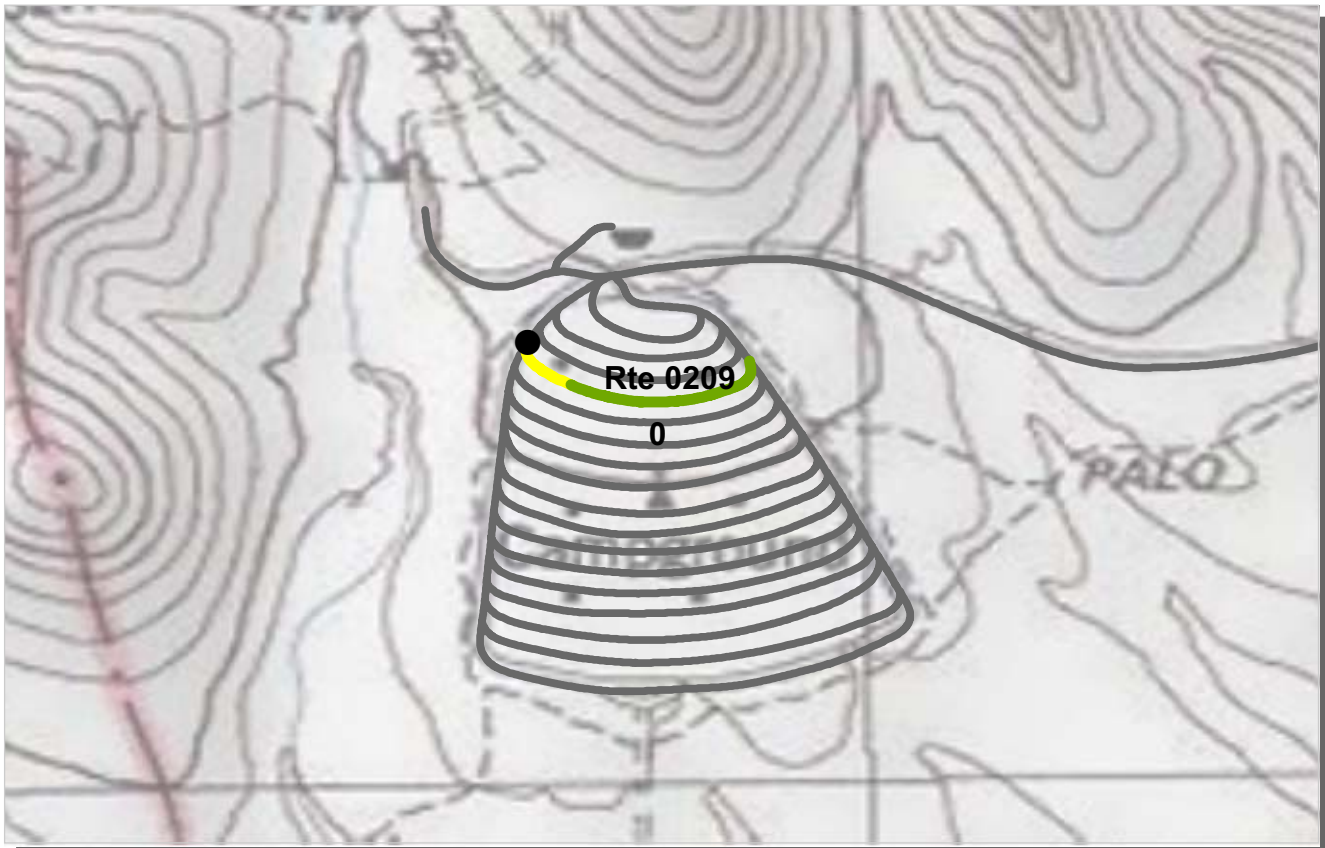
ROUTE: 0209 CAMPGROUND SITES 24-34 ACCESS

Section Number	0				
Section Length (mi)	0.15				
Cross Section Information					
Number of Lanes	1				
Paved Width (ft)	11				
Lane Width (ft)	11				
Roadway Condition Information					
SCR (Surface Condition Rating)	82				
PCR (Pavement Condition Rating)	82				
Distress Index Values					
Structural Crack Index	99				
Transverse Cracking Index	92				
Patching Index	100				
Rutting Index	82				
Roughness Condition Index (RCI)	NC

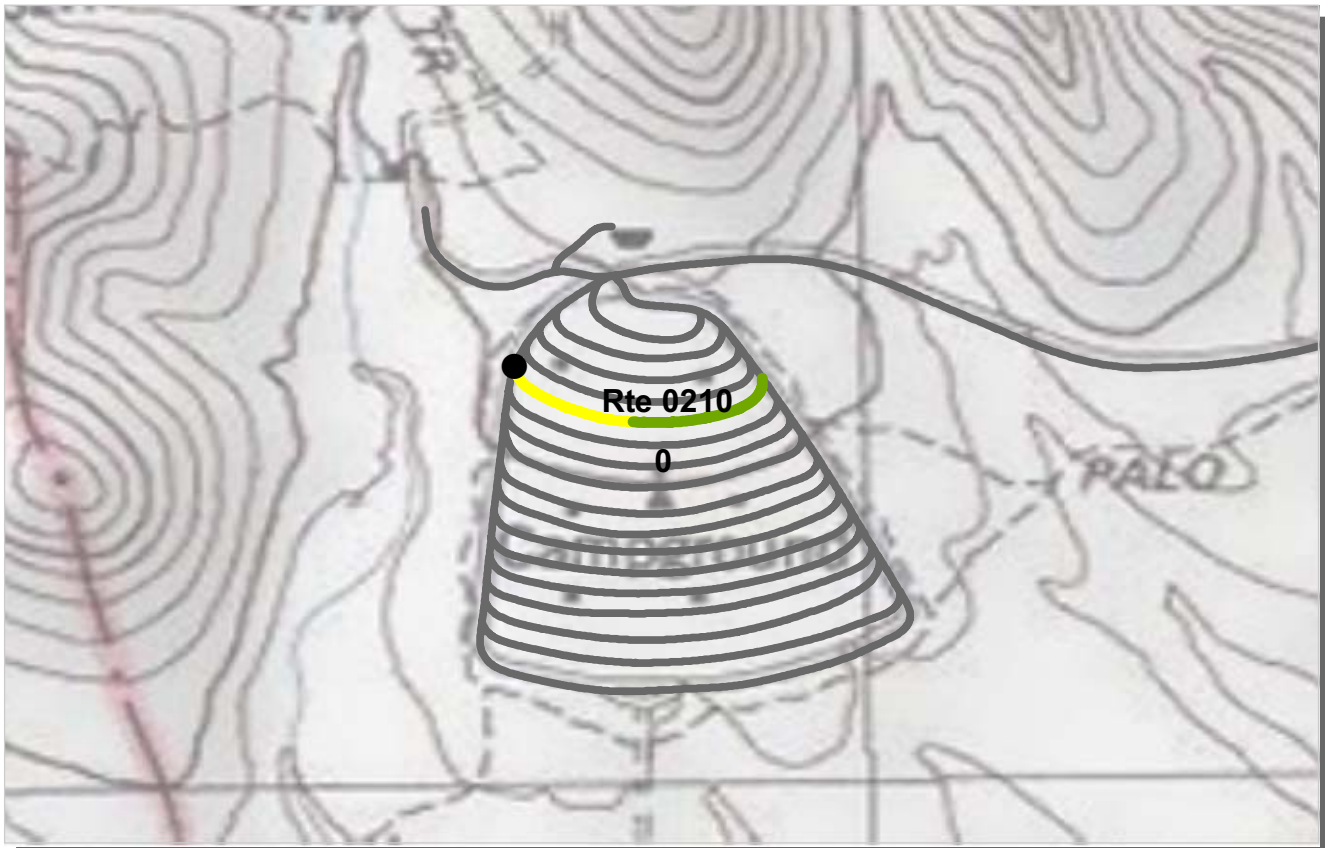
ROUTE: 0210 CAMPGROUND SITES 35-45 ACCESS

Section Number	0				
Section Length (mi)	0.16				
Cross Section Information					
Number of Lanes	1				
Paved Width (ft)	11				
Lane Width (ft)	11				
Roadway Condition Information					
SCR (Surface Condition Rating)	82				
PCR (Pavement Condition Rating)	82				
Distress Index Values					
Structural Crack Index	99				
Transverse Cracking Index	95				
Patching Index	100				
Rutting Index	82				
Roughness Condition Index (RCI)	NC

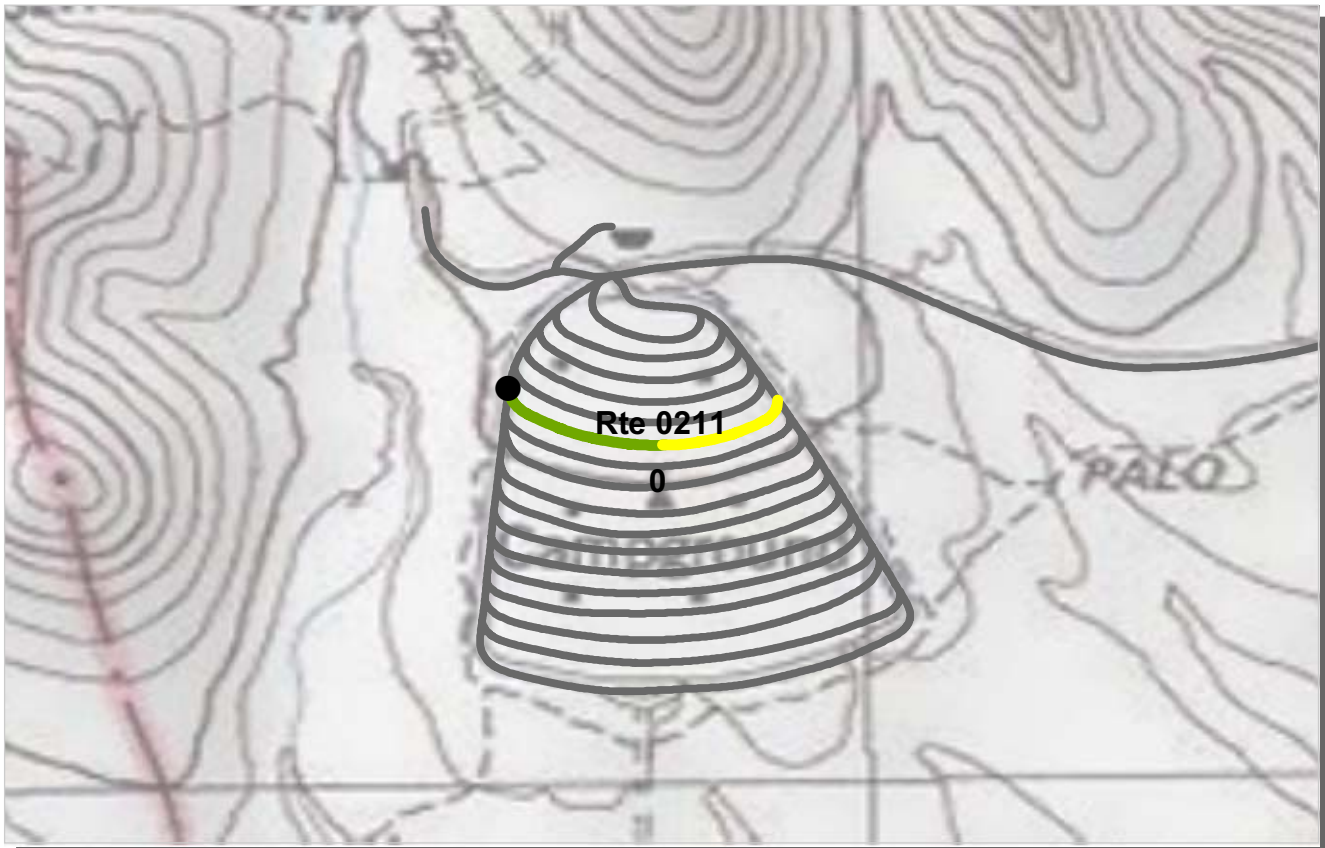
ROUTE: 0211 CAMPGROUND SITES 46-57 ACCESS

Section Number	0				
Section Length (mi)	0.17				
Cross Section Information					
Number of Lanes	1				
Paved Width (ft)	11				
Lane Width (ft)	11				
Roadway Condition Information					
SCR (Surface Condition Rating)	81				
PCR (Pavement Condition Rating)	81				
Distress Index Values					
Structural Crack Index	99				
Transverse Cracking Index	98				
Patching Index	100				
Rutting Index	81				
Roughness Condition Index (RCI)	NC

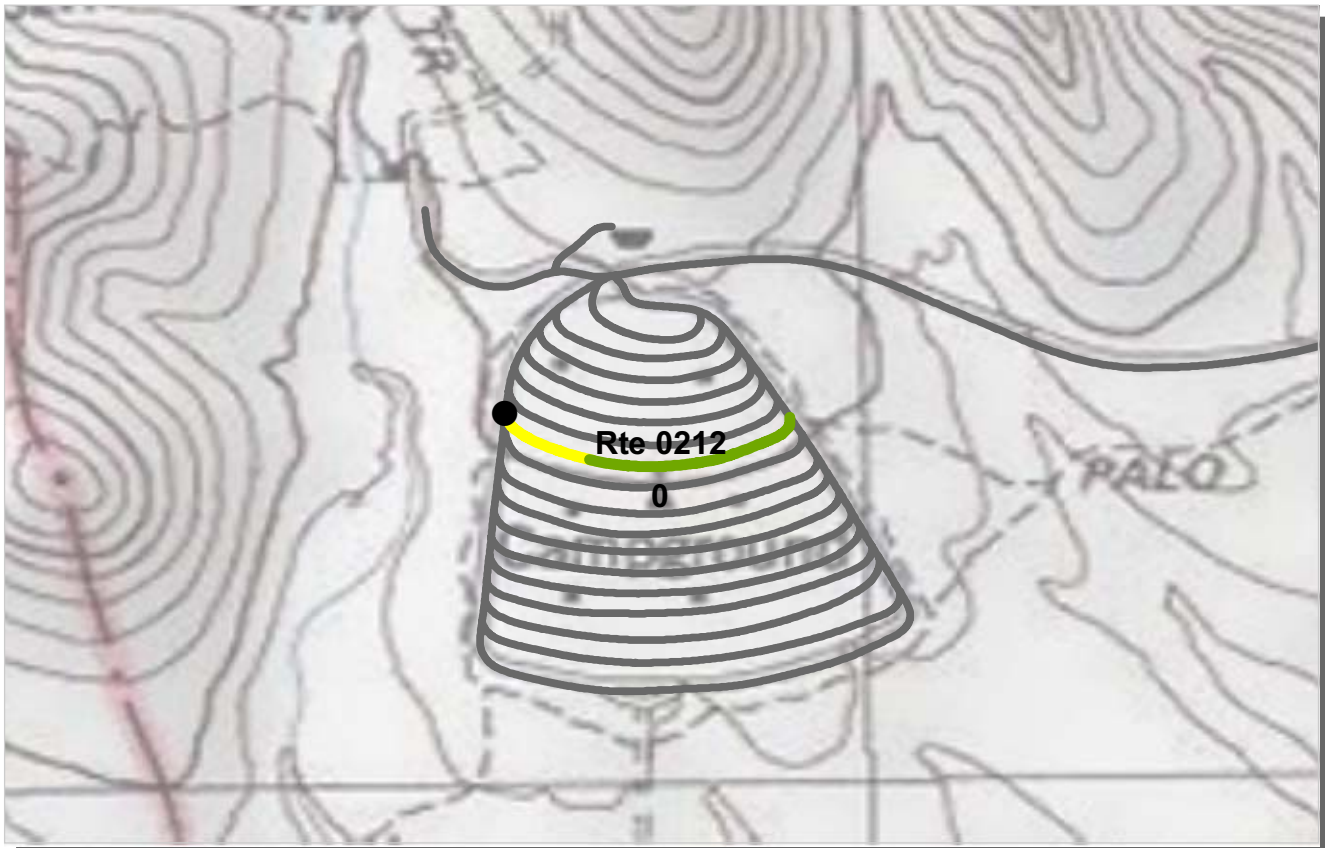
ROUTE: 0212 CAMPGROUND SITES 58-70 ACCESS

Section Number	0				
Section Length (mi)	0.18				
Cross Section Information					
Number of Lanes	1				
Paved Width (ft)	11				
Lane Width (ft)	11				
Roadway Condition Information					
SCR (Surface Condition Rating)	83				
PCR (Pavement Condition Rating)	83				
Distress Index Values					
Structural Crack Index	100				
Transverse Cracking Index	99				
Patching Index	100				
Rutting Index	83				
Roughness Condition Index (RCI)	NC

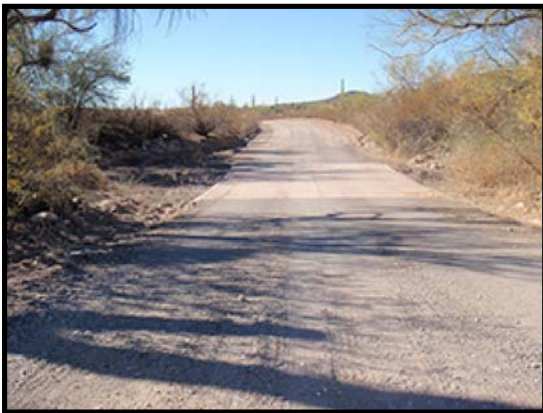
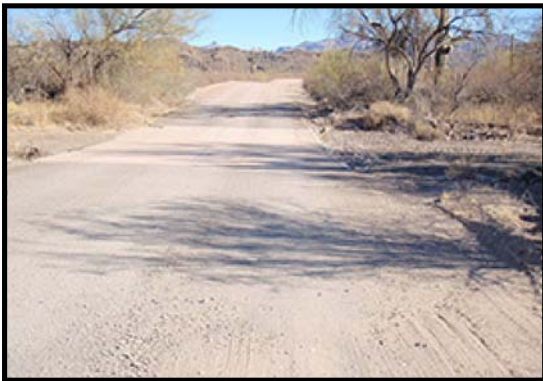
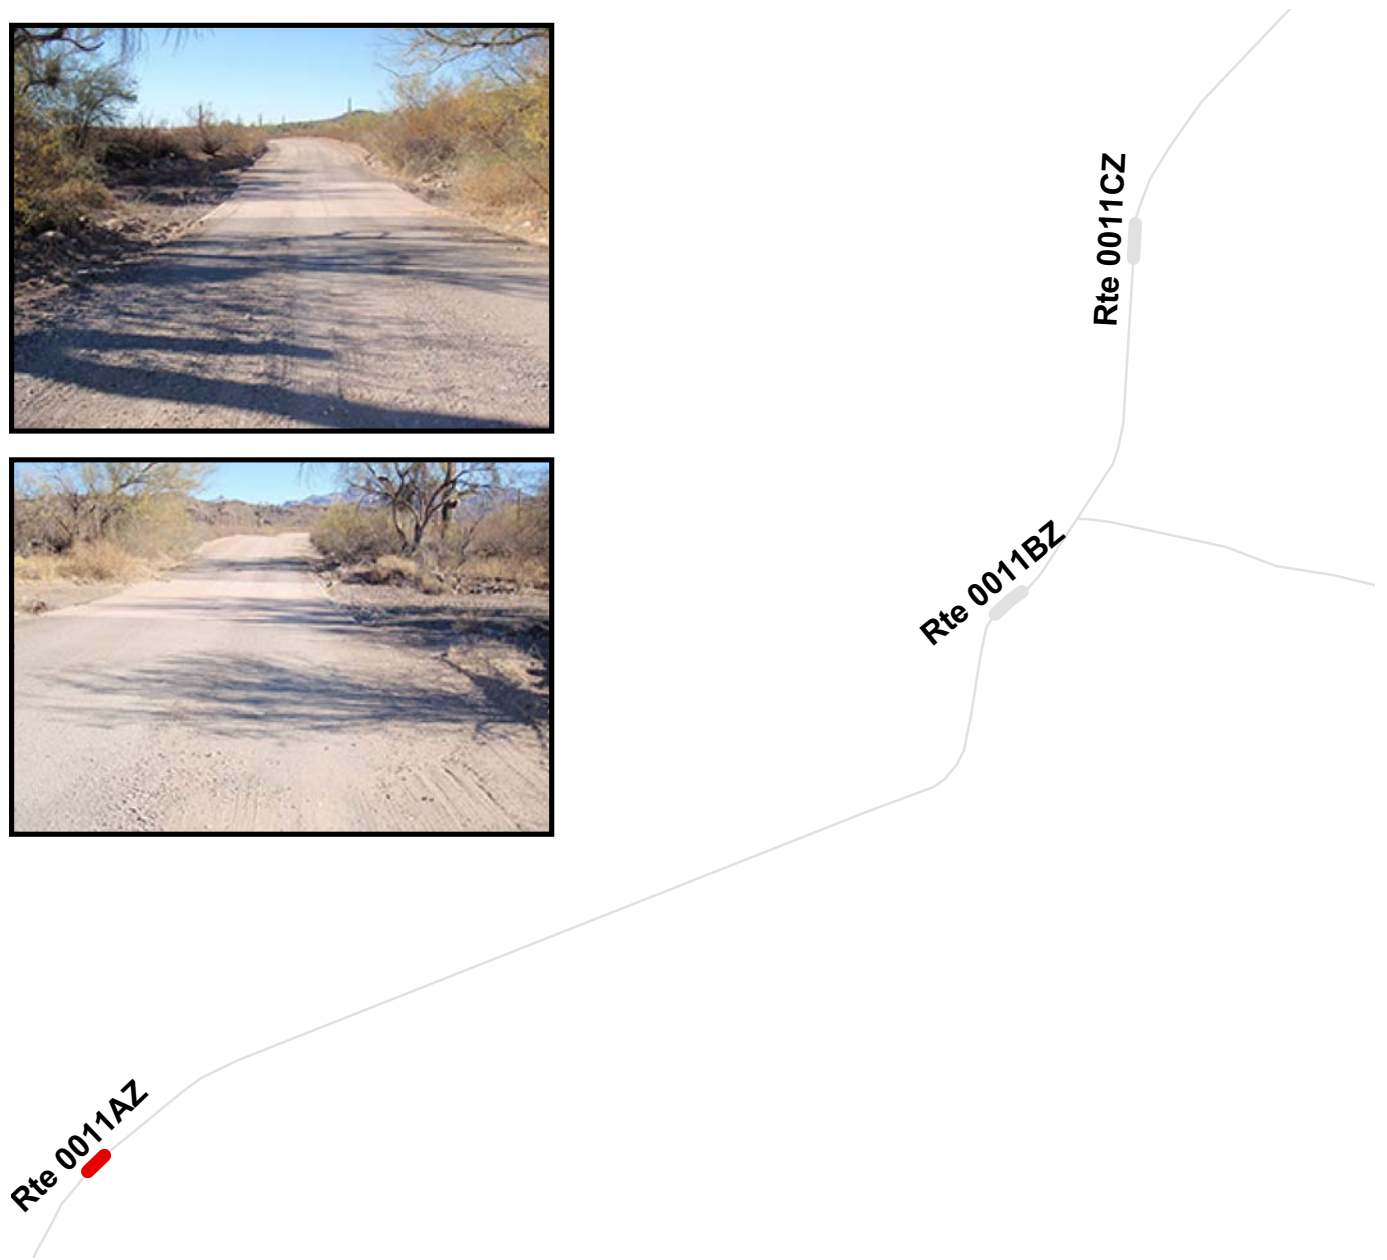
Route Number	Public / NonPublic	Date Visited	Area (sq ft)	Lane Miles *	Paved Length (mi)	Paved Width (ft)
0011AZ	PUBLIC	12/8/2010	1,848	0.03	0.02	17.5
Culverts	Drop Inlets	Gates	Curb & Gutter	Curb	PCR	Surface Type
0	0	0	NO CURB AND GUTTER	NO CURB	GOOD/90	AS

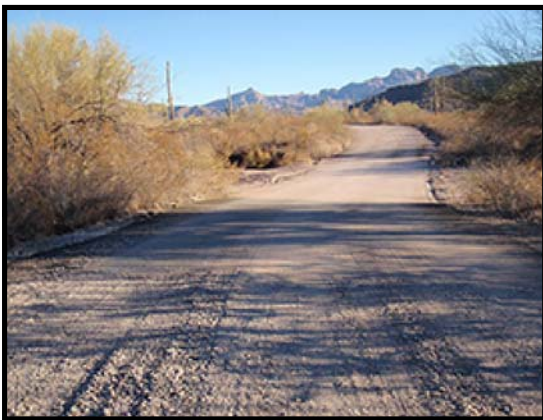
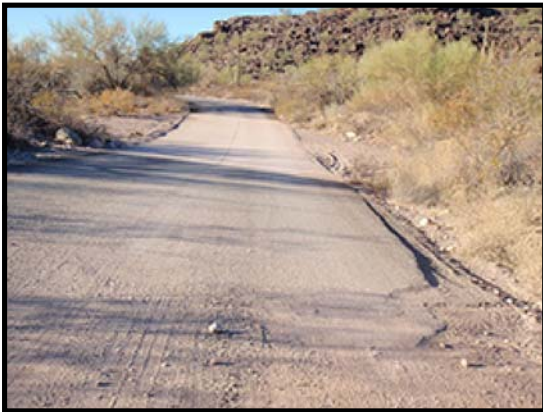
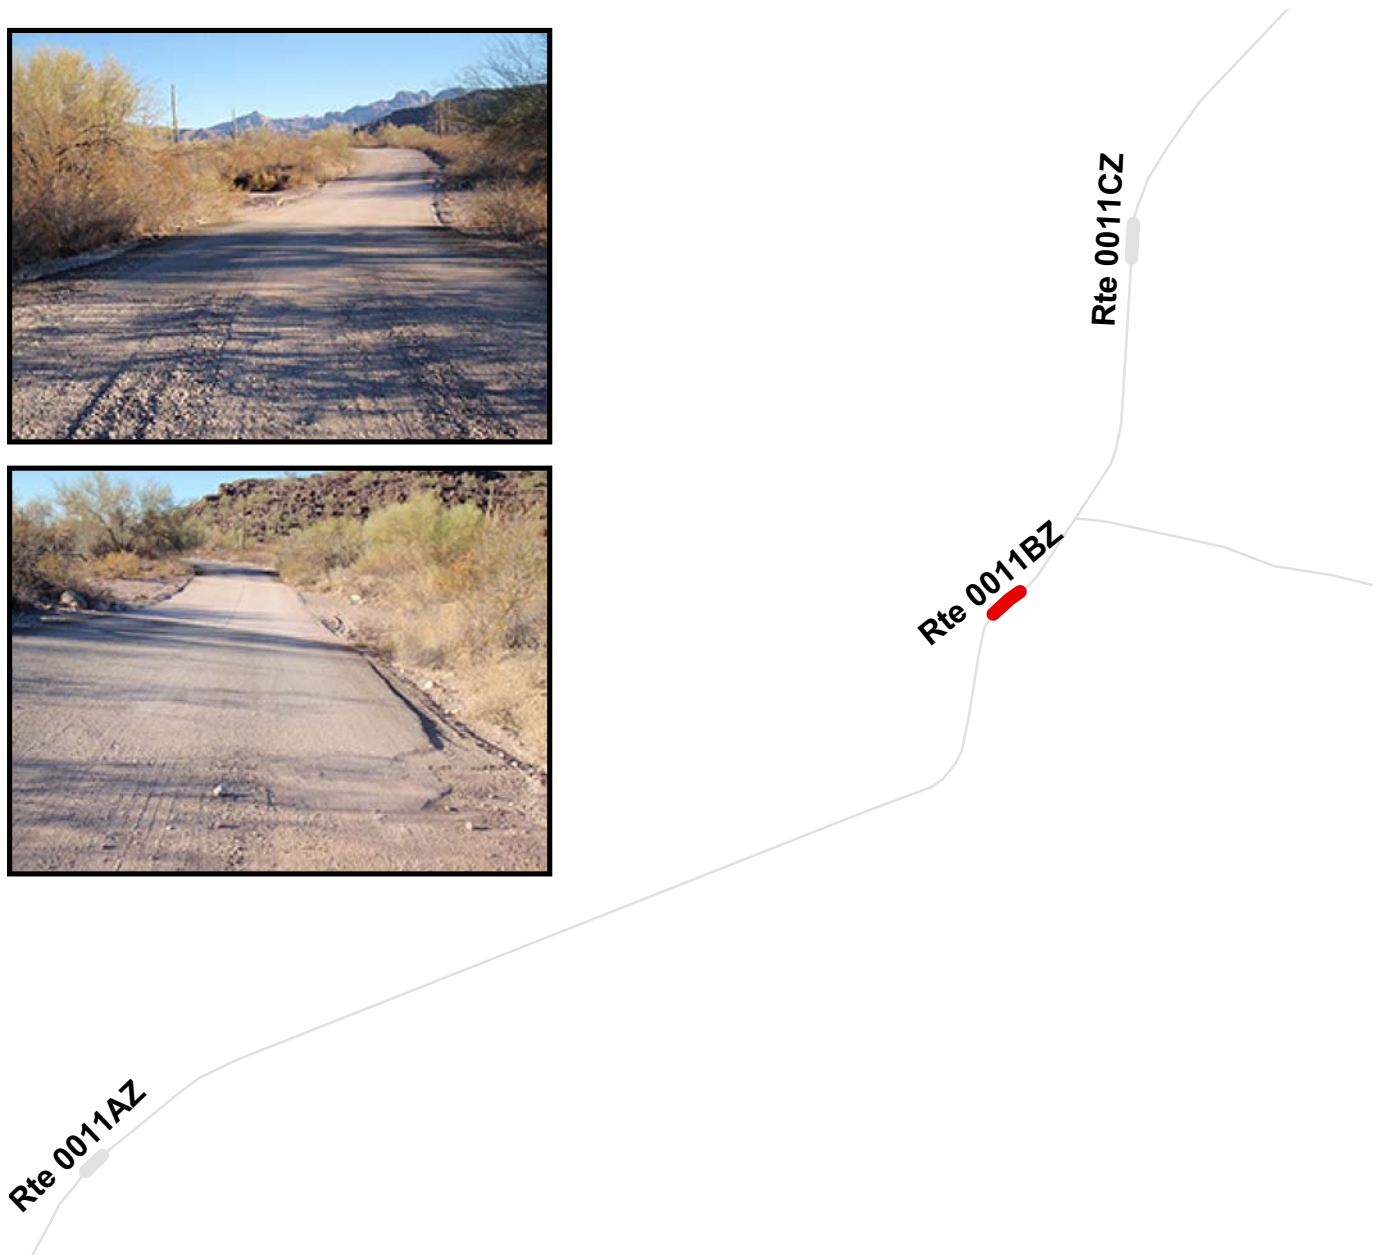
Route 0011BZ

Route Number	Public / NonPublic	Date Visited	Area (sq ft)	Lane Miles *	Paved Length (mi)	Paved Width (ft)
0011BZ	PUBLIC	12/8/2010	2,772	0.05	0.03	17.5
Culverts	Drop Inlets	Gates	Curb & Gutter	Curb	PCR	Surface Type
0	0	0	NO CURB AND GUTTER	NO CURB	GOOD/90	AS

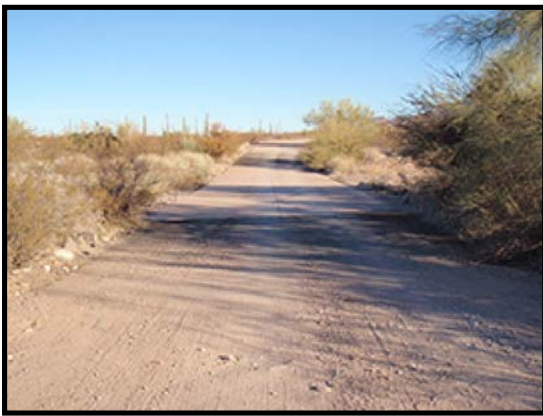
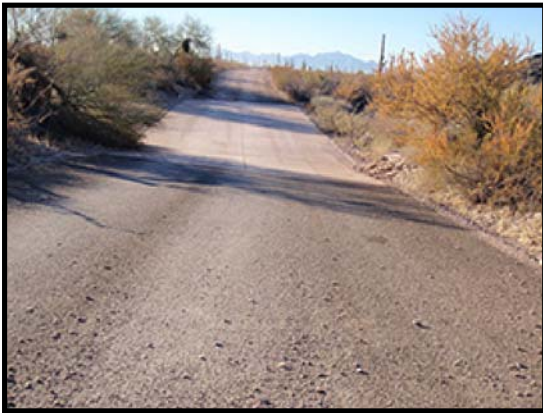
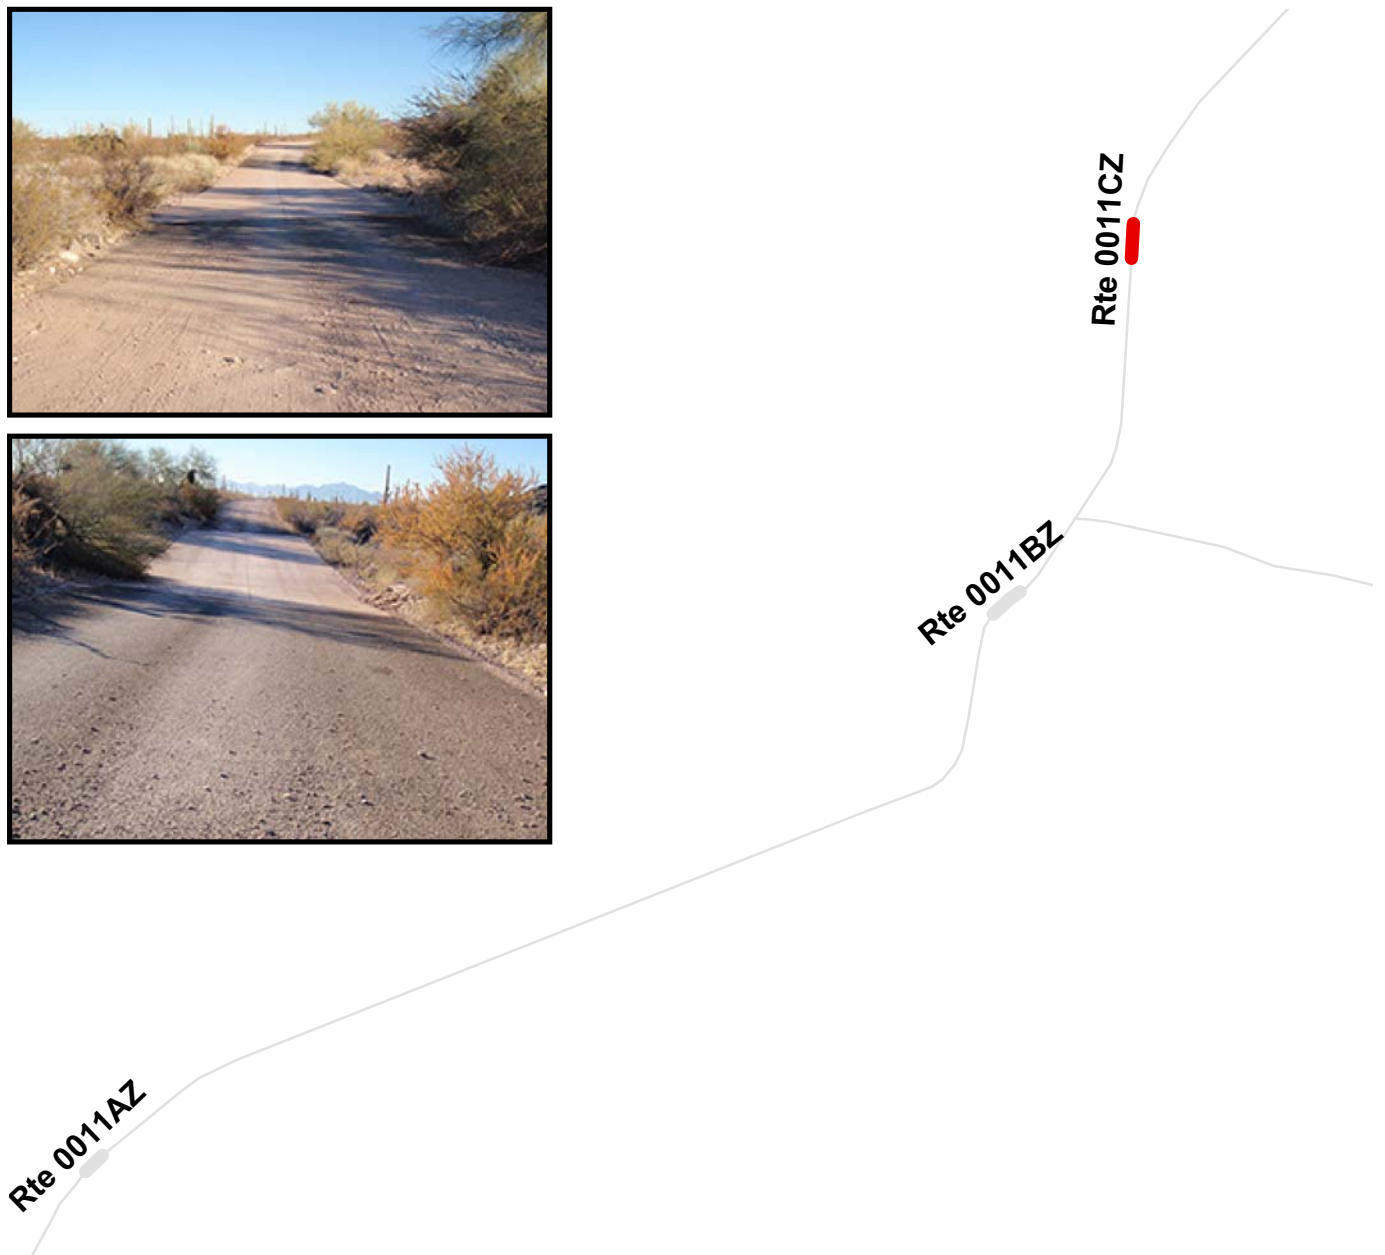
Route 0011CZ

Route Number	Public / NonPublic	Date Visited	Area (sq ft)	Lane Miles *	Paved Length (mi)	Paved Width (ft)
0011CZ	PUBLIC	12/8/2010	3,729	0.06	0.03	21.4
Culverts	Drop Inlets	Gates	Curb & Gutter	Curb	PCR	Surface Type
0	0	0	NO CURB AND GUTTER	NO CURB	FAIR/73	AS

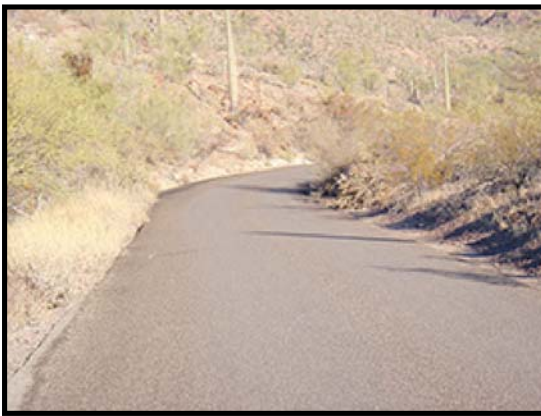
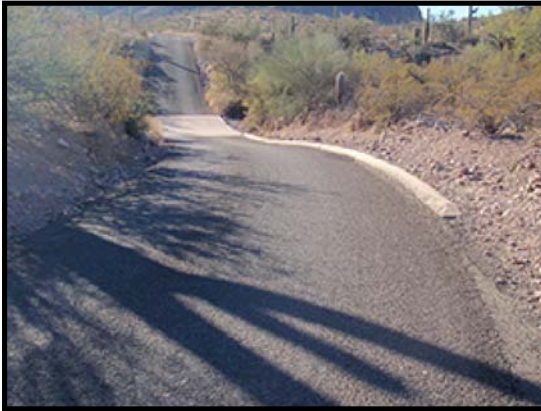
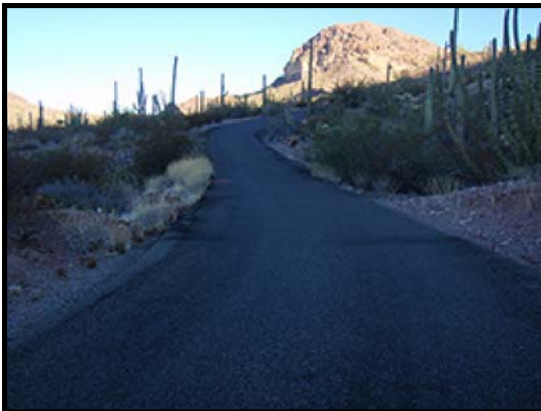
Route 0011DZ

Route Number	Public / NonPublic	Date Visited	Area (sq ft)	Lane Miles *	Paved Length (mi)	Paved Width (ft)
0011DZ	PUBLIC	12/8/2010	206,237	3.55	2.23	17.5
Culverts	Drop Inlets	Gates	Curb & Gutter	Curb	PCR	Surface Type
18	0	0	NO CURB AND GUTTER	CONCRETE CURB	FAIR/73	AS

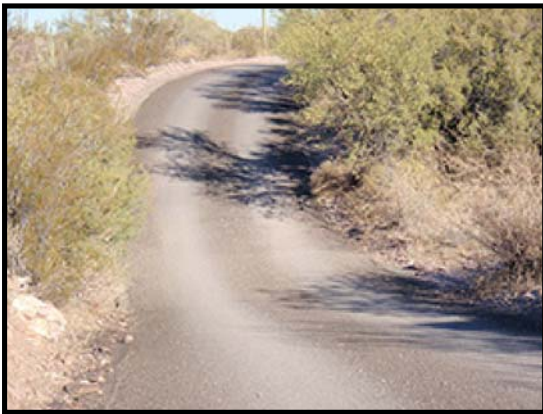
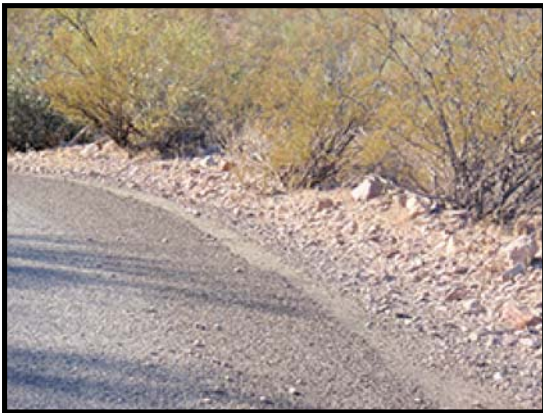
Route 0011EZ

Route Number	Public / NonPublic	Date Visited	Area (sq ft)	Lane Miles *	Paved Length (mi)	Paved Width (ft)
0011EZ	PUBLIC	12/8/2010	2,587	0.05	0.03	17.5
Culverts	Drop Inlets	Gates	Curb & Gutter	Curb	PCR	Surface Type
0	0	0	NO CURB AND GUTTER	NO CURB	GOOD/90	AS
