Federal Lands Highway Road Inventory Program

Road Inventory and Condition Assessment

Organ Pipe Cactus National Monument ORPI

Cycle 5 Report

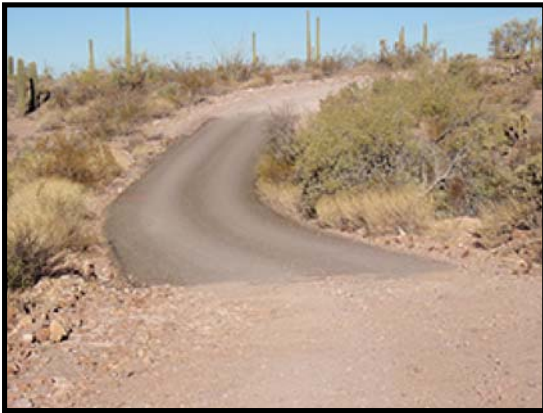
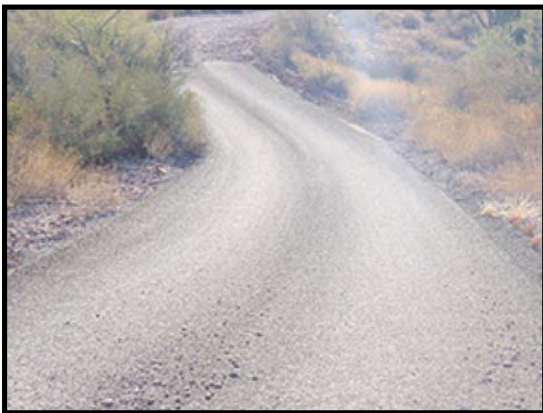
Route 0011FZ

Route Number	Public / NonPublic	Date Visited	Area (sq ft)	Lane Miles *	Paved Length (mi)	Paved Width (ft)
0011FZ	PUBLIC	12/8/2010	2,218	0.04	0.02	17.5
Culverts	Drop Inlets	Gates	Curb & Gutter	Curb	PCR	Surface Type
1	0	0	NO CURB AND GUTTER	NO CURB	GOOD/90	AS

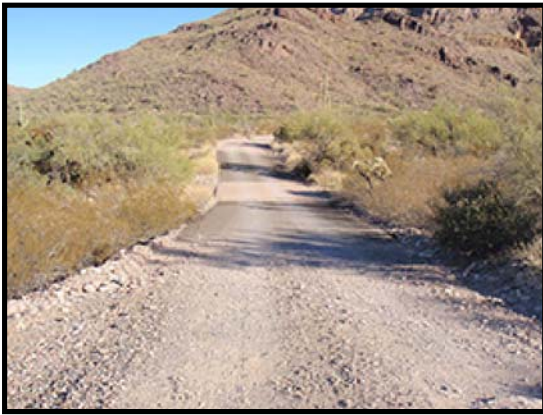
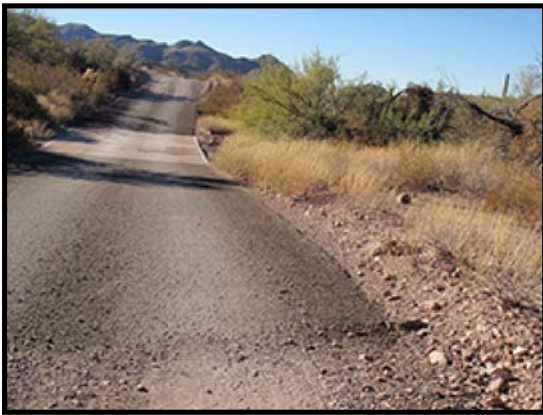
Route 0011GZ

Route Number	Public / NonPublic	Date Visited	Area (sq ft)	Lane Miles *	Paved Length (mi)	Paved Width (ft)
0011GZ	PUBLIC	12/8/2010	2,310	0.04	0.03	17.5
Culverts	Drop Inlets	Gates	Curb & Gutter	Curb	PCR	Surface Type
0	0	0	NO CURB AND GUTTER	NO CURB	GOOD/90	AS

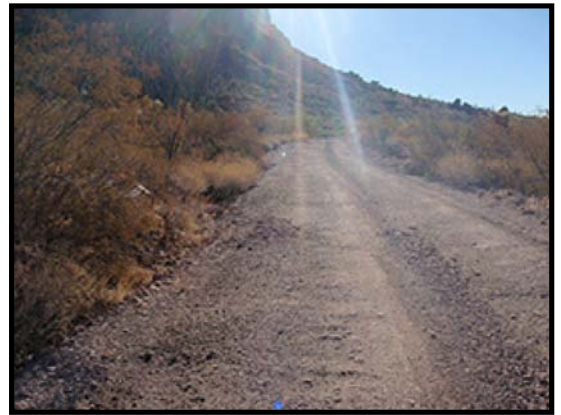
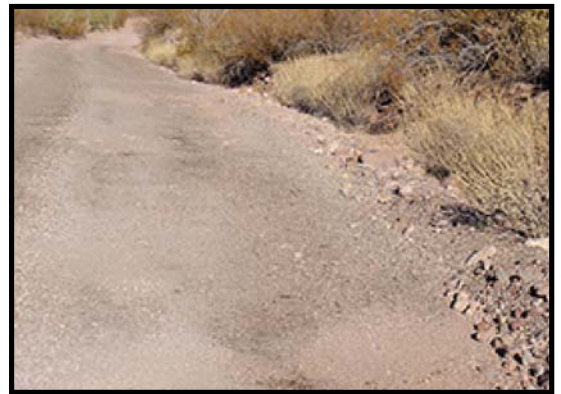
Route 0011HZ

Route Number	Public / NonPublic	Date Visited	Area (sq ft)	Lane Miles *	Paved Length (mi)	Paved Width (ft)
0011HZ	PUBLIC	12/8/2010	3,511	0.06	0.04	17.5
Culverts	Drop Inlets	Gates	Curb & Gutter	Curb	PCR	Surface Type
0	0	0	NO CURB AND GUTTER	NO CURB	POOR/45	AS

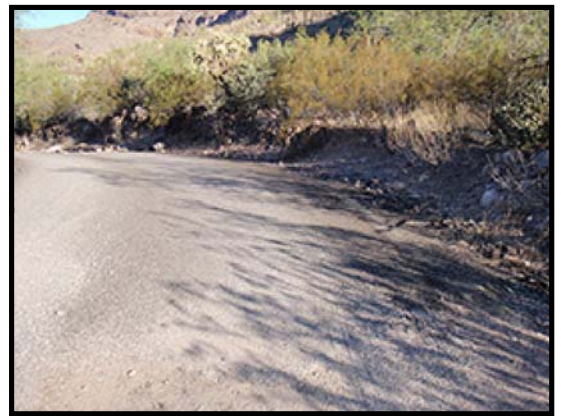
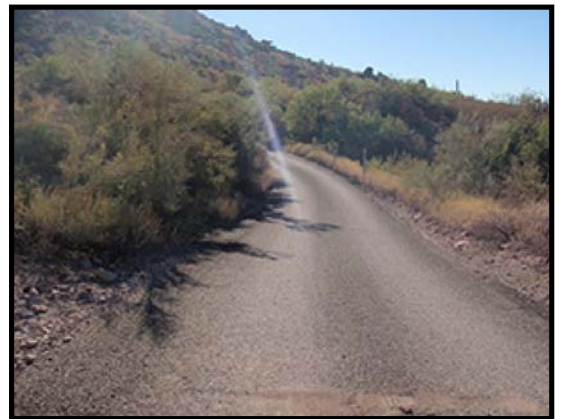
Route 0011IZ

Route Number	Public / NonPublic	Date Visited	Area (sq ft)	Lane Miles *	Paved Length (mi)	Paved Width (ft)
0011IZ	PUBLIC	12/8/2010	6,191	0.11	0.07	17.5
Culverts	Drop Inlets	Gates	Curb & Gutter	Curb	PCR	Surface Type
0	0	0	NO CURB AND GUTTER	NO CURB	GOOD/90	AS

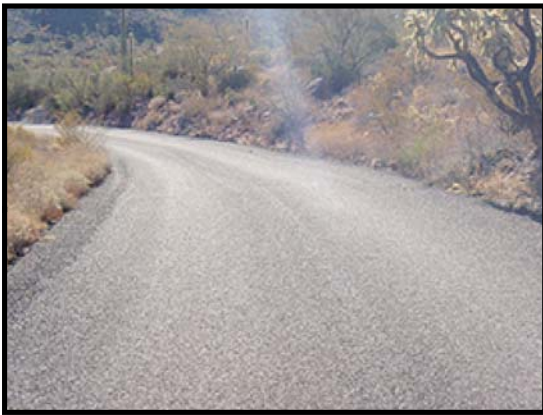
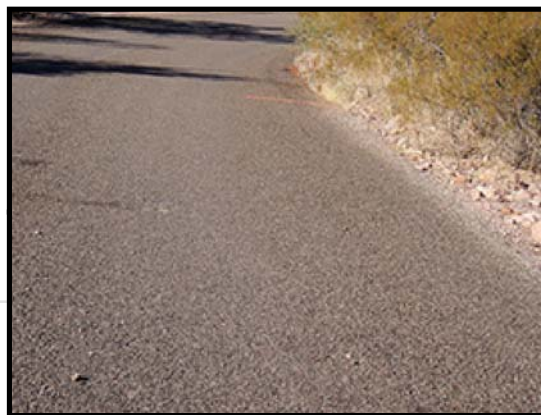
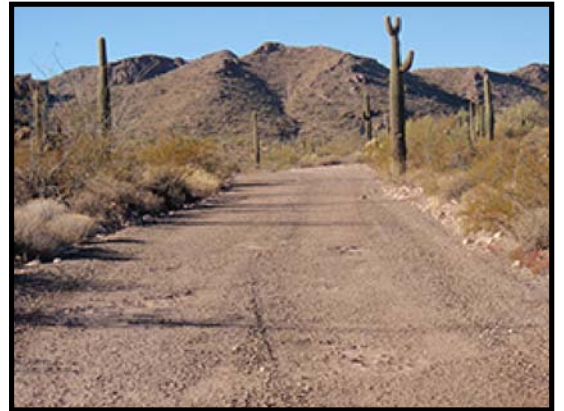
Route 0011JZ

Route Number	Public / NonPublic	Date Visited	Area (sq ft)	Lane Miles *	Paved Length (mi)	Paved Width (ft)
0011JZ	PUBLIC	12/8/2010	31,046	0.54	0.34	17.5
Culverts	Drop Inlets	Gates	Curb & Gutter	Curb	PCR	Surface Type
1	0	0	NO CURB AND GUTTER	NO CURB	GOOD/90	AS

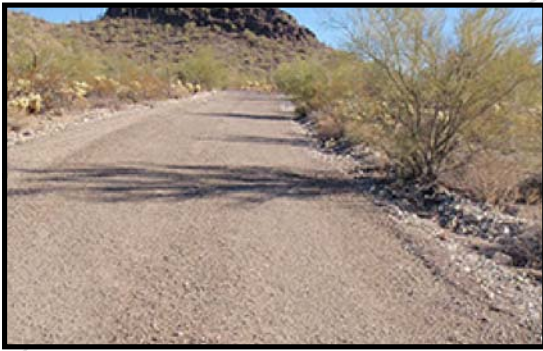
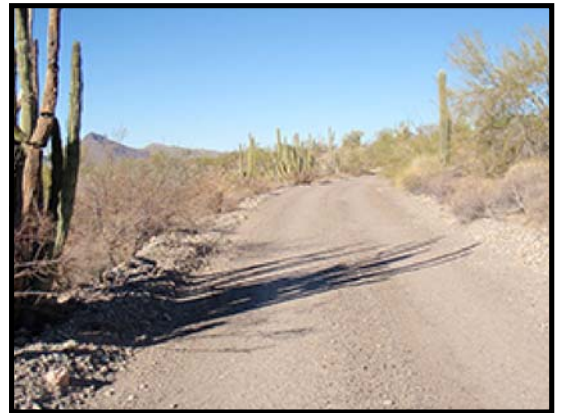
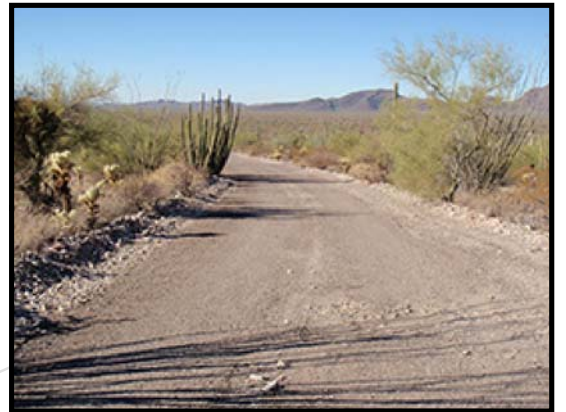
Route 0011NZ

Route Number	Public / NonPublic	Date Visited	Area (sq ft)	Lane Miles *	Paved Length (mi)	Paved Width (ft)
0011NZ	PUBLIC	12/8/2010	16,817	0.29	0.18	17.5
Culverts	Drop Inlets	Gates	Curb & Gutter	Curb	PCR	Surface Type
0	0	0	NO CURB AND GUTTER	NO CURB	FAIR/73	AS

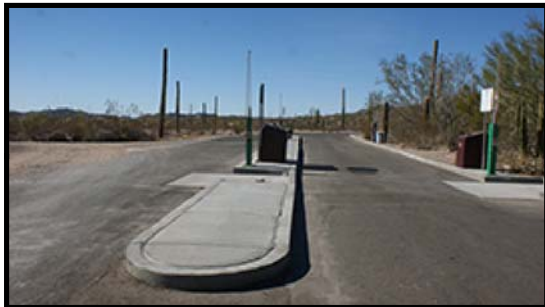
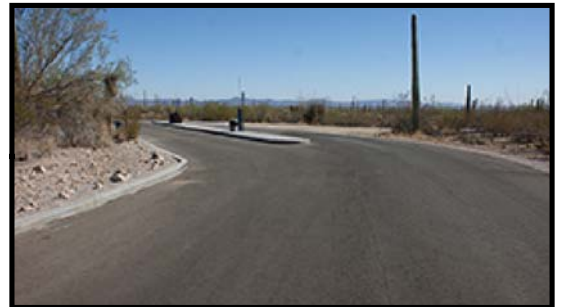
Route Number	Public / NonPublic	Date Visited	Area (sq ft)	Lane Miles *	Surface Type
0908	PUBLIC	12/8/2010	7,620	0.13	AS
Culverts	Drop Inlets	Gates	Curb & Gutter	Curb	PCR
0	0	0	NO CURB AND GUTTER	CONCRETE CURB	GOOD/90

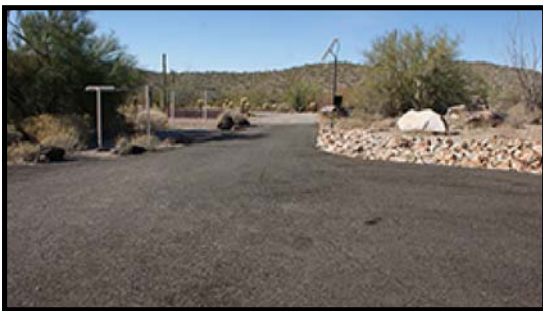
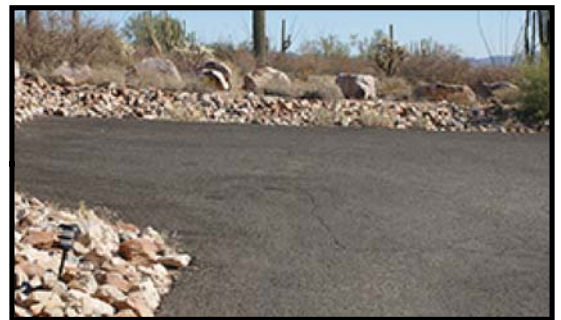
Route Number	Public / NonPublic	Date Visited	Area (sq ft)	Lane Miles *	Surface Type
0909	NONPUBLIC	12/8/2010	2,637	0.05	AS
Culverts	Drop Inlets	Gates	Curb & Gutter	Curb	PCR
0	0	0	NO CURB AND GUTTER	NO CURB	FAIR/73

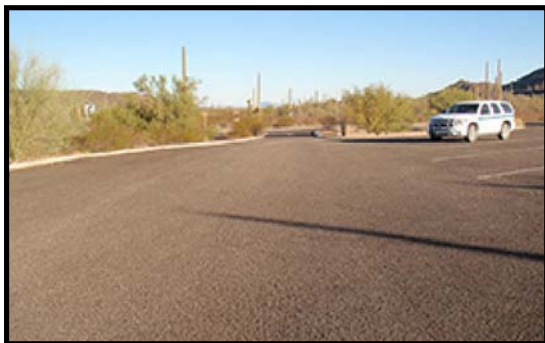
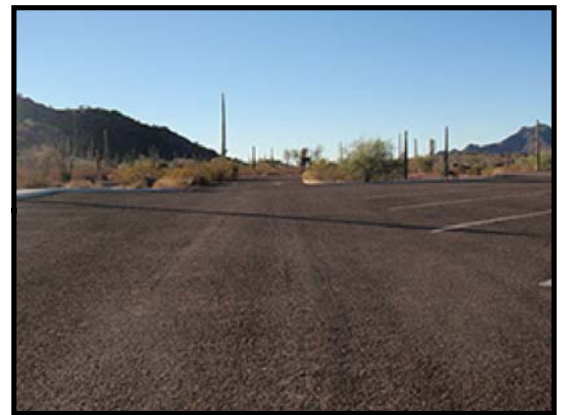
Route Number	Public / NonPublic	Date Visited	Area (sq ft)	Lane Miles *	Surface Type
0910	PUBLIC	12/8/2010	28,558	0.49	AS
Culverts	Drop Inlets	Gates	Curb & Gutter	Curb	PCR
1	0	0	NO CURB AND GUTTER	CONCRETE CURB	GOOD/90

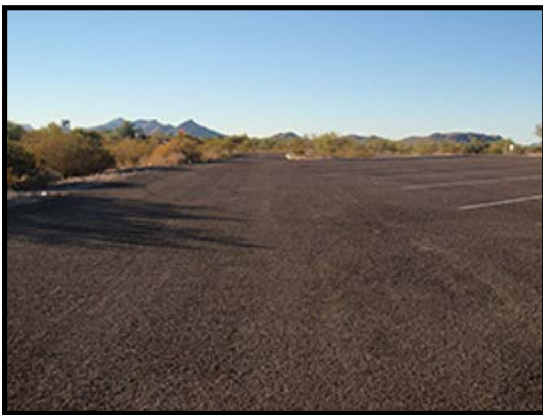
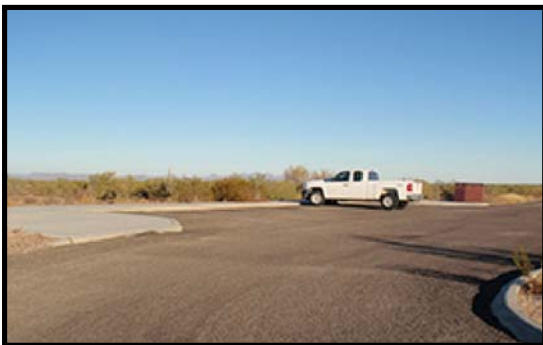
Route Number	Public / NonPublic	Date Visited	Area (sq ft)	Lane Miles *	Surface Type
0911	PUBLIC	12/8/2010	30,492	0.53	AS
Culverts	Drop Inlets	Gates	Curb & Gutter	Curb	PCR
0	0	0	NO CURB AND GUTTER	CONCRETE CURB	GOOD/90

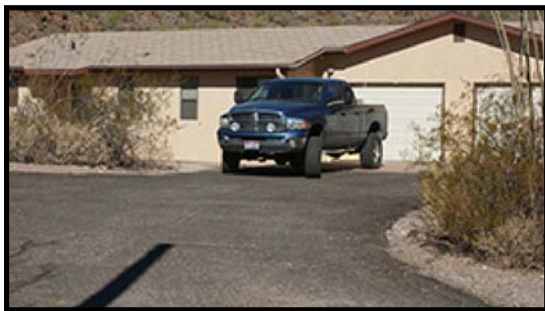
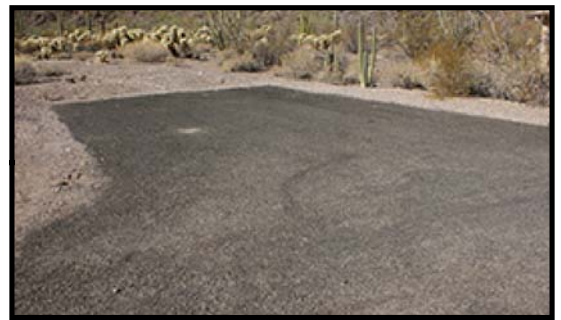
Route Number	Public / NonPublic	Date Visited	Area (sq ft)	Lane Miles *	Surface Type
0912	NONPUBLIC	12/8/2010	1,746	0.03	AS
Culverts	Drop Inlets	Gates	Curb & Gutter	Curb	PCR
0	0	0	NO CURB AND GUTTER	NO CURB	GOOD/90
