Federal Lands Highway Road Inventory Program

Road Inventory and Condition Assessment

Ozark National Scenic Riverways OZAR

Cycle 5 Report

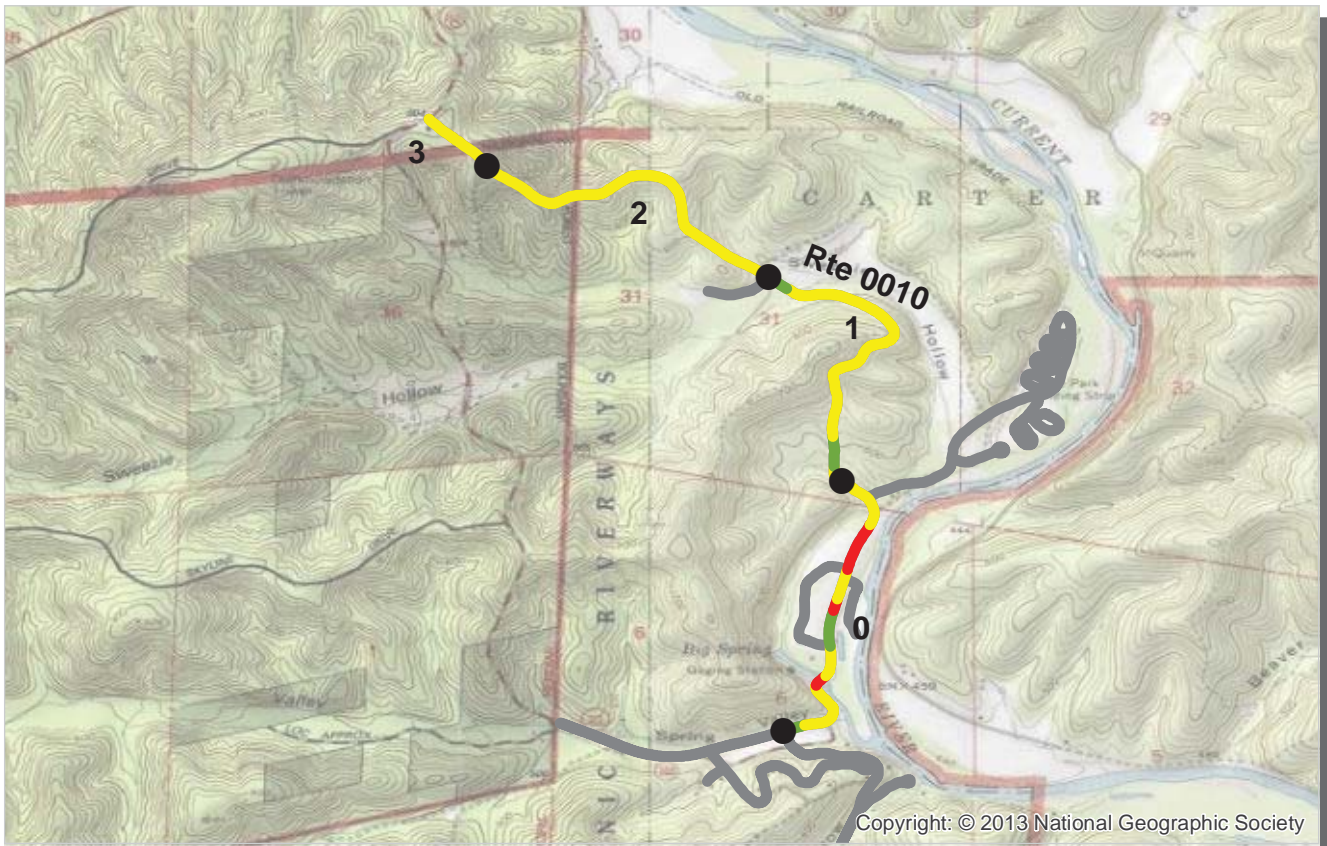
ROUTE: 0010 PEA VINE ROAD

Section Number	0	1	2	3	
Section Length (mi)	1.00	1.00	1.00	0.22	
Cross Section Information					
Number of Lanes	2	2	2	2	
Paved Width (ft)	22	20	19	19	
Lane Width (ft)	9	9	9	9	
Roadway Condition Information					
SCR (Surface Condition Rating)	63	NC	NC	88	
PCR (Pavement Condition Rating)	64	73	73	75	
Distress Index Values					
Structural Crack Index	63	NC	NC	98	
Transverse Cracking Index	90	NC	NC	100	
Patching Index	100	NC	NC	100	
Rutting Index	92	NC	NC	88	
Roughness Condition Index (RCI)	66	NC	NC	56

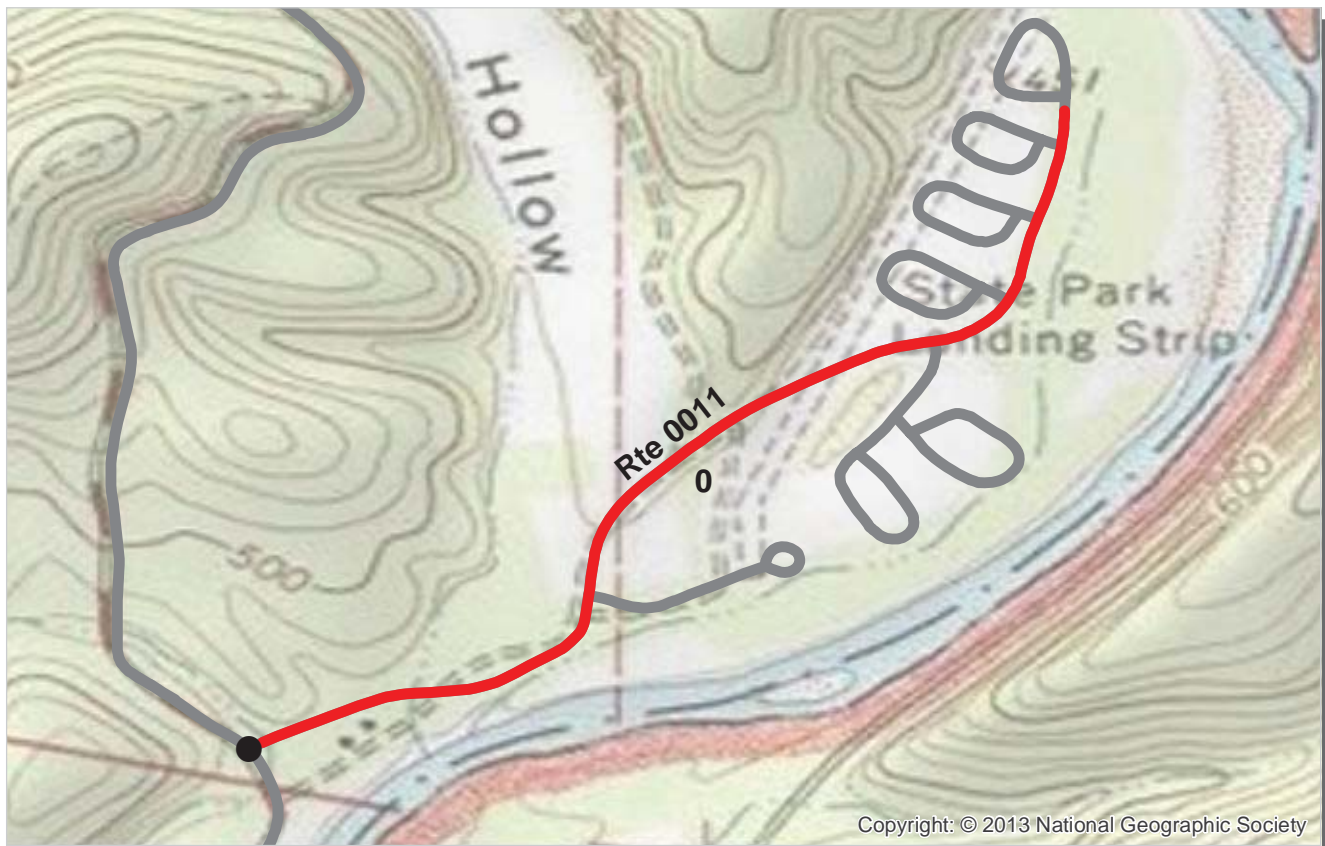
ROUTE: 0011 BIG SPRING CAMPGROUND ROAD

Section Number	0				
Section Length (mi)	0.83				
Cross Section Information					
Number of Lanes	2				
Paved Width (ft)	21				
Lane Width (ft)	10				
Roadway Condition Information					
SCR (Surface Condition Rating)	NC				
PCR (Pavement Condition Rating)	45				
Distress Index Values					
Structural Crack Index	NC				
Transverse Cracking Index	NC				
Patching Index	NC				
Rutting Index	NC				
Roughness Condition Index (RCI)	NC

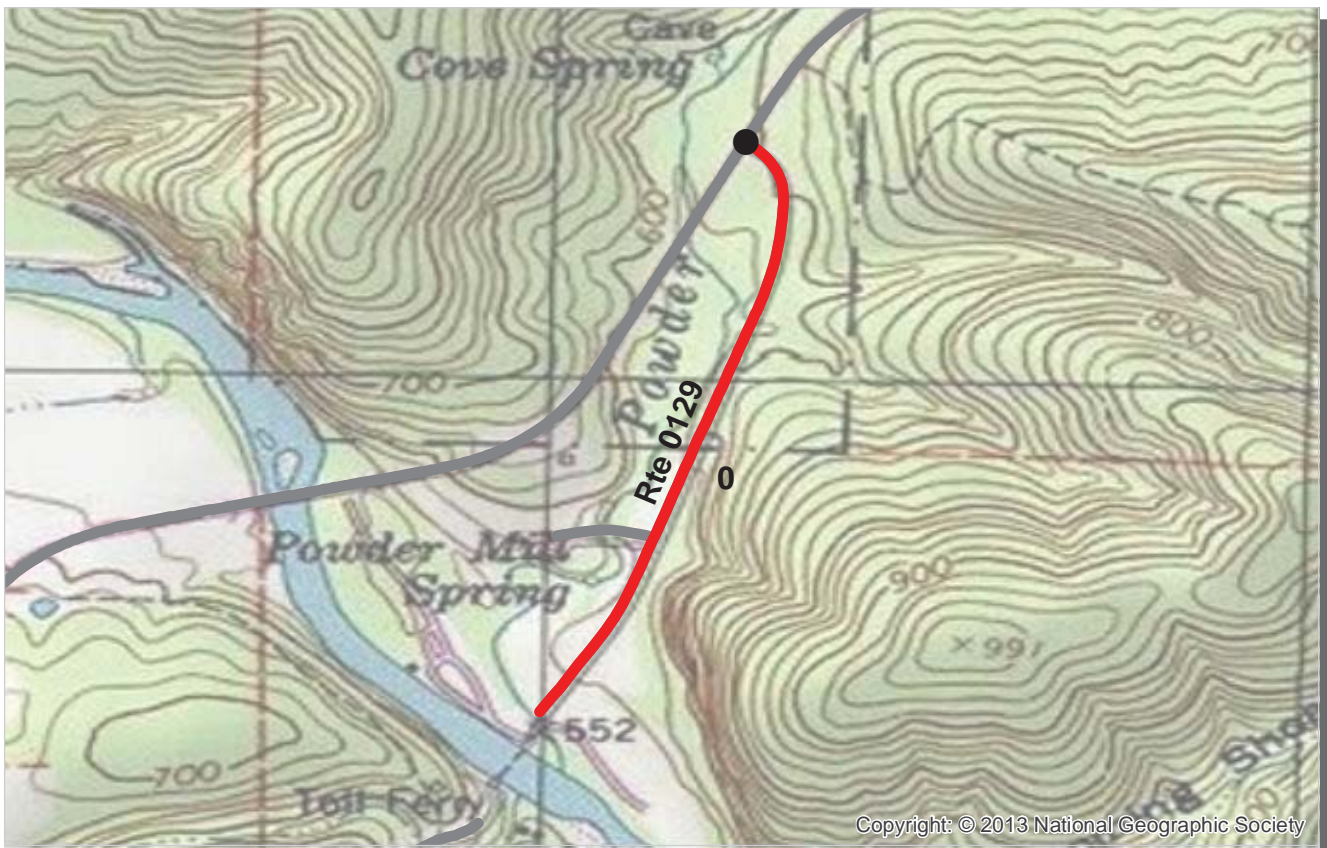
ROUTE: 0129 OLD STATE HIGHWAY 106 EAST ROAD

Section Number	0				
Section Length (mi)	0.64				
Cross Section Information					
Number of Lanes	2				
Paved Width (ft)	19				
Lane Width (ft)	9				
Roadway Condition Information					
SCR (Surface Condition Rating)	0				
PCR (Pavement Condition Rating)	23				
Distress Index Values					
Structural Crack Index	0				
Transverse Cracking Index	96				
Patching Index	100				
Rutting Index	94				
Roughness Condition Index (RCI)	58

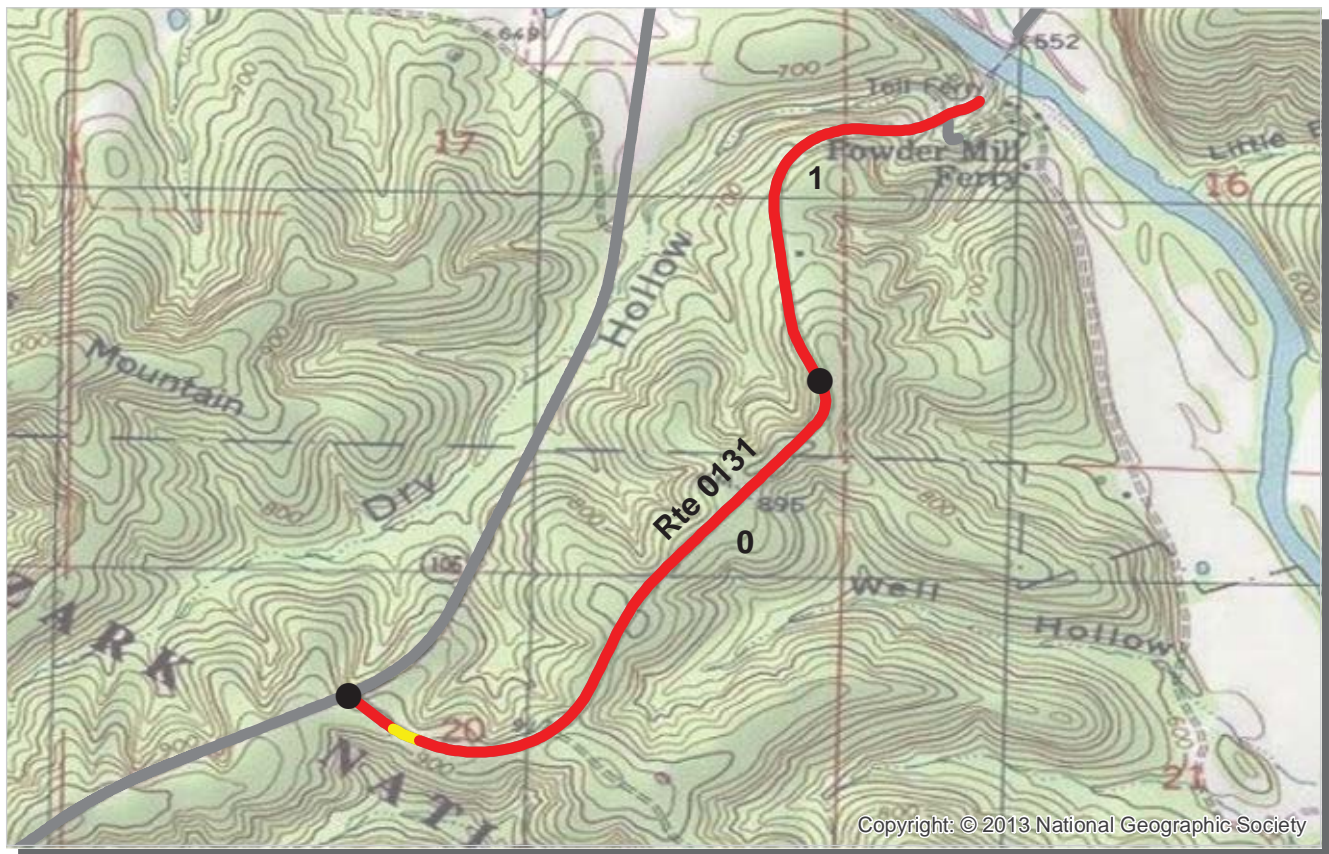
ROUTE: 0131 OLD STATE HIGHWAY 106 WEST ROAD

Section Number	0	1			
Section Length (mi)	1.00	0.66			
Cross Section Information					
Number of Lanes	2	2			
Paved Width (ft)	21	20			
Lane Width (ft)	9	9			
Roadway Condition Information					
SCR (Surface Condition Rating)	NC	0			
PCR (Pavement Condition Rating)	45	23			
Distress Index Values					
Structural Crack Index	NC	0			
Transverse Cracking Index	NC	100			
Patching Index	NC	100			
Rutting Index	NC	88			
Roughness Condition Index (RCI)	NC	57

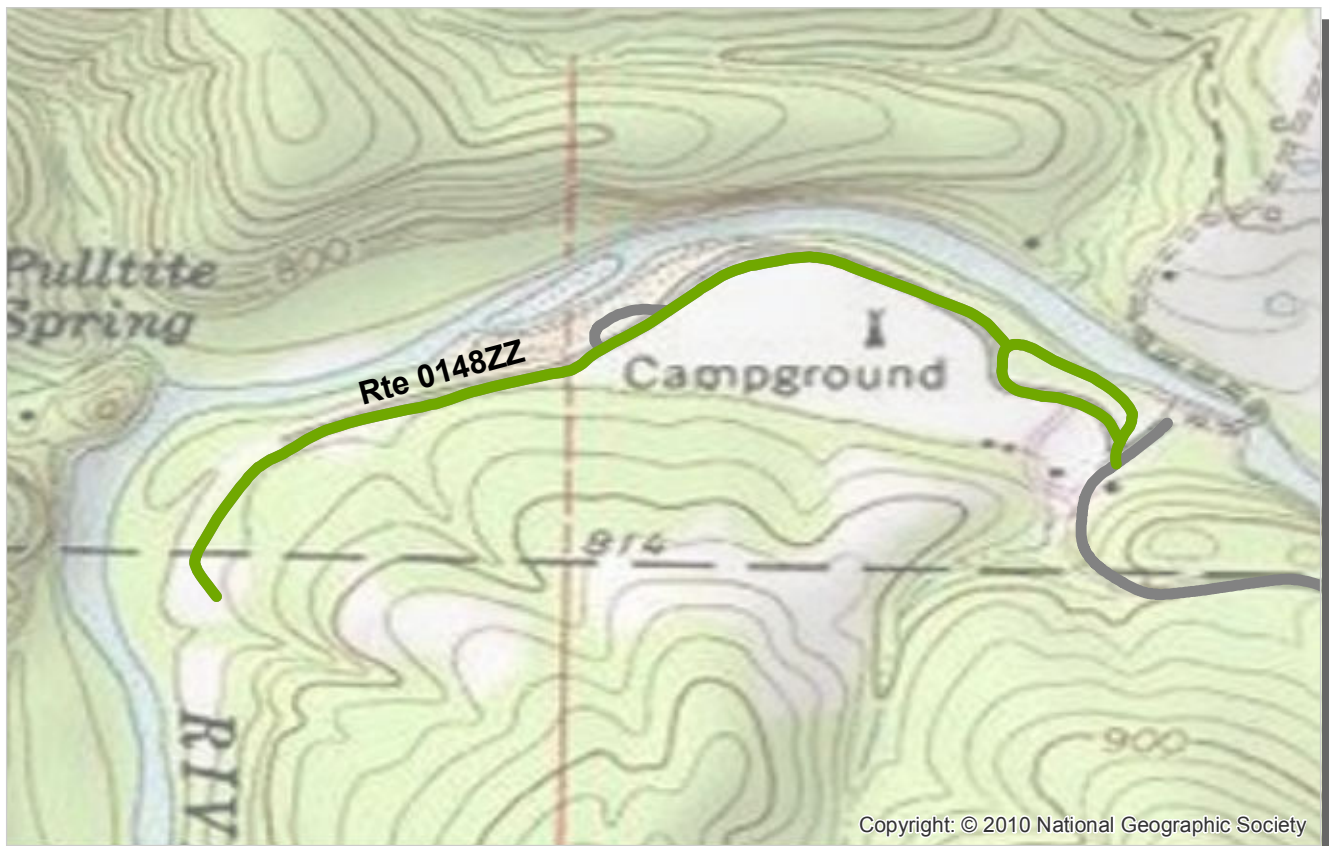
ROUTE: 0148ZZ PULLTITE CAMPGROUND ROADS

Section Number					
Section Length (mi)					
Cross Section Information					
Number of Lanes	N/A				
Paved Width (ft)	N/A				
Lane Width (ft)	N/A				
Roadway Condition Information					
SCR (Surface Condition Rating)	88				
PCR (Pavement Condition Rating)	88				
Distress Index Values					
Structural Crack Index	N/A				
Transverse Cracking Index	N/A				
Patching Index	N/A				
Rutting Index	N/A				
Roughness Condition Index (RCI)	N/A

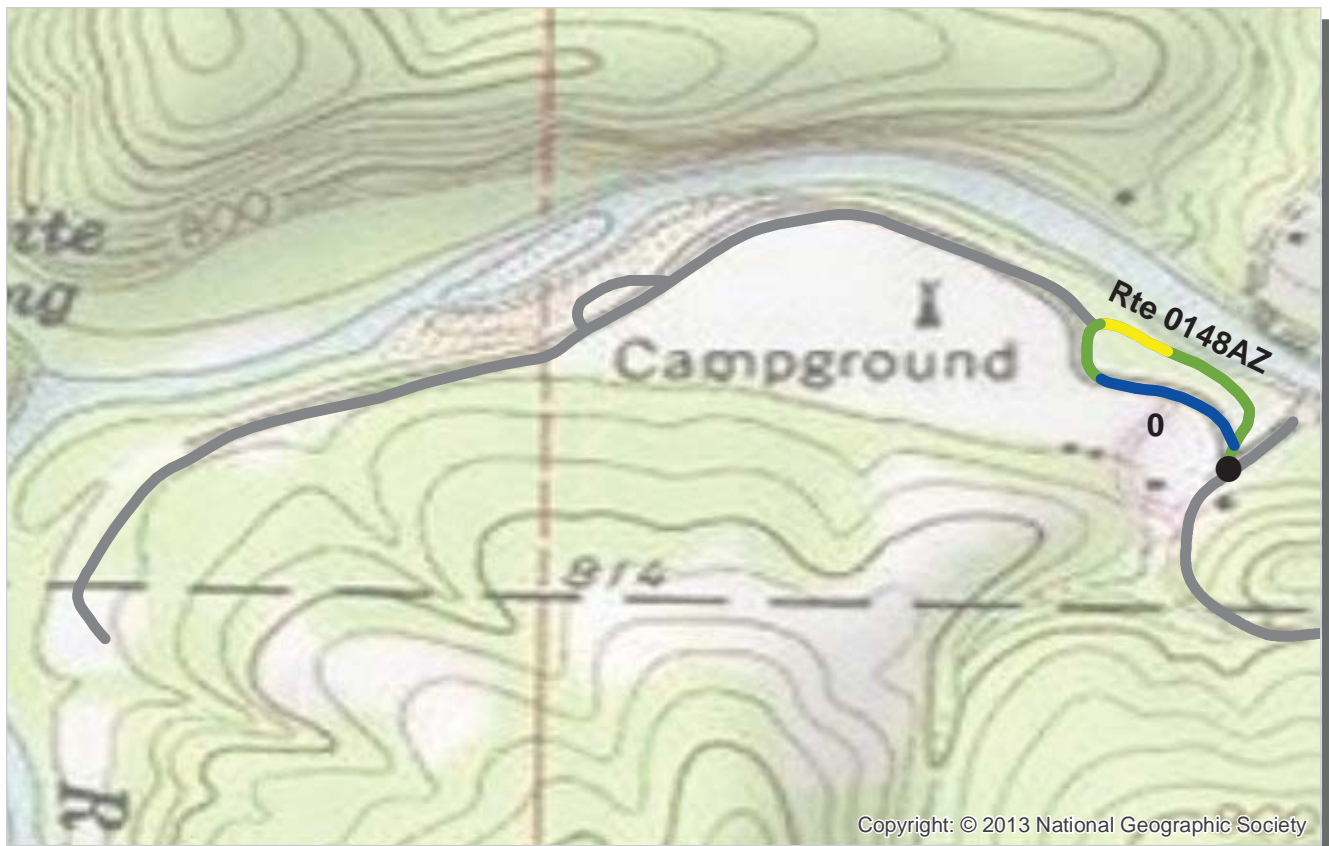
ROUTE: 0148AZ PULLTITE CAMPGROUND ROAD A

Section Number	0				
Section Length (mi)	0.26				
Cross Section Information					
Number of Lanes	1				
Paved Width (ft)	13				
Lane Width (ft)	13				
Roadway Condition Information					
SCR (Surface Condition Rating)	92				
PCR (Pavement Condition Rating)	92				
Distress Index Values					
Structural Crack Index	99				
Transverse Cracking Index	100				
Patching Index	100				
Rutting Index	92				
Roughness Condition Index (RCI)	NC

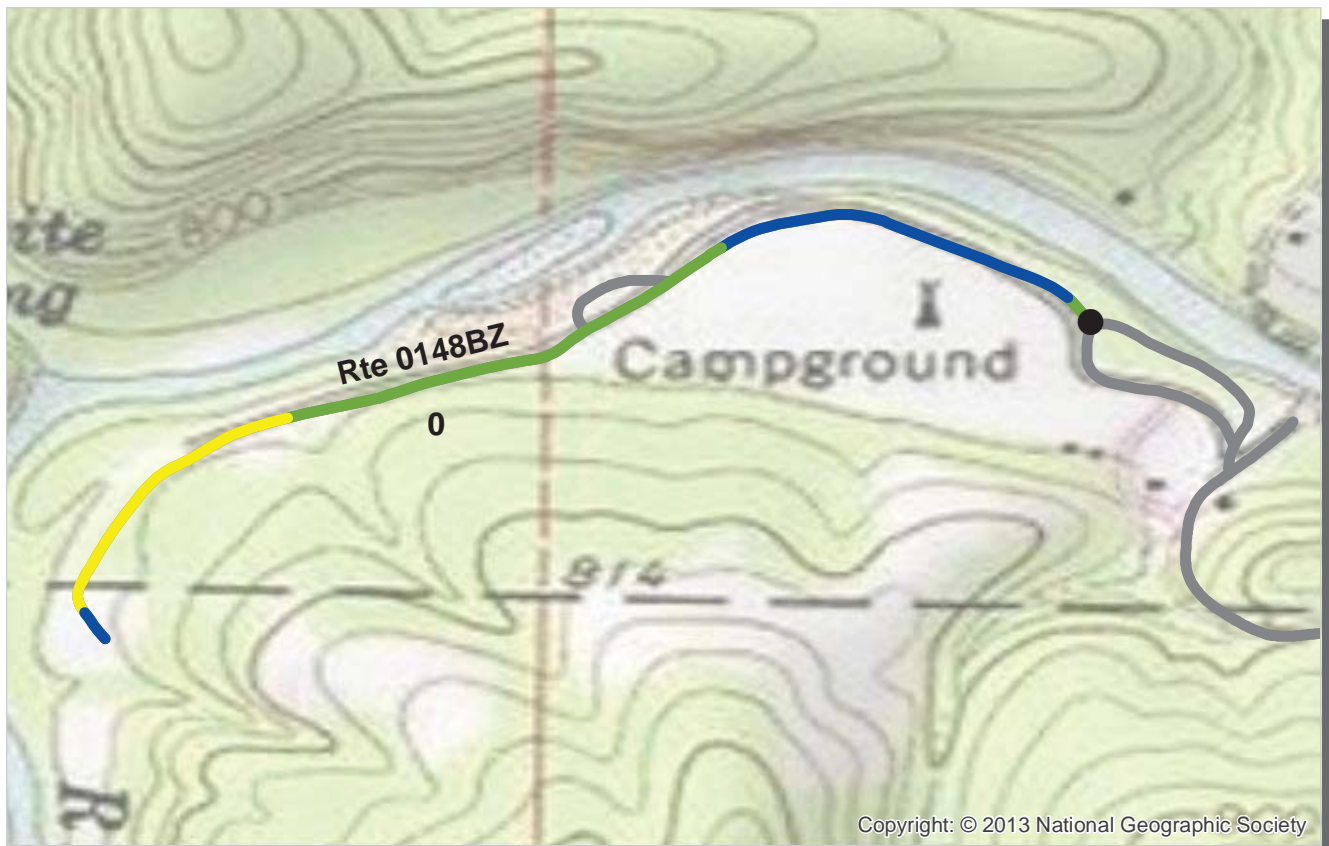
ROUTE: 0148BZ PULLTITE CAMPGROUND ROAD B

Section Number	0				
Section Length (mi)	0.68				
Cross Section Information					
Number of Lanes	2				
Paved Width (ft)	16				
Lane Width (ft)	8				
Roadway Condition Information					
SCR (Surface Condition Rating)	87				
PCR (Pavement Condition Rating)	87				
Distress Index Values					
Structural Crack Index	95				
Transverse Cracking Index	100				
Patching Index	100				
Rutting Index	87				
Roughness Condition Index (RCI)	NC

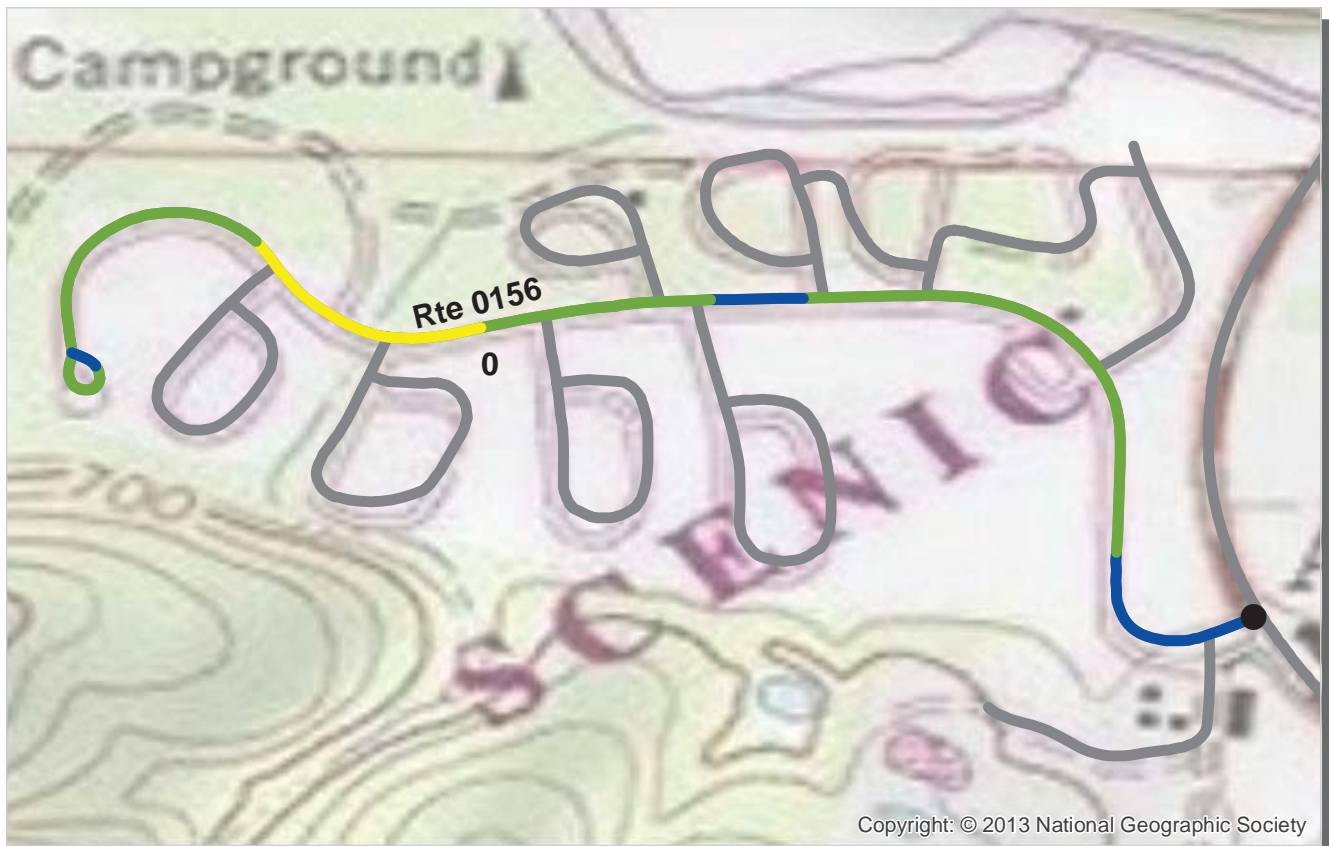
ROUTE: 0156 ALLEY SPRING CAMPGROUND ROAD

Section Number	0				
Section Length (mi)	0.79				
Cross Section Information					
Number of Lanes	2				
Paved Width (ft)	21				
Lane Width (ft)	9				
Roadway Condition Information					
SCR (Surface Condition Rating)	93				
PCR (Pavement Condition Rating)	93				
Distress Index Values					
Structural Crack Index	95				
Transverse Cracking Index	93				
Patching Index	100				
Rutting Index	95				
Roughness Condition Index (RCI)	NC

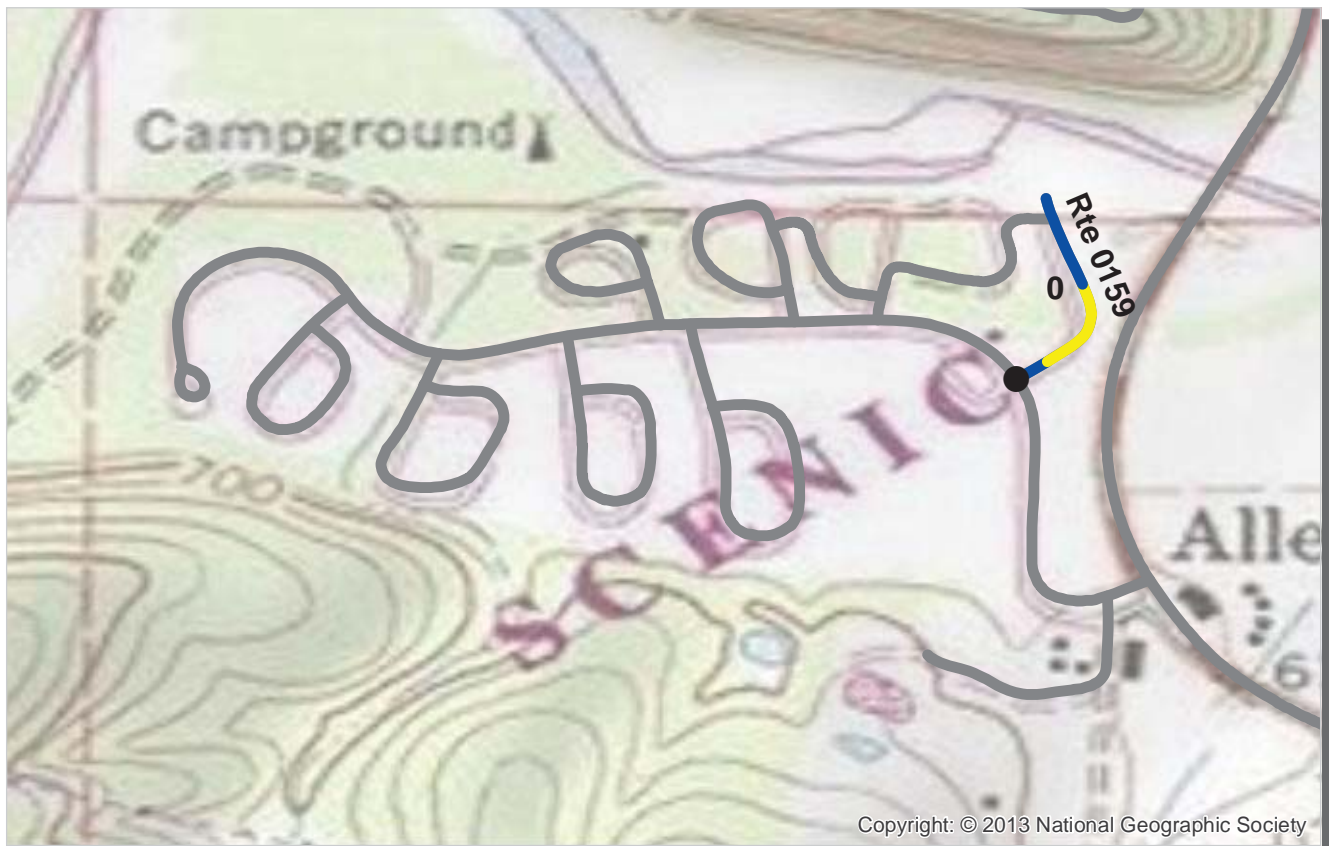
ROUTE: 0159 ALLEY SPRING BOAT LAUNCH ROAD

Section Number	0				
Section Length (mi)	0.14				
Cross Section Information					
Number of Lanes	2				
Paved Width (ft)	21				
Lane Width (ft)	10				
Roadway Condition Information					
SCR (Surface Condition Rating)	88				
PCR (Pavement Condition Rating)	88				
Distress Index Values					
Structural Crack Index	99				
Transverse Cracking Index	99				
Patching Index	100				
Rutting Index	88				
Roughness Condition Index (RCI)	NC

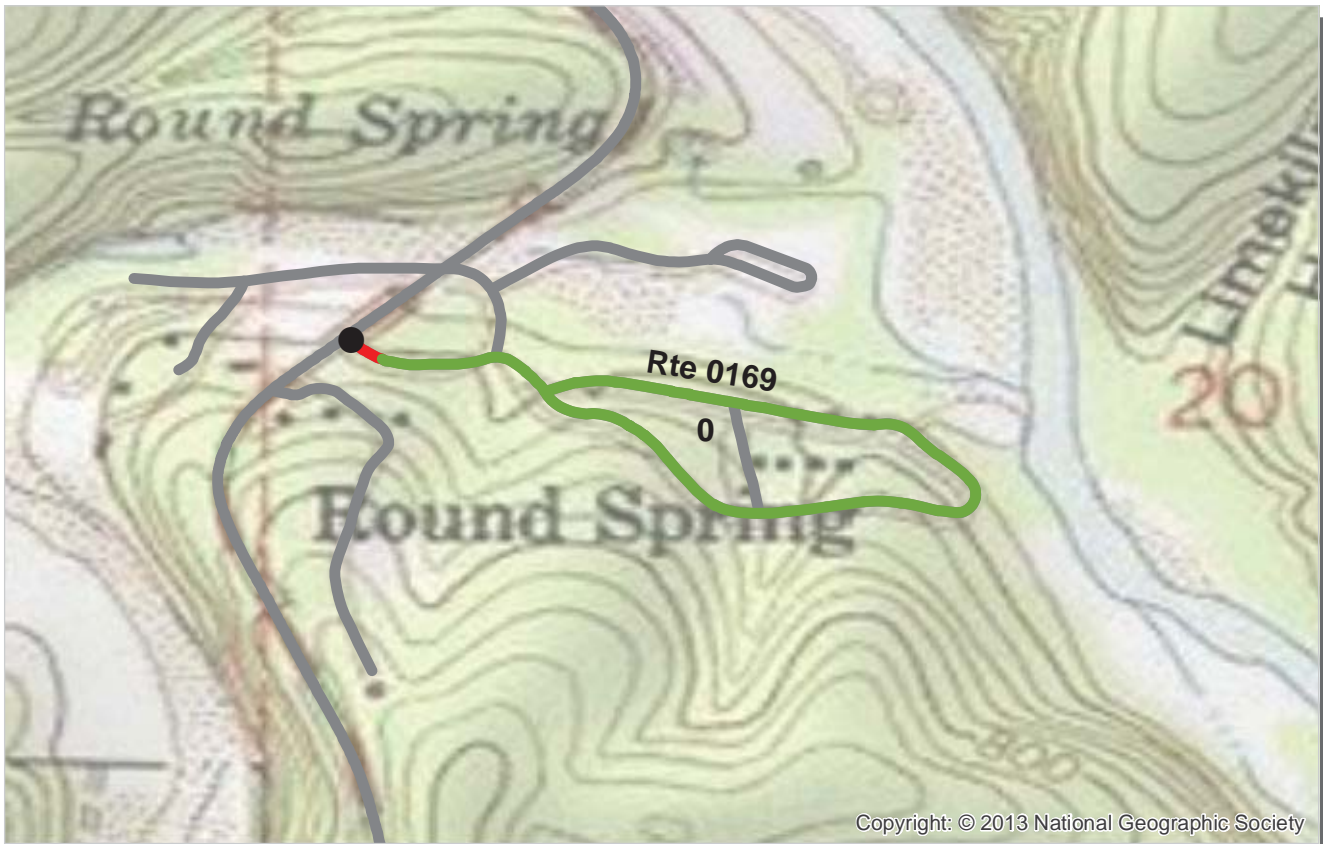
ROUTE: 0169 ROUND SPRING CAMPGROUND ROAD

Section Number	0				
Section Length (mi)	0.63				
Cross Section Information					
Number of Lanes	1				
Paved Width (ft)	17				
Lane Width (ft)	12				
Roadway Condition Information					
SCR (Surface Condition Rating)	88				
PCR (Pavement Condition Rating)	88				
Distress Index Values					
Structural Crack Index	96				
Transverse Cracking Index	99				
Patching Index	100				
Rutting Index	88				
Roughness Condition Index (RCI)	NC

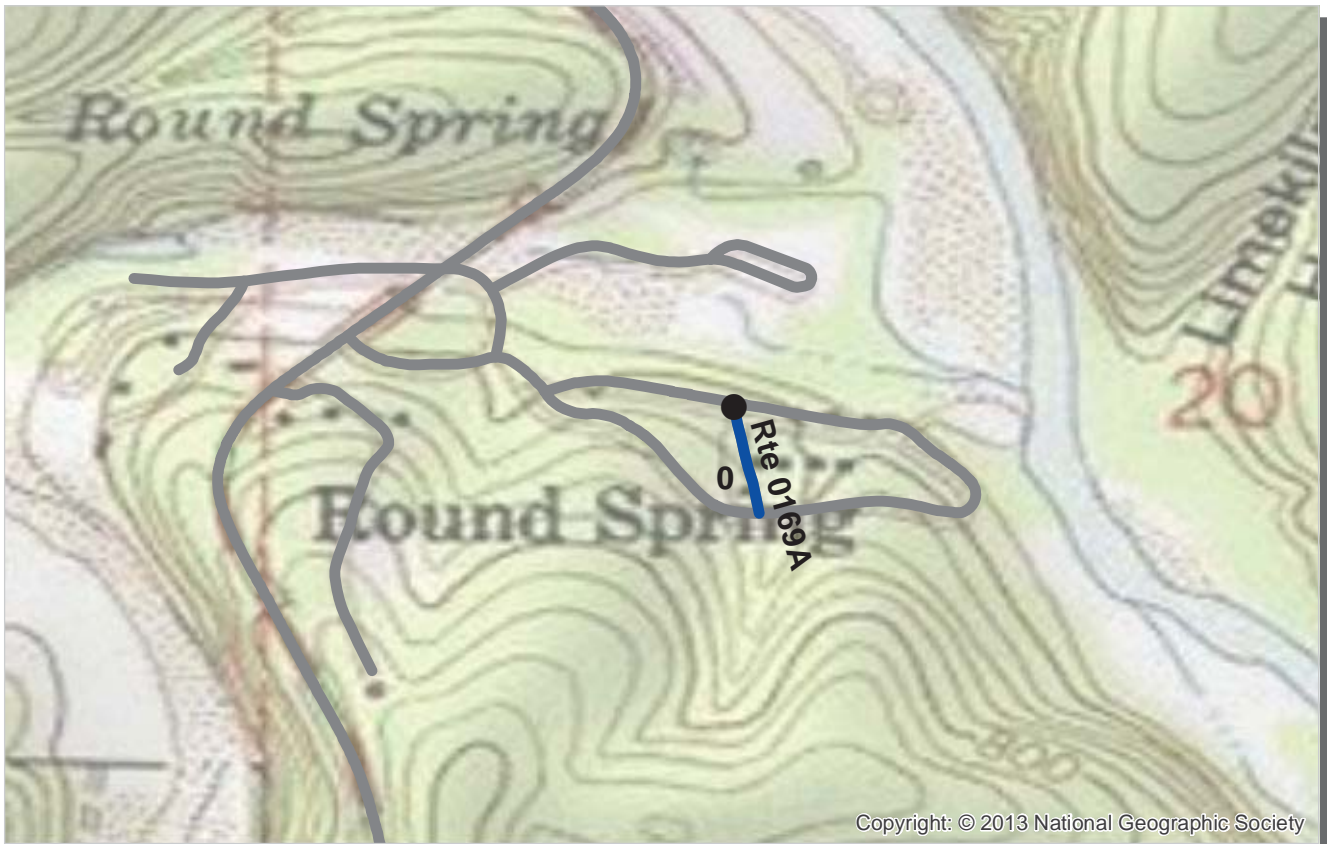
ROUTE: 0169A ROUND SPRING CAMPGROUND CUT OFF ROAD

Section Number	0				
Section Length (mi)	0.07				
Cross Section Information					
Number of Lanes	2				
Paved Width (ft)	21				
Lane Width (ft)	11				
Roadway Condition Information					
SCR (Surface Condition Rating)	97				
PCR (Pavement Condition Rating)	97				
Distress Index Values					
Structural Crack Index	97				
Transverse Cracking Index	100				
Patching Index	100				
Rutting Index	97				
Roughness Condition Index (RCI)	NC

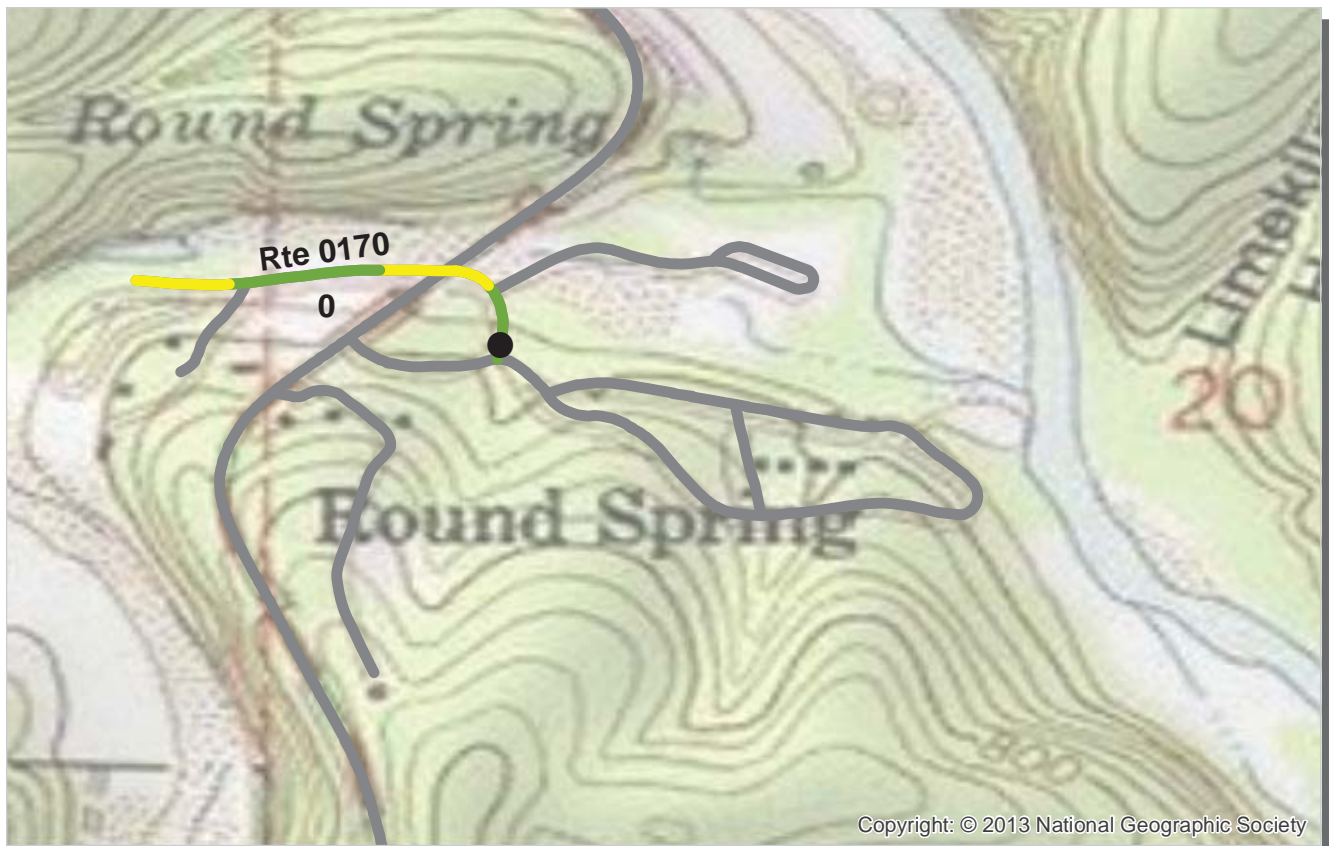
ROUTE: 0170 ROUND SPRING CAVE ACCESS ROAD

Section Number	0				
Section Length (mi)	0.23				
Cross Section Information					
Number of Lanes	2				
Paved Width (ft)	21				
Lane Width (ft)	11				
Roadway Condition Information					
SCR (Surface Condition Rating)	86				
PCR (Pavement Condition Rating)	86				
Distress Index Values					
Structural Crack Index	86				
Transverse Cracking Index	99				
Patching Index	100				
Rutting Index	87				
Roughness Condition Index (RCI)	NC

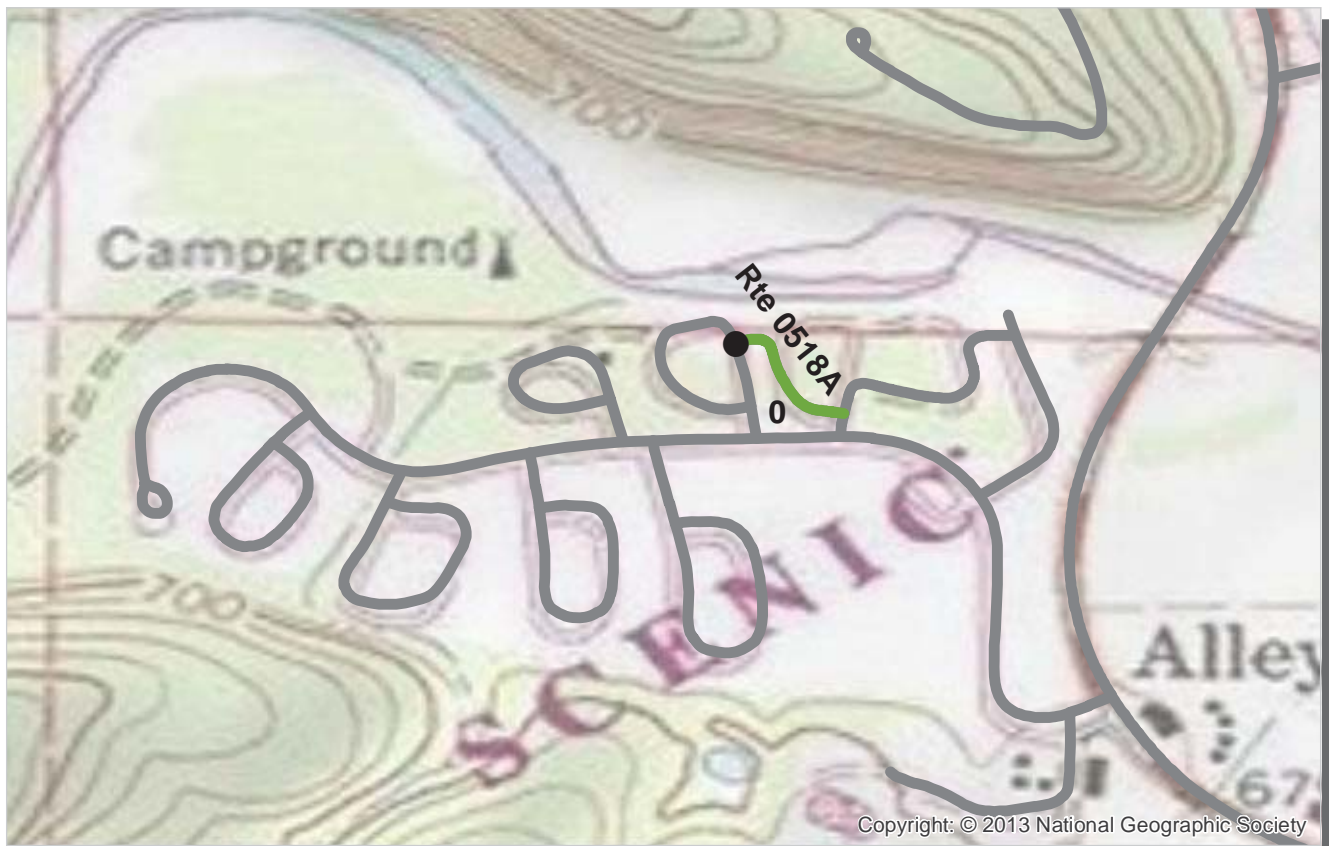
ROUTE: 0518A ALLEY SPRING CAMPGROUND LOOP A

Section Number	0				
Section Length (mi)	0.08				
Cross Section Information					
Number of Lanes	1				
Paved Width (ft)	12				
Lane Width (ft)	12				
Roadway Condition Information					
SCR (Surface Condition Rating)	NC				
PCR (Pavement Condition Rating)	90				
Distress Index Values					
Structural Crack Index	NC				
Transverse Cracking Index	NC				
Patching Index	NC				
Rutting Index	NC				
Roughness Condition Index (RCI)	NC

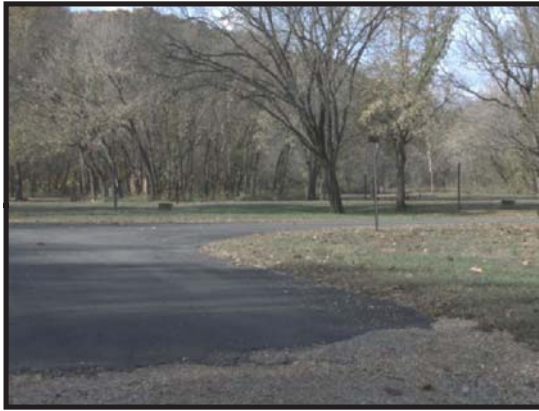
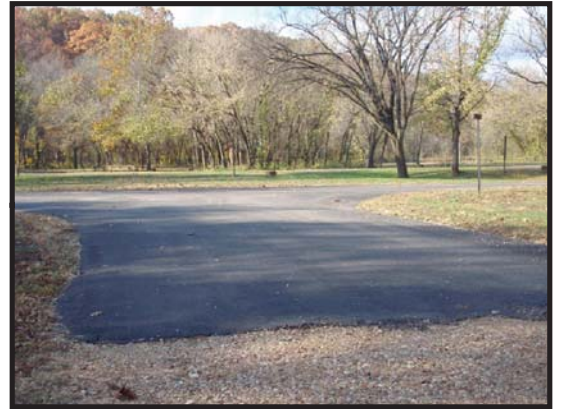
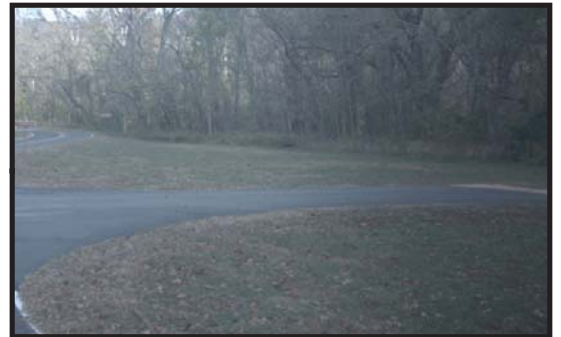
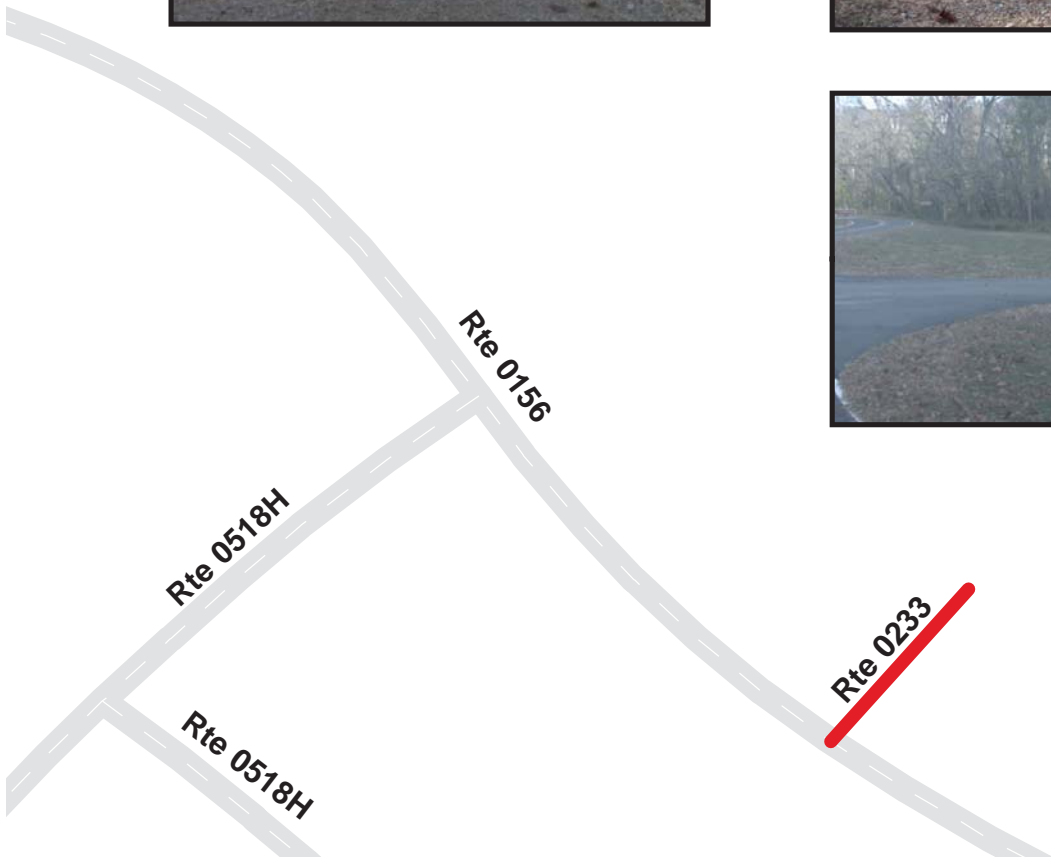
Route Number	Public / NonPublic	Date Visited	Area (sq ft)	Lane Miles *	Paved Length (mi)	Paved Width (ft)
0233	PUBLIC	10/25/2012	1,267	0.02	0.01	20
Culverts	Drop Inlets	Gates	Curb & Gutter	Curb	PCR	Surface Type
0	0	0	NO CURB AND GUTTER	NO CURB	GOOD/90	AS

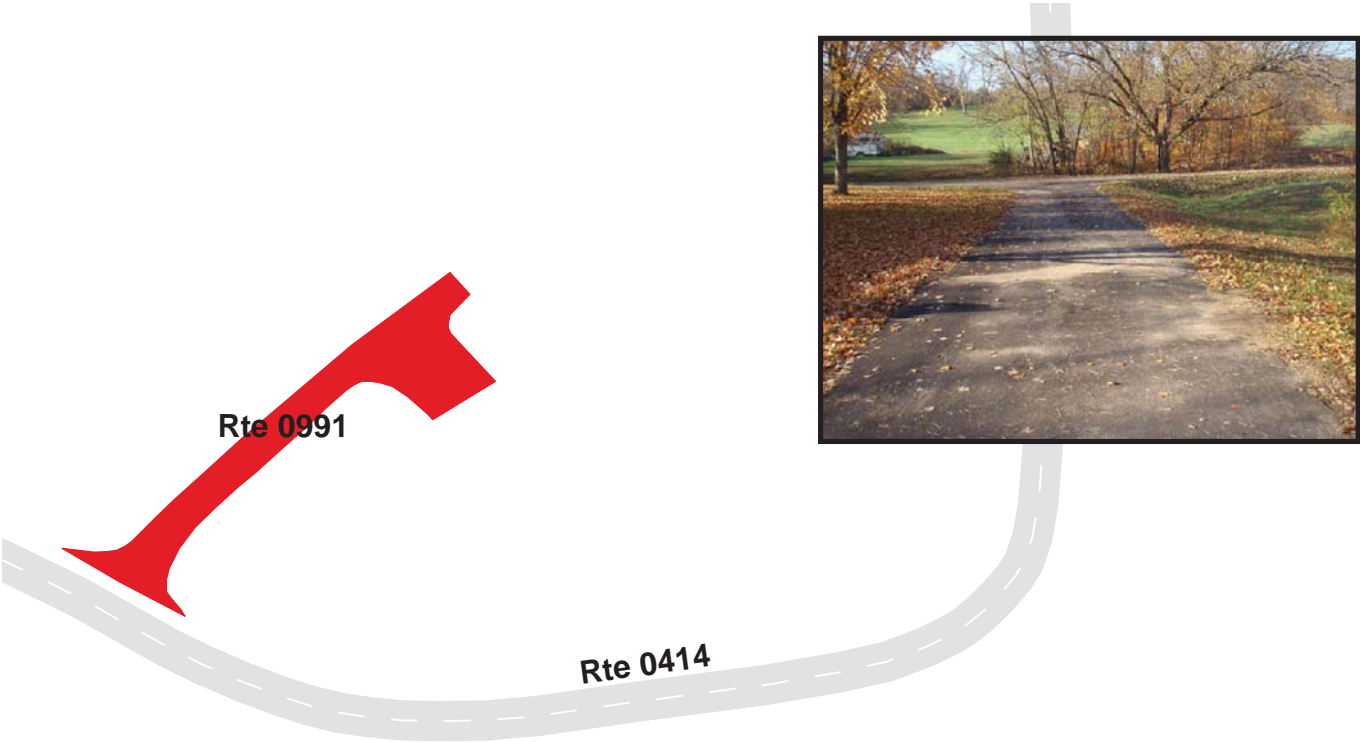
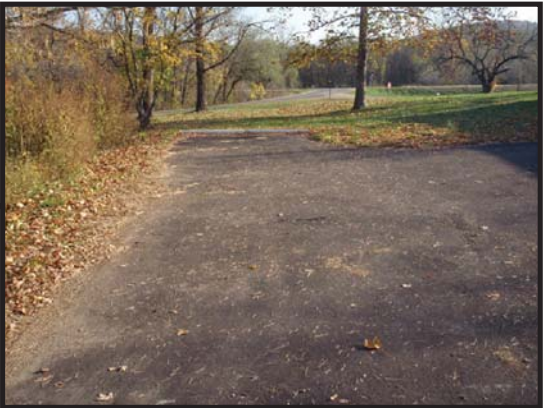
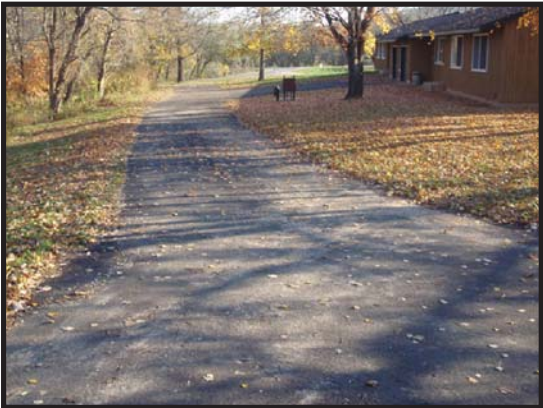
Route Number	Public / NonPublic	Date Visited	Area (sq ft)	Lane Miles *	Surface Type
0991	NONPUBLIC	10/25/2012	3,477	0.06	AS
Culverts	Drop Inlets	Gates	Curb & Gutter	Curb	PCR
0	0	0	NO CURB AND GUTTER	NO CURB	GOOD/90

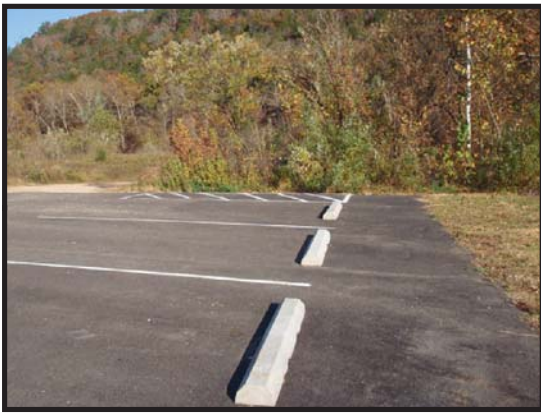
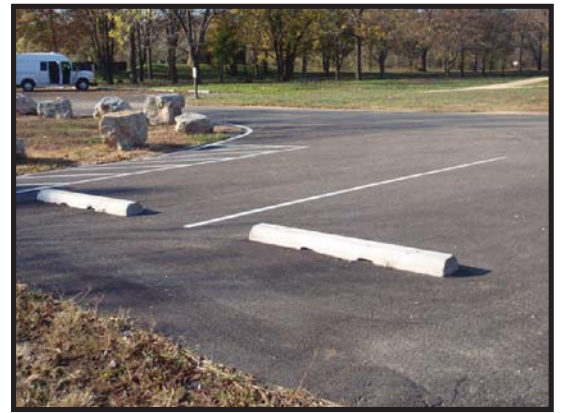
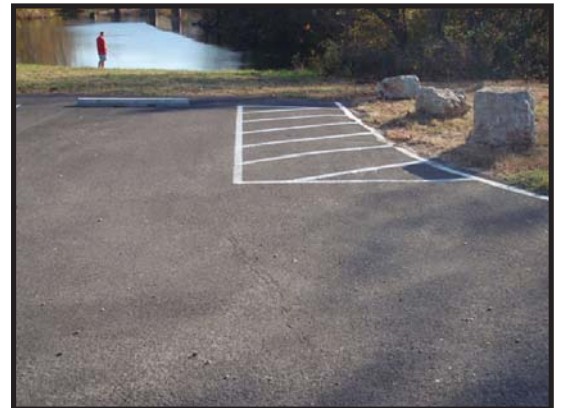
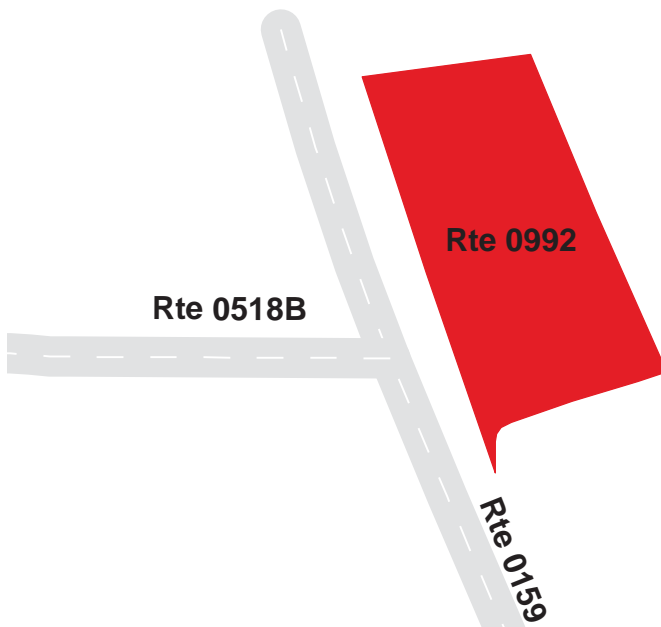
Route 0992

Route Number	Public / NonPublic	Date Visited	Area (sq ft)	Lane Miles *	Surface Type
0992	PUBLIC	10/25/2012	2,439	0.04	AS
Culverts	Drop Inlets	Gates	Curb & Gutter	Curb	PCR
0	0	0	NO CURB AND GUTTER	NO CURB	GOOD/90
