# Federal Lands Highway Road Inventory Program

Road Inventory and Condition Assessment

## Pecos National Historical Park PECO

### Cycle 5 Report

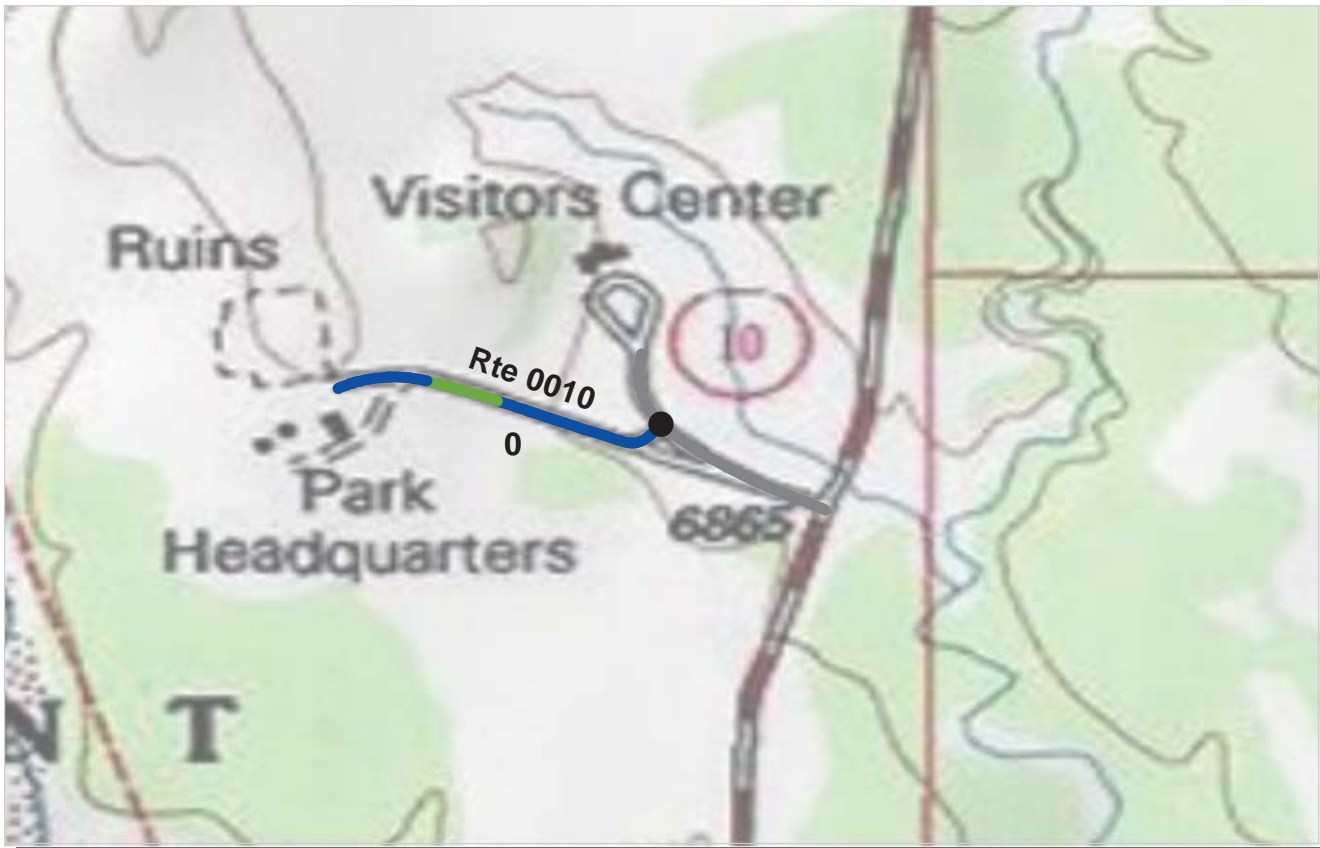
**ROUTE: 0010 PARK HEADQUARTERS ACCESS ROAD**

PCR    Poor ■    Fair ■    Good ■    Excellent ■    No Data ■  
           (0 - 60)           (61 - 84)           (85 - 94)           (95 - 100)

<b>Section Number</b>	0				
<b>Section Length (mi)</b>	0.19				
<b>Cross Section Information</b>					
Number of Lanes	2				
Paved Width (ft)	21				
Lane Width (ft)	11				
<b>Roadway Condition Information</b>					
SCR (Surface Condition Rating)	95				
PCR (Pavement Condition Rating)	95				
<b>Distress Index Values</b>					
Structural Crack Index	95				
Transverse Cracking Index	95				
Patching Index	100				
Rutting Index	98				
Roughness Condition Index (RCI)	NC

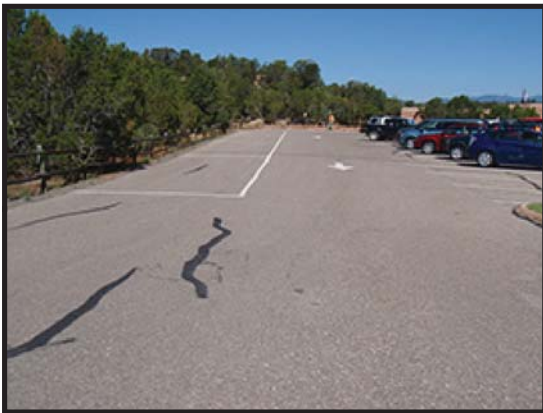
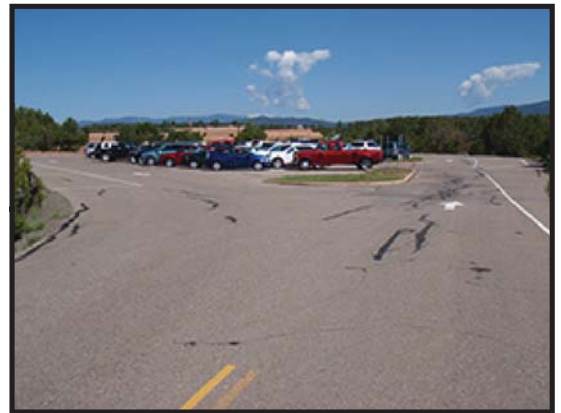
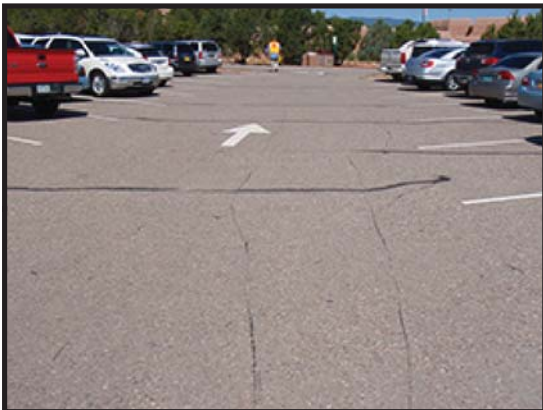
Route Number	Public / NonPublic	Date Visited	Area (sq ft)	Lane Miles *	Surface Type
0900	PUBLIC	9/5/2011	29,149	0.50	AS
Culverts	Drop Inlets	Gates	Curb & Gutter	Curb	PCR
0	0	0	NO CURB AND GUTTER	CONCRETE CURB	FAIR/73

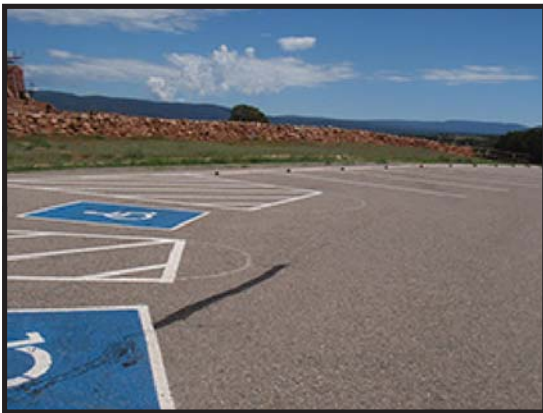
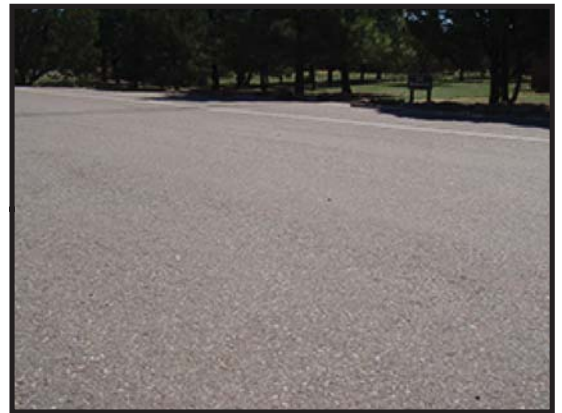
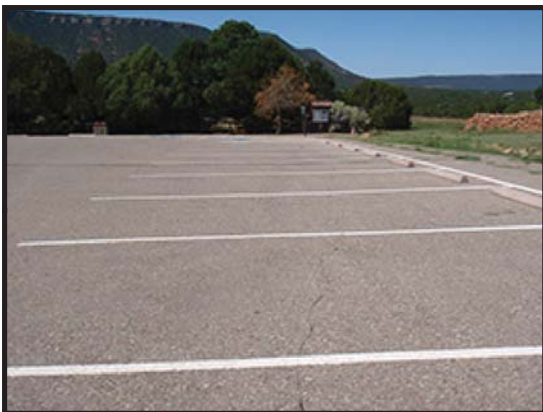
## Route 0901

Route Number	Public / NonPublic	Date Visited	Area (sq ft)	Lane Miles *	Surface Type
0901	PUBLIC	9/5/2011	15,185	0.26	AS
Culverts	Drop Inlets	Gates	Curb & Gutter	Curb	PCR
0	0	0	NO CURB AND GUTTER	NO CURB	FAIR/73
