Federal Lands Highway Road Inventory Program

Road Inventory and Condition Assessment

Petrified Forest National Park PEFO

Cycle 5 Report

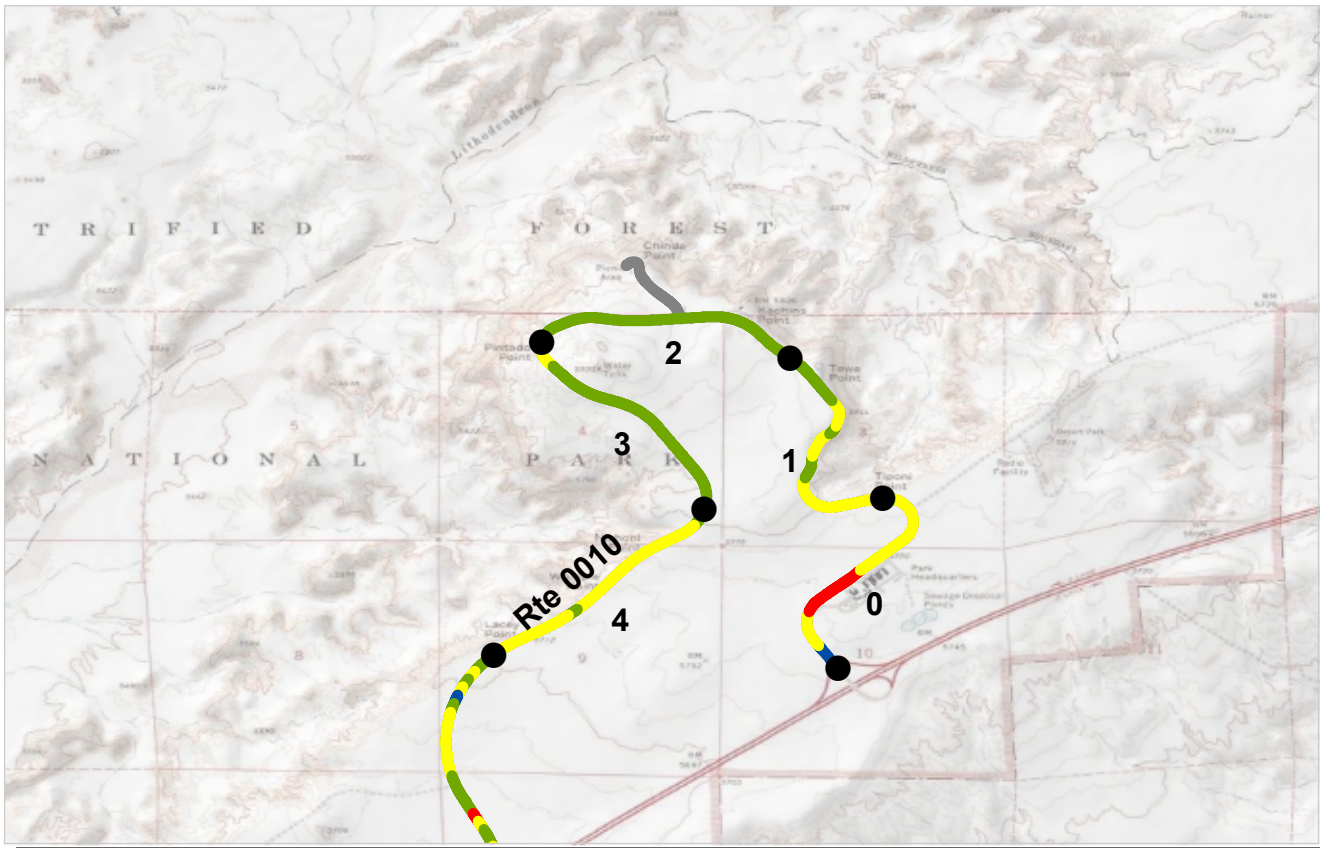
ROUTE: 0010 NORTH-SOUTH HIGHWAY

<i>Section Number</i>	0	1	2	3	4
<i>Section Length (mi)</i>	1.00	1.00	1.00	1.00	1.00
<i>Cross Section Information</i>					
Number of Lanes	2	2	2	2	2
Paved Width (ft)	31	28	27	28	25
Lane Width (ft)	12	10	10	11	10
<i>Roadway Condition Information</i>					
SCR (Surface Condition Rating)	73	81	86	87	91
PCR (Pavement Condition Rating)	69	85	90	91	77
<i>Distress Index Values</i>					
Structural Crack Index	73	81	91	96	96
Transverse Cracking Index	93	86	86	87	91
Patching Index	100	100	100	100	100
Rutting Index	90	97	95	92	91
Roughness Condition Index (RCI)	64	90	95	96	55

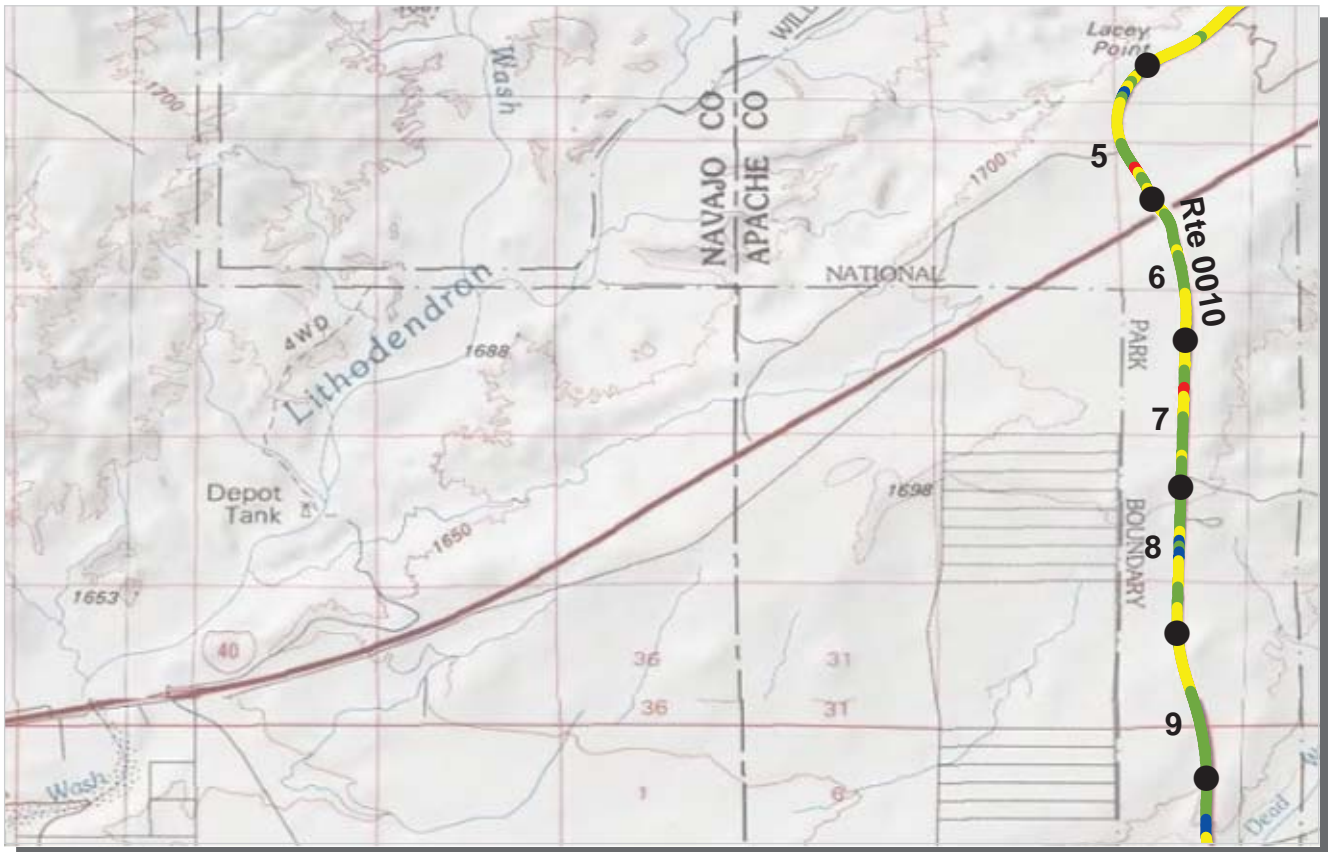
ROUTE: 0010 NORTH-SOUTH HIGHWAY

<i>Section Number</i>	5	6	7	8	9
<i>Section Length (mi)</i>	1.00	1.00	1.00	1.00	1.00
<i>Cross Section Information</i>					
Number of Lanes	2	2	2	2	2
Paved Width (ft)	26	28	25	25	26
Lane Width (ft)	10	9	9	9	9
<i>Roadway Condition Information</i>					
SCR (Surface Condition Rating)	91	92	87	89	88
PCR (Pavement Condition Rating)	83	84	84	83	86
<i>Distress Index Values</i>					
Structural Crack Index	93	96	95	97	94
Transverse Cracking Index	91	92	95	94	92
Patching Index	100	100	100	100	100
Rutting Index	93	92	87	89	88
Roughness Condition Index (RCI)	70	72	80	73	83

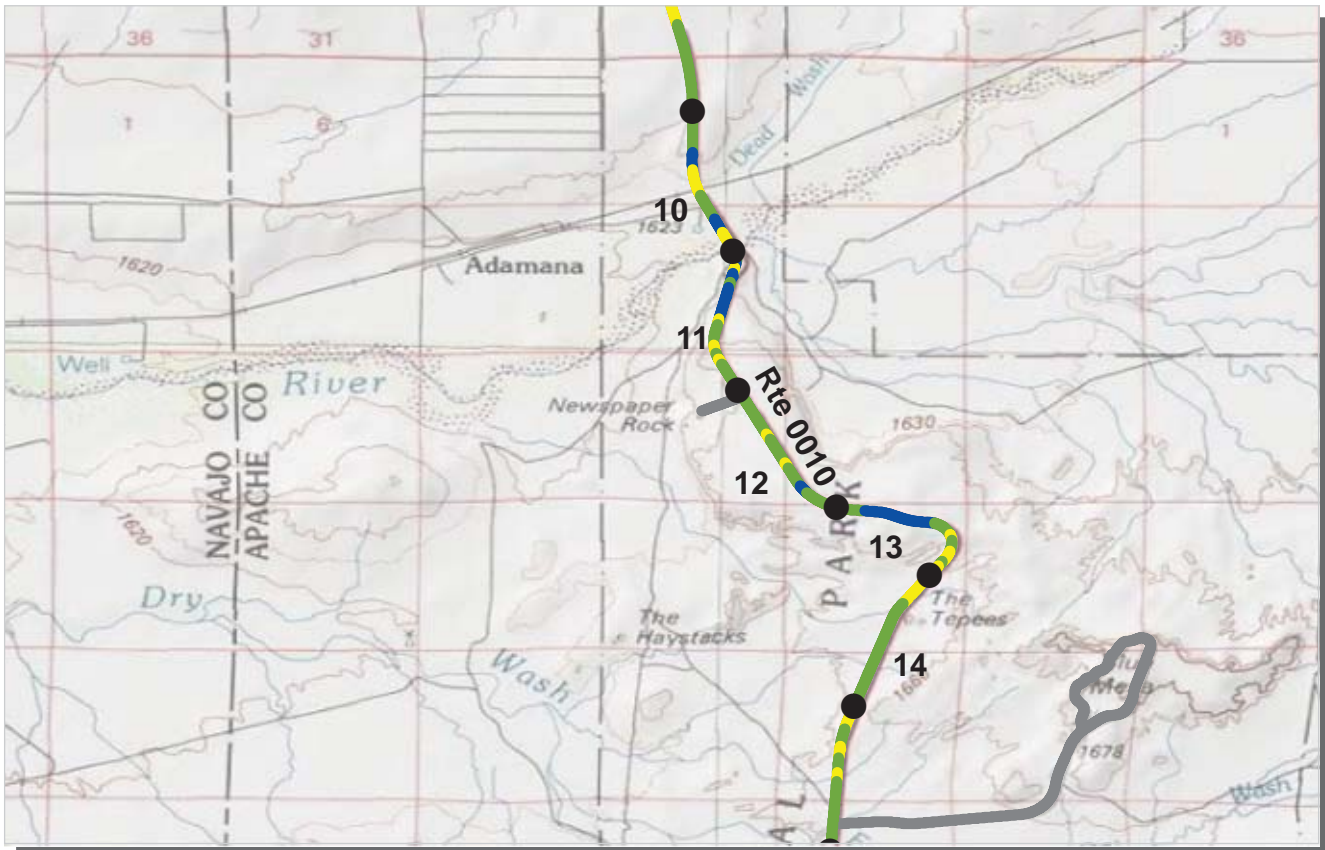
ROUTE: 0010 NORTH-SOUTH HIGHWAY

Section Number	10	11	12	13	14
Section Length (mi)	1.00	1.00	1.00	1.00	1.00
Cross Section Information					
Number of Lanes	2	2	2	2	2
Paved Width (ft)	29	26	26	26	26
Lane Width (ft)	10	9	10	10	10
Roadway Condition Information					
SCR (Surface Condition Rating)	93	91	85	91	86
PCR (Pavement Condition Rating)	89	91	89	89	87
Distress Index Values					
Structural Crack Index	95	100	100	100	100
Transverse Cracking Index	93	99	100	100	99
Patching Index	100	100	100	100	100
Rutting Index	96	91	85	91	86
Roughness Condition Index (RCI)	84	90	94	87	89

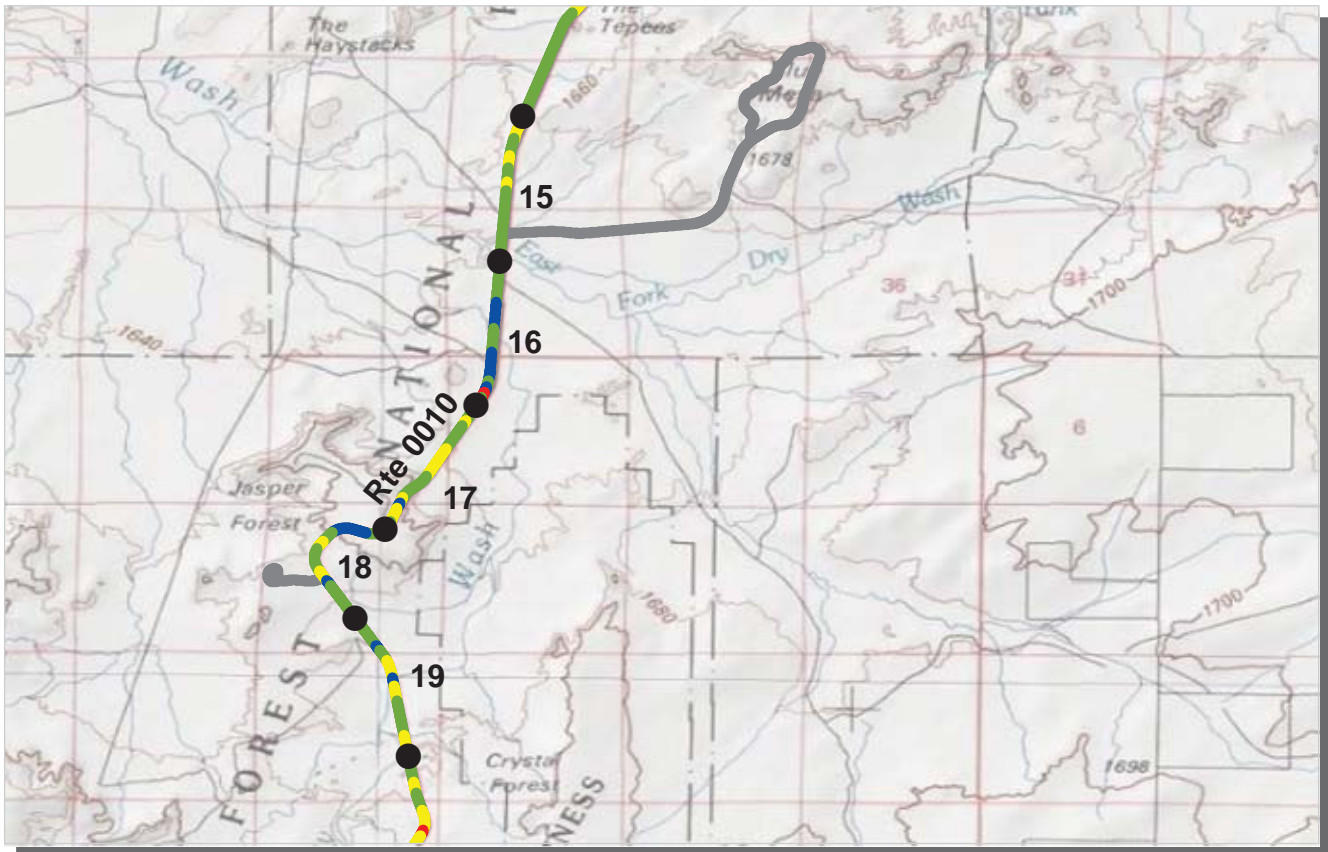
ROUTE: 0010 NORTH-SOUTH HIGHWAY

<i>Section Number</i>	15	16	17	18	19
<i>Section Length (mi)</i>	1.00	1.00	1.00	1.00	1.00
<i>Cross Section Information</i>					
Number of Lanes	2	2	2	2	2
Paved Width (ft)	26	27	30	26	27
Lane Width (ft)	10	10	10	10	10
<i>Roadway Condition Information</i>					
SCR (Surface Condition Rating)	89	96	96	95	94
PCR (Pavement Condition Rating)	88	94	86	90	86
<i>Distress Index Values</i>					
Structural Crack Index	98	98	96	97	97
Transverse Cracking Index	97	96	96	95	94
Patching Index	100	100	100	100	100
Rutting Index	89	99	97	98	96
Roughness Condition Index (RCI)	86	92	70	82	73

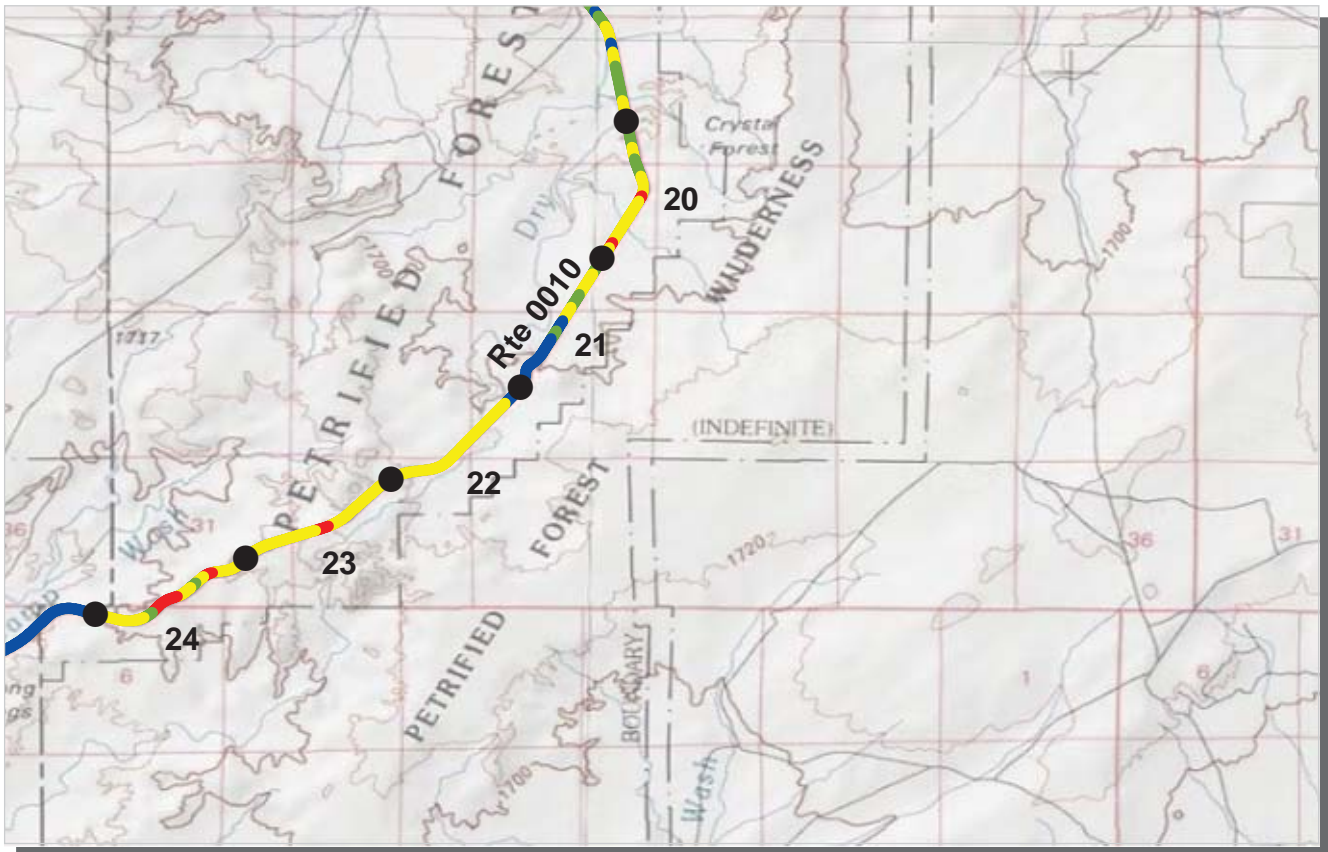
ROUTE: 0010 NORTH-SOUTH HIGHWAY

<i>Section Number</i>	20	21	22	23	24
<i>Section Length (mi)</i>	1.00	1.00	1.00	1.00	1.00
<i>Cross Section Information</i>					
Number of Lanes	2	2	2	2	2
Paved Width (ft)	28	27	26	26	25
Lane Width (ft)	10	9	10	10	10
<i>Roadway Condition Information</i>					
SCR (Surface Condition Rating)	92	94	89	85	75
PCR (Pavement Condition Rating)	78	91	77	71	66
<i>Distress Index Values</i>					
Structural Crack Index	92	94	94	85	75
Transverse Cracking Index	93	96	97	94	93
Patching Index	100	100	100	100	100
Rutting Index	94	97	89	88	89
Roughness Condition Index (RCI)	57	87	58	50	52

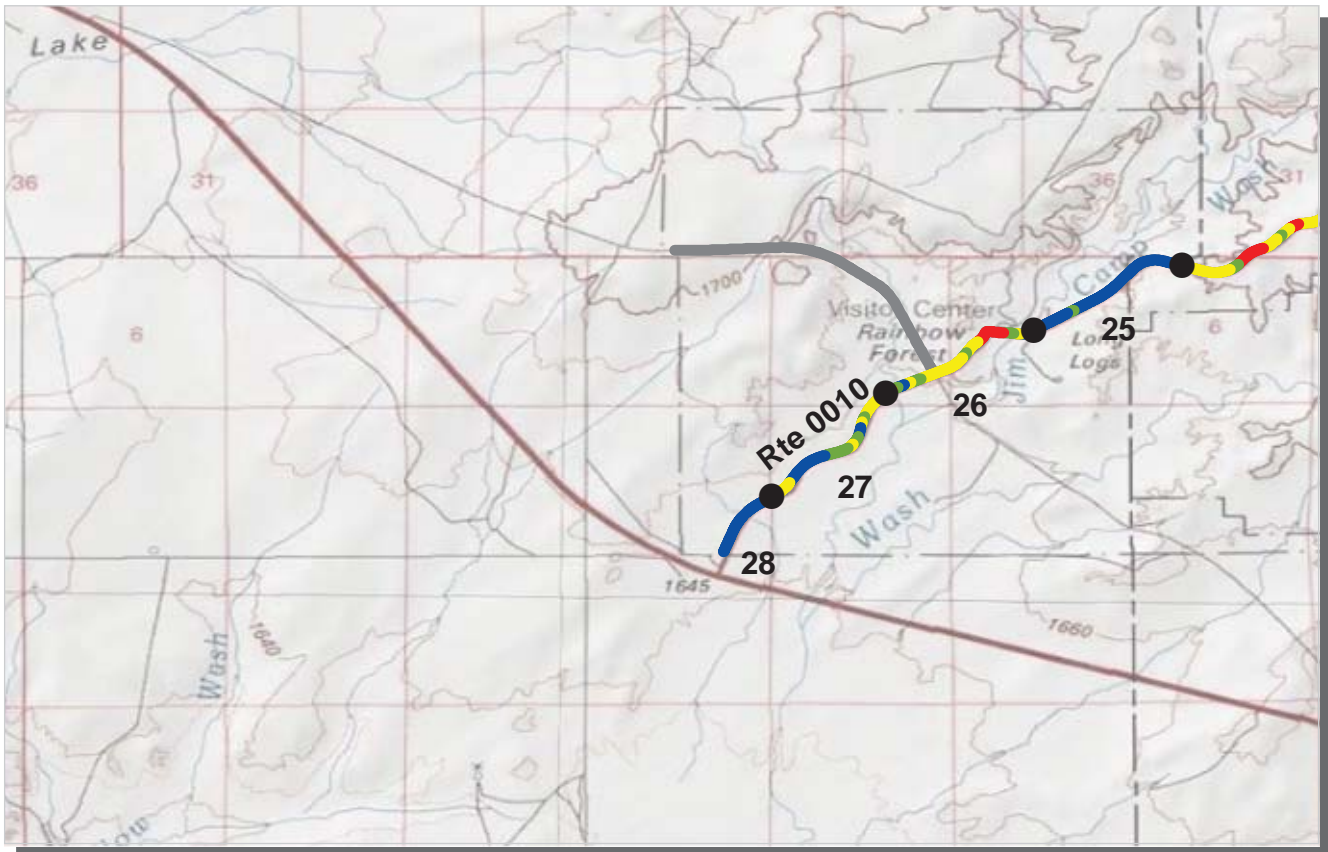
ROUTE: 0010 NORTH-SOUTH HIGHWAY

<i>Section Number</i>	25	26	27	28	
<i>Section Length (mi)</i>	1.00	1.00	1.00	0.48	
<i>Cross Section Information</i>					
Number of Lanes	2	2	2	2	
Paved Width (ft)	25	29	29	26	
Lane Width (ft)	10	10	10	10	
<i>Roadway Condition Information</i>					
SCR (Surface Condition Rating)	99	89	89	99	
PCR (Pavement Condition Rating)	99	75	85	99	
<i>Distress Index Values</i>					
Structural Crack Index	99	96	98	99	
Transverse Cracking Index	100	97	98	100	
Patching Index	100	100	100	100	
Rutting Index	99	89	89	99	
Roughness Condition Index (RCI)	100	55	80	100

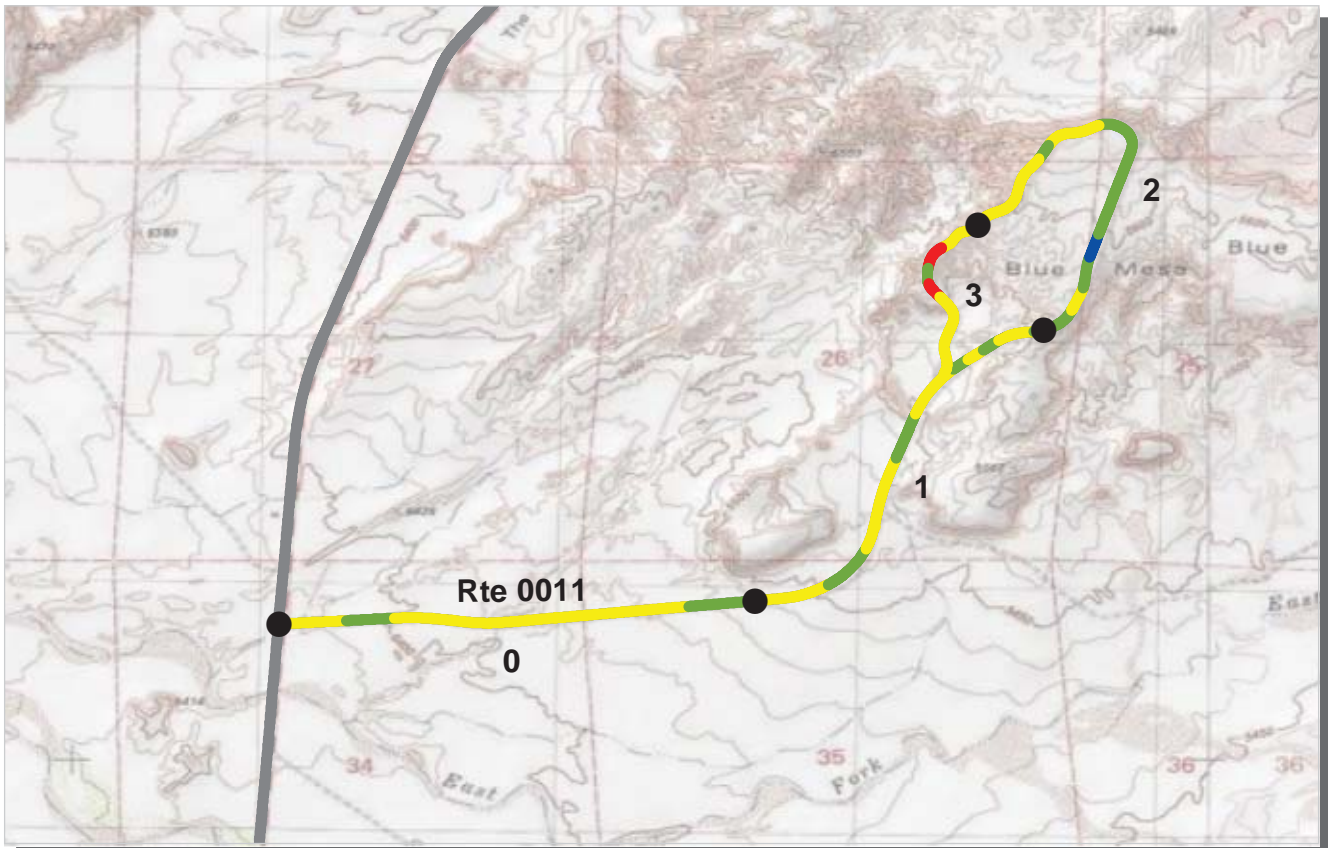
ROUTE: 0011 BLUE MESA ROAD

Section Number	0	1	2	3
Section Length (mi)	1.00	1.00	1.00	0.45
Cross Section Information				
Number of Lanes	2	2	1	1
Paved Width (ft)	25	23	15	14
Lane Width (ft)	11	12	15	14
Roadway Condition Information				
SCR (Surface Condition Rating)	91	92	93	85
PCR (Pavement Condition Rating)	79	81	85	67
Distress Index Values				
Structural Crack Index	96	94	98	95
Transverse Cracking Index	93	93	95	95
Patching Index	100	100	100	99
Rutting Index	91	92	93	85
Roughness Condition Index (RCI)	62	65	72	39

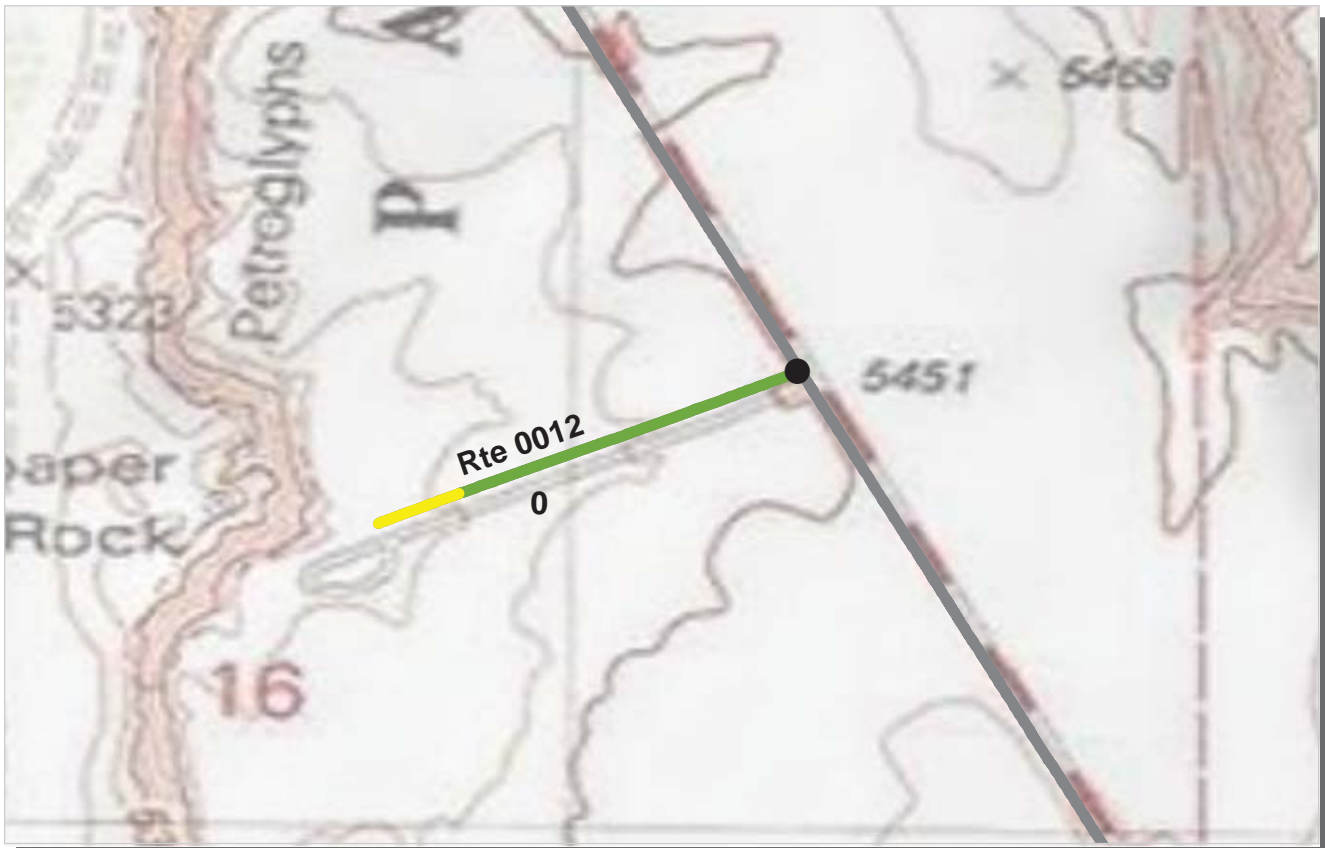
ROUTE: 0012 NEWSPAPER ROCK ROAD

Section Number	0				
Section Length (mi)	0.25				
Cross Section Information					
Number of Lanes	2				
Paved Width (ft)	22				
Lane Width (ft)	9				
Roadway Condition Information					
SCR (Surface Condition Rating)	88				
PCR (Pavement Condition Rating)	88				
Distress Index Values					
Structural Crack Index	94				
Transverse Cracking Index	90				
Patching Index	100				
Rutting Index	88				
Roughness Condition Index (RCI)	NC

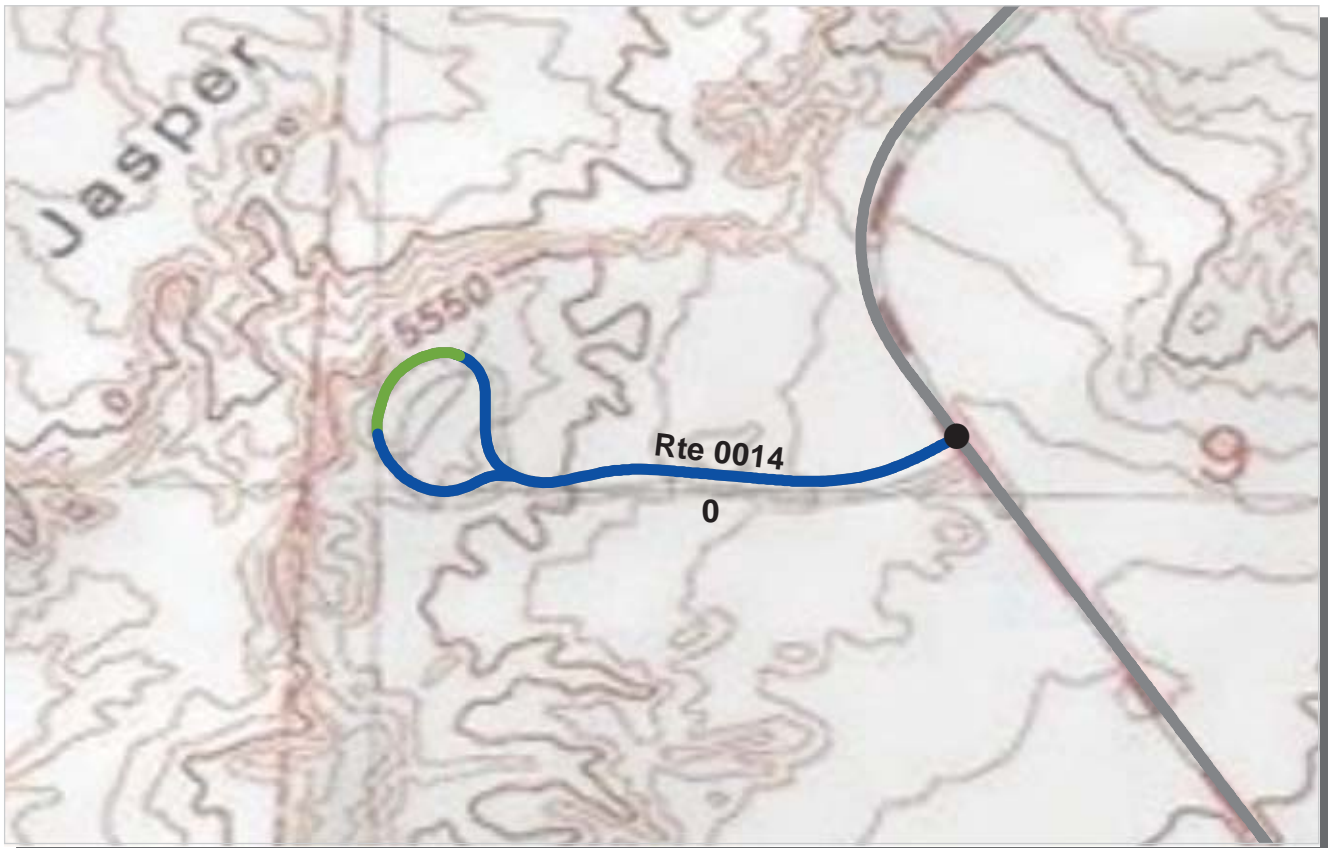
ROUTE: 0014 JASPER FOREST ROAD

Section Number	0				
Section Length (mi)	0.51				
Cross Section Information					
Number of Lanes	2				
Paved Width (ft)	19				
Lane Width (ft)	10				
Roadway Condition Information					
SCR (Surface Condition Rating)	97				
PCR (Pavement Condition Rating)	97				
Distress Index Values					
Structural Crack Index	99				
Transverse Cracking Index	99				
Patching Index	100				
Rutting Index	97				
Roughness Condition Index (RCI)	NC

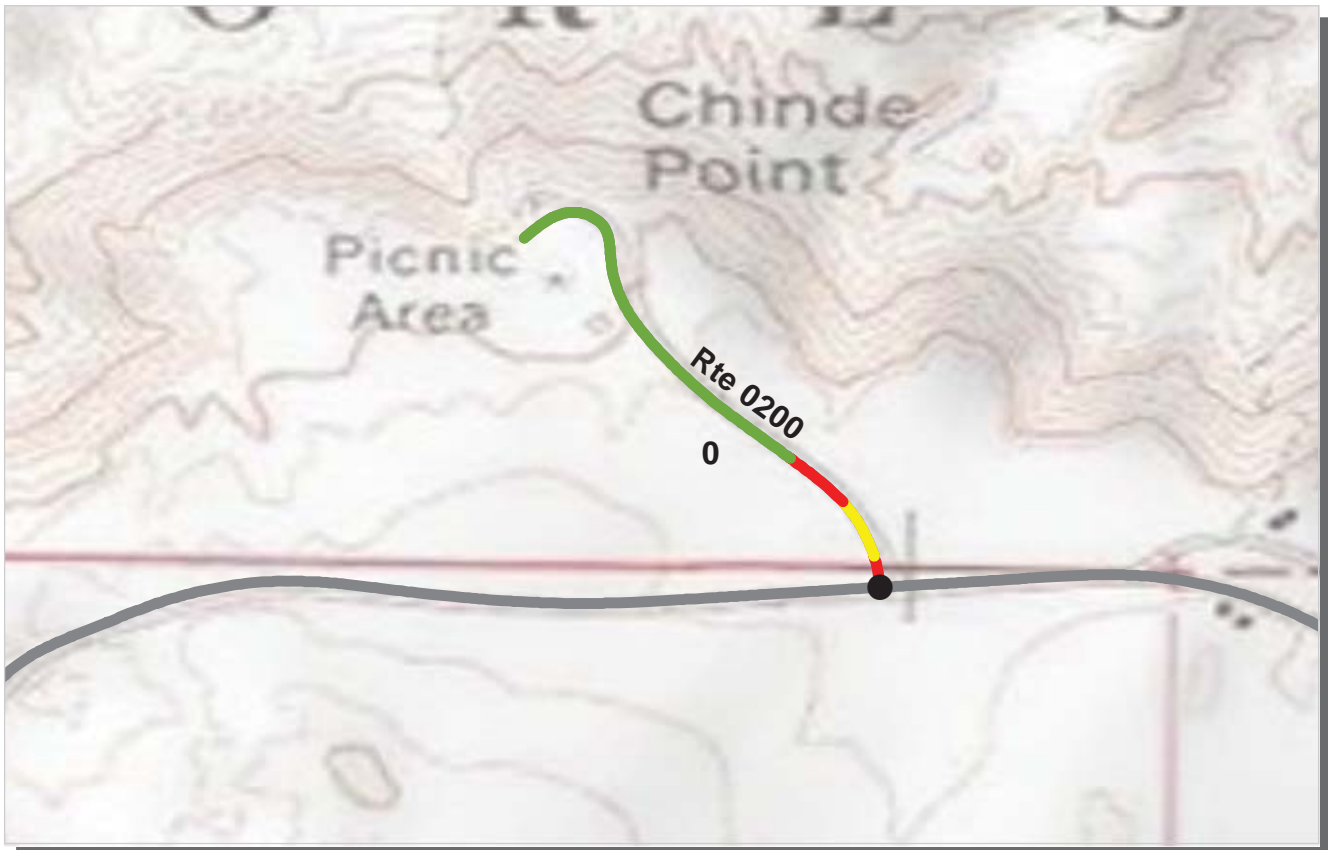
ROUTE: 0200 CHINDE POINT ACCESS ROAD

Section Number	0				
Section Length (mi)	0.34				
Cross Section Information					
Number of Lanes	2				
Paved Width (ft)	22				
Lane Width (ft)	11				
Roadway Condition Information					
SCR (Surface Condition Rating)	85				
PCR (Pavement Condition Rating)	85				
Distress Index Values					
Structural Crack Index	88				
Transverse Cracking Index	85				
Patching Index	100				
Rutting Index	98				
Roughness Condition Index (RCI)	NC

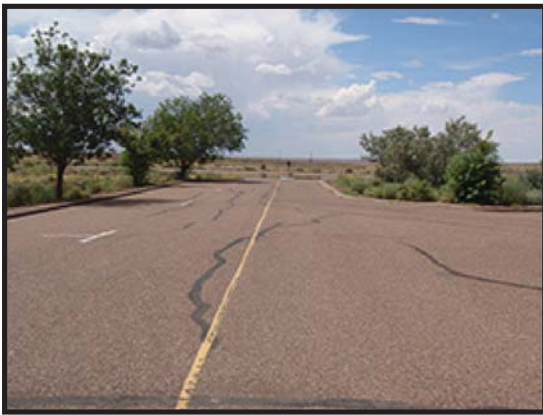
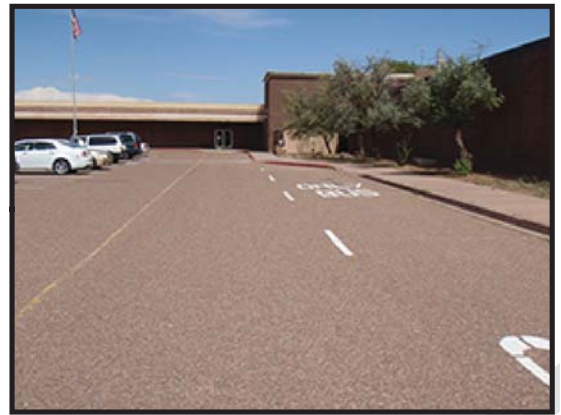
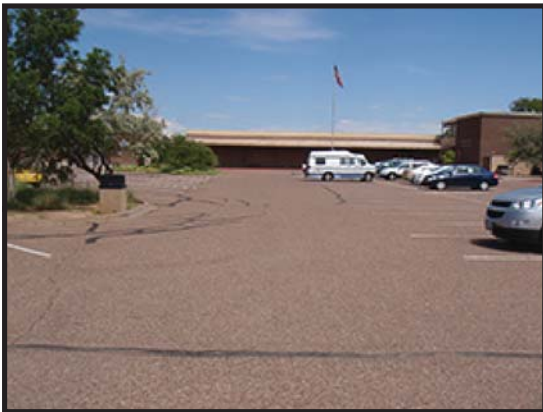
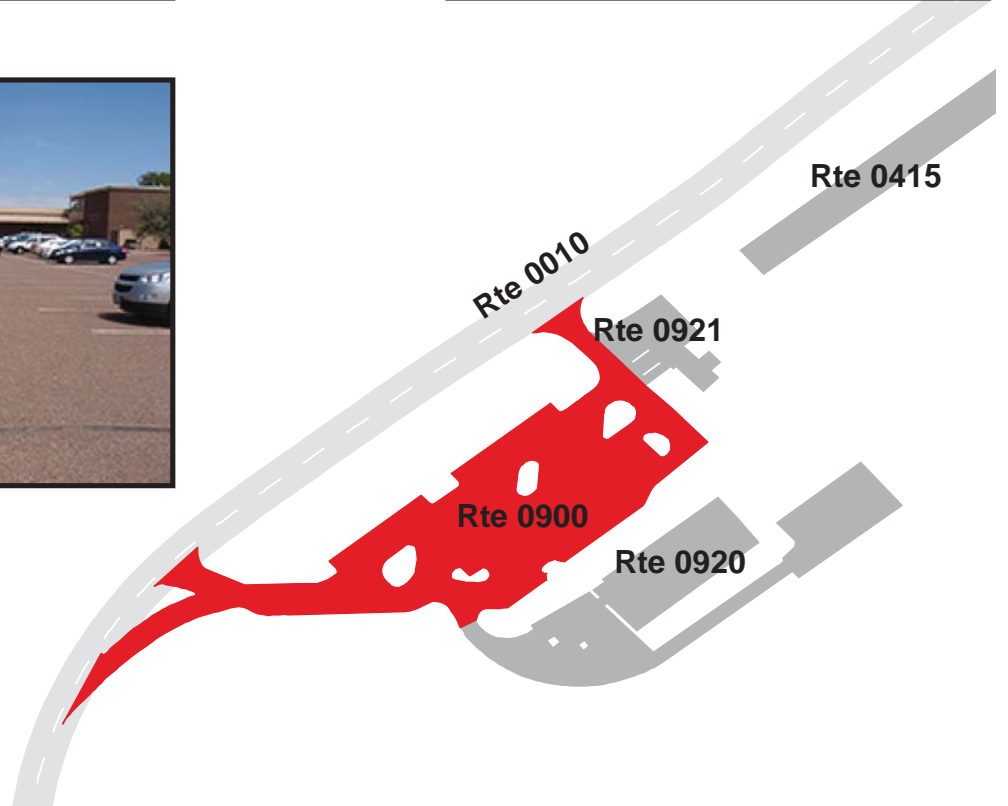
Route 0907

Route Number	Public / NonPublic	Date Visited	Area (sq ft)	Lane Miles *	Surface Type
0907	PUBLIC	9/1/2011	43,495	0.75	AS
Culverts	Drop Inlets	Gates	Curb & Gutter	Curb	PCR
0	3	0	CONCRETE CURB AND GUTTER	CONCRETE CURB	POOR/45

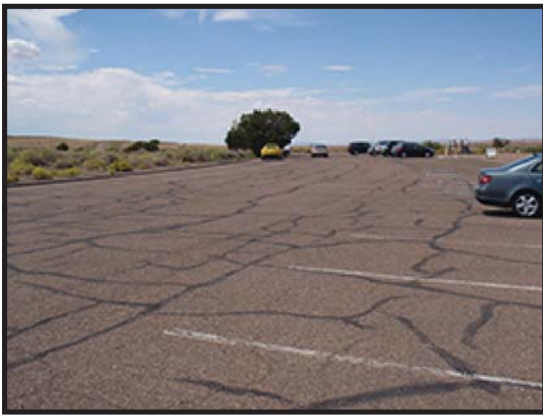
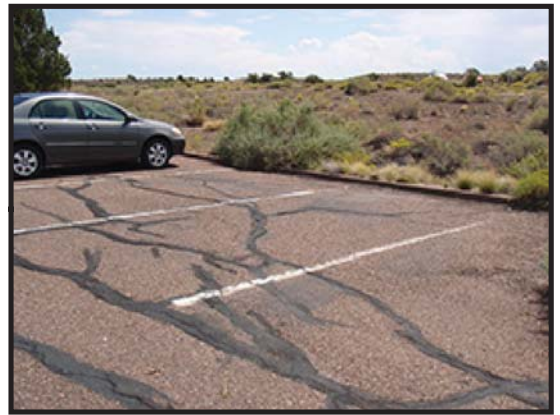
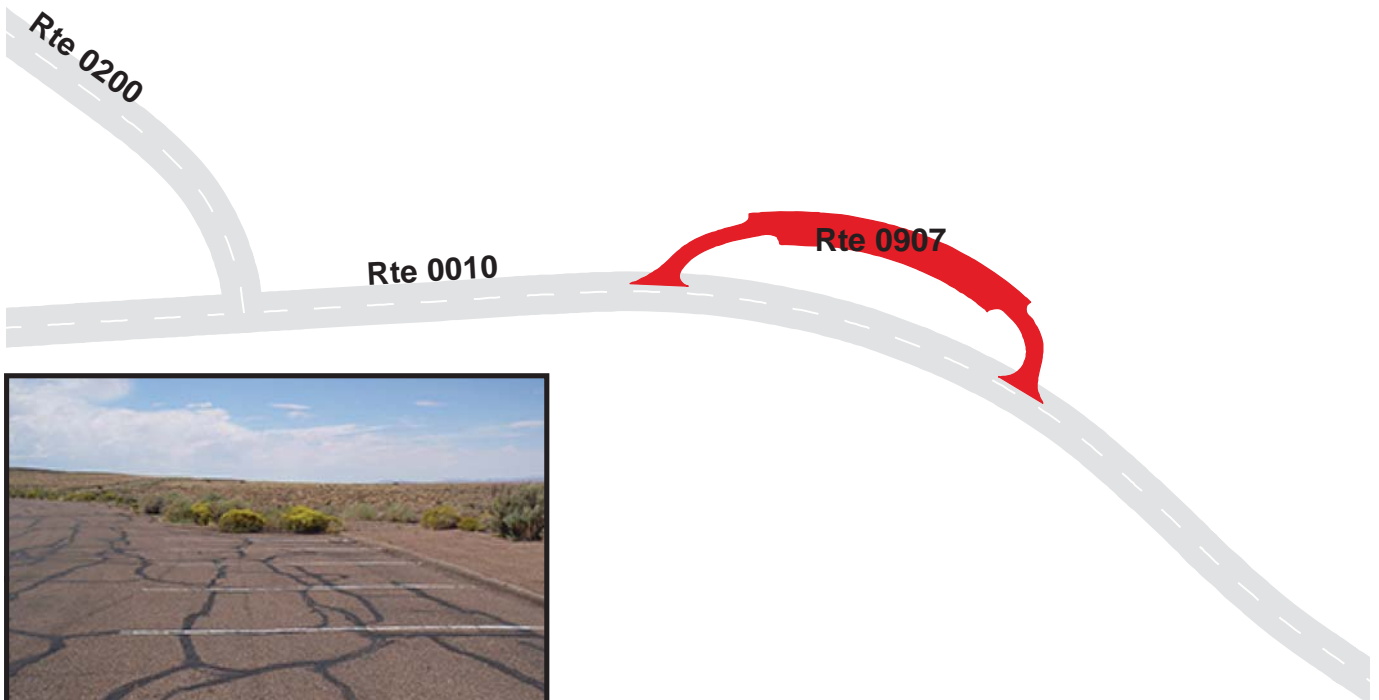
Route 0912

Route Number	Public / NonPublic	Date Visited	Area (sq ft)	Lane Miles *	Surface Type
0912	PUBLIC	9/1/2011	38,011	0.65	AS
Culverts	Drop Inlets	Gates	Curb & Gutter	Curb	PCR
0	2	0	NO CURB AND GUTTER	STONE CURB	FAIR/73

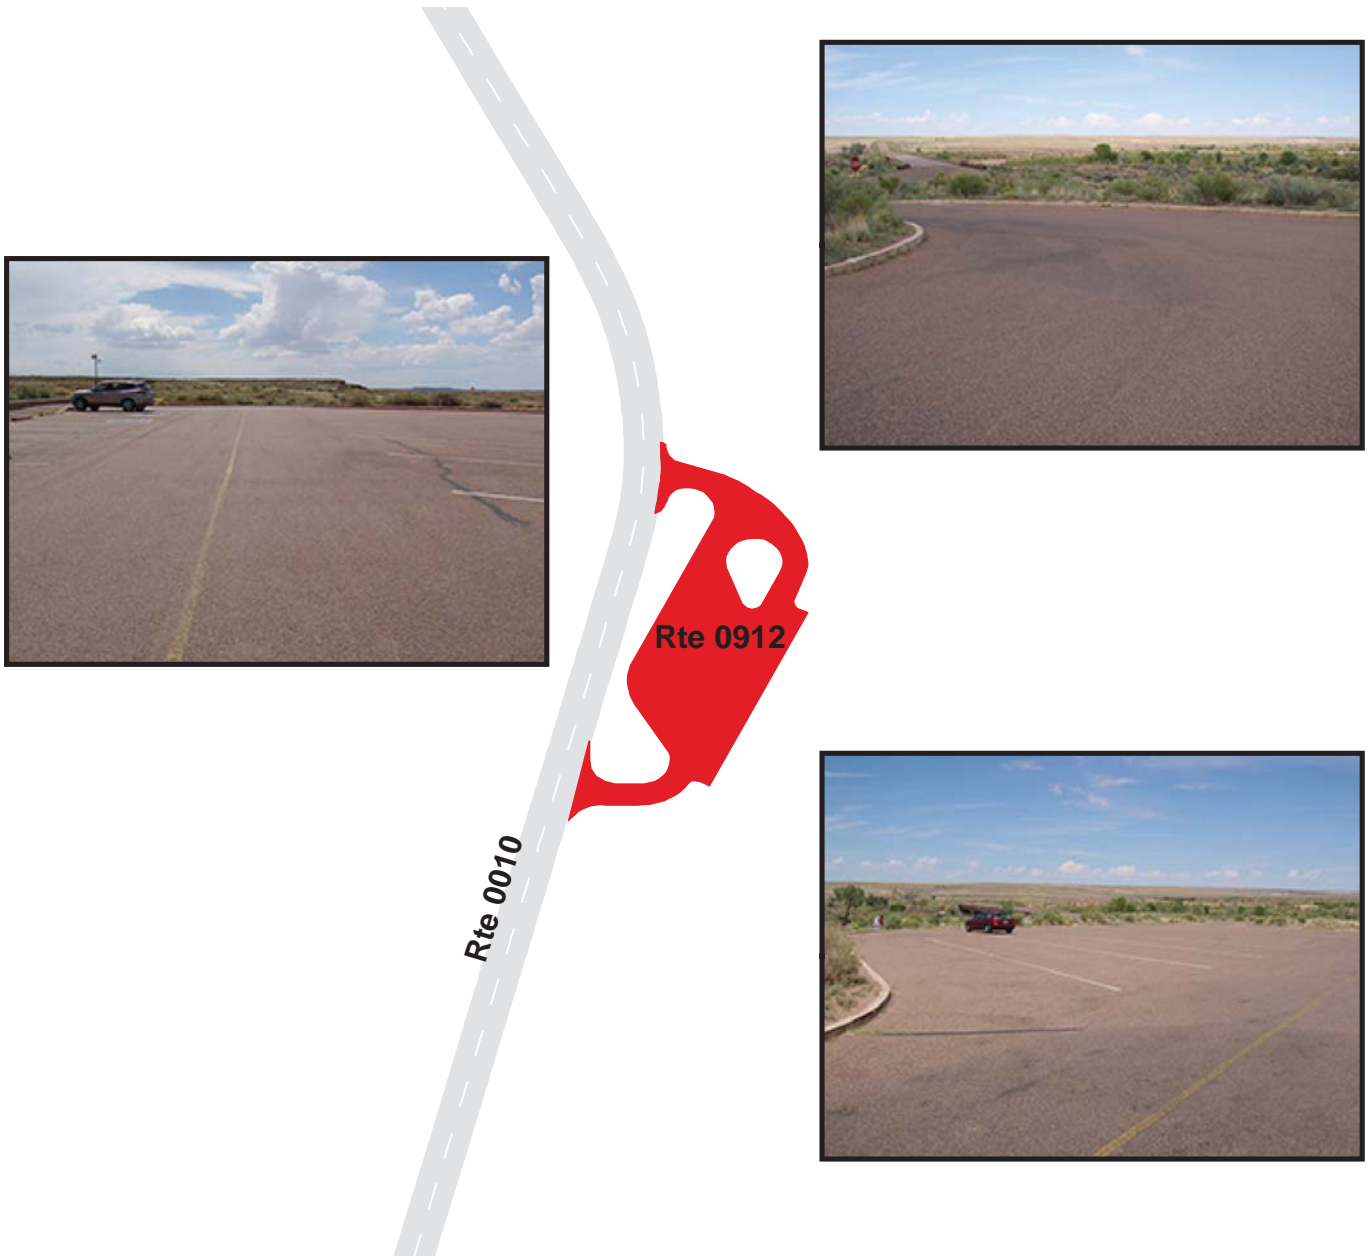
Route 0919

Route Number	Public / NonPublic	Date Visited	Area (sq ft)	Lane Miles *	Surface Type
0919	NONPUBLIC	9/1/2011	4,628	0.08	AS
Culverts	Drop Inlets	Gates	Curb & Gutter	Curb	PCR
0	0	0	NO CURB AND GUTTER	NO CURB	POOR/45

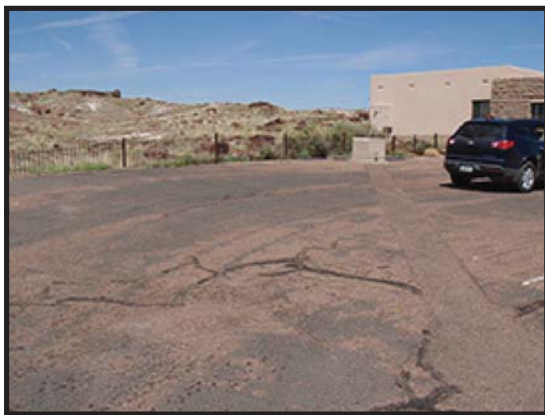
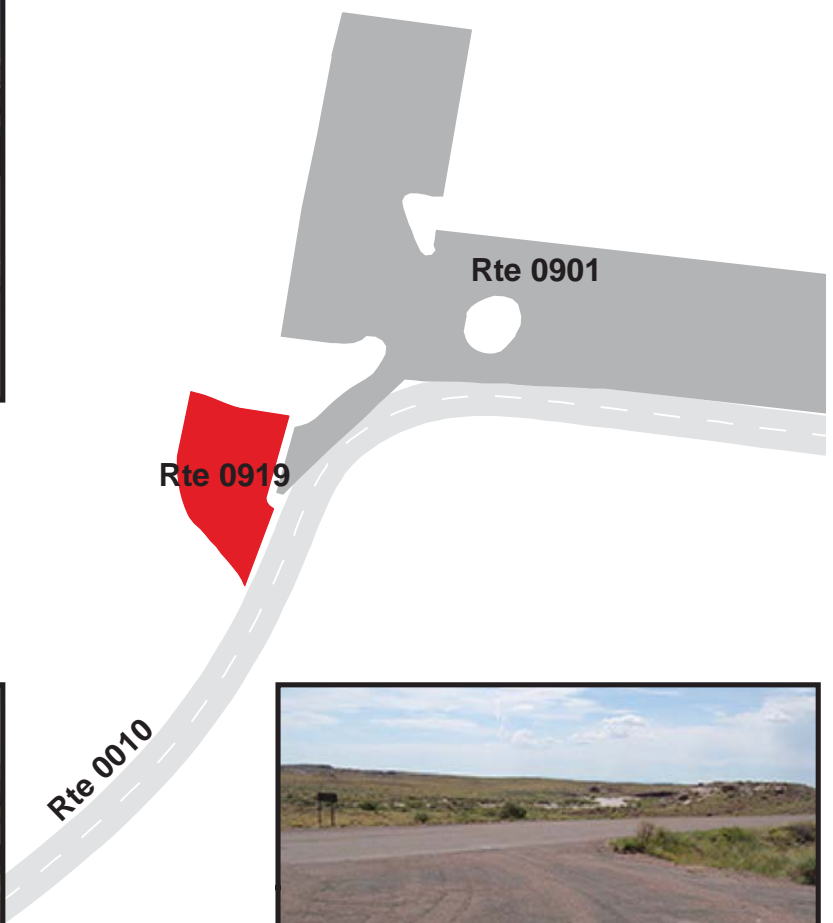
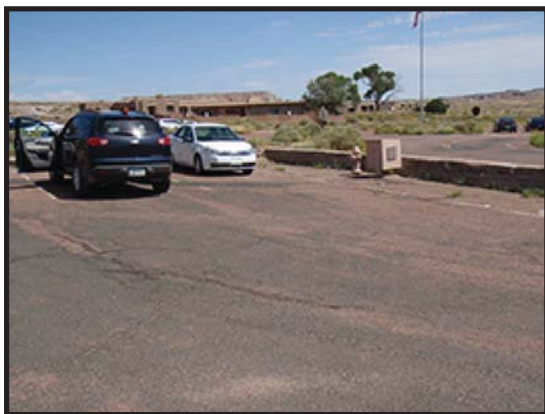
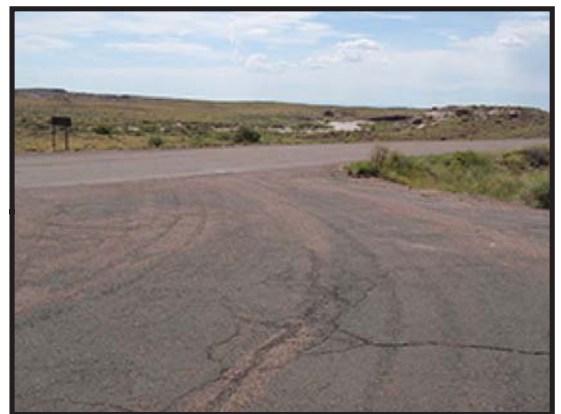
Route 0920

Route Number	Public / NonPublic	Date Visited	Area (sq ft)	Lane Miles *	Surface Type
0920	NONPUBLIC	9/1/2011	52,706	0.91	AS
Culverts	Drop Inlets	Gates	Curb & Gutter	Curb	PCR
0	5	1	CONCRETE CURB AND GUTTER	CONCRETE CURB	FAIR/73

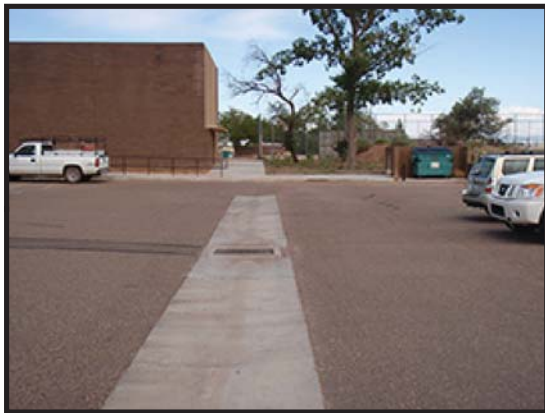
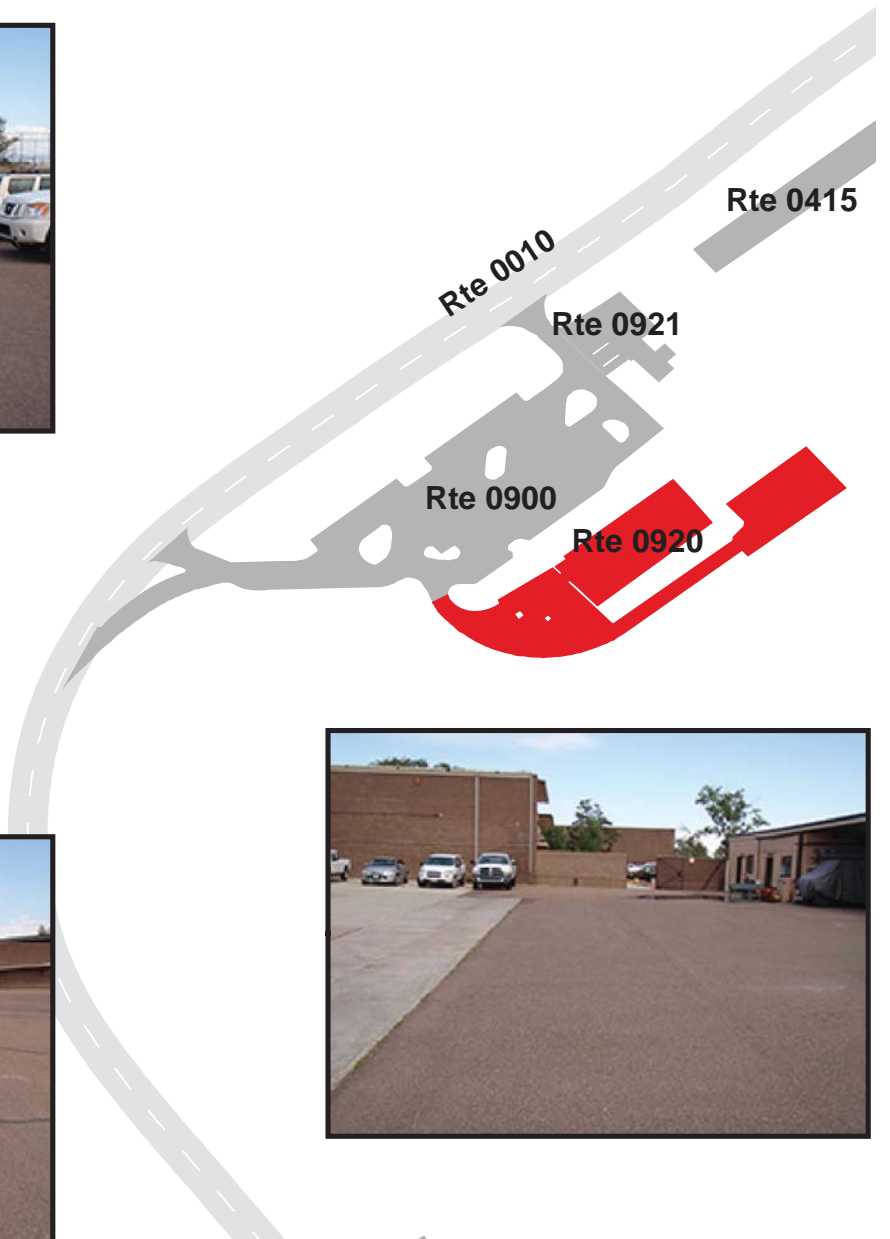
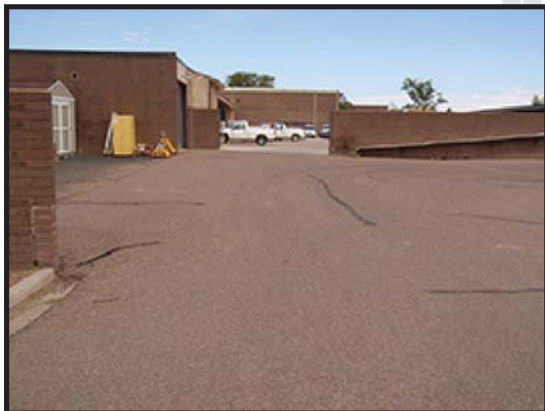
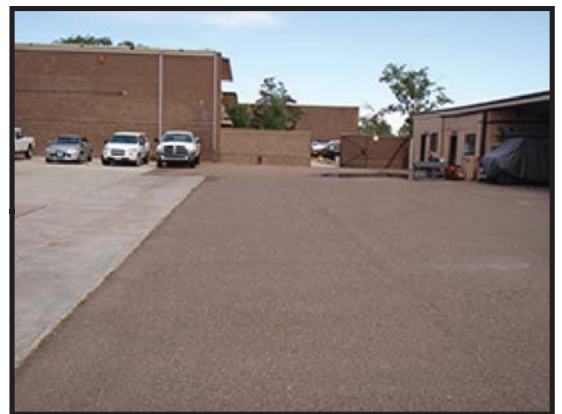
Route 0921

Route Number	Public / NonPublic	Date Visited	Area (sq ft)	Lane Miles *	Surface Type
0921	PUBLIC	9/1/2011	10,911	0.19	AS
Culverts	Drop Inlets	Gates	Curb & Gutter	Curb	PCR
0	0	0	NO CURB AND GUTTER	NO CURB	POOR/45

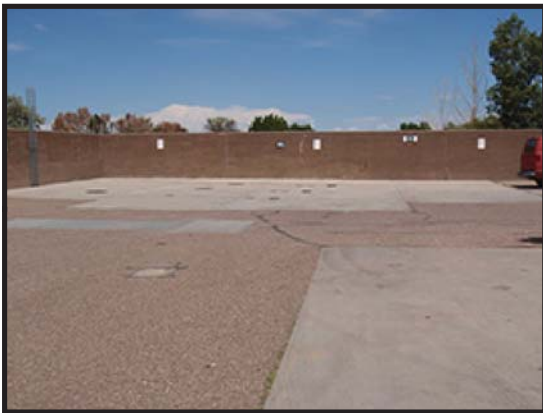
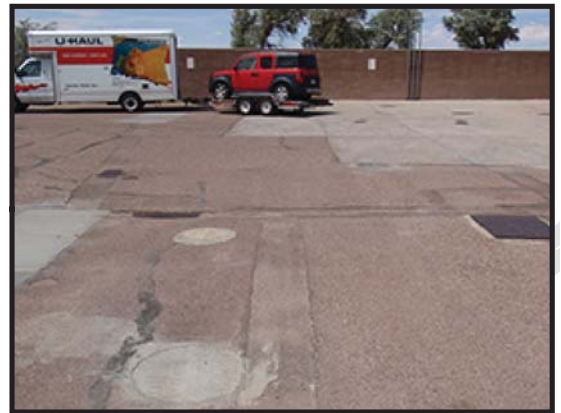
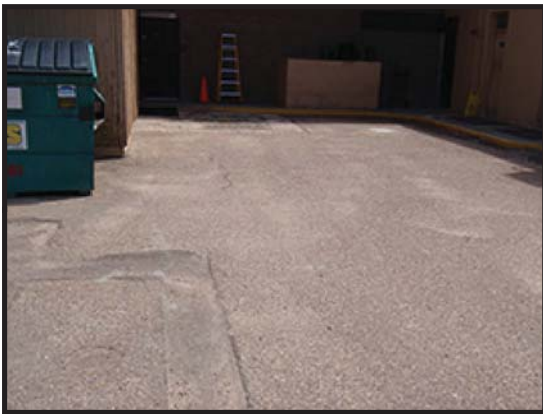
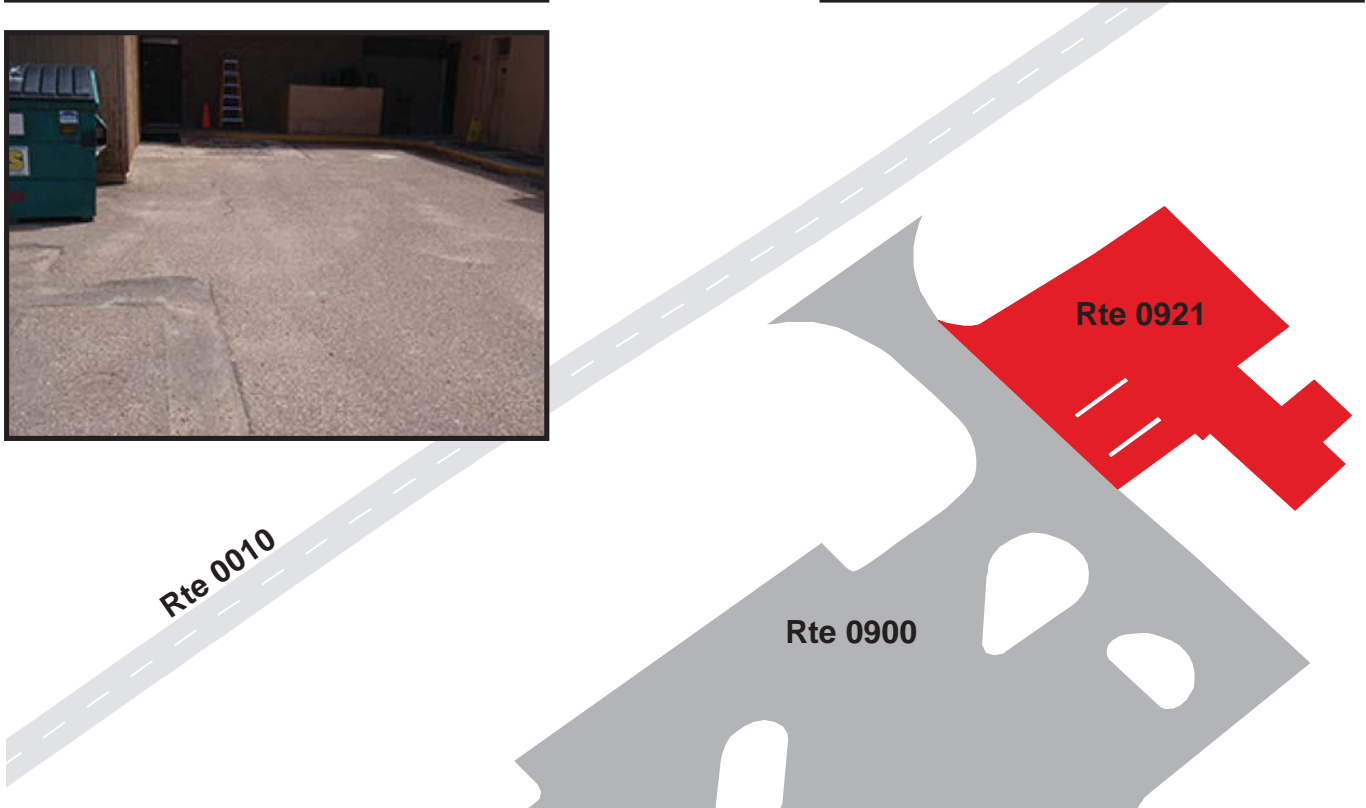
Route 0923

Route Number	Public / NonPublic	Date Visited	Area (sq ft)	Lane Miles *	Surface Type
0923	PUBLIC	9/1/2011	5,257	0.09	CO
Culverts	Drop Inlets	Gates	Curb & Gutter	Curb	PCR
0	2	0	NO CURB AND GUTTER	CONCRETE CURB	POOR/45
