Federal Lands Highway Road Inventory Program

Road Inventory and Condition Assessment

Petrified Forest National Park PEFO

Cycle 5 Report

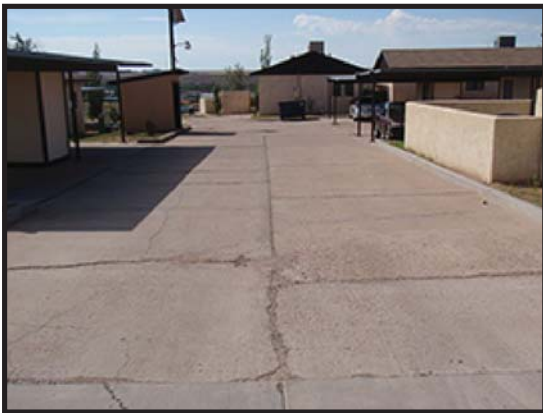
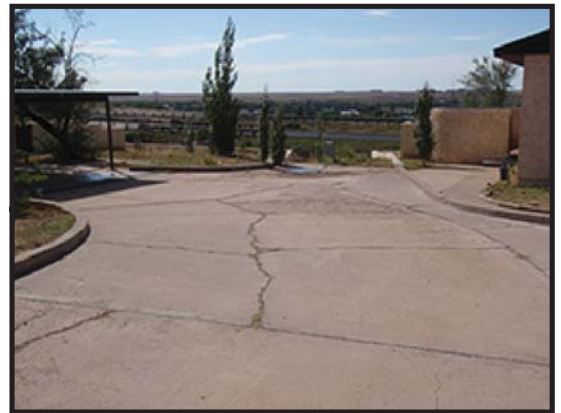
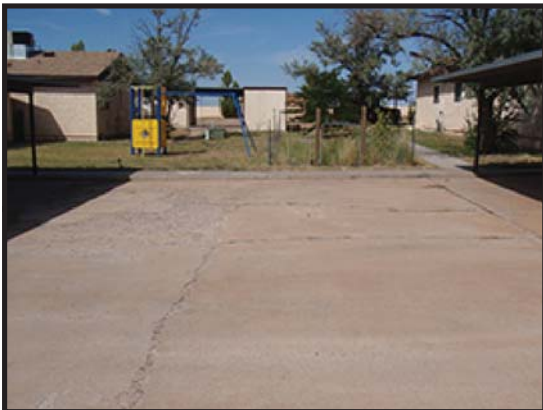
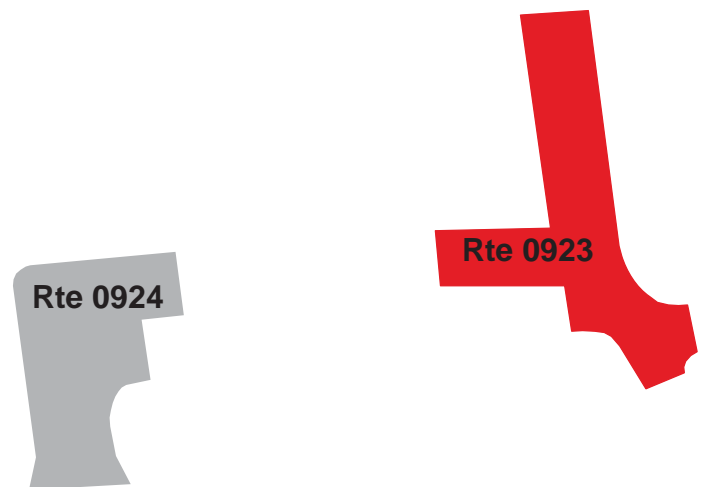
Route 0924

Route Number	Public / NonPublic	Date Visited	Area (sq ft)	Lane Miles *	Surface Type
0924	PUBLIC	9/1/2011	4,225	0.07	CO
Culverts	Drop Inlets	Gates	Curb & Gutter	Curb	PCR
0	0	0	NO CURB AND GUTTER	CONCRETE CURB	POOR/45
