Federal Lands Highway Road Inventory Program

Road Inventory and Condition Assessment

Petersburg National Battlefield PETE

Cycle 5 Report

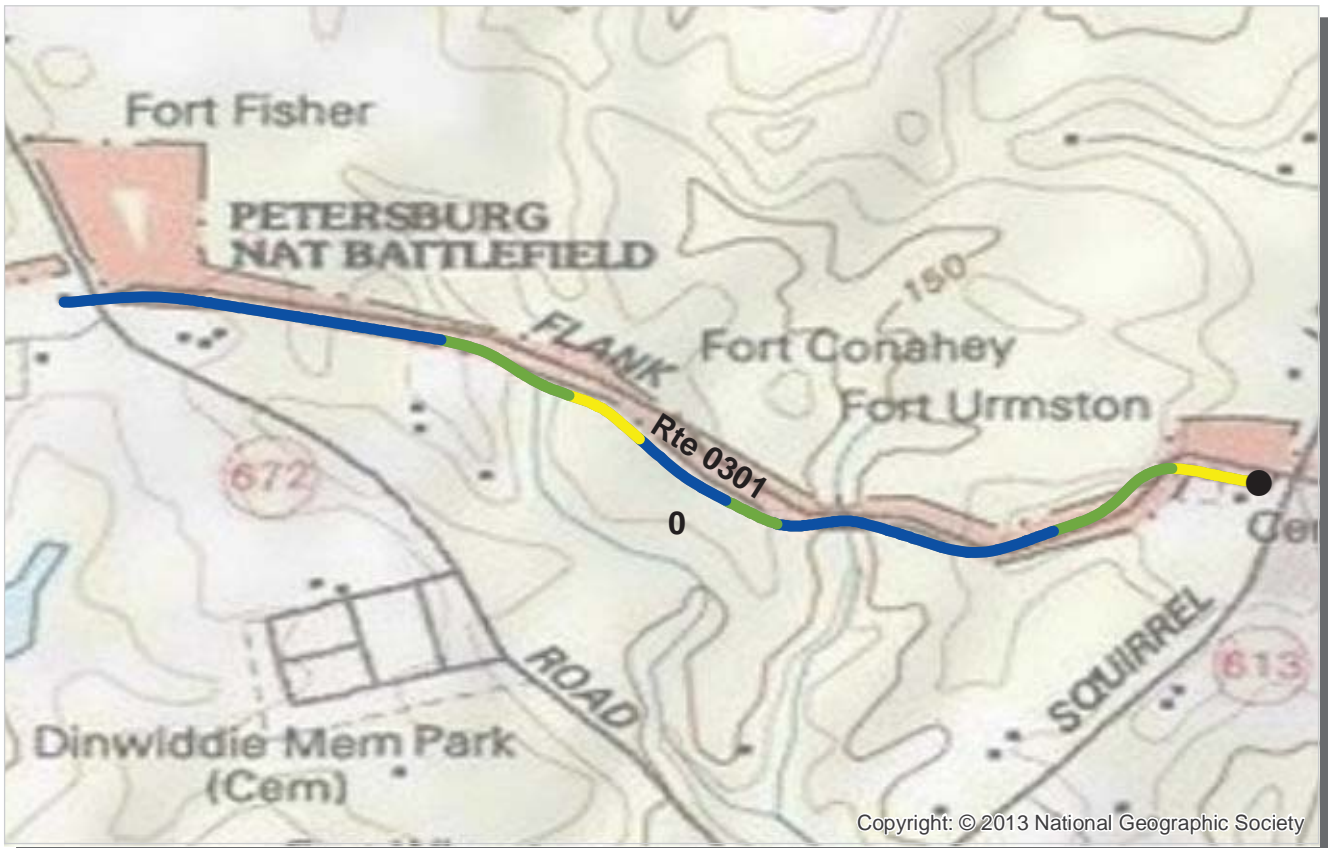
ROUTE: 0301 FLANK ROAD

Section Number	0				
Section Length (mi)	0.90				
Cross Section Information					
Number of Lanes	2				
Paved Width (ft)	20				
Lane Width (ft)	9				
Roadway Condition Information					
SCR (Surface Condition Rating)	100				
PCR (Pavement Condition Rating)	92				
Distress Index Values					
Structural Crack Index	100				
Transverse Cracking Index	100				
Patching Index	100				
Rutting Index	100				
Roughness Condition Index (RCI)	80

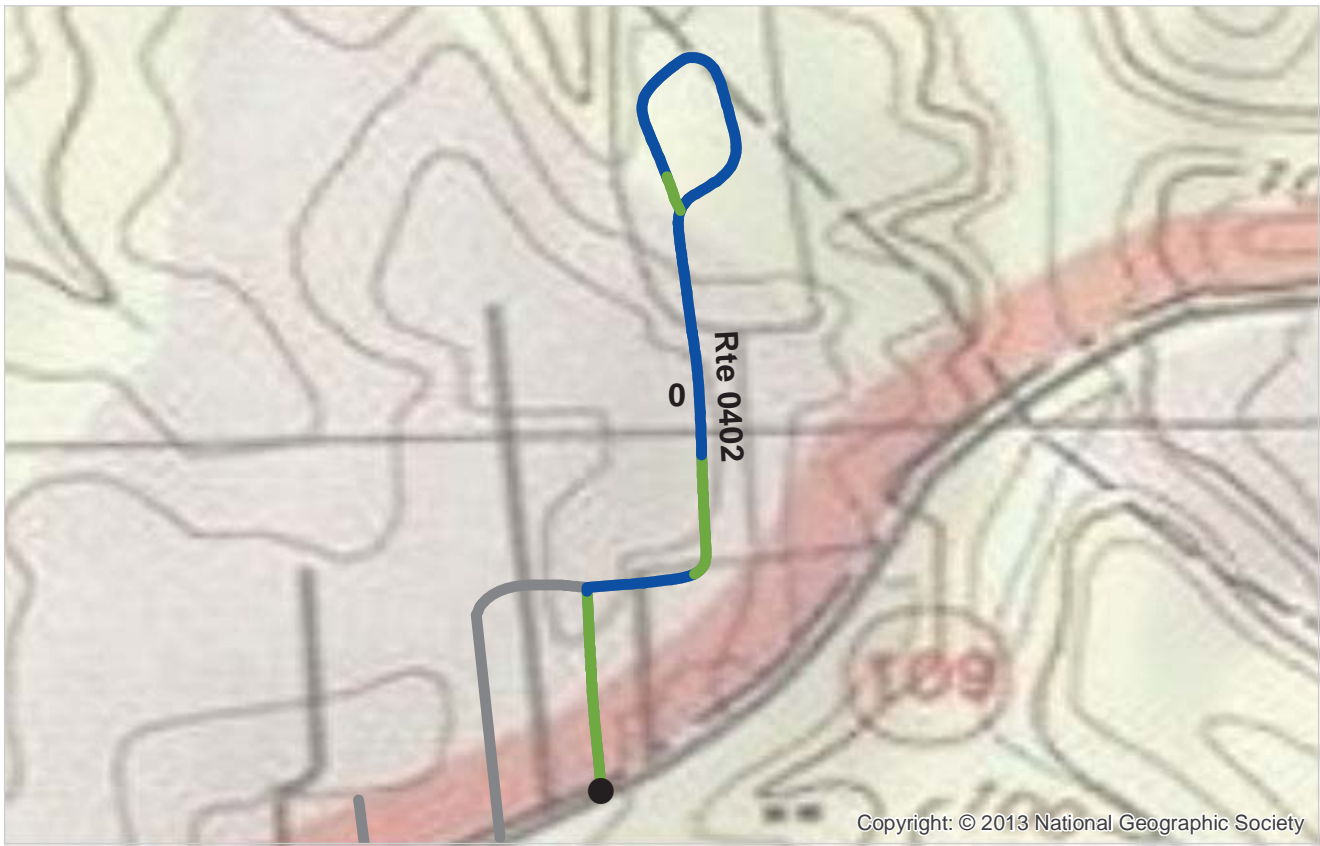
ROUTE: 0402 HEADQUARTERS ACCESS ROAD

Section Number	0				
Section Length (mi)	0.49				
Cross Section Information					
Number of Lanes	1				
Paved Width (ft)	12				
Lane Width (ft)	12				
Roadway Condition Information					
SCR (Surface Condition Rating)	95				
PCR (Pavement Condition Rating)	95				
Distress Index Values					
Structural Crack Index	100				
Transverse Cracking Index	100				
Patching Index	100				
Rutting Index	95				
Roughness Condition Index (RCI)	N/A

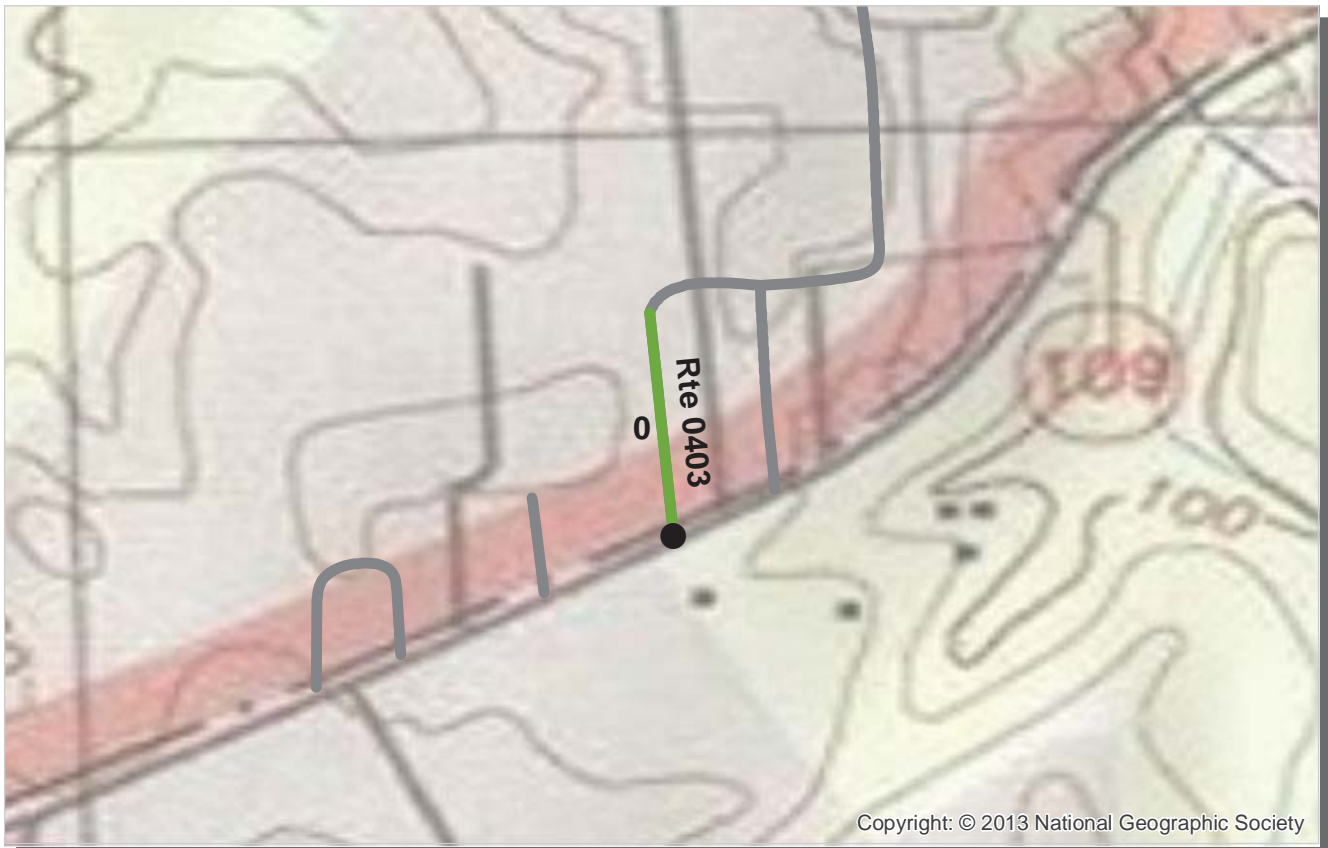
ROUTE: 0403 RANGER ACCESS ROAD

Section Number	0				
Section Length (mi)	0.11				
Cross Section Information					
Number of Lanes	1				
Paved Width (ft)	12				
Lane Width (ft)	12				
Roadway Condition Information					
SCR (Surface Condition Rating)	90				
PCR (Pavement Condition Rating)	90				
Distress Index Values					
Structural Crack Index	100				
Transverse Cracking Index	100				
Patching Index	100				
Rutting Index	90				
Roughness Condition Index (RCI)	N/A

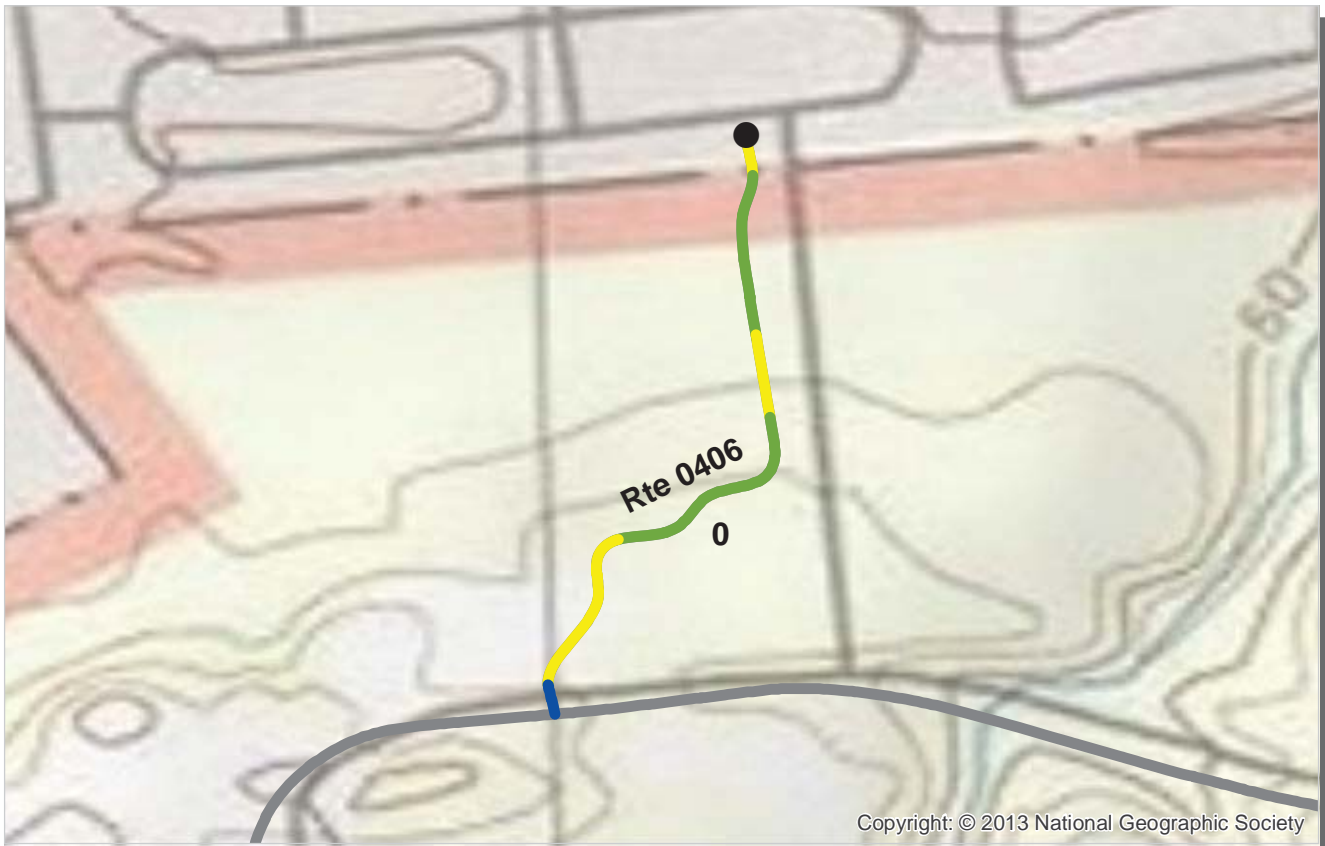
ROUTE: 0406 SERVICE ROAD

Section Number	0				
Section Length (mi)	0.33				
Cross Section Information					
Number of Lanes	1				
Paved Width (ft)	13				
Lane Width (ft)	13				
Roadway Condition Information					
SCR (Surface Condition Rating)	88				
PCR (Pavement Condition Rating)	88				
Distress Index Values					
Structural Crack Index	99				
Transverse Cracking Index	99				
Patching Index	100				
Rutting Index	88				
Roughness Condition Index (RCI)	N/A

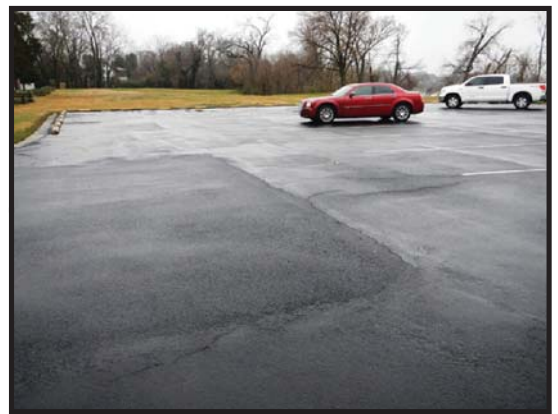
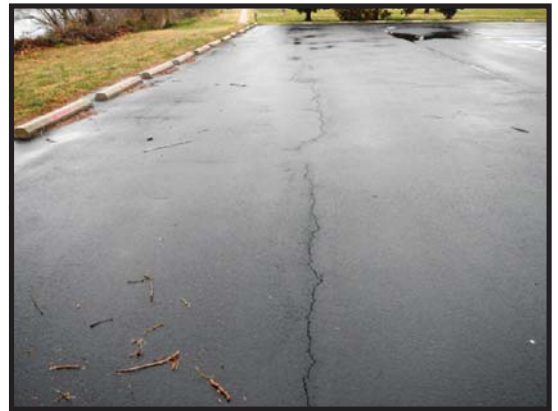
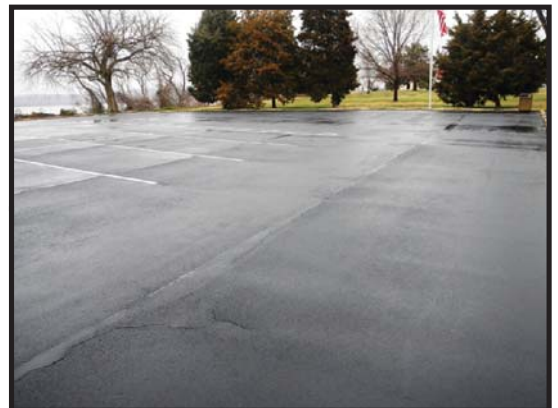
Route Number	Public / NonPublic	Date Visited	Area (sq ft)	Lane Miles *	Surface Type
0900	PUBLIC	2/10/2013	23,113	0.40	AS
Culverts	Drop Inlets	Gates	Curb & Gutter	Curb	PCR
0	0	0	NO CURB AND GUTTER	NO CURB	POOR/45

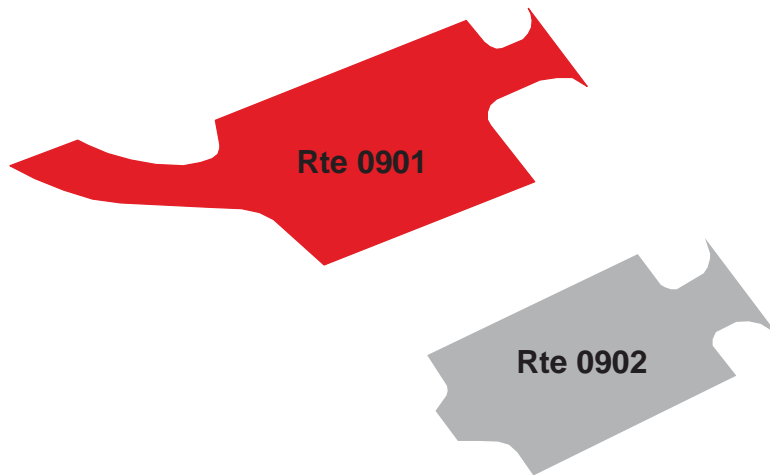
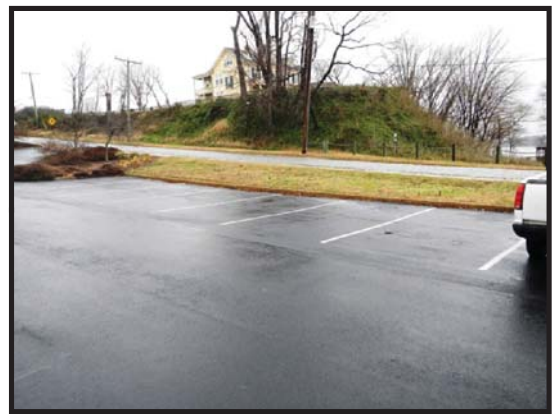
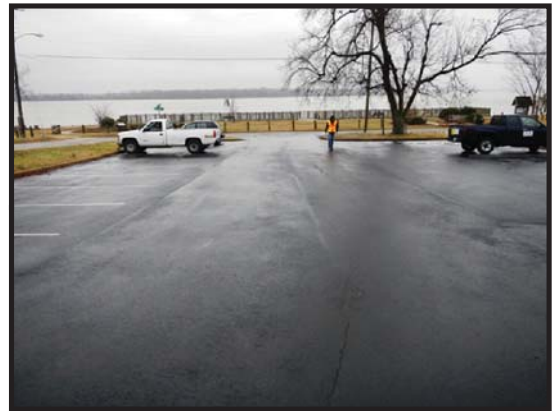
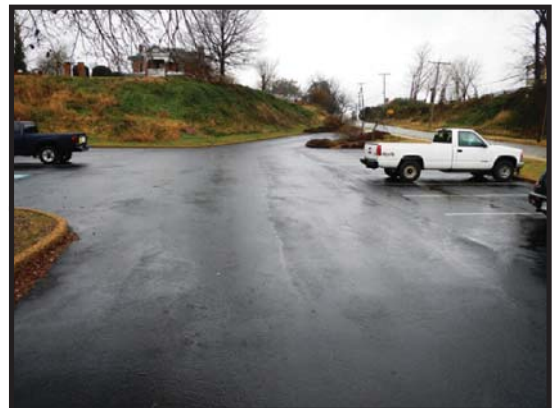
Route 0901

Route Number	Public / NonPublic	Date Visited	Area (sq ft)	Lane Miles *	Surface Type
0901	PUBLIC	2/11/2013	8,678	0.15	AS
Culverts	Drop Inlets	Gates	Curb & Gutter	Curb	PCR
0	0	0	NO CURB AND GUTTER	CONCRETE & WOOD CURB	FAIR/73

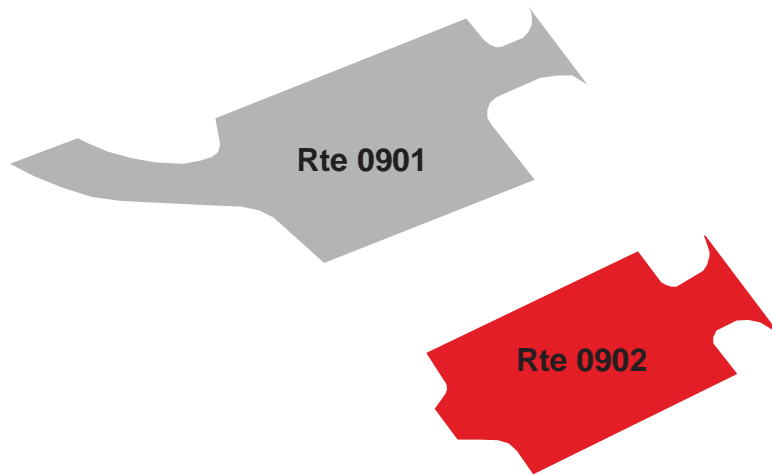
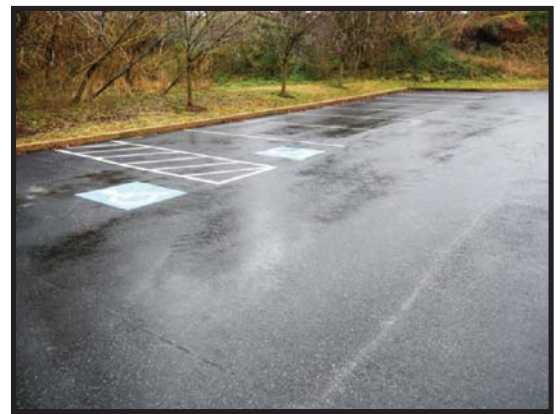
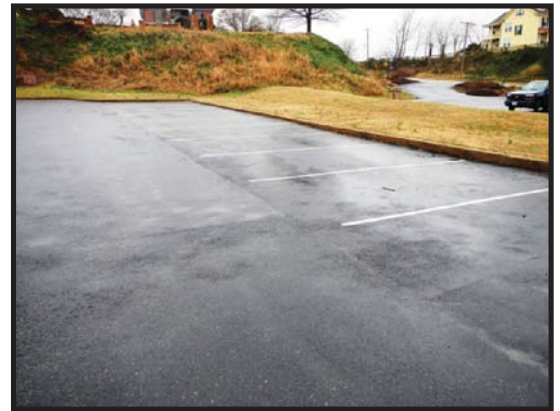
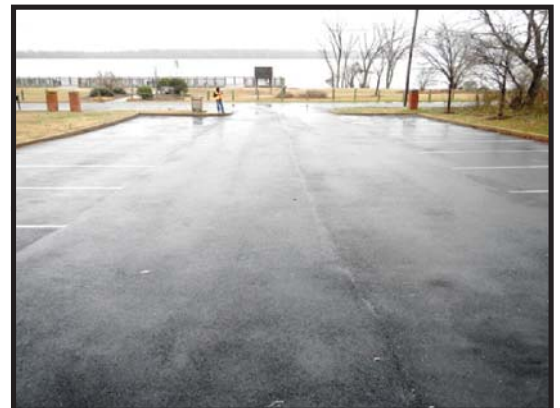
Route 0902

Route Number	Public / NonPublic	Date Visited	Area (sq ft)	Lane Miles *	Surface Type
0902	PUBLIC	2/11/2013	6,177	0.11	AS
Culverts	Drop Inlets	Gates	Curb & Gutter	Curb	PCR
0	0	0	NO CURB AND GUTTER	CONCRETE CURB	GOOD/90

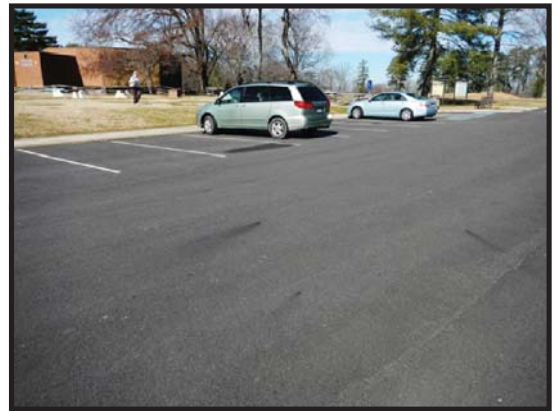
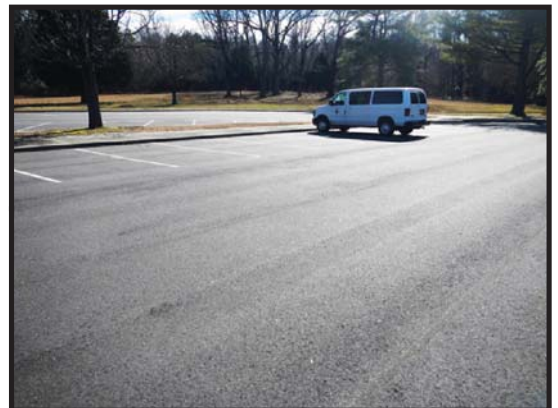
Route 0904

Route Number	Public / NonPublic	Date Visited	Area (sq ft)	Lane Miles *	Surface Type
0904	PUBLIC	2/12/2013	42,573	0.73	AS
Culverts	Drop Inlets	Gates	Curb & Gutter	Curb	PCR
0	5	0	NO CURB AND GUTTER	CONCRETE CURB	GOOD/90

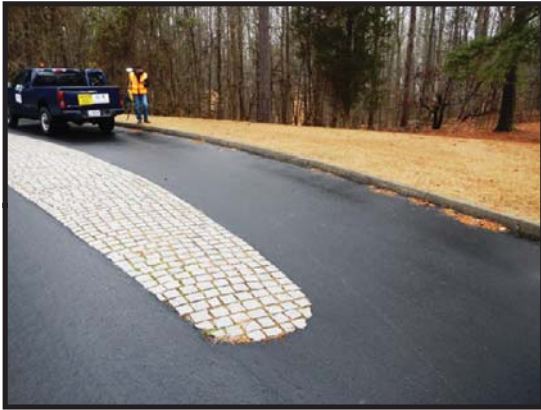
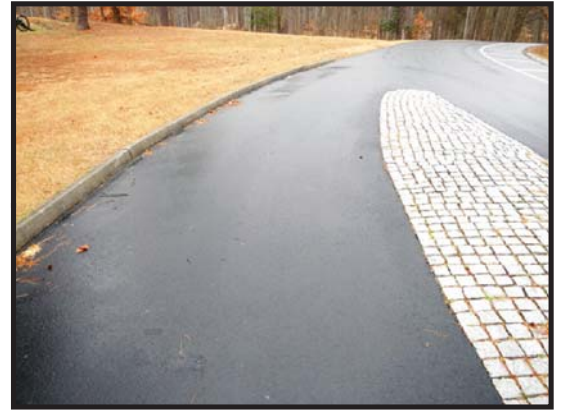
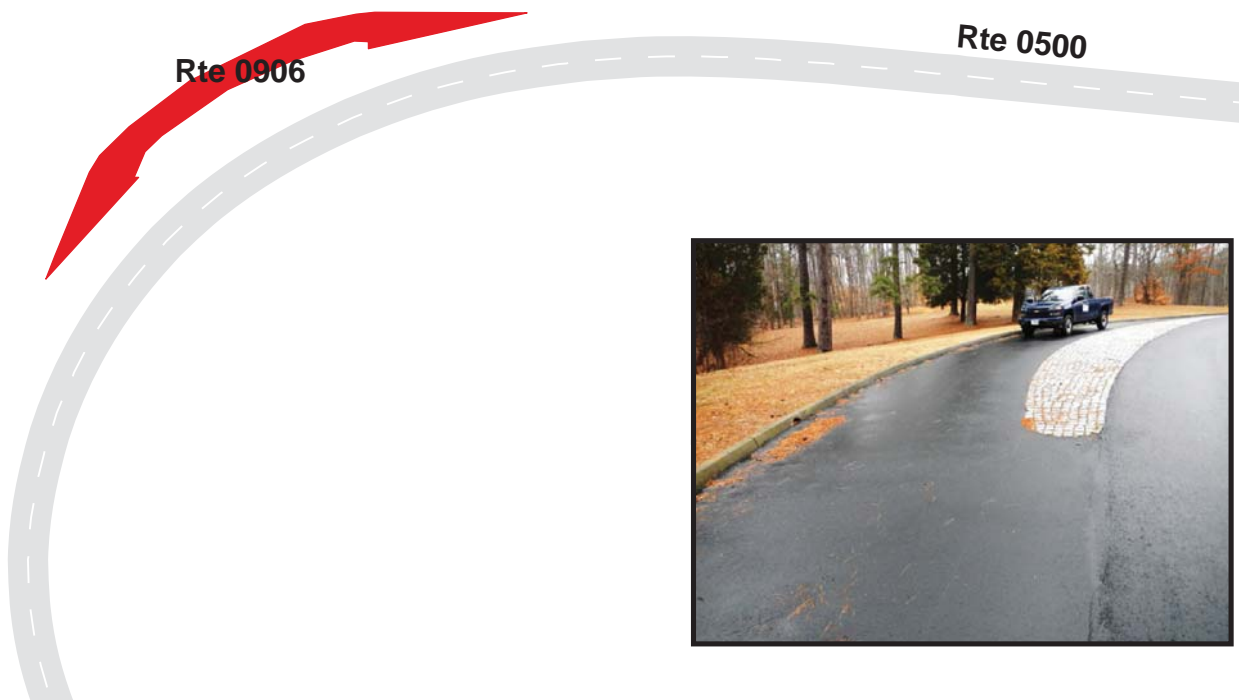
Route Number	Public / NonPublic	Date Visited	Area (sq ft)	Lane Miles *	Surface Type
0906	PUBLIC	2/11/2013	1,376	0.02	AS
Culverts	Drop Inlets	Gates	Curb & Gutter	Curb	PCR
0	1	0	NO CURB AND GUTTER	CONCRETE CURB	GOOD/90

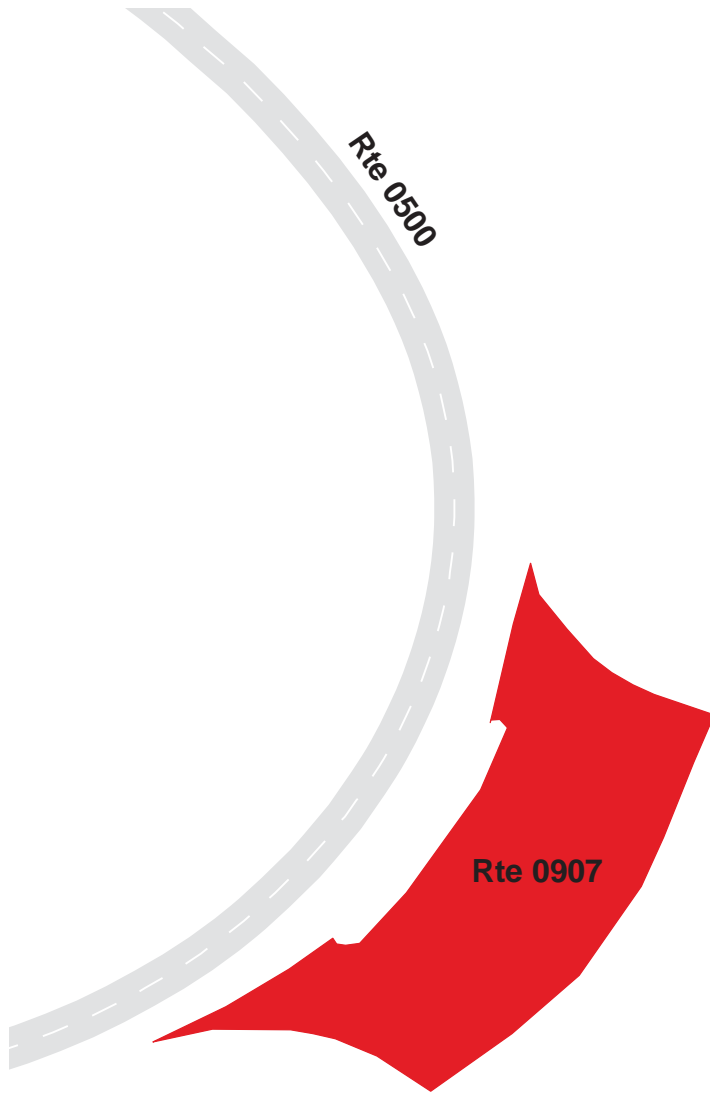
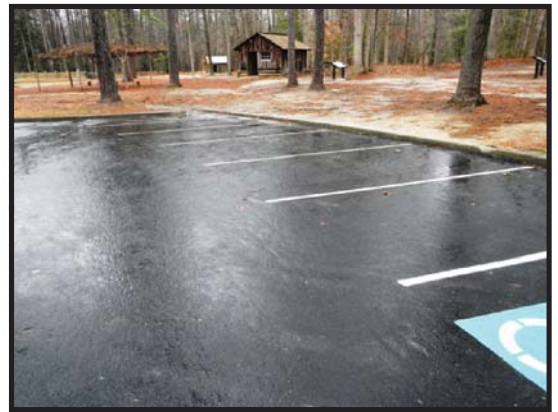
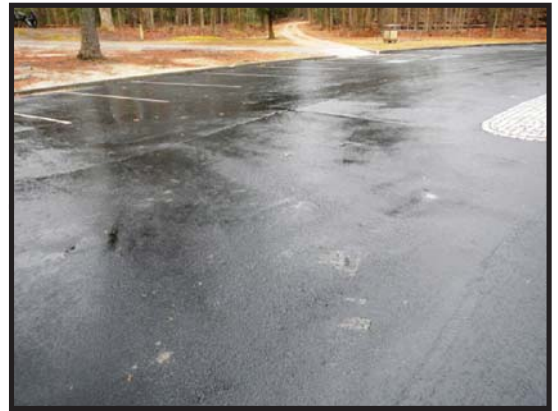
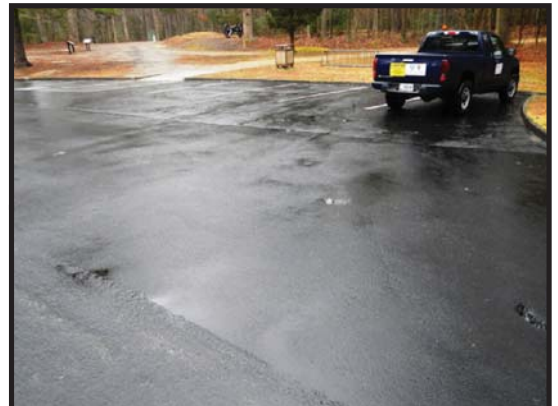
Route 0907

Route Number	Public / NonPublic	Date Visited	Area (sq ft)	Lane Miles *	Surface Type
0907	PUBLIC	2/11/2013	5,073	0.09	AS
Culverts	Drop Inlets	Gates	Curb & Gutter	Curb	PCR
0	1	0	NO CURB AND GUTTER	CONCRETE CURB	GOOD/90

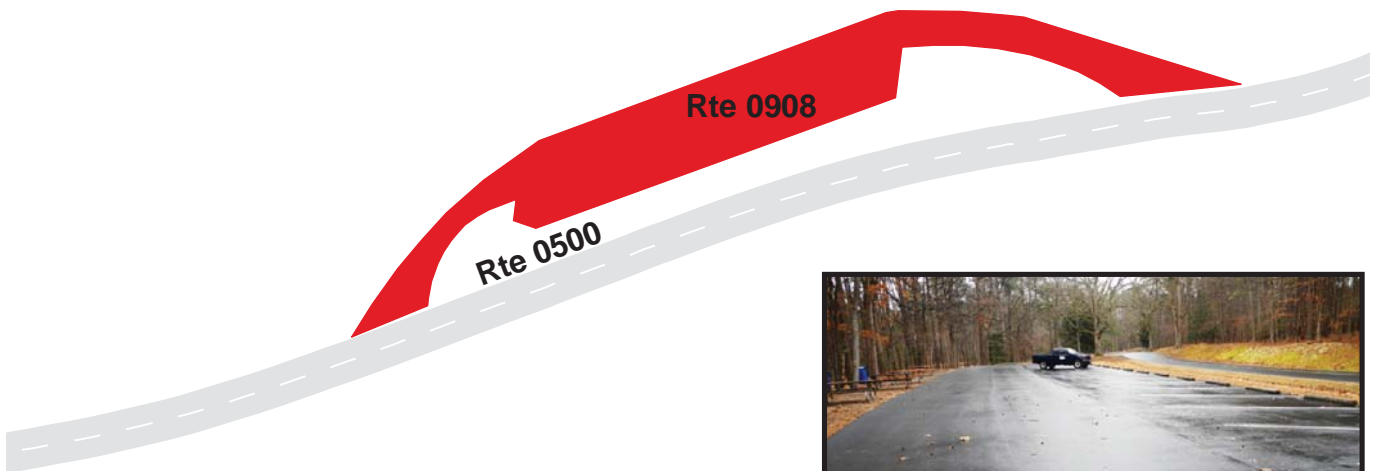
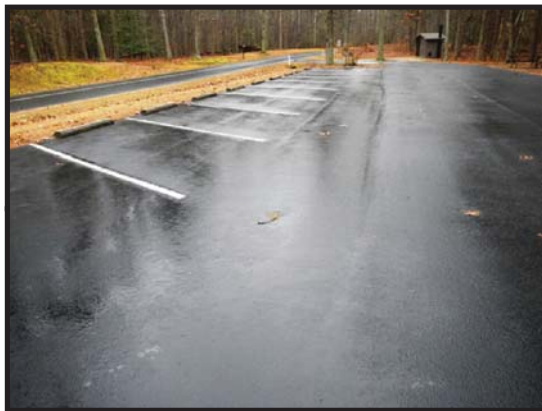
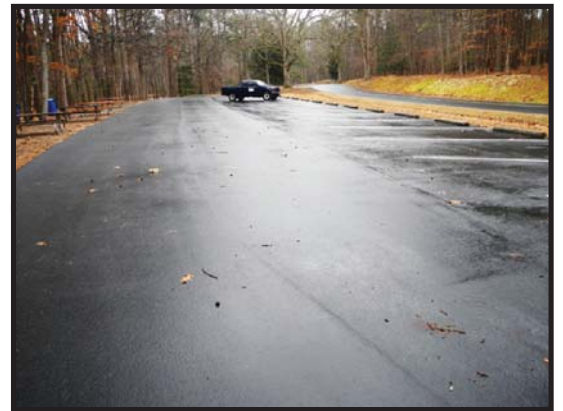
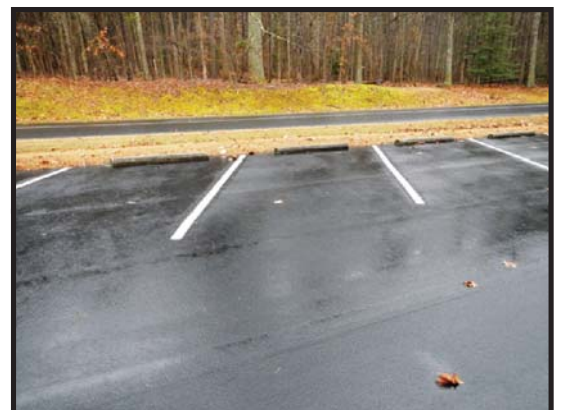
Route 0908

Route Number	Public / NonPublic	Date Visited	Area (sq ft)	Lane Miles *	Surface Type
0908	PUBLIC	2/11/2013	11,877	0.20	AS
Culverts	Drop Inlets	Gates	Curb & Gutter	Curb	PCR
1	0	0	NO CURB AND GUTTER	NO CURB	GOOD/90

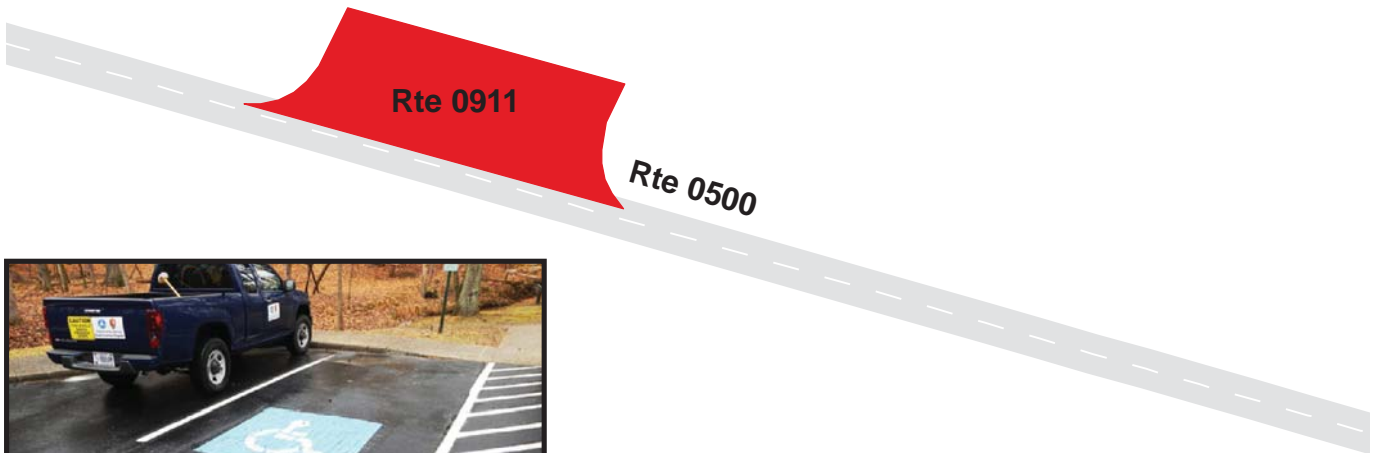
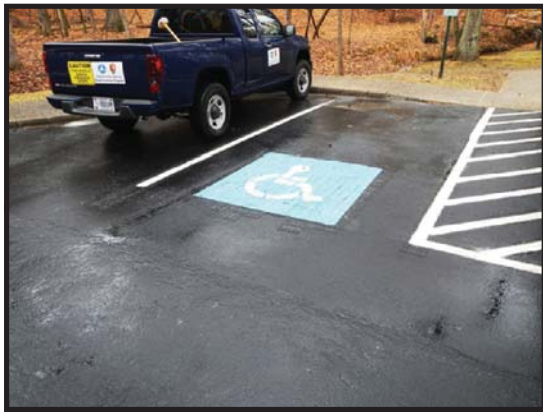
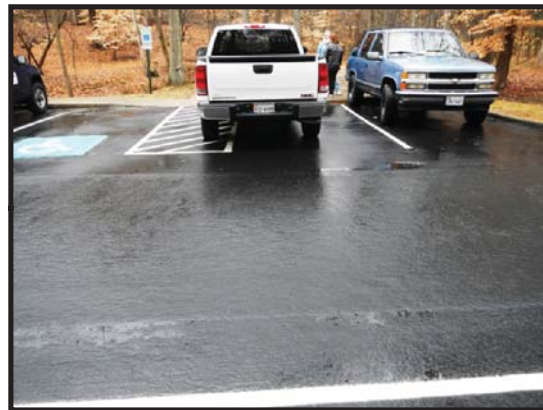
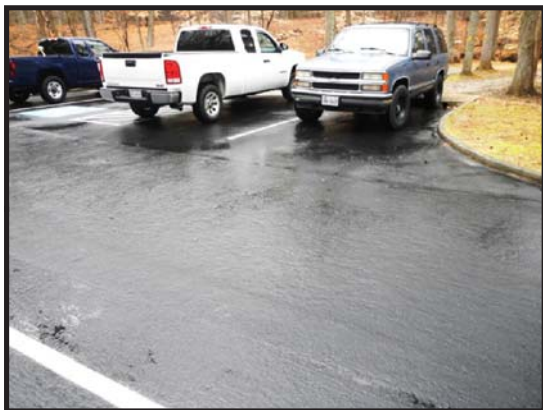
Route 0911

Route Number	Public / NonPublic	Date Visited	Area (sq ft)	Lane Miles *	Surface Type
0911	PUBLIC	2/11/2013	1,381	0.02	AS
Culverts	Drop Inlets	Gates	Curb & Gutter	Curb	PCR
0	1	0	NO CURB AND GUTTER	CONCRETE CURB	GOOD/90

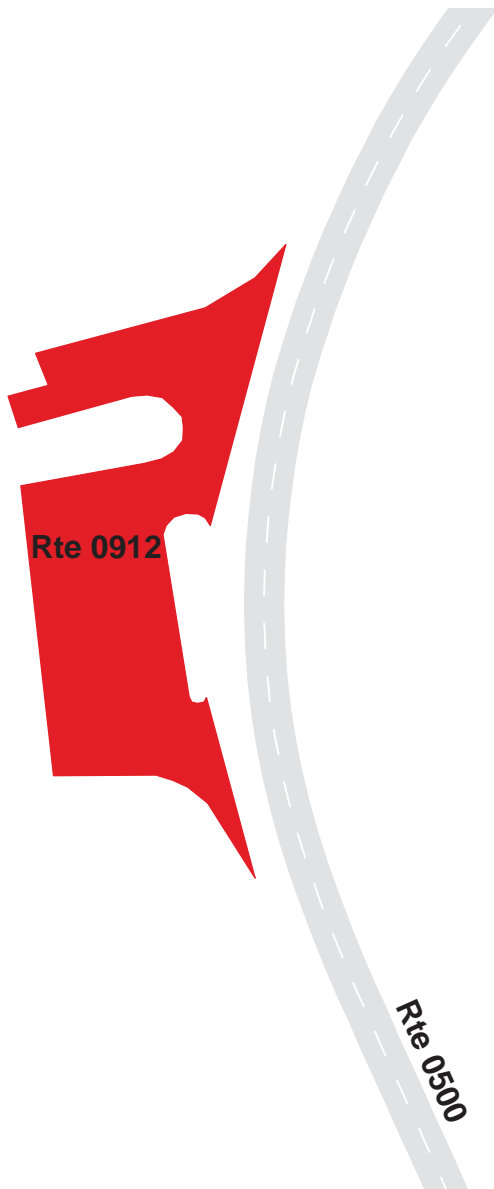
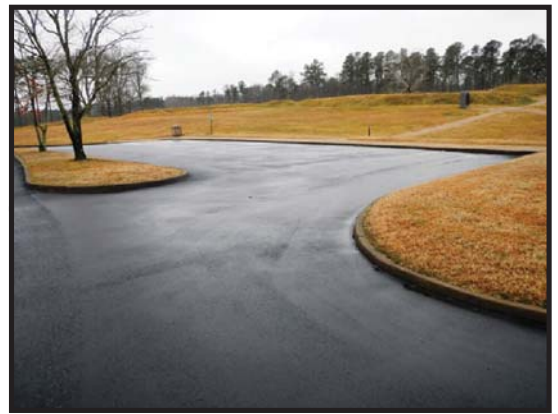
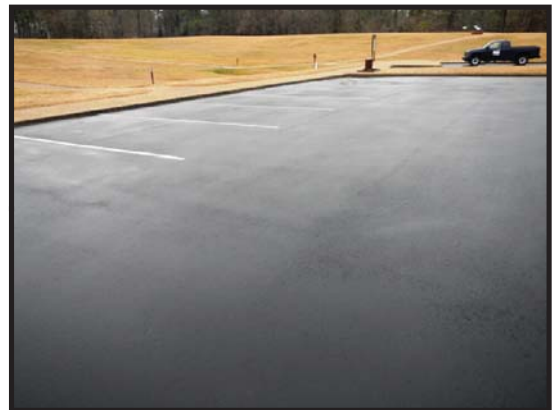
Route 0912

Route Number	Public / NonPublic	Date Visited	Area (sq ft)	Lane Miles *	Surface Type
0912	PUBLIC	2/11/2013	7,026	0.12	AS
Culverts	Drop Inlets	Gates	Curb & Gutter	Curb	PCR
0	2	0	NO CURB AND GUTTER	CONCRETE CURB	GOOD/90

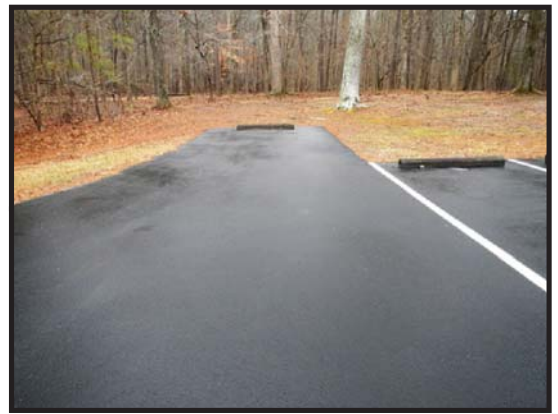
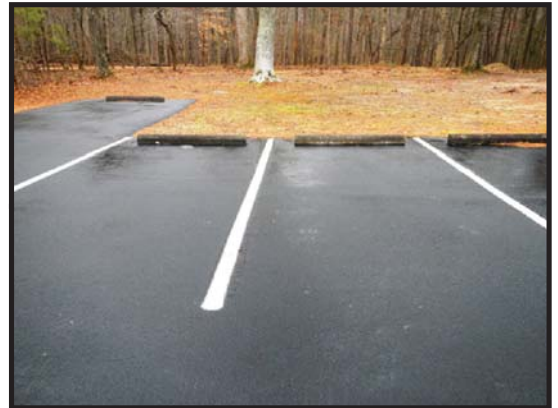
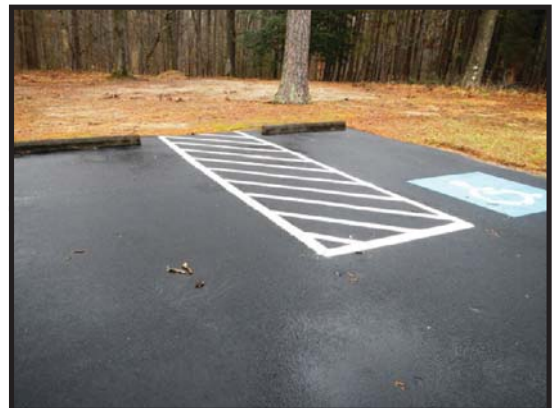
Route Number	Public / NonPublic	Date Visited	Area (sq ft)	Lane Miles *	Surface Type
0913	PUBLIC	2/11/2013	2,292	0.04	AS
Culverts	Drop Inlets	Gates	Curb & Gutter	Curb	PCR
0	0	0	NO CURB AND GUTTER	NO CURB	GOOD/90

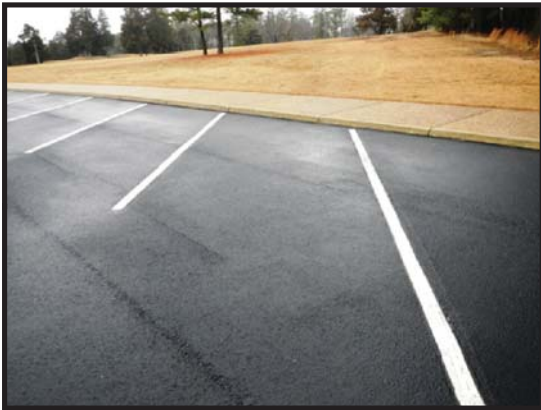
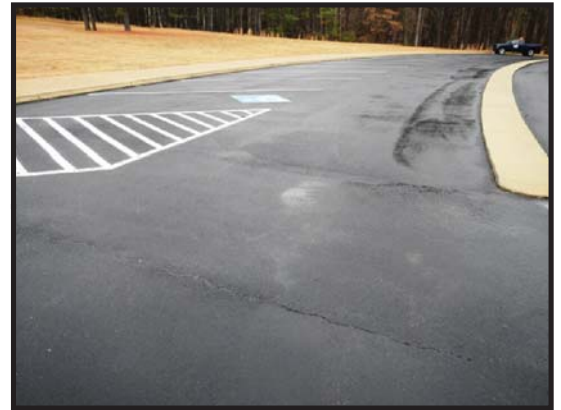
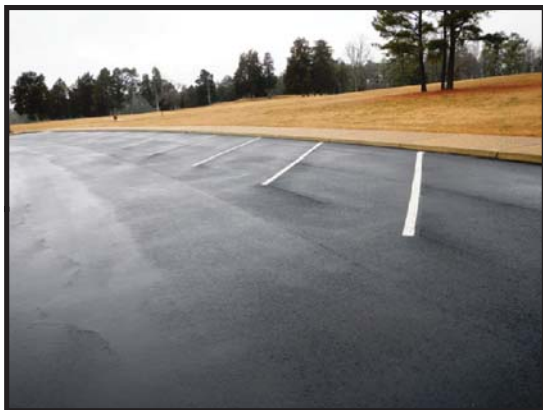
Route Number	Public / NonPublic	Date Visited	Area (sq ft)	Lane Miles *	Surface Type
0915	PUBLIC	2/11/2013	6,784	0.12	AS
Culverts	Drop Inlets	Gates	Curb & Gutter	Curb	PCR
0	0	0	NO CURB AND GUTTER	CONCRETE CURB	FAIR/73

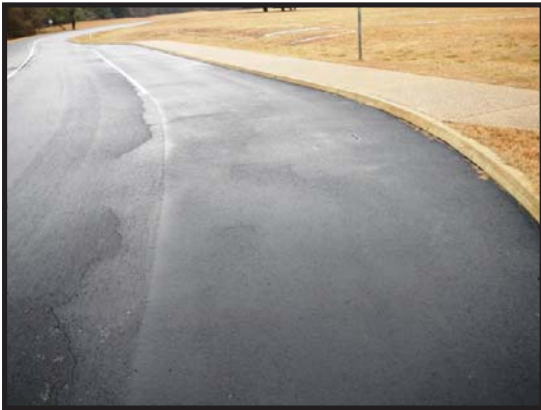
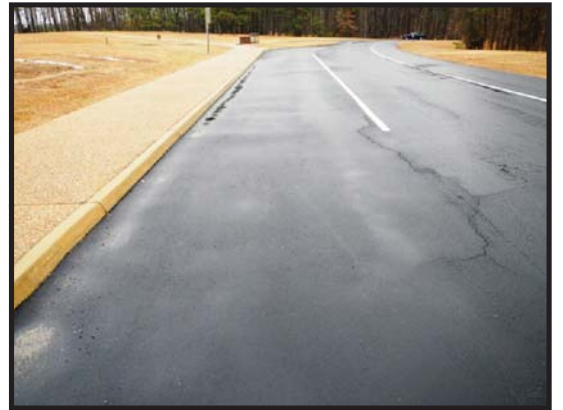
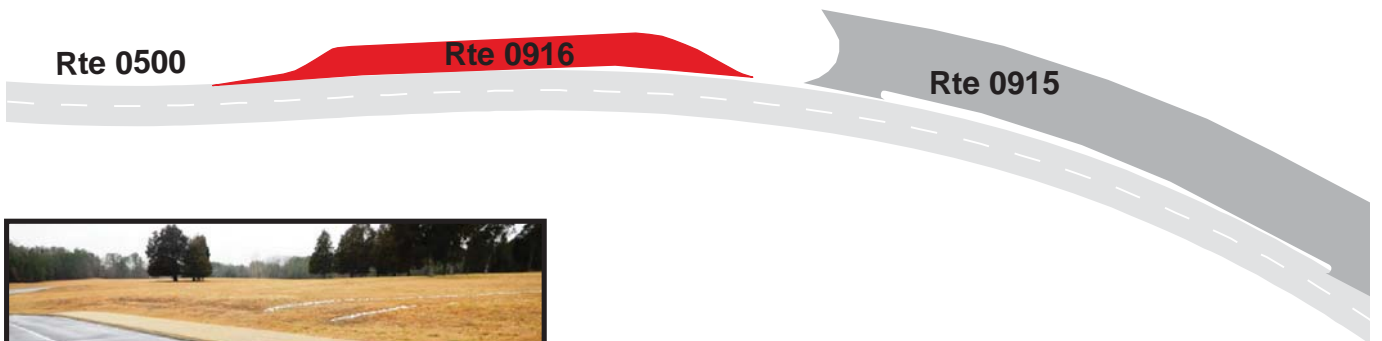
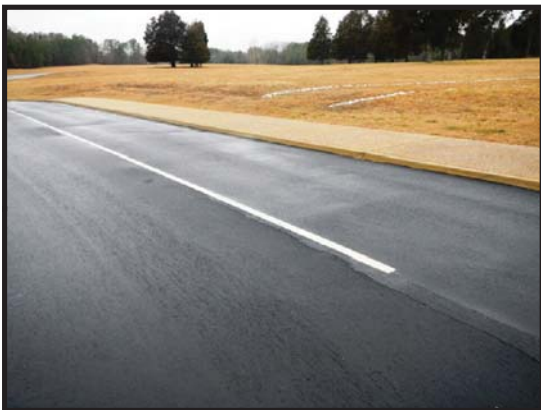
Route Number	Public / NonPublic	Date Visited	Area (sq ft)	Lane Miles *	Surface Type
0916	PUBLIC	2/11/2013	1,876	0.03	AS
Culverts	Drop Inlets	Gates	Curb & Gutter	Curb	PCR
0	0	0	NO CURB AND GUTTER	CONCRETE CURB	GOOD/90

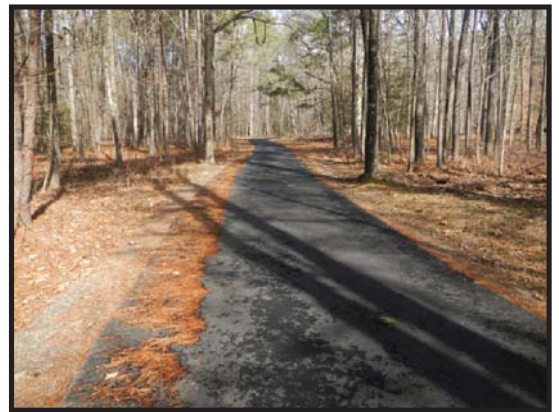
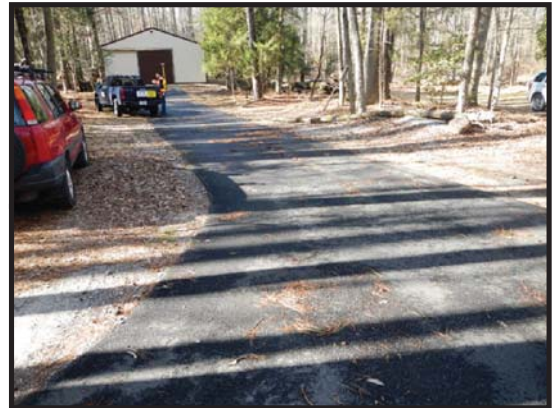
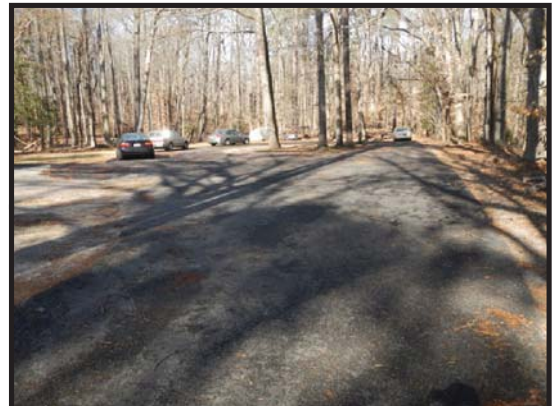
Route Number	Public / NonPublic	Date Visited	Area (sq ft)	Lane Miles *	Surface Type
0919	NONPUBLIC	2/11/2013	18,006	0.31	AS
Culverts	Drop Inlets	Gates	Curb & Gutter	Curb	PCR
1	0	0	NO CURB AND GUTTER	NO CURB	GOOD/90

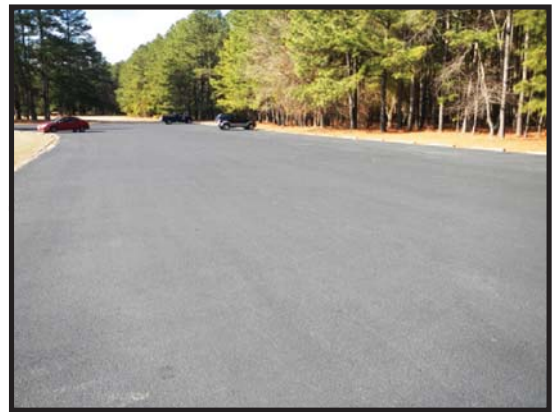
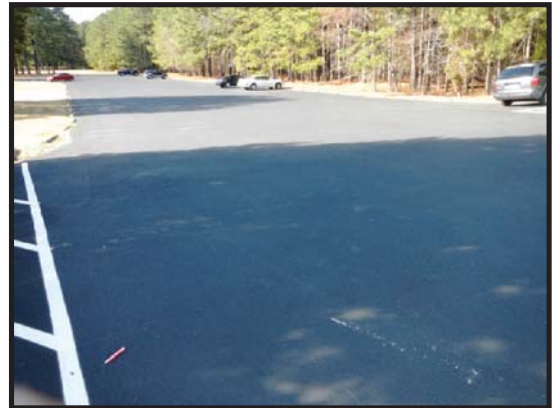
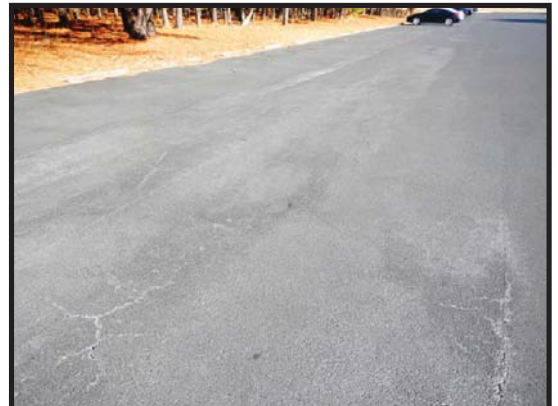
Route Number	Public / NonPublic	Date Visited	Area (sq ft)	Lane Miles *	Surface Type
0920	PUBLIC	2/11/2013	35,370	0.61	AS
Culverts	Drop Inlets	Gates	Curb & Gutter	Curb	PCR
0	0	2	NO CURB AND GUTTER	NO CURB	FAIR/73

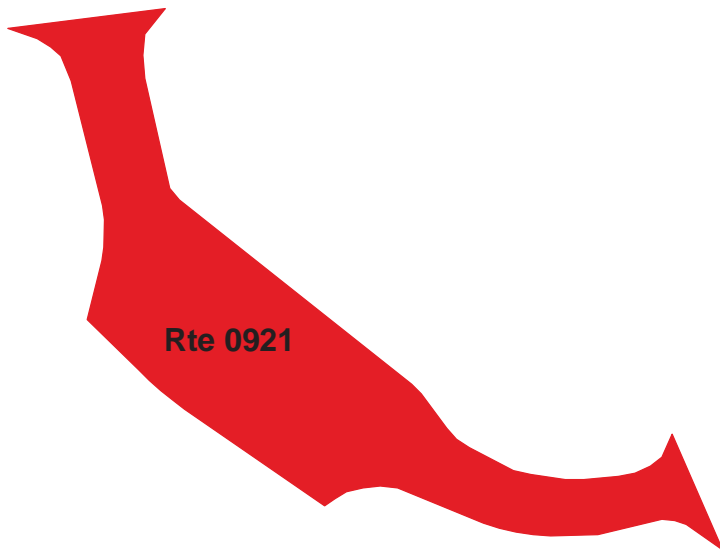
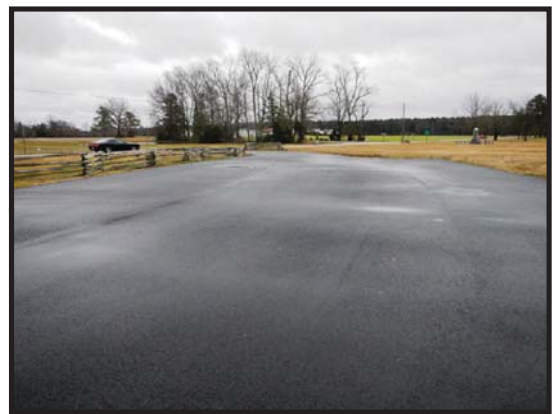
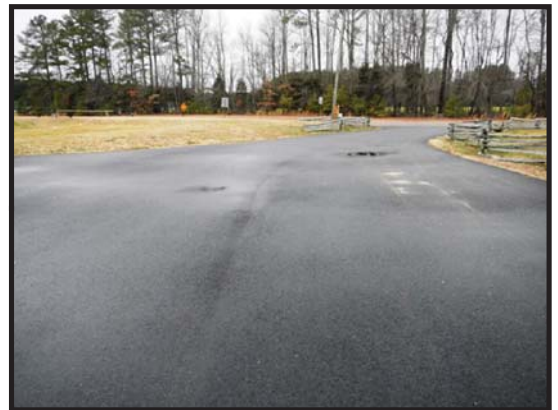
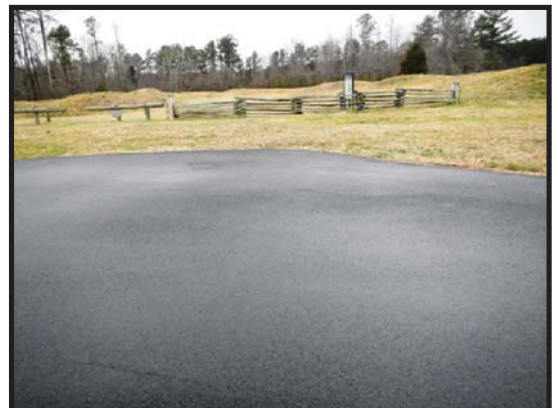
Route Number	Public / NonPublic	Date Visited	Area (sq ft)	Lane Miles *	Surface Type
0921	PUBLIC	2/11/2013	8,540	0.15	AS
Culverts	Drop Inlets	Gates	Curb & Gutter	Curb	PCR
0	0	0	NO CURB AND GUTTER	NO CURB	GOOD/90

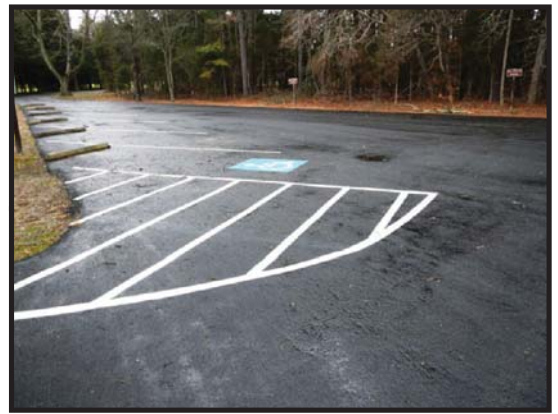
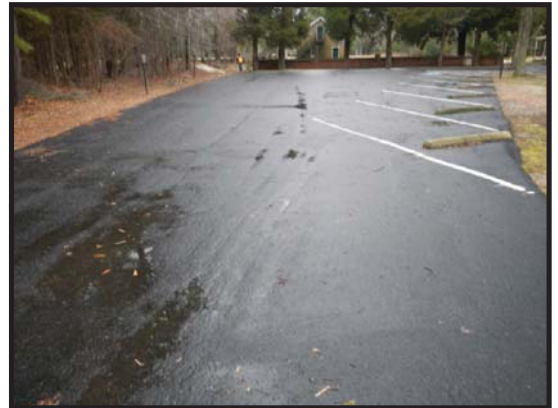
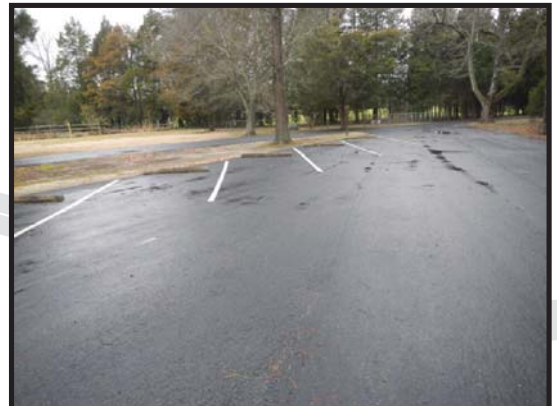
Route Number	Public / NonPublic	Date Visited	Area (sq ft)	Lane Miles *	Surface Type
0922	PUBLIC	2/11/2013	9,653	0.17	AS
Culverts	Drop Inlets	Gates	Curb & Gutter	Curb	PCR
0	0	0	NO CURB AND GUTTER	NO CURB	GOOD/90

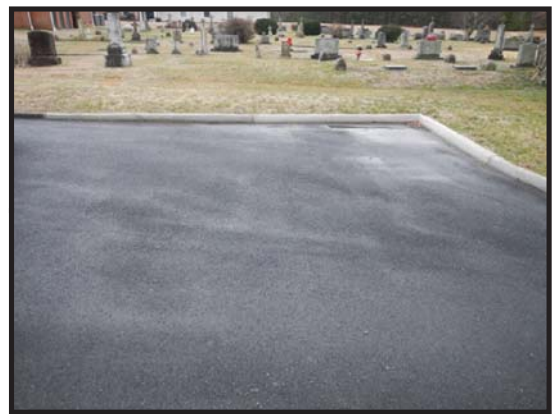
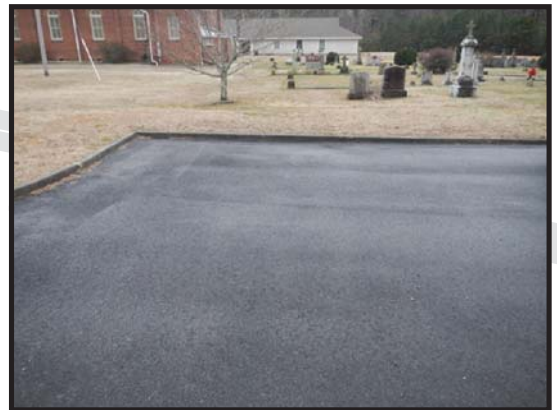
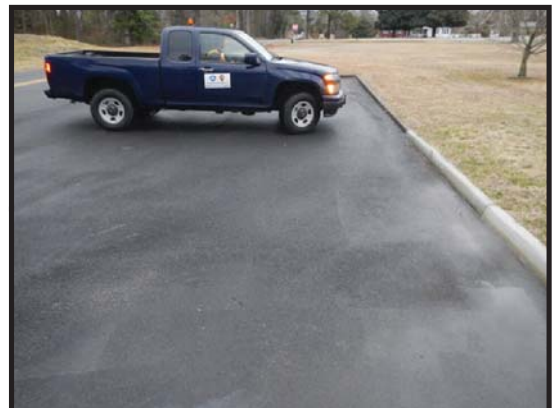
Route Number	Public / NonPublic	Date Visited	Area (sq ft)	Lane Miles *	Surface Type
0923	PUBLIC	2/11/2013	1,214	0.02	AS
Culverts	Drop Inlets	Gates	Curb & Gutter	Curb	PCR
0	0	0	NO CURB AND GUTTER	CONCRETE CURB	GOOD/90

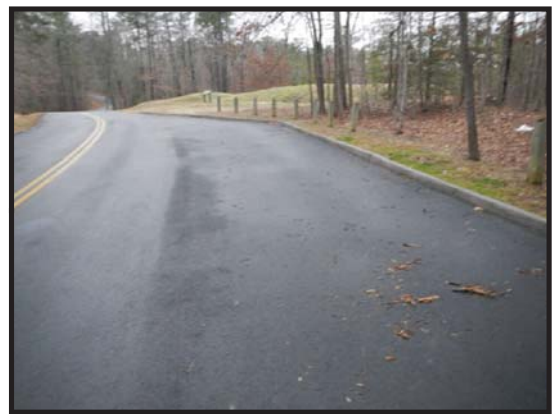
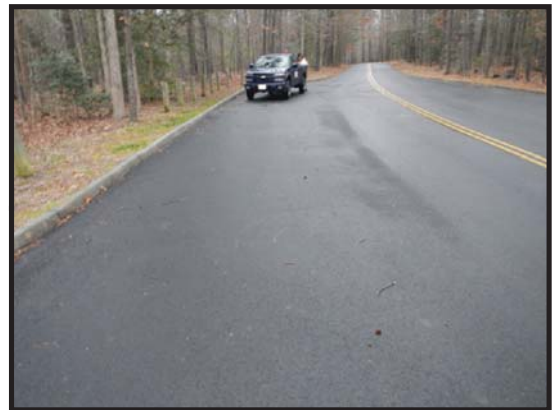
Route Number	Public / NonPublic	Date Visited	Area (sq ft)	Lane Miles *	Surface Type
0924	PUBLIC	2/11/2013	2,241	0.04	AS
Culverts	Drop Inlets	Gates	Curb & Gutter	Curb	PCR
0	0	0	NO CURB AND GUTTER	CONCRETE CURB	GOOD/90
