Federal Lands Highway Road Inventory Program

Road Inventory and Condition Assessment

Petersburg National Battlefield PETE

Cycle 5 Report

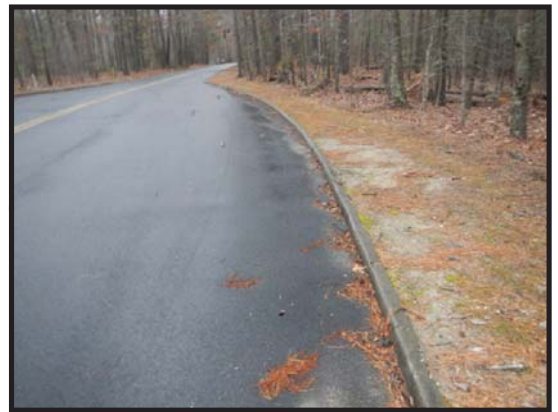
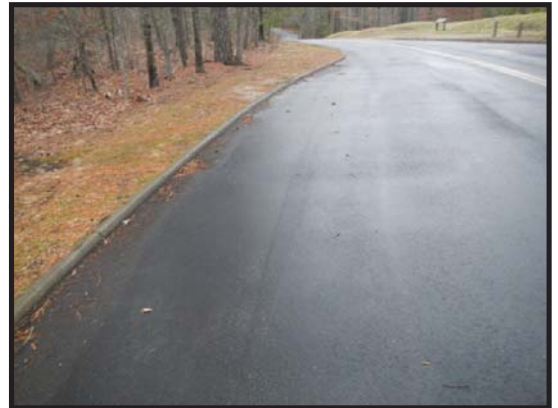
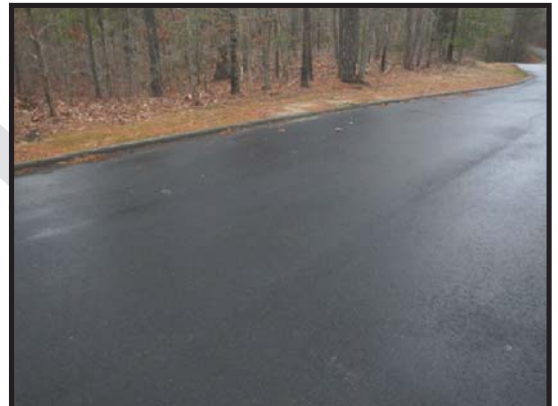
Route Number	Public / NonPublic	Date Visited	Area (sq ft)	Lane Miles *	Surface Type
0925	PUBLIC	2/11/2013	1,595	0.03	AS
Culverts	Drop Inlets	Gates	Curb & Gutter	Curb	PCR
0	0	0	NO CURB AND GUTTER	CONCRETE CURB	GOOD/90

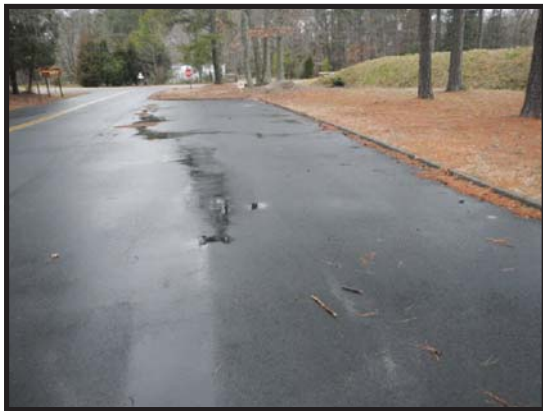
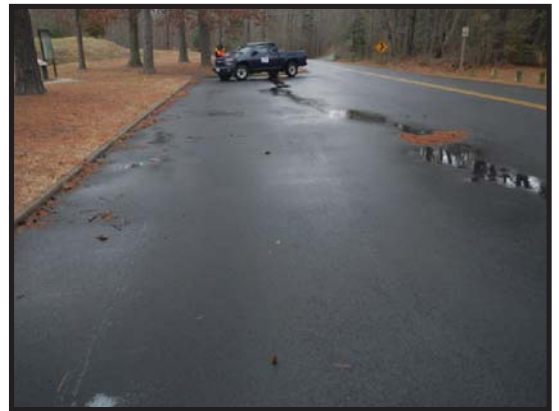
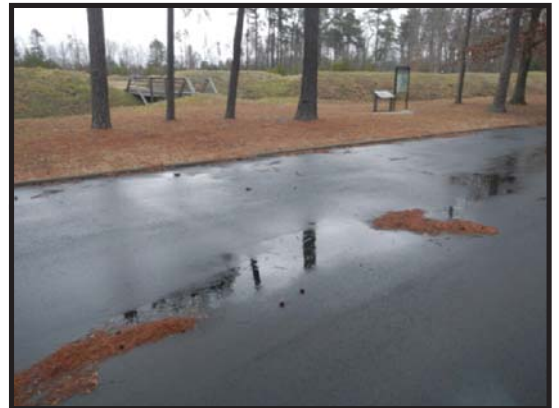
Route Number	Public / NonPublic	Date Visited	Area (sq ft)	Lane Miles *	Surface Type
0926	PUBLIC	2/11/2013	2,127	0.04	AS
Culverts	Drop Inlets	Gates	Curb & Gutter	Curb	PCR
0	0	0	NO CURB AND GUTTER	CONCRETE CURB	GOOD/90

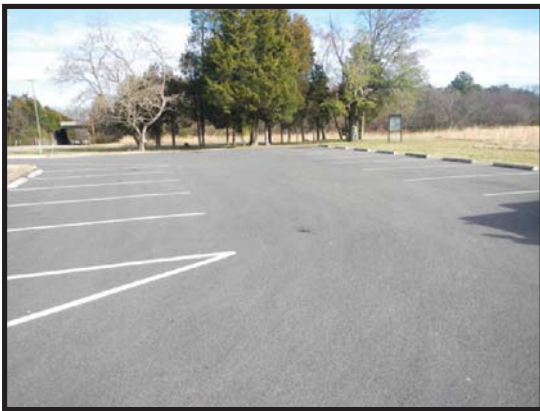
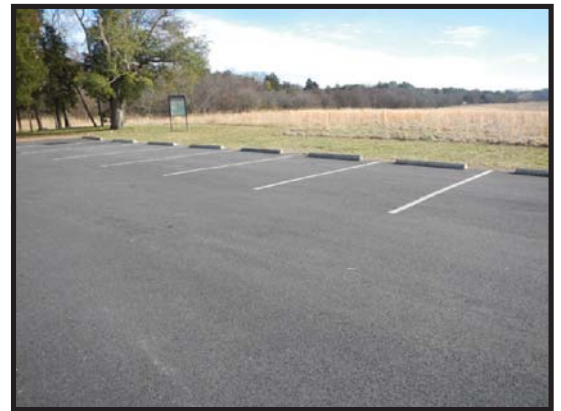
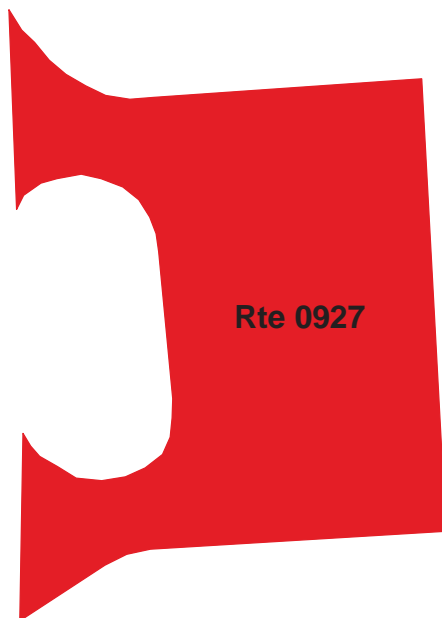
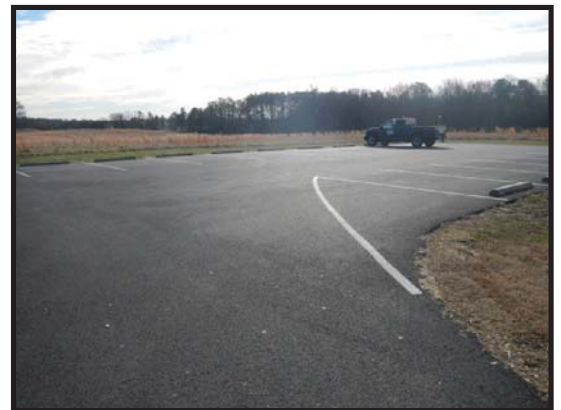
Route Number	Public / NonPublic	Date Visited	Area (sq ft)	Lane Miles *	Surface Type
0927	PUBLIC	2/11/2013	8,338	0.14	AS
Culverts	Drop Inlets	Gates	Curb & Gutter	Curb	PCR
0	0	0	NO CURB AND GUTTER	NO CURB	GOOD/90
