# Federal Lands Highway Road Inventory Program

Road Inventory and Condition Assessment

## Petroglyph National Monument PETR

### Cycle 5 Report

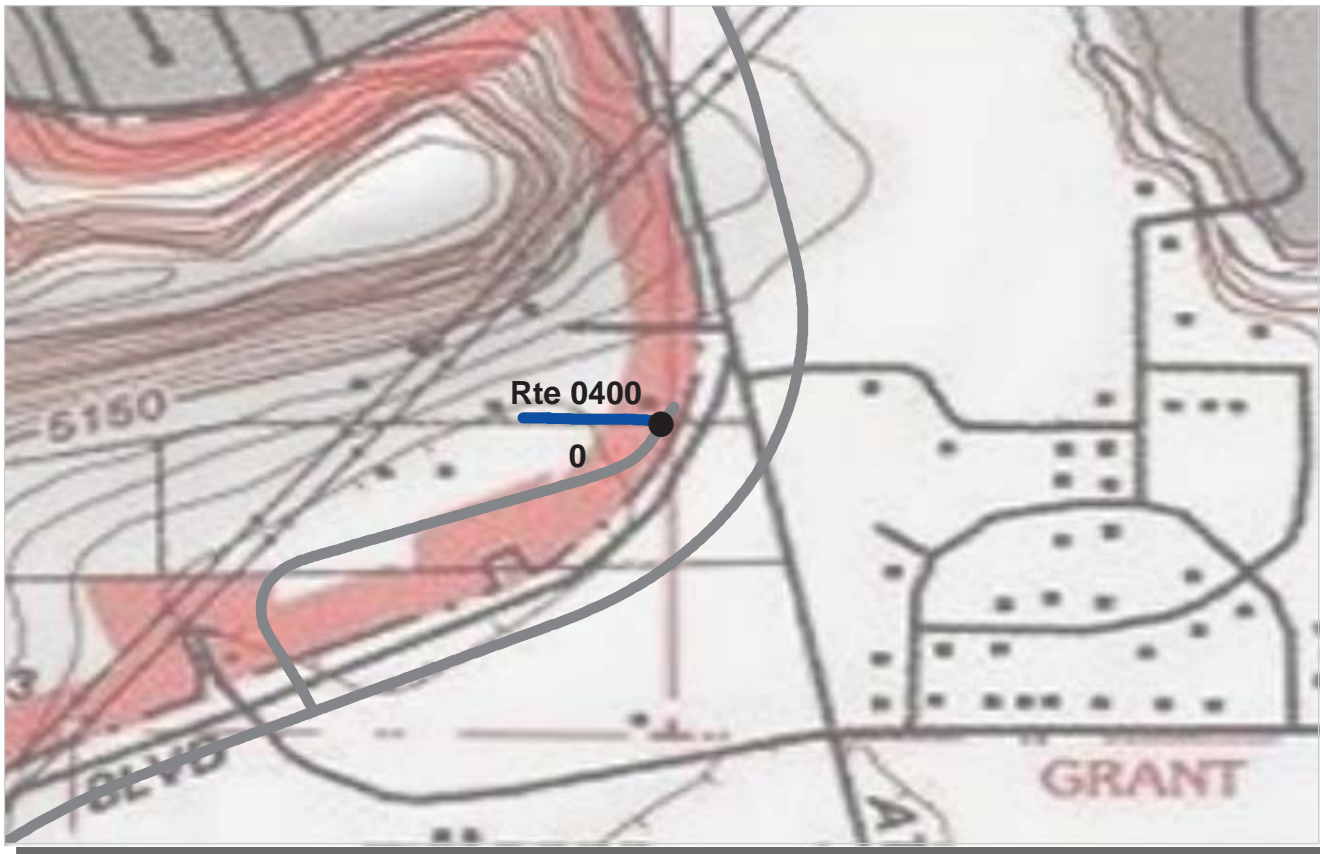
**ROUTE: 0400 LAVA SHADOWS ROAD**

<b>Section Number</b>	0				
<b>Section Length (mi)</b>	0.07				
<b>Cross Section Information</b>					
Number of Lanes	2				
Paved Width (ft)	20				
Lane Width (ft)	10				
<b>Roadway Condition Information</b>					
SCR (Surface Condition Rating)	99				
PCR (Pavement Condition Rating)	99				
<b>Distress Index Values</b>					
Structural Crack Index	100				
Transverse Cracking Index	99				
Patching Index	100				
Rutting Index	100				
Roughness Condition Index (RCI)	NC

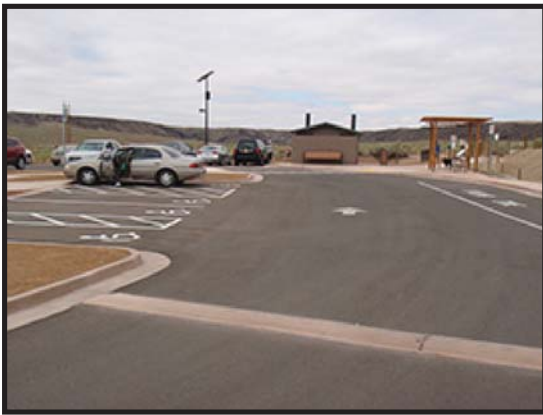
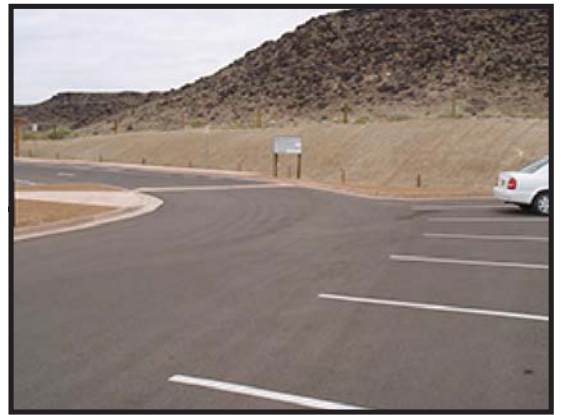
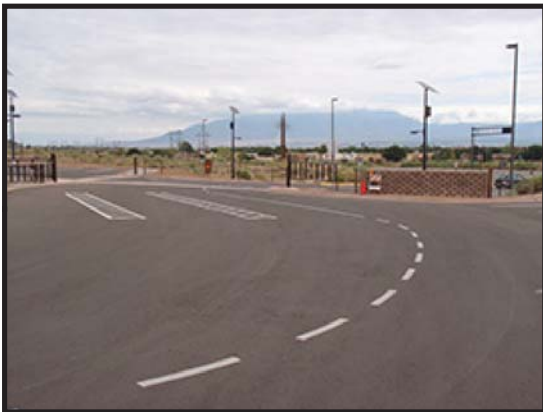
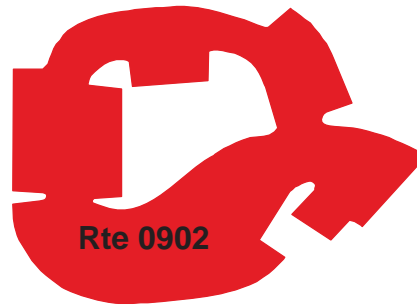
## Route 0902

Route Number	Public / NonPublic	Date Visited	Area (sq ft)	Lane Miles *	Surface Type
0902	PUBLIC	9/4/2011	32,435	0.56	AS
Culverts	Drop Inlets	Gates	Curb & Gutter	Curb	PCR
0	0	2	CONCRETE CURB AND GUTTER	NO CURB	EXCELLENT/97

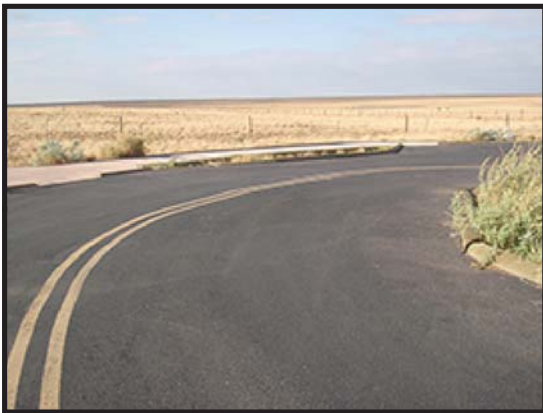
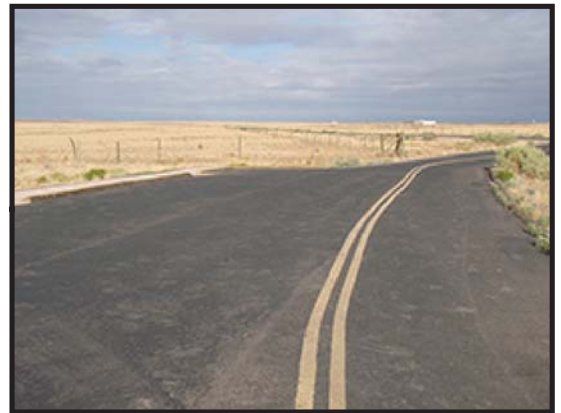
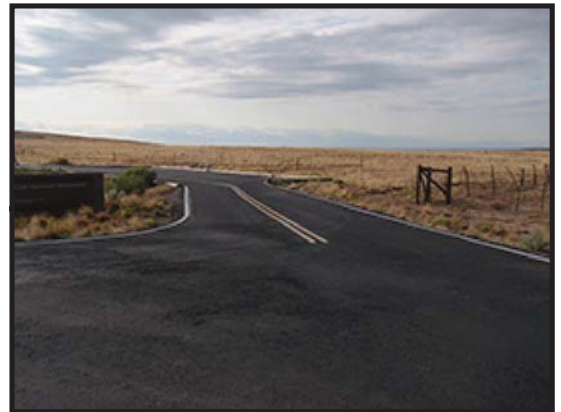
## Route 0904

Route Number	Public / NonPublic	Date Visited	Area (sq ft)	Lane Miles *	Surface Type
0904	PUBLIC	9/4/2011	15,136	0.26	AS
Culverts	Drop Inlets	Gates	Curb & Gutter	Curb	PCR
1	0	1	NO CURB AND GUTTER	WOOD CURB	EXCELLENT/97

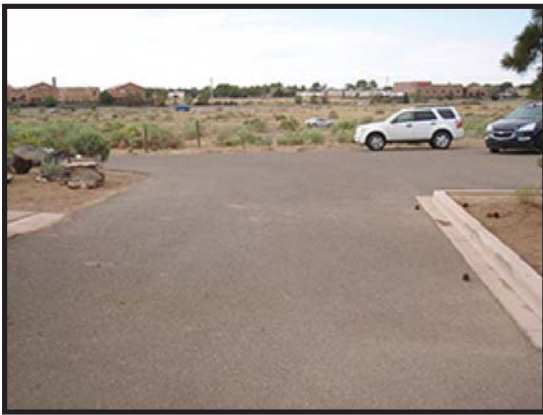
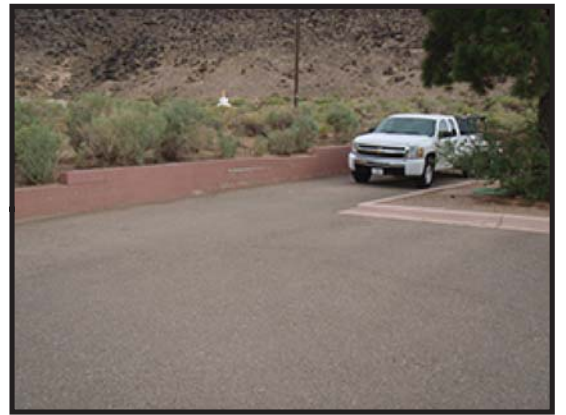
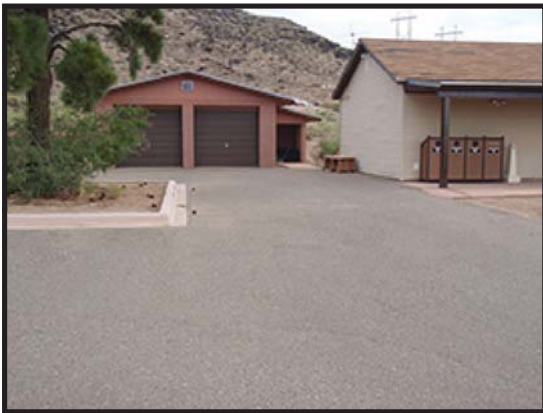
## Route 0905

Route Number	Public / NonPublic	Date Visited	Area (sq ft)	Lane Miles *	Surface Type
0905	PUBLIC	9/4/2011	3,633	0.06	AS
Culverts	Drop Inlets	Gates	Curb & Gutter	Curb	PCR
0	0	0	CONCRETE CURB AND GUTTER	NO CURB	GOOD/90

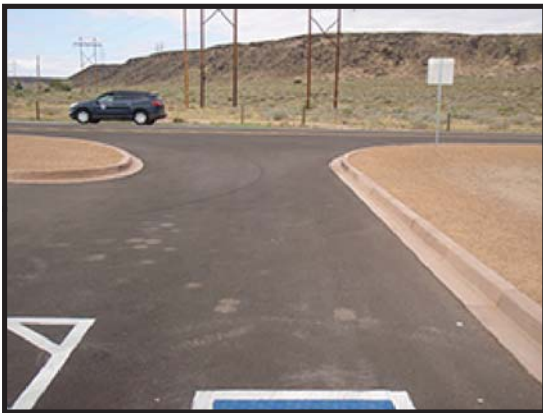
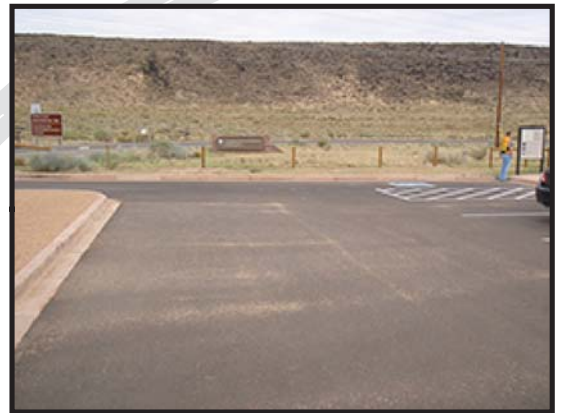
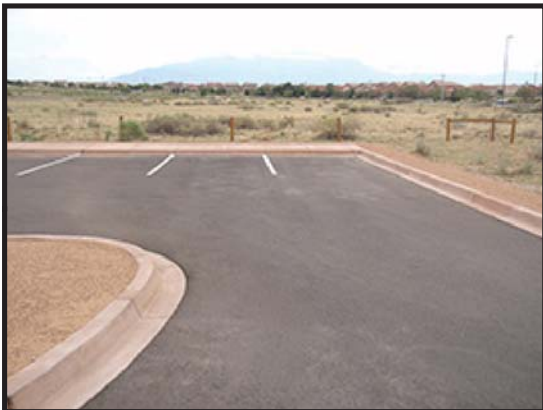
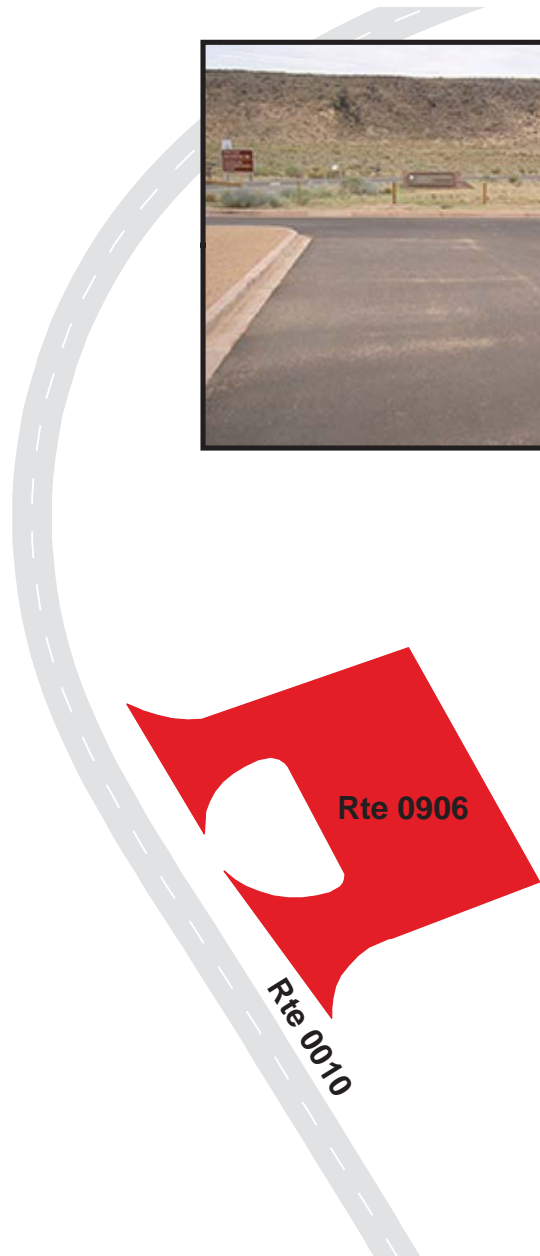
## Route 0906

Route Number	Public / NonPublic	Date Visited	Area (sq ft)	Lane Miles *	Surface Type
0906	PUBLIC	9/4/2011	5,148	0.09	AS
Culverts	Drop Inlets	Gates	Curb & Gutter	Curb	PCR
0	0	0	CONCRETE CURB AND GUTTER	NO CURB	EXCELLENT/97

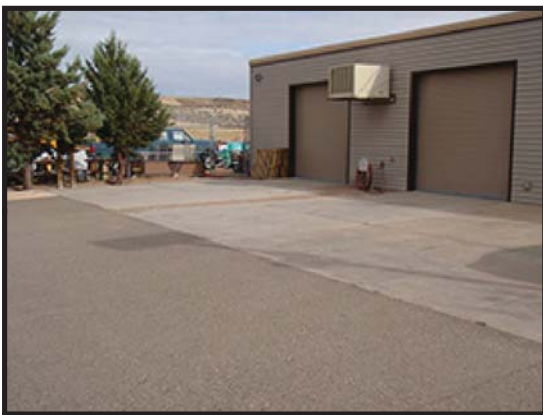
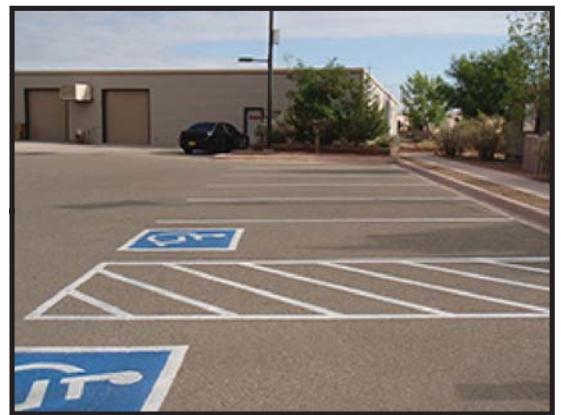
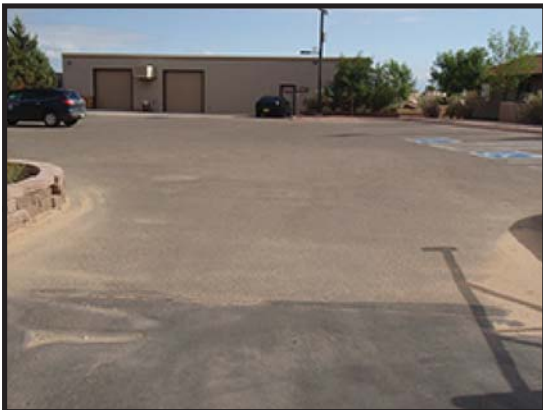
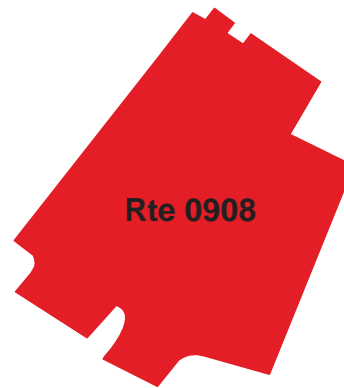
## Route 0908

Route Number	Public / NonPublic	Date Visited	Area (sq ft)	Lane Miles *	Surface Type
0908	PUBLIC	9/4/2011	10,648	0.18	AS
Culverts	Drop Inlets	Gates	Curb & Gutter	Curb	PCR
0	0	2	CONCRETE CURB AND GUTTER	NO CURB	GOOD/90
