Federal Lands Highway Road Inventory Program

Road Inventory and Condition Assessment

Pinnacles National Monument

Cycle 5 Report

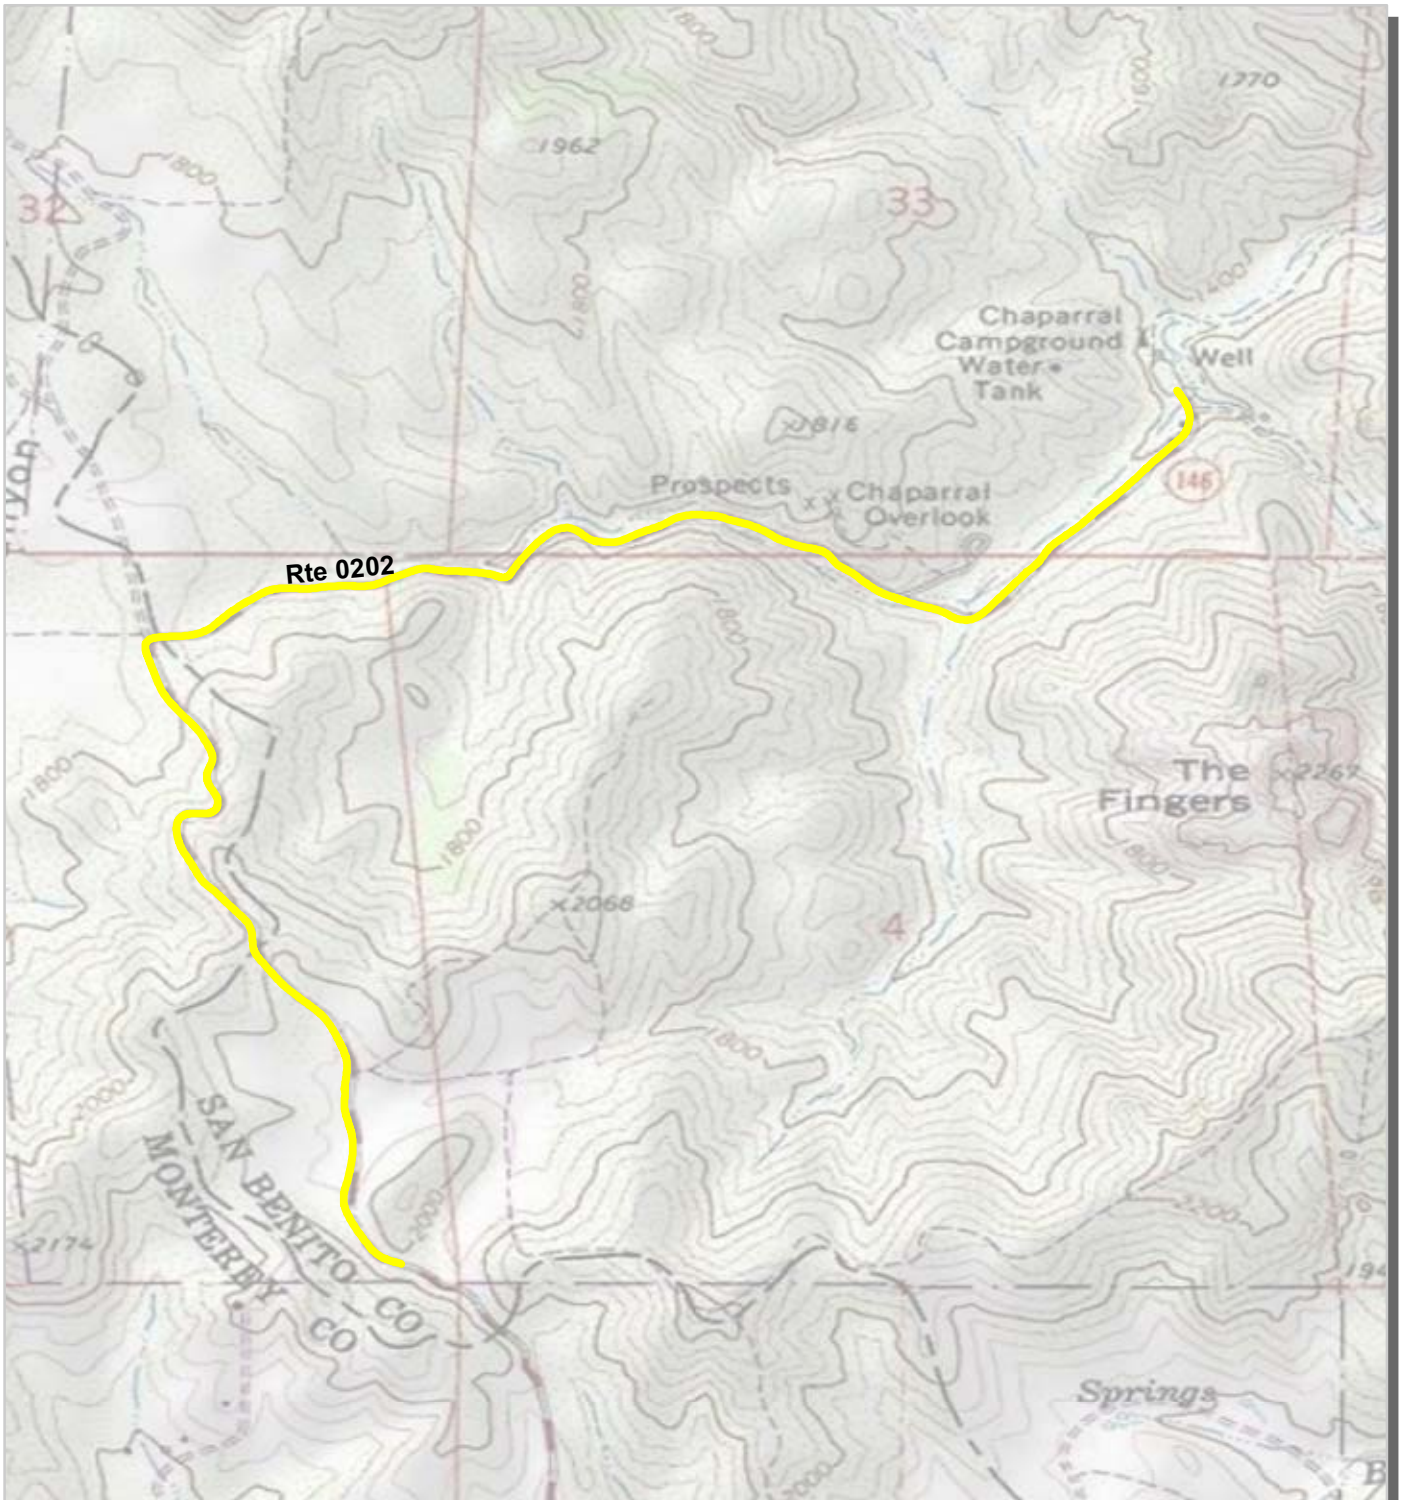
**Pinnacles National Monument
Route Condition Map
PCR - Mile by Mile
Area 1**

PCR	Poor		Fair		Good		Excellent		No Data	
	(0 - 60)		(61 - 84)		(85 - 94)		(95 - 100)

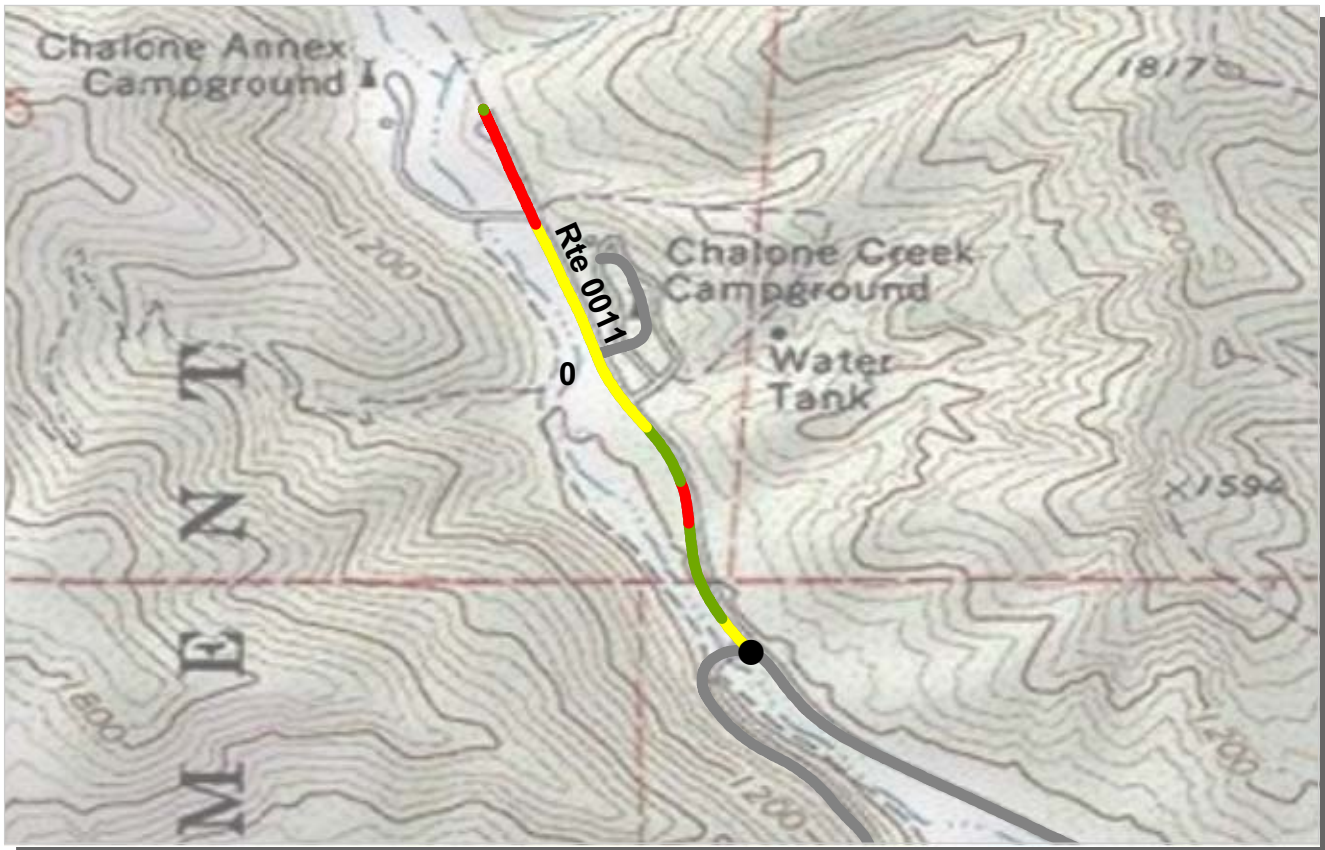
ROUTE: 0011 CHALONE CREEK ROAD

Section Number	0				
Section Length (mi)	0.58				
Cross Section Information					
Number of Lanes	2				
Paved Width (ft)	22				
Lane Width (ft)	10				
Roadway Condition Information					
SCR (Surface Condition Rating)	71				
PCR (Pavement Condition Rating)	61				
Distress Index Values					
Structural Crack Index	71				
Transverse Cracking Index	81				
Patching Index	98				
Rutting Index	96				
Roughness Condition Index (RCI)	45

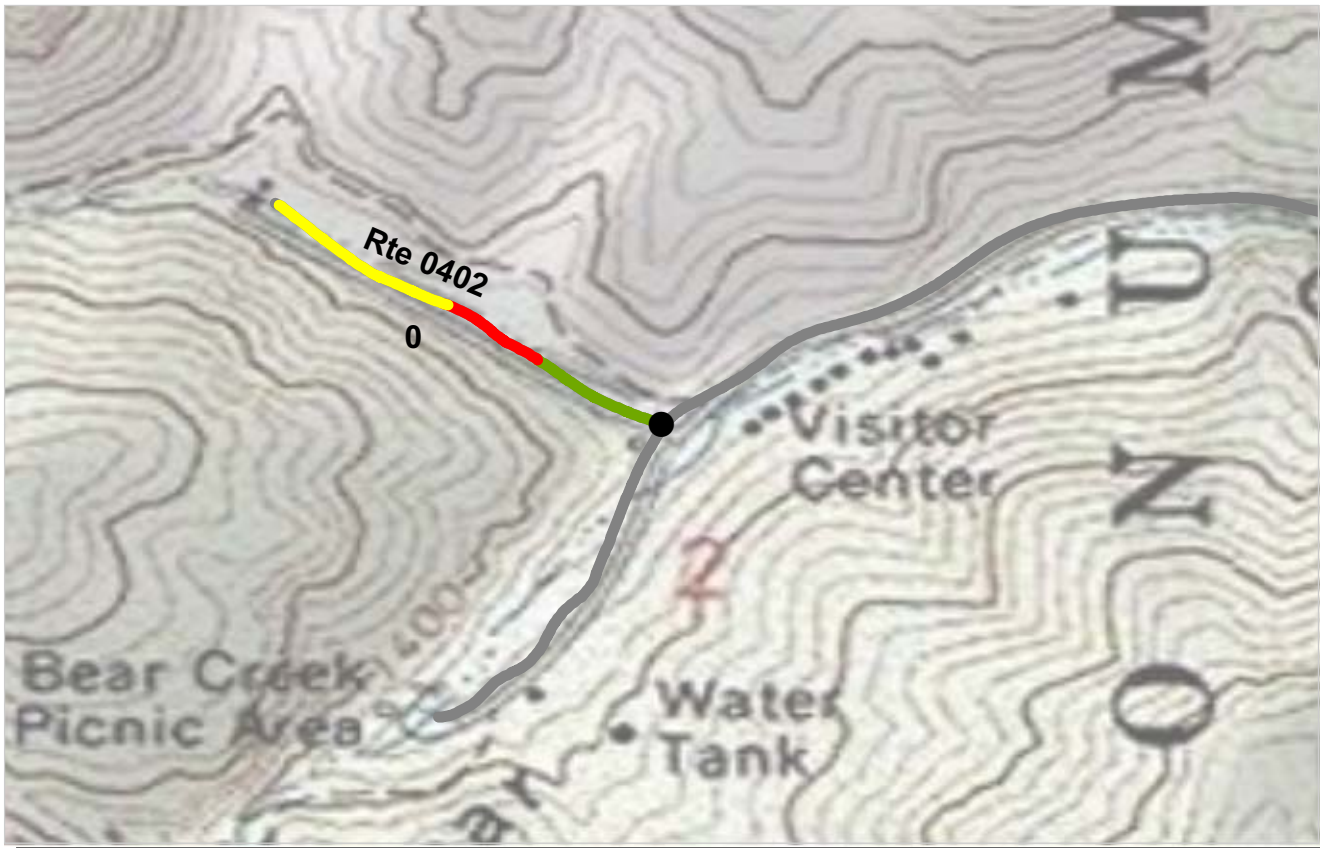
ROUTE: 0402 CONDOR GULCH ROAD

Section Number	0				
Section Length (mi)	0.25				
Cross Section Information					
Number of Lanes	1				
Paved Width (ft)	13				
Lane Width (ft)	13				
Roadway Condition Information					
SCR (Surface Condition Rating)	49				
PCR (Pavement Condition Rating)	49				
Distress Index Values					
Structural Crack Index	49				
Transverse Cracking Index	97				
Patching Index	100				
Rutting Index	83				
Roughness Condition Index (RCI)	NC

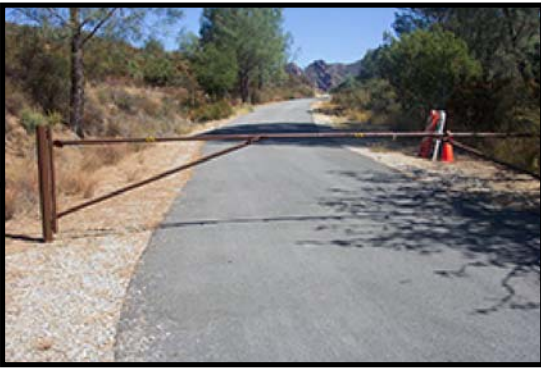
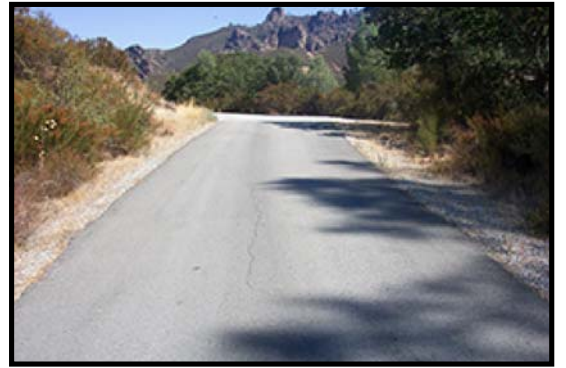
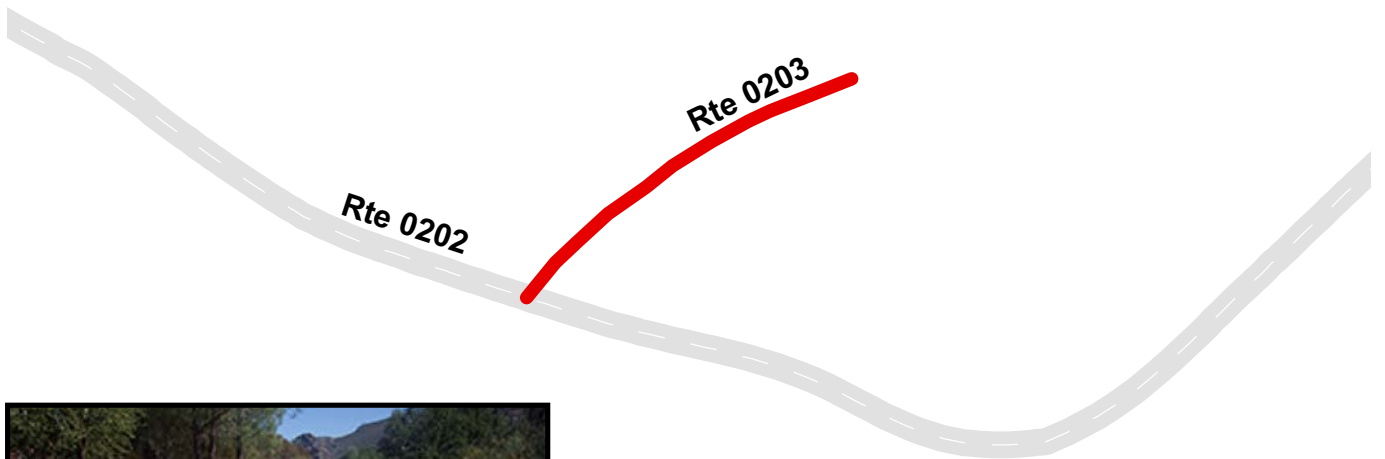
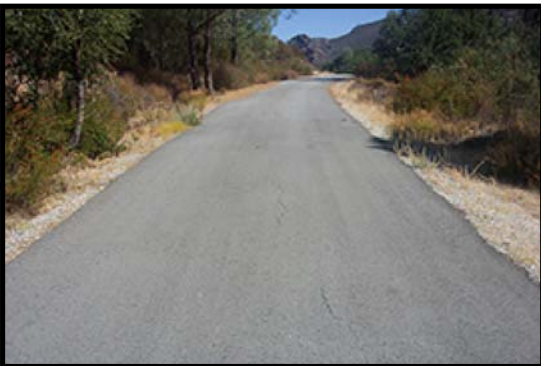
Route Number	Public / NonPublic	Date Visited	Area (sq ft)	Lane Miles *	Paved Length (mi)	Paved Width (ft)
0203	PUBLIC	9/20/2011	3,801	0.07	0.06	12.2
Culverts	Drop Inlets	Gates	Curb & Gutter	Curb	PCR	Surface Type
1	0	1	NO CURB AND GUTTER	NO CURB	GOOD/90	AS

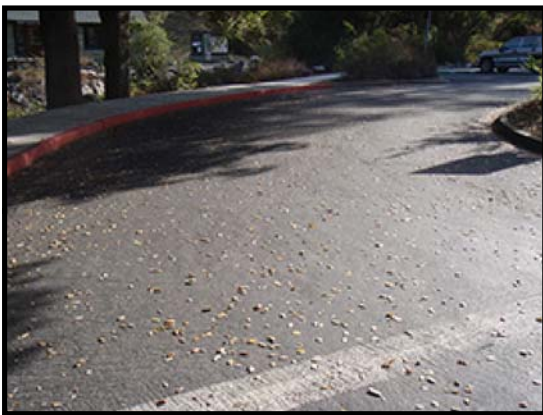
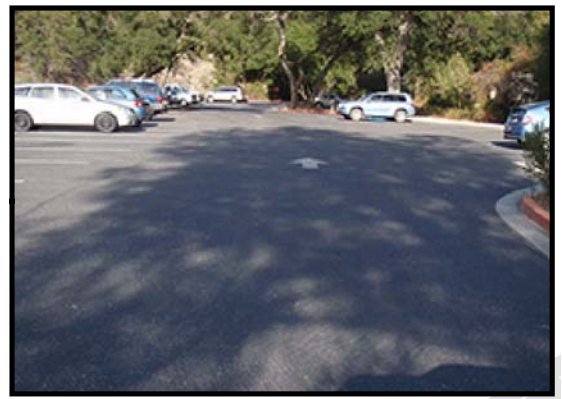
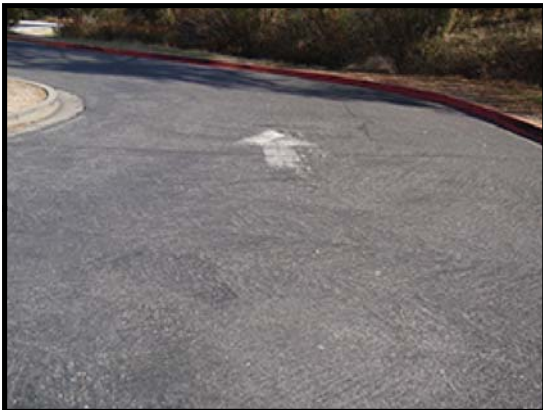
Route Number	Public / NonPublic	Date Visited	Area (sq ft)	Lane Miles *	Surface Type
0900	PUBLIC	11/18/2010	17,597	0.30	AS
Culverts	Drop Inlets	Gates	Curb & Gutter	Curb	PCR
0	1	0	CONCRETE CURB AND GUTTER	NO CURB	GOOD/90

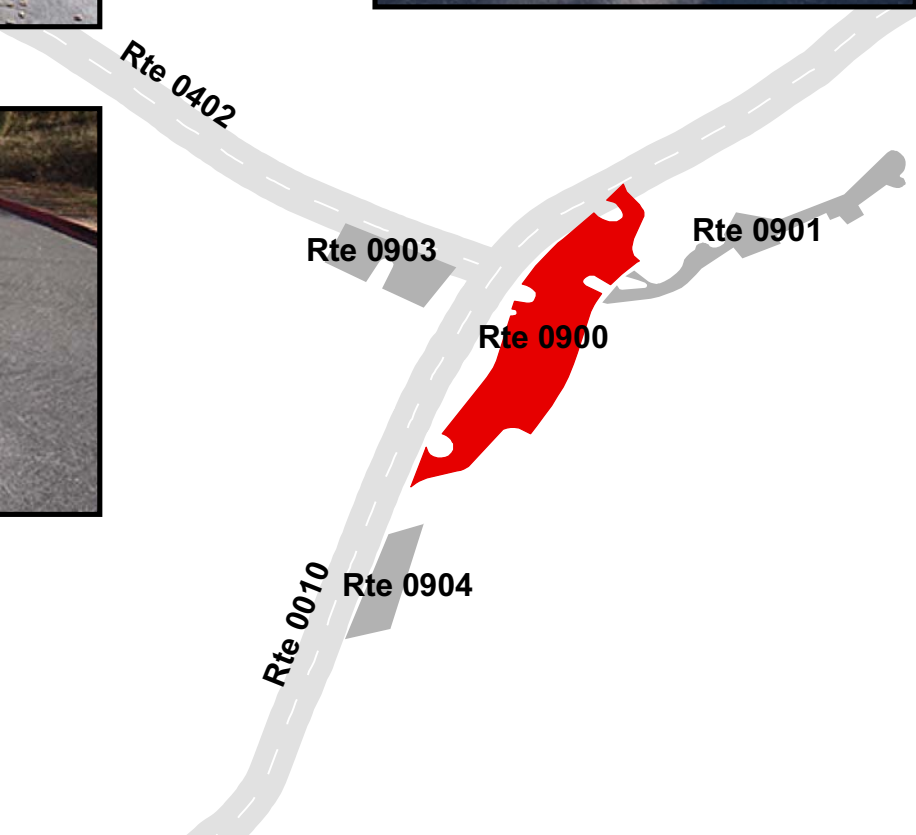
Route 0901

Route Number	Public / NonPublic	Date Visited	Area (sq ft)	Lane Miles *	Surface Type
0901	NONPUBLIC	11/18/2010	6,237	0.11	AS
Culverts	Drop Inlets	Gates	Curb & Gutter	Curb	PCR
1	0	0	NO CURB AND GUTTER	NO CURB	FAIR/73

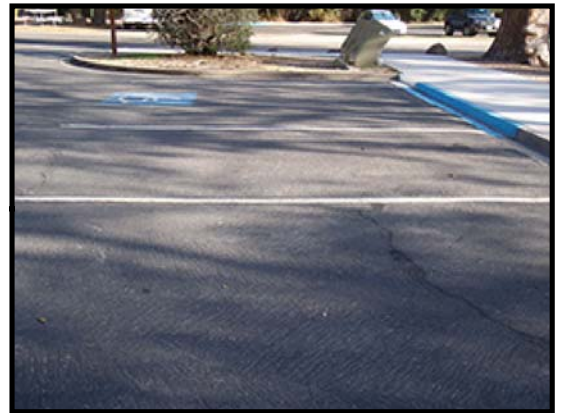
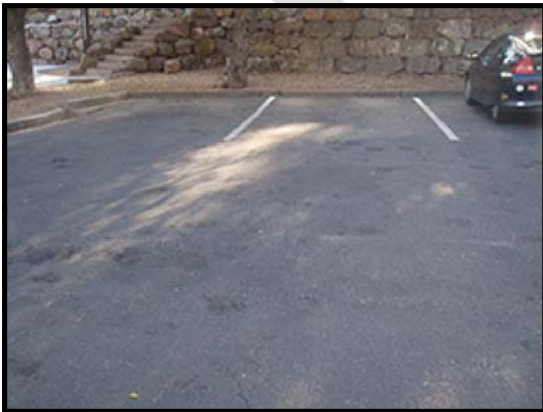
Route Number	Public / NonPublic	Date Visited	Area (sq ft)	Lane Miles *	Surface Type
0903	PUBLIC	11/18/2010	4,506	0.08	AS
Culverts	Drop Inlets	Gates	Curb & Gutter	Curb	PCR
0	0	0	CONCRETE CURB AND GUTTER	NO CURB	GOOD/90

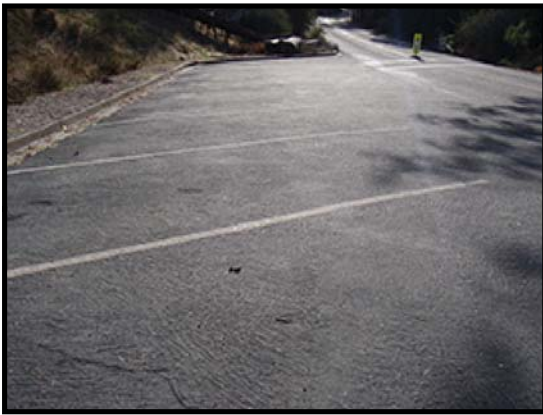
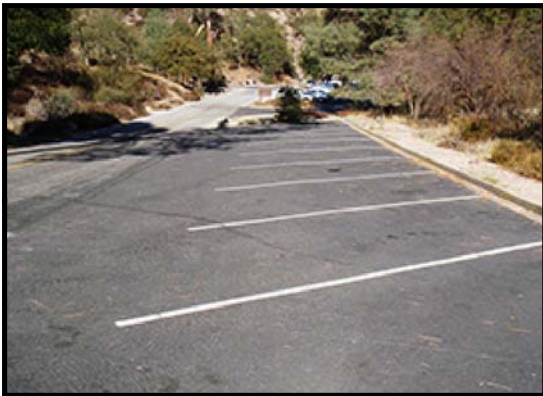
Route Number	Public / NonPublic	Date Visited	Area (sq ft)	Lane Miles *	Surface Type
0904	PUBLIC	11/18/2010	3,535	0.06	AS
Culverts	Drop Inlets	Gates	Curb & Gutter	Curb	PCR
0	0	0	CONCRETE CURB AND GUTTER	NO CURB	GOOD/90

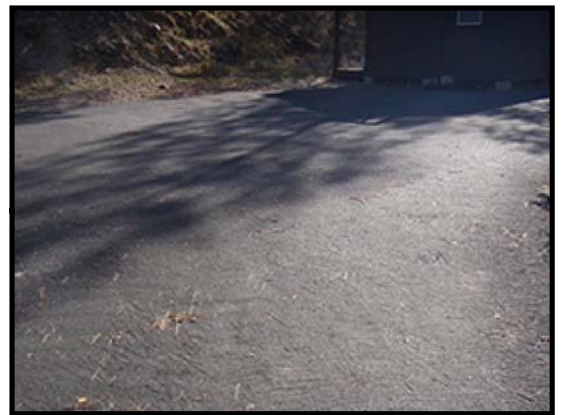
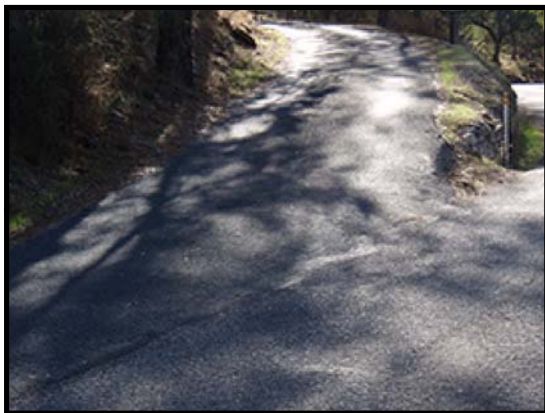
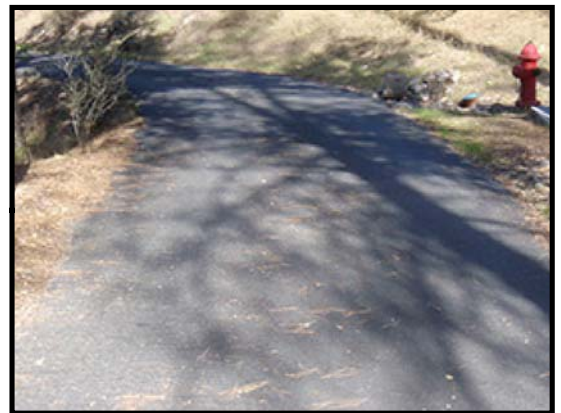
Route Number	Public / NonPublic	Date Visited	Area (sq ft)	Lane Miles *	Surface Type
0905	NONPUBLIC	11/18/2010	4,729	0.08	AS
Culverts	Drop Inlets	Gates	Curb & Gutter	Curb	PCR
1	0	0	NO CURB AND GUTTER	NO CURB	GOOD/90

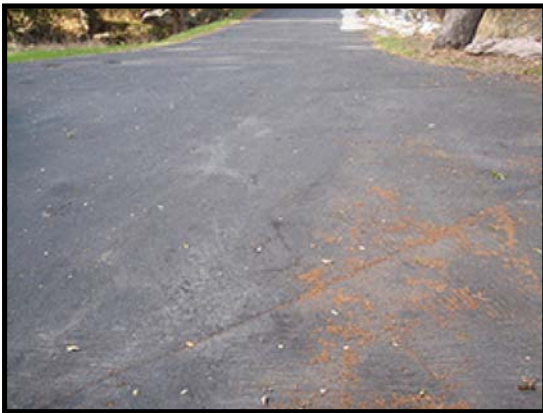
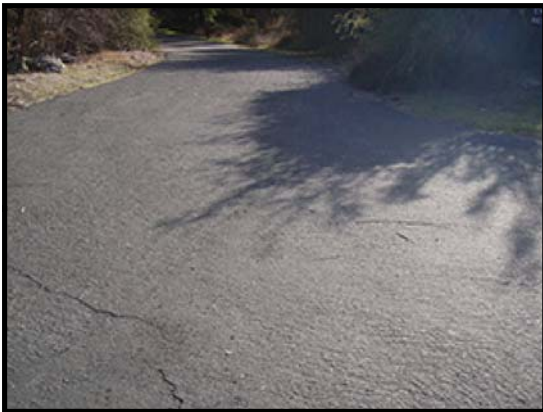
Route 0906

Route Number	Public / NonPublic	Date Visited	Area (sq ft)	Lane Miles *	Surface Type
0906	NONPUBLIC	11/18/2010	3,647	0.06	AS
Culverts	Drop Inlets	Gates	Curb & Gutter	Curb	PCR
1	0	0	NO CURB AND GUTTER	NO CURB	FAIR/73

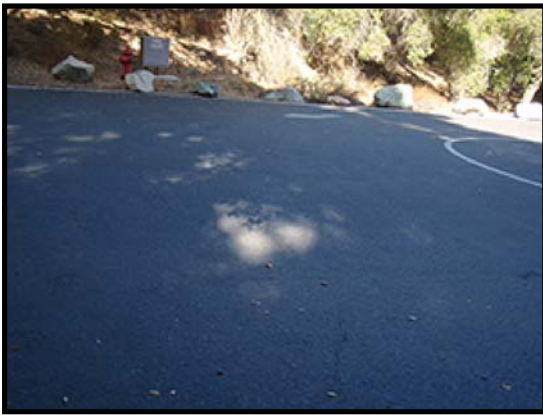
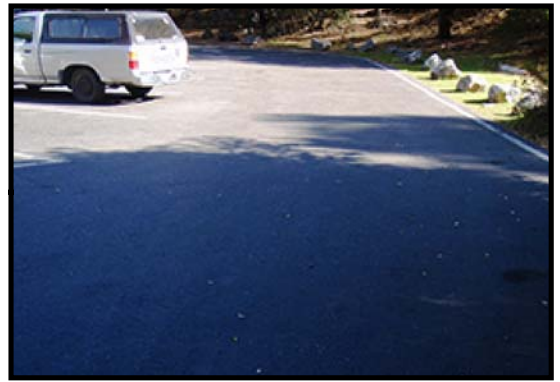
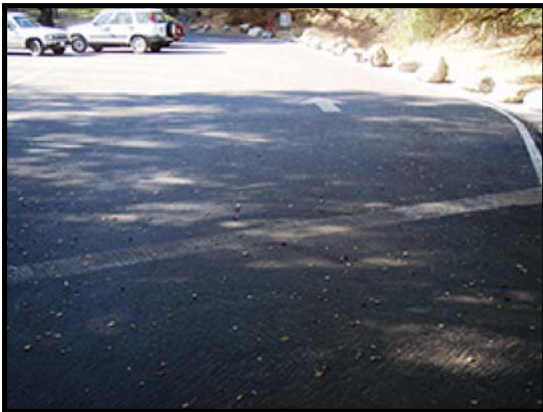
Route 0907

Route Number	Public / NonPublic	Date Visited	Area (sq ft)	Lane Miles *	Surface Type
0907	PUBLIC	11/18/2010	8,067	0.14	AS
Culverts	Drop Inlets	Gates	Curb & Gutter	Curb	PCR
0	0	0	NO CURB AND GUTTER	NO CURB	GOOD/90

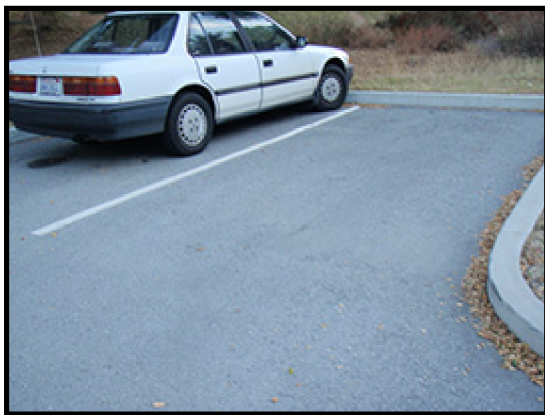
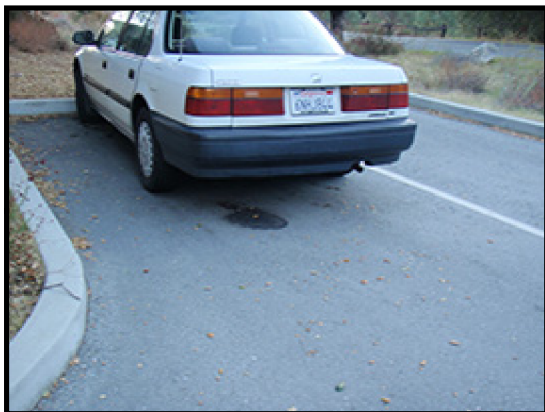
Route Number	Public / NonPublic	Date Visited	Area (sq ft)	Lane Miles *	Surface Type
0908AZ	PUBLIC	11/18/2010	380	0.01	AS
Culverts	Drop Inlets	Gates	Curb & Gutter	Curb	PCR
0	0	0	NO CURB AND GUTTER	CONCRETE CURB	GOOD/90

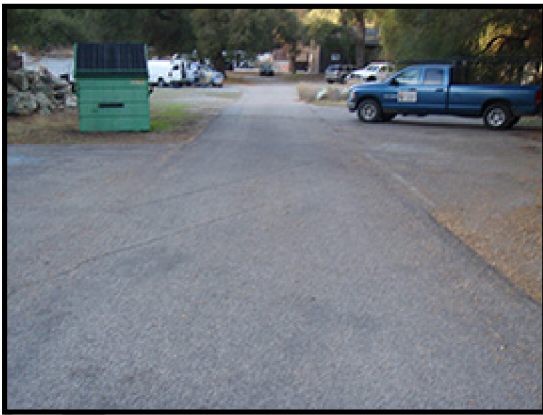
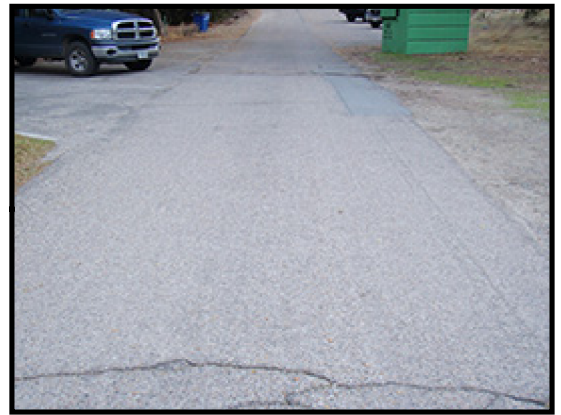
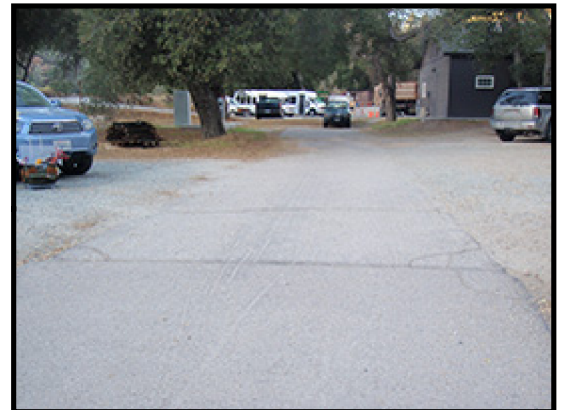
Route 0908BZ

Route Number	Public / NonPublic	Date Visited	Area (sq ft)	Lane Miles *	Surface Type
0908BZ	PUBLIC	11/18/2010	8,491	0.15	AS
Culverts	Drop Inlets	Gates	Curb & Gutter	Curb	PCR
0	0	0	NO CURB AND GUTTER	NO CURB	POOR/45

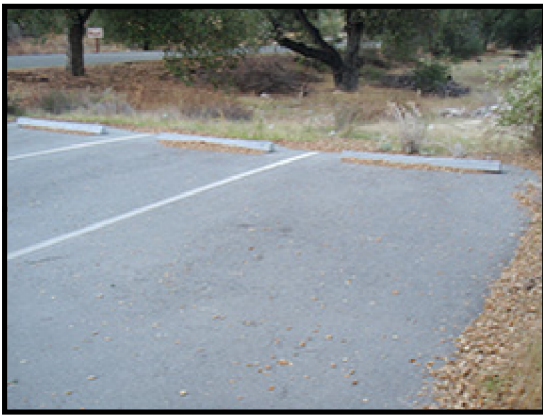
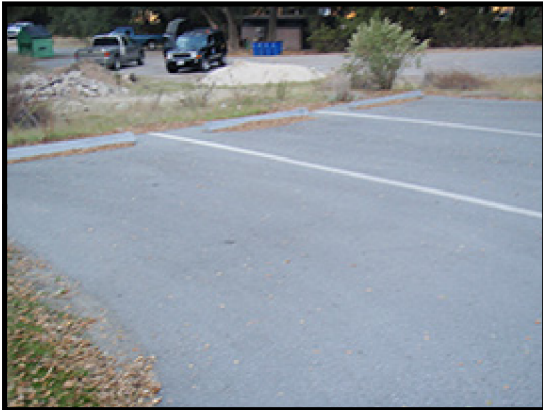
Route 0908CZ

Route Number	Public / NonPublic	Date Visited	Area (sq ft)	Lane Miles *	Surface Type
0908CZ	PUBLIC	11/18/2010	566	0.01	AS
Culverts	Drop Inlets	Gates	Curb & Gutter	Curb	PCR
0	0	0	NO CURB AND GUTTER	NO CURB	GOOD/90

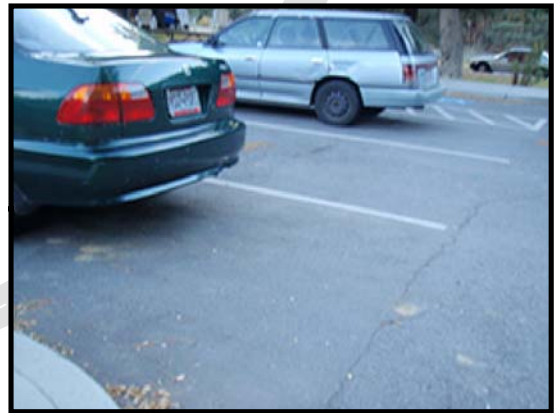
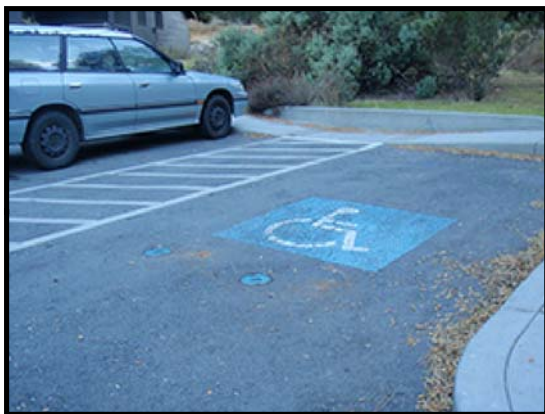
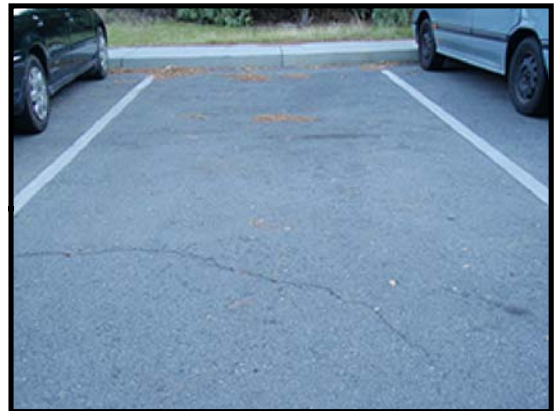
Route 0908DZ

Route Number	Public / NonPublic	Date Visited	Area (sq ft)	Lane Miles *	Surface Type
0908DZ	PUBLIC	11/18/2010	811	0.01	AS
Culverts	Drop Inlets	Gates	Curb & Gutter	Curb	PCR
0	0	0	NO CURB AND GUTTER	CONCRETE CURB	GOOD/90

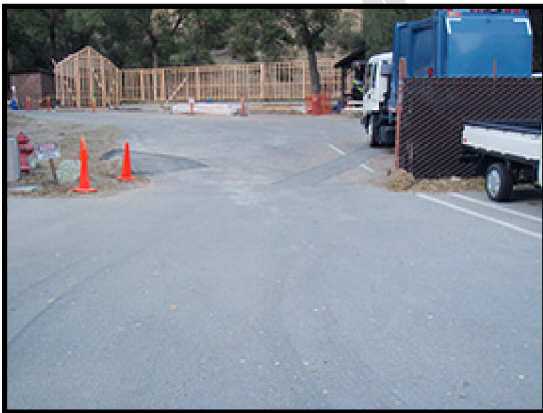
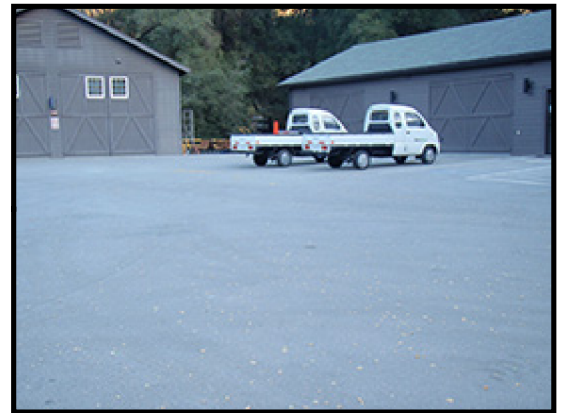
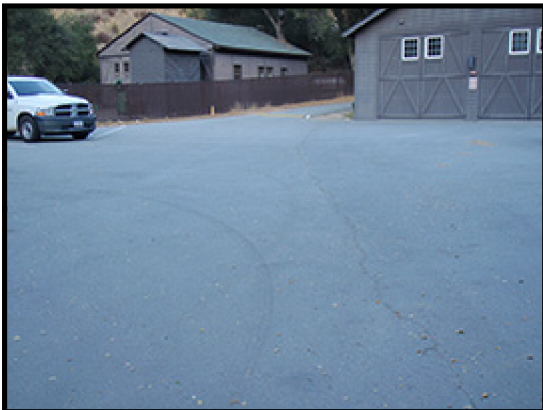
Route 0909

Route Number	Public / NonPublic	Date Visited	Area (sq ft)	Lane Miles *	Surface Type
0909	NONPUBLIC	11/18/2010	26,317	0.45	AS
Culverts	Drop Inlets	Gates	Curb & Gutter	Curb	PCR
1	0	2	NO CURB AND GUTTER	ASPHALT CURB	FAIR/73

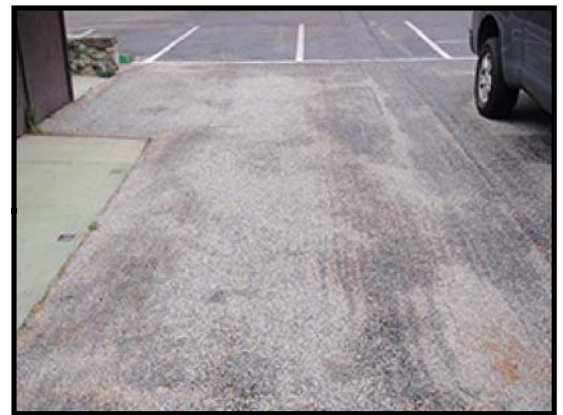
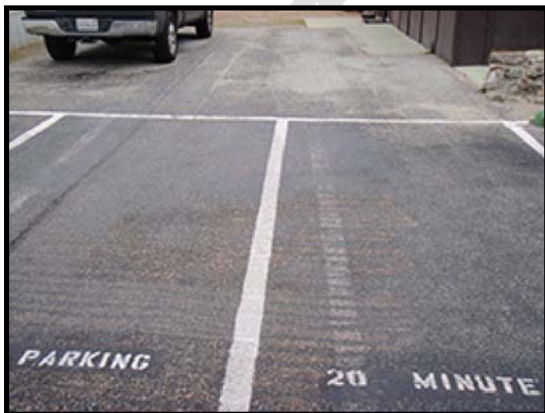
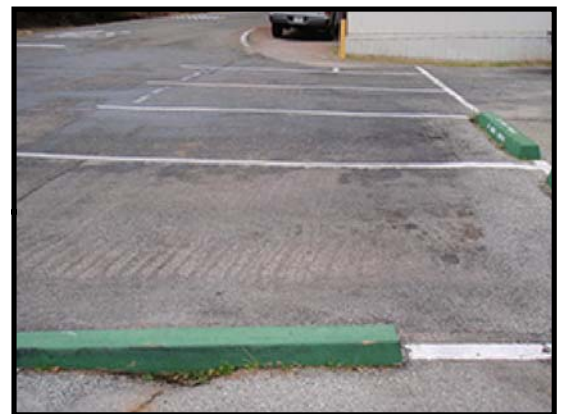
Route 0911

Route Number	Public / NonPublic	Date Visited	Area (sq ft)	Lane Miles *	Surface Type
0911	PUBLIC	11/19/2010	1,687	0.03	AS
Culverts	Drop Inlets	Gates	Curb & Gutter	Curb	PCR
0	0	0	NO CURB AND GUTTER	NO CURB	GOOD/90

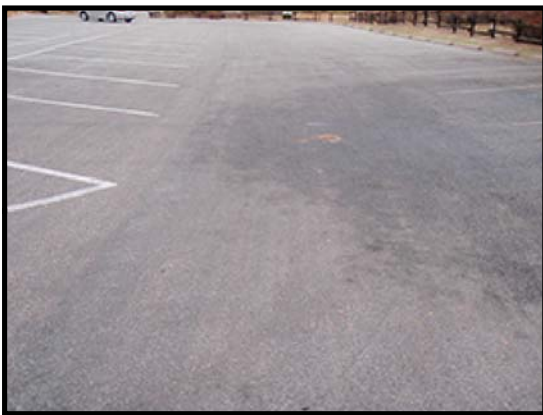
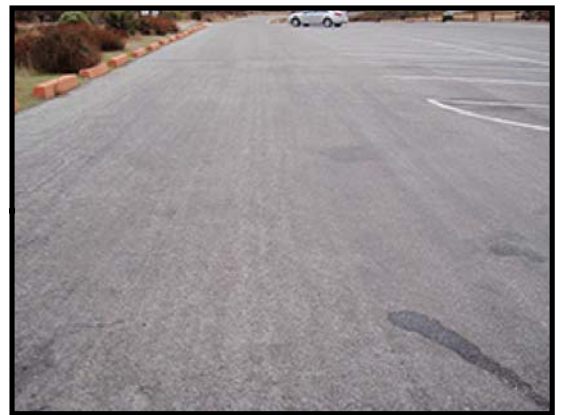
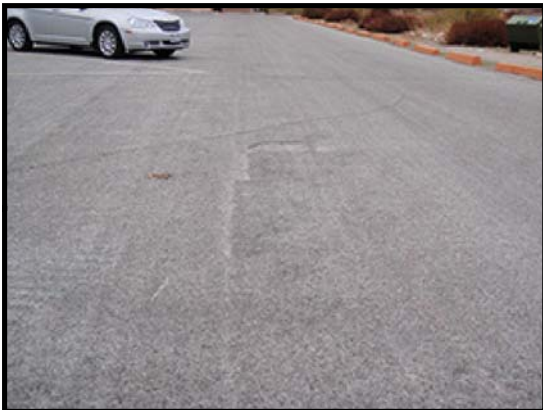
Route 0912

Route Number	Public / NonPublic	Date Visited	Area (sq ft)	Lane Miles *	Surface Type
0912	PUBLIC	11/19/2010	19,532	0.34	AS
Culverts	Drop Inlets	Gates	Curb & Gutter	Curb	PCR
0	0	0	NO CURB AND GUTTER	NO CURB	GOOD/90

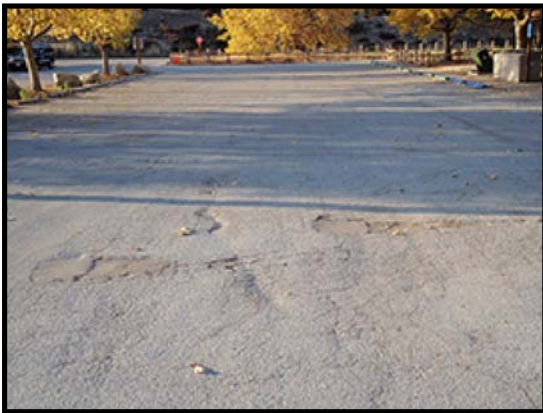
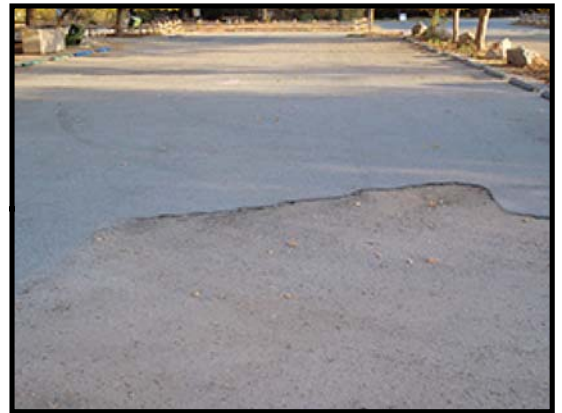
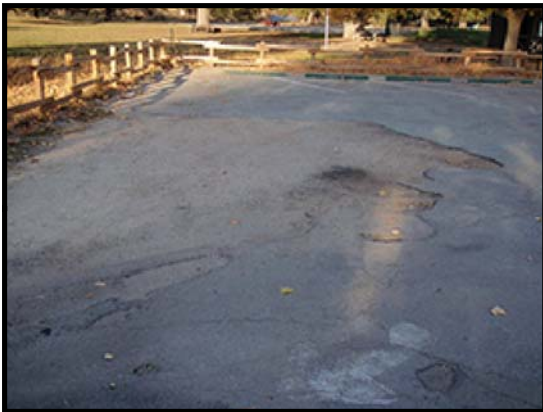
Route 0915

Route Number	Public / NonPublic	Date Visited	Area (sq ft)	Lane Miles *	Surface Type
0915	PUBLIC	11/18/2010	10,220	0.18	AS
Culverts	Drop Inlets	Gates	Curb & Gutter	Curb	PCR
0	0	0	NO CURB AND GUTTER	NO CURB	FAIR/73

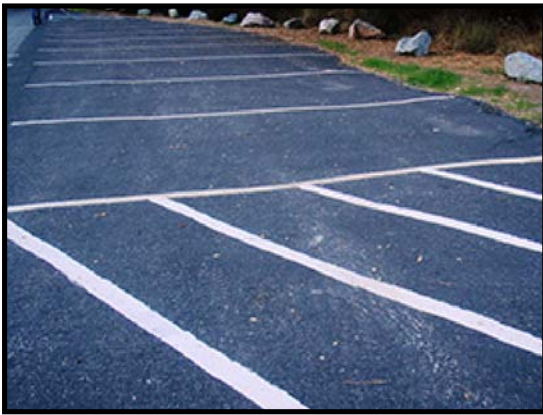
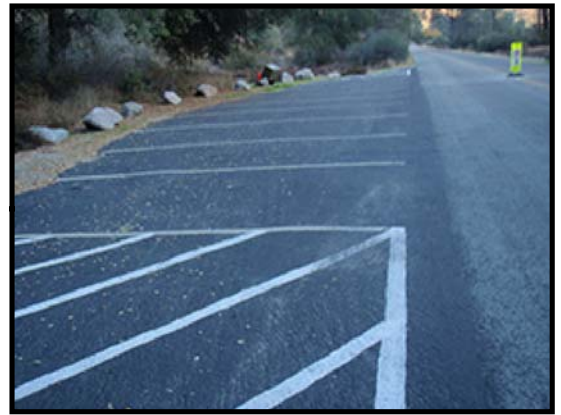
Route 0917

Route Number	Public / NonPublic	Date Visited	Area (sq ft)	Lane Miles *	Surface Type
0917	PUBLIC	11/18/2010	3,130	0.05	AS
Culverts	Drop Inlets	Gates	Curb & Gutter	Curb	PCR
0	0	0	NO CURB AND GUTTER	NO CURB	GOOD/90
