Federal Lands Highway Road Inventory Program

Road Inventory and Condition Assessment

Pipestone National Monument PIPE

Cycle 5 Report

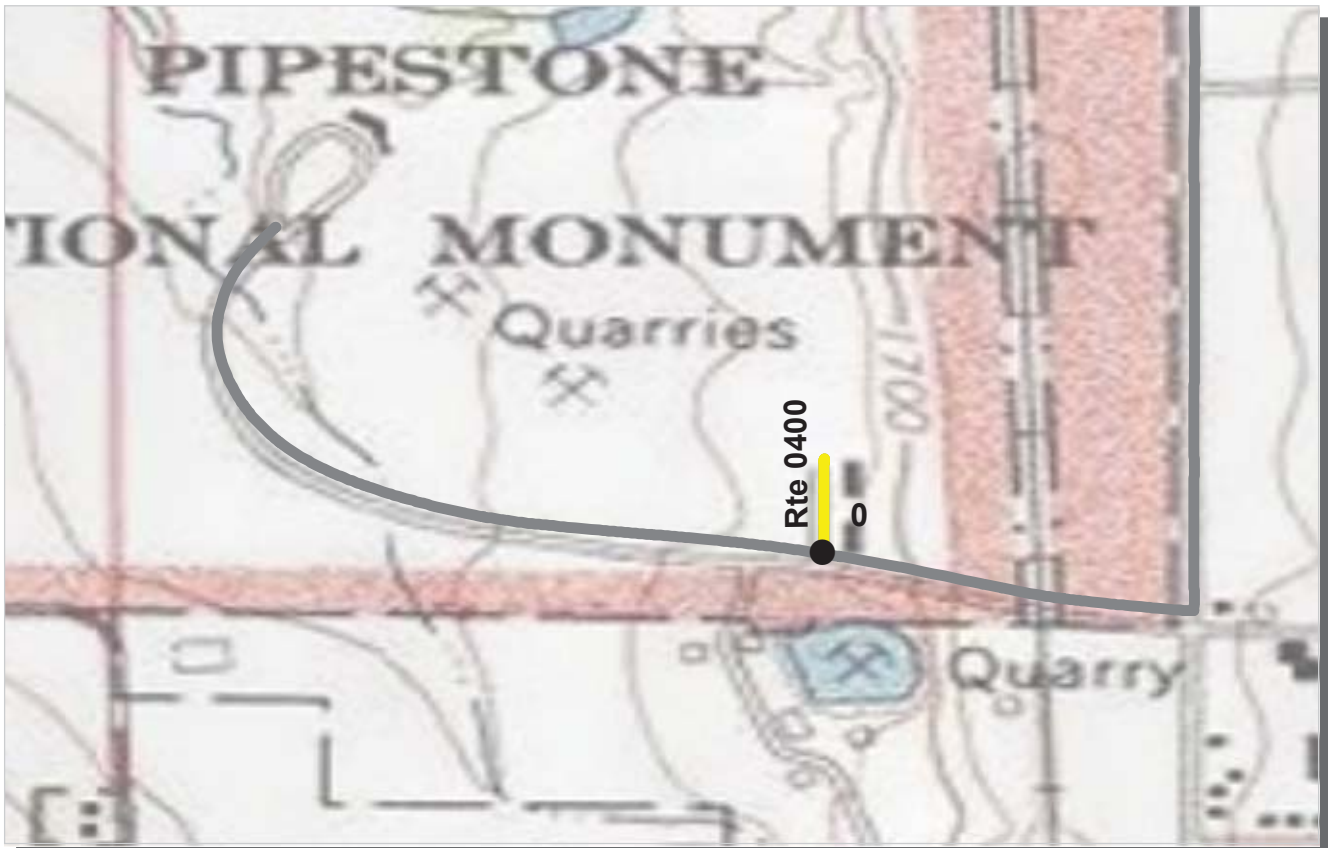
ROUTE: 0400 NORTH RESERVATION AVENUE

<i>Section Number</i>	0				
<i>Section Length (mi)</i>	0.06				
<i>Cross Section Information</i>					
Number of Lanes	2				
Paved Width (ft)	16				
Lane Width (ft)	8				
<i>Roadway Condition Information</i>					
SCR (Surface Condition Rating)	69				
PCR (Pavement Condition Rating)	69				
<i>Distress Index Values</i>					
Structural Crack Index	99				
Transverse Cracking Index	69				
Patching Index	100				
Rutting Index	100				
Roughness Condition Index (RCI)	NC

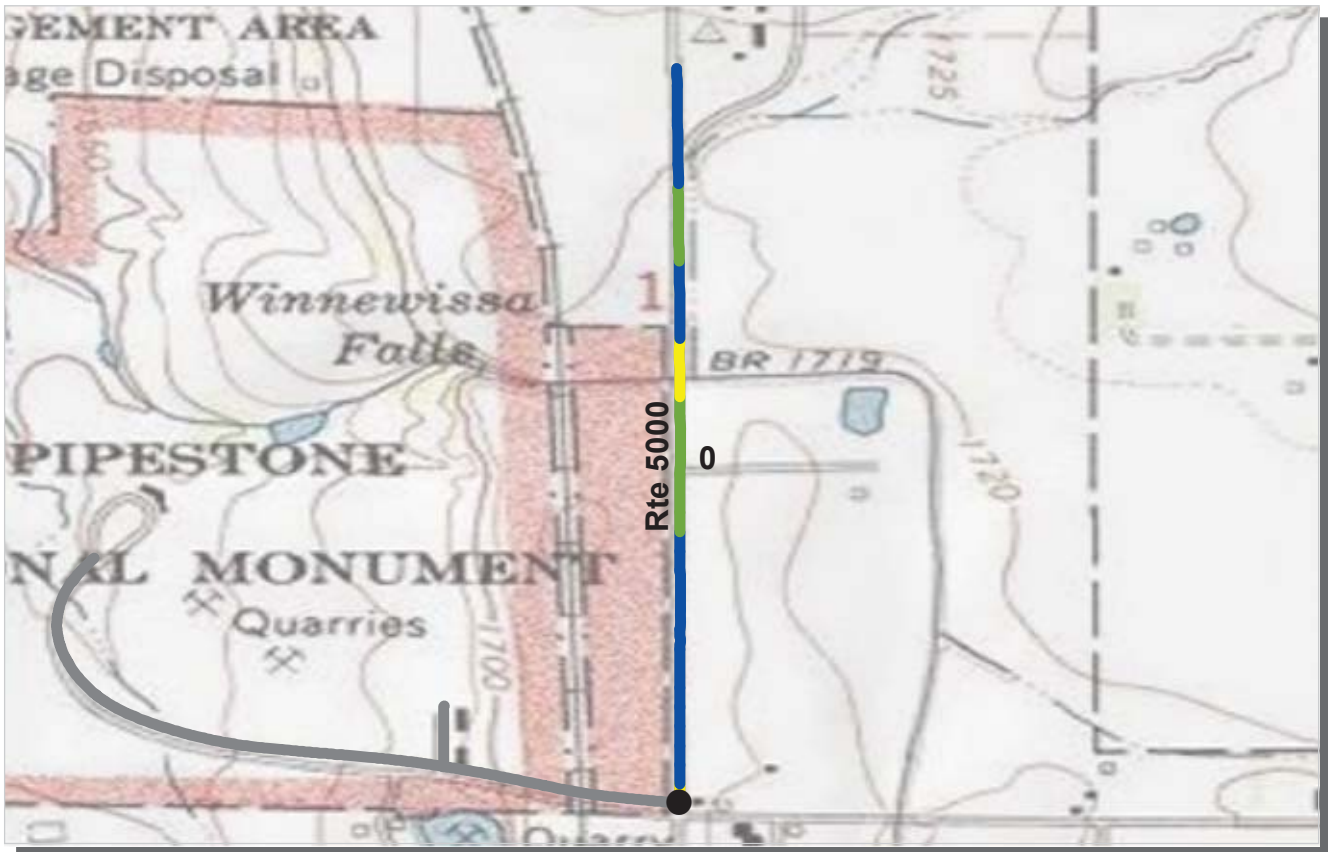
ROUTE: 5000 HIAWATHA AVENUE

<i>Section Number</i>	0				
<i>Section Length (mi)</i>	0.76				
<i>Cross Section Information</i>					
Number of Lanes	2				
Paved Width (ft)	26				
Lane Width (ft)	13				
<i>Roadway Condition Information</i>					
SCR (Surface Condition Rating)	91				
PCR (Pavement Condition Rating)	95				
<i>Distress Index Values</i>					
Structural Crack Index	91				
Transverse Cracking Index	94				
Patching Index	100				
Rutting Index	100				
Roughness Condition Index (RCI)	100

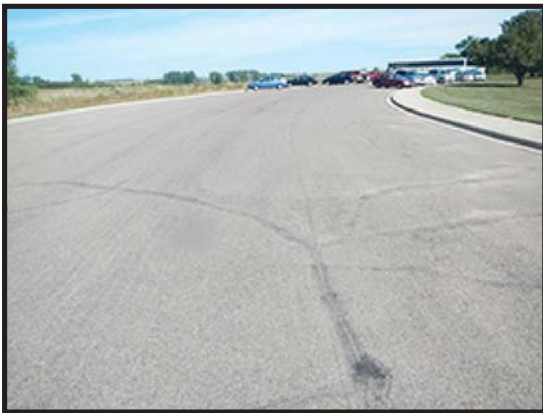
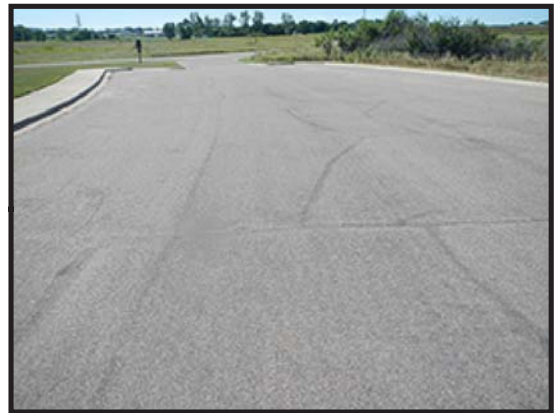
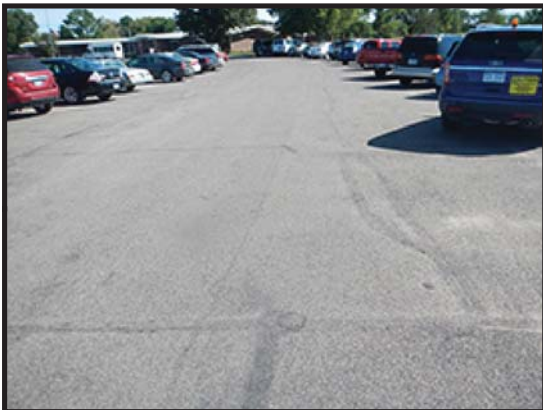
Route 0901

Route Number	Public / NonPublic	Date Visited	Area (sq ft)	Lane Miles *	Surface Type
0901	NONPUBLIC	8/17/2012	5,397	0.09	AS
Culverts	Drop Inlets	Gates	Curb & Gutter	Curb	PCR
0	1	0	CONCRETE CURB AND GUTTER	NO CURB	POOR/45

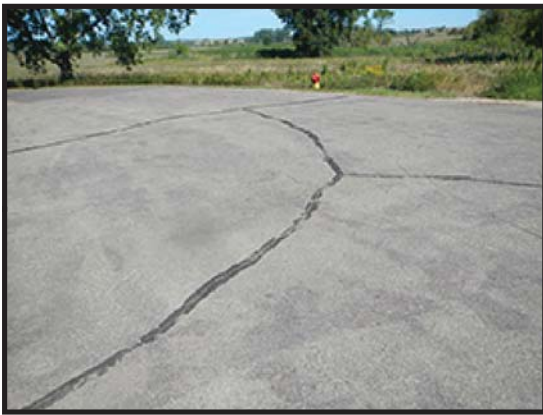
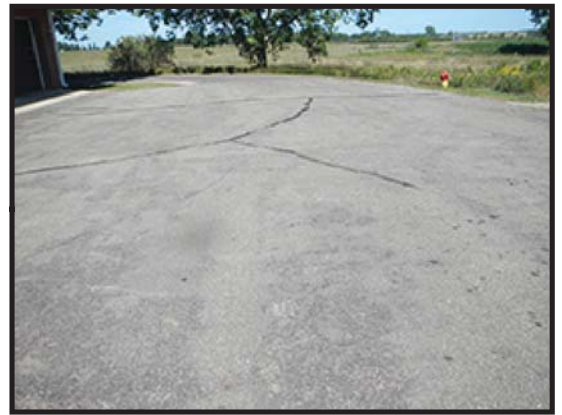
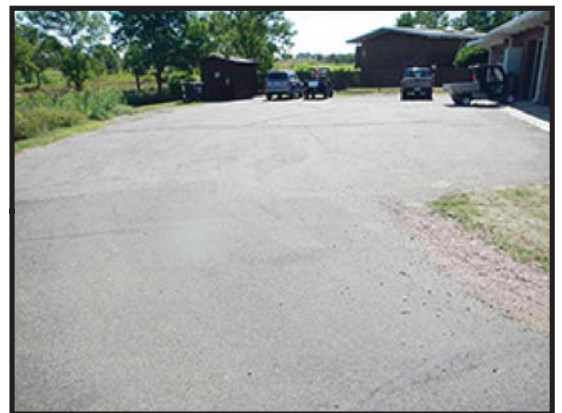
Route 0902

Route Number	Public / NonPublic	Date Visited	Area (sq ft)	Lane Miles *	Surface Type
0902	PUBLIC	8/17/2012	8,000	0.14	AS
Culverts	Drop Inlets	Gates	Curb & Gutter	Curb	PCR
1	0	2	NO CURB AND GUTTER	NO CURB	FAIR/73

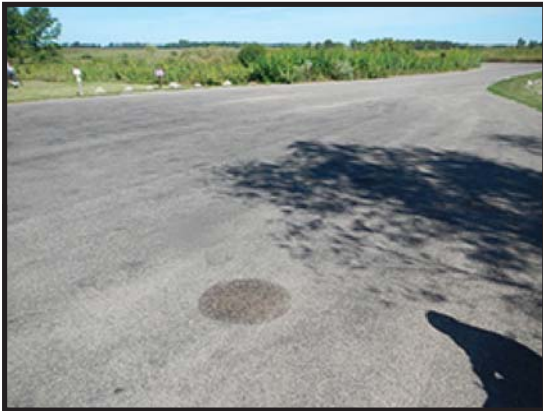
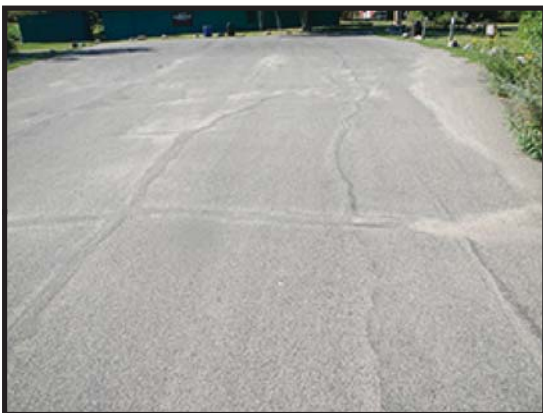
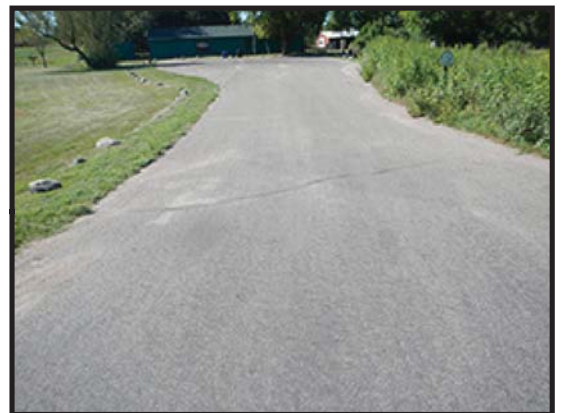
Route 0903

Route Number	Public / NonPublic	Date Visited	Area (sq ft)	Lane Miles *	Surface Type
0903	PUBLIC	8/17/2012	1,325	0.02	AS
Culverts	Drop Inlets	Gates	Curb & Gutter	Curb	PCR
0	0	0	NO CURB AND GUTTER	CONCRETE CURB	FAIR/73
