Federal Lands Highway Road Inventory Program

Road Inventory and Condition Assessment

Pictured Rocks National Lakeshore PIRO

Cycle 5 Report

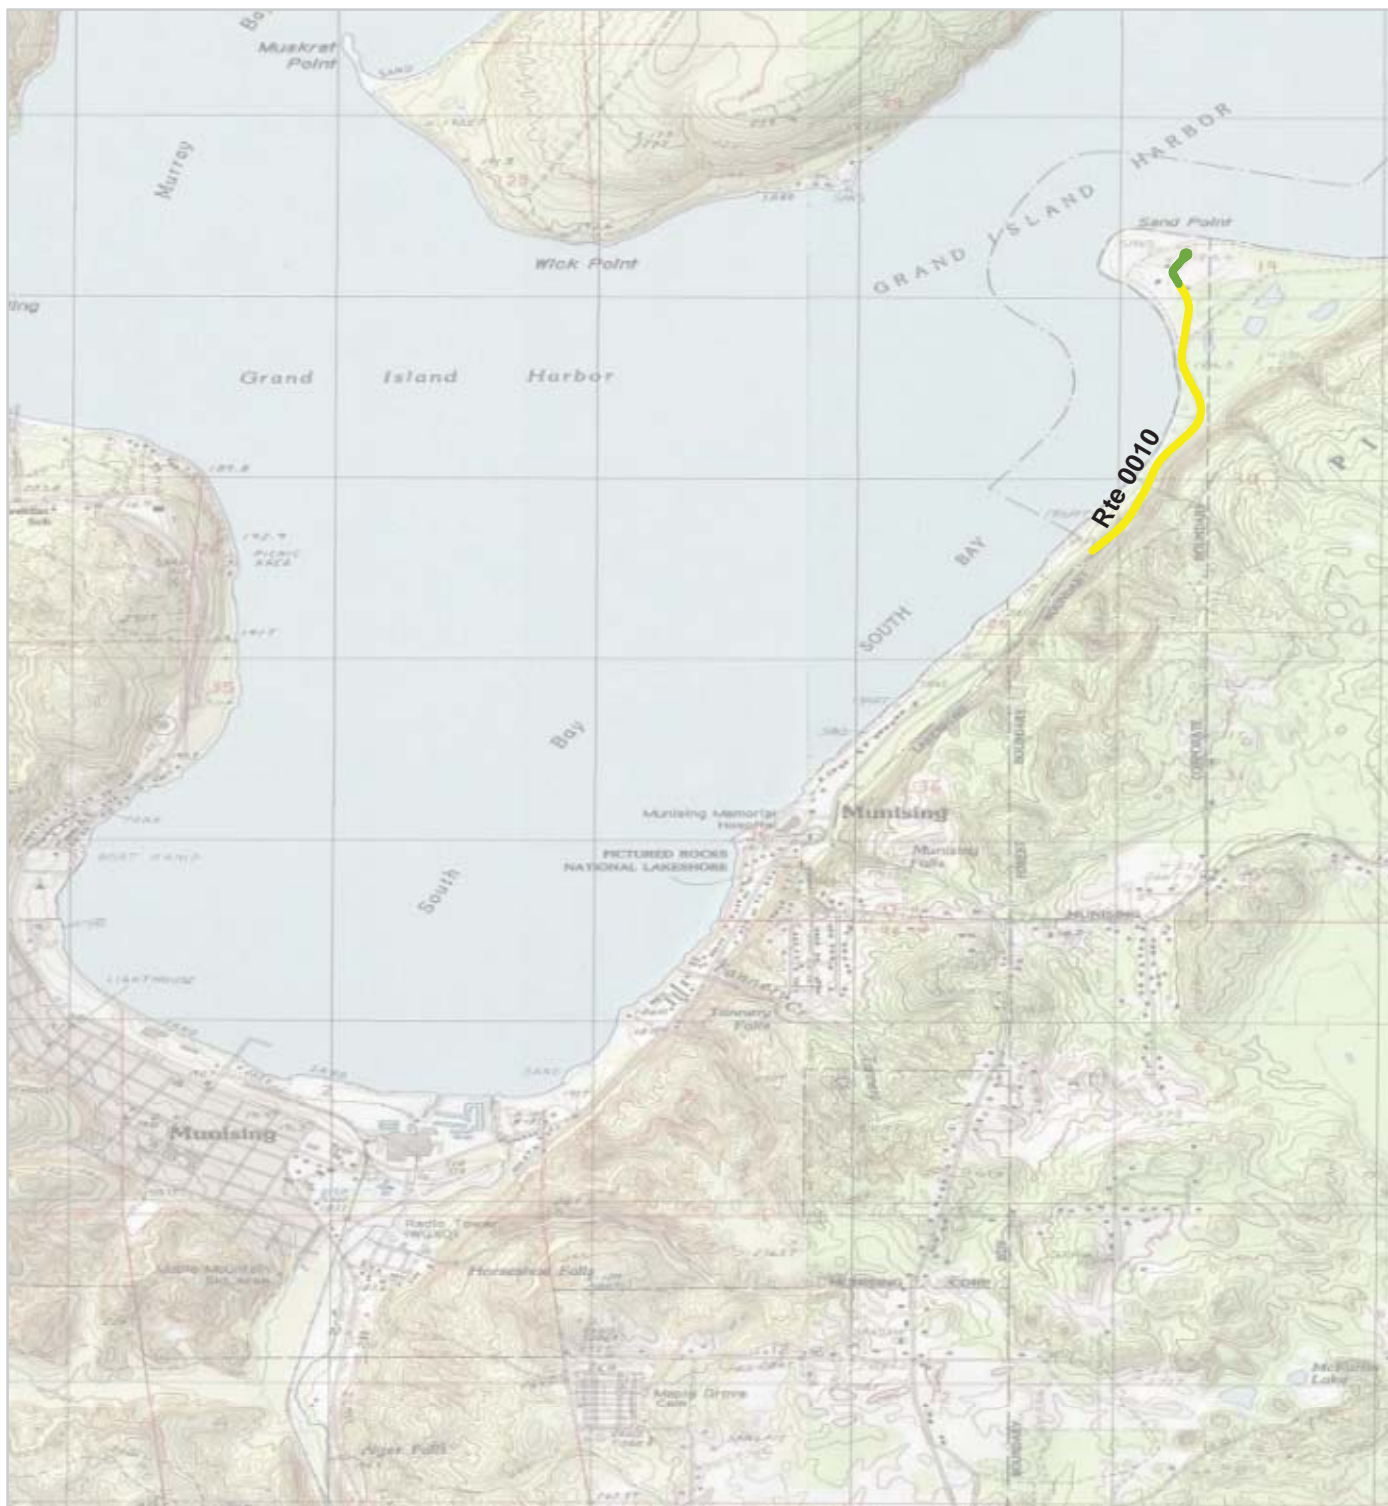
Pictured Rocks National Lakeshore Route Condition Map PCR - Mile by Mile Area 1

PCR	Poor		Fair		Good		Excellent		No Data	
	(0 - 60)		(61 - 84)	(85 - 94)		(95 - 100)

* If the PCR rating is not available for a section, the SCR rating will be displayed. See appendix for definitions and formulas.

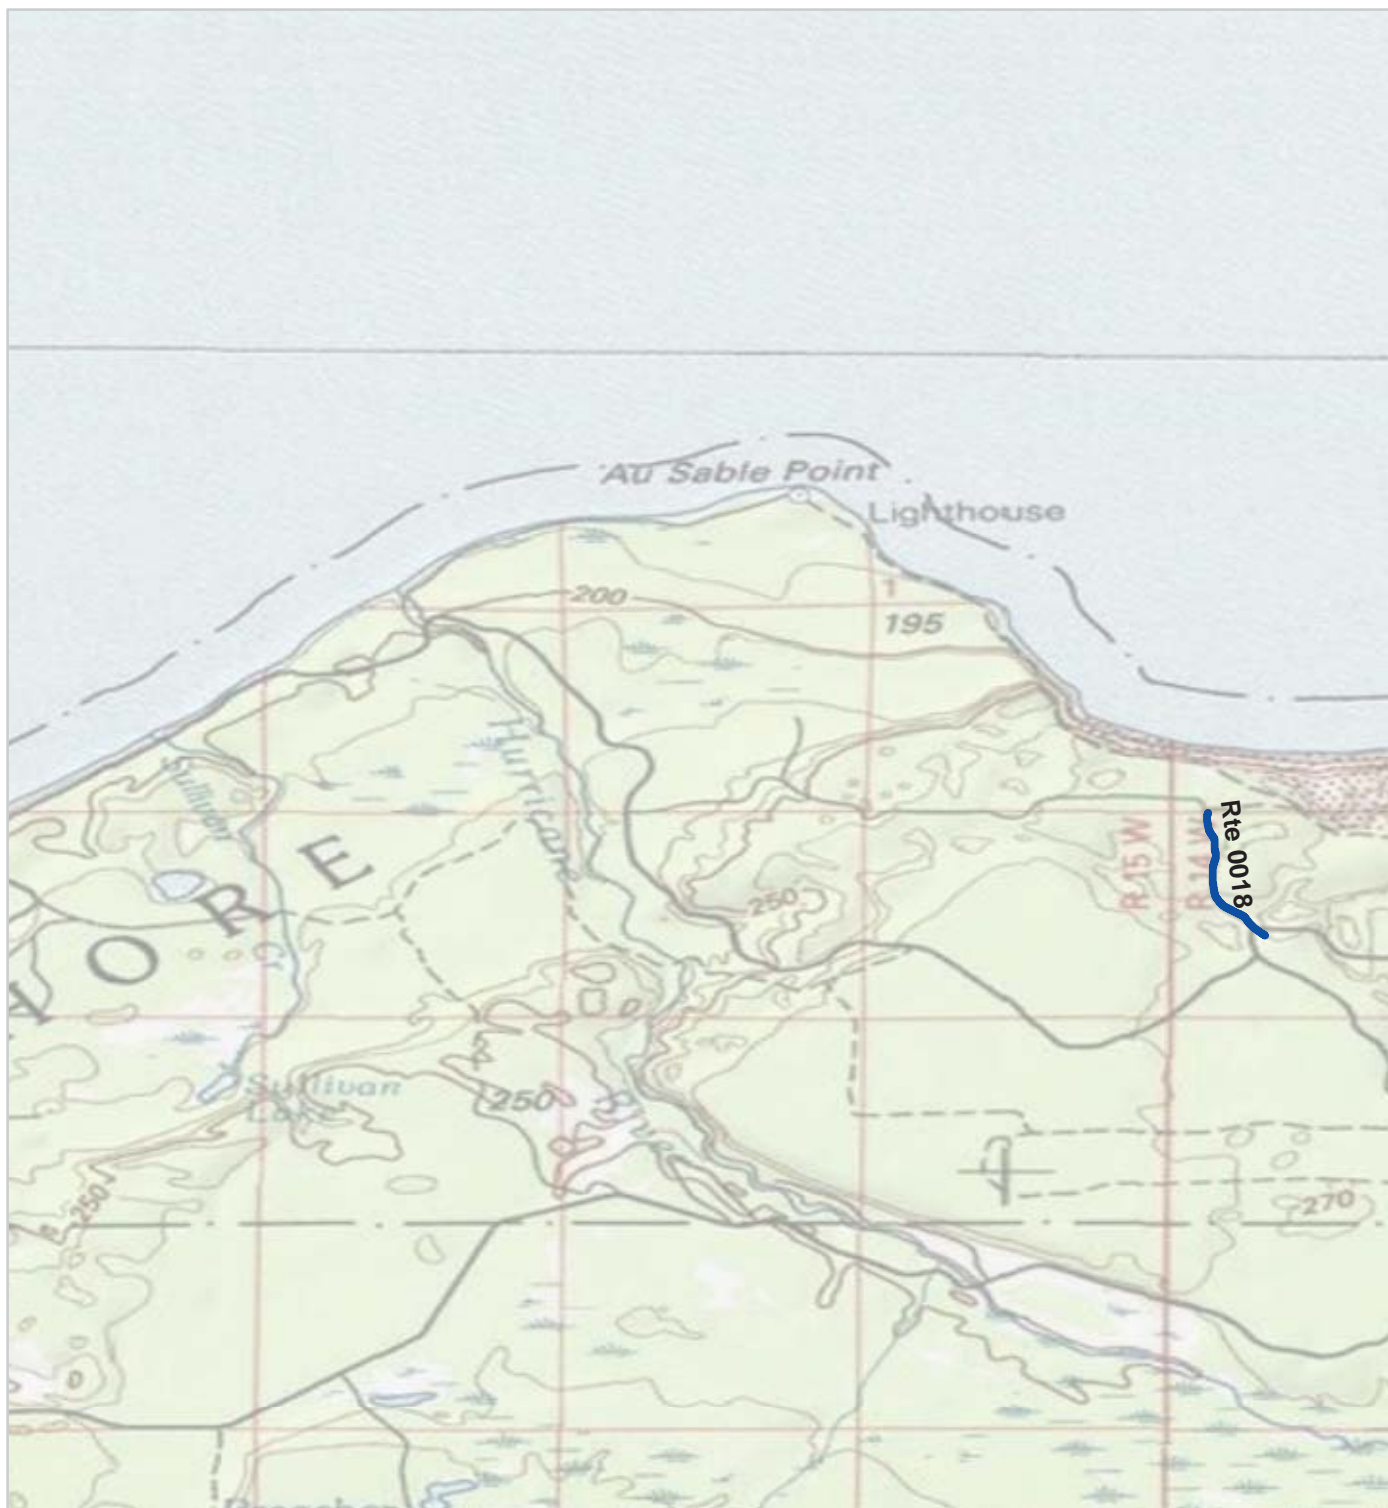
**Pictured Rocks National Lakeshore
Route Condition Map
PCR - Mile by Mile
Area 3**

PCR	Poor	Fair	Good	Excellent	No Data
	(0 - 60)	(61 - 84)	(85 - 94)	(95 - 100)

* If the PCR rating is not available for a section, the SCR rating will be displayed. See appendix for definitions and formulas.

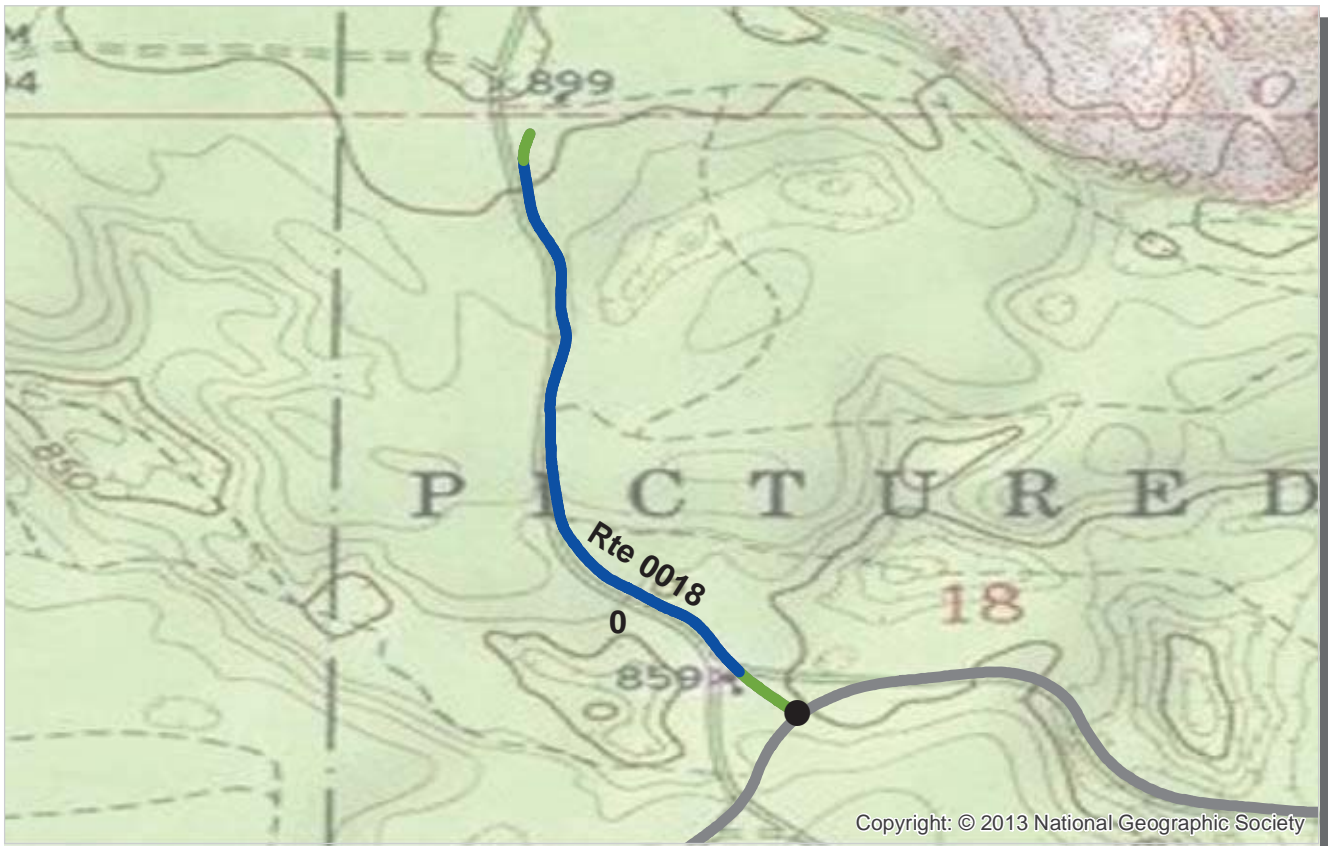
ROUTE: 0018 LOG SLIDE ROAD

Section Number	0				
Section Length (mi)	0.67				
Cross Section Information					
Number of Lanes	2				
Paved Width (ft)	18				
Lane Width (ft)	9				
Roadway Condition Information					
SCR (Surface Condition Rating)	99				
PCR (Pavement Condition Rating)	99				
Distress Index Values					
Structural Crack Index	100				
Transverse Cracking Index	100				
Patching Index	100				
Rutting Index	99				
Roughness Condition Index (RCI)	100

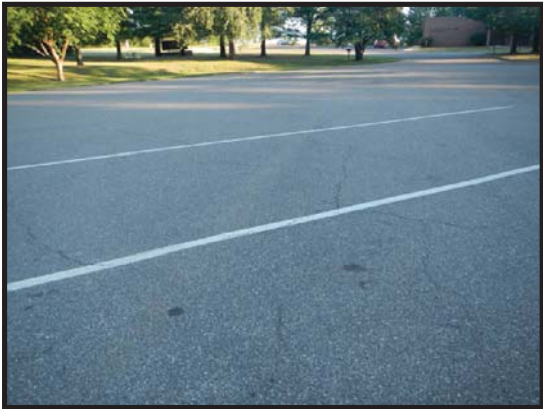
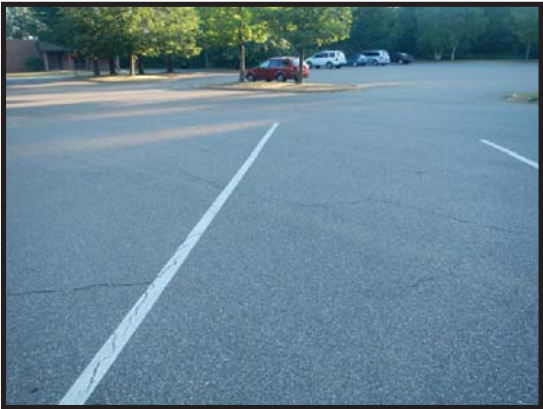
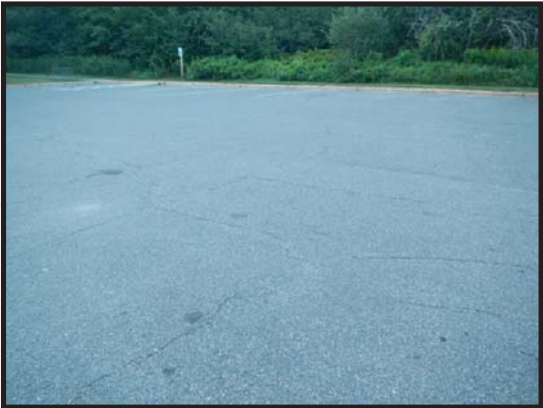
Route Number	Public / NonPublic	Date Visited	Area (sq ft)	Lane Miles *	Surface Type
0900	PUBLIC	8/9/2012	39,779	0.69	AS
Culverts	Drop Inlets	Gates	Curb & Gutter	Curb	PCR
0	0	0	CONCRETE CURB AND GUTTER	NO CURB	POOR/45

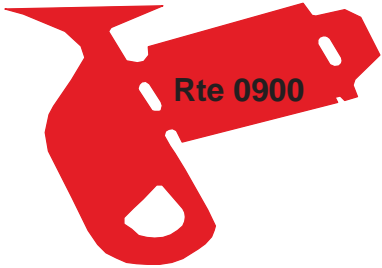
Route 0901ZZ

Route Number	Public / NonPublic	Date Visited	Area (sq ft)	Lane Miles *	Surface Type
0901Z	PUBLIC	8/9/2012	8,902	0.15	AS
Culverts	Drop Inlets	Gates	Curb & Gutter	Curb	PCR
0	0	0	NO CURB AND GUTTER	NO CURB	FAIR/73

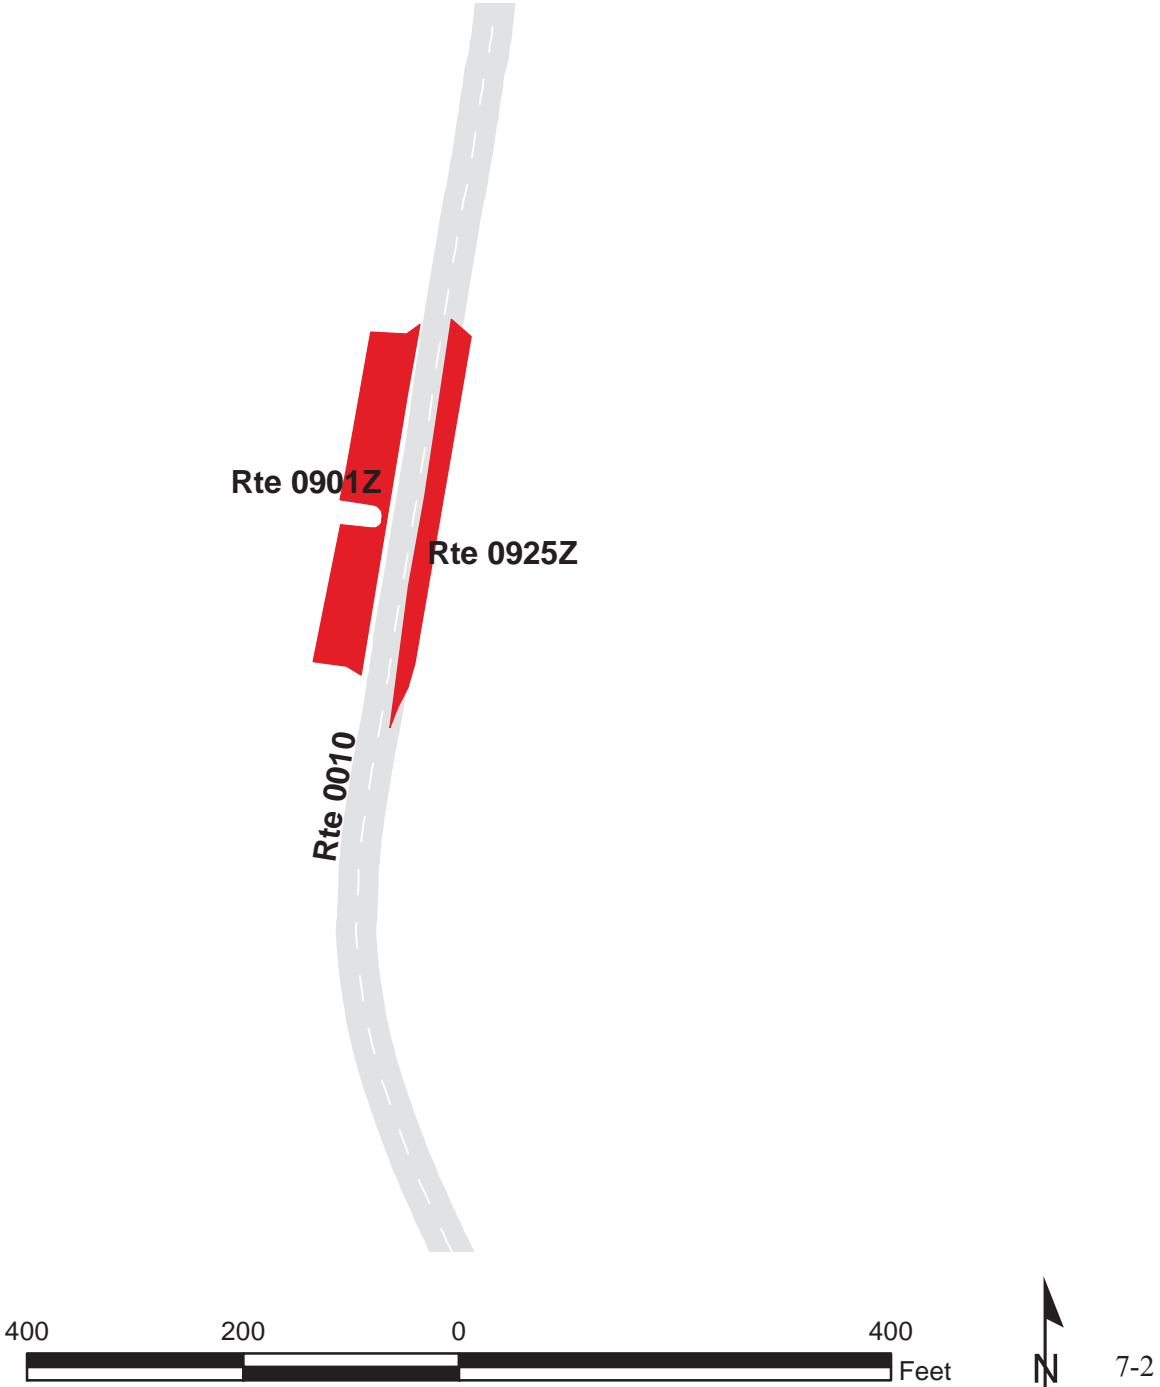
Route Number	Public / NonPublic	Date Visited	Area (sq ft)	Lane Miles *	Surface Type
0901ZZ	PUBLIC	8/9/2012	13,196	0.23	AS
Culverts	Drop Inlets	Gates	Curb & Gutter	Curb	PCR
0	0	0	NO CURB AND GUTTER	NO CURB	SUMMARY/73

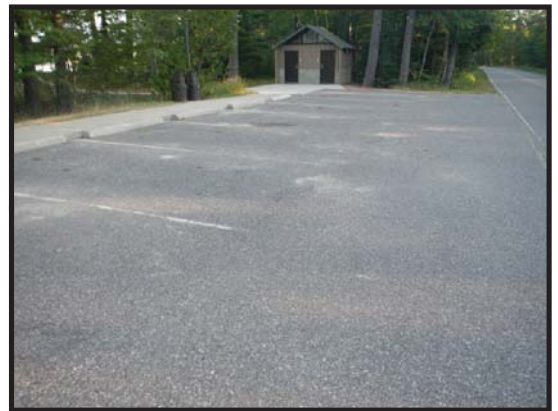
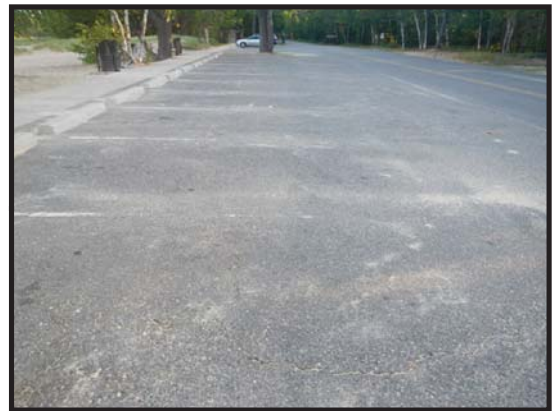
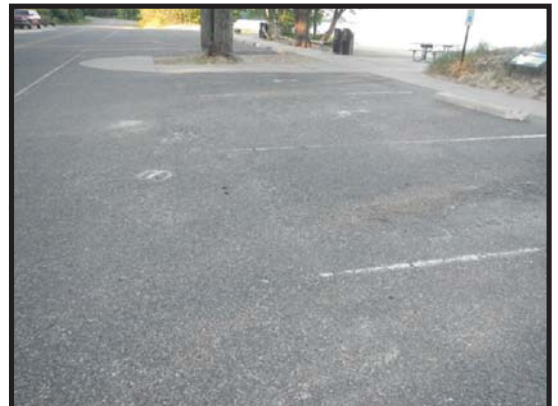
Route 0925Z

Route Number	Public / NonPublic	Date Visited	Area (sq ft)	Lane Miles *	Surface Type
0925Z	PUBLIC	8/9/2012	4,294	0.07	AS
Culverts	Drop Inlets	Gates	Curb & Gutter	Curb	PCR
0	0	0	NO CURB AND GUTTER	NO CURB	FAIR/73

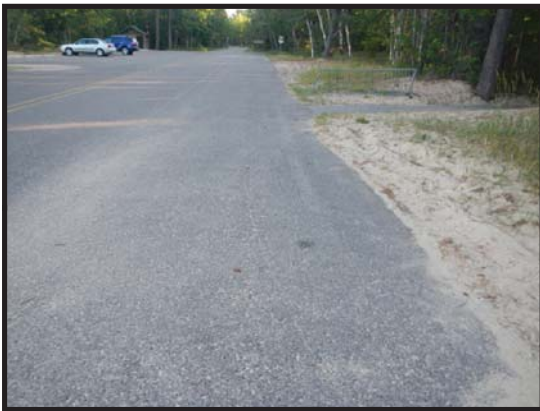
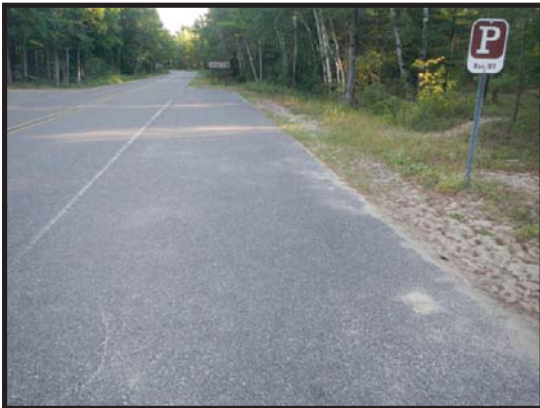
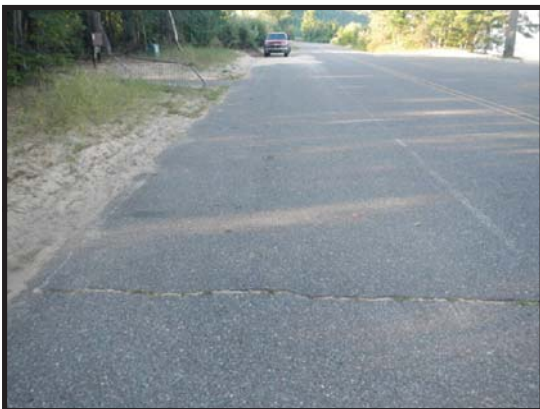
Route 0903A

Route Number	Public / NonPublic	Date Visited	Area (sq ft)	Lane Miles *	Surface Type
0903A	NONPUBLIC	8/9/2012	23,076	0.40	AS
Culverts	Drop Inlets	Gates	Curb & Gutter	Curb	PCR
0	0	2	NO CURB AND GUTTER	NO CURB	GOOD/90

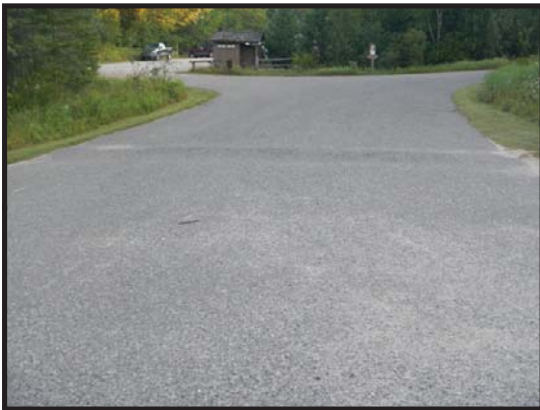
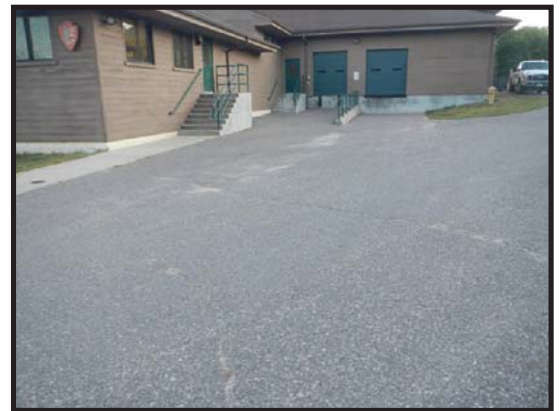
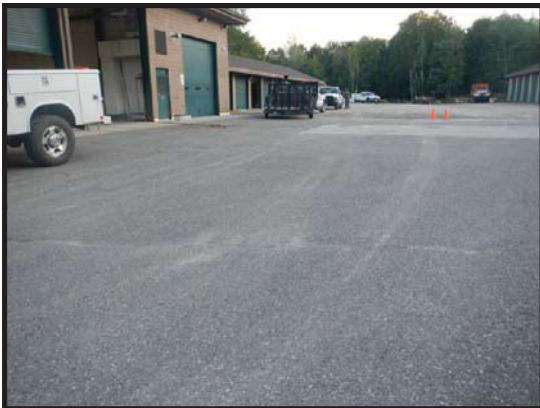
Route 0905

Route Number	Public / NonPublic	Date Visited	Area (sq ft)	Lane Miles *	Surface Type
0905	PUBLIC	8/8/2012	82,182	1.42	AS
Culverts	Drop Inlets	Gates	Curb & Gutter	Curb	PCR
0	3	0	CONCRETE CURB AND GUTTER	NO CURB	FAIR/73

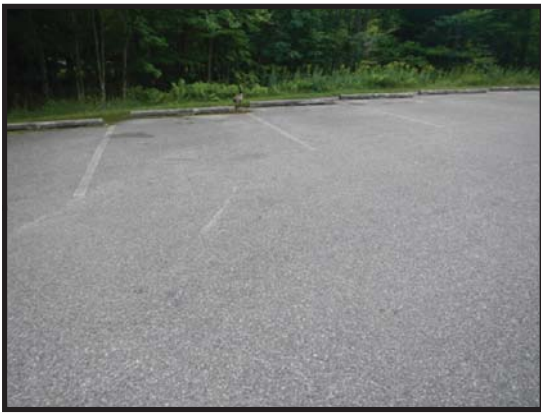
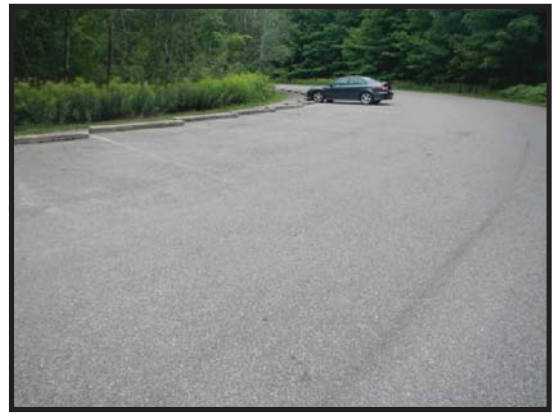
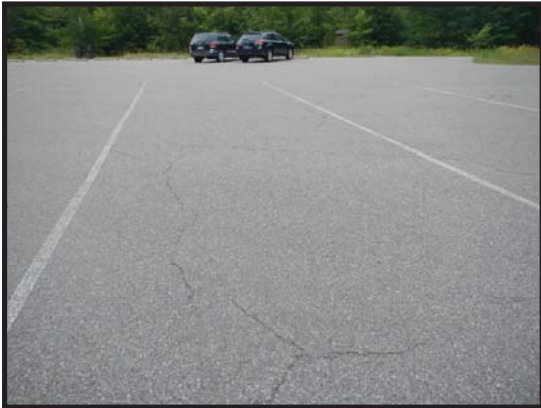
Route 0906

Route Number	Public / NonPublic	Date Visited	Area (sq ft)	Lane Miles *	Surface Type
0906	PUBLIC	8/8/2012	12,155	0.21	AS
Culverts	Drop Inlets	Gates	Curb & Gutter	Curb	PCR
0	0	0	NO CURB AND GUTTER	NO CURB	FAIR/73

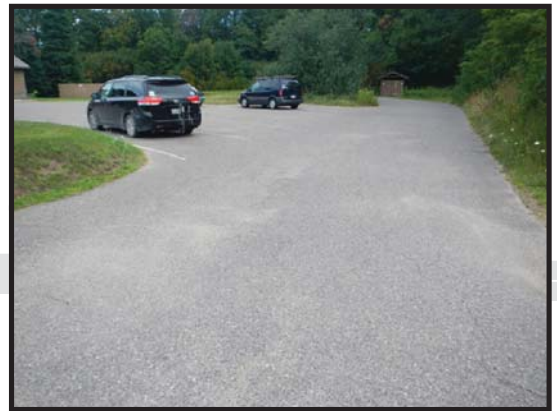
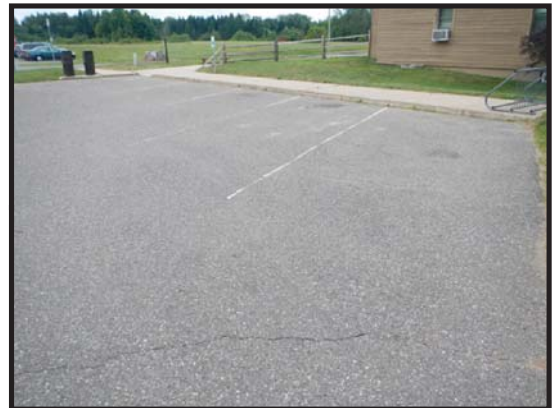
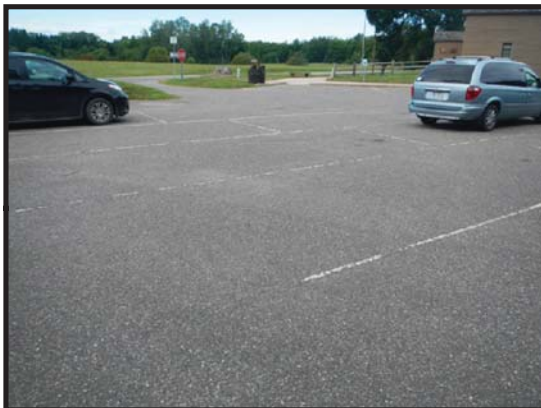
Route 0907

Route Number	Public / NonPublic	Date Visited	Area (sq ft)	Lane Miles *	Surface Type
0907	PUBLIC	8/8/2012	15,213	0.26	AS
Culverts	Drop Inlets	Gates	Curb & Gutter	Curb	PCR
0	0	0	NO CURB AND GUTTER	NO CURB	FAIR/73

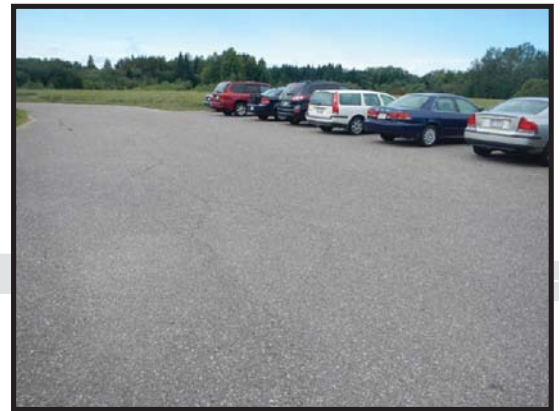
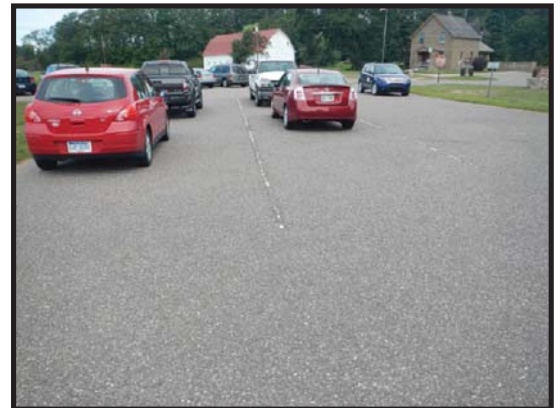
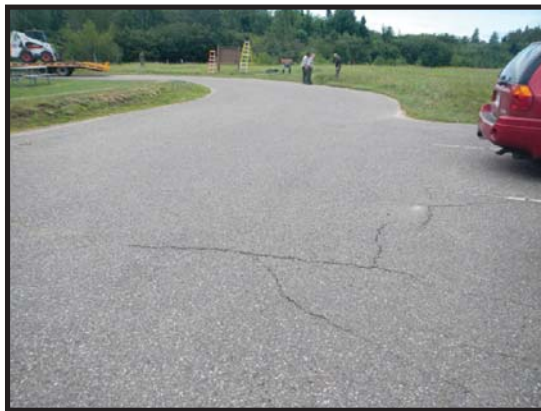
Route 0908

Route Number	Public / NonPublic	Date Visited	Area (sq ft)	Lane Miles *	Surface Type
0908	PUBLIC	8/8/2012	57,286	0.99	AS
Culverts	Drop Inlets	Gates	Curb & Gutter	Curb	PCR
0	0	0	NO CURB AND GUTTER	NO CURB	GOOD/90

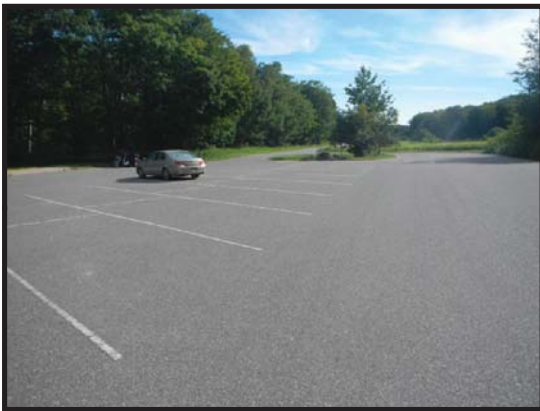
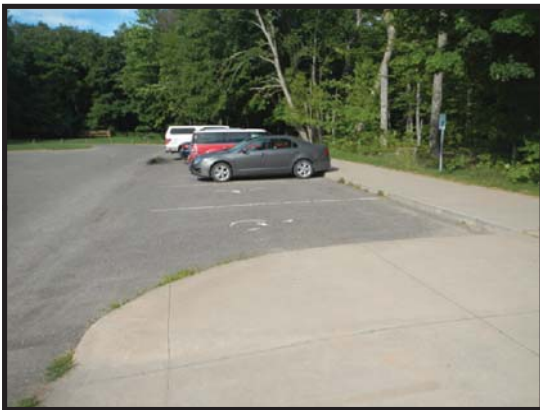
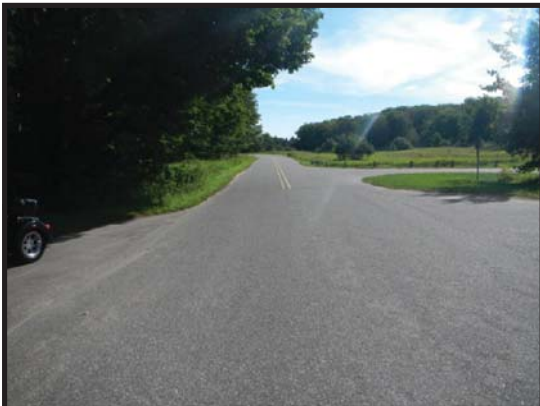
Route 0916

Route Number	Public / NonPublic	Date Visited	Area (sq ft)	Lane Miles *	Surface Type
0916	PUBLIC	8/8/2012	33,141	0.57	AS
Culverts	Drop Inlets	Gates	Curb & Gutter	Curb	PCR
0	0	1	NO CURB AND GUTTER	WOOD CURB	GOOD/90

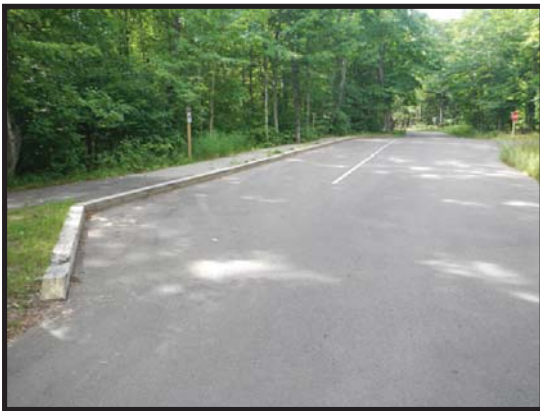
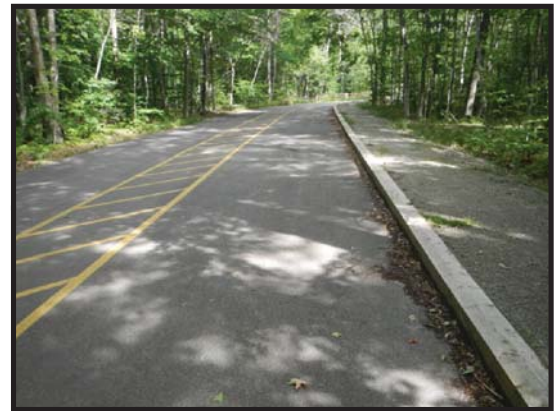
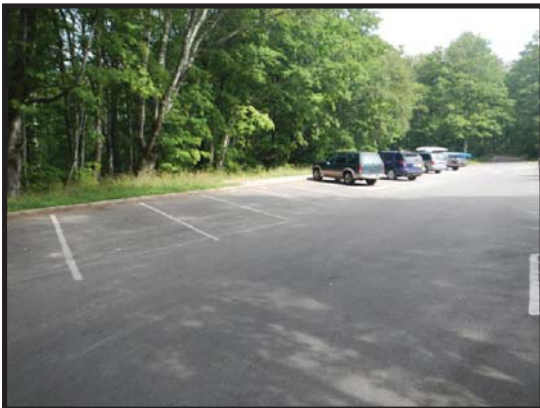
Route 0928

Route Number	Public / NonPublic	Date Visited	Area (sq ft)	Lane Miles *	Surface Type
0928	PUBLIC	8/8/2012	5,803	0.10	AS
Culverts	Drop Inlets	Gates	Curb & Gutter	Curb	PCR
0	0	0	NO CURB AND GUTTER	NO CURB	GOOD/90
