Road Inventory and Condition Assessment

Point Reyes National Seashore
PORE – 8530

Cycle 5 Report

Prepared By: Federal Highway Administration
Road Inventory Program (RIP)
Data Collection Date: 02/2010
Report Date: 06/2011

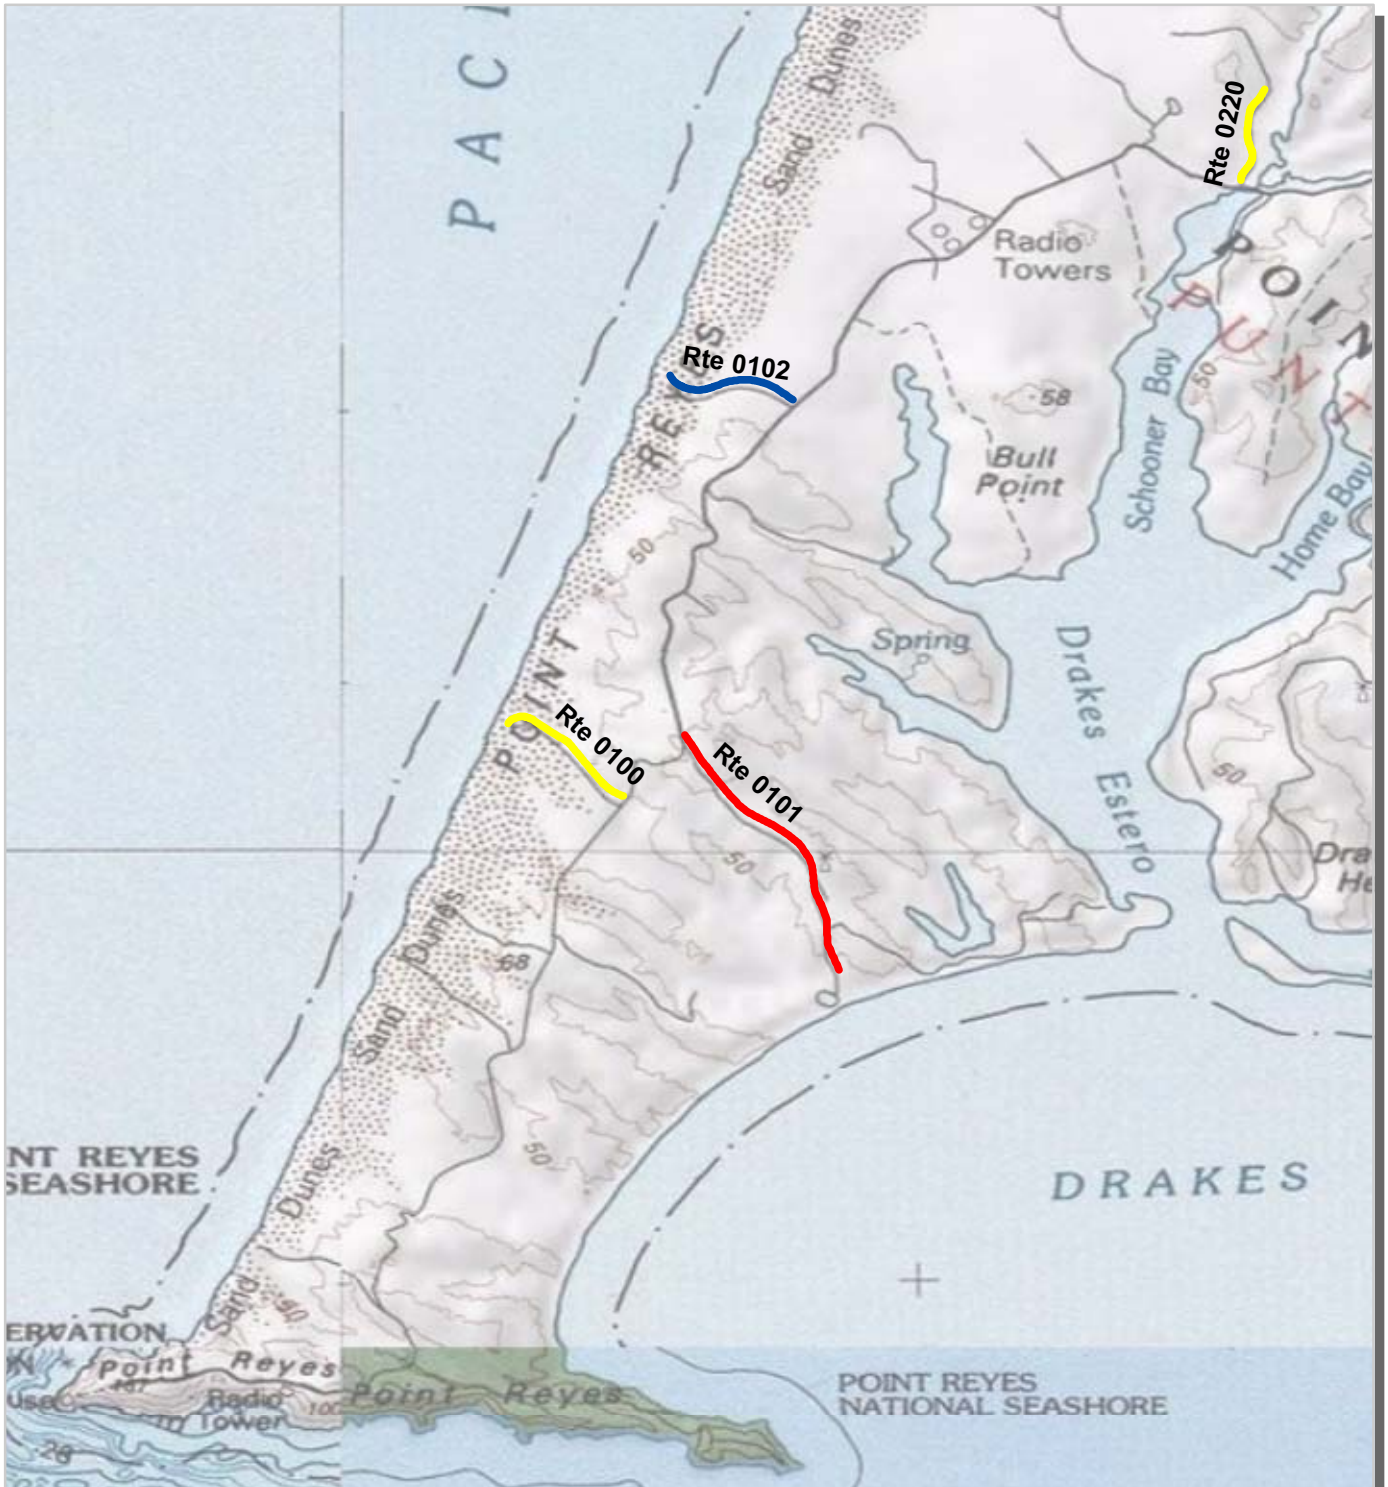
Point Reyes National Seashore Route Condition Map PCR - Mile by Mile Area 2

PCR	Poor		Fair		Good		Excellent		No Data	
	(0 - 60)		(61 - 84)	(85 - 94)	(95 - 100)

* If the PCR rating is not available for a section, the SCR rating will be displayed. See appendix for definitions and formulas.

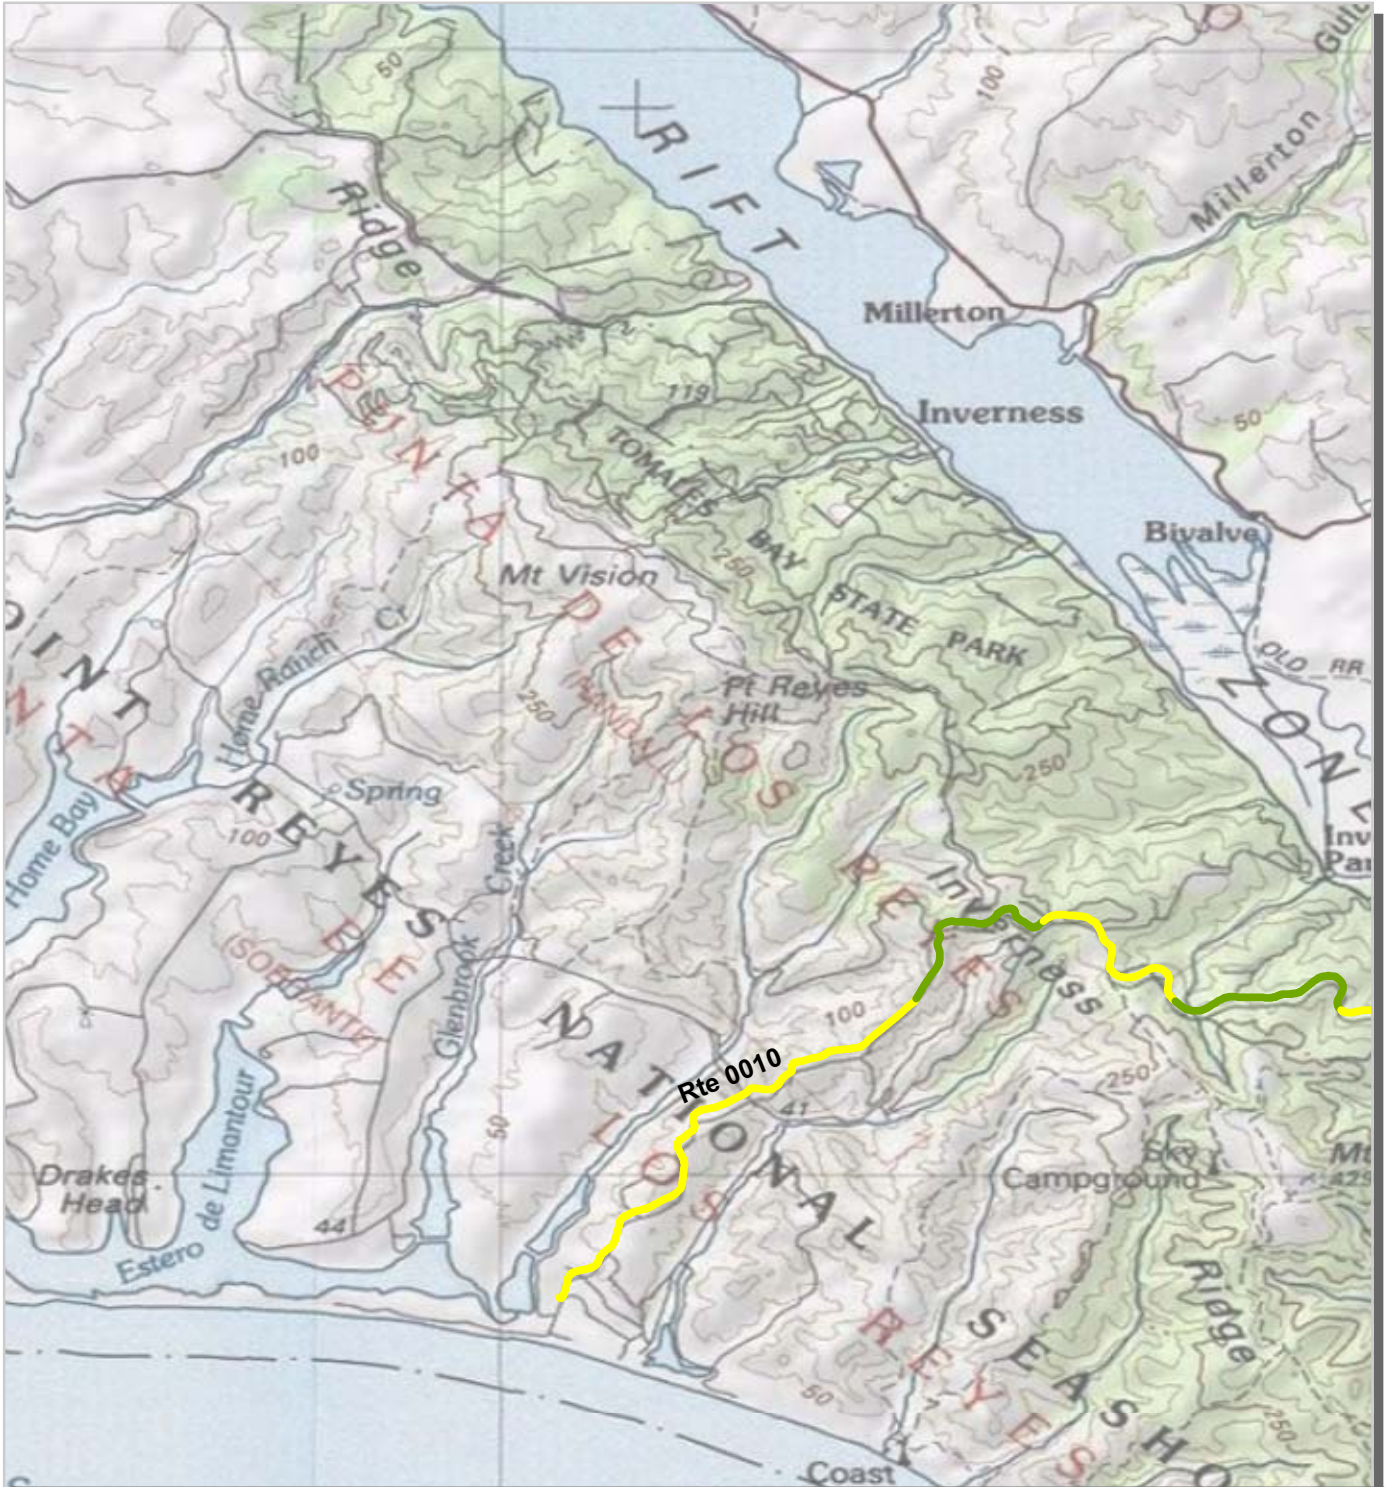
**Point Reyes National Seashore
Route Condition Map
PCR - Mile by Mile
Area 3**

PCR	Poor	Fair	Good	Excellent	No Data
	(0 - 60)	(61 - 84)	(85 - 94)	(95 - 100)

* If the PCR rating is not available for a section, the SCR rating will be displayed. See appendix for definitions and formulas.

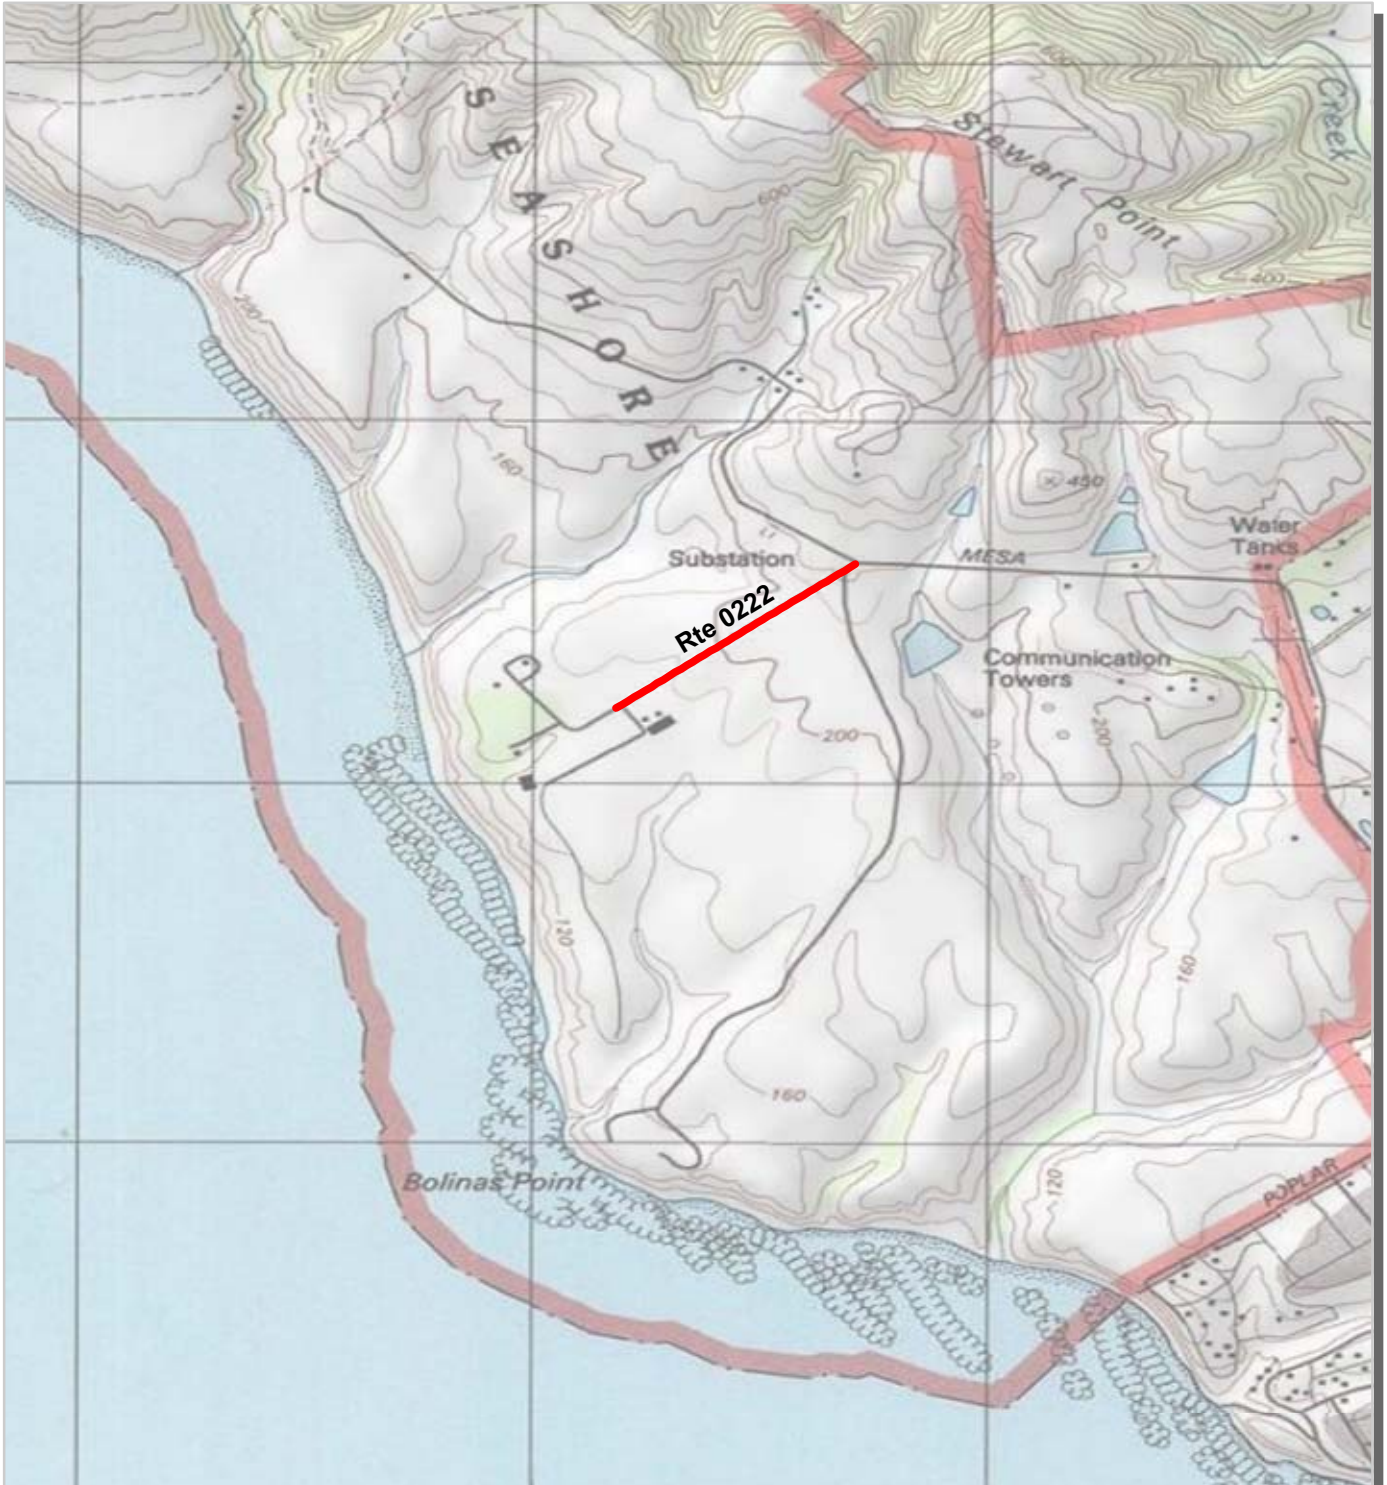
**Point Reyes National Seashore
Route Condition Map
PCR - Mile by Mile
Area 5**

PCR	Poor		Fair		Good		Excellent		No Data	
	(0 - 60)		(61 - 84)	(85 - 94)	(95 - 100)

* If the PCR rating is not available for a section, the SCR rating will be displayed. See appendix for definitions and formulas.

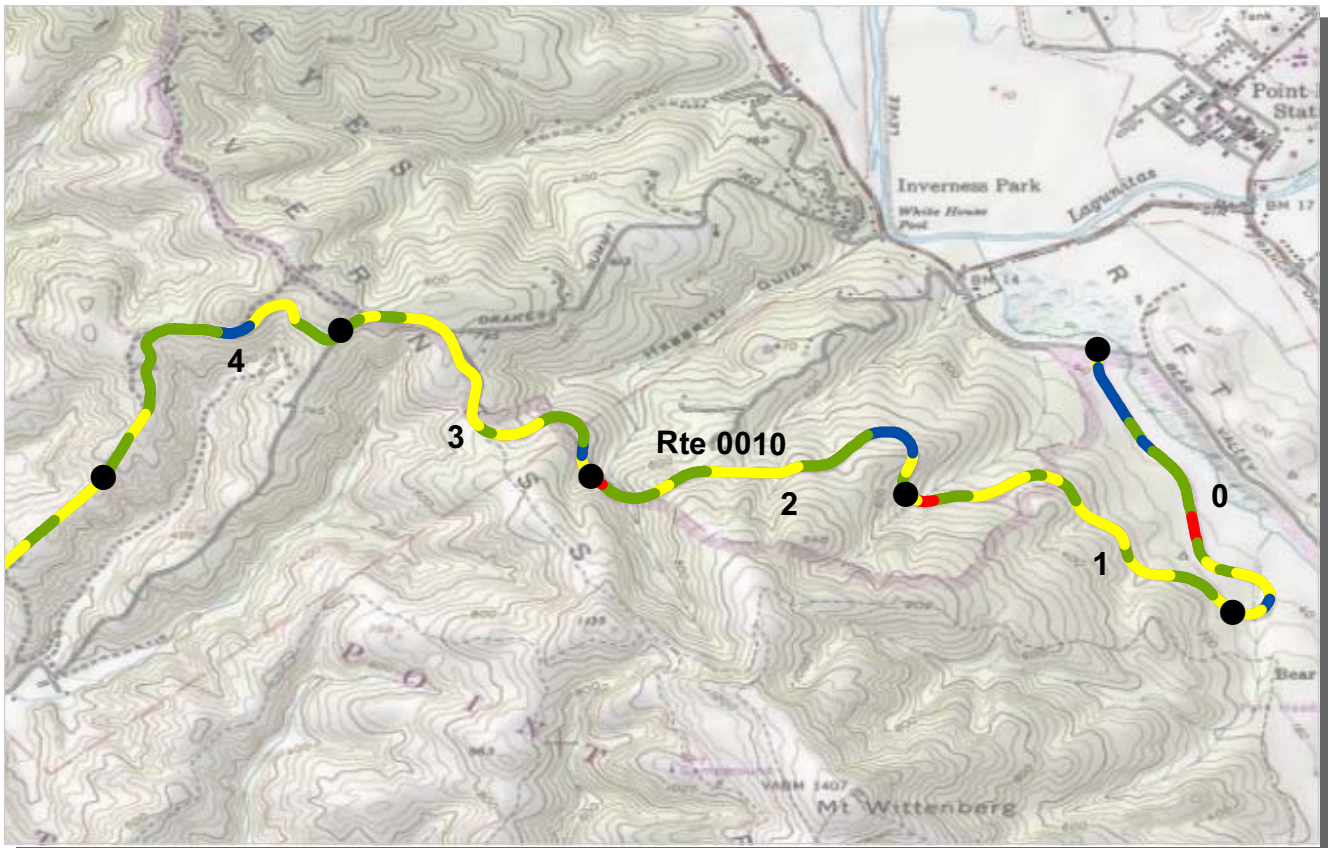
ROUTE: 0010 LIMANTOUR ROAD

<i>Section Number</i>	0	1	2	3	4
<i>Section Length (mi)</i>	1.00	1.00	1.00	1.00	1.00
<i>Cross Section Information</i>					
Number of Lanes	2	2	2	2	2
Paved Width (ft)	33	32	31	28	24
Lane Width (ft)	14	14	14	13	12
<i>Roadway Condition Information</i>					
SCR (Surface Condition Rating)	61	92	93	90	92
PCR (Pavement Condition Rating)	72	82	86	80	87
<i>Distress Index Values</i>					
Structural Crack Index	61	97	96	97	97
Transverse Cracking Index	96	99	100	100	99
Patching Index	100	100	100	100	100
Rutting Index	94	92	93	90	92
Roughness Condition Index (RCI)	88	66	75	65	80

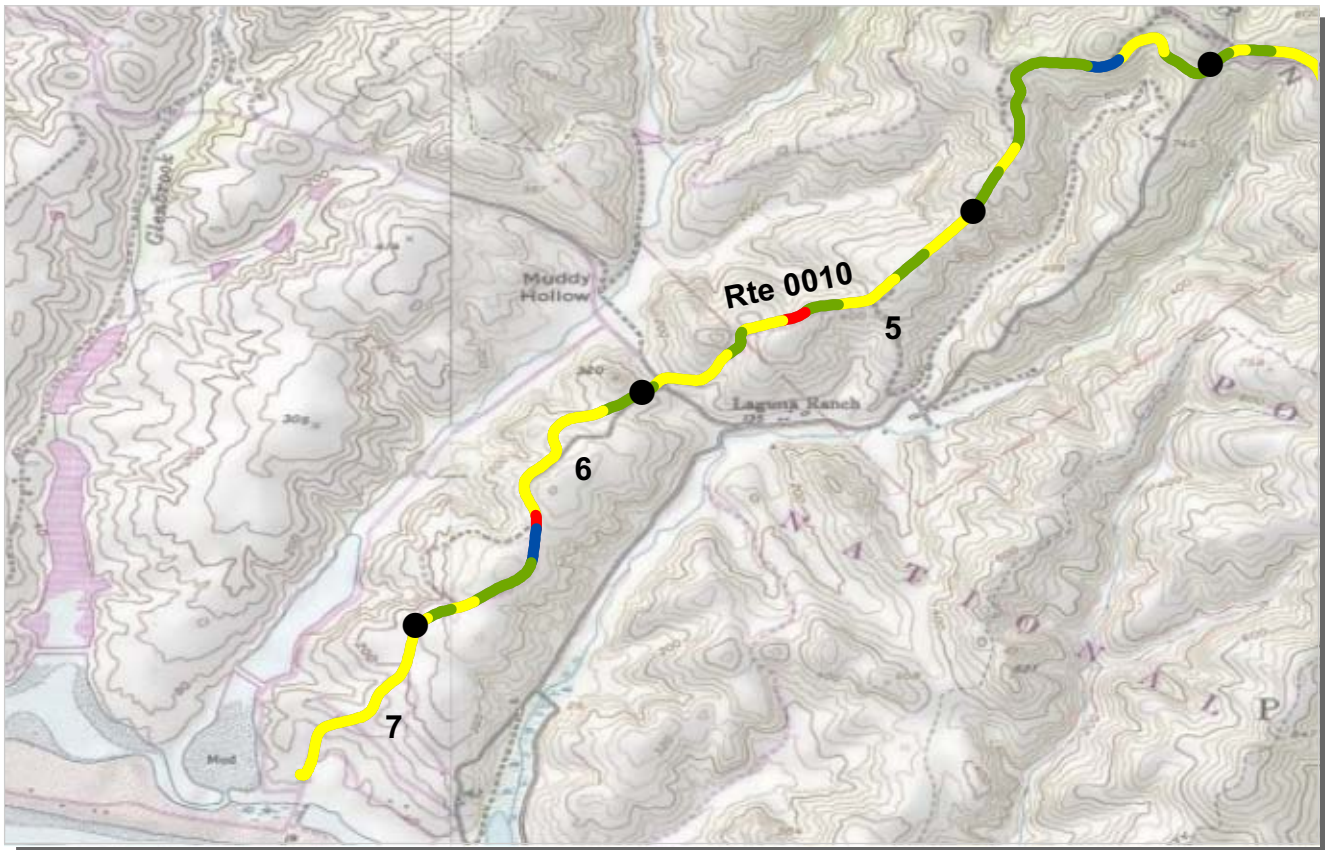
ROUTE: 0010 LIMANTOUR ROAD

<i>Section Number</i>	5	6	7		
<i>Section Length (mi)</i>	1.00	1.00	0.57		
<i>Cross Section Information</i>					
Number of Lanes	2	2	2		
Paved Width (ft)	24	24	24		
Lane Width (ft)	11	12	12		
<i>Roadway Condition Information</i>					
SCR (Surface Condition Rating)	89	94	89		
PCR (Pavement Condition Rating)	79	80	71		
<i>Distress Index Values</i>					
Structural Crack Index	96	99	96		
Transverse Cracking Index	99	100	99		
Patching Index	100	100	100		
Rutting Index	89	94	89		
Roughness Condition Index (RCI)	64	59	45

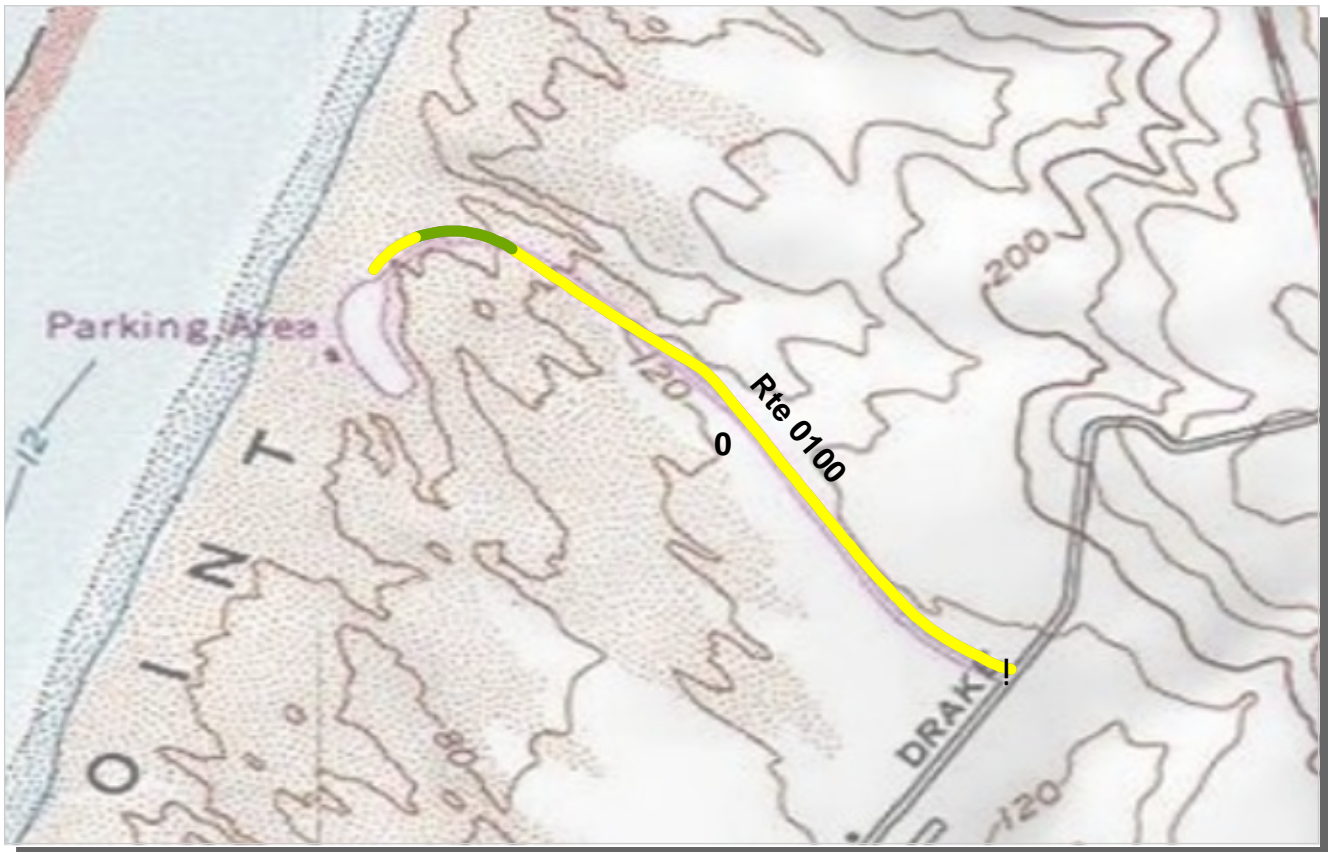
ROUTE: 0100 SOUTH BEACH ROAD

Section Number	0				
Section Length (mi)	0.70				
Cross Section Information					
Number of Lanes	2				
Paved Width (ft)	23				
Lane Width (ft)	11				
Roadway Condition Information					
SCR (Surface Condition Rating)	85				
PCR (Pavement Condition Rating)	71				
Distress Index Values					
Structural Crack Index	99				
Transverse Cracking Index	99				
Patching Index	100				
Rutting Index	85				
Roughness Condition Index (RCI)	49

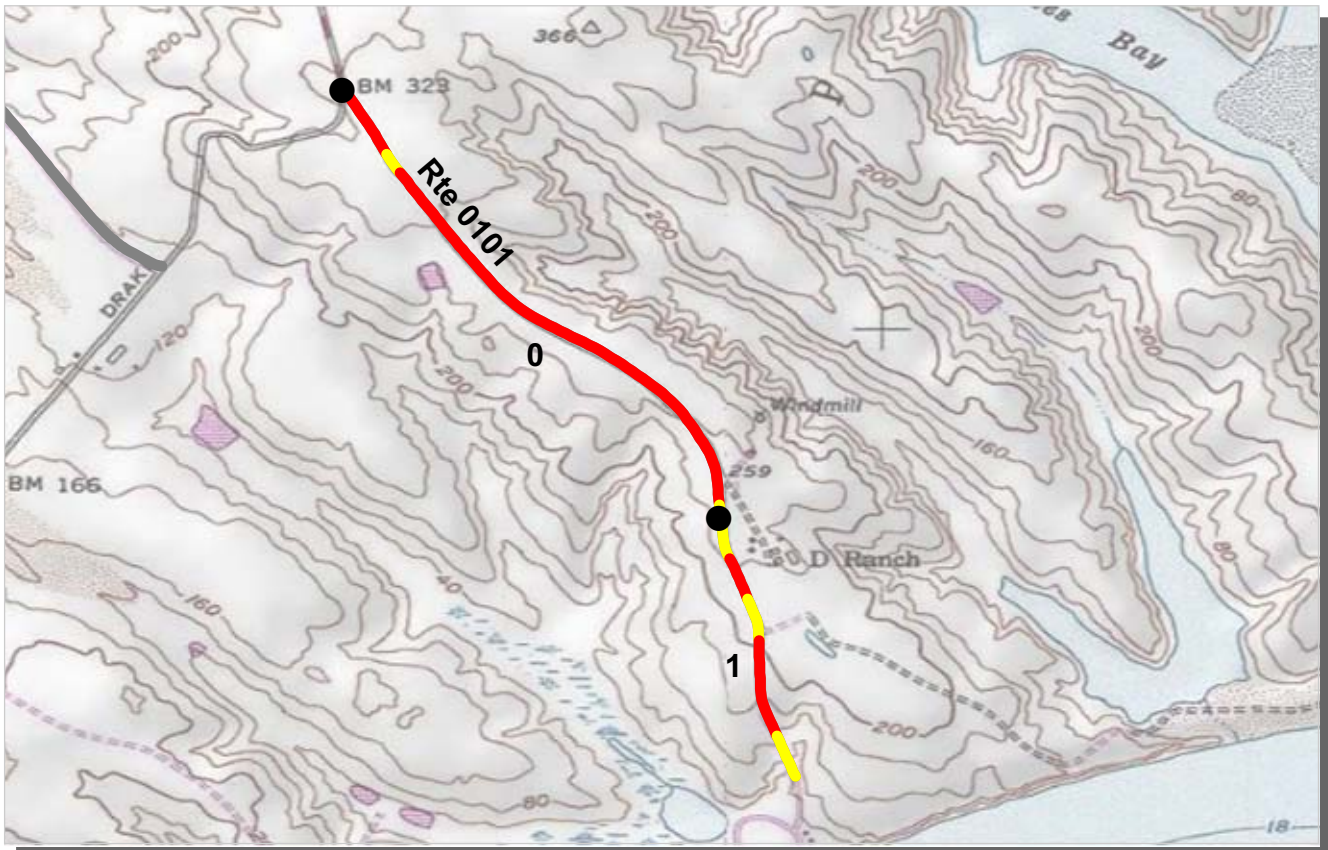
ROUTE: 0101 DRAKES BEACH ROAD

<i>Section Number</i>	0	1			
<i>Section Length (mi)</i>	1.00	0.50			
<i>Cross Section Information</i>					
Number of Lanes	2	2			
Paved Width (ft)	33	32			
Lane Width (ft)	14	13			
<i>Roadway Condition Information</i>					
SCR (Surface Condition Rating)	0	0			
PCR (Pavement Condition Rating)	33	35			
<i>Distress Index Values</i>					
Structural Crack Index	0	0			
Transverse Cracking Index	98	98			
Patching Index	99	100			
Rutting Index	93	95			
Roughness Condition Index (RCI)	83	87

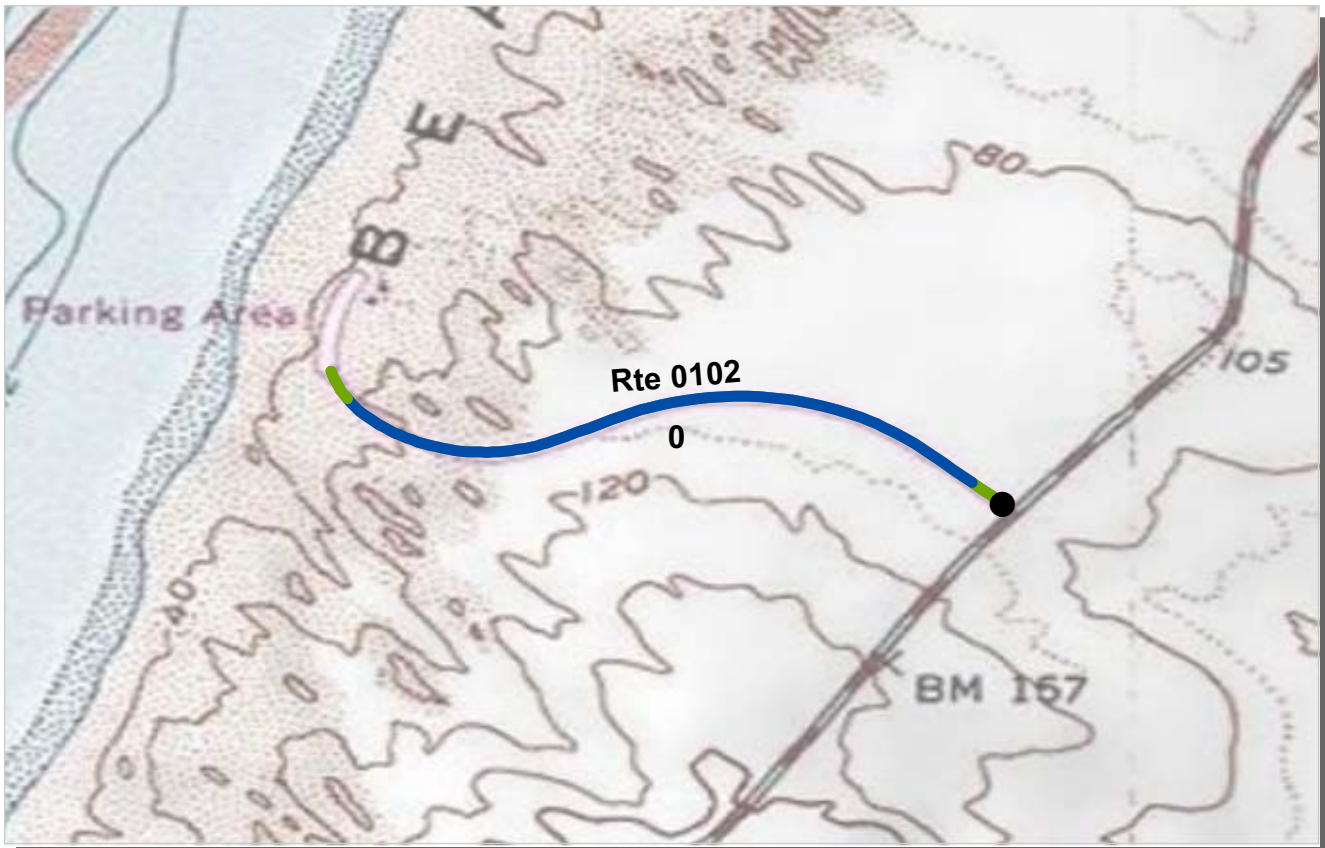
ROUTE: 0102 NORTH BEACH ROAD

Section Number	0				
Section Length (mi)	0.60				
Cross Section Information					
Number of Lanes	2				
Paved Width (ft)	33				
Lane Width (ft)	13				
Roadway Condition Information					
SCR (Surface Condition Rating)	97				
PCR (Pavement Condition Rating)	98				
Distress Index Values					
Structural Crack Index	100				
Transverse Cracking Index	100				
Patching Index	100				
Rutting Index	97				
Roughness Condition Index (RCI)	100

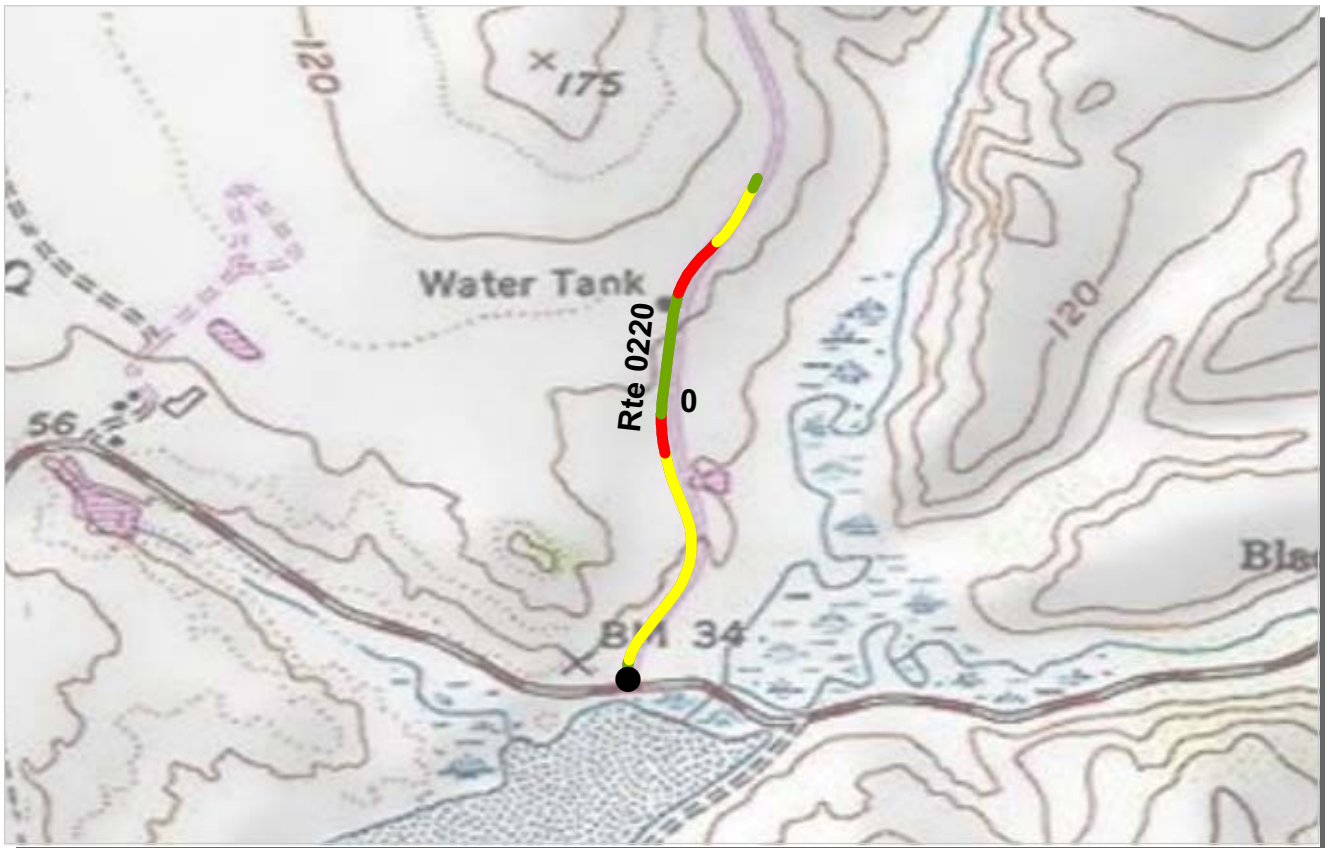
ROUTE: 0220 US COAST GUARD CEMETERY ROAD

Section Number	0				
Section Length (mi)	0.53				
Cross Section Information					
Number of Lanes	2				
Paved Width (ft)	19				
Lane Width (ft)	9				
Roadway Condition Information					
SCR (Surface Condition Rating)	63				
PCR (Pavement Condition Rating)	60				
Distress Index Values					
Structural Crack Index	63				
Transverse Cracking Index	100				
Patching Index	98				
Rutting Index	95				
Roughness Condition Index (RCI)	56

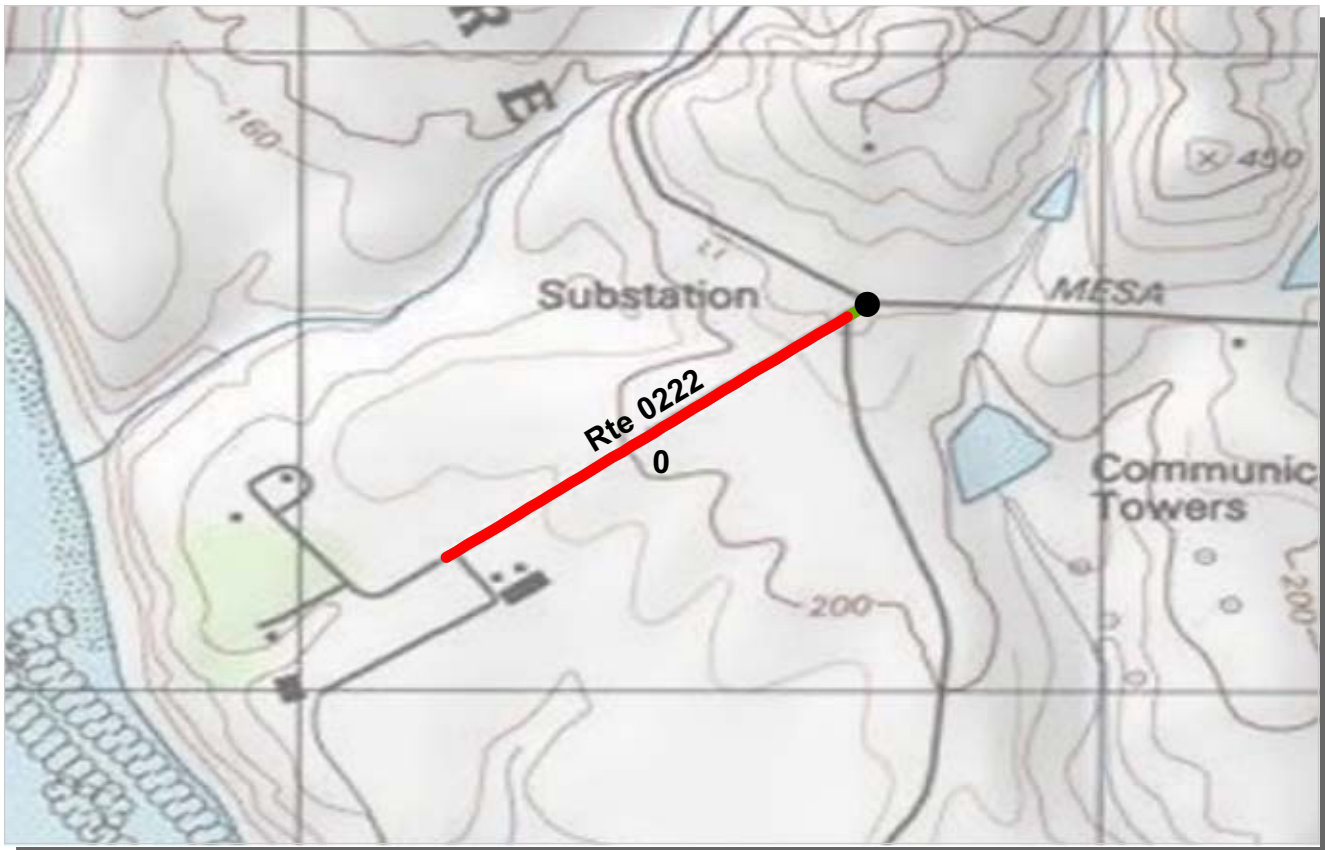
ROUTE: 0222 COMMONWEAL ROAD

Section Number	0				
Section Length (mi)	0.41				
Cross Section Information					
Number of Lanes	1				
Paved Width (ft)	13				
Lane Width (ft)	13				
Roadway Condition Information					
SCR (Surface Condition Rating)	0				
PCR (Pavement Condition Rating)	0				
Distress Index Values					
Structural Crack Index	0				
Transverse Cracking Index	99				
Patching Index	100				
Rutting Index	61				
Roughness Condition Index (RCI)	NC

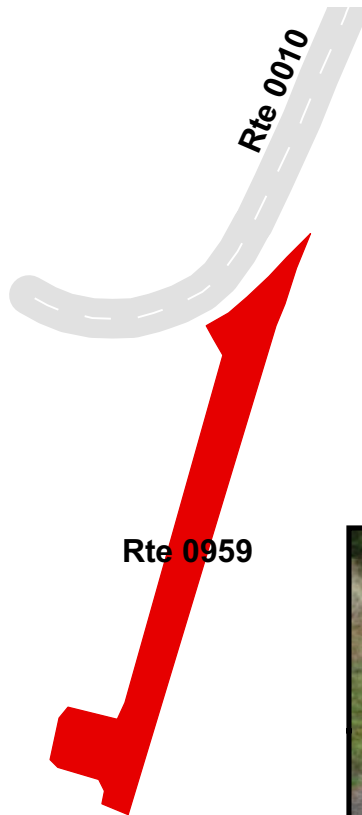
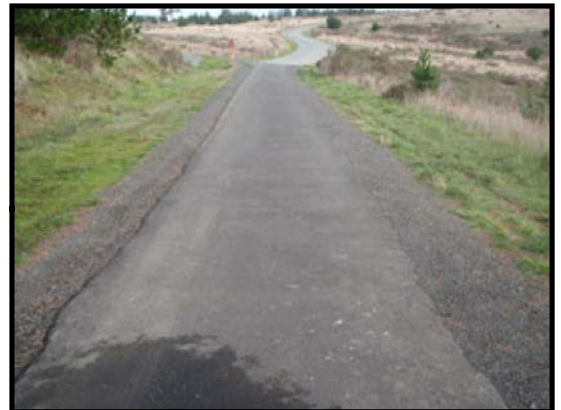
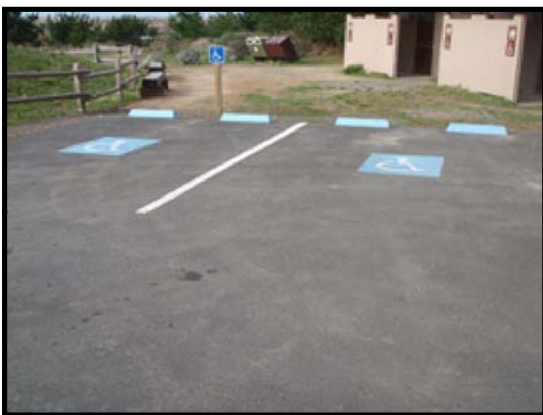
Route 0959

Route Number	Public / NonPublic	Date Visited	Area (sq ft)	Lane Miles *	Surface Type
0959	PUBLIC	1/28/2010	4,576	0.08	AS
Culverts	Drop Inlets	Gates	Curb & Gutter	Curb	PCR
1	0	0	NO CURB AND GUTTER	NO CURB	GOOD/90

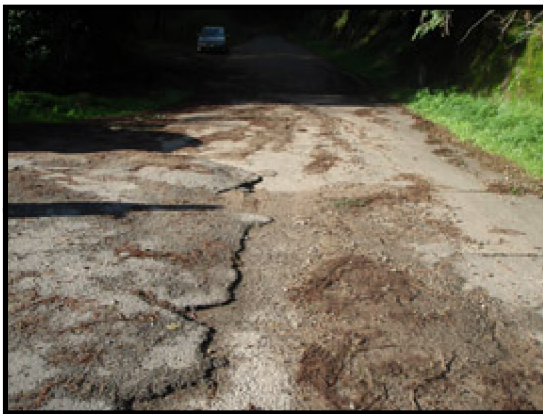
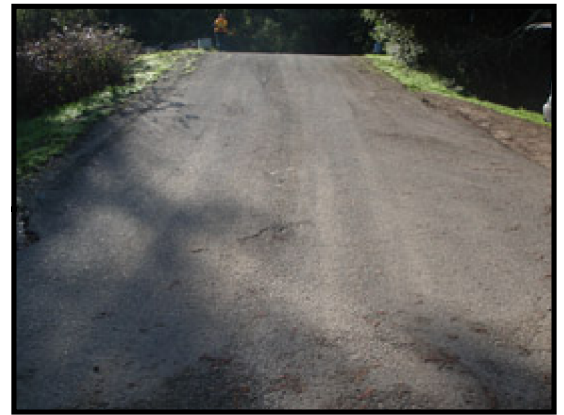
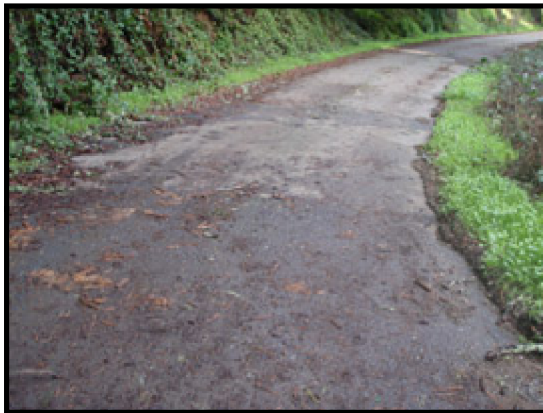
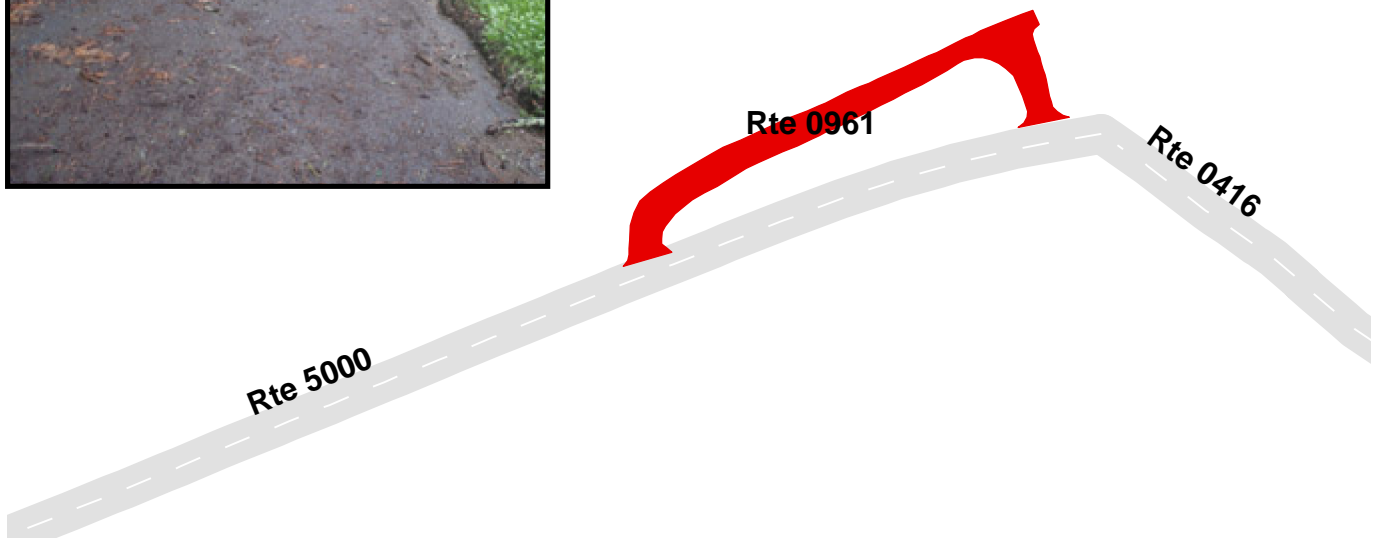
Route 0961

Route Number	Public / NonPublic	Date Visited	Area (sq ft)	Lane Miles *	Surface Type
0961	PUBLIC	1/28/2010	14,296	0.25	AS
Culverts	Drop Inlets	Gates	Curb & Gutter	Curb	PCR
2	0	0	NO CURB AND GUTTER	NO CURB	POOR/45

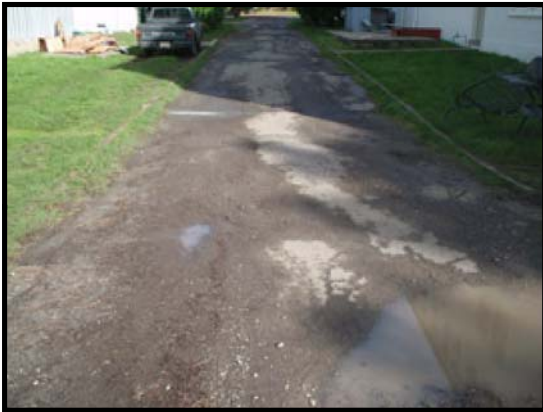
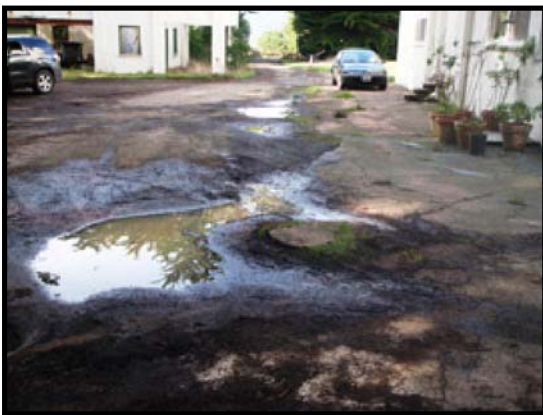
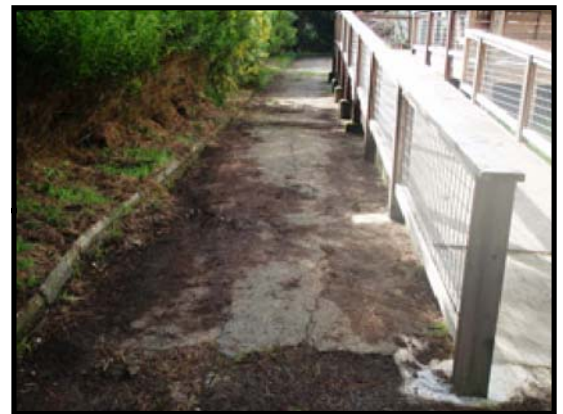
Route Number	Public / NonPublic	Date Visited	Area (sq ft)	Lane Miles *	Surface Type
0962	PUBLIC	1/28/2010	30,883	0.53	AS
Culverts	Drop Inlets	Gates	Curb & Gutter	Curb	PCR
0	0	2	CONCRETE CURB AND GUTTER	CONCRETE CURB	POOR/45
