Federal Lands Highway Road Inventory Program

Road Inventory and Condition Assessment

Prince William Forest Park PRWI

Cycle 5 Report

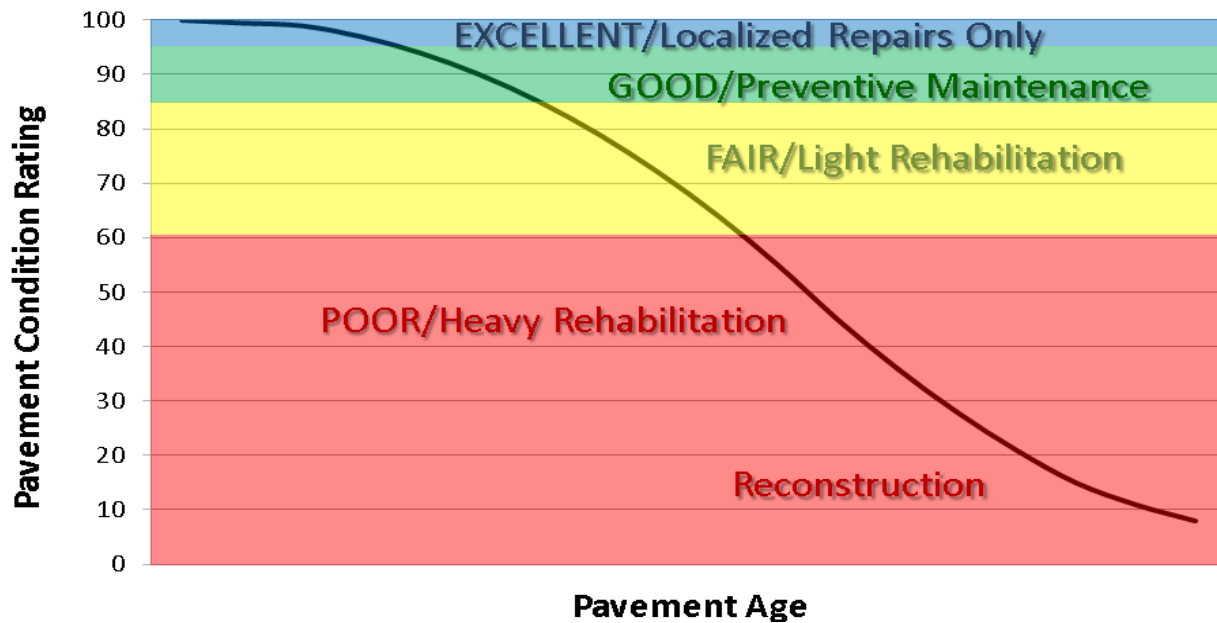
Condition Categories and Treatments

- Excellent/New: PCR of 95-100. Pavements in this range will require only spot repairs
- Good: PCR of 85-94. Pavements in this range will likely be candidates for Preventive Maintenance. Examples include Chip and Slurry Seals, Micro Surfacing and Thin Overlays.
- Fair: PCR of 61-84. Pavements in this range will likely be candidates of Light Rehabilitation (L3R). Examples include single-lift overlays up to 2.5 inches in total thickness, milling and overlays.
- Poor: PCR of 0-60. Pavements in this range will likely be candidates of Heavy Rehabilitation or Reconstruction (H3R or 4R). Examples include Pulverization, Multiple Lift Overlays, and Reconstruction.

At this time, specific Maintenance and Rehabilitation activities should be evaluated and recommended at the project level. Site-specific conditions that influence treatment type should be determined based on performing a subsurface investigation and/or pavement condition survey, and not be based solely on RIP data. Additionally, RIP produces a snapshot of conditions the year in which the data was collected. For further information or to obtain additional Pavement Management System's data from our Highway Pavement Management Application (HPMA) please contact the Eastern Federal Lands pavement team.

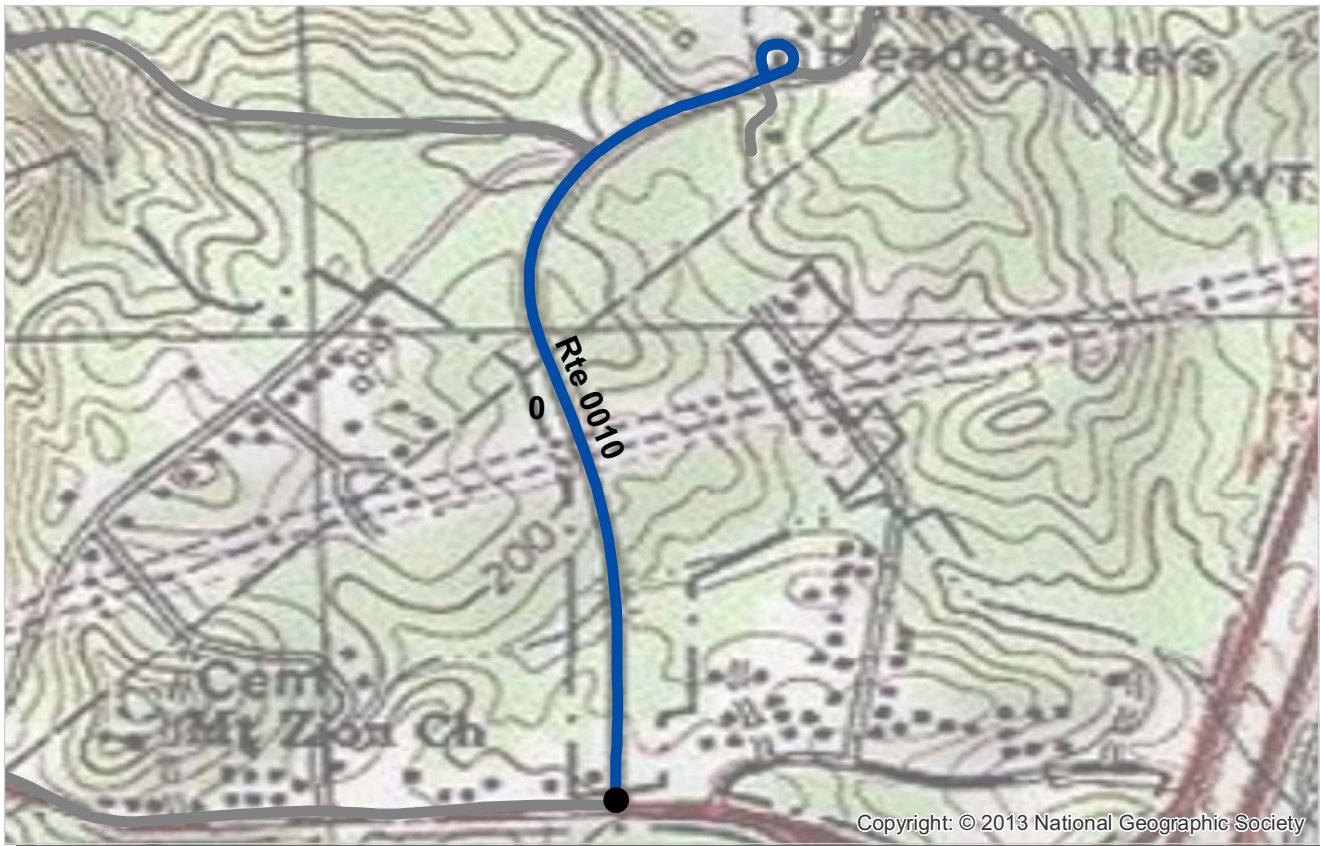
ROUTE: 0010 PARK ENTRANCE ROAD

| SCR (Surface Condition Rating) | 100 | | | | |
| PCR (Pavement Condition Rating) | 100 | | | | |
| Structural Crack Index | 100 | | | | |
| Transverse Cracking Index | 100 | | | | |

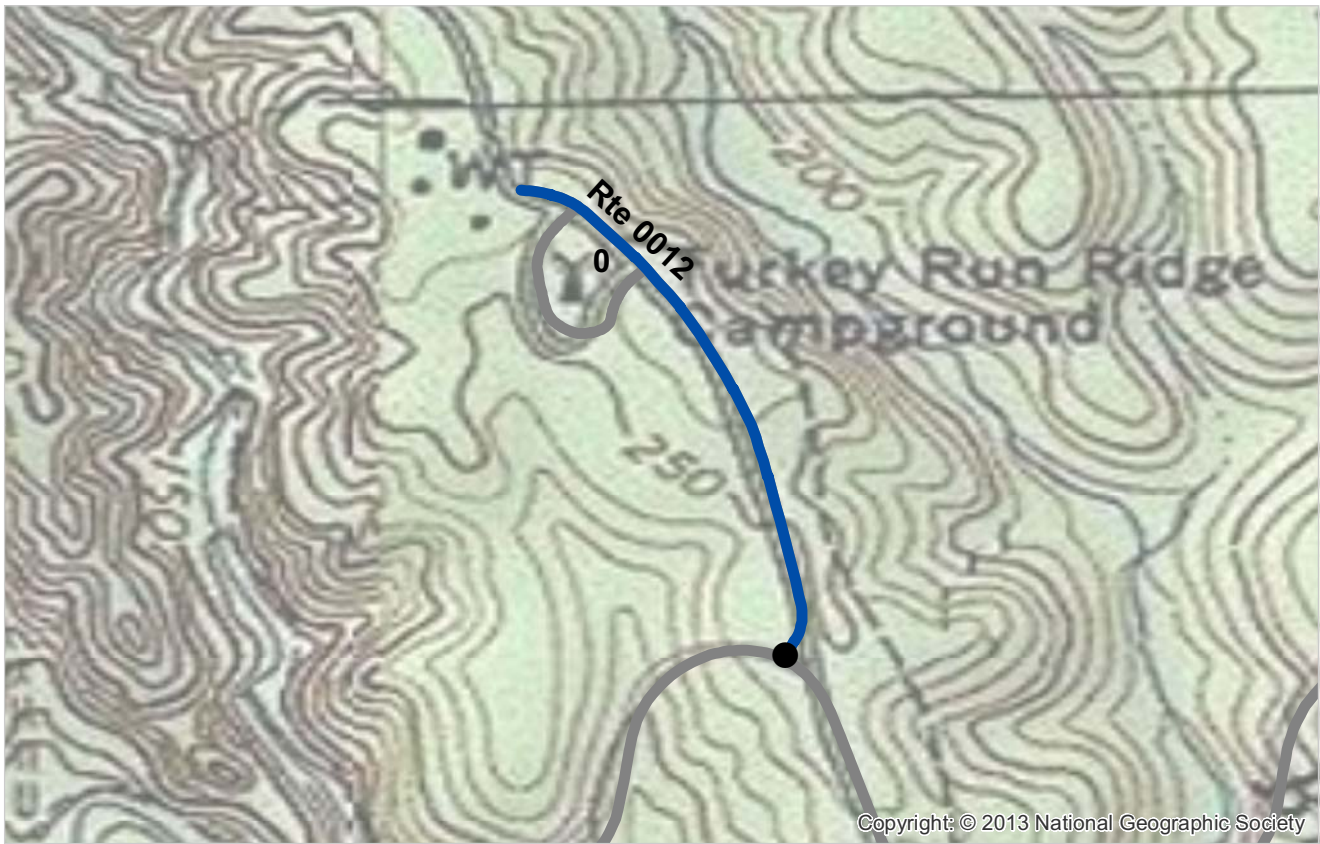
ROUTE: 0012 TURKEY RUN ACCESS ROAD

| SCR (Surface Condition Rating) | 99 | | | | |
| PCR (Pavement Condition Rating) | 99 | | | | |
| Structural Crack Index | 100 | | | | |
| Transverse Cracking Index | 100 | | | | |

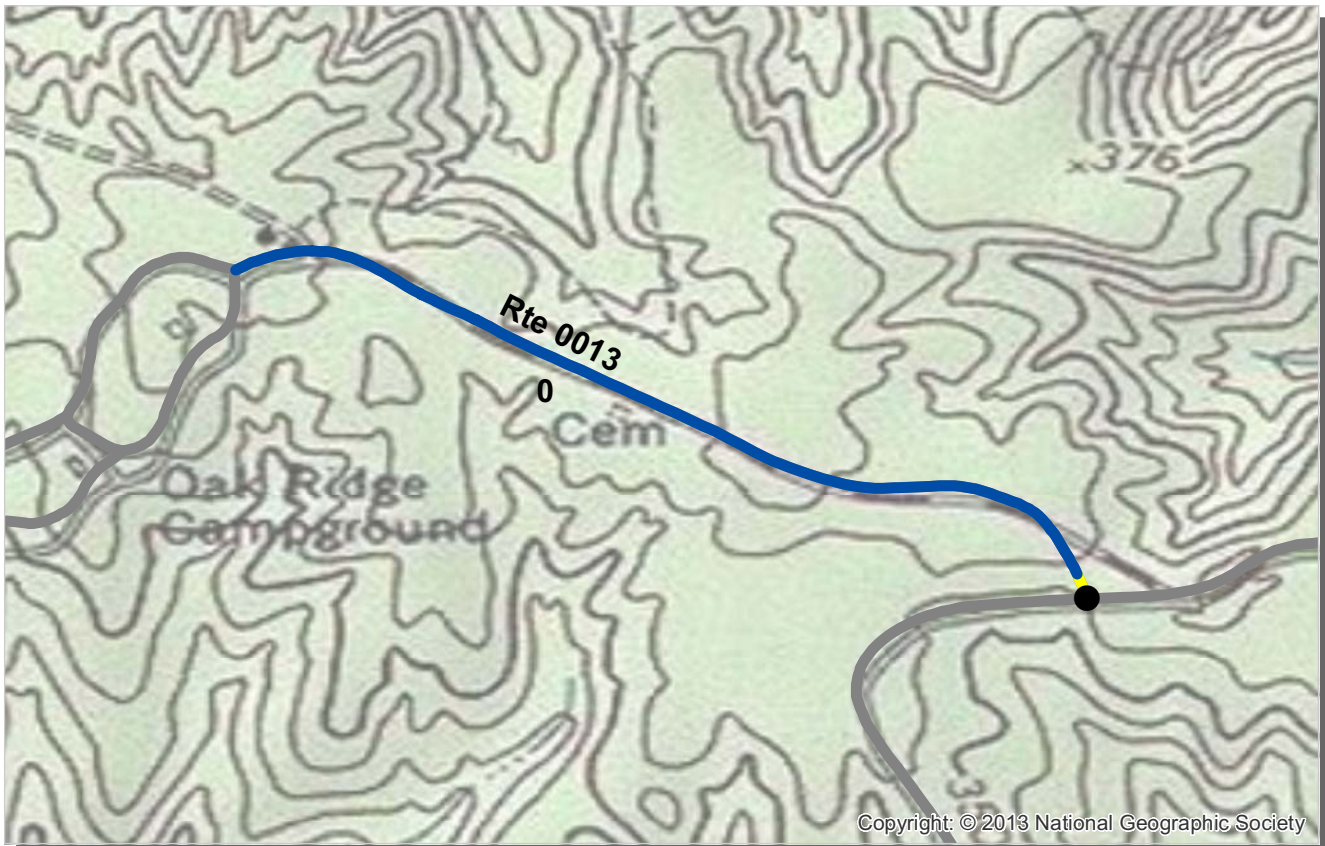
ROUTE: 0013 OAK RIDGE ROAD

| SCR (Surface Condition Rating) | 99 | | | | |
| PCR (Pavement Condition Rating) | 99 | | | | |
| Structural Crack Index | 100 | | | | |
| Transverse Cracking Index | 100 | | | | |
| Roughness Condition Index (RCI) | 99 | | | | |

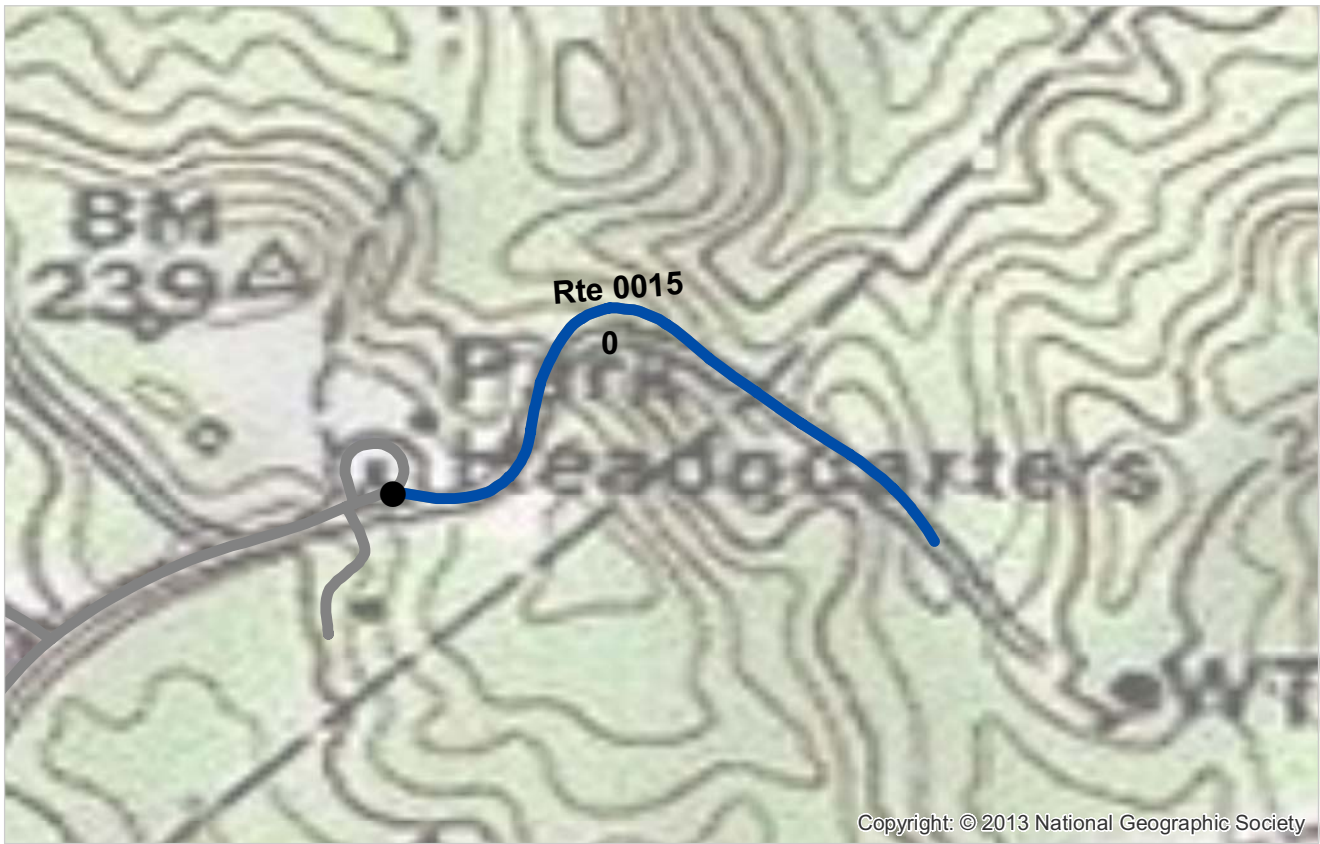
ROUTE: 0015 TELEGRAPH ROAD

| SCR (Surface Condition Rating) | 98 | | | | |
| PCR (Pavement Condition Rating) | 98 | | | | |
| Structural Crack Index | 100 | | | | |
| Transverse Cracking Index | 100 | | | | |

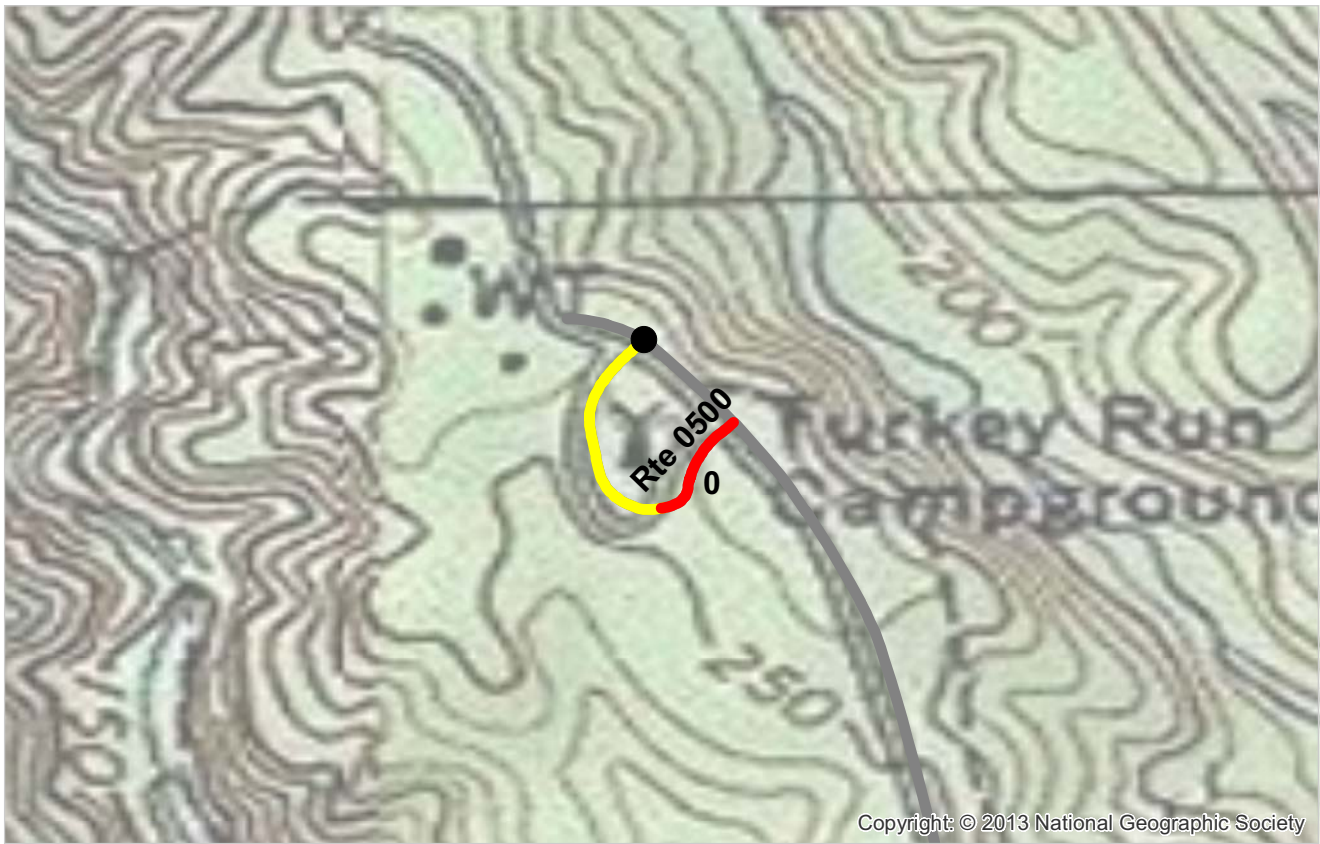
ROUTE: 0500 TURKEY RUN CAMPGROUND LOOP

| SCR (Surface Condition Rating) | 57 | | | | |
| PCR (Pavement Condition Rating) | 57 | | | | |
| Structural Crack Index | 57 | | | | |
| Transverse Cracking Index | 87 | | | | |

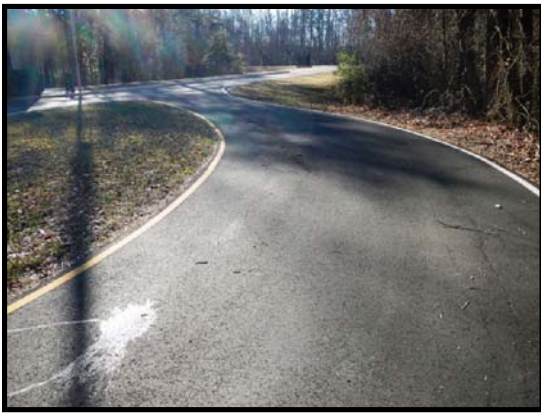
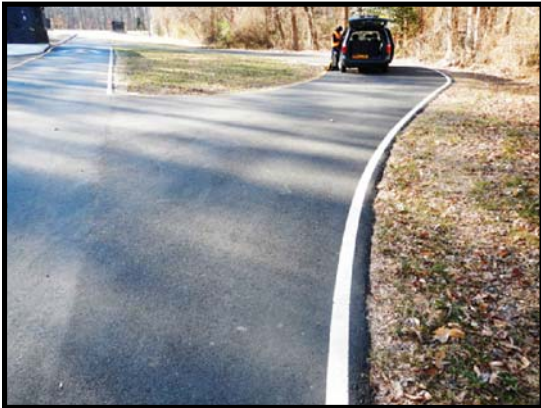
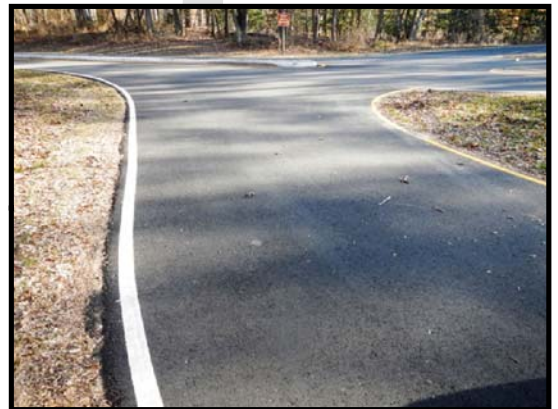
Route 0901BZ

| Route Number | Public / NonPublic | Date Visited | Area (sq ft) | Lane Miles * | Surface Type |
|---|---|---|---|---|---|
| 0 | 0 | 0 | NO CURB AND GUTTER | NO CURB | EXCELLENT/97 |

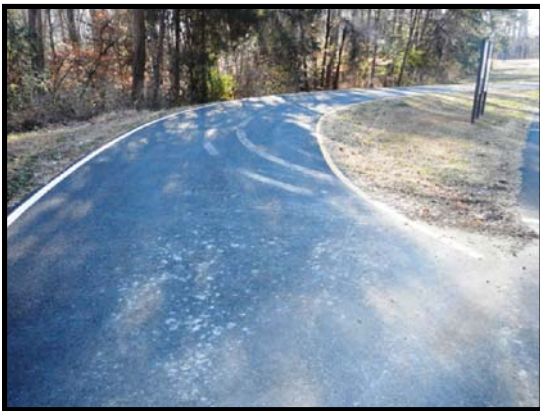
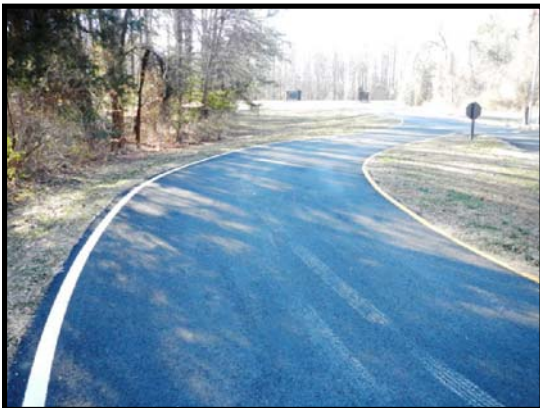
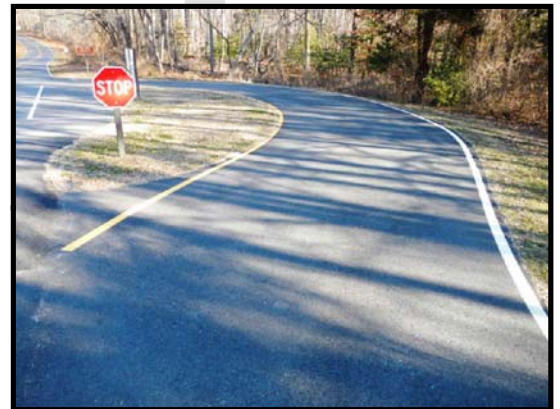
Route 0911

| Route Number | Public / NonPublic | Date Visited | Area (sq ft) | Lane Miles * | Surface Type |
|---|---|---|---|---|---|
| 0 | 1 | 0 | NO CURB AND GUTTER | NO CURB | EXCELLENT/97 |

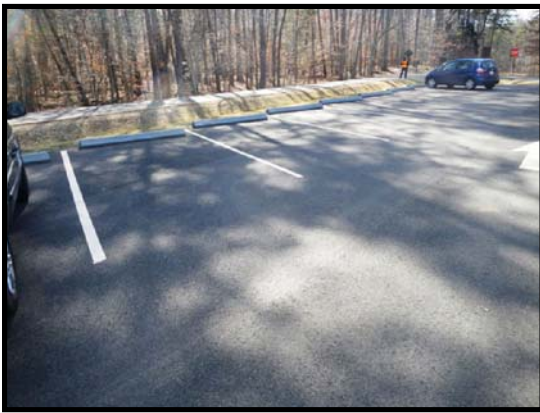
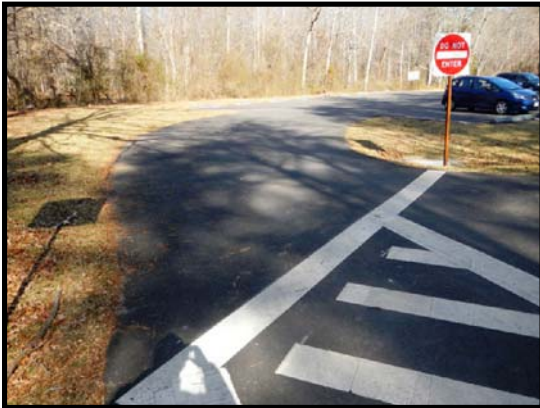
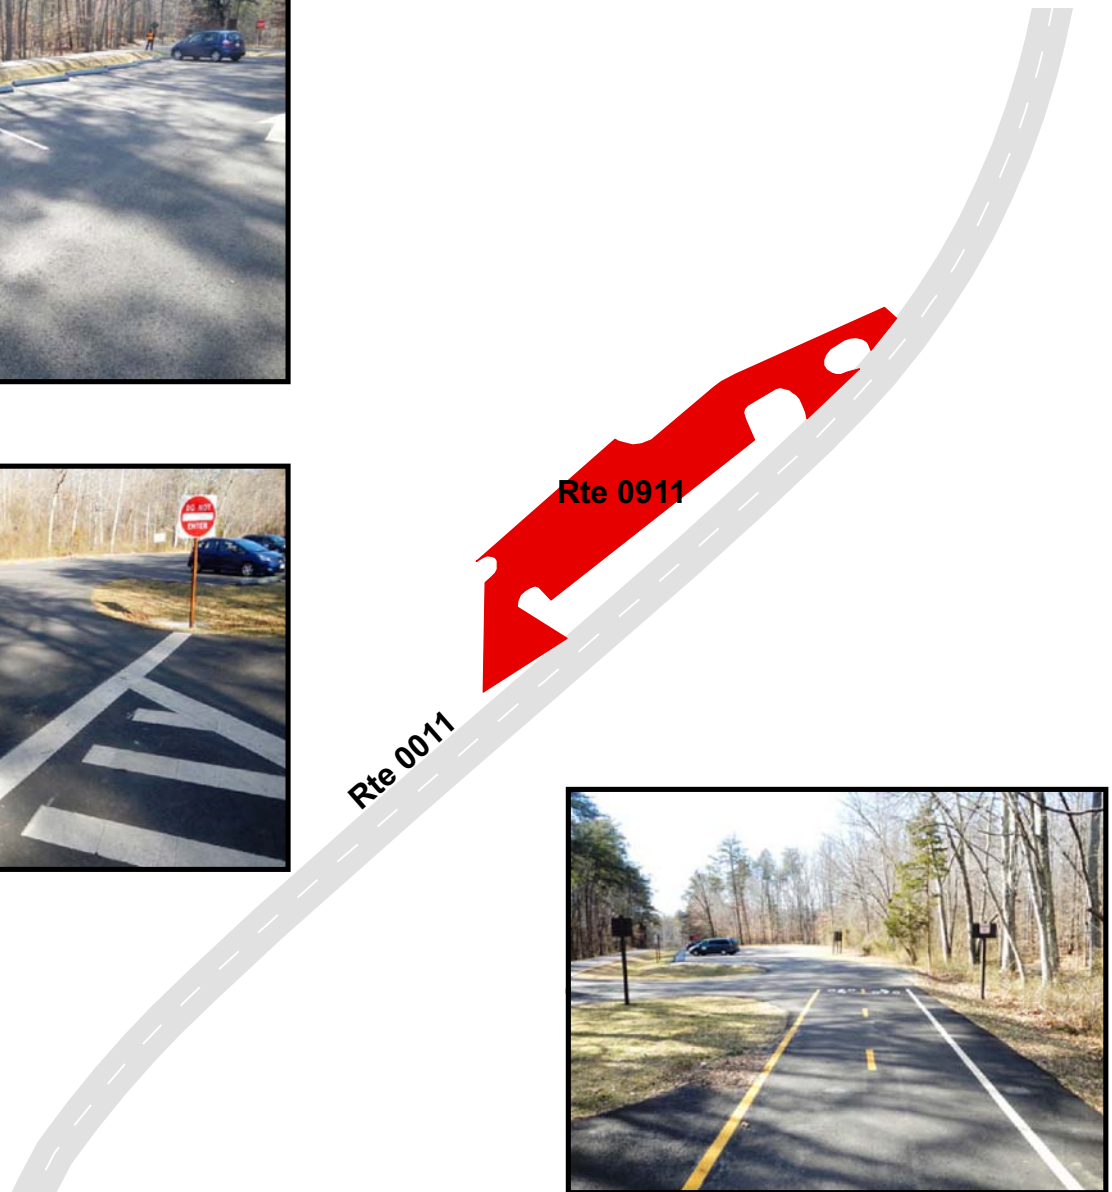
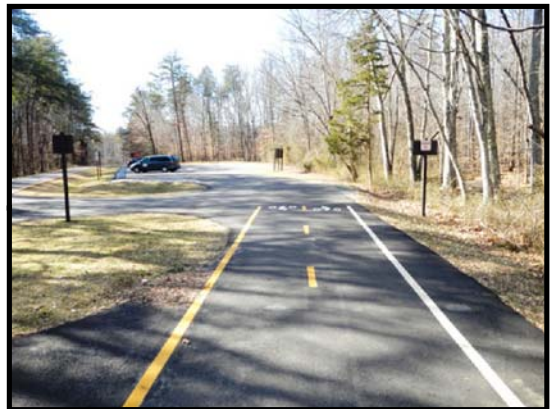
Route 0928ZZ

| Route Number | Public / NonPublic | Date Visited | Area (sq ft) | Lane Miles * | Surface Type |
|---|---|---|---|---|---|
| 1 | 1 | 0 | NO CURB AND GUTTER | NO CURB | EXCELLENT/97 |

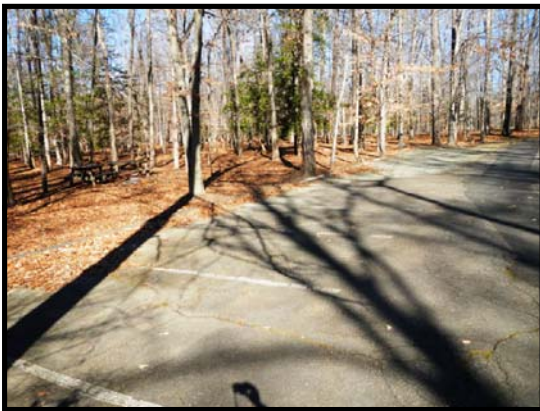
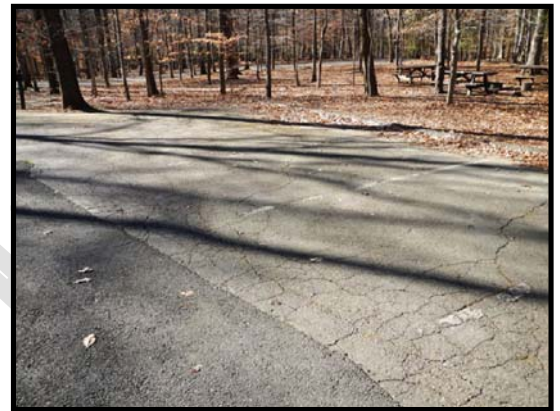
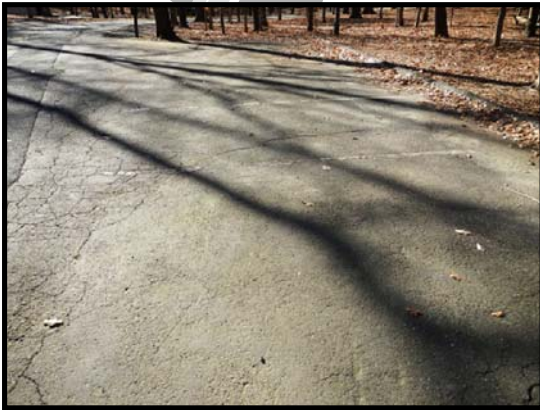
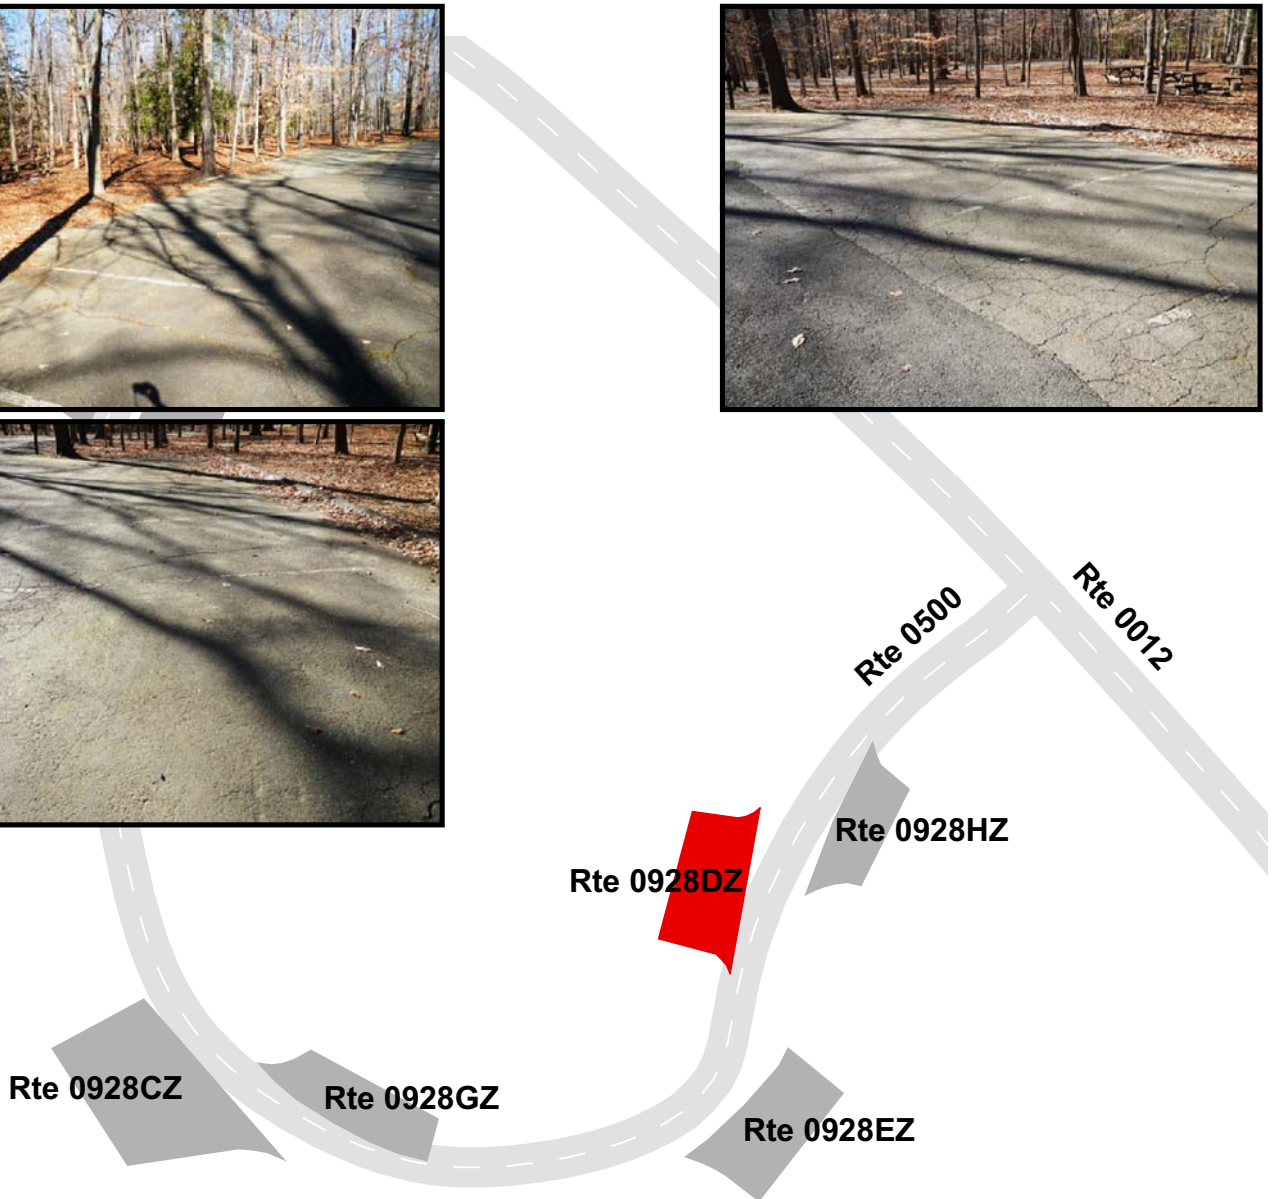
Route 0928EZ

| Route Number | Public / NonPublic | Date Visited | Area (sq ft) | Lane Miles * | Surface Type |
|---|---|---|---|---|---|
| 0 | 0 | 0 | NO CURB AND GUTTER | ASPHALT CURB | POOR/45 |

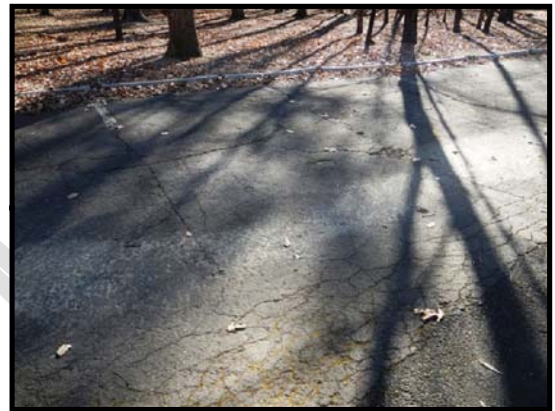
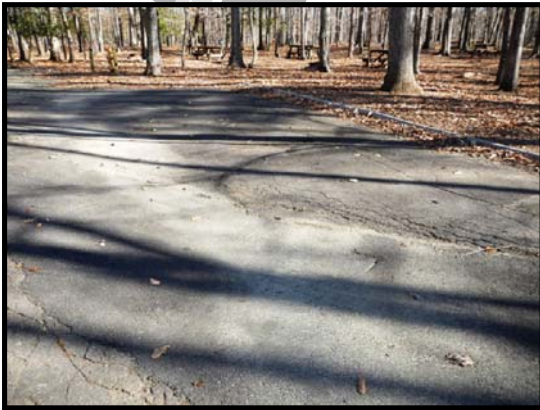
Route 0928FZ

| Route Number | Public / NonPublic | Date Visited | Area (sq ft) | Lane Miles * | Surface Type |
|---|---|---|---|---|---|
| 0 | 0 | 0 | NO CURB AND GUTTER | NO CURB | POOR/45 |

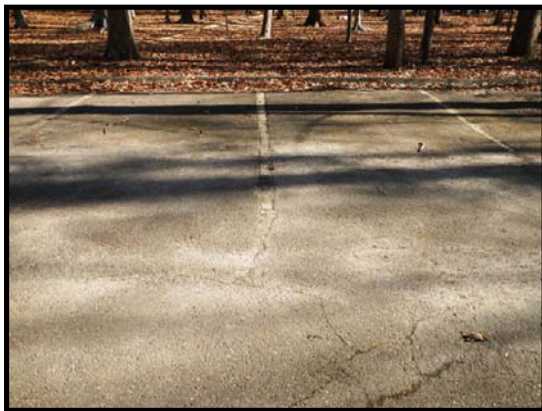
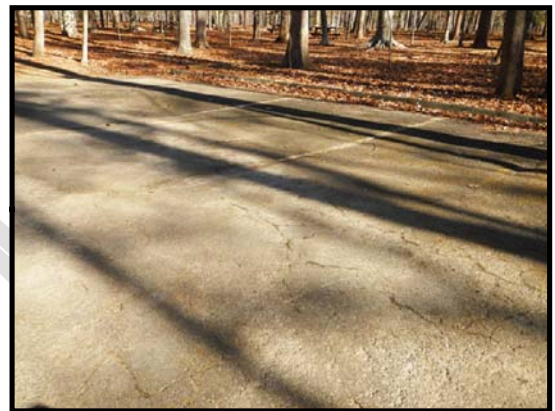
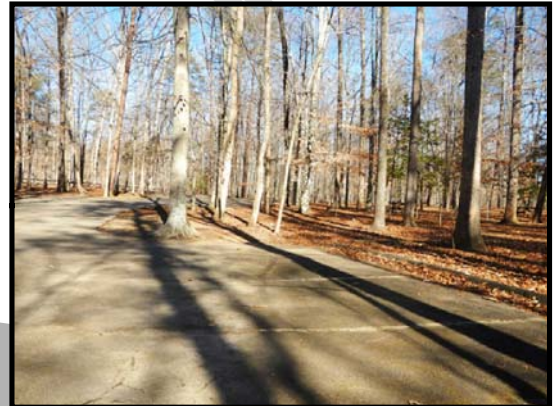
Route 0928GZ

| Route Number | Public / NonPublic | Date Visited | Area (sq ft) | Lane Miles * | Surface Type |
|---|---|---|---|---|---|
| 0 | 0 | 0 | NO CURB AND GUTTER | ASPHALT CURB | POOR/45 |

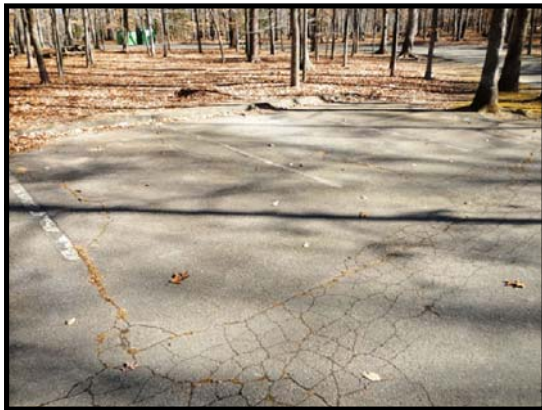
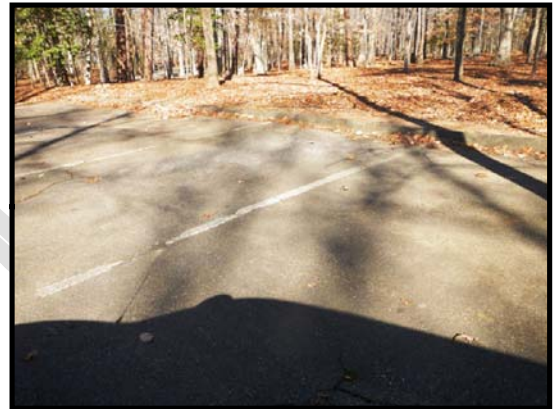
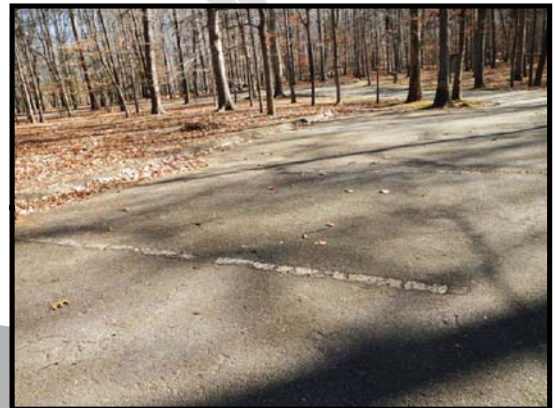
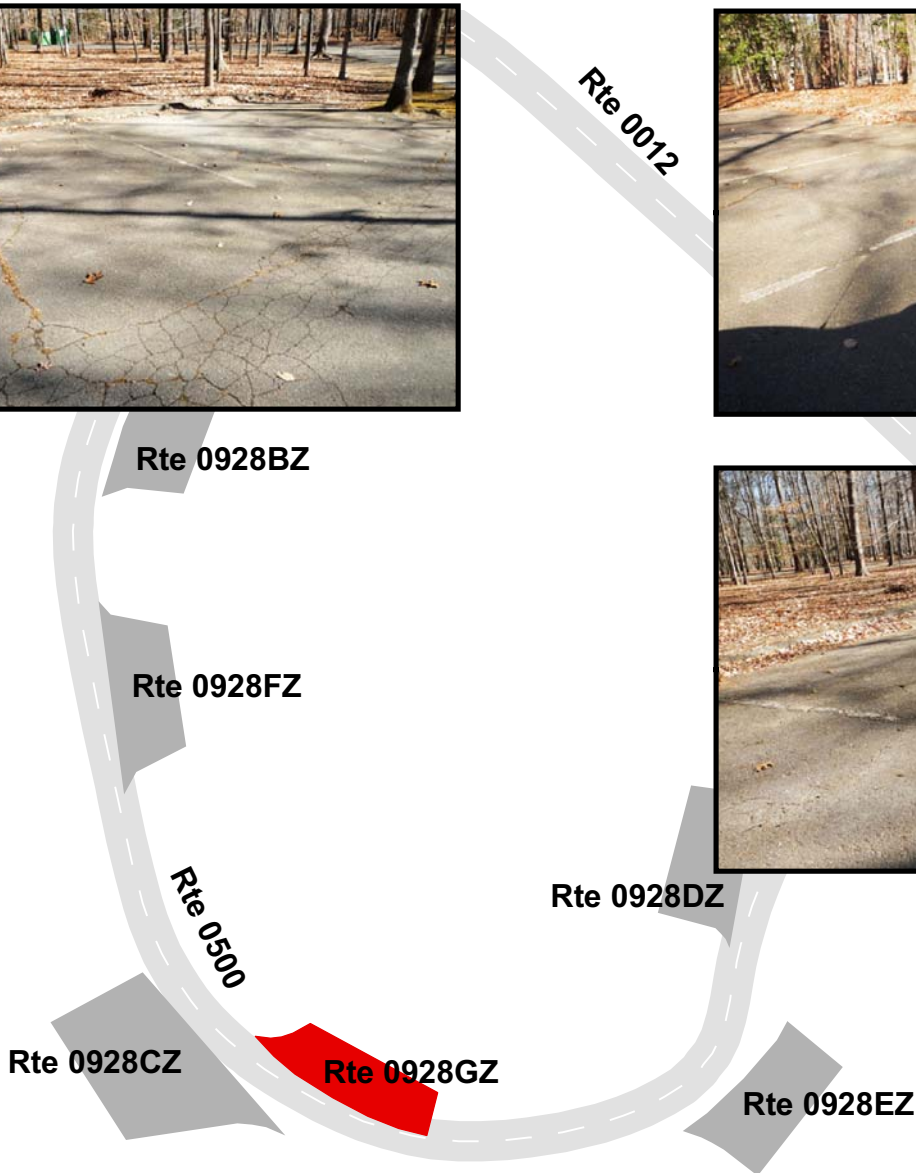
Route 0928HZ

| Route Number | Public / NonPublic | Date Visited | Area (sq ft) | Lane Miles * | Surface Type |
|---|---|---|---|---|---|
| 0 | 0 | 0 | NO CURB AND GUTTER | ASPHALT CURB | POOR/45 |

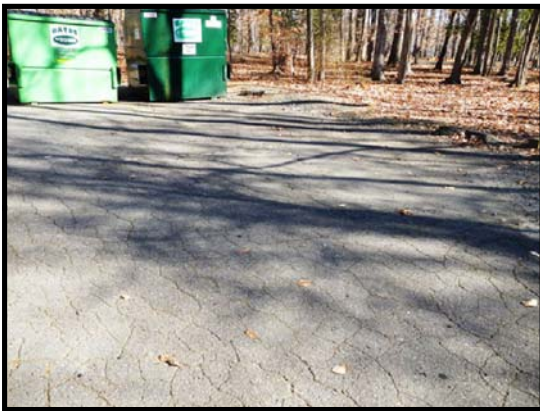
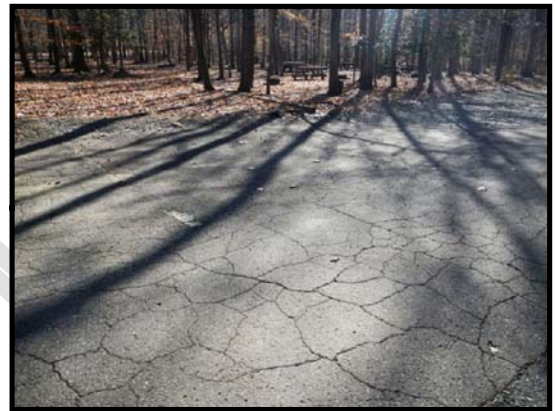
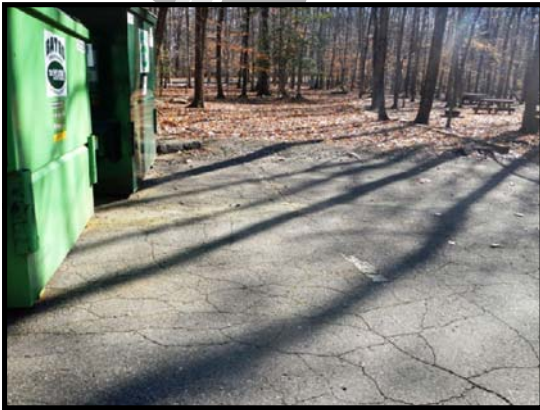
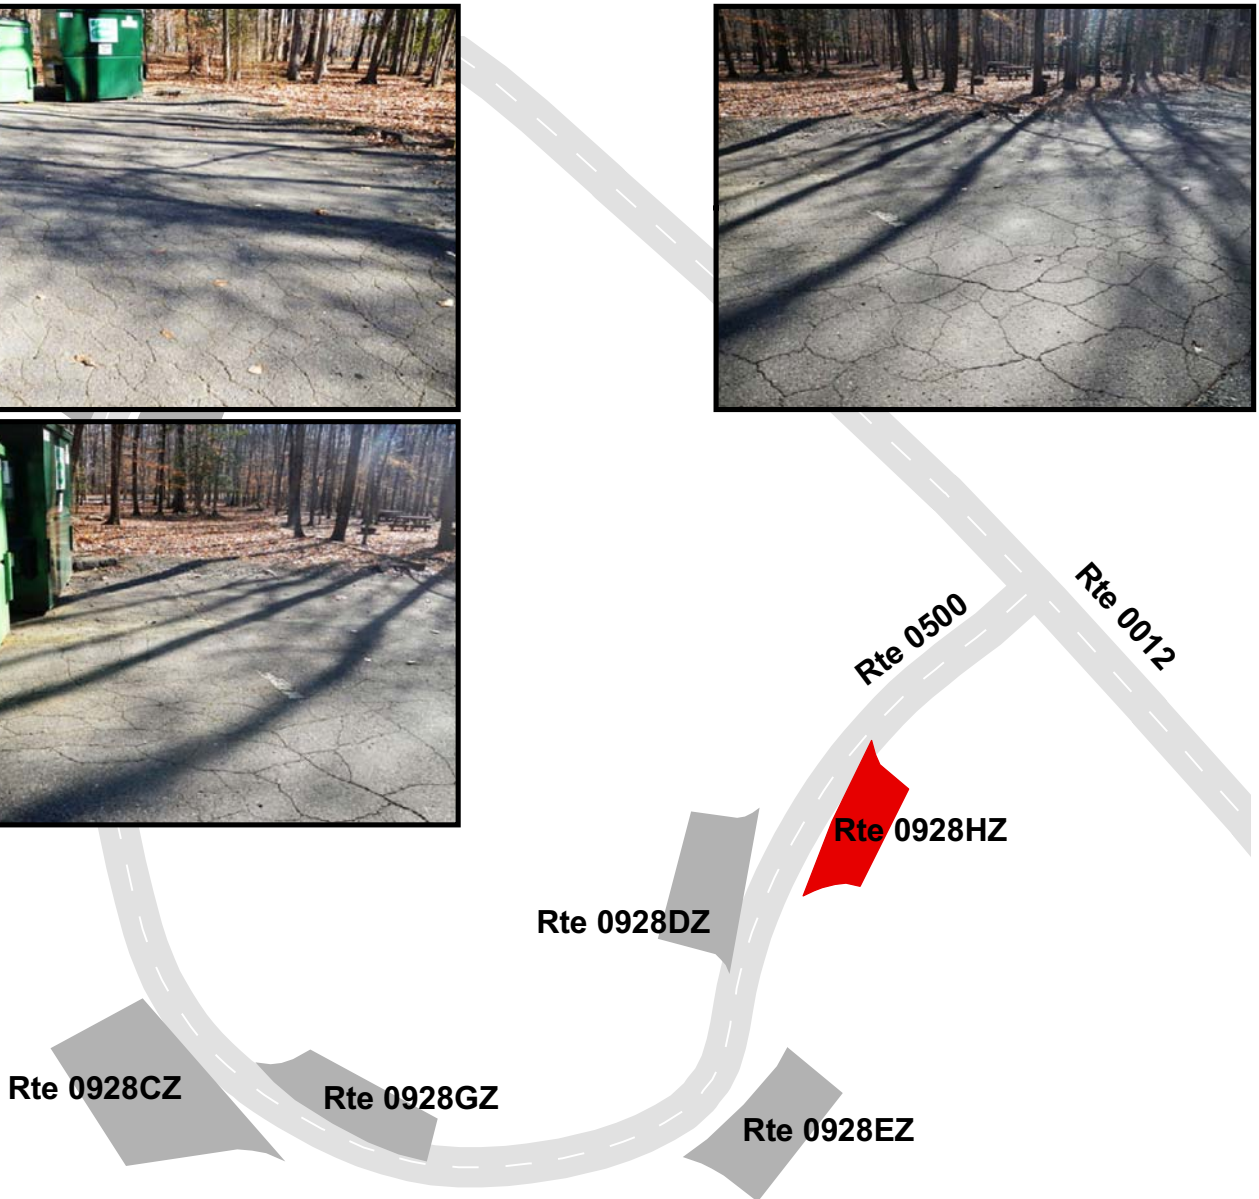
| Route Number | Public / NonPublic | Date Visited | Area (sq ft) | Lane Miles * | Surface Type |
|---|---|---|---|---|---|
| 0 | 0 | 0 | NO CURB AND GUTTER | ASPHALT CURB | POOR/45 |

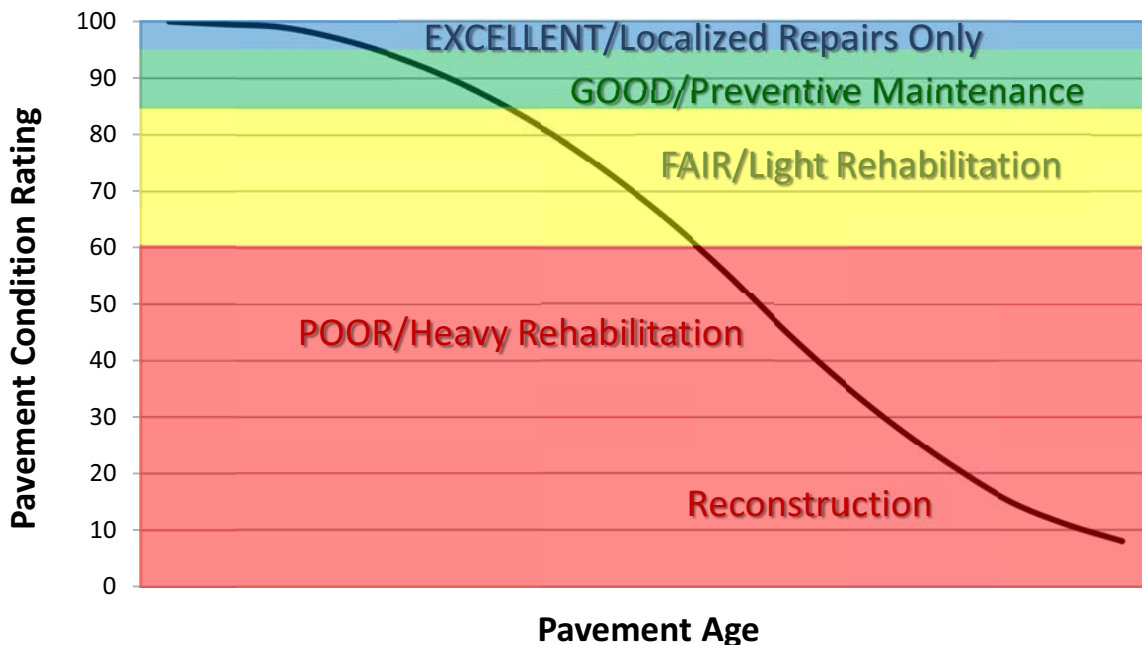
Condition Categories and Treatments

- Excellent/New: PCR of 95-100. Pavements in this range will require only spot repairs.
- Good: PCR of 85-94. Pavements in this range will likely be candidates for Preventive Maintenance. Examples include Chip and Slurry Seals, Micro Surfacing and Thin Overlays.
- Fair: PCR of 61-84. Pavements in this range will likely be candidates of Light Rehabilitation (L3R). Examples include single-lift overlays up to 2.5 inches in total thickness, milling and overlays.
- Poor: PCR of 60 or below. Pavements in this range will likely be candidates of Heavy Rehabilitation or Reconstruction (H3R or 4R). Examples include Pulverization, Multiple Lift Overlays, and Reconstruction.

Specific Maintenance and Rehabilitation activities should be evaluated and recommended at the project level. Site-specific conditions that influence treatment type should be determined based on performing a subsurface investigation and/or pavement condition survey, and not be based solely on RIP data. Additionally, RIP produces a snapshot of conditions the year in which the data was collected. For further information or to obtain additional Pavement Management System’s data from our Highway Pavement Management Application (HPMA) please contact the Eastern Federal Lands pavement team.
